Periodic Review Report

(Reporting Period March 28, 2020 to March 28, 2023)

Former Orangeburg Pipe Manufacturing – Lowe's Site

NYSDEC Site #: V00579

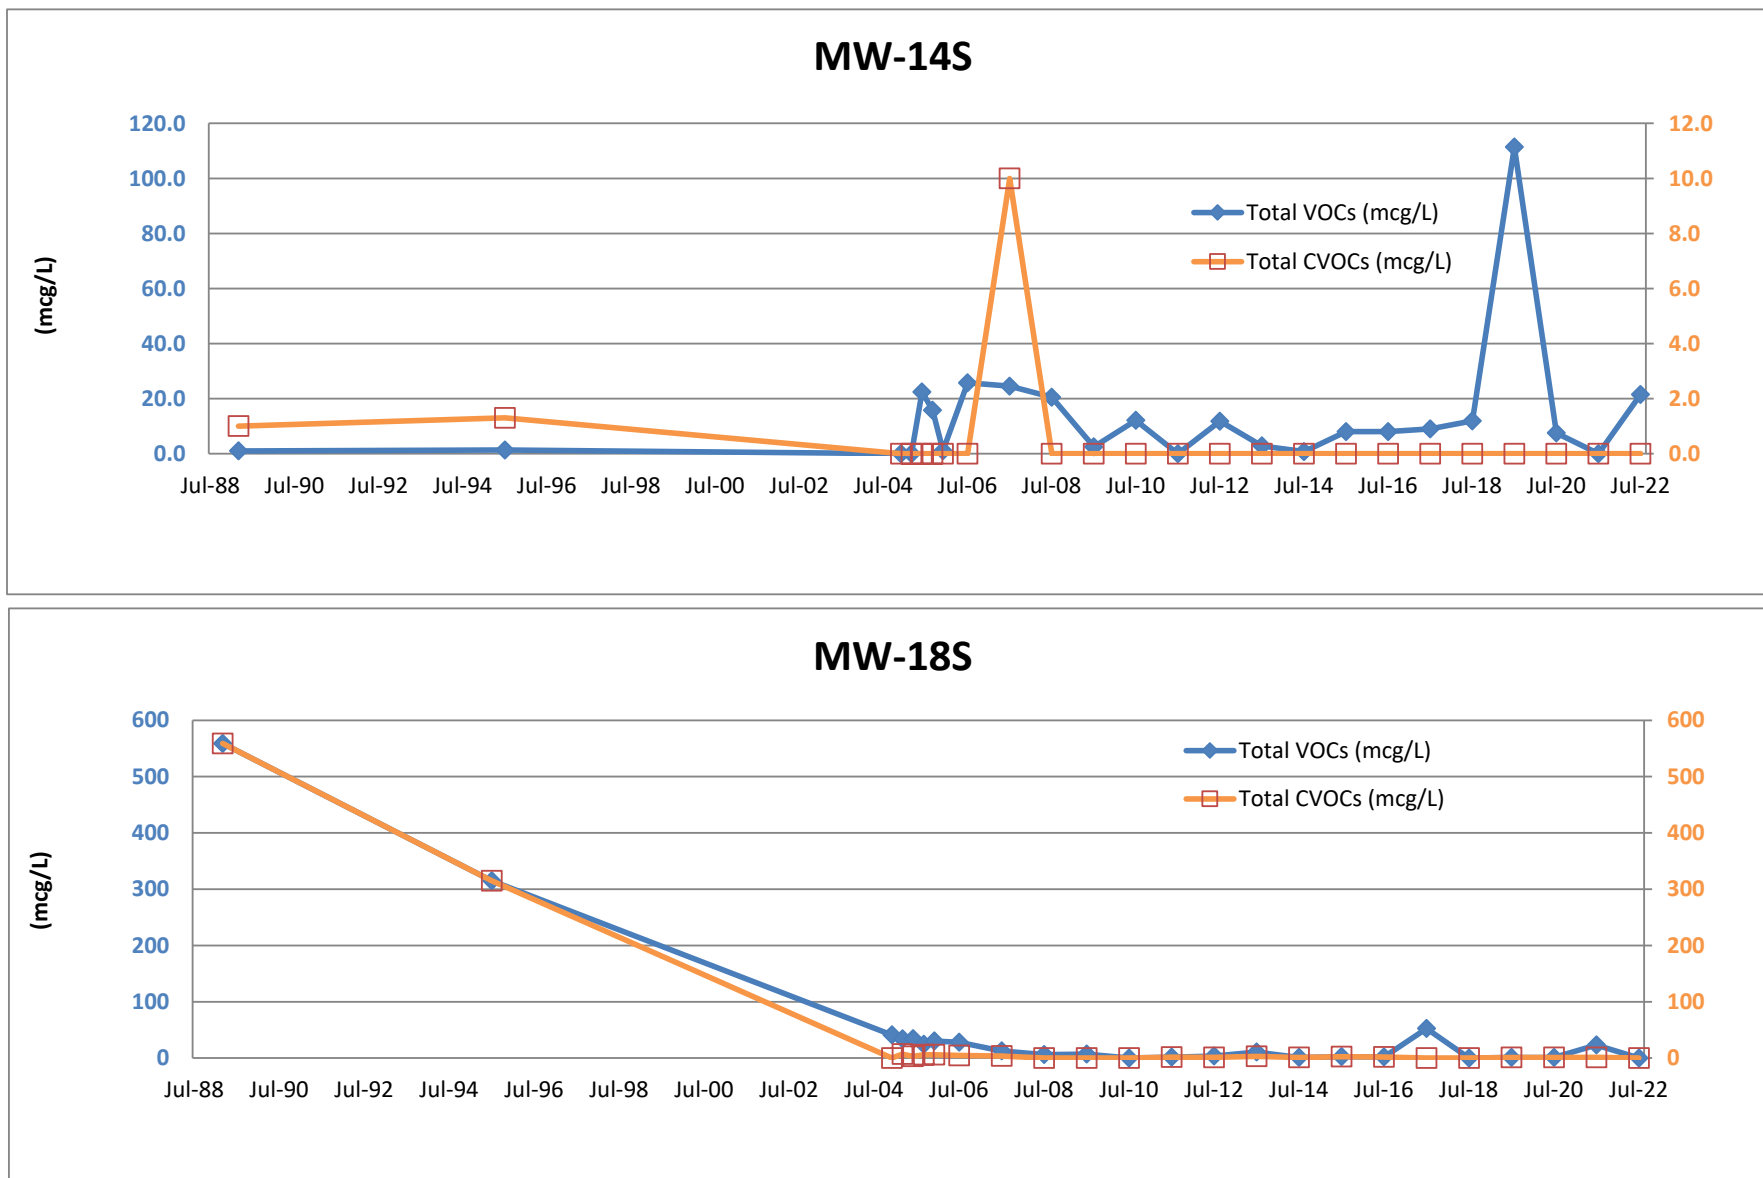
Figure 7

Groundwater Monitoring Wells
Total VOCs Data Summary Graphs (1989 to Present)
Orangeburg Holdings - Lowe's Site

* - Removed from annual monitoring program after 2014 sampling event.

Table 4 summarizes the VOC results from the site monitoring wells since the sampling program began. Where a new well was constructed in 2003 as a replacement for a well abandoned during construction of the shopping center, the test results are grouped for the two wells as a single location. It should be noted that MW03-12S has historically been dry and was dry during the three sampling events included in this PRR interval.

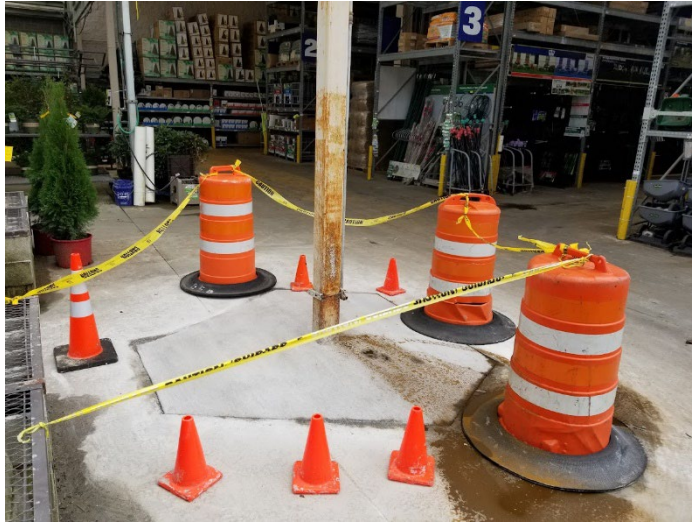
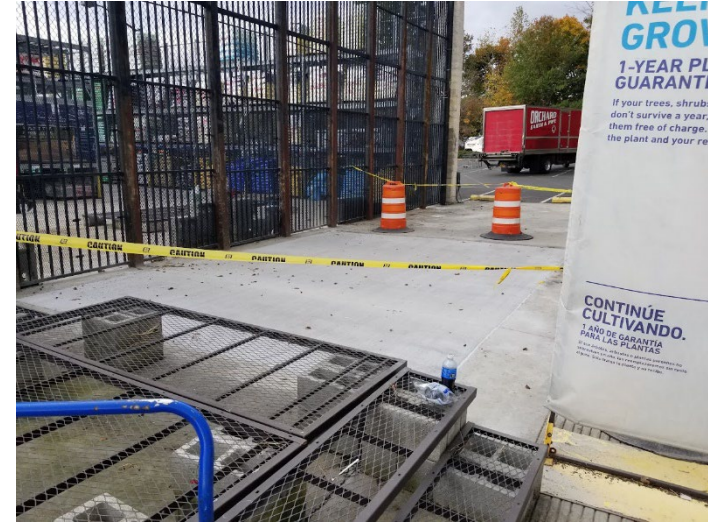
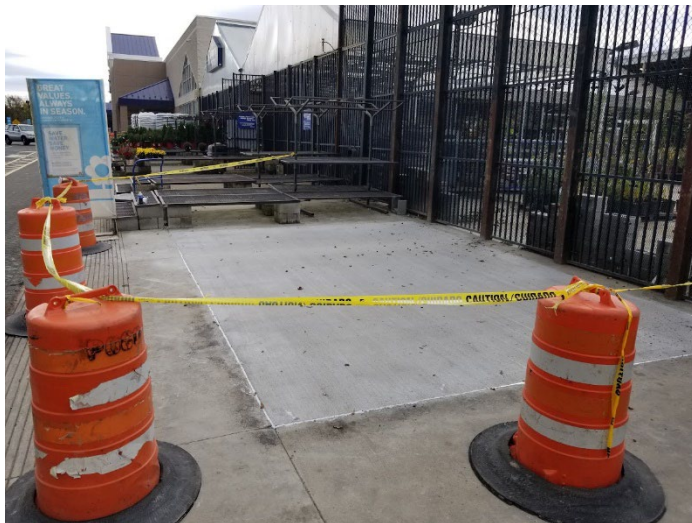
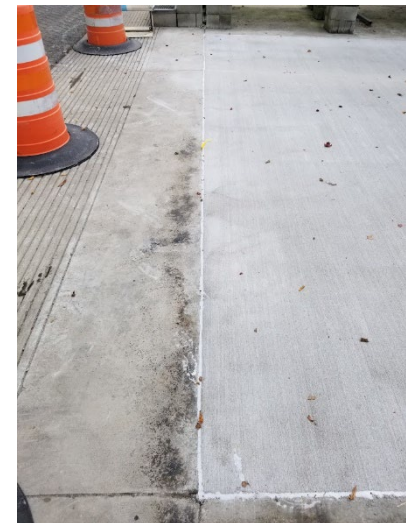
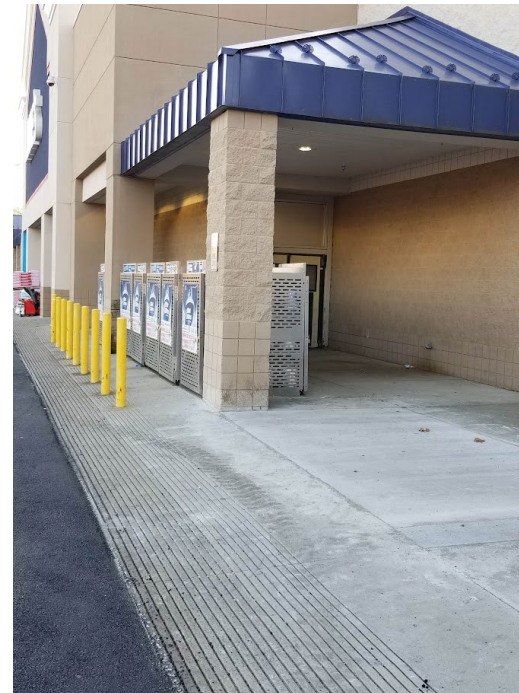
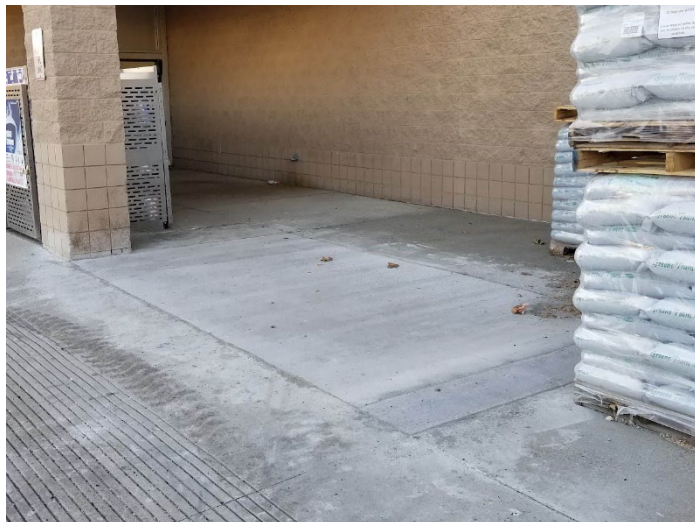
PHOTO LOG – Concrete Slab Replacement Activity Garden Area – October 2020

Photos of Replaced Concrete Slab Areas

2. As part of these parking lot repair activities in the Fall of 2020, Lowe's submitted a proposal to install a small catch basin in front of the Garden Center in a low spot in the parking lot where water was observed to pool to Orangeburg Holdings LLC and HDR for review and comment. The new catch basin was a shallow unit (18-inch depth). The contractor ran a shallow trench to a nearby existing parking lot catch basin. HDR observed the excavation activities, which did not encounter any historic fill materials or the demarcation fabric (indicating the work did not disturb the historic fill materials below the cap). Appendix A contains photos taken during the asphalt replacement and catch basin installation activities.

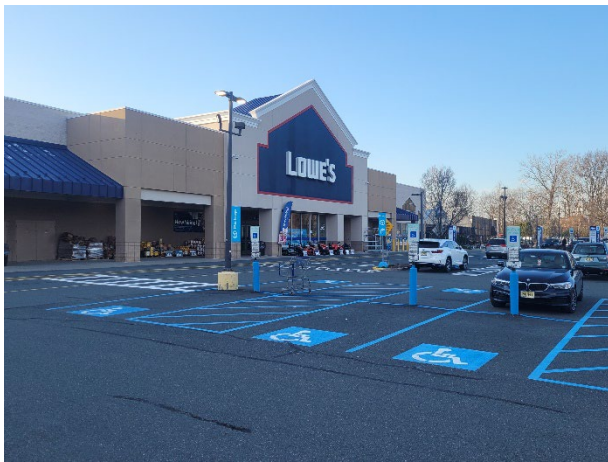
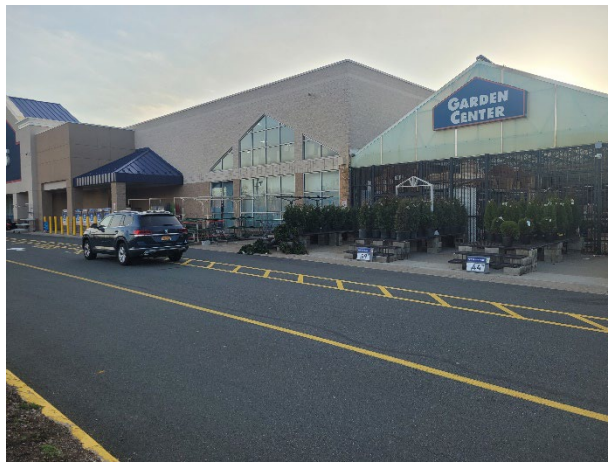
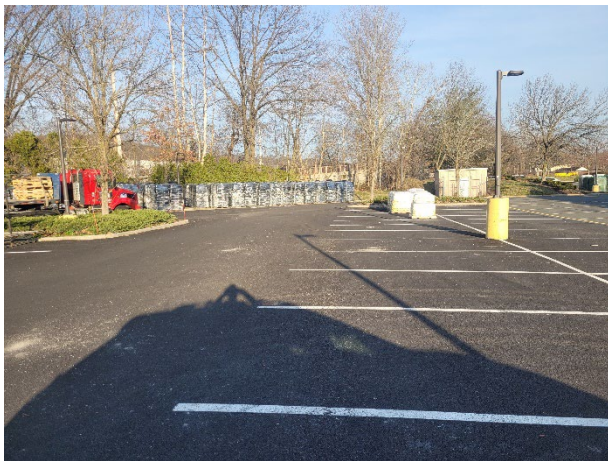
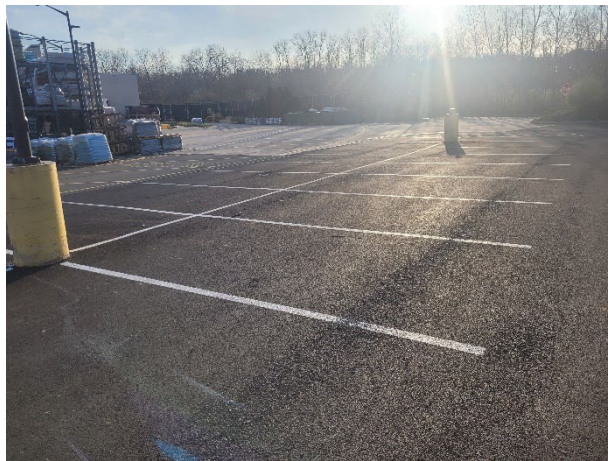
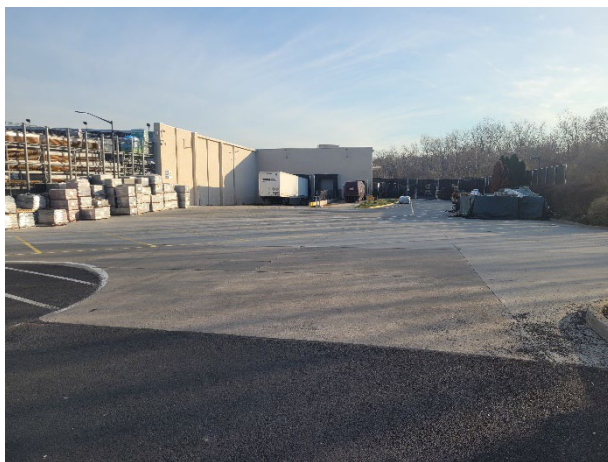
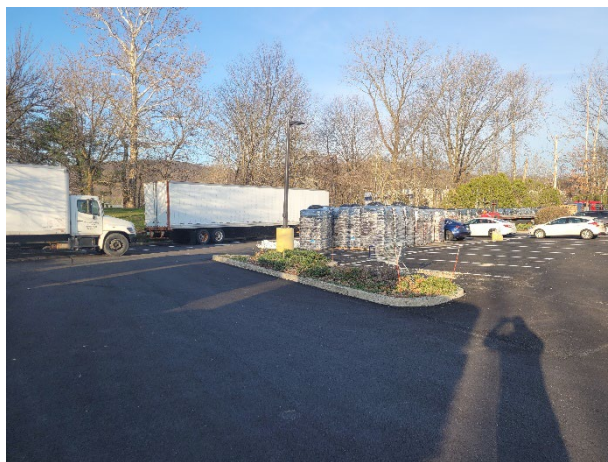
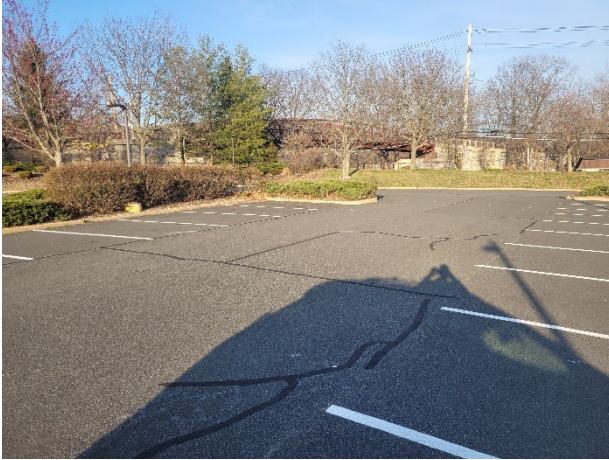
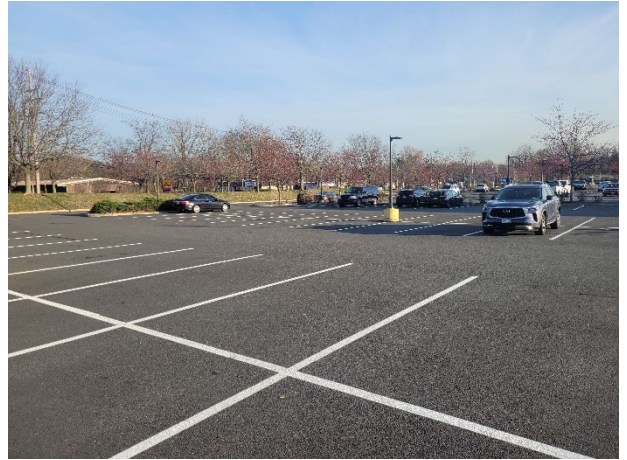
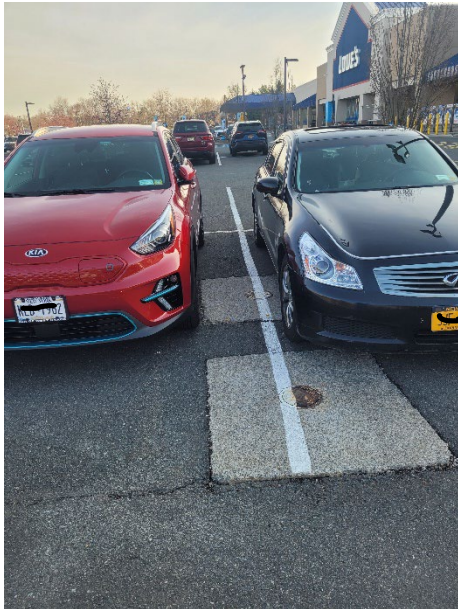
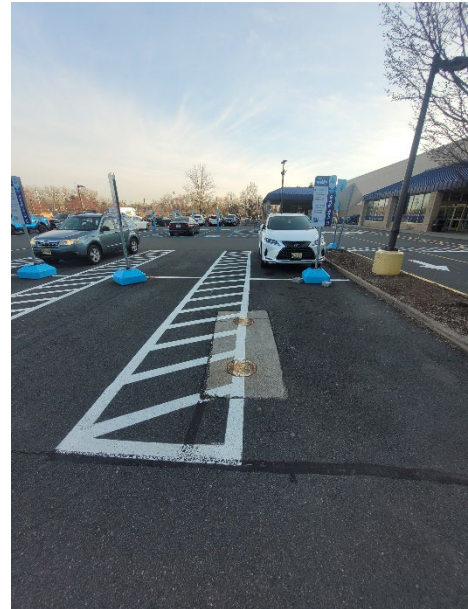
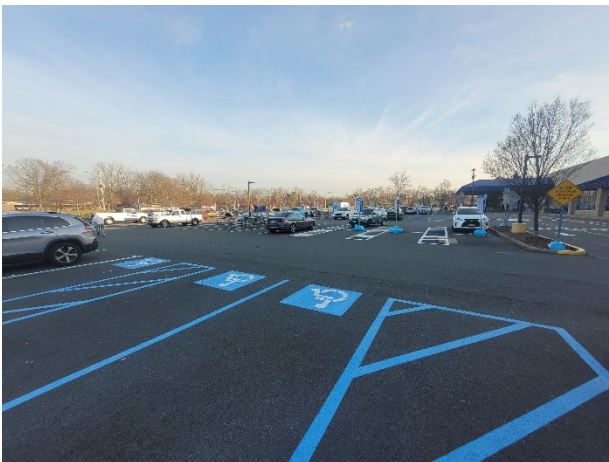
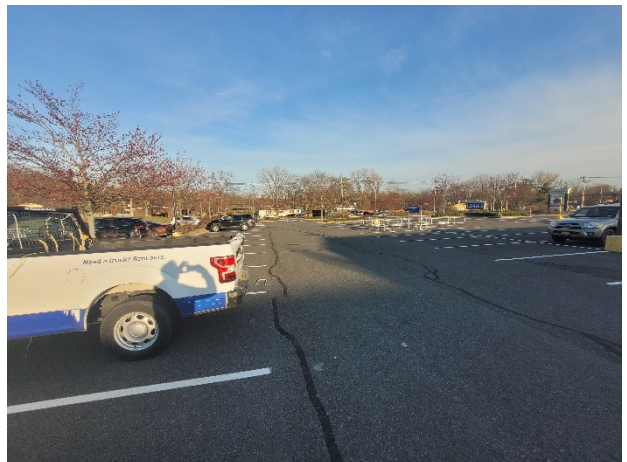
PHOTO LOG – Site Cap Condition – March 2023

Photos of Site Cap
