Summary of Site Data &
Remedial Activities

BUFFALO BRAKE BEAM
Rigel Enterprises Site

REMEDIAL ACTIVITIES REPORT

**Fuel Oil Spill Area
NYDEC spill # 0009396
Buffalo Brake Beam Site
400 Ingham Ave
Lackawanna, NY**

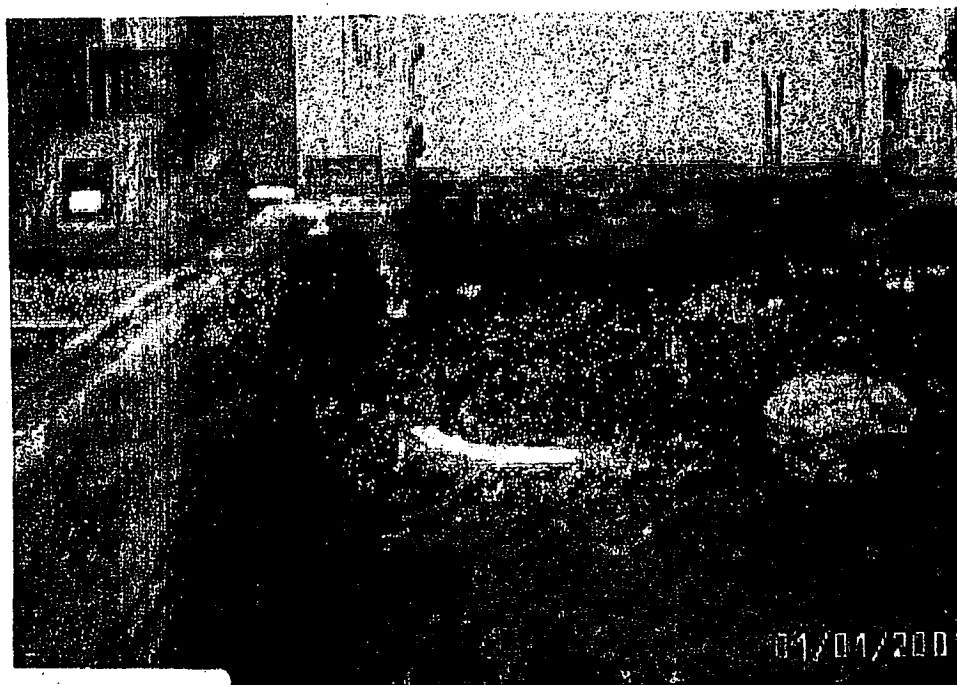
Photographs of Excavation

The concrete floor was broken up, in the identified area of contamination, using the machine mounted hydraulic hammer. Excavation commenced at the southwest corner of the main floor of the crane bay and the rail siding retaining wall. Significant odors of aged gasoline were encountered at shallow depth in this corner. Excavation proceeded to the north following the west wall of the crane bay to just past the next column line. Odors diminished both with depth and distance from the southwest corner.

No visual evidence of contamination was observed in the excavation with the exception of sheen present on the soil in the conduit bedding following the top of the footing of the rail siding retaining wall. This visual evidence diminished as the excavation proceeded to the east and was no longer observed at the eastern end of the excavation.

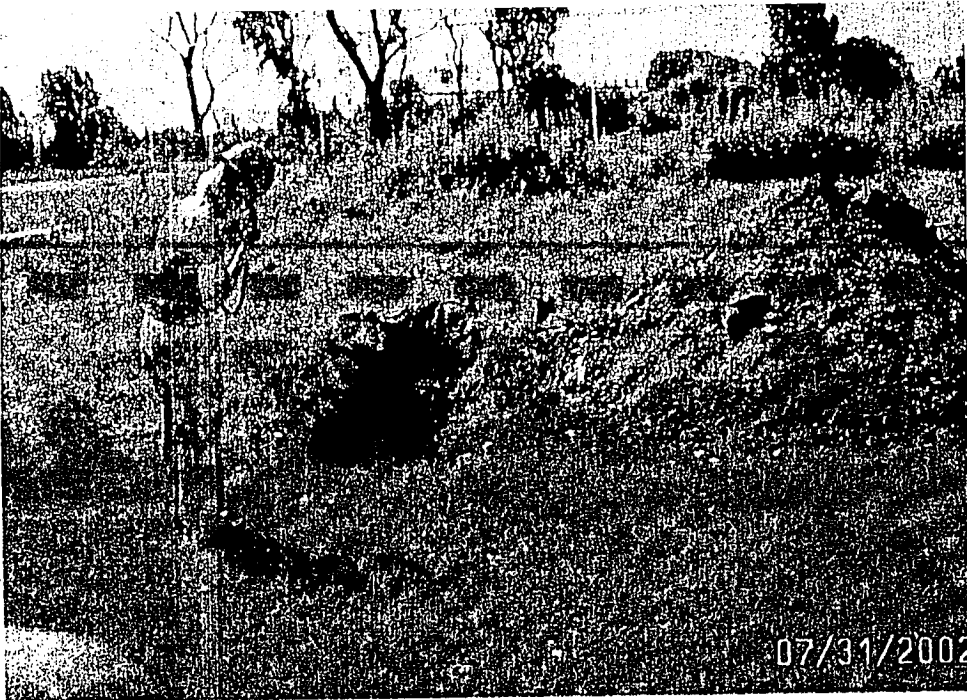
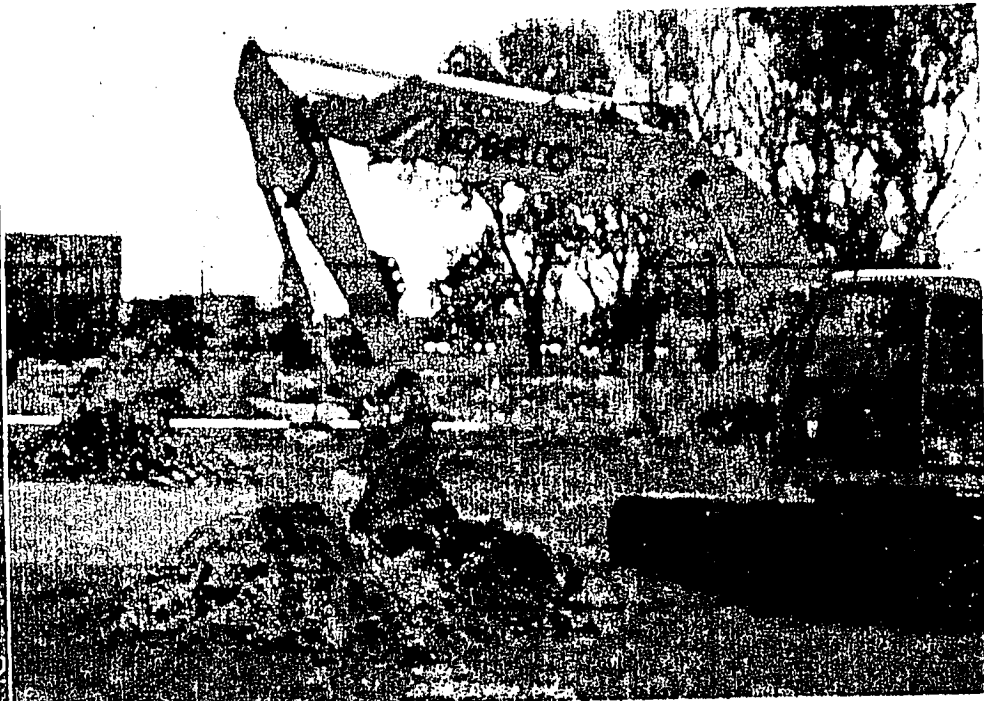
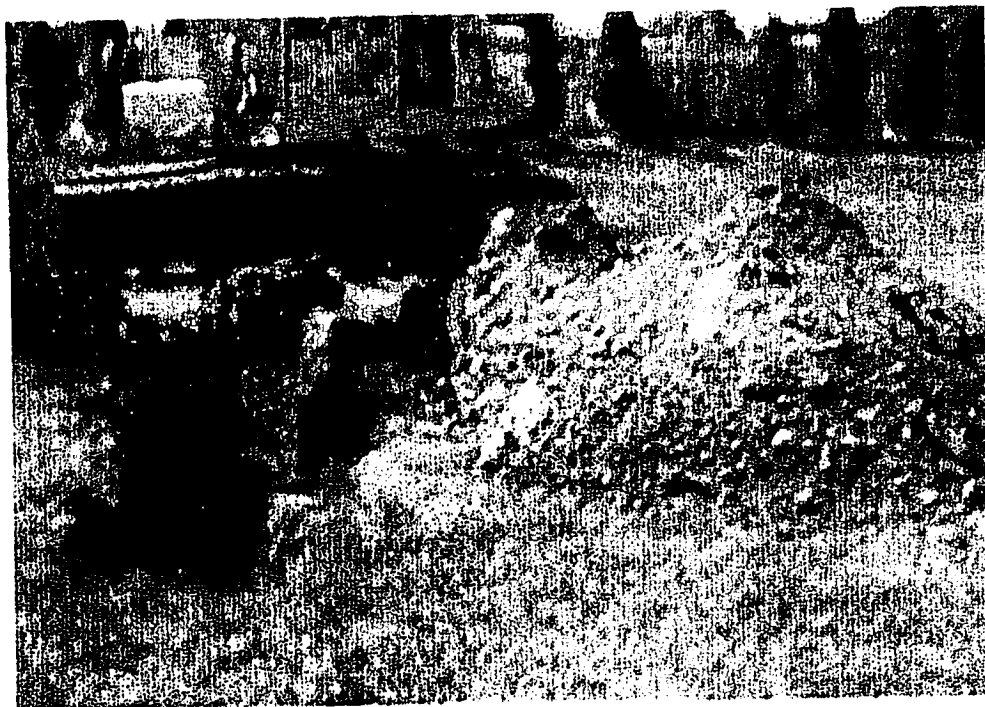
Photographs of the test pits are attached.

Two test pits were installed 47 feet apart in an east-west line straddling the center point of the lawn area. The test pits were 14 feet long north to south, 2 feet wide and to a depth of 3.5' and 6' respectively. Material was removed in one foot lifts, observed and screened with the PID. The material removed was natural soil mixed with large shot rock. No PID readings were observed in either test pit. The depth of the test pits were limited when large limestone boulders were encountered which the excavator could not remove. There was no evidence of the burial of any demolition debris or other disposal activity in this area. No samples were collected and the excavations were backfilled.
