Periodic Review Report

*400 Ingham Avenue Site (VCP Site No. V00625)
400 Ingham Avenue
Lackawanna, New York*

January 2022
Revised April 2022

**400 INGHAM AVENUE
(NYSDEC SITE No V00625)**

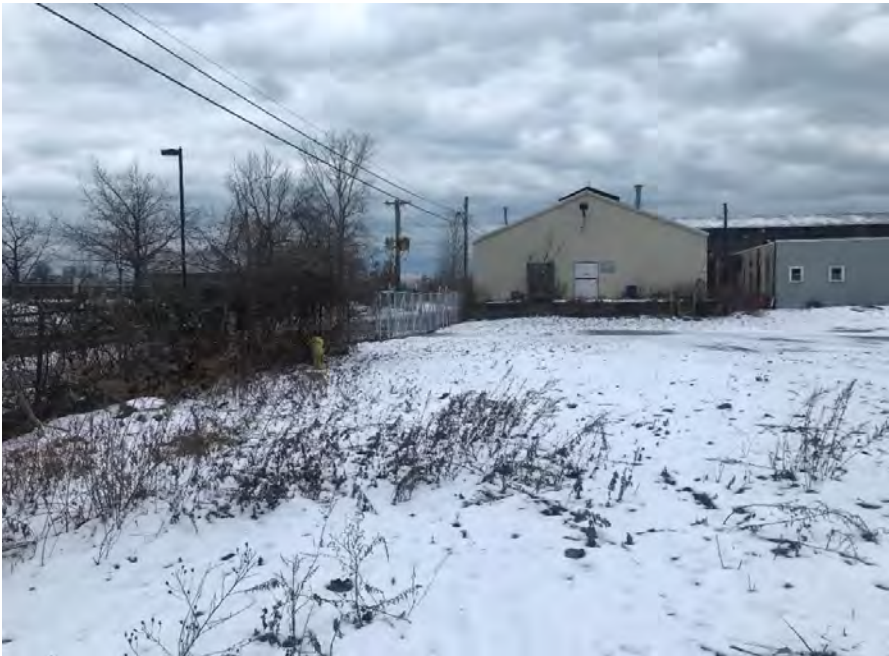
Client Name: Empire Building Diagnostics		Site Location: 400 Ingham Avenue (VCP.V00625)	Project No.: B0572-021-003
Photo No. 1	Date 01/05/22

Direction Photo Taken: West			
Description: Southeastern corner of property facing west. Including the southern portion of Area 4.

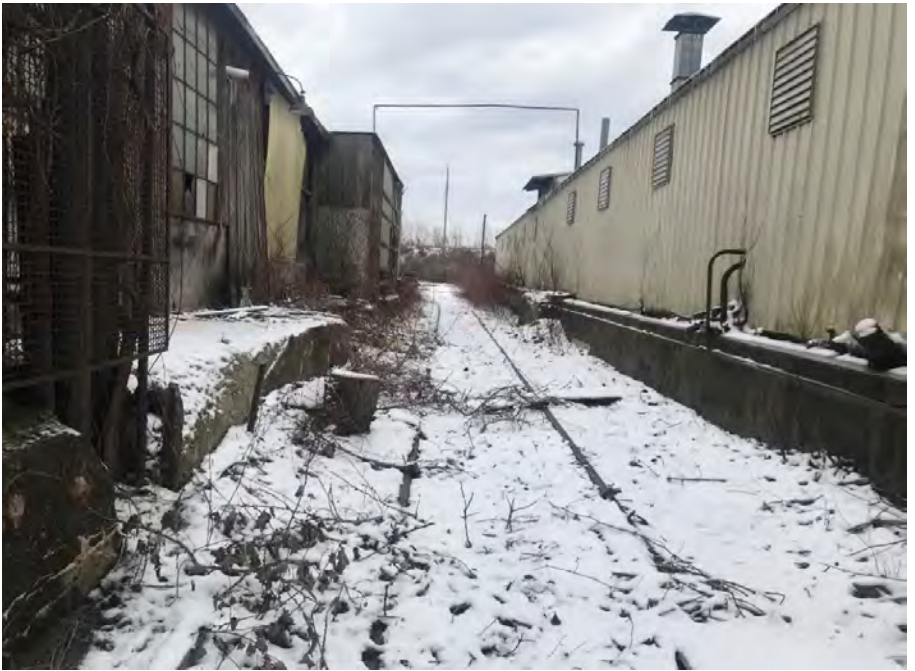
Client Name: Empire Building Diagnostics		Site Location: 400 Ingham Avenue (VCP.V00625)	Project No.: B0572-021-003
Photo No. 3	Date 01/05/22

Direction Photo Taken: East			
Description: Railroad siding.

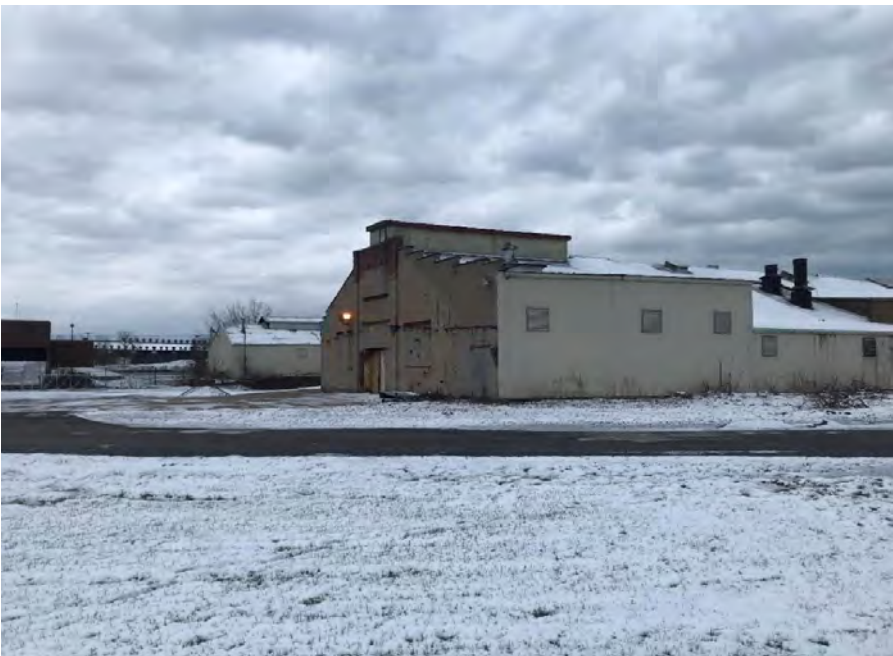
Client Name: Empire Building Diagnostics		Site Location: 400 Ingham Avenue (VCP.V00625)	Project No.: B0572-021-003
Photo No. 5	Date 01/05/22

Direction Photo Taken: South			
Description: Northeastern corner of property facing Southwest.

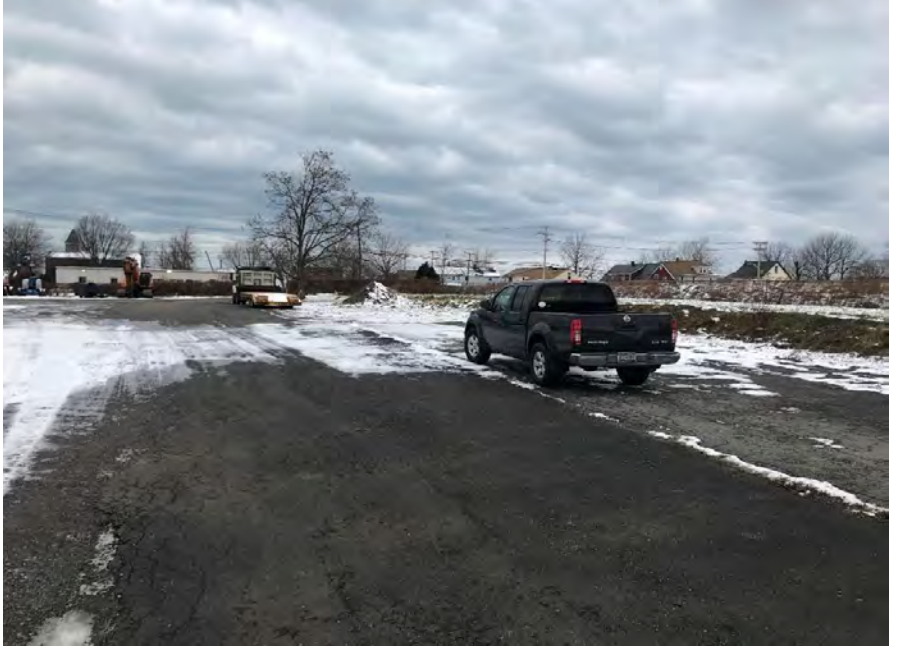
Client Name: Empire Building Diagnostics		Site Location: 400 Ingham Avenue (VCP.V00625)	Project No.: B0572-021-003
Photo No. 7	Date 01/05/22

Direction Photo Taken: East			
Description: North side of site overlooking Area 1. Soil pile in background generated by previous entity.

- The existing cover system does not appear to be compromised;
- Site use is conformant with the Declaration of Covenants and Restrictions; and
- Evidence of a fill pile was observed on the Site north of the entrance drive off Ingham St.

No corrective actions are recommended at this time except for proper characterization and management of the unknown fill pile. At this time 400 Ingham LLC is planning for installation of six (6) exterior support columns to allow for construction of a covered pergola entrance roof on the east side of the office building in mid-2022. The roof will cover an existing outdoor concrete pad and is well outside of the 5 areas of concern. The columns will sit on subgrade concrete sonotube piers (12" diameter x 48" deep) that will be augered into the subgrade, generating less than 1 CY of spoils from auger cuttings. A pre-disturbance notification will be provided to the Department in advance of the work that will describe the construction activities and the repairs to the concrete pad surrounding the piers. 400 Ingham LLC plans to concurrently characterize the pier cuttings and fill pile for disposal at a sanitary landfill facility. The materials landfill approval and disposal documentation will be furnished for inclusion in the next PRR.

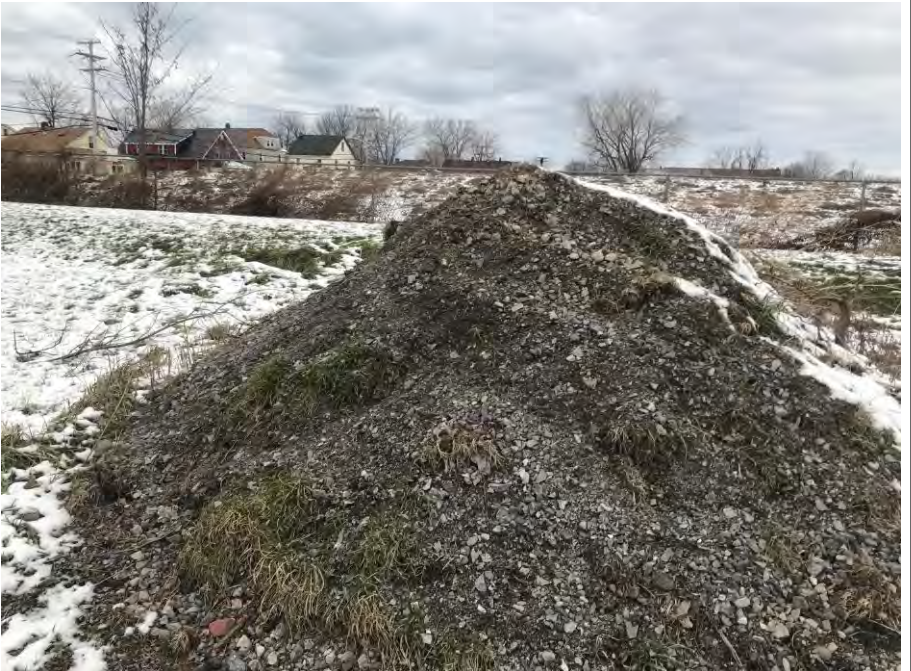
Client Name: Empire Building Diagnostics		Site Location: 400 Ingham Avenue (VCP.V00625)	Project No.: B0572-021-003
Photo No. 9	Date 01/05/22

Direction Photo Taken: Northeast			
Description: Northeastern corner of NW Parking Area facing northeast. Soil and stone pile is located just west of area 1 (generated by others).

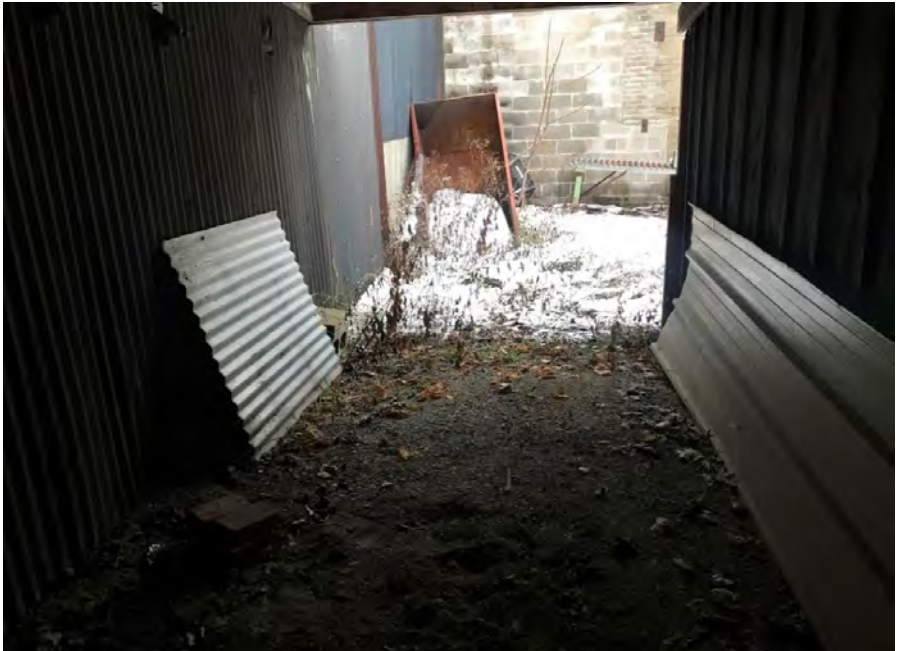
Photo No. 10	Date 01/05/22

Direction Photo Taken: North		
Description: Entrance to central courtyard. Overlooking Area 5.

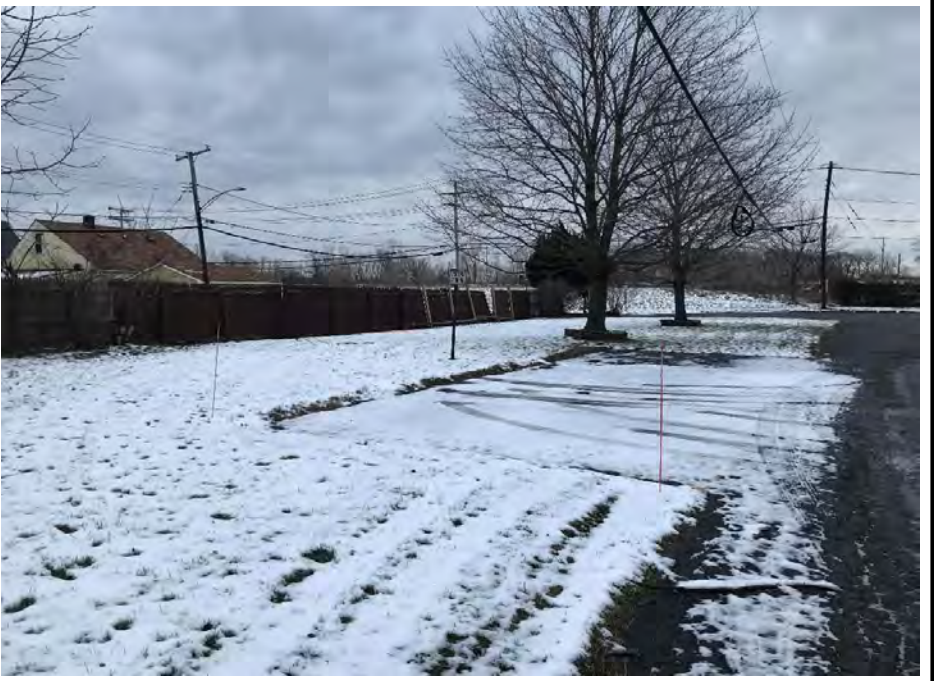
Client Name: Empire Building Diagnostics		Site Location: 400 Ingham Avenue (VCP.V00625)	Project No.: B0572-021-003
Photo No. 13	Date 01/05/22

Direction Photo Taken: Northeast			
Description: Northwestern corner of property facing northeast.

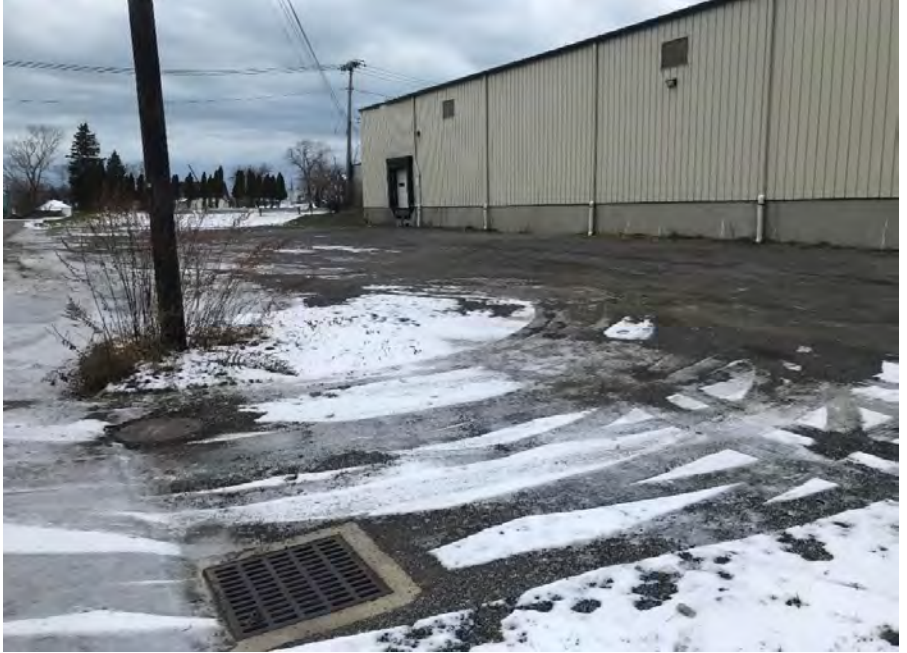
Client Name: Empire Building Diagnostics		Site Location: 400 Ingham Avenue (VCP.V00625)	Project No.: B0572-021-003
Photo No. 15	Date 01/05/22

Direction Photo Taken: West			
Description: Southeastern corner of property facing west.

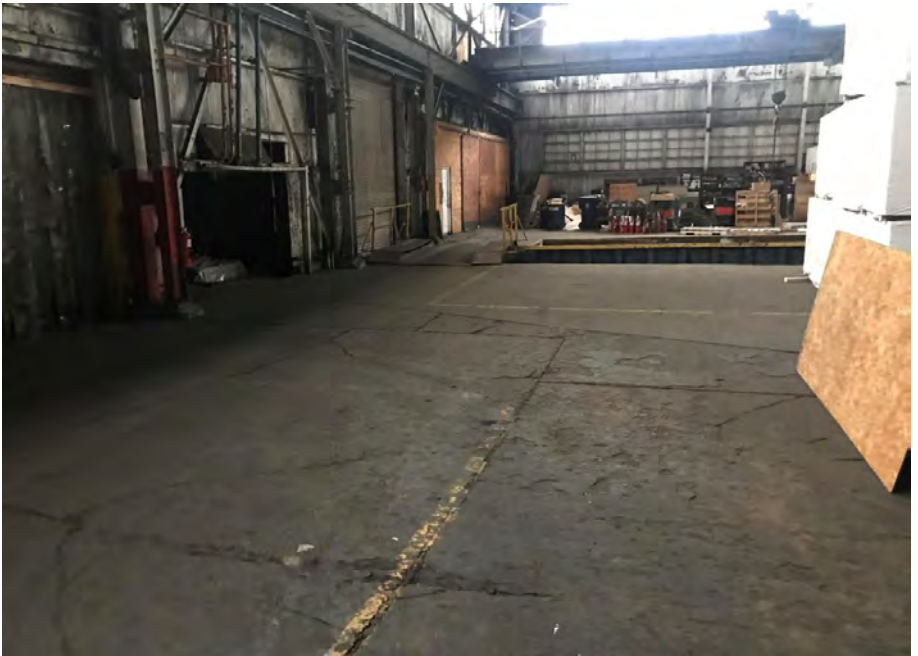
Client Name: Empire Building Diagnostics		Site Location: 400 Ingham Avenue (VCP.V00625)	Project No.: B0572-021-003
Photo No. 17	Date 01/05/22

- Area 3 - The cover in Area 3 consisted of concrete floors. The concrete floor surface, where visible, appeared to be in good condition. No deterioration or significant cracks were noted.
- Area 4 - The cover in the vicinity of Area 4 includes grass cover, an asphalt driveway and concrete pad, and an aggregate surfaced parking/storage lot. Evidence of recent disturbance to the vegetation and gravel areas was not observed. Hardscape areas appeared competent. No deterioration or significant cracks were noted.
- Area 5 - The cover observed in the vicinity of Area 5 consisted of concrete floors. The concrete floor surface, where visible, appeared to be in good condition. No deterioration or significant cracks were noted.

Direction Photo Taken: South			
Description: Overlooking Area 3, inside former manufacturing building.
