**SITE INVESTIGATION REPORT
DOBBS FERRY WATERFRONT PARK
DOBBS FERRY, NEW YORK**

**Village of Dobbs Ferry
112 Main Street
Dobbs Ferry, New York 10522**

**Potomac-Hudson Environmental, Inc.
PO Box 1206, 166 W. 16th Street
New York, New York 10011
(212) 243-3574**

November 2002

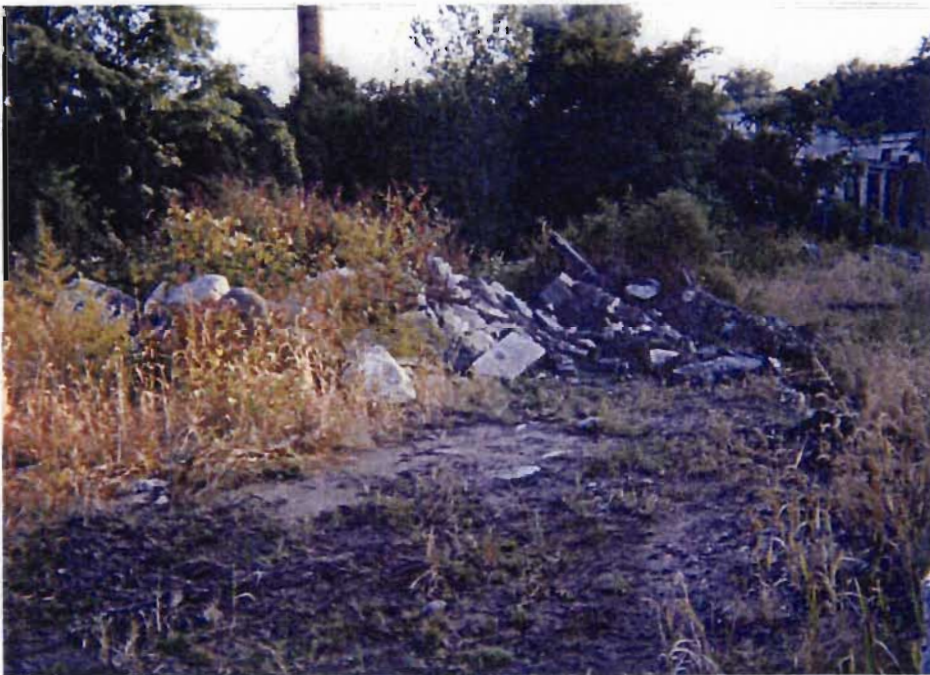
Debris Piles
NORTH END OF
SITE

VIEW EAST

Visual observations during the test pit program indicated the presence of a large amount of debris (household and construction type) in all five test pits, with the largest amount of household debris found in test pits TP-1, TP-2 and TP-3, all located in the central to southern portion of the playing field area. Aside from the concentrations of soil contaminants above the NYSDEC Recommended Soil Cleanup Objectives, the presence of this type of debris should be considered in the design of the field. Geotechnical issues such as soil settling and debris shifting should be taken into consideration in the final site design.

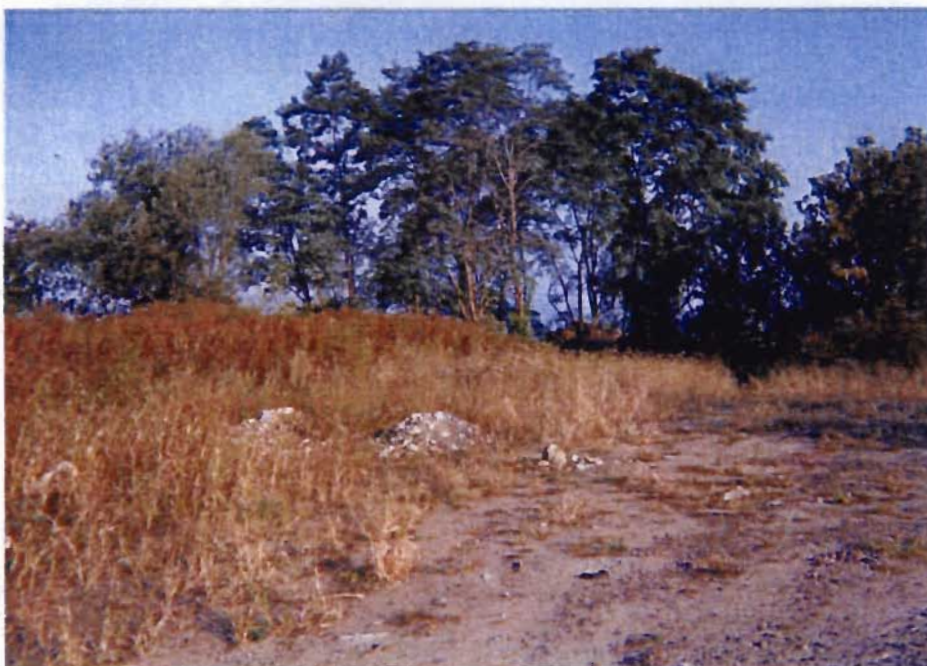
Debris Piles
NORTH END OF SITE
VIEW NW

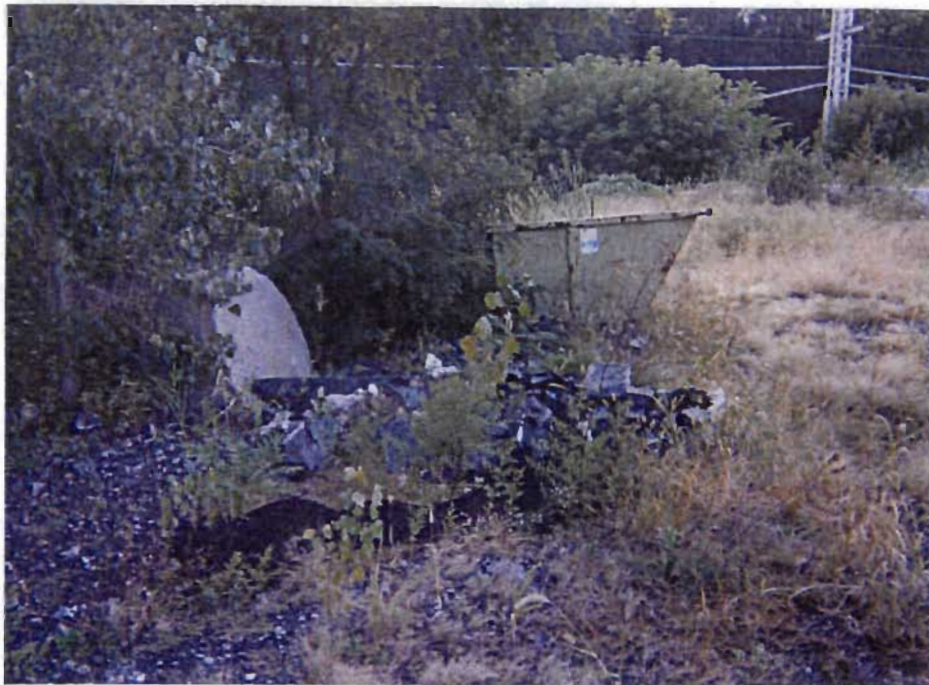
Debris AT NORTH
END OF SITE
VIEW EAST

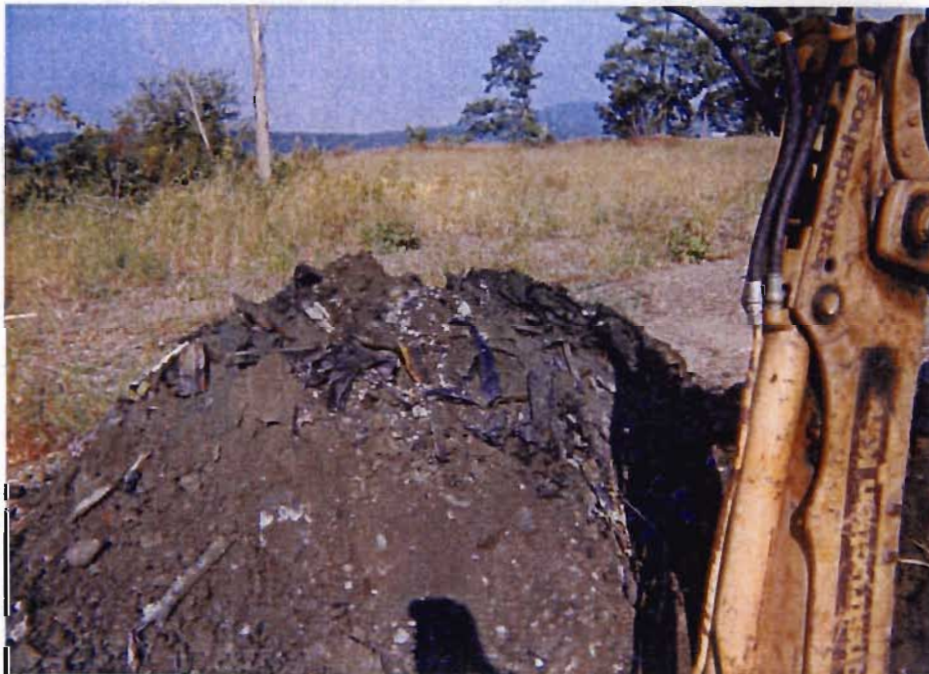
TEST PIT 1

Potomac-Hudson		Test Pit Log		Test Pit No.: TP-1
				Page 1 of 1
Client: Village of Dobbs Ferry			Date Start: 10/1/02	
Project Name: Dobbs Ferry Waterfront Park			Date Finish: 10/1/02	
Project No.: 405		Location: Dobbs Ferry Waterfront Park		
Contractor: Goldstar Environmental, Inc.		Dobbs Ferry, New York		Elevation:
Equipment: Backhoe				Datum:
Sampling Method: Test Pit		Sample Interval:		Depth to Water: ~ 10 ft
Logged By: Ed Phillips		Test Pit Dimensions - Length: 6 ft Width: 3 ft		Depth: 10 ft
Depth (ft)	Sample No.	PID/FID (ppm)	Lithologic Description	Remarks
	TP-1A (0-0.5 ft)	0	Brown/black f-c Sand, silt and gravel, cobbles and wood	
1		0	Brown/black f-c Sand, silt and gravel, cobbles and wood; styrofoam, tiles	
2				
3			Large wood, newspapers, books, fabric sample book, rope, boulders in brown/black f-c Sand, silt and gravel	
4				
5				
6				
7				
8				
9	TP-1B (9.5-10 ft)	10 to 12		
10			End of Test Pit

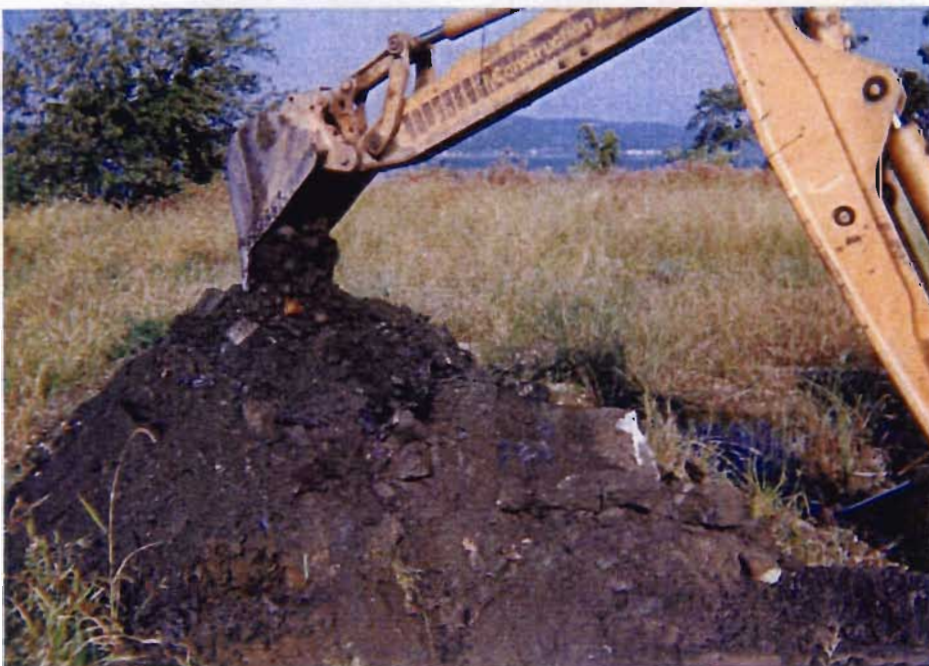
TEST PIT 2

Potomac-Hudson		Test Pit Log		Test Pit No.: TP-2
				Page 1 of 1
Client: Village of Dobbs Ferry				Date Start: 10/1/02
Project Name: Dobbs Ferry Waterfront Park				Date Finish: 10/1/02
Project No.: 405		Location: Dobbs Ferry Waterfront Park		
Contractor: Goldstar Environmental, Inc.		Dobbs Ferry, New York		Elevation:
Equipment: Backhoe				Datum:
Sampling Method: Test Pit		Sample Interval:		Depth to Water: ~ 10 ft
Logged By: Ed Phillips		Test Pit Dimensions - Length: 6 ft Width: 3 ft		Depth: 10 ft
Depth (ft)	Sample No.	PID/FID (ppm)	Lithologic Description	Remarks
	TP-2A (0-0.5 ft)	0	Surface - grass, wood chips Gray/brown f-c Sand, gravel, wood, cloth, plastic bags, boulders, fan blades, wire, rubber, metal	
1				
2				
3				
4				
5				
6				
7				
8				
9	TP-2B (9.5-10 ft)		Material wet at bottom of test pit.	
10			End of Test Pit	
11				
12				
13				
14				
15

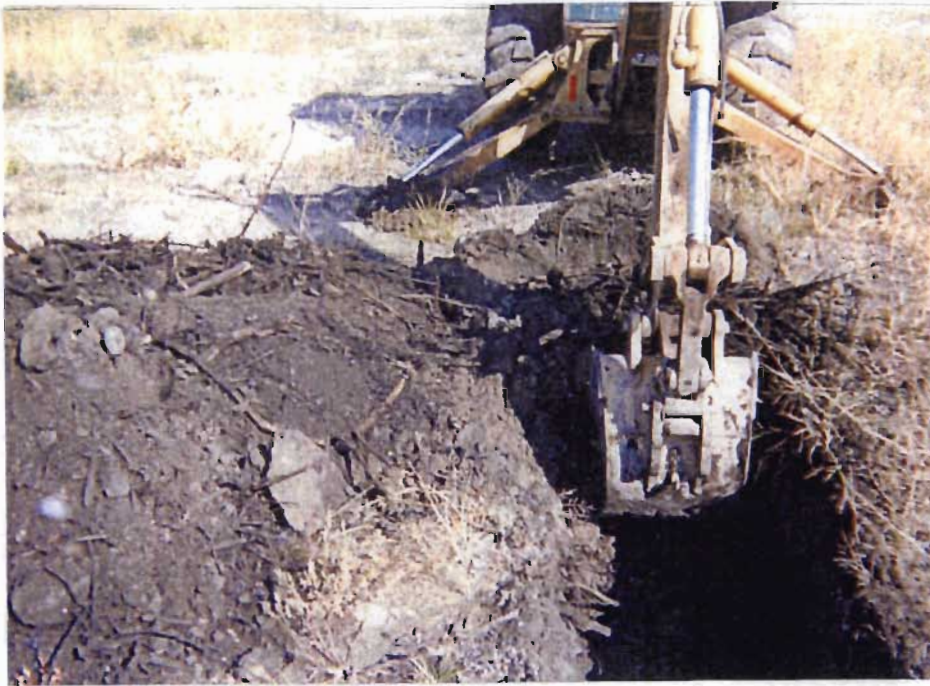
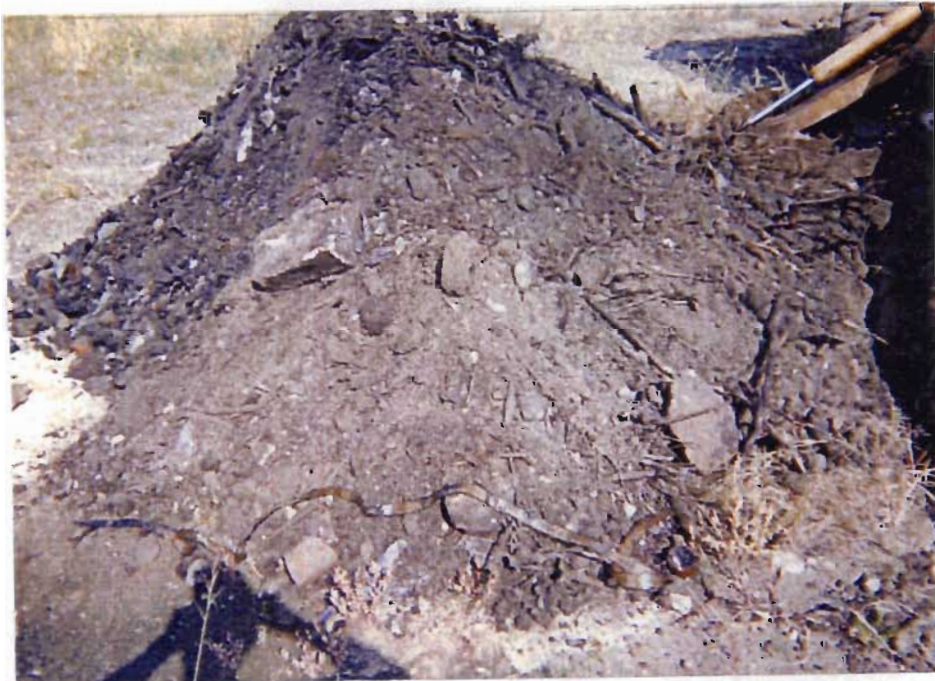
TEST PIT 3

Potomac-Hudson		Test Pit Log		Test Pit No.: TP-3
				Page 1 of 1
Client: Village of Dobbs Ferry				Date Start: 10/1/02
Project Name: Dobbs Ferry Waterfront Park				Date Finish: 10/1/02
Project No.: 405	Location: Dobbs Ferry Waterfront Park			
Contractor: Goldstar Environmental, Inc.	Dobbs Ferry, New York			Elevation:
Equipment: Backhoe				Datum:
Sampling Method: Test Pit	Sample Interval:	Depth to Water: ~ 10 ft		
Logged By: Ed Phillips	Test Pit Dimensions - Length: 6 ft Width: 3 ft		Depth: 10 ft	
Depth (ft)	Sample No.	PID/FID (ppm)	Lithologic Description	Remarks
	TP-3A (0-0.5 ft)	0	Black/brown f-c Sand, silt, gravel. Wood, large volume of roots, cobbles, boulders, plastic.	
1				
2			Black/brown f-c Sand, silt, gravel. Wood, cobbles, boulders, plastic, concrete, movie film, can of tire inflator.	
3				
4				
5				
6		3 to 6 from 6 ft to 10 ft		
7				
8				
9	TP-3B (9.5-10 ft)		Bottom of test pit damp.	
10			End of Test Pit

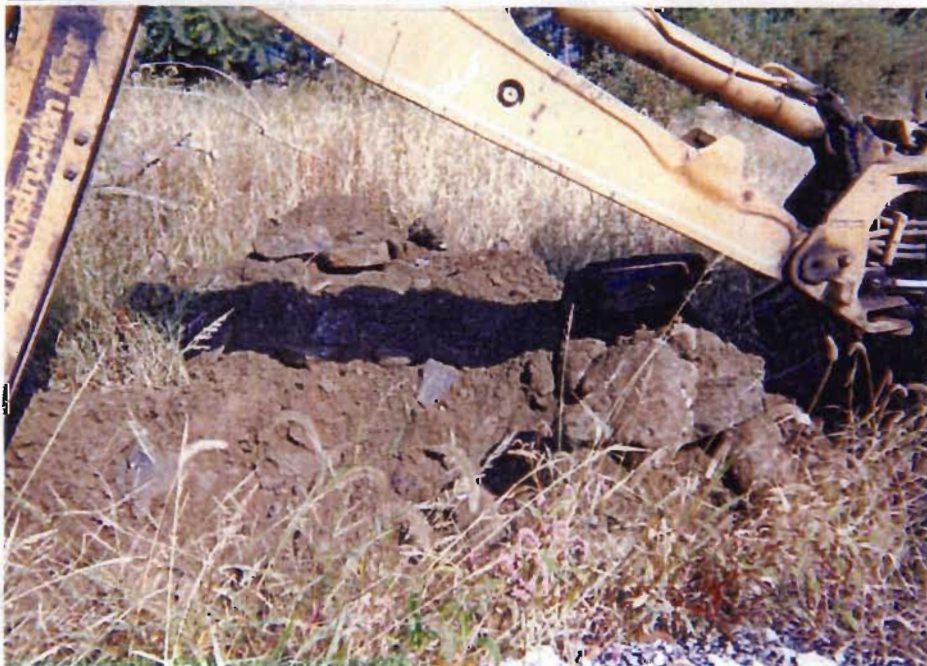
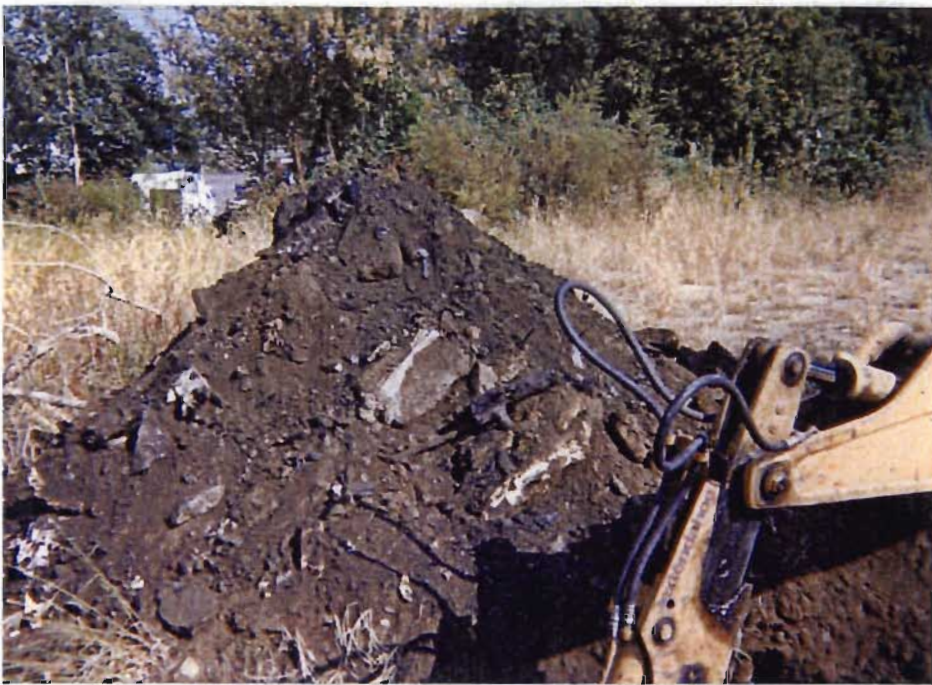
TEST PIT 4

Potomac-Hudson		Test Pit Log		Test Pit No.: TP-4
				Page 1 of 1
Client: Village of Dobbs Ferry				Date Start: 10/1/02
Project Name: Dobbs Ferry Waterfront Park				Date Finish: 10/1/02
Project No.: 405	Location: Dobbs Ferry Waterfront Park			
Contractor: Goldstar Environmental, Inc.	Dobbs Ferry, New York			Elevation:
Equipment: Backhoe				Datum:
Sampling Method: Test Pit	Sample Interval:		Depth to Water: ~ 11 ft	
Logged By: Ed Phillips	Test Pit Dimensions - Length: 6 ft Width: 3 ft		Depth: 11 ft	
Depth (ft)	Sample No.	PID/FID (ppm)	Lithologic Description	Remarks
	TP-4A (0-0.5 ft)	0	Gravel, concrete, brick, clay pipe in black/brown f-c Sand and silt, slate	directly adjacent to pile. Pile appears at surface.
1				
2		0	Wood pieces in black/brown f-c Sand and silt, gravel	
3				
4				
5				
6		0	Same as above with metal pipe fencing posts in concrete.	
7				
8				
9				
10	TP-4B (10-11 ft)	0	Black f-c Sand, silt, plastic, wood, rubber, concrete, boulders	Hole caving in.

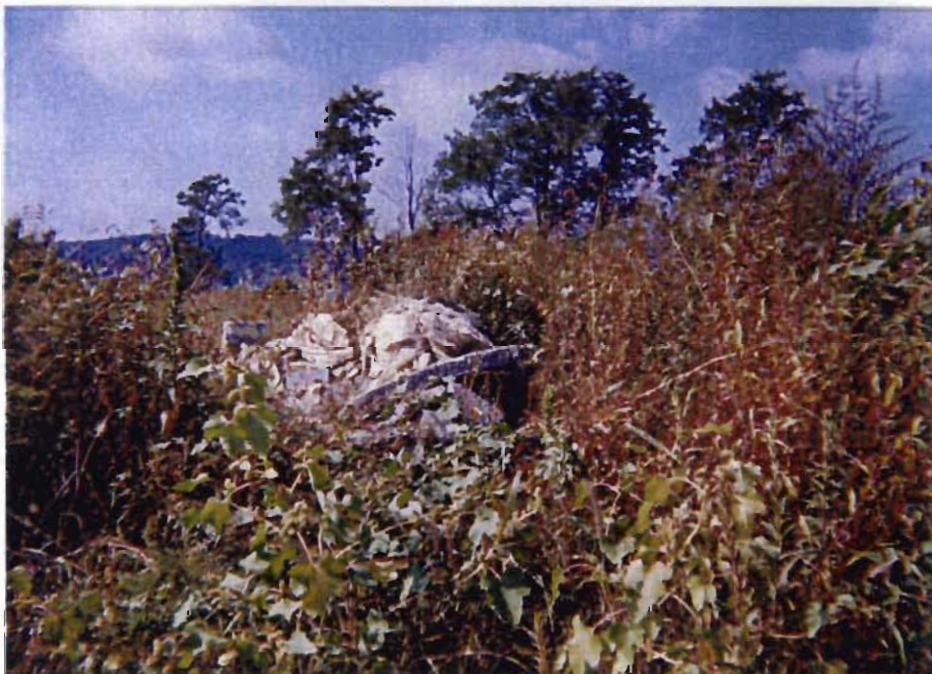
Debris Pile Next
TO TEST PIT 5

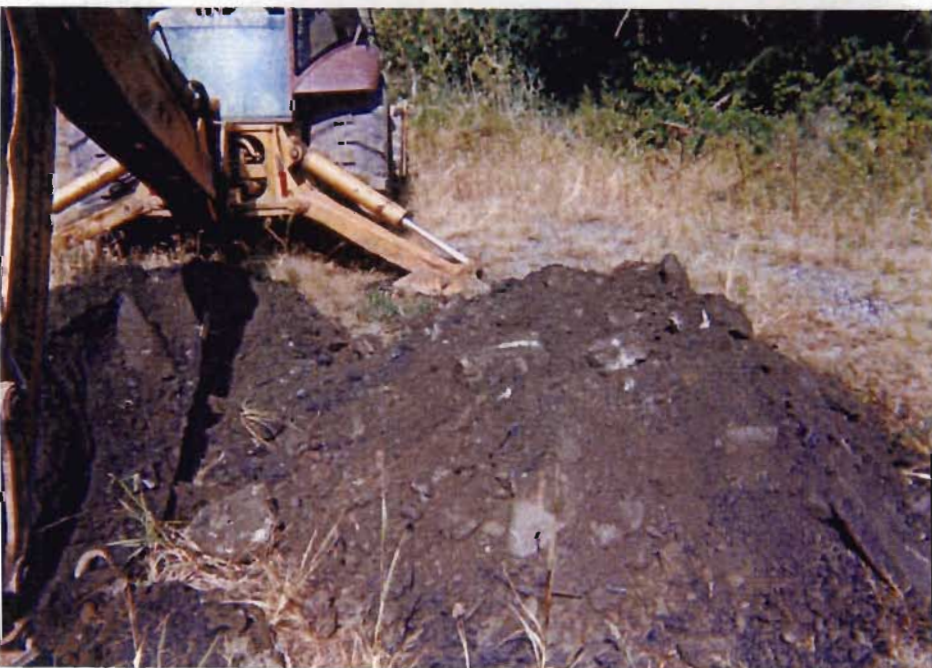
TEST PIT 5

Potomac-Hudson		Test Pit Log		Test Pit No.: TP-5
				Page 1 of 1
Client: Village of Dobbs Ferry			Date Start: 10/1/02	
Project Name: Dobbs Ferry Waterfront Park			Date Finish: 10/1/02	
Project No.: 405		Location: Dobbs Ferry Waterfront Park		
Contractor: Goldstar Environmental, Inc.		Dobbs Ferry, New York		Elevation:
Equipment: Backhoe				Datum:
Sampling Method: Test Pit		Sample Interval:		Depth to Water: ~ 10 ft
Logged By: Ed Phillips		Test Pit Dimensions - Length: 6 ft Width: 3 ft		Depth: 10 ft
Depth (ft)	Sample No.	PID/FID (ppm)	Lithologic Description	Remarks
	TP-5A (0-0.5 ft)	0	Black f-c Sand, silt, gravel	Adjacent to pile of large boulders, slate, f-c Sand, silt, gravel, plastic, concrete, wood, cinder block
1		0	Black/brown f-c Sand, silt, gravel, cobbles, concrete	
2				
3				
4				
5				
6				
7				
8				
9	TP-5B (and Dup. TP-5C) (9.5-10 ft)			
10			End of Test Pit	
11				
12				
13				
14				
15
