Hunts Point Food Distribution Center

Community Air Monitoring Plan for the Food Center Drive Greenway

Hunts Point, Bronx, New York

May 2013

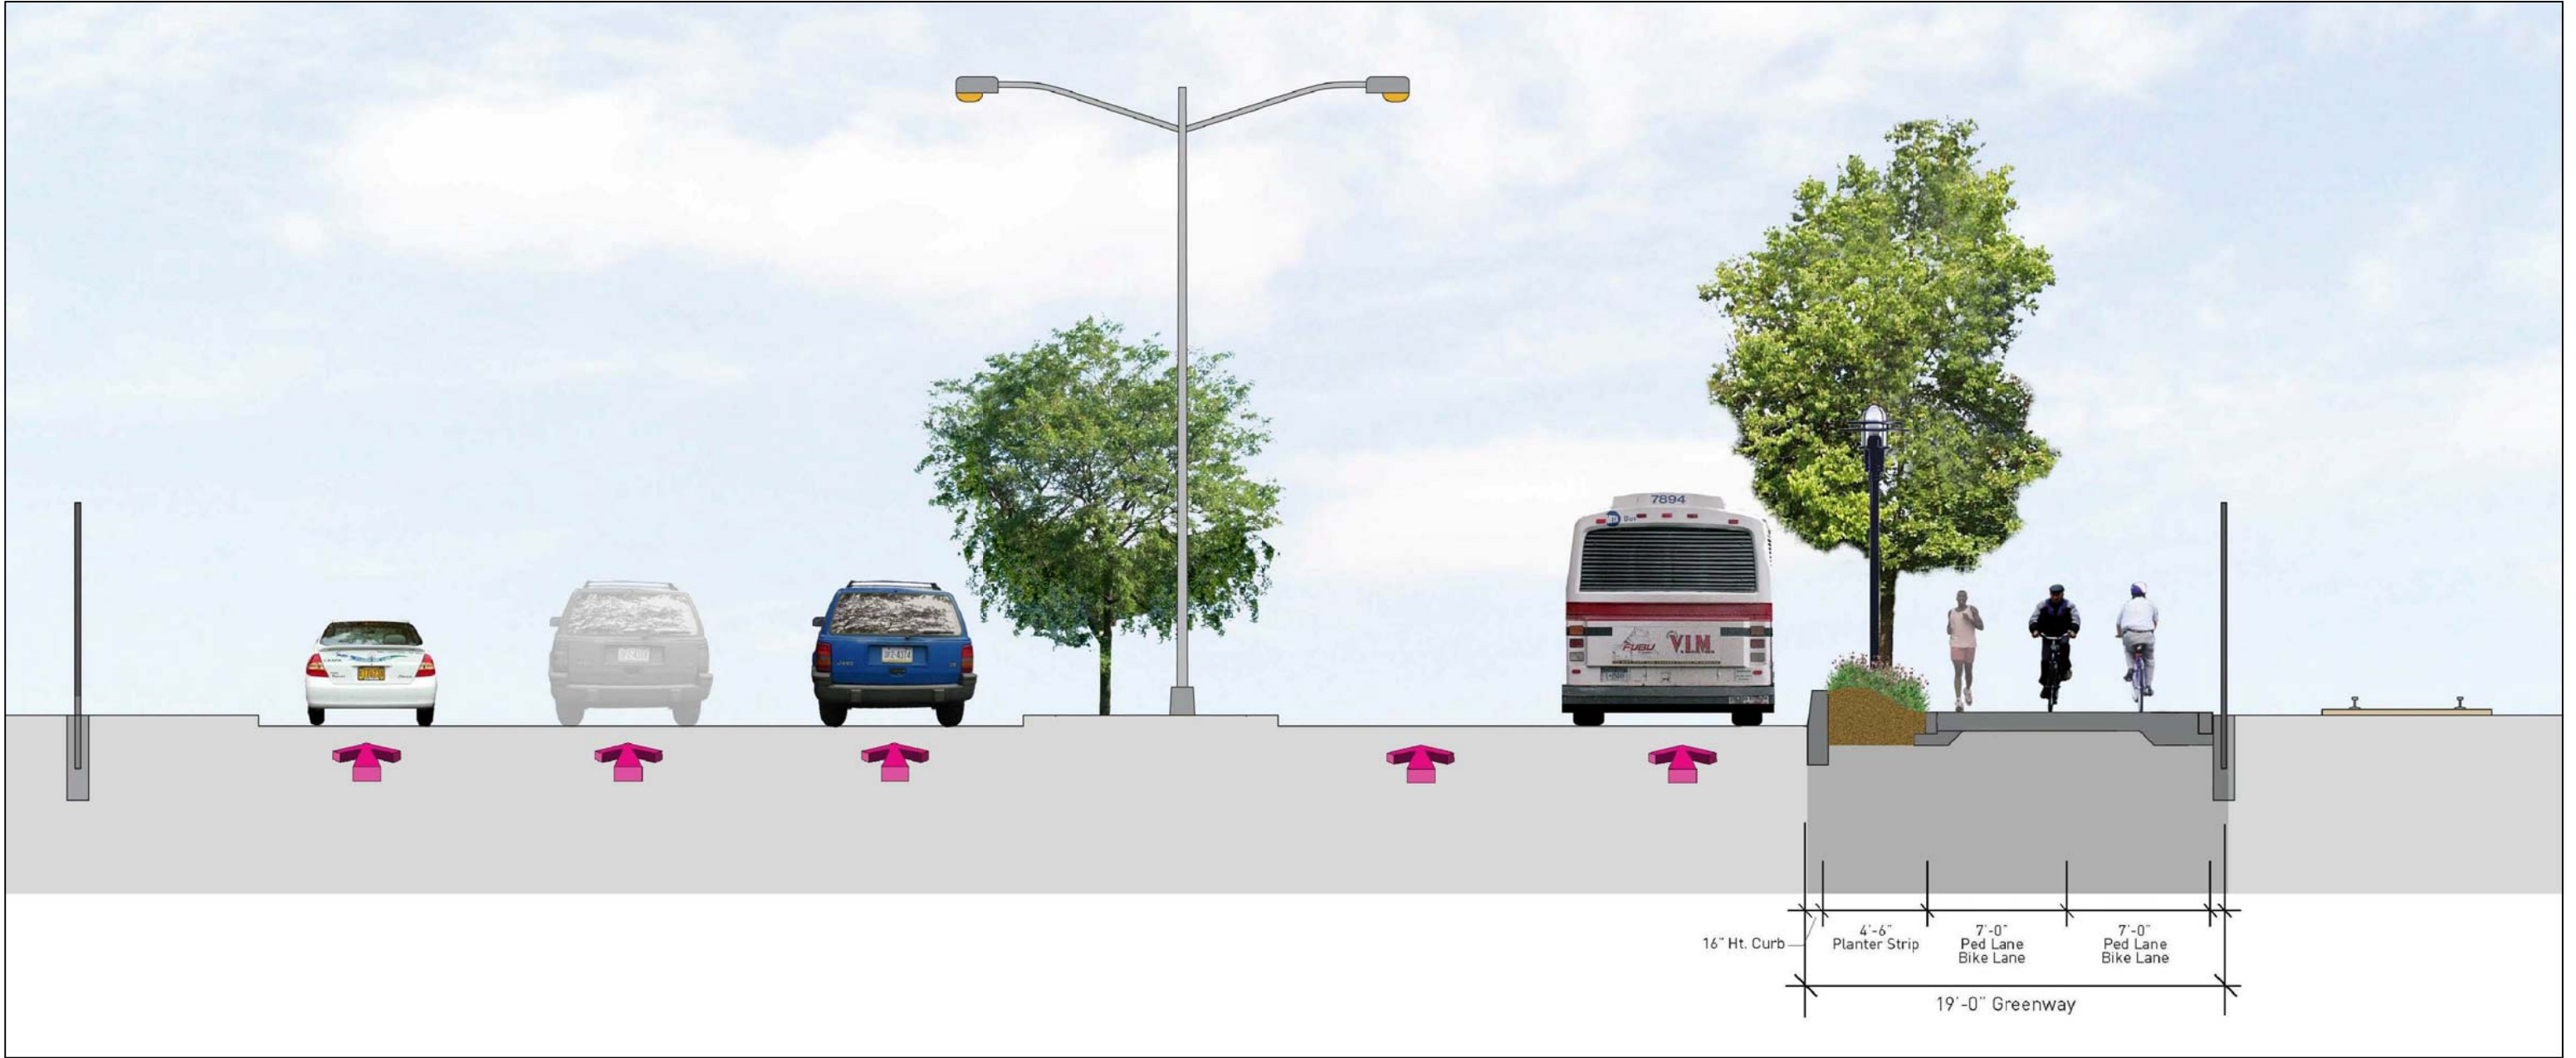
DATE	3/12/2012
FIGURE	3

SOURCE: MATHEWS NIELSON LANDSCAPE ARCHITECTS,
GREENWAY SECTION A, SLOPED PLANTING STRIP

Greenway Construction - Condition 1

The Greenway construction project is 1.3 miles long with an average depth of excavation of approximately 2 feet below the existing ground surface. The construction of the 19 foot wide greenway is enabled by conversion of the street to one-way circulation, thereby gaining a vehicular lane and allowing the outer most lane and adjacent sidewalk (next to the Iroquois Easement) to be converted for use as the shared bicycle and pedestrian route, with planting. Due to varying utilities and land use conditions, the greenway will have three different cross-sections (shown on Figures 3, 4 and 5):

- Condition 1: The greenway is a 19 foot wide shared path separated from the roadway by a sloped planting strip with a 16 inch high curb.
- Condition 2: The greenway remains a 19 foot wide shared path separated from the roadway by a flush planting strip on the roadway side, protected by a 6 inch high curb.
- Condition 3: This condition occurs when the right-of way narrows from 100 foot to 80 foot at the north end of the project area, near the Produce Market entrance. The greenway is a 12 foot wide shared path adjacent to the road, without planting, with a 6 inch high curb.

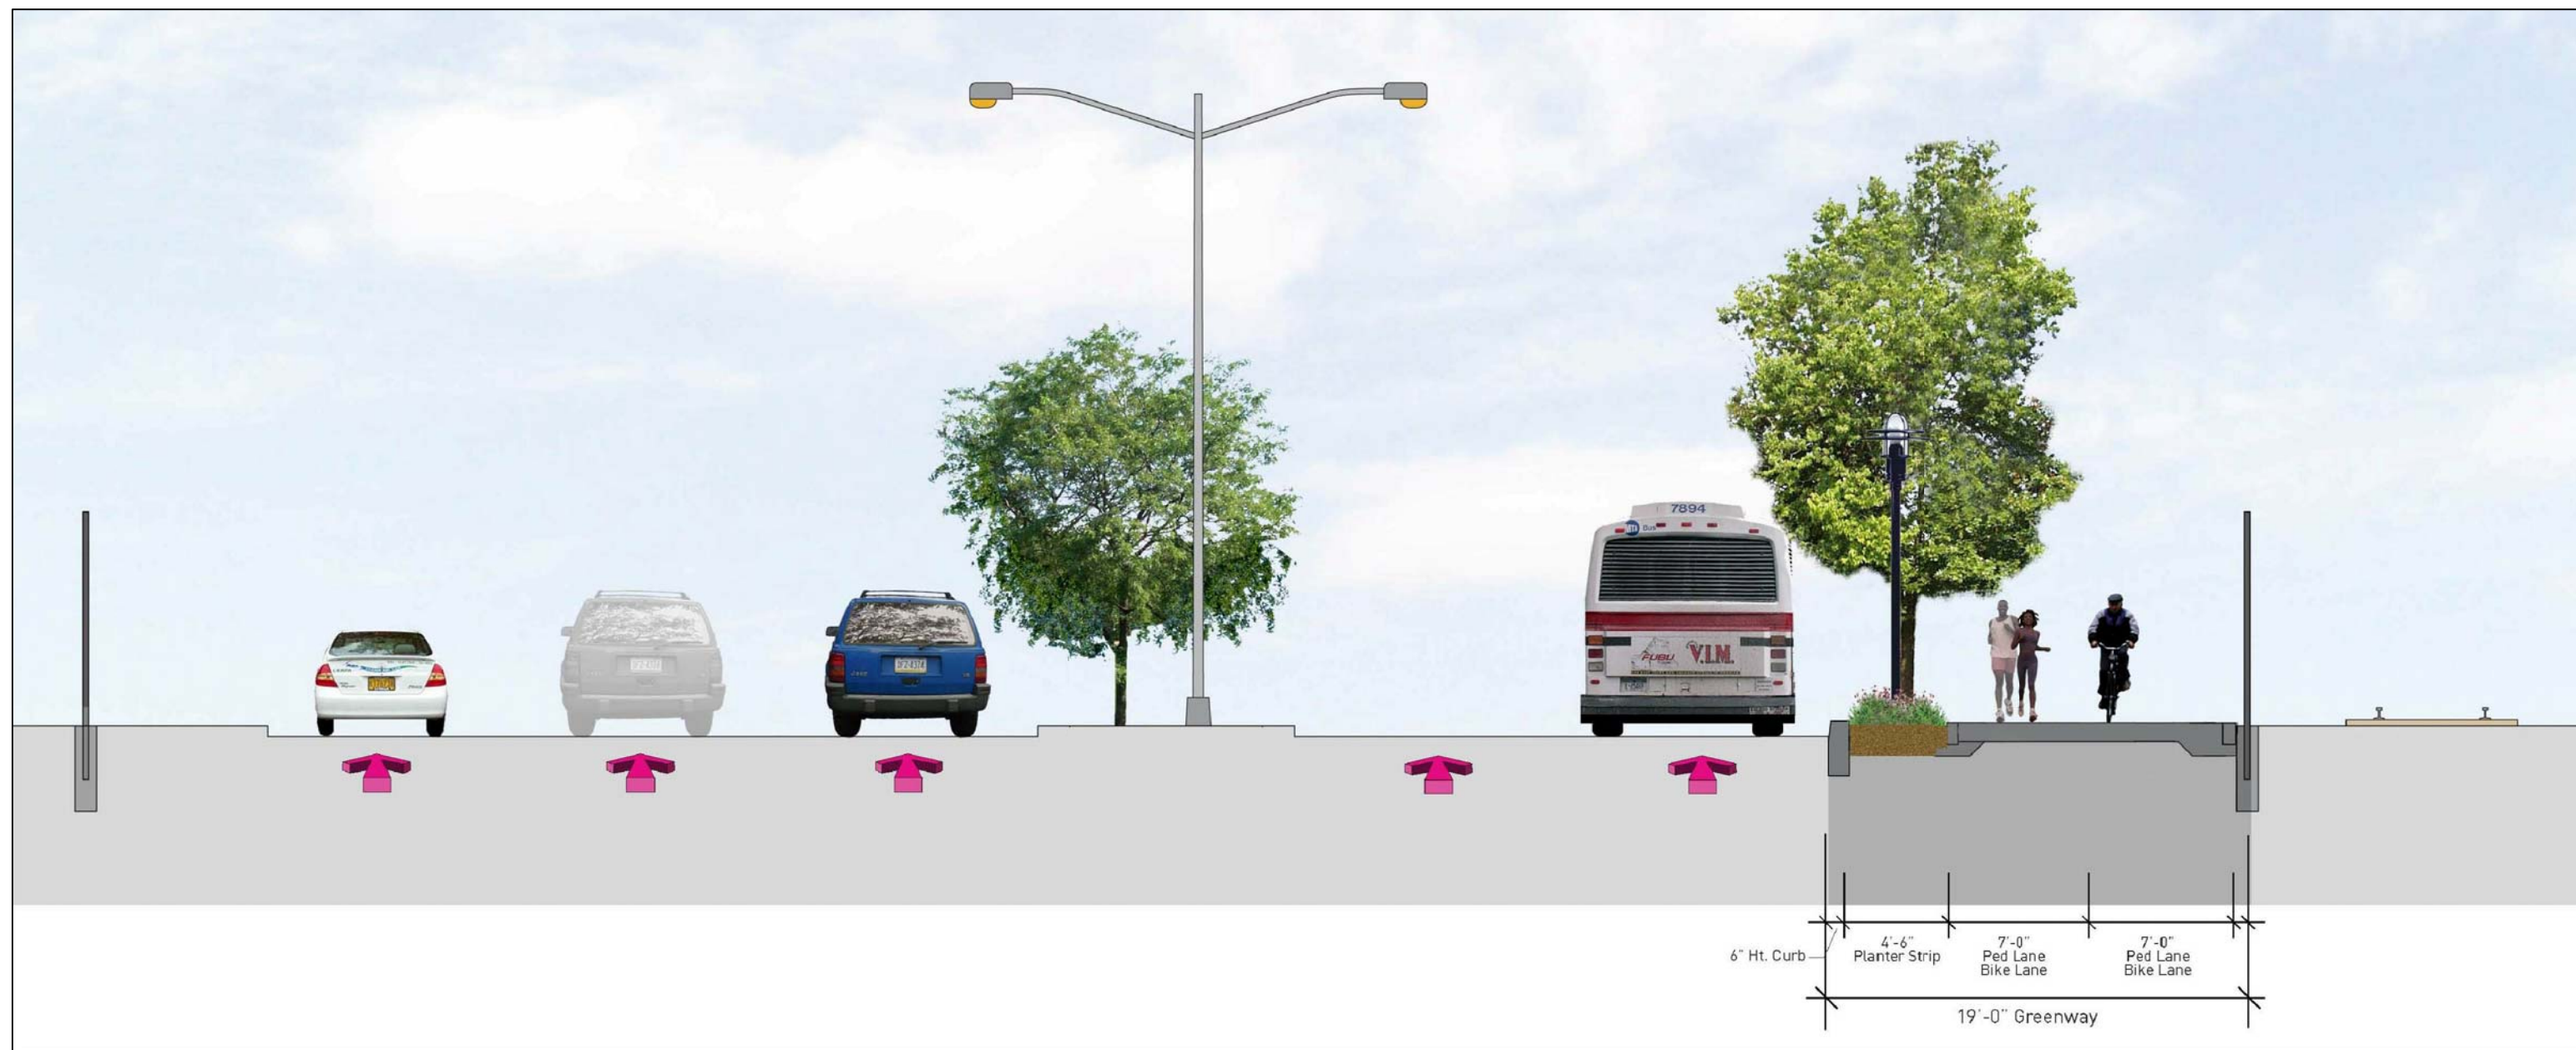
4

SOURCE: MATHEWS NIELSON LANDSCAPE ARCHITECTS,
GREENWAY SECTION B, FLUSH PLANTING STRIP

Greenway Construction - Condition 2

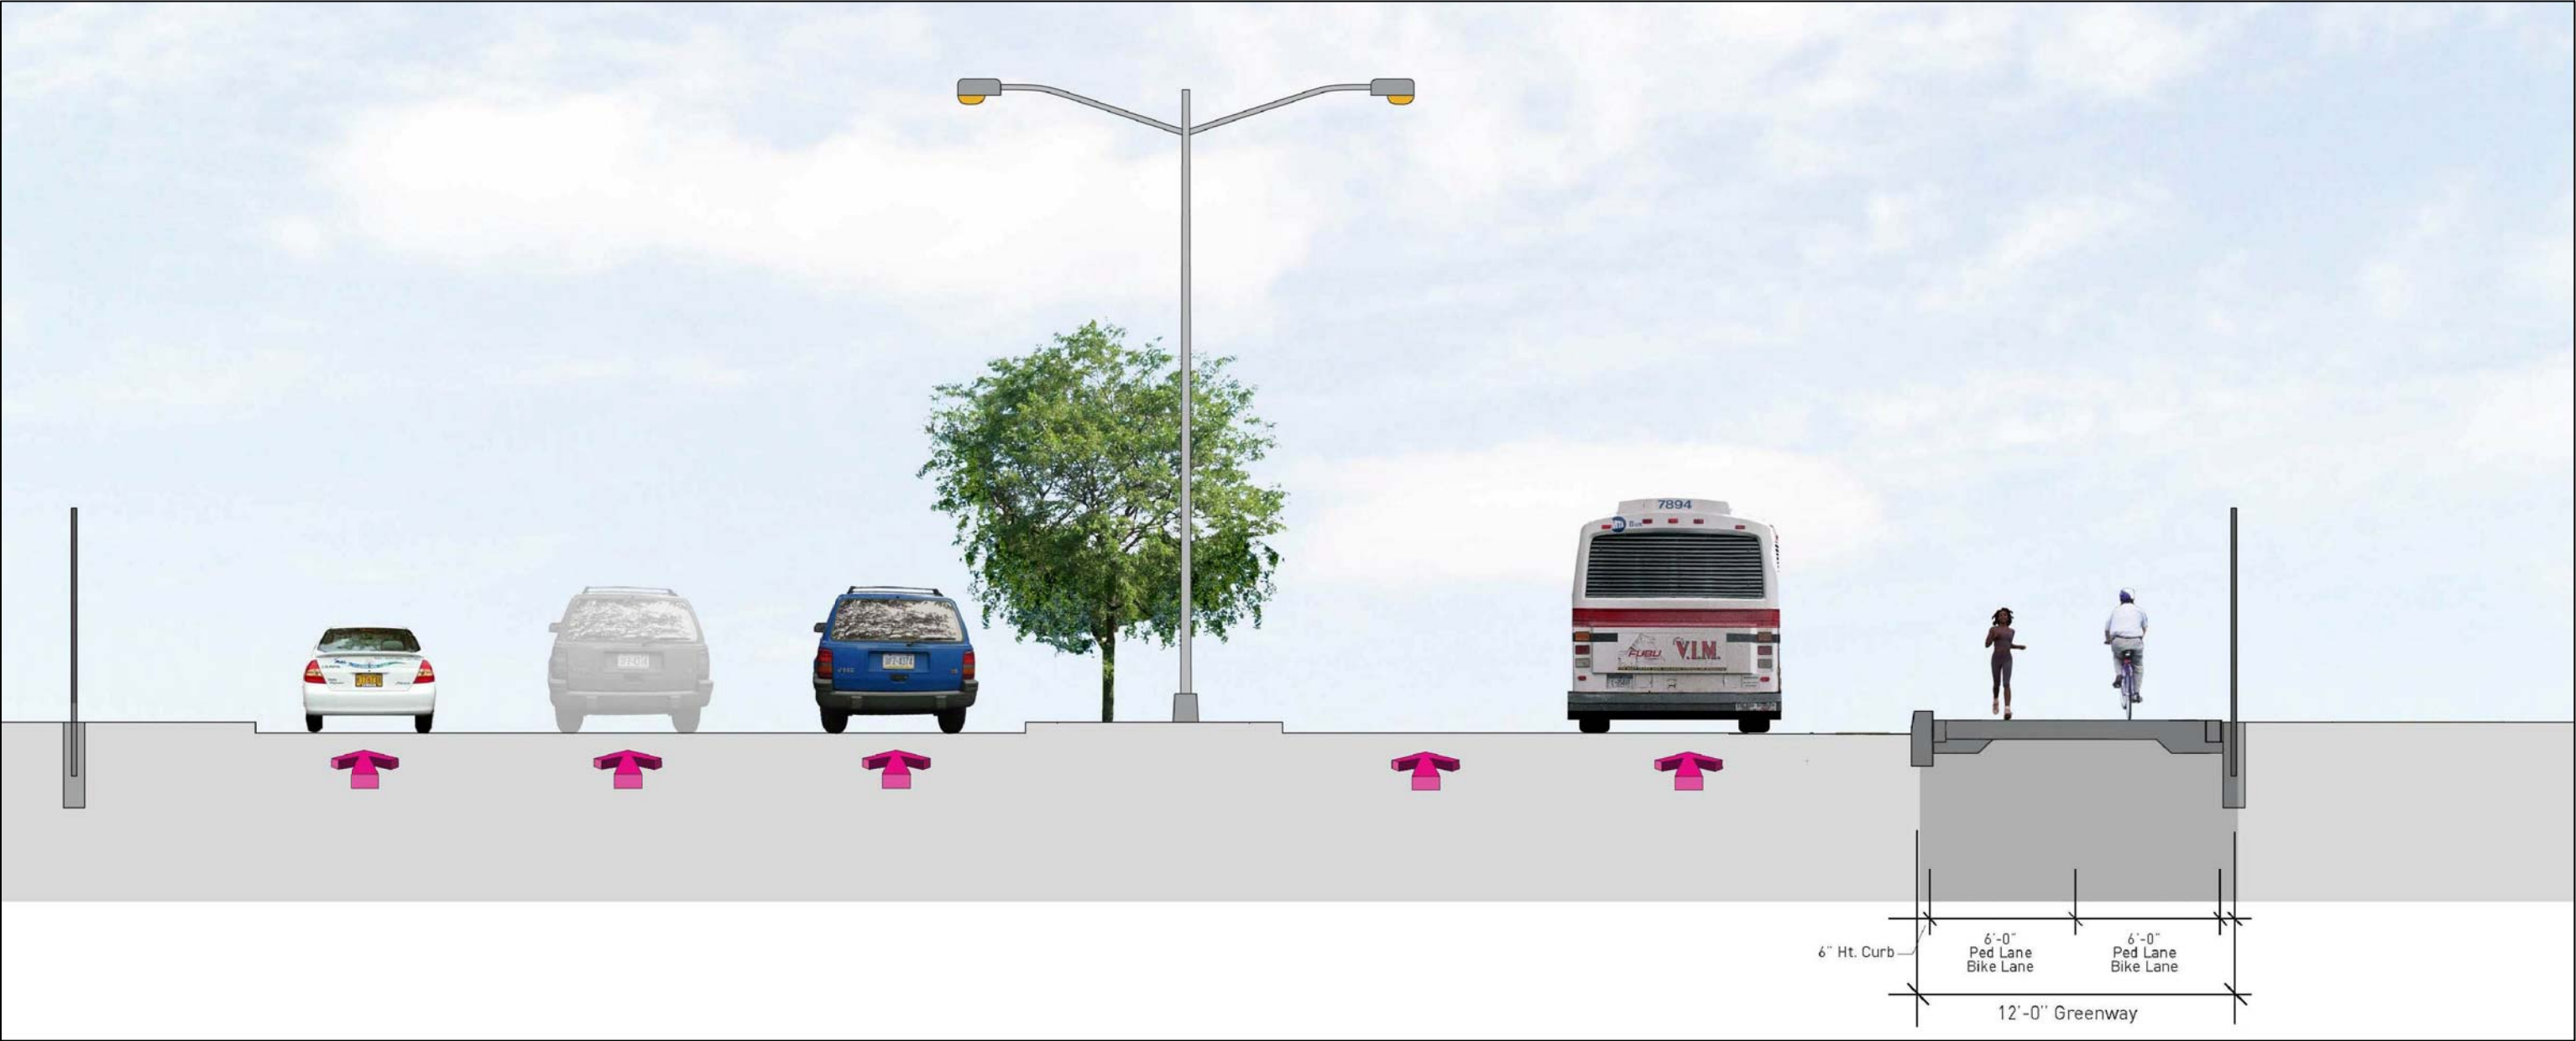
SOURCE: MATHEWS NIELSON LANDSCAPE ARCHITECTS,
GREENWAY SECTION C, NO PLANTING STRIP

Greenway Construction - Condition 3

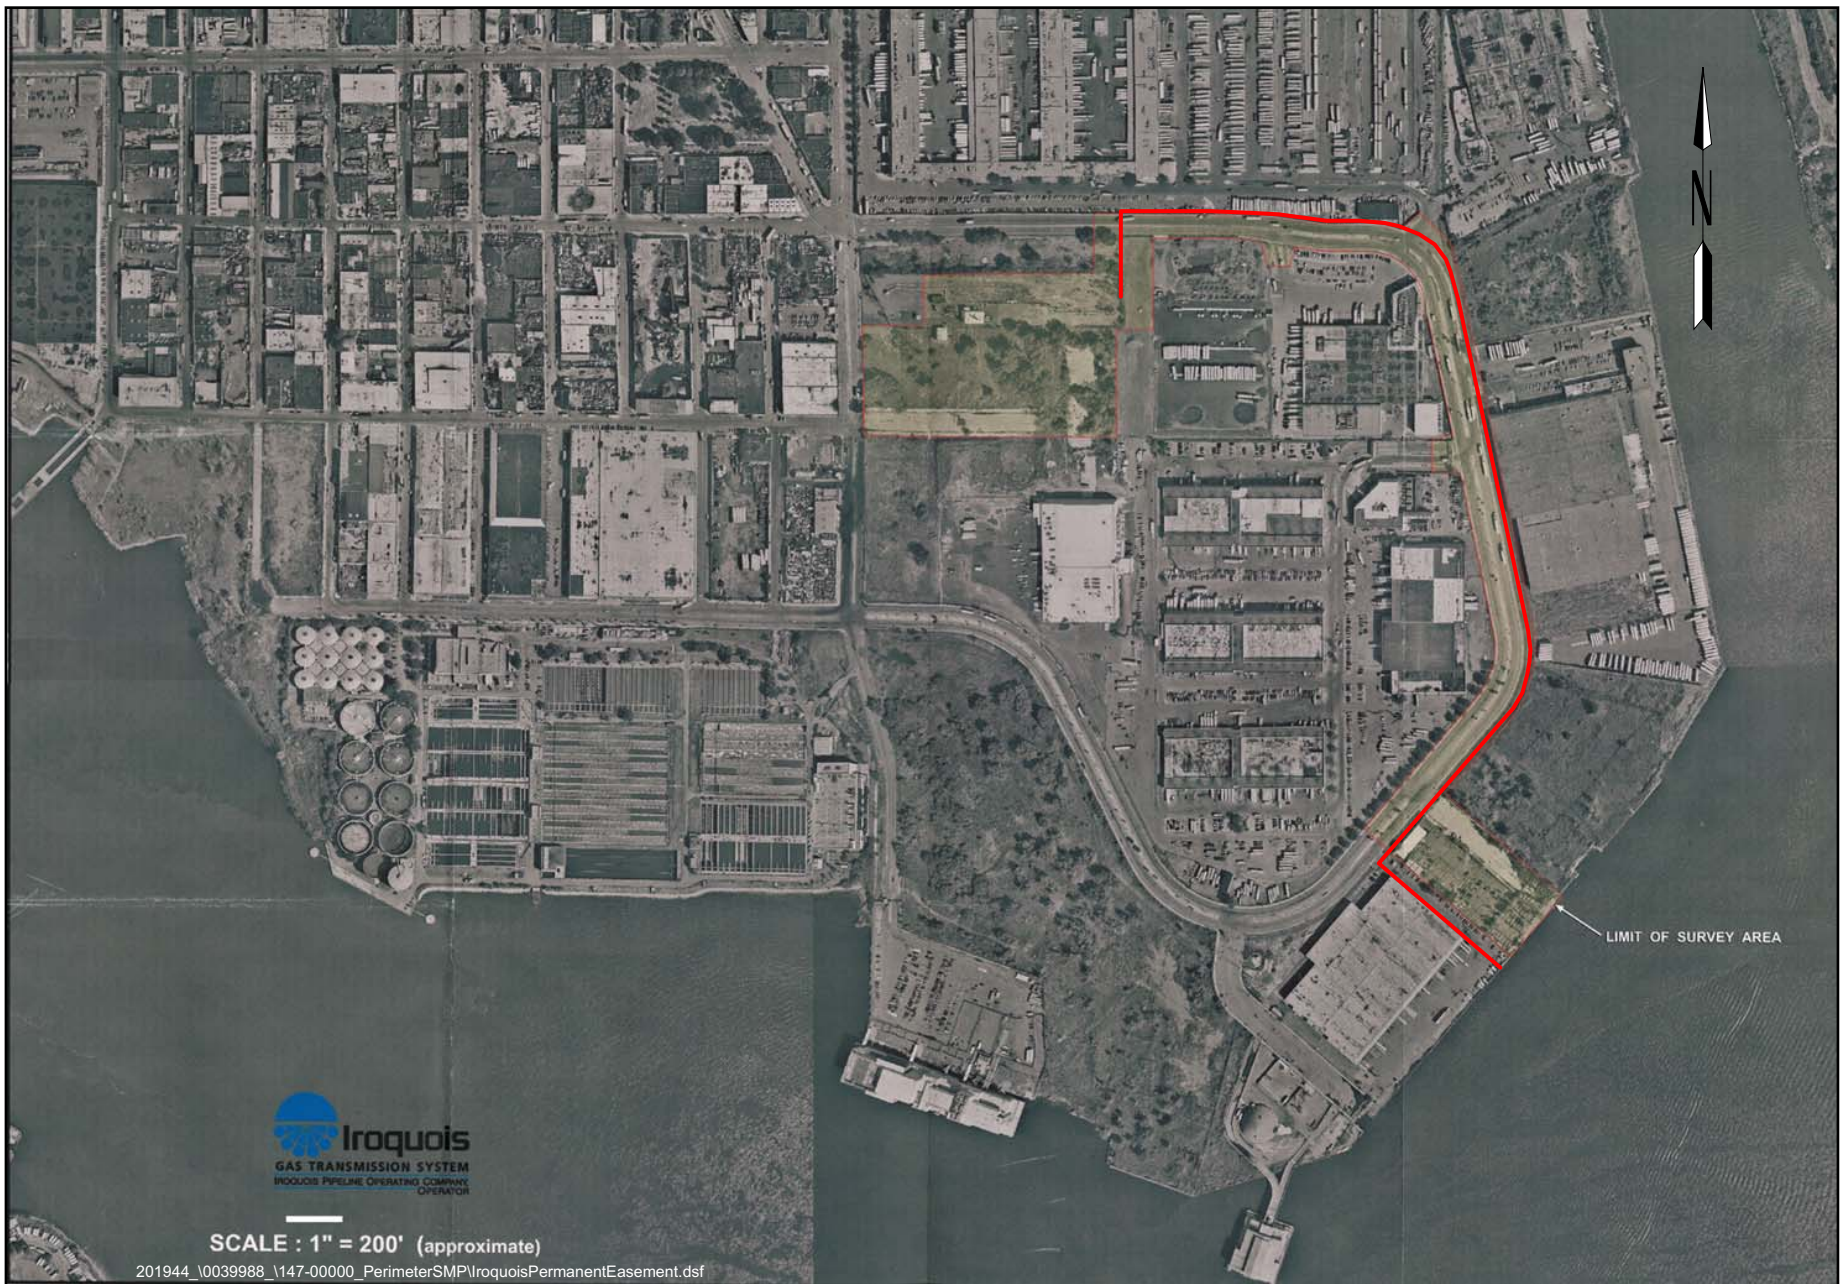
Figure
1

The proposed FCD Greenway Construction will impact two NYSDEC Voluntary Cleanup Program (VCP) Sites both located along FCD in the Hunts Point Food Distribution Center (HPFDC) of the Bronx, New York (refer to Figure 1). These two VCP sites are the Perimeter Site portion of FCD and the Consolidated Edison of New York, Inc. (Con Edison) areas.

shown on Figure 1. The deed restriction will be identified by adjacent parcel lot and block numbers due to the current site not being identified as a specific lot and block number. In the event that in the future the City of New York identifies this Site as a specific tax lot and block number, that designation will be made. However, at this time, it is intended by the City of New York to place a deed restriction on the properties located within the Hunts Point Food Distribution Center Meat Market and the Iroquois Pipeline / Perimeter Site.

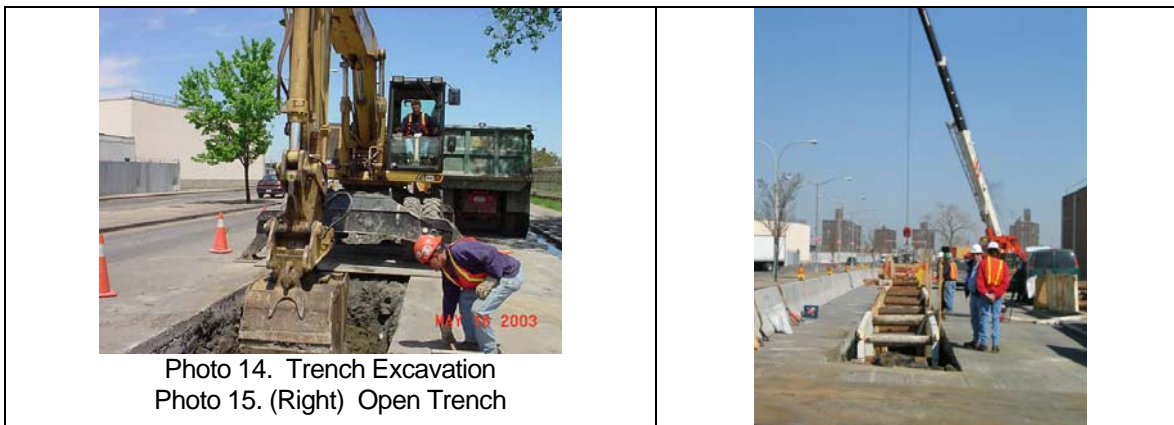
For trench excavation, asphalt and concrete was stripped back, loaded and delivered to the Bronx City Recycling facility. Soil and fill were then excavated using a Caterpillar M320 Wheel Excavator (Photos 14 and 15). Trenches were opened in 24 foot sections pulling back soil/fill in lifts. As the material was removed, any changes were noted and screening was performed by ENSR using a PID. Soils were visually inspected by LMS for previously described signs of waste material. As the excavation was advanced and the initial screening at the trench was completed, the soils were trucked to the Site C soil staging area and placed in the appropriate pile. LMS documented where each load was staged to help correlate sample results to the excavated areas. Before the truck departed, each load was visually inspected for loose material and/or saturated soils in order to prevent littering of the roadway.

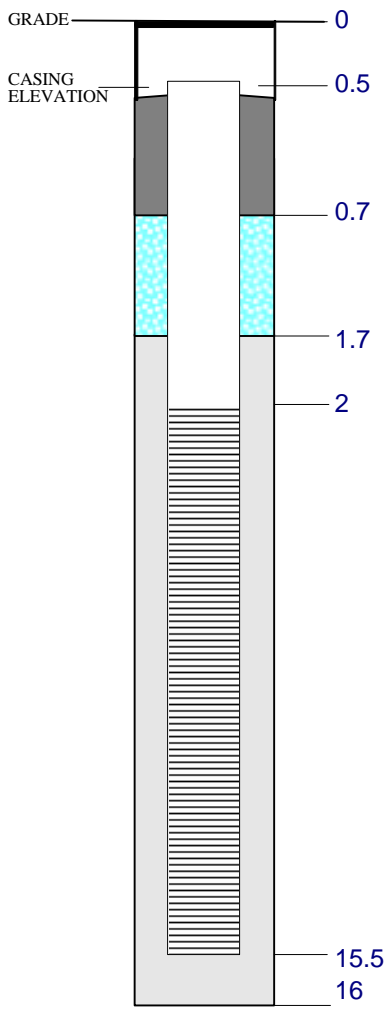
MONITORING WELL COMPLETION LOG		PROJECT NUMBER: 0781-020																																
PROJECT NAME: Iroquois Gas Pipeline		WELL No.: MW-11																																
CLIENT: NYC EDC																																		
LOCATION: Food Center Drive at intersect of Bay Street Ave. south of rail way																																		
DATE DRILLED: 11-Sep-02	DATE DEVELOPED: 24-Sep-02	WELL CONSTRUCTION COMPLETED: 11-Sep-02																																
DEVELOPING METHOD: Surged, bailed and pumped with submersible whale pump

<p style="text-align: center;">NOT TO SCALE</p>	<p>INSPECTOR: Beronica Lee</p> <p>DRILLING CONTRACTOR: Warren George Inc.</p> <p>TYPE OF WELL: 2"</p> <p>STATIC WATER LEVEL: 6.65 DATE: 9/16/2002</p> <p>MEASURING POINT: TOC TOTAL DEPTH OF WELL: 15.03 TOTAL DEPTH OF BORING: 16</p> <table border="1" style="width: 100%; border-collapse: collapse;"> <tr> <td style="padding: 5px;">DRILLING METHOD</td> <td style="padding: 5px;">TYPE: Hollow Stem Auger</td> </tr> <tr> <td style="padding: 5px;">DIAMETER: 6"</td> <td style="padding: 5px;">CASING: 2"</td> </tr> <tr> <td style="padding: 5px;">SAMPLING METHOD</td> <td style="padding: 5px;">TYPE: Split Spoon</td> </tr> <tr> <td style="padding: 5px;">DIAMETER: 2"</td> <td style="padding: 5px;">WEIGHT: 135 lb</td> </tr> <tr> <td style="padding: 5px;">FALL: 2'</td> <td style="padding: 5px;">INTERVAL: 6"</td> </tr> <tr> <td style="padding: 5px;">RISER PIPE LEFT IN PLACE</td> <td style="padding: 5px;">MATERIAL: PVC</td> </tr> <tr> <td style="padding: 5px;">DIAMETER: 2"</td> <td style="padding: 5px;">LENGTH: 2'</td> </tr> <tr> <td colspan="2" style="padding: 5px;">JOINT TYPE: Threaded</td> </tr> <tr> <td style="padding: 5px;">SCREEN</td> <td style="padding: 5px;">MATERIAL: PVC</td> </tr> <tr> <td style="padding: 5px;">INTERVAL: 2'-15.5'</td> <td style="padding: 5px;">DIAMETER: 2"</td> </tr> <tr> <td style="padding: 5px;">STRATIGRAPHIC UNITS SCREENED:</td> <td style="padding: 5px;">SLOT SIZE: 0.010"</td> </tr> <tr> <td style="padding: 5px;">FILTER PACK</td> <td style="padding: 5px;">GRADE: #1</td> </tr> <tr> <td style="padding: 5px;">SAND: Quartz</td> <td style="padding: 5px;">GRAVEL:</td> </tr> <tr> <td colspan="2" style="padding: 5px;">NATURAL:</td> </tr> <tr> <td style="padding: 5px;">AMOUNT: 3 bags</td> <td style="padding: 5px;">INTERVAL:</td> </tr> <tr> <td colspan="2" style="padding: 5px;">SEAL(s)</td> </tr> </table>		DRILLING METHOD	TYPE: Hollow Stem Auger	DIAMETER: 6"	CASING: 2"	SAMPLING METHOD	TYPE: Split Spoon	DIAMETER: 2"	WEIGHT: 135 lb	FALL: 2'	INTERVAL: 6"	RISER PIPE LEFT IN PLACE	MATERIAL: PVC	DIAMETER: 2"	LENGTH: 2'	JOINT TYPE: Threaded		SCREEN	MATERIAL: PVC	INTERVAL: 2'-15.5'	DIAMETER: 2"	STRATIGRAPHIC UNITS SCREENED:	SLOT SIZE: 0.010"	FILTER PACK	GRADE: #1	SAND: Quartz	GRAVEL:	NATURAL:		AMOUNT: 3 bags	INTERVAL:	SEAL(s)

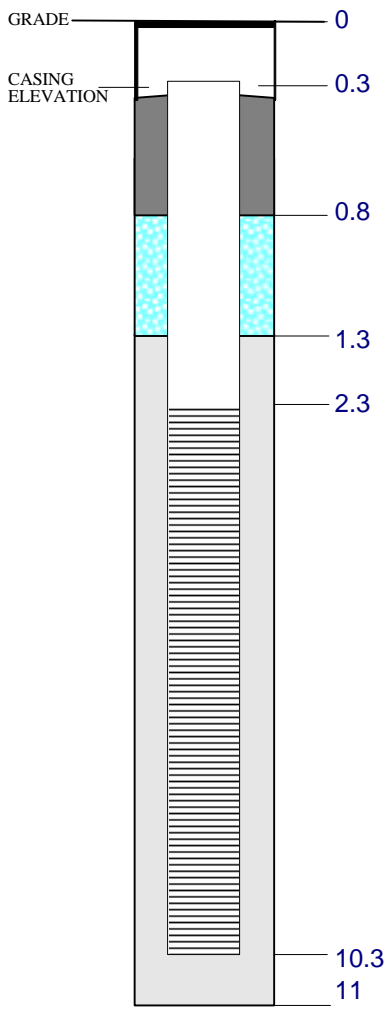
MONITORING WELL COMPLETION LOG		PROJECT NUMBER: 0781-020																																
PROJECT NAME: Iroquois Gas Pipeline		WELL No.: MW-12																																
CLIENT: NYC EDC																																		
LOCATION: 1400 Food Center Dr. across from A&P																																		
DATE DRILLED: 16-Sep-02	DATE DEVELOPED: 24-Sep-02	WELL CONSTRUCTION COMPLETED: 16-Sep-02																																
DEVELOPING METHOD: Surged, bailed and pumped with submersible whale pump

<p style="text-align: center;">NOT TO SCALE</p>	<p>INSPECTOR: Beronica Lee</p> <p>DRILLING CONTRACTOR: Warren George Inc.</p> <p>TYPE OF WELL: 2"</p> <p>STATIC WATER LEVEL: 6.06 DATE: 9/16/2002</p> <p>MEASURING POINT: TOC TOTAL DEPTH OF WELL: 10 TOTAL DEPTH OF BORING: 11</p> <table border="1" style="width: 100%; border-collapse: collapse;"> <tr> <td style="padding: 2px;">DRILLING METHOD</td> <td style="padding: 2px;">TYPE: Hollow Stem Auger</td> </tr> <tr> <td style="padding: 2px;">DIAMETER: 6"</td> <td style="padding: 2px;">CASING: 2"</td> </tr> <tr> <td style="padding: 2px;">SAMPLING METHOD</td> <td style="padding: 2px;">TYPE: Split Spoon</td> </tr> <tr> <td style="padding: 2px;">DIAMETER: 2"</td> <td style="padding: 2px;">WEIGHT: 135 lb</td> </tr> <tr> <td style="padding: 2px;">FALL: 2'</td> <td style="padding: 2px;">INTERVAL: 6"</td> </tr> <tr> <td style="padding: 2px;">RISER PIPE LEFT IN PLACE</td> <td style="padding: 2px;">MATERIAL: PVC</td> </tr> <tr> <td style="padding: 2px;">DIAMETER: 2"</td> <td style="padding: 2px;">LENGTH: 2'</td> </tr> <tr> <td colspan="2" style="padding: 2px;">JOINT TYPE: Threaded</td> </tr> <tr> <td style="padding: 2px;">SCREEN</td> <td style="padding: 2px;">MATERIAL: PVC</td> </tr> <tr> <td style="padding: 2px;">INTERVAL: 2'-10'</td> <td style="padding: 2px;">DIAMETER: 2"</td> </tr> <tr> <td style="padding: 2px;">STRATIGRAPHIC UNITS SCREENED:</td> <td style="padding: 2px;">SLOT SIZE: 0.010"</td> </tr> <tr> <td style="padding: 2px;">FILTER PACK</td> <td style="padding: 2px;">GRADE: #1</td> </tr> <tr> <td style="padding: 2px;">SAND: Quartz</td> <td style="padding: 2px;">GRAVEL:</td> </tr> <tr> <td colspan="2" style="padding: 2px;">NATURAL:</td> </tr> <tr> <td style="padding: 2px;">AMOUNT: 4 bags</td> <td style="padding: 2px;">INTERVAL: 1.3'-11'</td> </tr> <tr> <td colspan="2" style="padding: 2px;">SEAL(s)</td> </tr> </table>		DRILLING METHOD	TYPE: Hollow Stem Auger	DIAMETER: 6"	CASING: 2"	SAMPLING METHOD	TYPE: Split Spoon	DIAMETER: 2"	WEIGHT: 135 lb	FALL: 2'	INTERVAL: 6"	RISER PIPE LEFT IN PLACE	MATERIAL: PVC	DIAMETER: 2"	LENGTH: 2'	JOINT TYPE: Threaded		SCREEN	MATERIAL: PVC	INTERVAL: 2'-10'	DIAMETER: 2"	STRATIGRAPHIC UNITS SCREENED:	SLOT SIZE: 0.010"	FILTER PACK	GRADE: #1	SAND: Quartz	GRAVEL:	NATURAL:		AMOUNT: 4 bags	INTERVAL: 1.3'-11'	SEAL(s)

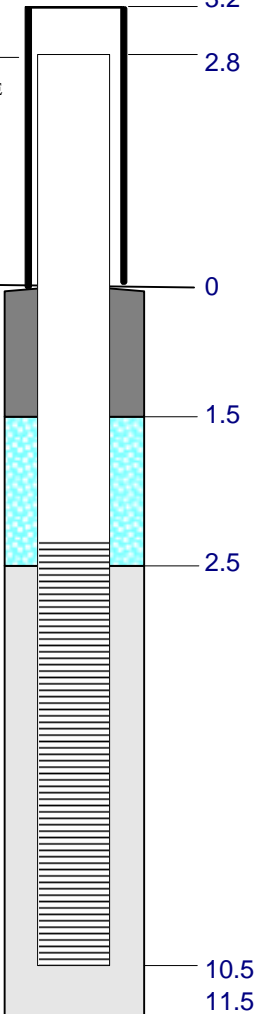
MONITORING WELL COMPLETION LOG		PROJECT NUMBER: 0781-020																										
PROJECT NAME: Iroquois Gas Pipeline		WELL No.: MW-13																										
CLIENT: NYC EDC																												
LOCATION: Food Center Drive at intersect of Bay Street Ave. south of rail way																												
DATE DRILLED: 13-Sep-02	DATE DEVELOPED: 24-Sep-02	WELL CONSTRUCTION COMPLETED: 13-Sep-02																										
DEVELOPING METHOD: Bailed and submersible whale pump																												
<div style="display: flex; align-items: center;"> <div style="writing-mode: vertical-rl; transform: rotate(180deg); font-size: small; margin-right: 5px;"> PROTECTIVE CASING CASING DISTANCE FROM SURFACE GRADE ELEVATION </div>

<div style="margin-left: 10px;"> <p>3.2</p> <p>2.8</p> <p>0</p> <p>1.5</p> <p>2.5</p> <p>10.5</p> <p>11.5</p> </div> </div> <p style="text-align: center; margin-top: 10px;">NOT TO SCALE</p>	<div style="display: flex; flex-direction: column;"> <div style="margin-bottom: 10px;"> INSPECTOR: Beronica Lee DRILLING CONTRACTOR: Warren George Inc. TYPE OF WELL: 2" </div> <div style="margin-bottom: 10px;"> STATIC WATER LEVEL: 6.65 DATE: 9/16/2002 MEASURING POINT: TOC TOTAL DEPTH OF WELL: 15.1 TOTAL DEPTH OF BORING: </div> <div style="margin-bottom: 10px;"> <table border="1" style="width: 100%; border-collapse: collapse;"> <tr> <td style="width: 60%; padding: 2px;">DRILLING METHOD</td> <td style="padding: 2px;">TYPE: Hollow Stem Auger</td> </tr> <tr> <td style="padding: 2px;">DIAMETER: 6"</td> <td style="padding: 2px;">CASING: 2"</td> </tr> </table> </div> <div style="margin-bottom: 10px;"> <table border="1" style="width: 100%; border-collapse: collapse;"> <tr> <td style="width: 60%; padding: 2px;">SAMPLING METHOD</td> <td style="padding: 2px;">TYPE: Split Spoon</td> </tr> <tr> <td style="padding: 2px;">DIAMETER: 2"</td> <td style="padding: 2px;">WEIGHT: 135 lb.</td> </tr> <tr> <td style="padding: 2px;">FALL: 2'</td> <td style="padding: 2px;">INTERVAL: 6"</td> </tr> </table> </div> <div style="margin-bottom: 10px;"> <table border="1" style="width: 100%; border-collapse: collapse;"> <tr> <td style="width: 60%; padding: 2px;">RISER PIPE LEFT IN PLACE</td> <td style="padding: 2px;">MATERIAL: PVC</td> </tr> <tr> <td style="padding: 2px;">DIAMETER: LENGTH: JOINT TYPE: Threaded</td> <td></td> </tr> </table> </div> <div style="margin-bottom: 10px;"> <table border="1" style="width: 100%; border-collapse: collapse;"> <tr> <td style="width: 60%; padding: 2px;">SCREEN</td> <td style="padding: 2px;">MATERIAL: PVC</td> </tr> <tr> <td style="padding: 2px;">INTERVAL: 5.5'-10.5' DIAMETER: 2"</td> <td></td> </tr> <tr> <td style="padding: 2px;">STRATIGRAPHIC UNITS SCREENED:</td> <td style="padding: 2px;">SLOT SIZE: 0.010"</td> </tr> </table> </div> <div style="margin-bottom: 10px;"> <table border="1" style="width: 100%; border-collapse: collapse;"> <tr> <td style="width: 60%; padding: 2px;">FILTER PACK</td> <td style="padding: 2px;">GRADE: #1</td> </tr> <tr> <td style="padding: 2px;">SAND: Quartz GRAVEL: NATURAL:</td> <td></td> </tr> <tr> <td style="padding: 2px;">AMOUNT: INTERVAL:</td> <td></td> </tr> </table> </div> <div style="background-color: #cccccc; padding: 2px;">SEAL(s)</div> </div>		DRILLING METHOD	TYPE: Hollow Stem Auger	DIAMETER: 6"	CASING: 2"	SAMPLING METHOD	TYPE: Split Spoon	DIAMETER: 2"	WEIGHT: 135 lb.	FALL: 2'	INTERVAL: 6"	RISER PIPE LEFT IN PLACE	MATERIAL: PVC	DIAMETER: LENGTH: JOINT TYPE: Threaded		SCREEN	MATERIAL: PVC	INTERVAL: 5.5'-10.5' DIAMETER: 2"		STRATIGRAPHIC UNITS SCREENED:	SLOT SIZE: 0.010"	FILTER PACK	GRADE: #1	SAND: Quartz GRAVEL: NATURAL:		AMOUNT: INTERVAL:
