**FINAL  
SITE INSPECTION PRIORITIZATION  
HUDSON RIVER PSYCHIATRIC CENTER  
POUGHKEEPSIE, DUTCHESS COUNTY, NEW YORK**

# ENGINEERING INVESTIGATIONS AT INACTIVE HAZARDOUS WASTE SITES

## PHASE II INVESTIGATION

Hudson River Psychiatric Center Site No. 314063  
Town of Poughkeepsie Dutchess County

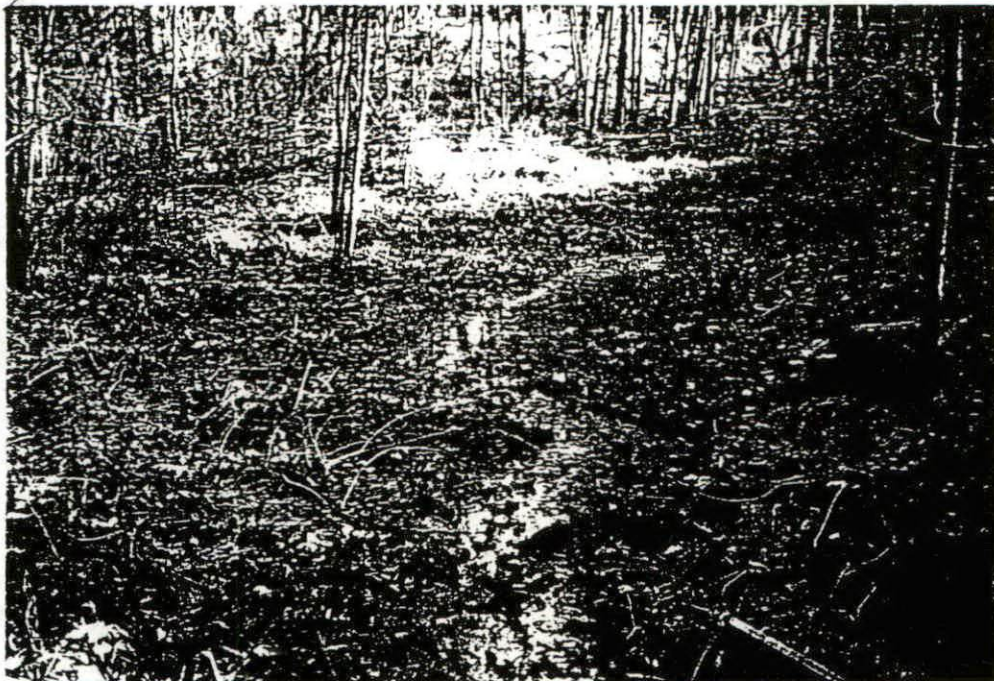
PHOTO 1. Area 1. Looking southeast at stream with debris and leachate.

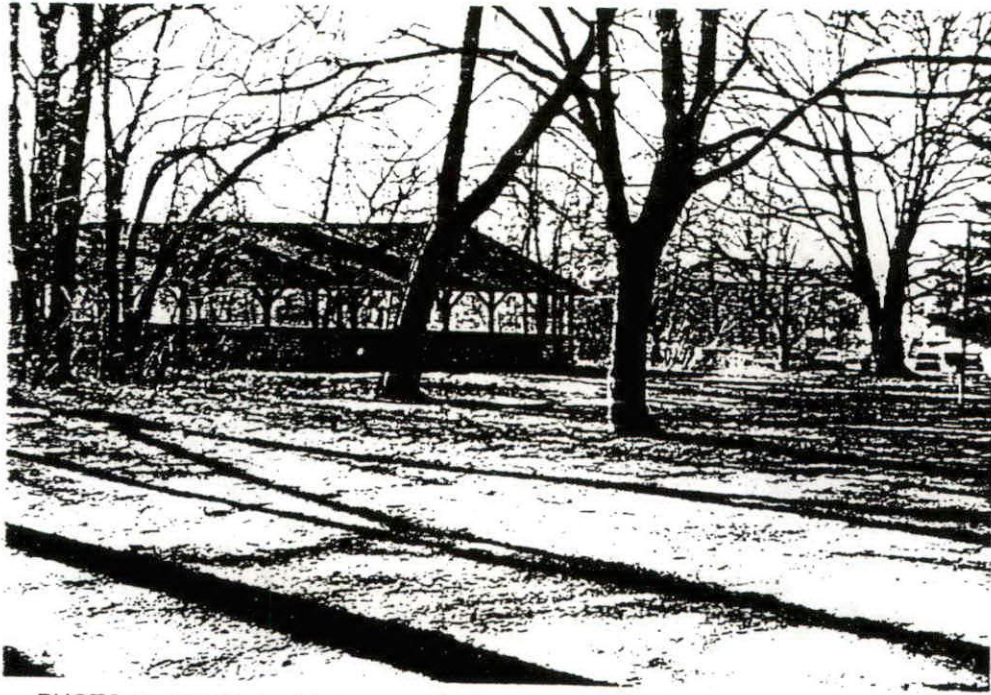
PHOTO 5. Area 6. Looking west at picnic pavilion.
