Re: Periodic Review Report
One Buffalo Street Site (VCP Site No. V-00659-9)

PERIODIC REVIEW REPORT

ONE BUFFALO STREET SITE
HAMBURG, NEW YORK

VCP SITE NUMBER V- 00659- 9

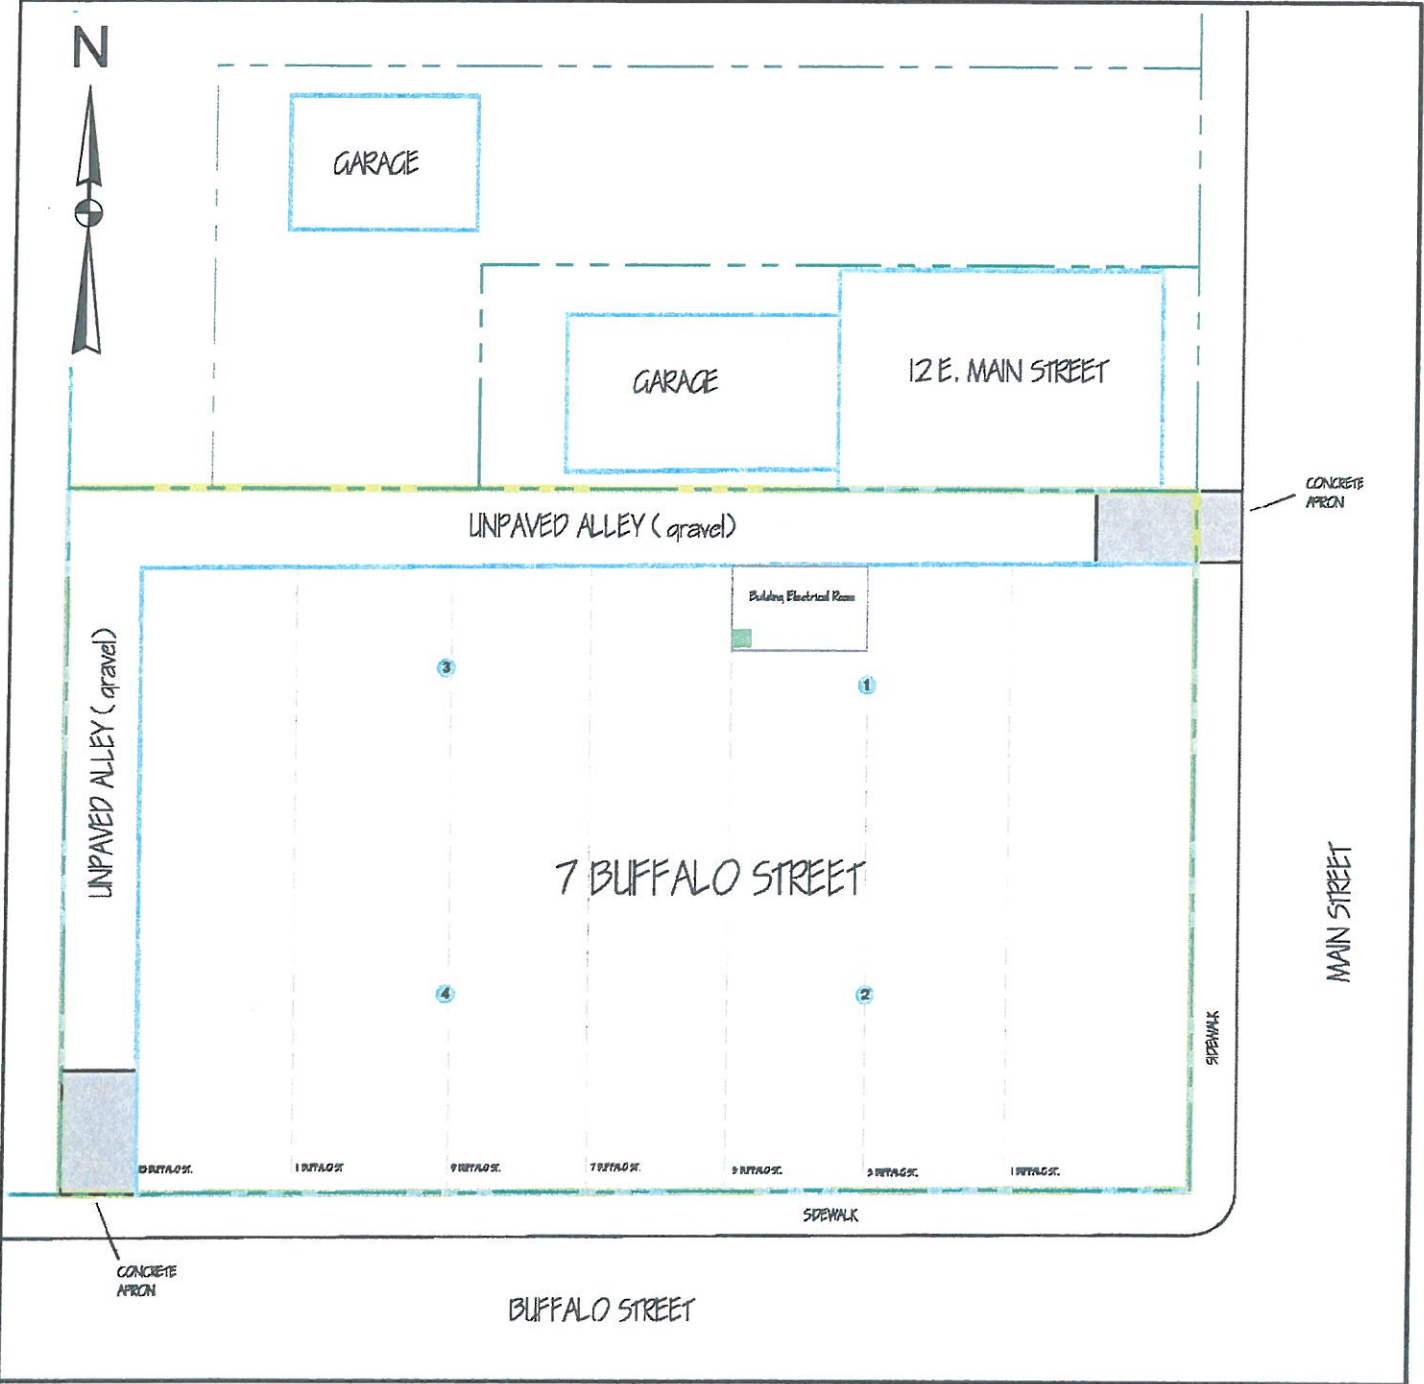
FIGURE NO. 2

SITE PLAN

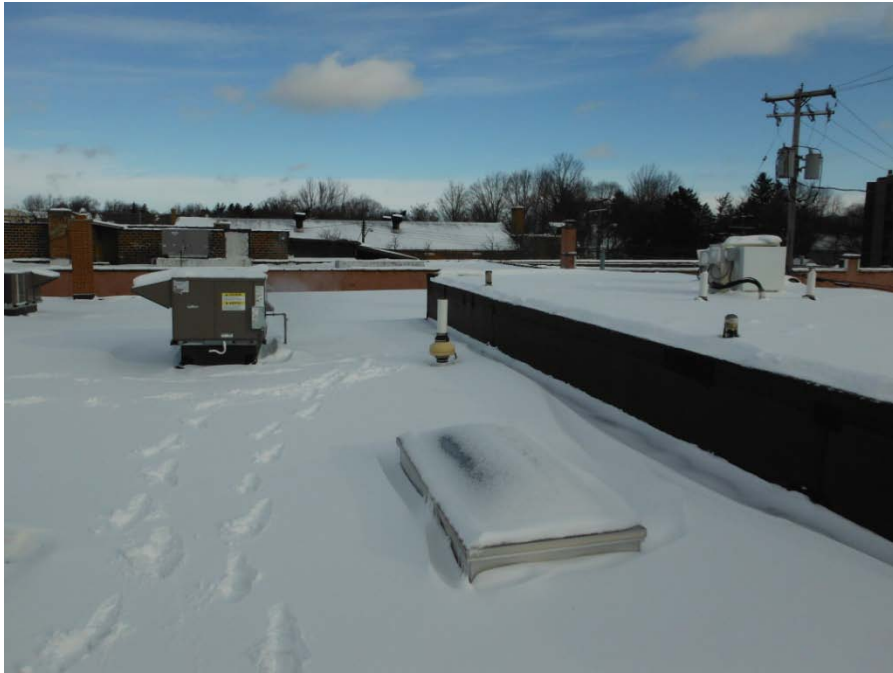
Photograph 1 – Northern SSV Mitigation Roof Fan

The SMP requires the proper operation and maintenance of the SSV mitigation system. TVGA evaluated the operation of the SSV mitigation system during the biennial site inspection. TVGA observed the discharge locations on the roof of the building, and the locations were free of ice and snow build-up. Additionally, while on the roof TVGA confirmed that both the north branch and south branch fans were operating and that air was flowing out of the vent pipes. TVGA and Mr. Reekie manually tripped the alarms on the SSV mitigation system monitoring system to confirm system operation by de-energizing both the north and south SSV mitigation fans. The north branch system monitoring gauges changed from green indicator lights to red indicator lights and an audible alarm sounded within a few minutes. However, while the fan was noted to be working, the south branch indicator light and alarm did not activate when manually tripped. Because the fan was operational this deficiency does not impact the performance of the SSV mitigation system. Mr. Reekie indicated that he contacted Mitigation Tech who will be onsite within a week to examine and correct this deficiency. A separate letter will be sent to NYSDEC to confirm this deficiency has been corrected.

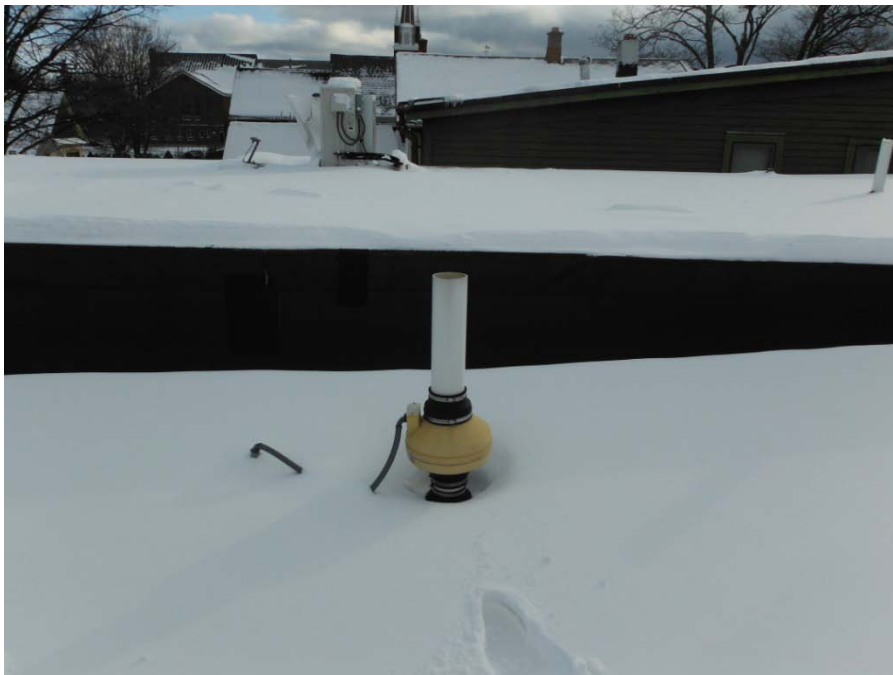
Photograph 2 – Southern SSV Mitigation Roof Fan

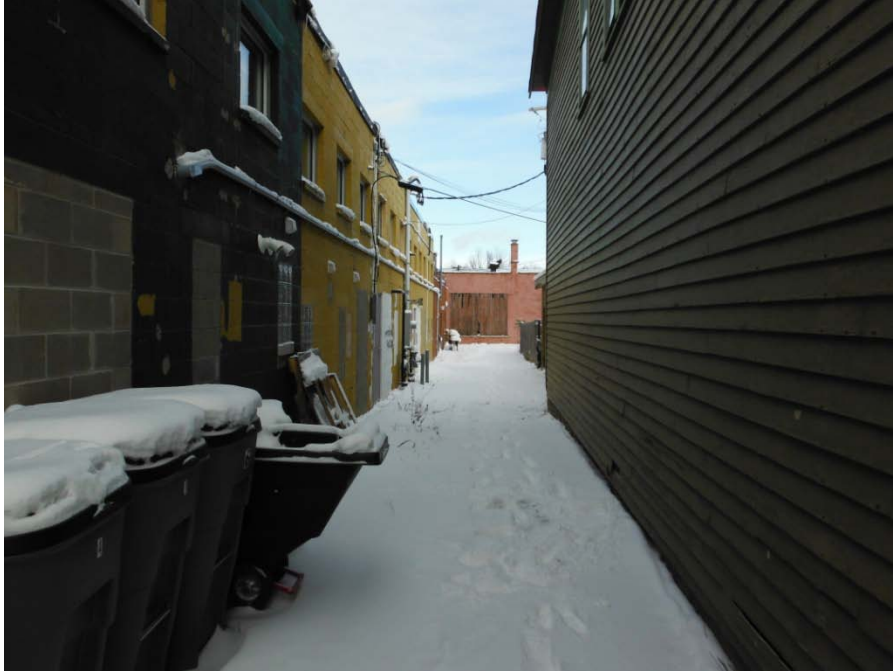
Photograph 3 – Unpaved Alleyway (East of the Building)

According to the SMP, the alley immediately to the east of the building was to remain unpaved. Although covered with snow, a walk through of the alley confirmed that the alley surfaces were unpaved and consisted of gravel and/or dirt, with the exception of a small concrete apron that extends from East Main Street to approximately ten feet behind 1 Buffalo Street. This concrete apron has been in place for a few years and is not anticipated to impact the performance of the SSV mitigation system.

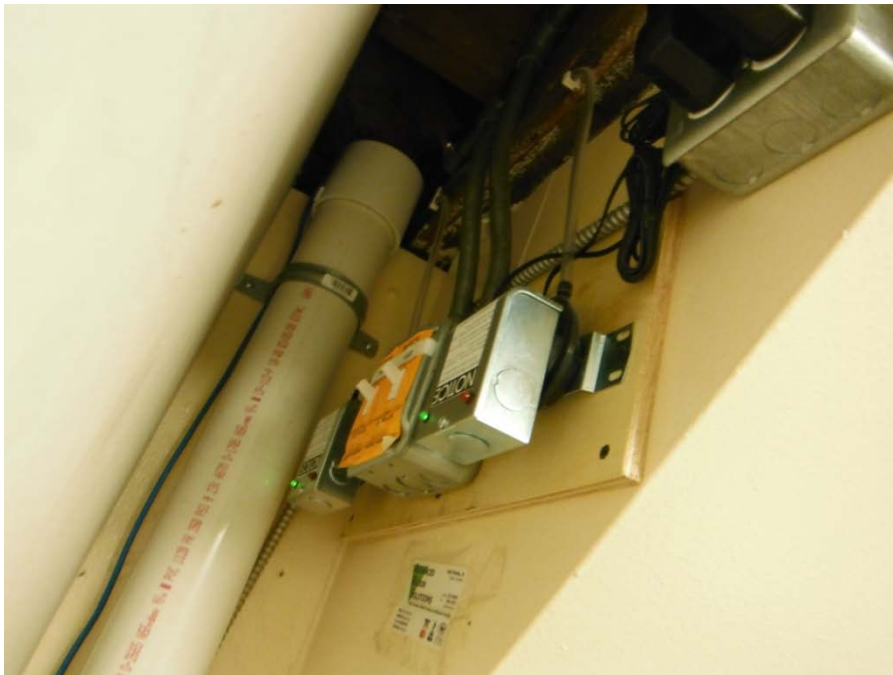
Photograph 4 – SSV Mitigation System Controls and Monitoring Equipment

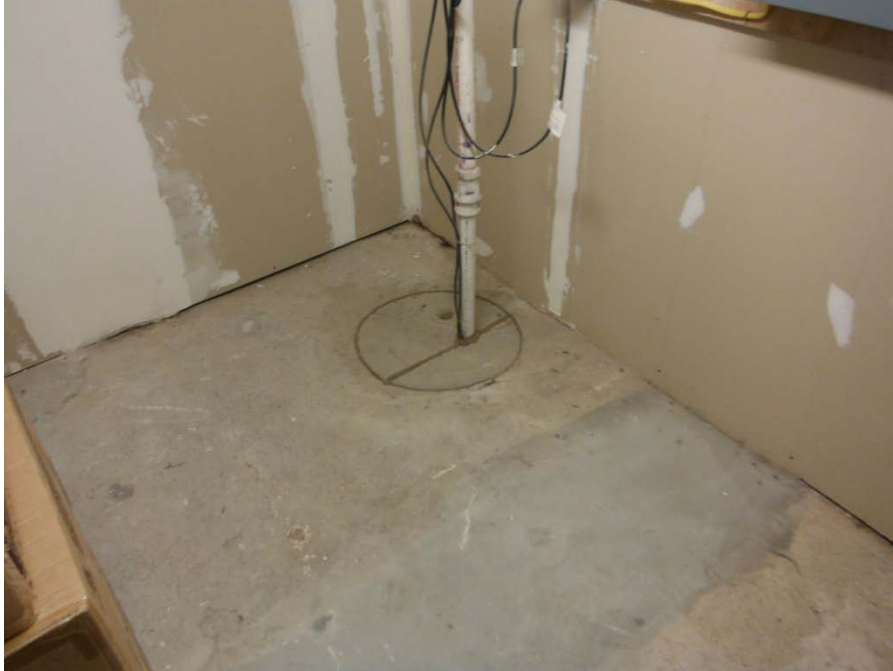
Photograph 5 – Sealed Sump in Building Basement

The SMP requires the connection of the sump to the sanitary sewer at all times, and that any additional sumps installed in the future will also be connected to the sanitary sewer. TVGA evaluated the condition of the sump in the basement of 11 Buffalo Street during the site inspection. A lexan cover is sealed over the sump, and all plumbing connections appeared intact. The cover and seal were not disturbed during the inspection. Additionally, no new sumps were observed in the basement of the building and no modification to the sump or the connection to the sanitary sewer occurred during the recent building renovations.
