# PERIODIC REVIEW REPORT

**ONE BUFFALO STREET SITE  
HAMBURG, NEW YORK**

**(VCP SITE NO. V-00659-9)**

Prepared for:  
**One Buffalo Street, Inc.**

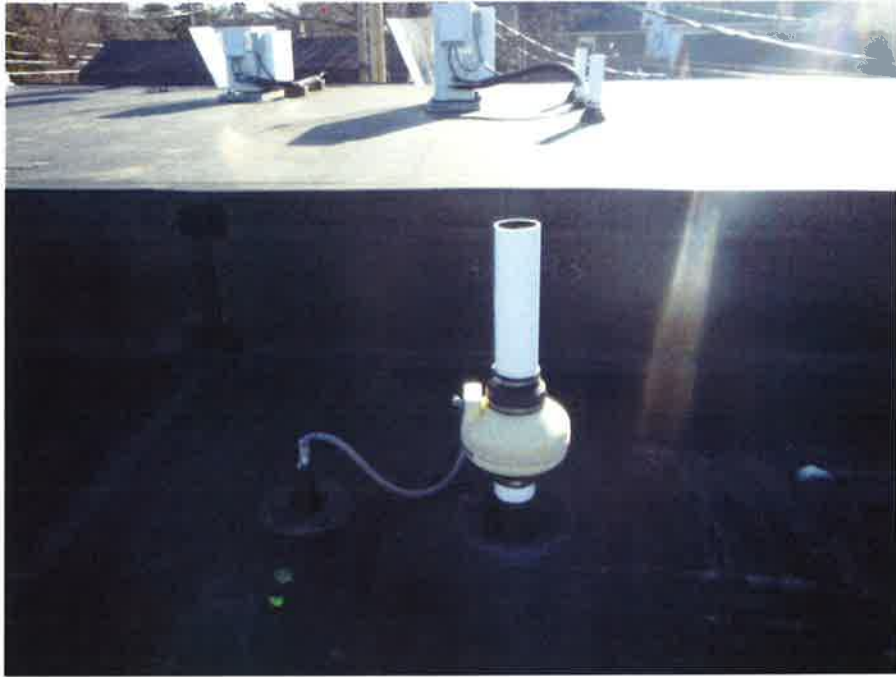
Photograph 1 – Northern SSV Mitigation Roof Fan

The SMP requires the proper operation and maintenance of the SSV mitigation system. KHEOPS evaluated the operation of the SSV mitigation system during the biennial site inspection. KHEOPS observed the discharge locations on the roof of the building, and the locations were free of ice and snow build-up. Additionally, while on the roof, KHEOPS confirmed that both the north branch and south branch fans were operating and that air was flowing out of the vent pipes. KHEOPS and Mr. Struebel manually tripped the alarms on the SSV mitigation system monitoring system to confirm system operation by de-energizing both the north and south SSV mitigation fans. The north branch system monitoring gauges changed from green indicator lights to red indicator lights and an audible alarm sounded within a few seconds.

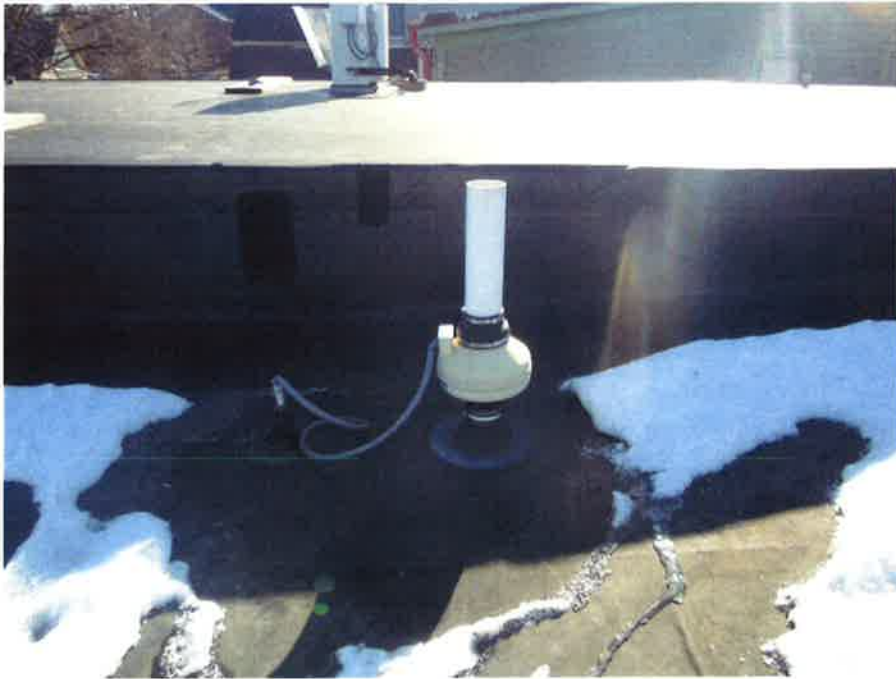
Photograph 2 – Southern SSV Mitigation Roof Fan

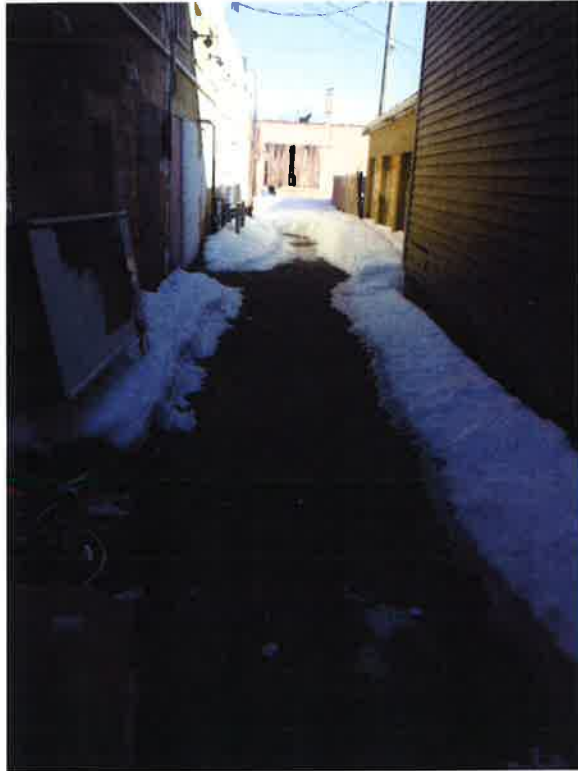
According to the SMP, the alley immediately to the east of the building was to remain unpaved. Although partially covered with snow, a walk-through of the alley confirmed that the alley surfaces were unpaved and consisted of gravel and/or dirt, with the exception of a small concrete apron that extends from East Main Street to approximately ten feet behind 1 Buffalo Street. This concrete apron has been in place for a few years and is not anticipated to impact the performance of the SSV mitigation system.

Photograph 3 – Unpaved Alleyway (East of the Building)

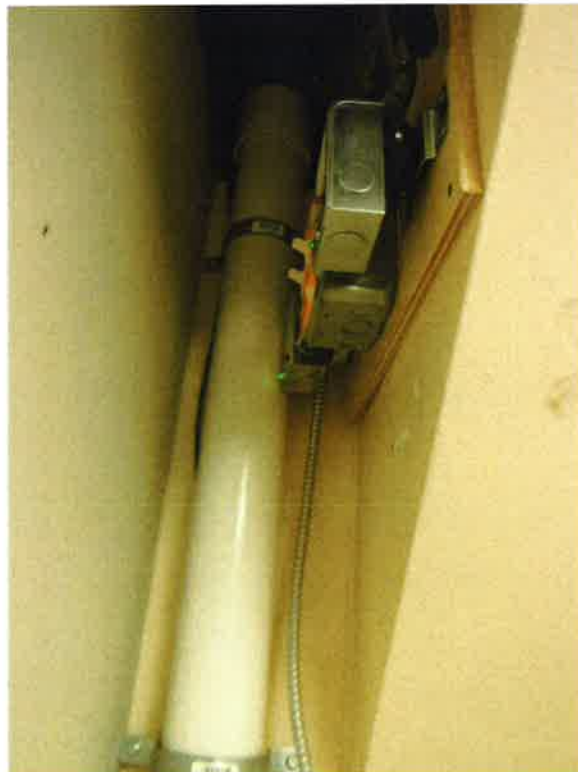
Photograph 4 – SSV Mitigation System Controls and Monitoring Equipment

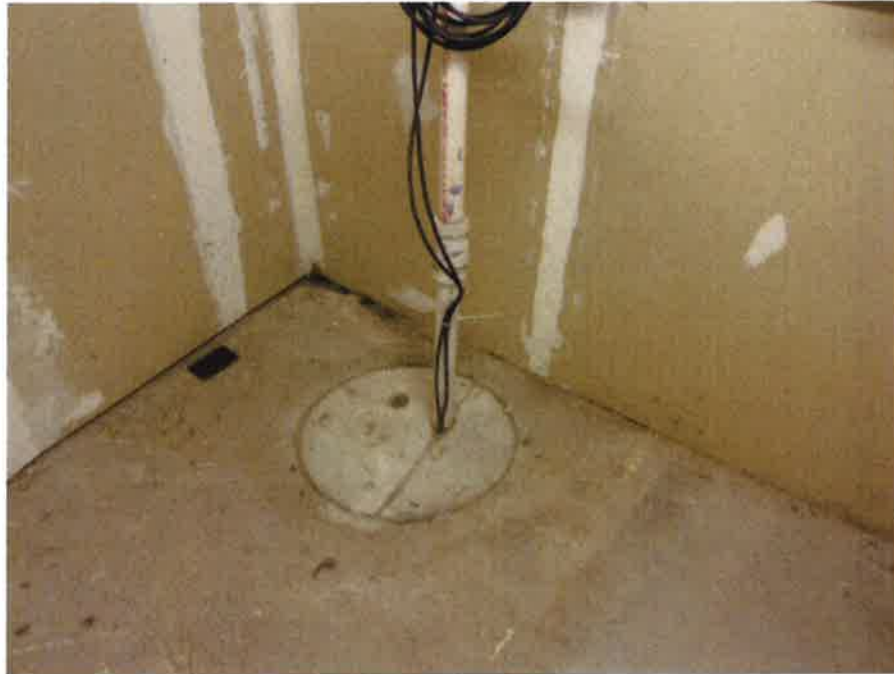
basement of 11 Buffalo Street during the site inspection. A lexan cover is sealed over the sump, and all plumbing connections appeared intact. The cover and seal were not disturbed during the inspection. Additionally, no new sumps were observed in the basement of the building and no modification to the sump or the connection to the sanitary sewer had occurred with the exception of Mr. Struebel having to change a switch associated with the sump.

Photograph 5 – Sealed Sump in Building Basement
