***Final Remedial Report
303 Woodward Ave.***

EnSol has prepared this **Final Remedial Report** to document remedial activities performed at the property and document the environmental conditions at the site prior to putting the property back in service.

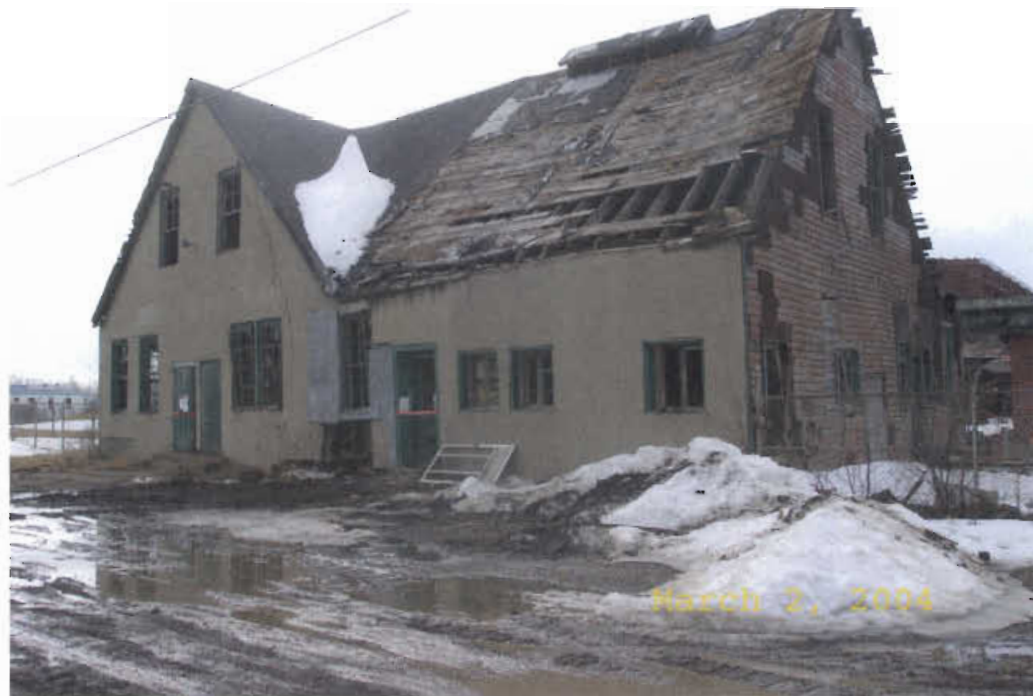
The site is a former steel ball bearing manufacturing facility (The Excelsior Steel Ball Company) that dates back to 1887. The Excelsior Steel Ball Company was founded and operated by the Roughead family of Tonawanda. Activities at the site, typical of metal working facilities, ceased in the late 1990's. The site is characteristic of brownfield sites in that the structures and equipment associated with the past manufacture of steel ball bearings remained on site. The 2.19-acre property originally included three structures used for manufacturing, maintenance and storage. A topographic survey of site conditions prior to site clean up and restoration is provided on Sheets 2-1 and 2-2, Building Demolition. The 25,000 sft main structure (**Bldg. 1**) was the manufacturing facility that housed metalworking equipment, machine shop area, heat treating equipment, inventory storage, shipping and office areas. There were two auxiliary structures on site located to the north and east of the main structure (**Bldgs. 2 and 3**). They appeared to have been used for facility maintenance and storage. The auxiliary buildings were approximately 6,400 and 1,400 sft in area. Photographs of the structures at the site prior to cleanup activities (Photos 1 – 3) are provided in **Attachment 2**. As shown in the site photographs, the structures were extremely dilapidated.

1 - Existing Site Conditions

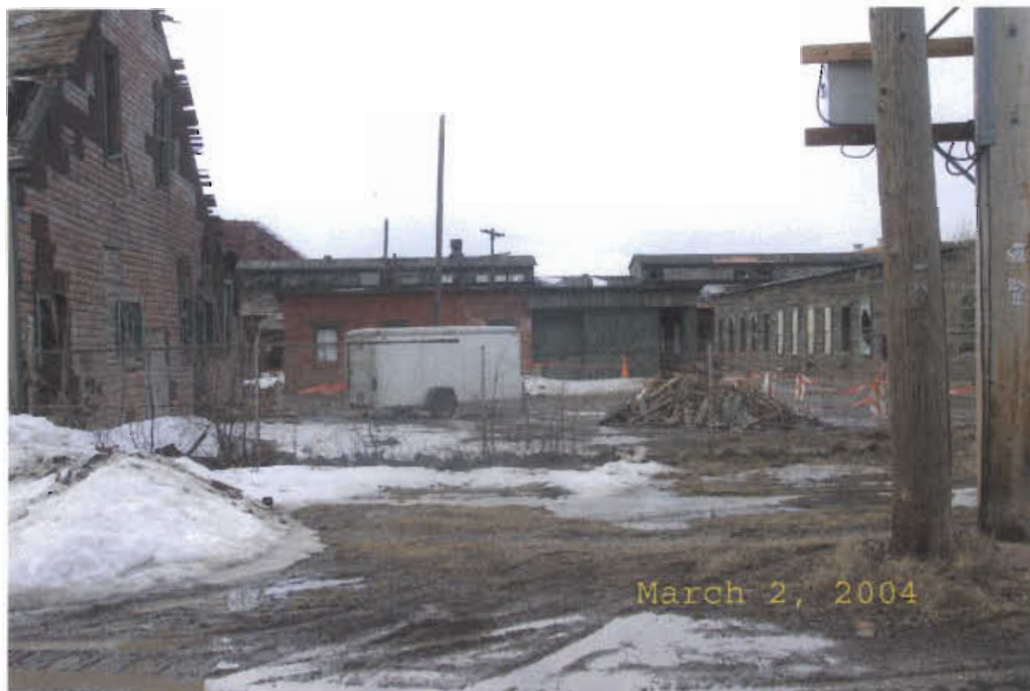
2 - Existing Site Conditions

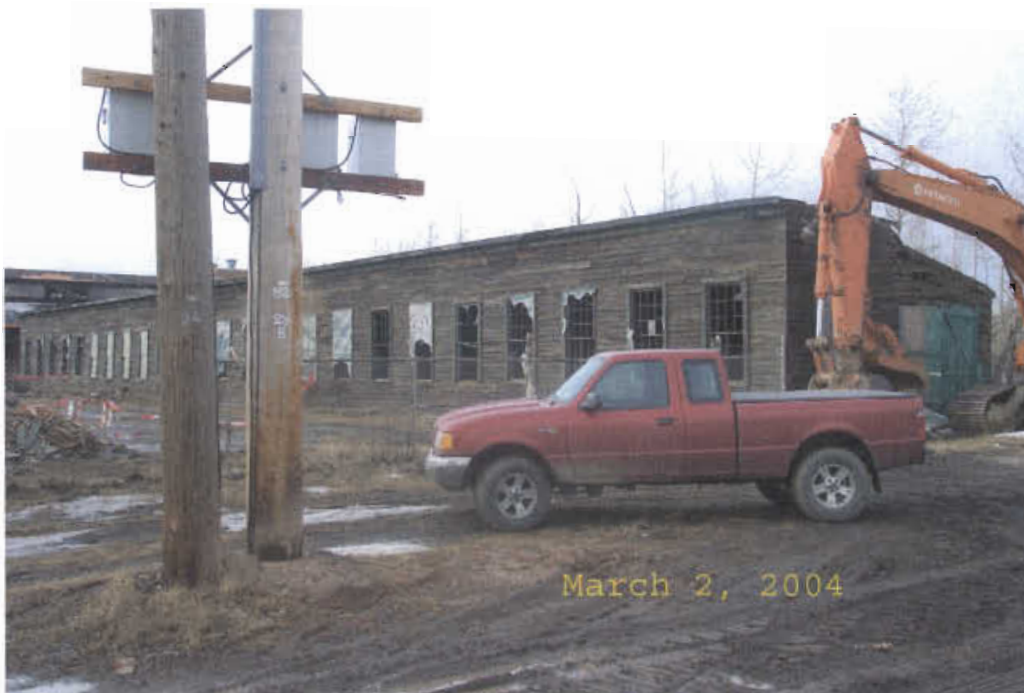
3 - Existing Site Conditions

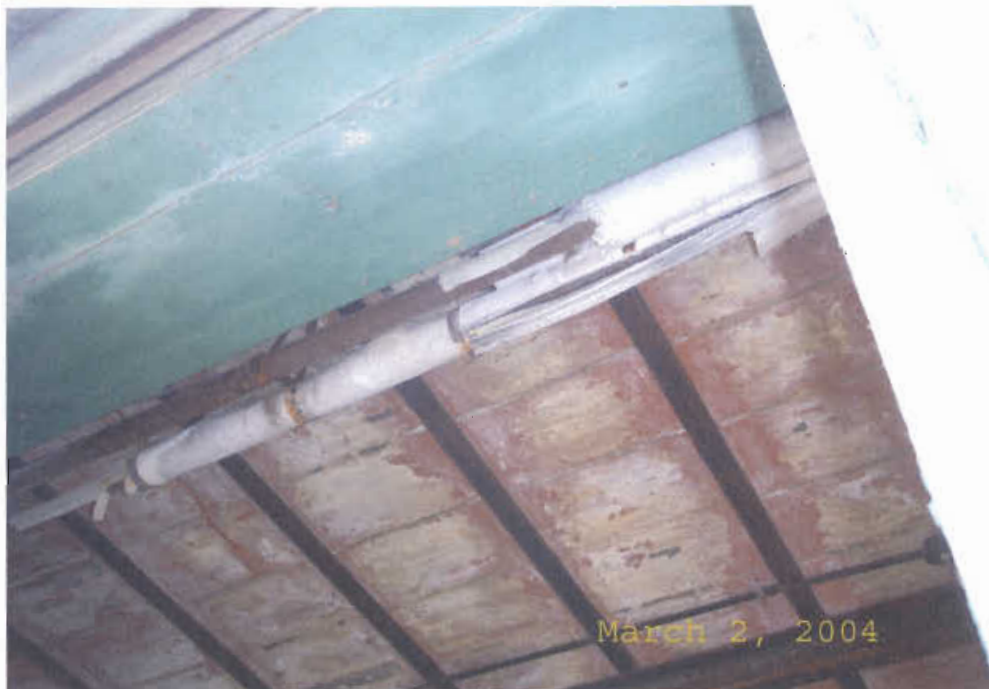
4 - ACM: Pipe Insulation

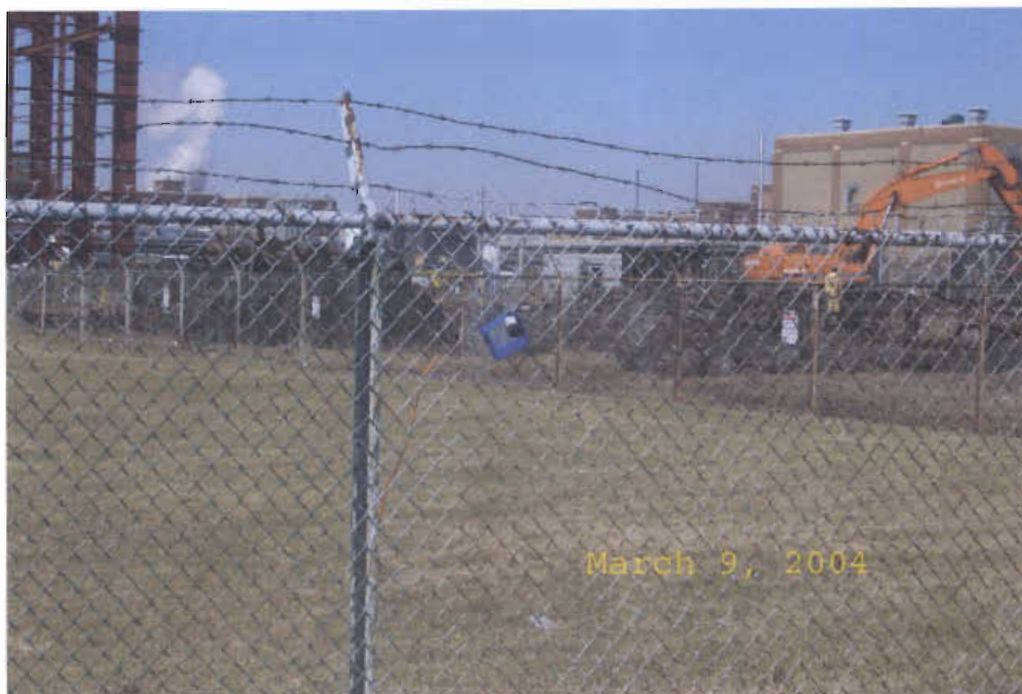
5 - Dust Particulate Meter at Site Perimeter

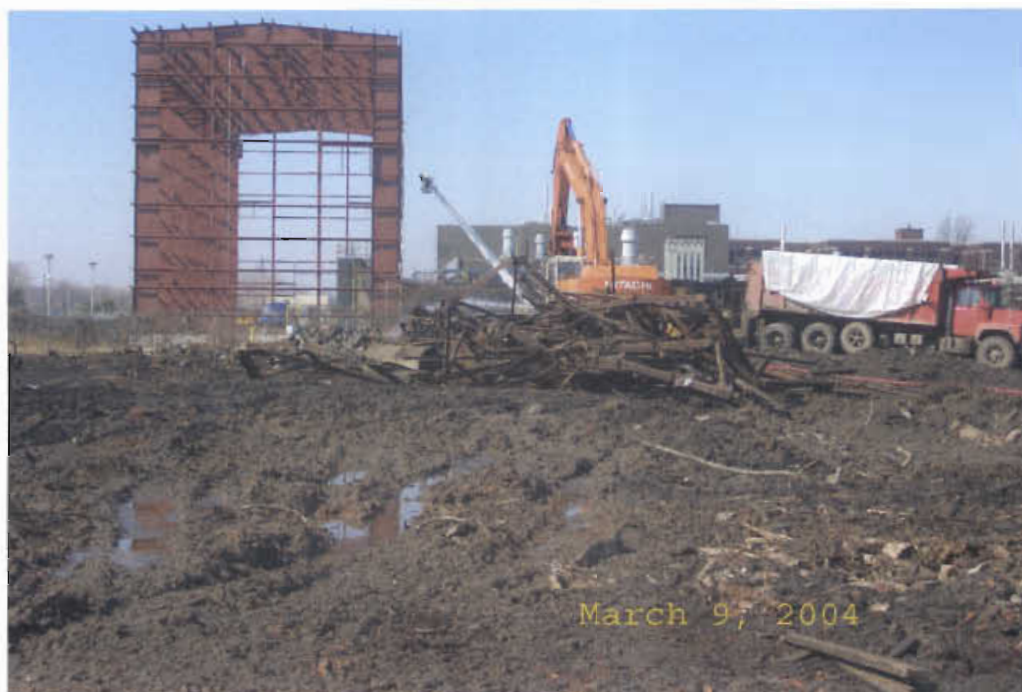
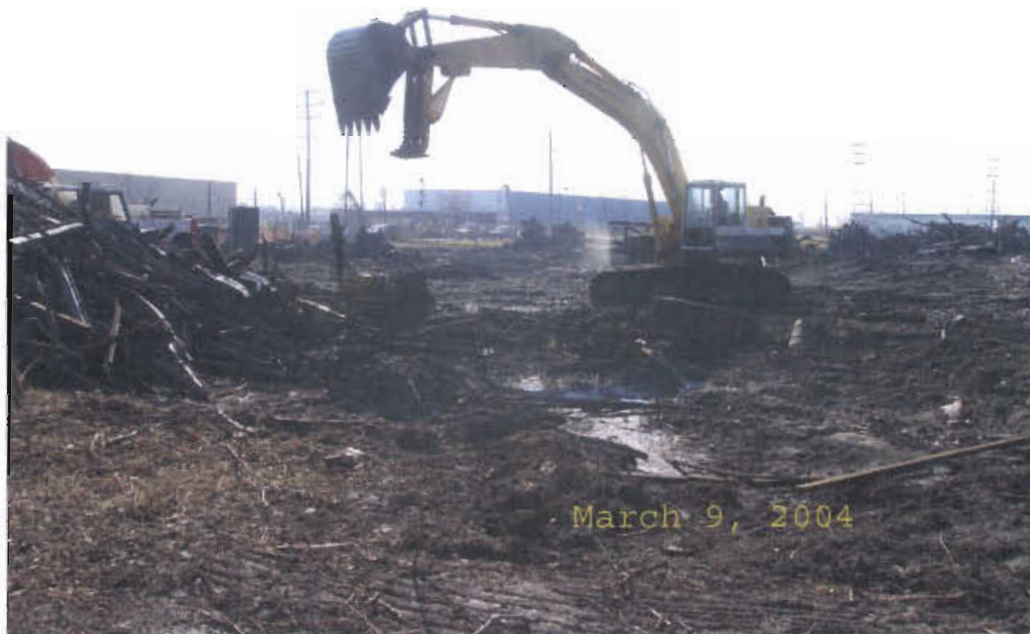
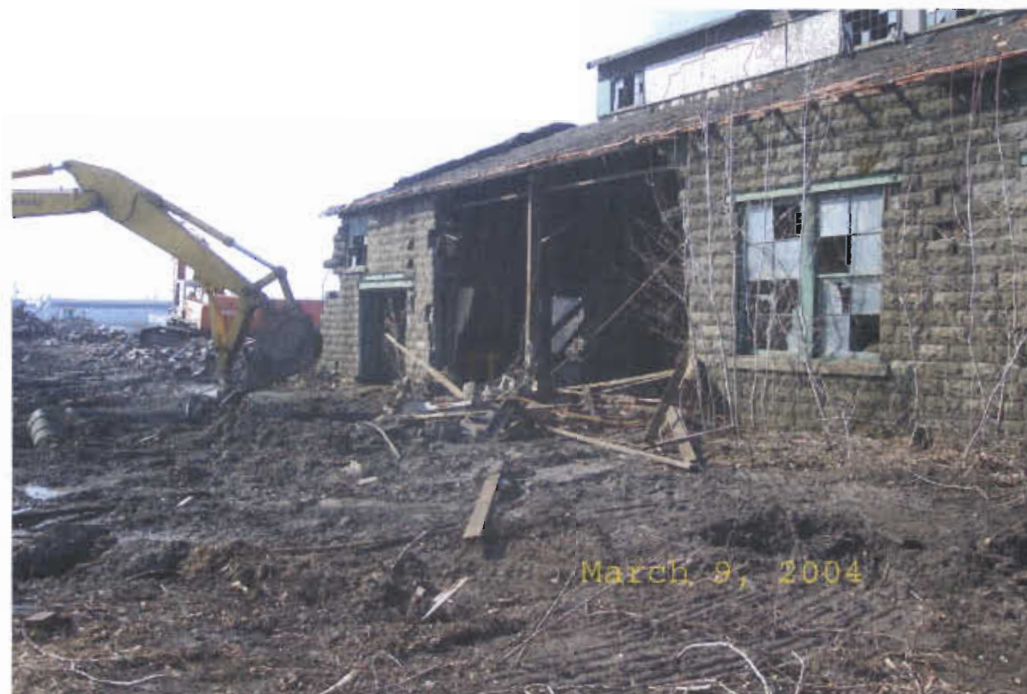
6 - Building Demolition

7 - Building Demolition

8 - Building Demolition

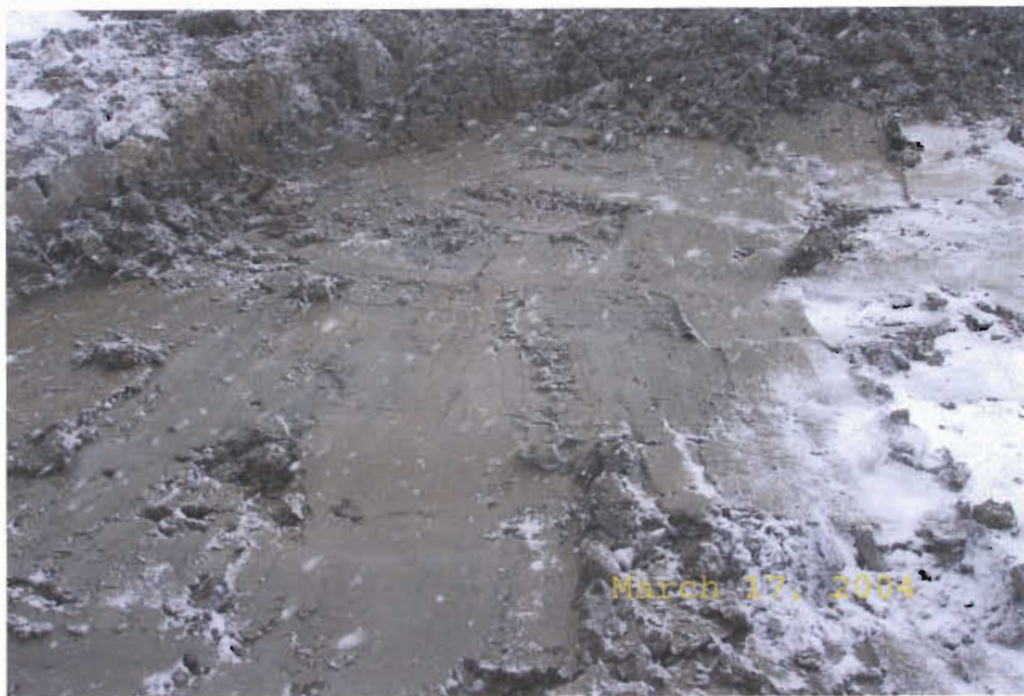
9 - Clay Layer at 2' Depth

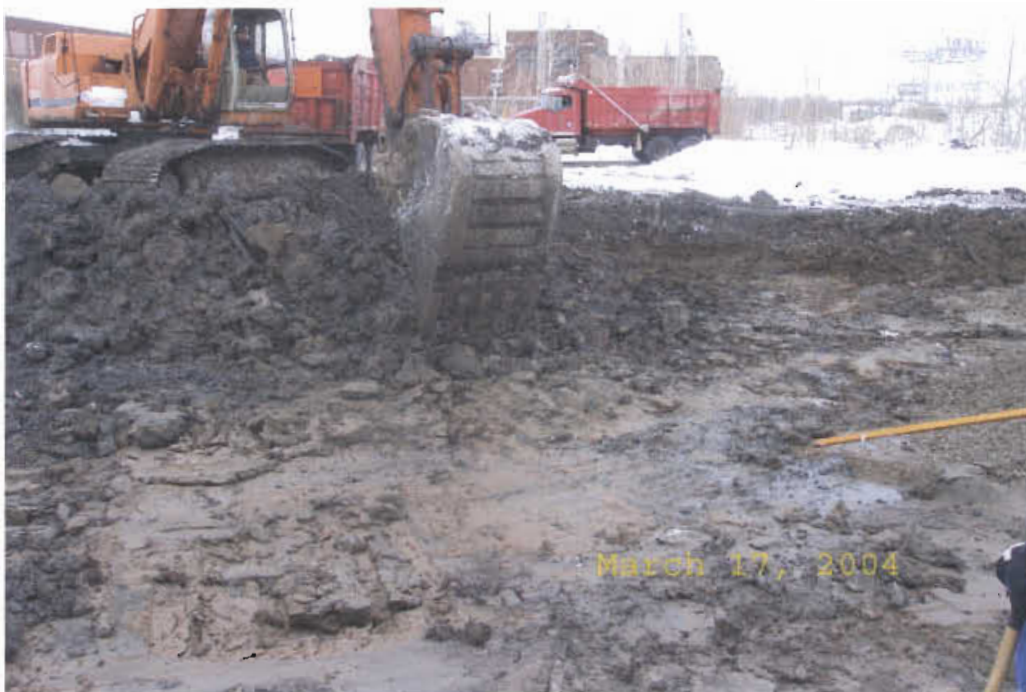
Contaminated soil was found in the UST area and 570 tons was excavated for off-site disposal at the Tonawanda Landfill. NYSDEC assigned spill number: 0375414 to the site in December 2003. Verification sample results from the tank excavation floor and walls met TAGM 4046 cleanup levels. Tank excavation dimensions are shown on **Figure 1, UST Excavation**. Based on the analytical results, EnSol was satisfied that contaminated material was removed to the furthest extent practicable and requested that NYSDEC give the site a "closed" status. The excavation was backfilled with clean soil. The tank closure report, **Excavation of USTs and Contaminated Soil**, was prepared to document tank and soil removal and testing and was submitted to NYSDEC on Feb. 3, 2004. A copy of the report is included as Attachment 3 of

10 - Excavation in Tank Area

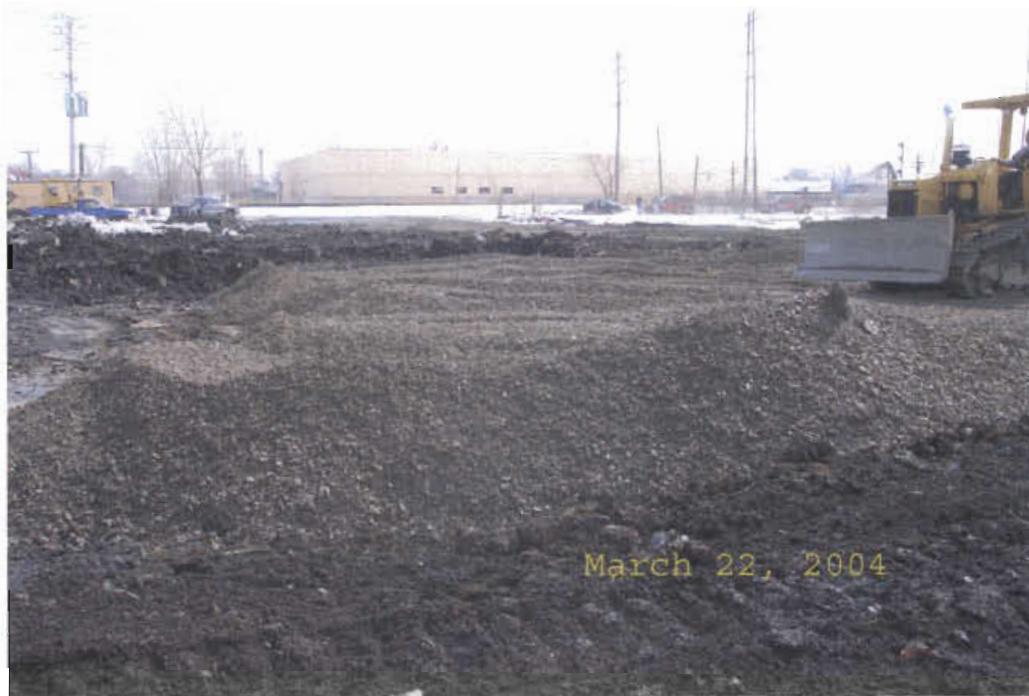
11 - #2 Stone Backfill

Due to compaction of the stone from hauling operations, additional soil was placed within the footprint of the frame storage building to a depth of approximately six inches. The areas that were backfilled with soil material were top coated with a 2" layer of compost, also obtained from Town sources. The compost was then covered with a layer of hay mulch. Photos 14, 15 and 16 depict final site conditions.

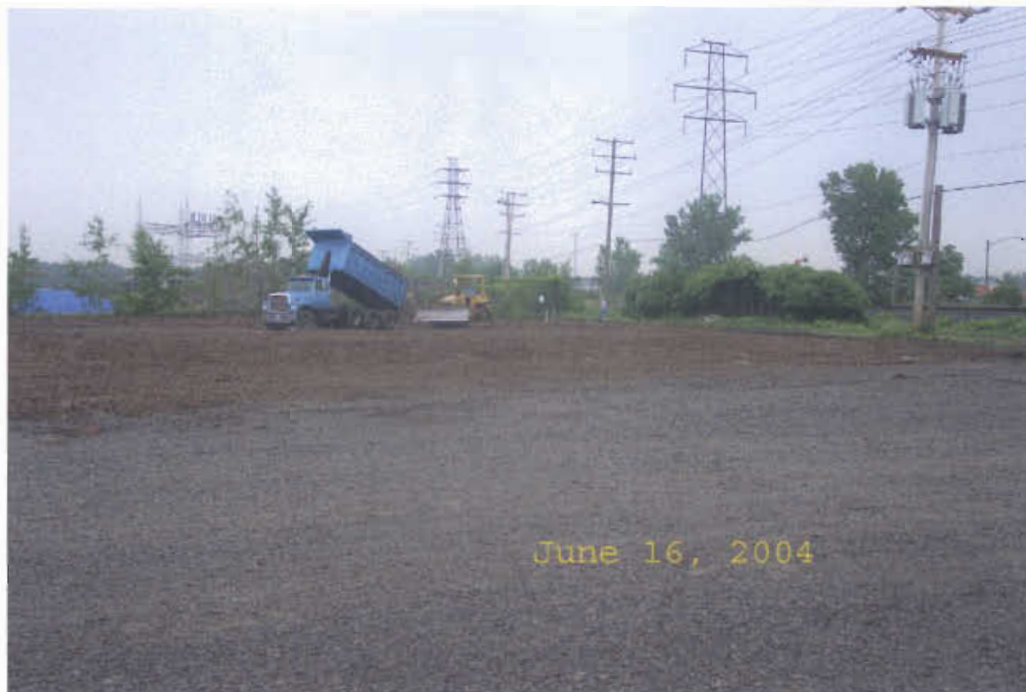
12 - Soil Backfill

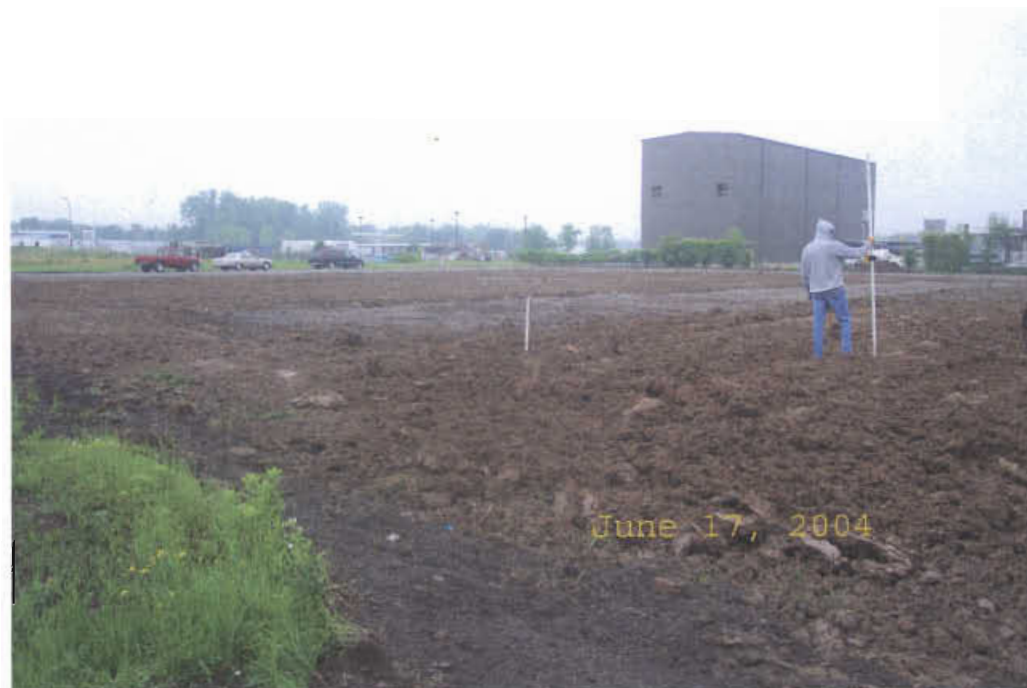
13 - Verification of 2' Cover Depth

The remedial alternative selected for the voluntary cleanup at 303 Woodward Avenue included the placement of a two-foot layer of stone over the building footprint areas and a two-foot layer of clean soil over the remaining portions of the site that needed remediation. The purpose of the stone/soil cover was to eliminate potential exposures to original site soils that contain contaminants at levels below hazardous criteria. These contaminants include RCRA metals and semi-volatile compounds.

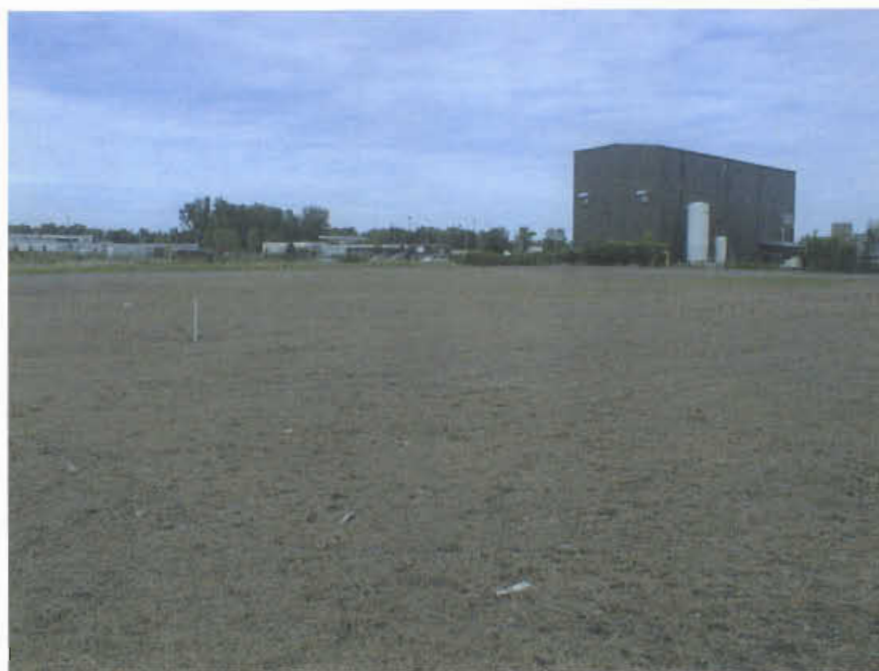
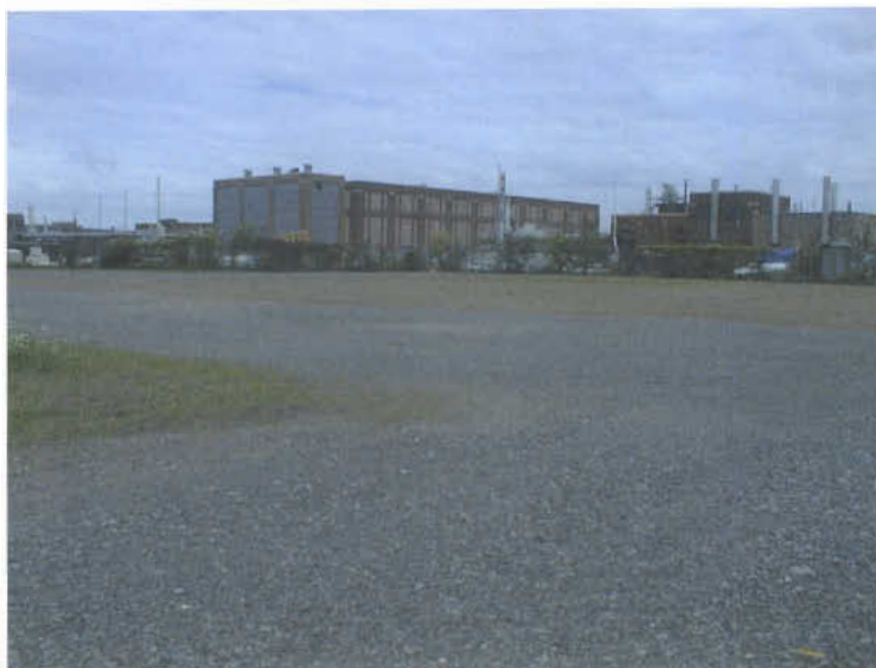
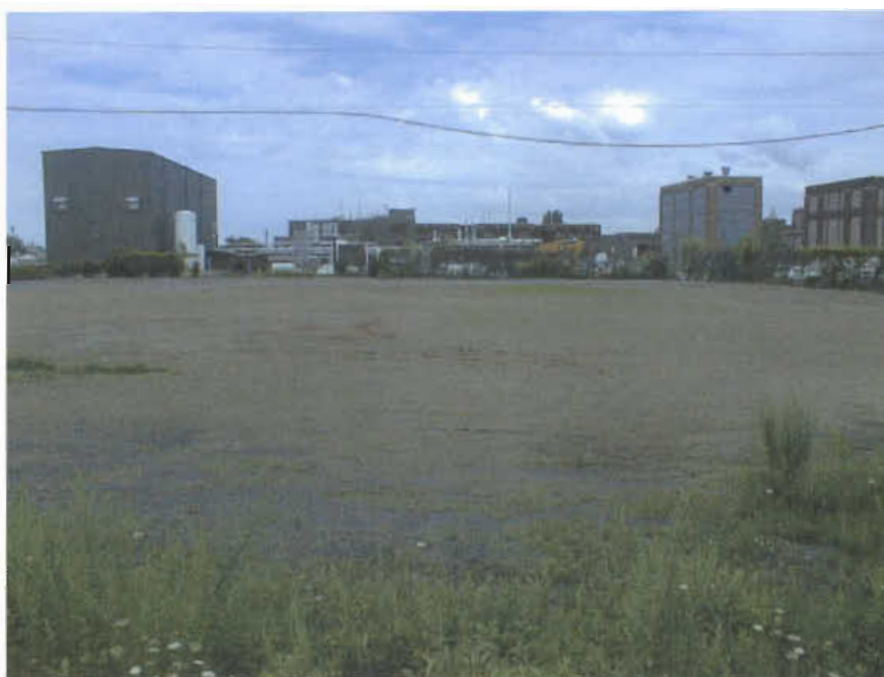
14 - Final Conditions

15 - Final Conditions

16 - Final Conditions
