SENECA MEADOWS, INC.  
Facility Number SOS08  
Permit Number 8-4532-00023 /00001-0

# SENECA MEADOWS LANDFILL 2019 ANNUAL REPORT

FEBRUARY 2020

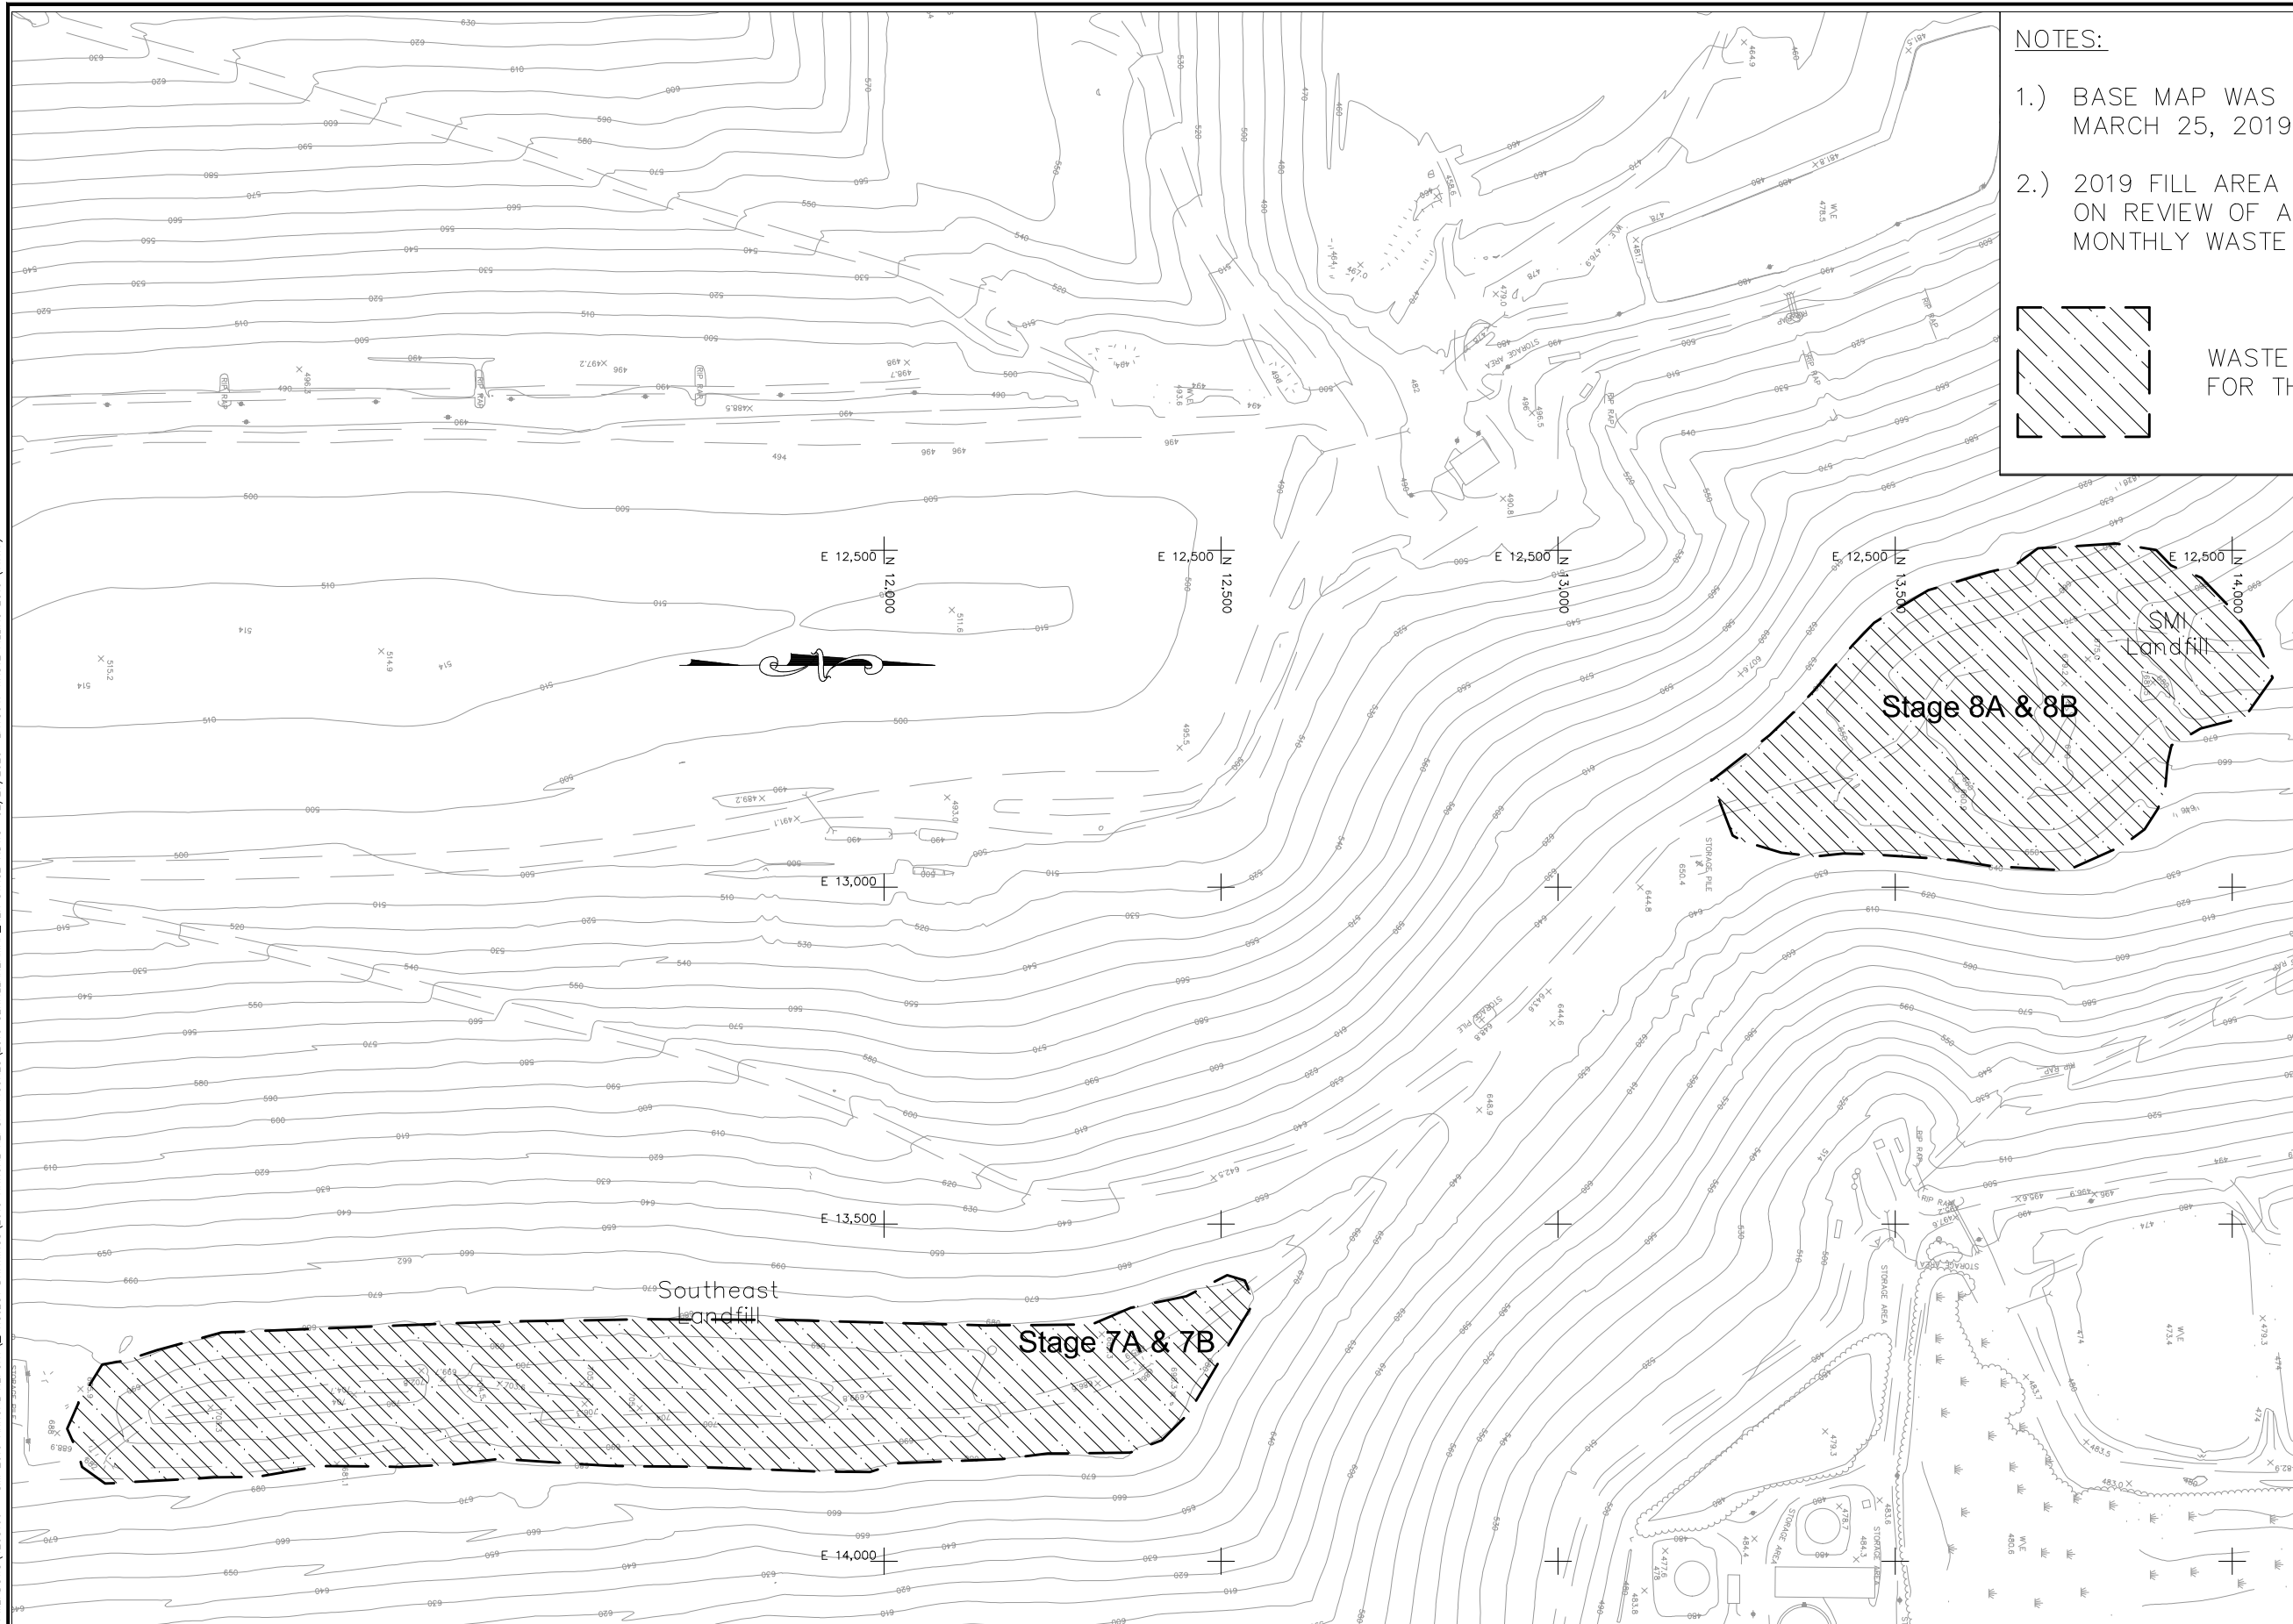
X:\PROJECTS\SENECA MEADOWS\4203166 - SMI 2019 ANNUAL REPORT\PROJECT DRAWINGS\2019 ANNUAL REPORT FIGURES\2019 GENFILLREMAP\_NEX STAGE 7.DWG 02/27/2020 LAYOUT: WASTE FILLING 2019 (11X17)

- 1.) BASE MAP WAS DEVELOPED FROM THE MARCH 25, 2019 AERIAL TOPOGRAPHY.
- 2.) 2019 FILL AREA LOCATIONS WERE OBTAINED ON REVIEW OF AND COMPARISON OF THE MONTHLY WASTE PLACEMENT FIELD SURVEYS.

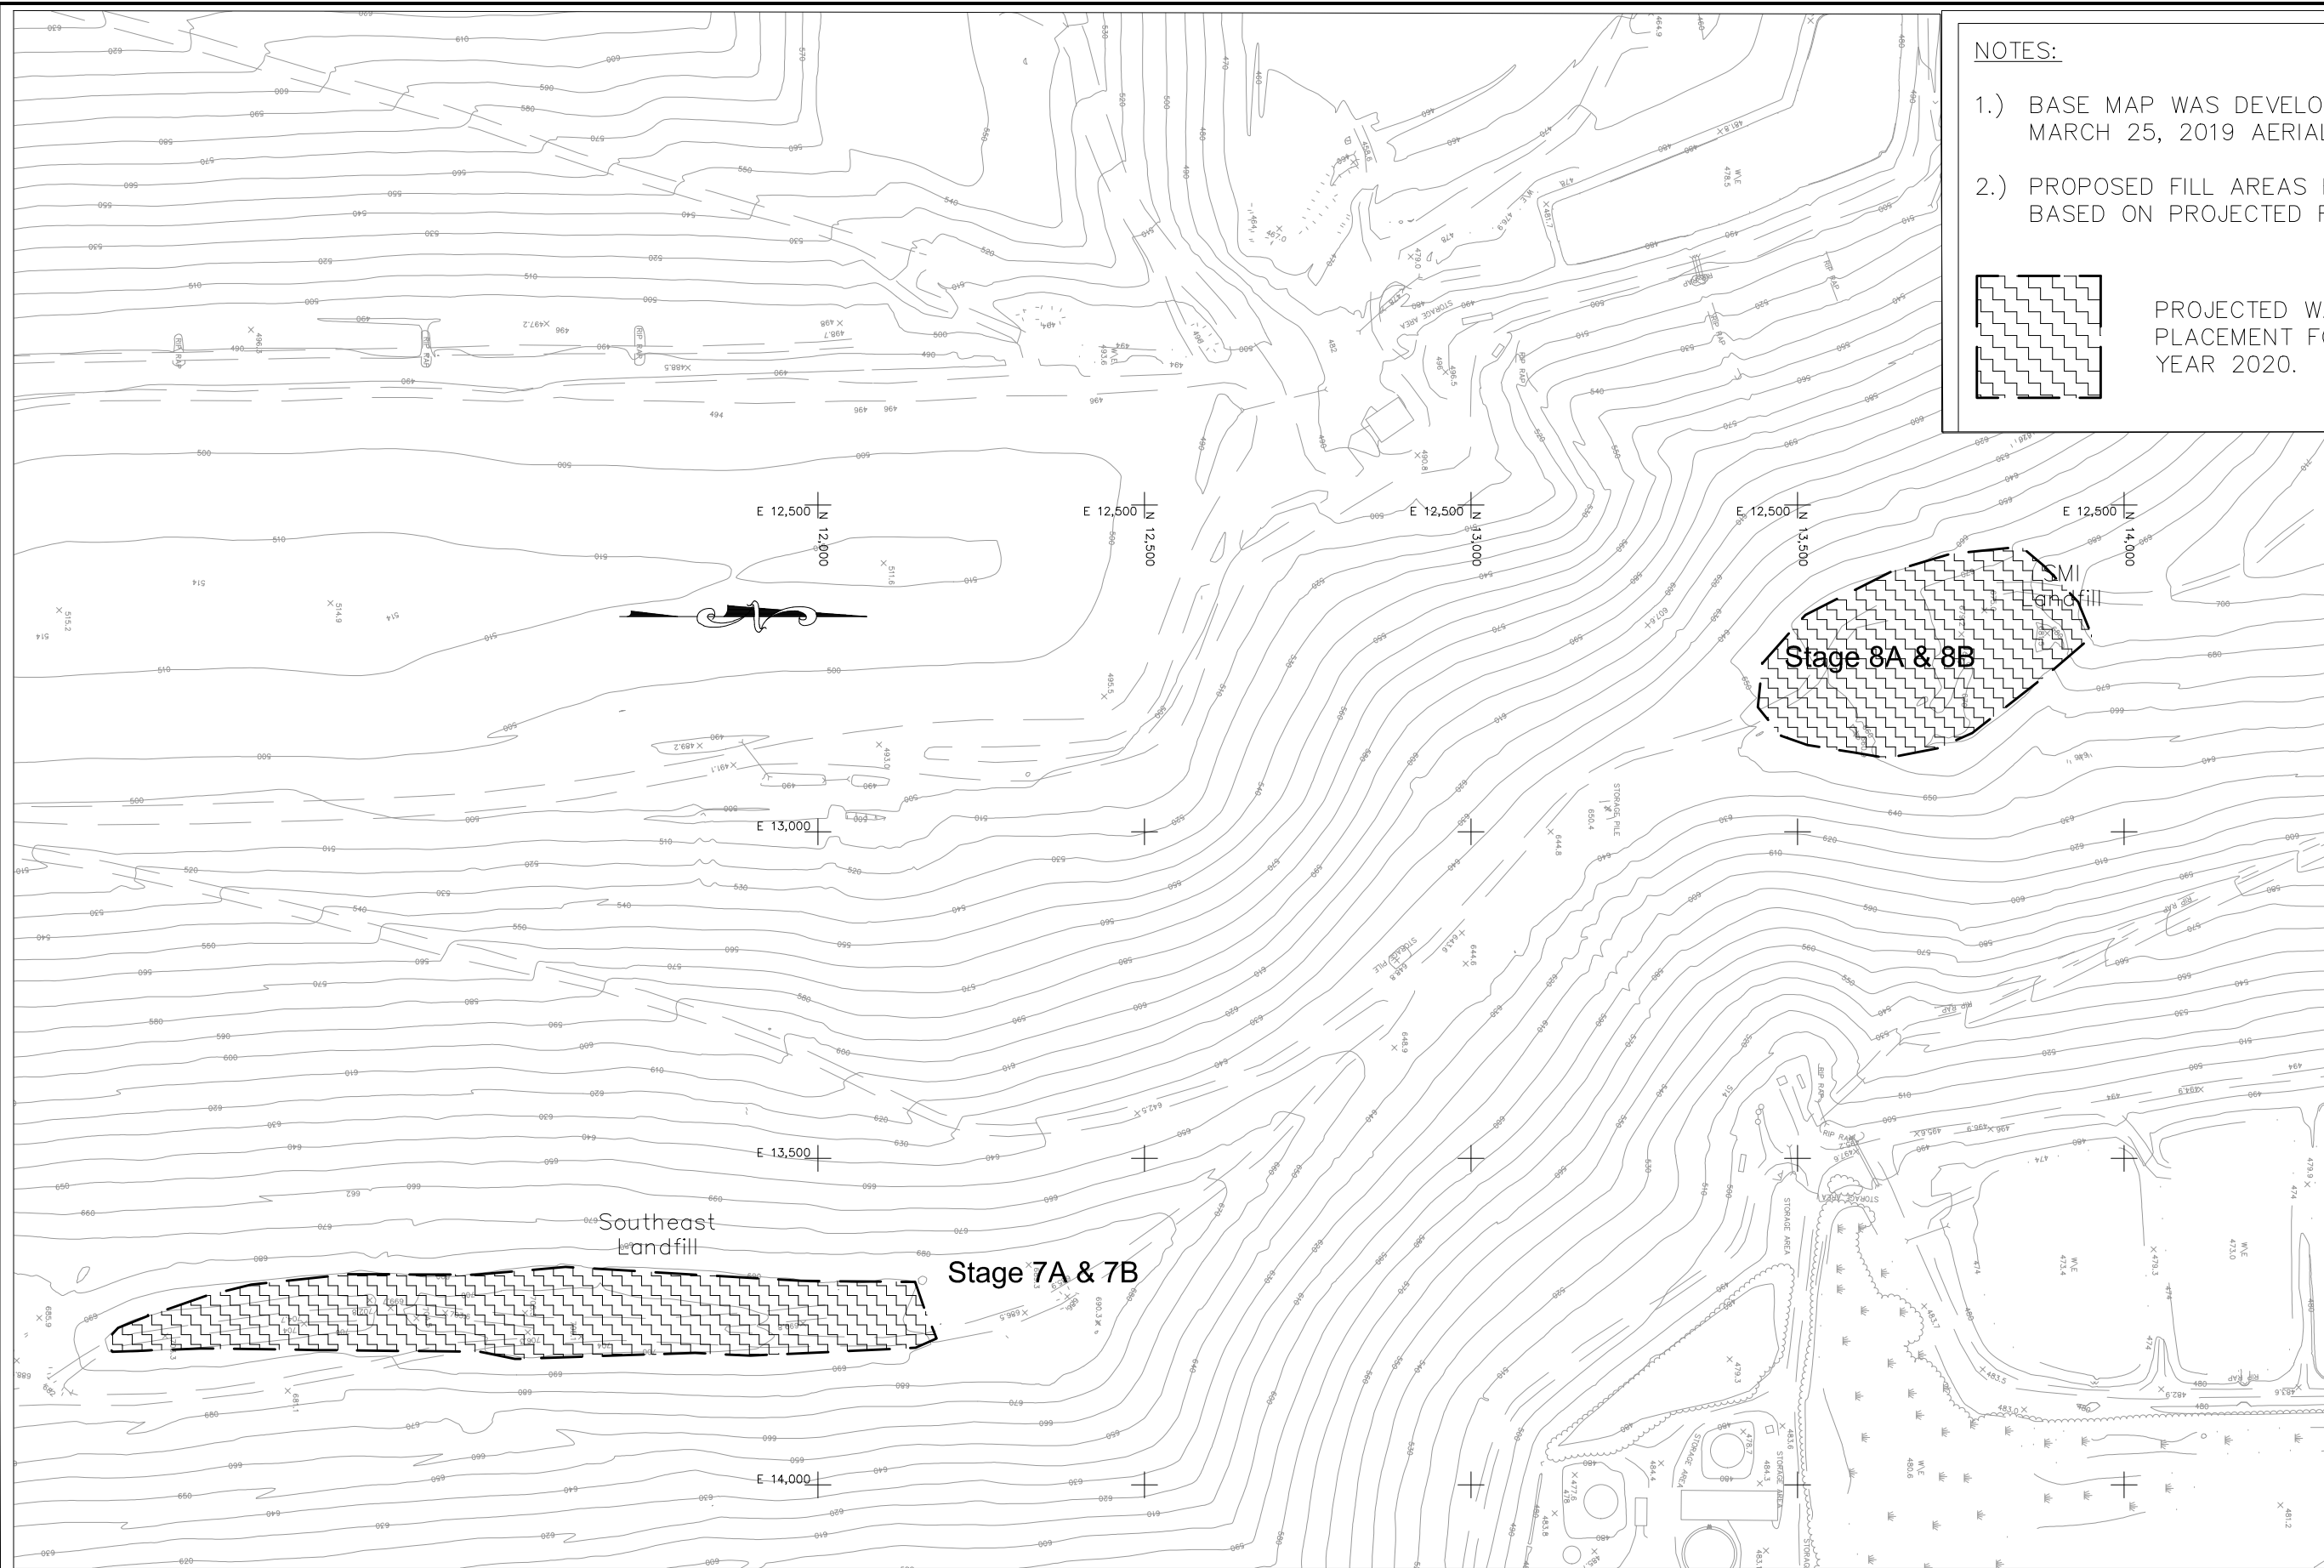
X:\PROJECTS\SENECA MEADOWS\4203166 - SMI 2019 ANNUAL REPORT\PROJECT DRAWINGS\2019 ANNUAL REPORT FIGURES\2019 GENFILLAREA\_MAP\_STAGE 7.DWG 02/27/2020 LAYOUT: GEN FILL AREA\_2020 (11X17)

- 1.) BASE MAP WAS DEVELOPED FROM THE MARCH 25, 2019 AERIAL TOPOGRAPHY.
- 2.) PROPOSED FILL AREAS FOR 2020 ARE BASED ON PROJECTED FILL PROGRESSIONS.

Near-term waste filling will continue within the constructed and certified landfill areas which include Stage 6A and 6B and, will commence in Stage 6C during 2020. The approximate locations of waste placement in the Stages 7/8, and Stage 6A/B are depicted on Figures 2-1, and 2-3, respectively. Additionally, it is noted that the SELF/EX-2 area contains plateau and veneer fills that represent significant remaining air space that may be utilized for future waste placement. The specific locations of veneer fills that may be utilized will depend on operational considerations and will be determined at a later time.

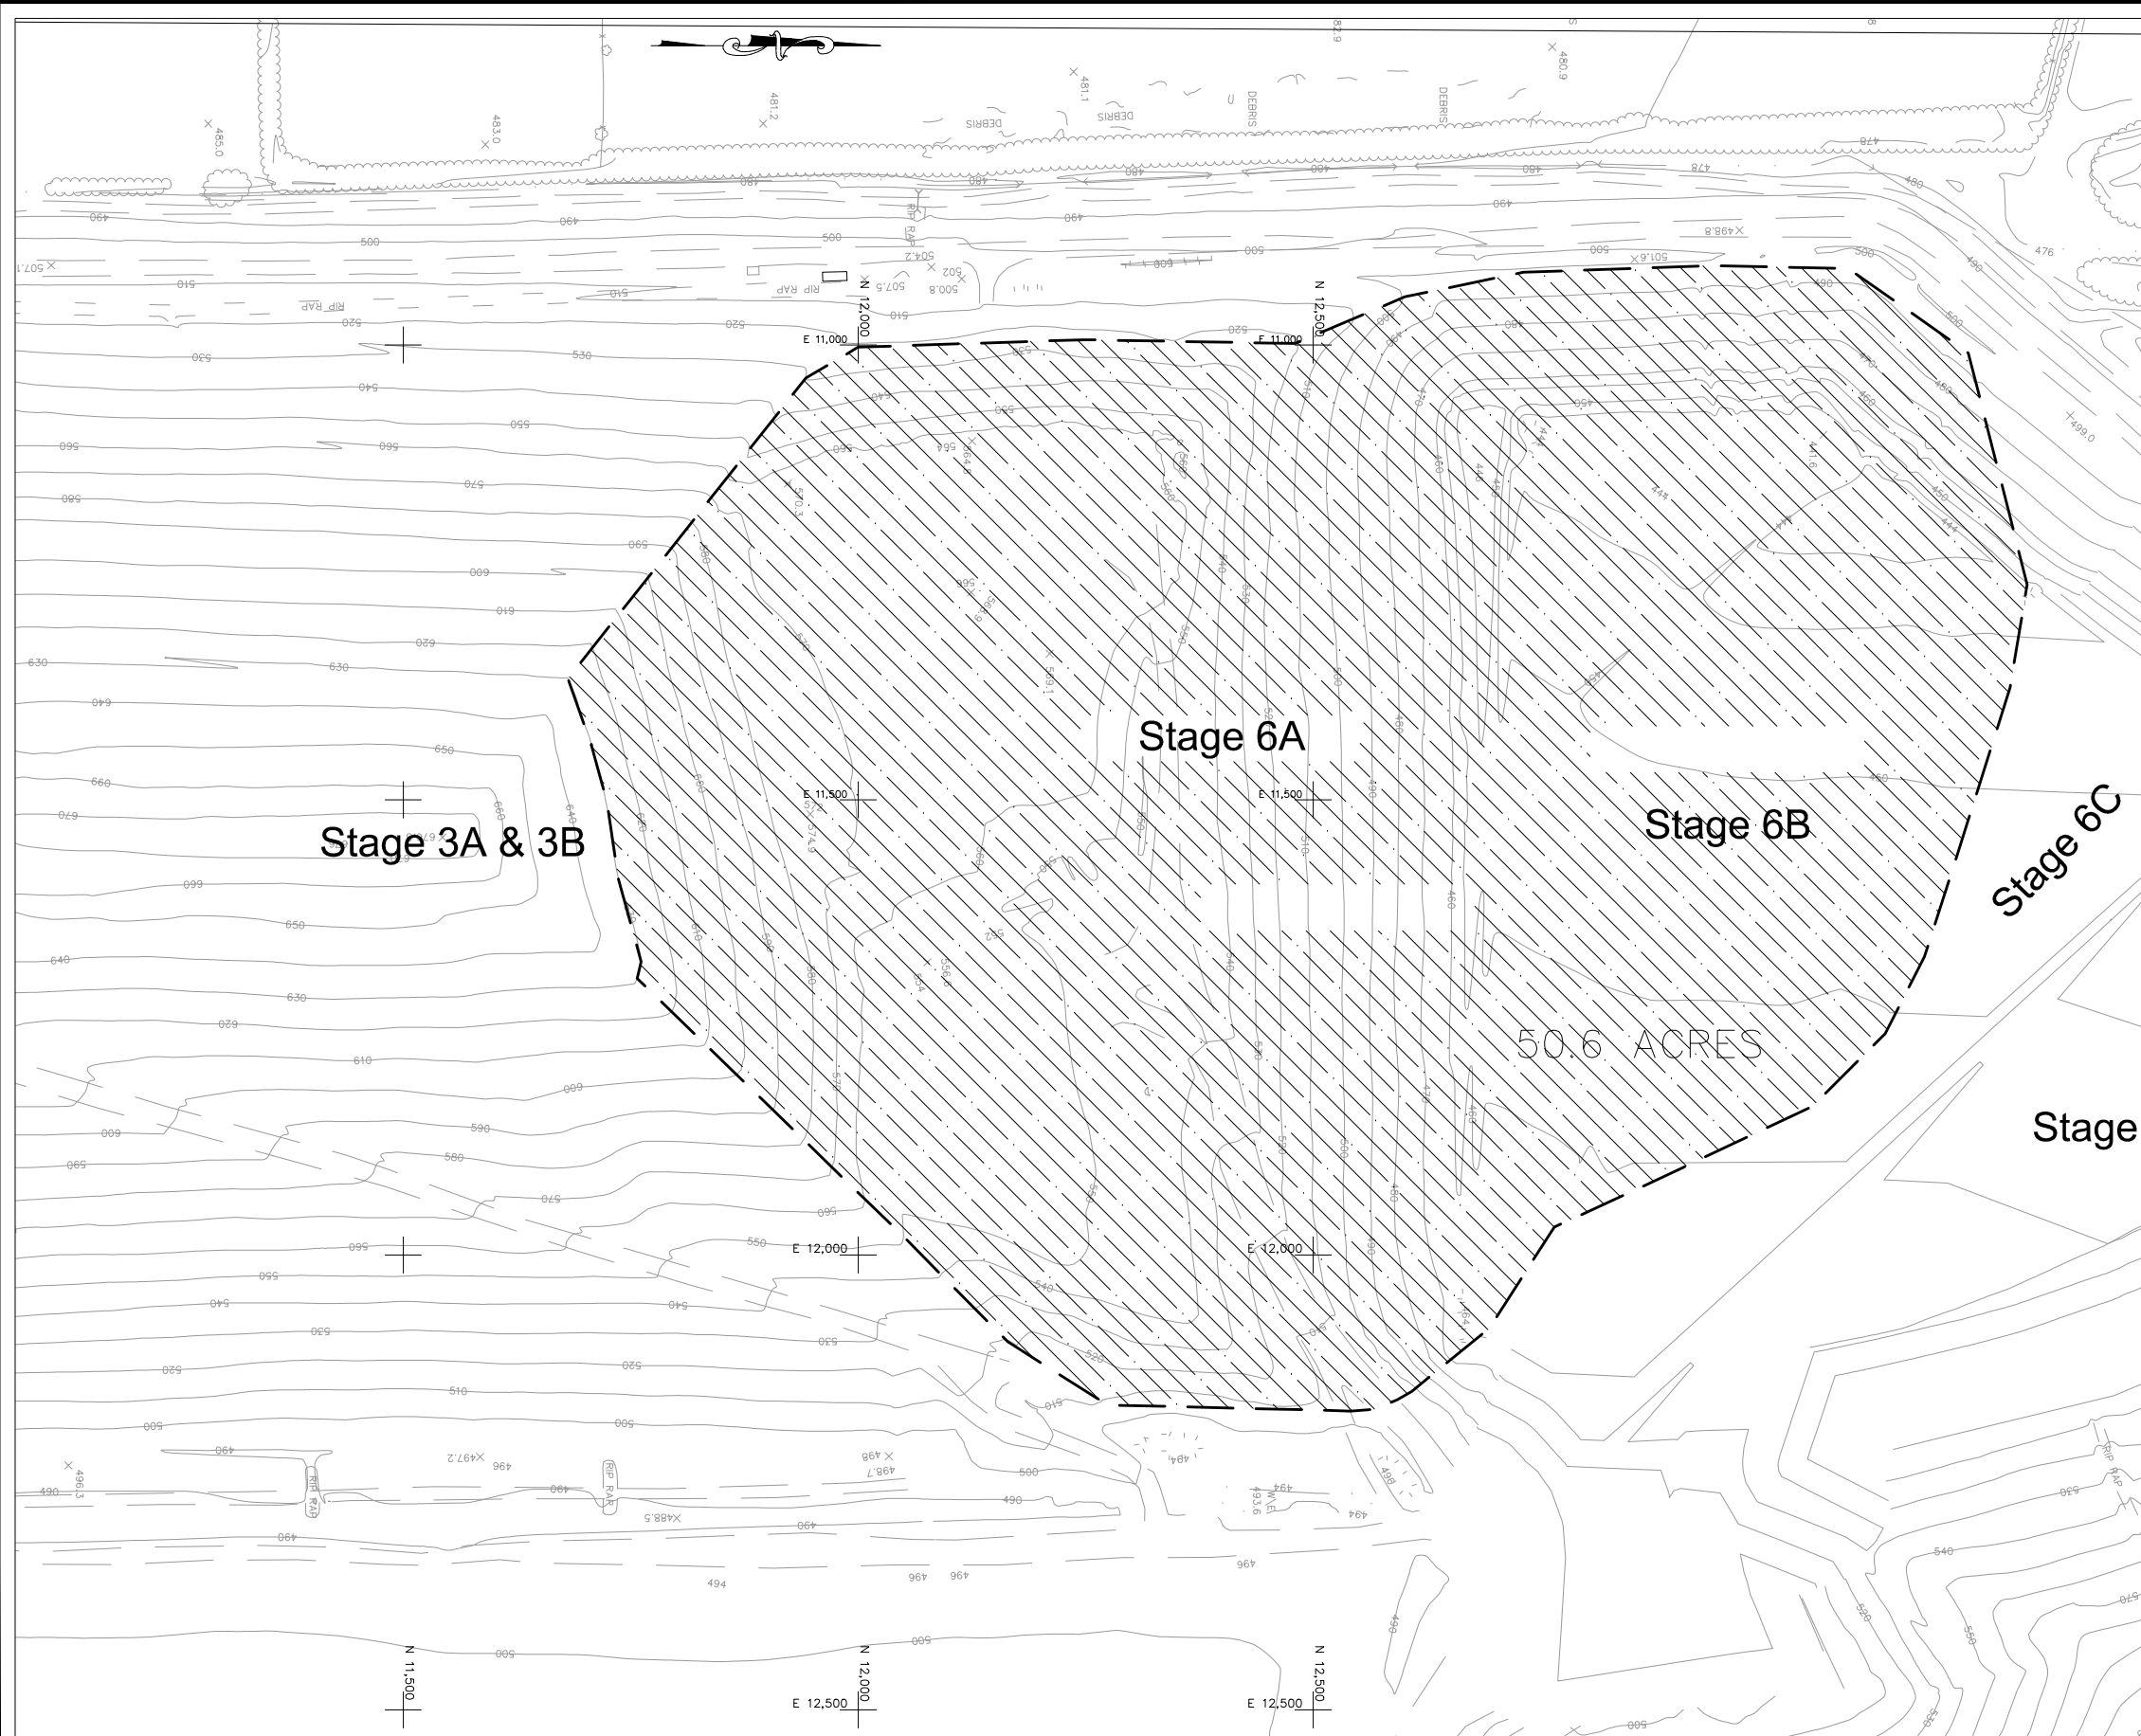
X:\PROJECTS\SENECA MEADOWS\4203166 - SMI 2019 ANNUAL REPORT\PROJECT DRAWINGS\2019 ANNUAL REPORT FIGURES\2019 GENFILLREMAP\_MEX STAGE 6A.DWG 02/27/2020 LAYOUT: WASTE FILLING\_2019(11X17)

- 1.) BASE MAP WAS DEVELOPED FROM THE MARCH 25, 2019 AERIAL TOPOGRAPHY.
- 2.) 2019 FILL AREA LOCATIONS WERE OBTAINED BASED ON REVIEW OF AND COMPARISON OF THE MONTHLY WASTE PLACEMENT FIELD SURVEYS.

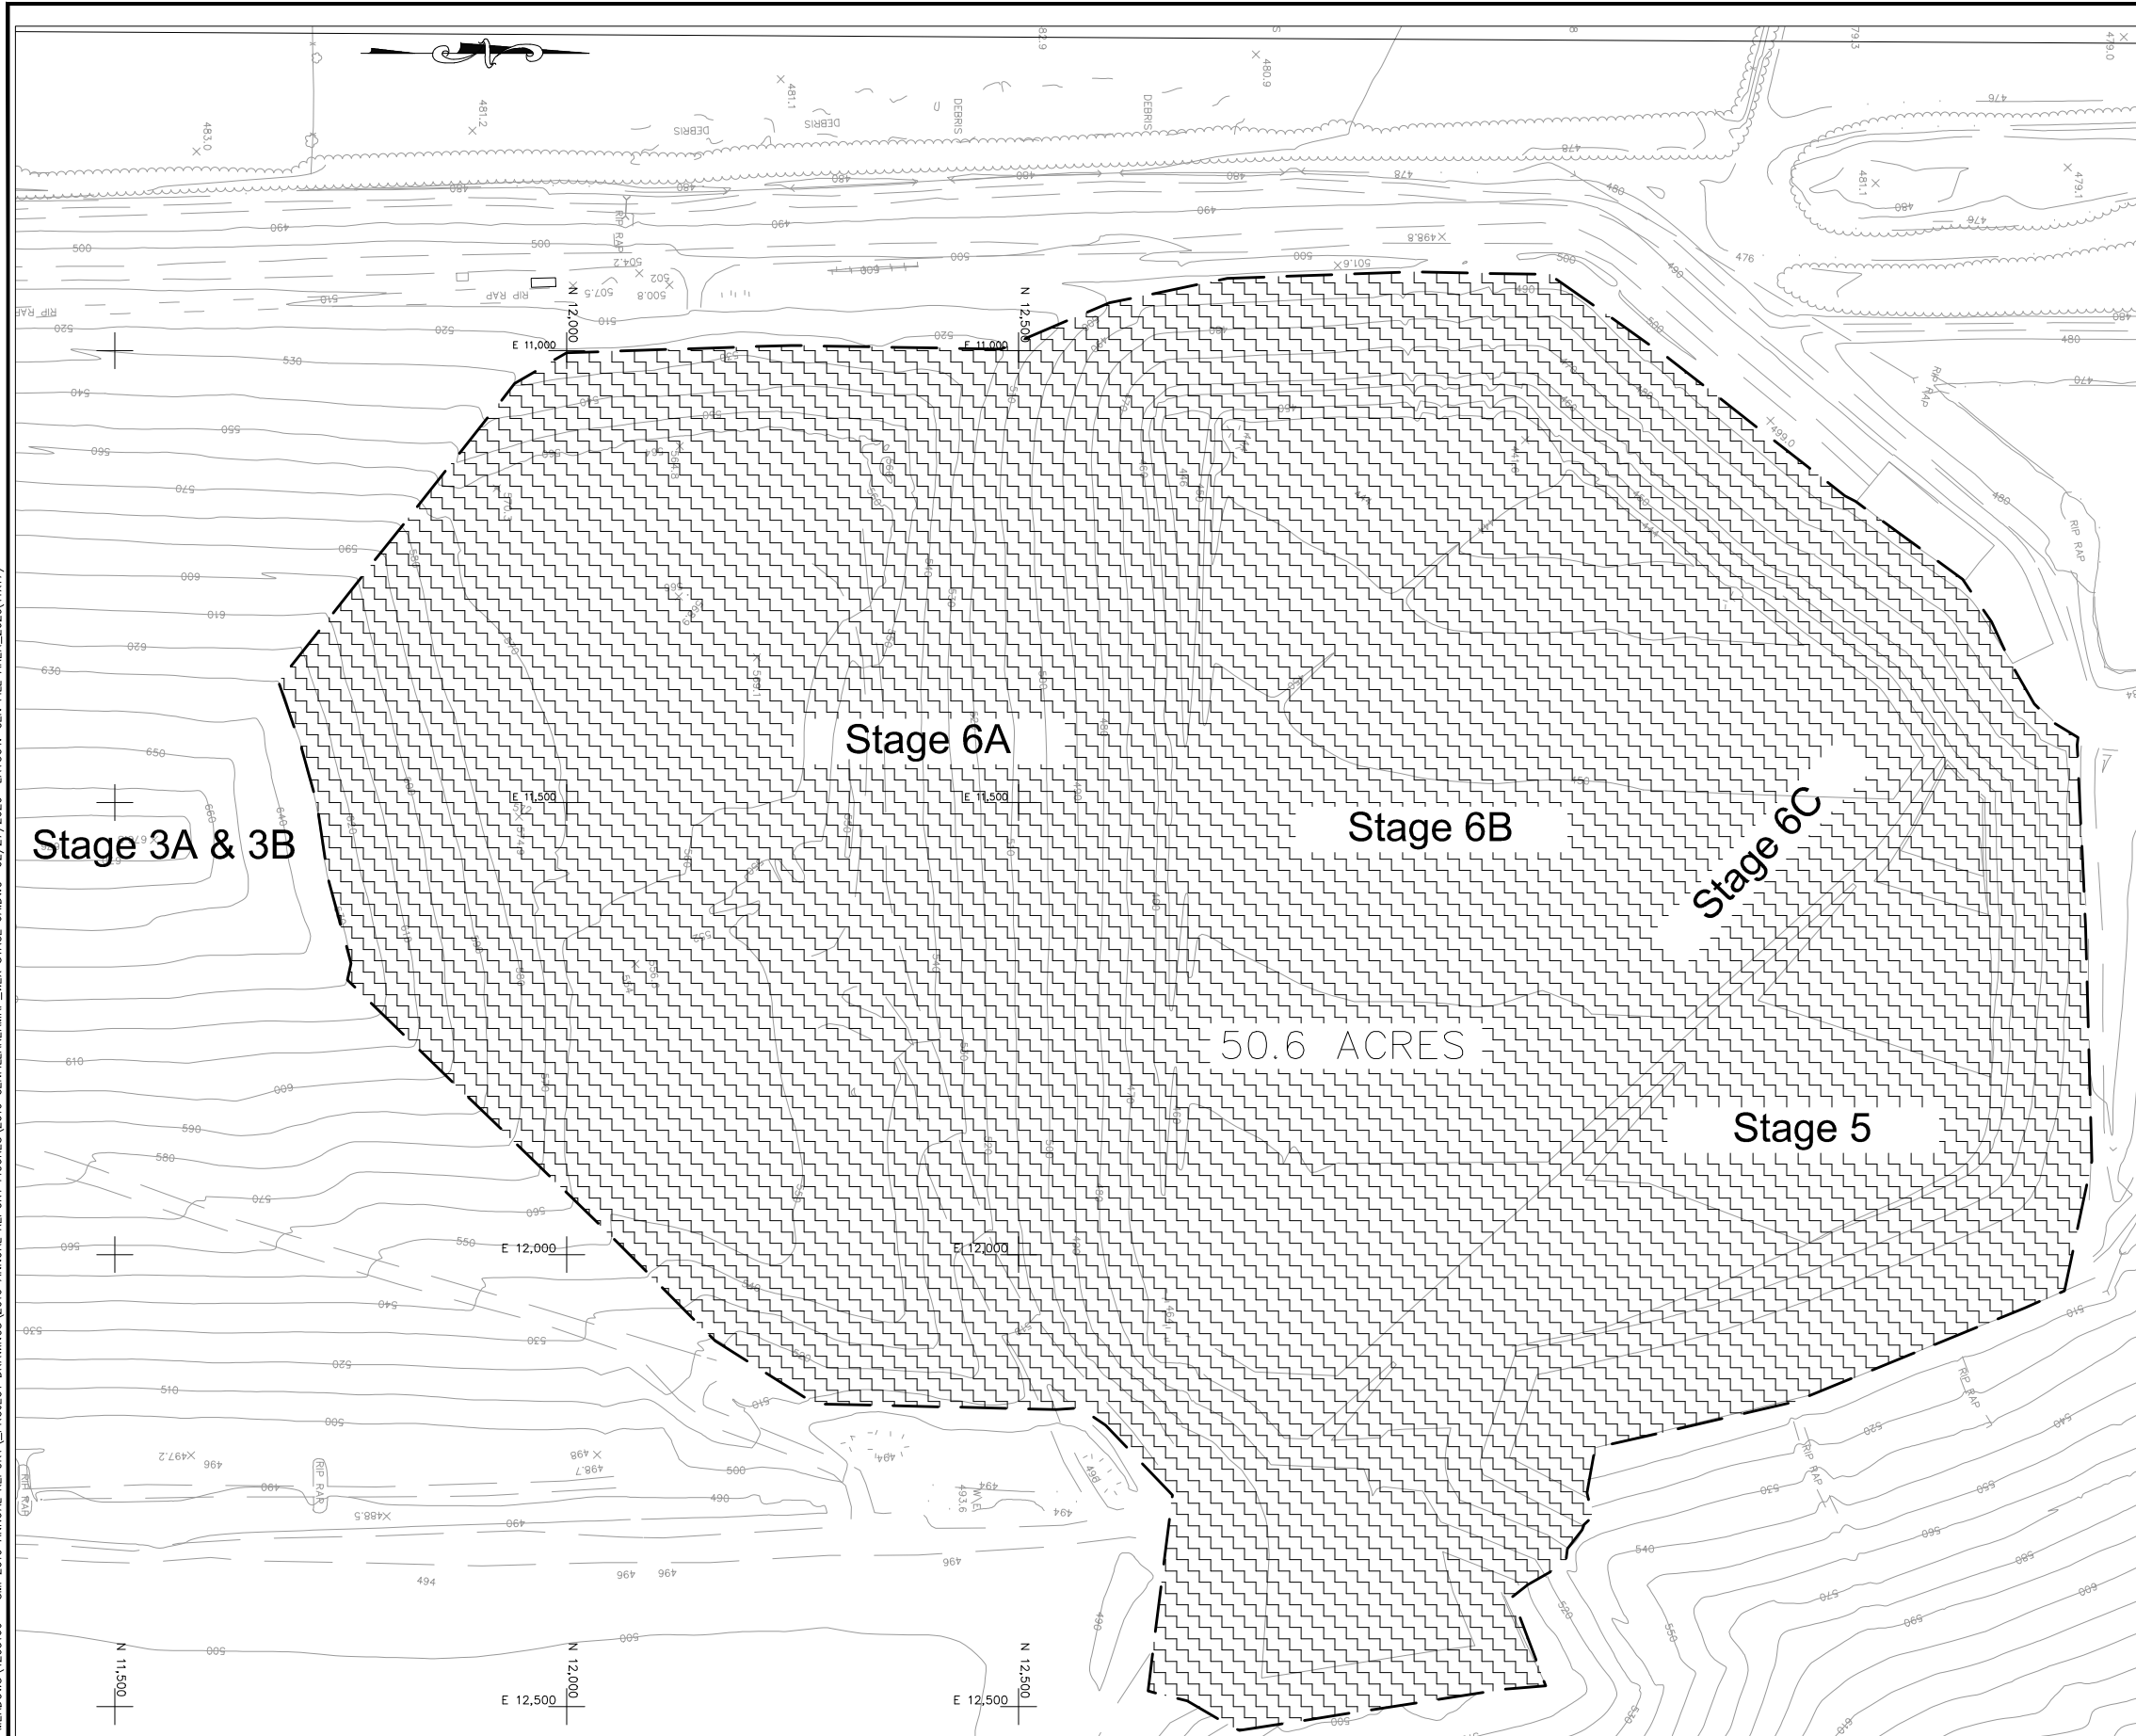
X:\PROJECTS\SENECA MEADOWS\4203166 - SMI 2019 ANNUAL REPORT\PROJECT DRAWINGS\2019 ANNUAL REPORT FIGURES\2019 GENFILLAREMAP\_MEX\_STAGE 6A.DWG 02/27/2020 LAYOUT: GEN FILL AREA\_2020(1X17)

- 1.) BASE MAP WAS DEVELOPED FROM THE MARCH 25, 2019 AERIAL TOPOGRAPHY.
- 2.) PROPOSED FILL AREAS FOR 2020 ARE BASED ON PROJECTED FILL PROGRESSIONS.

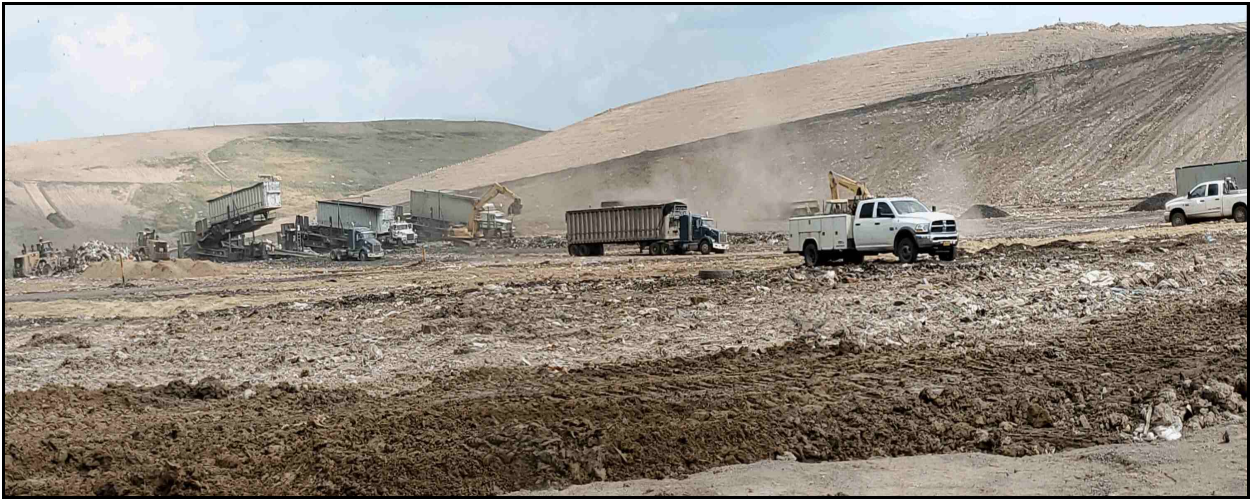
The following figures describe the observed activities during the period of the facility sound surveys, including waste placement operations at the active Stage 6 landfill area with compactors and bulldozers, trailer tippers, commercial tractor trailers, and soil trucks. The figures also describe maintenance operations, including soil loading and placement, watering, sweeping, leachate system cleaning, and odor and dust neutralizing. The figures further describe observed construction activities including excavation and transport of soils, grading, and drilling at Stage 5, and leachate system installation, which contributed to the operational noise levels.

Stage 6 Landfill, viewed from west

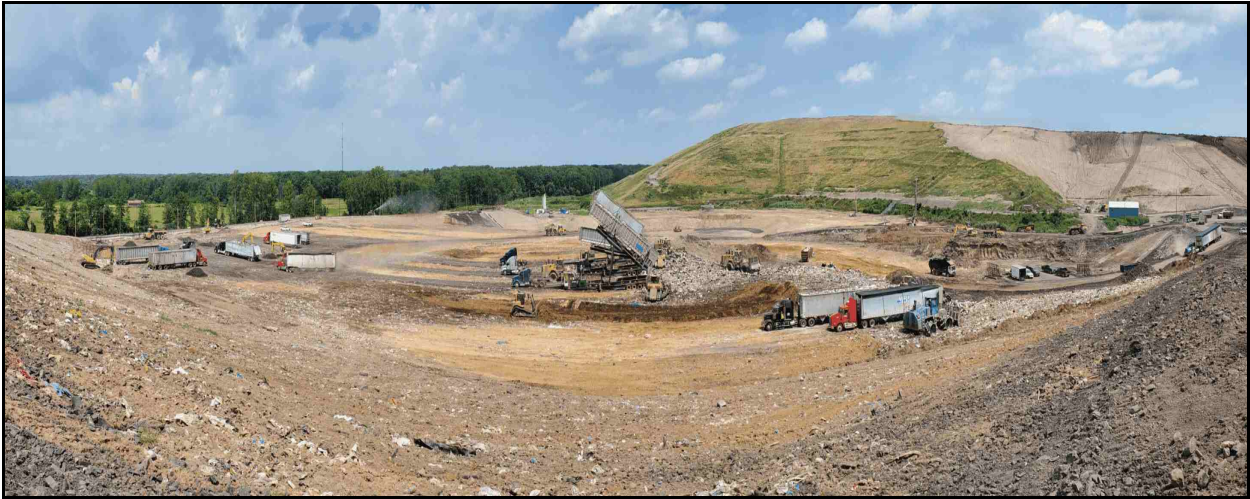
Stage 6 Landfill, viewed from south

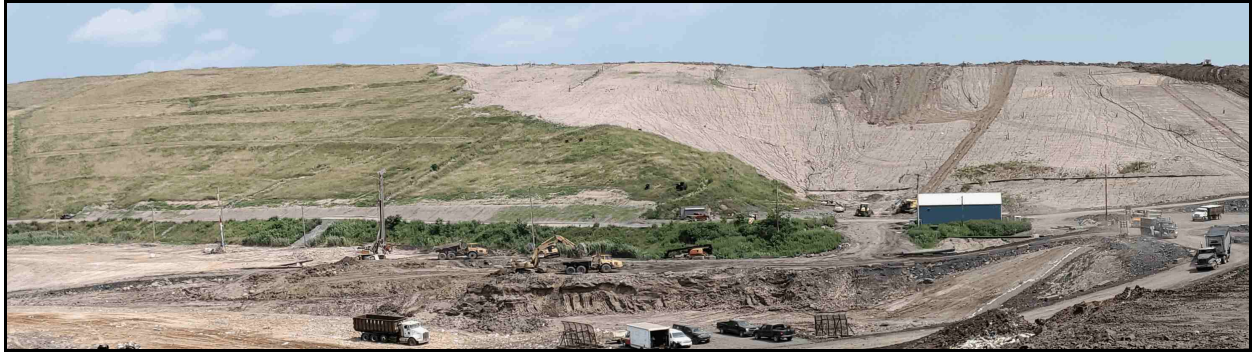
Fill and soil placement was occurring on top of the NEX landfill on the right side of the photo, adjacent to the SMI landfill, left.

NEX soil unloading and placement, viewed from west

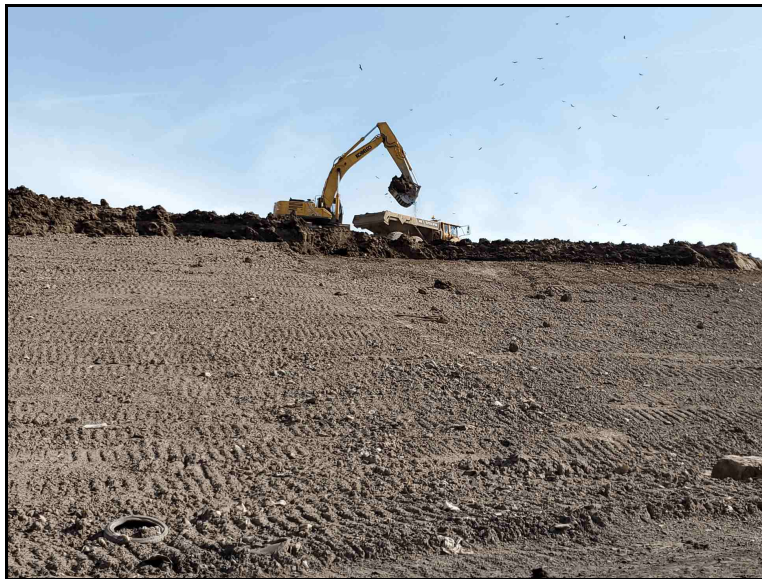
Soil was being loaded onto trucks from the top of the WEX Stage 3-4 berm using excavators for transport to other areas.

Soil loading on top of WEX Stage 3-4

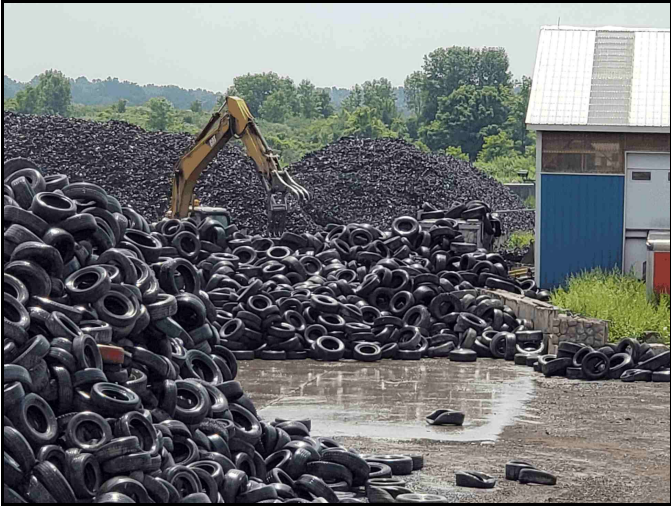
Sorting operations were being performed at the tire recycling facility with a claw excavator, as shown below. The operations did not produce significant noise.

Tire sorting

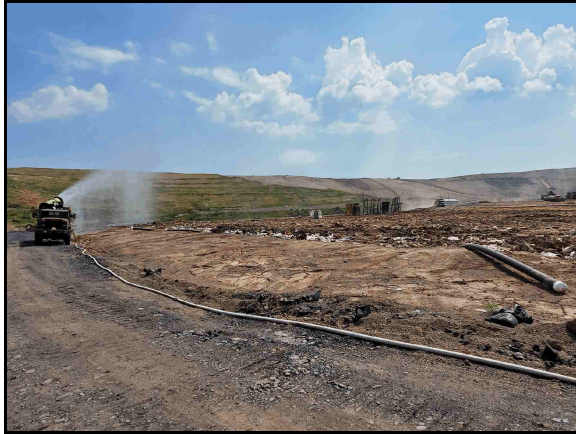
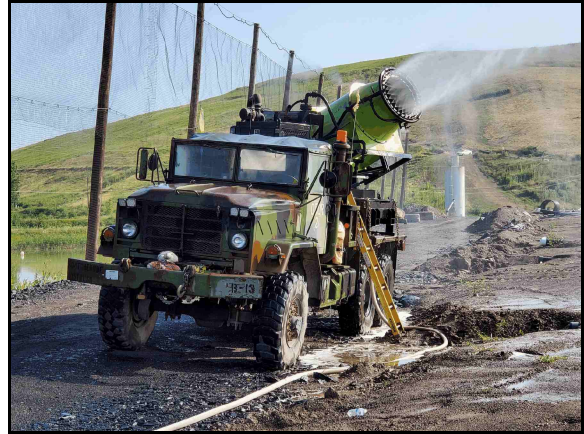
One or two odor and dust neutralizing systems were in operation on the western edge of Stage 6.

Odor and dust neutralizing systems

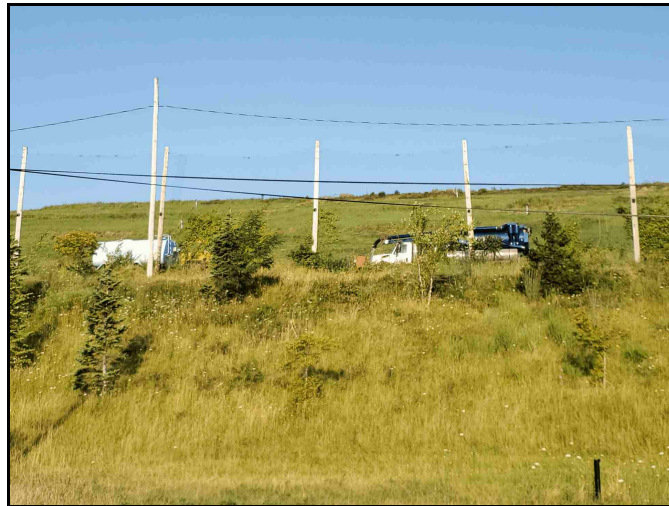
Maintenance of the leachate collection was being performed on the eastern side of the SELF berm. The system was not audible at the eastern property line.

Leachate collection system maintenance

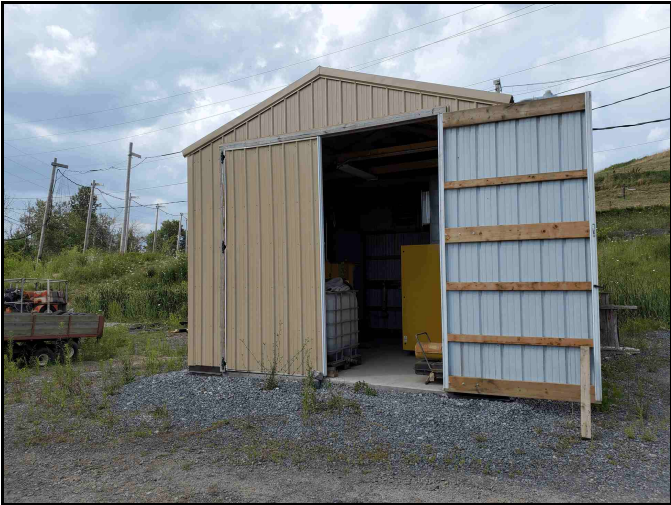
Fixed odor neutralizing sprayer systems were in rotating use around the landfill at various locations. A pump system is installed in a building enclosure located at the southwest corner of the WEX landfill area, as shown below.

Odor neutralizing system in noise enclosure

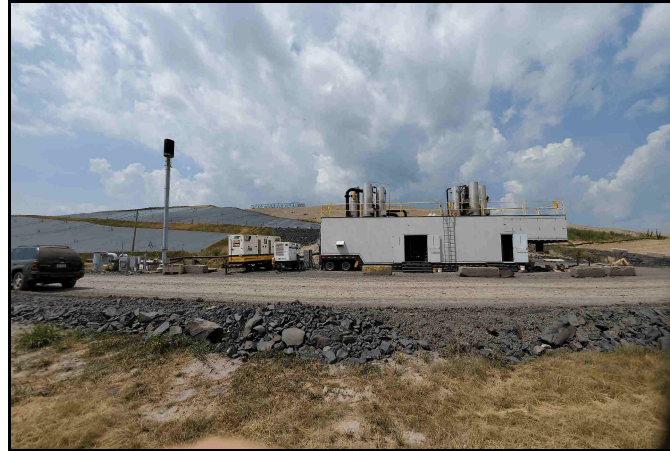
A flare stack and blower was in use at the base of the east side of the WEX berm. The trailer system is a facility in development that was not in use during the sound surveys.

Flare system

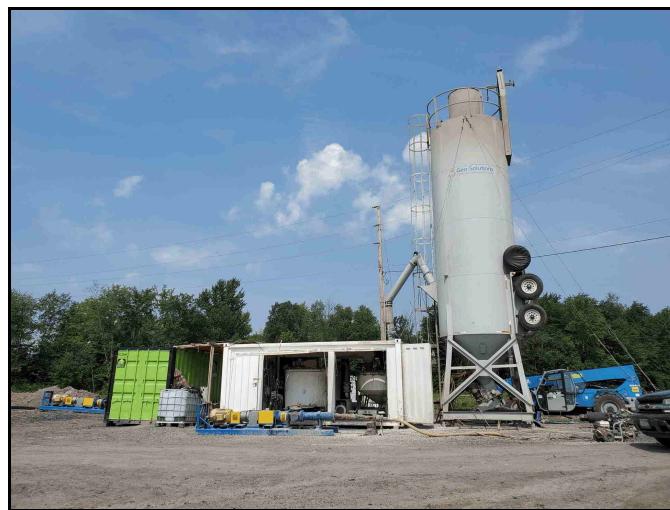
A portable concrete batch plant and construction equipment was located on the western side of Stage 5. The concrete plant was not in operation during the sound surveys.

Construction equipment at Stage 5

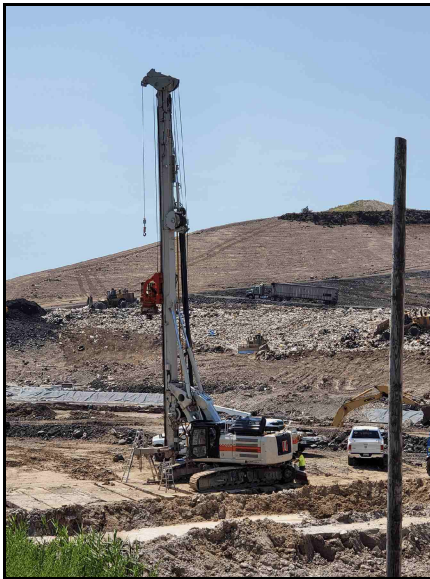
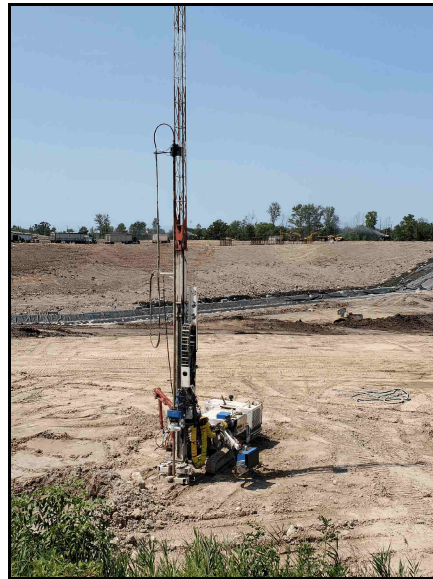
Soil drilling was in progress with two vertical drilling rigs on the eastern area of Stage 5.

Construction at Stage 5

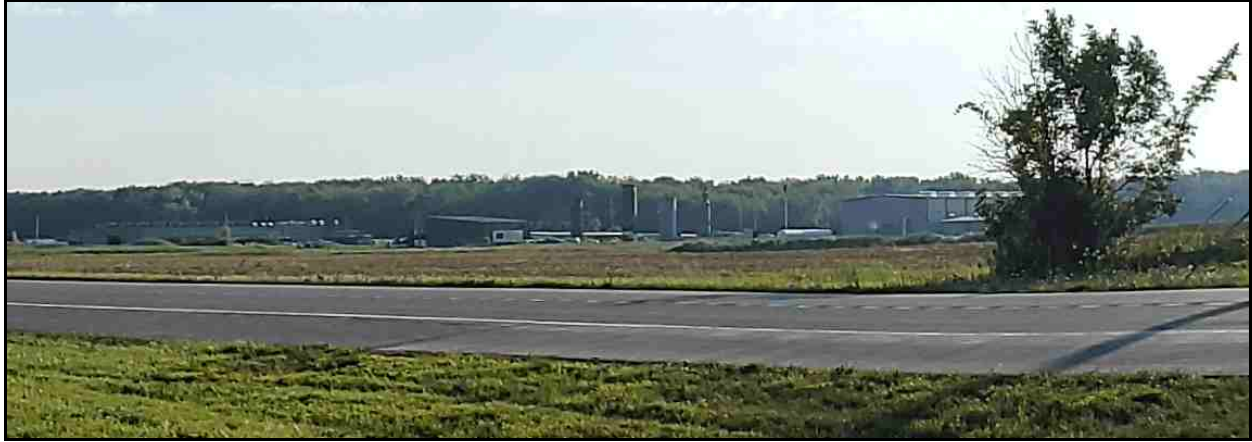
The Seneca Energy, Inc. landfill gas-to-energy plant in the Renewable Resource Park is shown below, with the High BTU plant on the right. The facility includes gas turbine generators in the enclosed buildings and flare stacks between the buildings, at the center of the photograph. The facility noise is perceptible at Locations 1 and 2 on the eastern boundary of the landfill facility.
