SENECA MEADOWS, INC.  
Facility Number SOS08  
Permit Number 8-4532-00023 /00001-0

# SENECA MEADOWS LANDFILL 2019 ANNUAL REPORT

FEBRUARY 2020

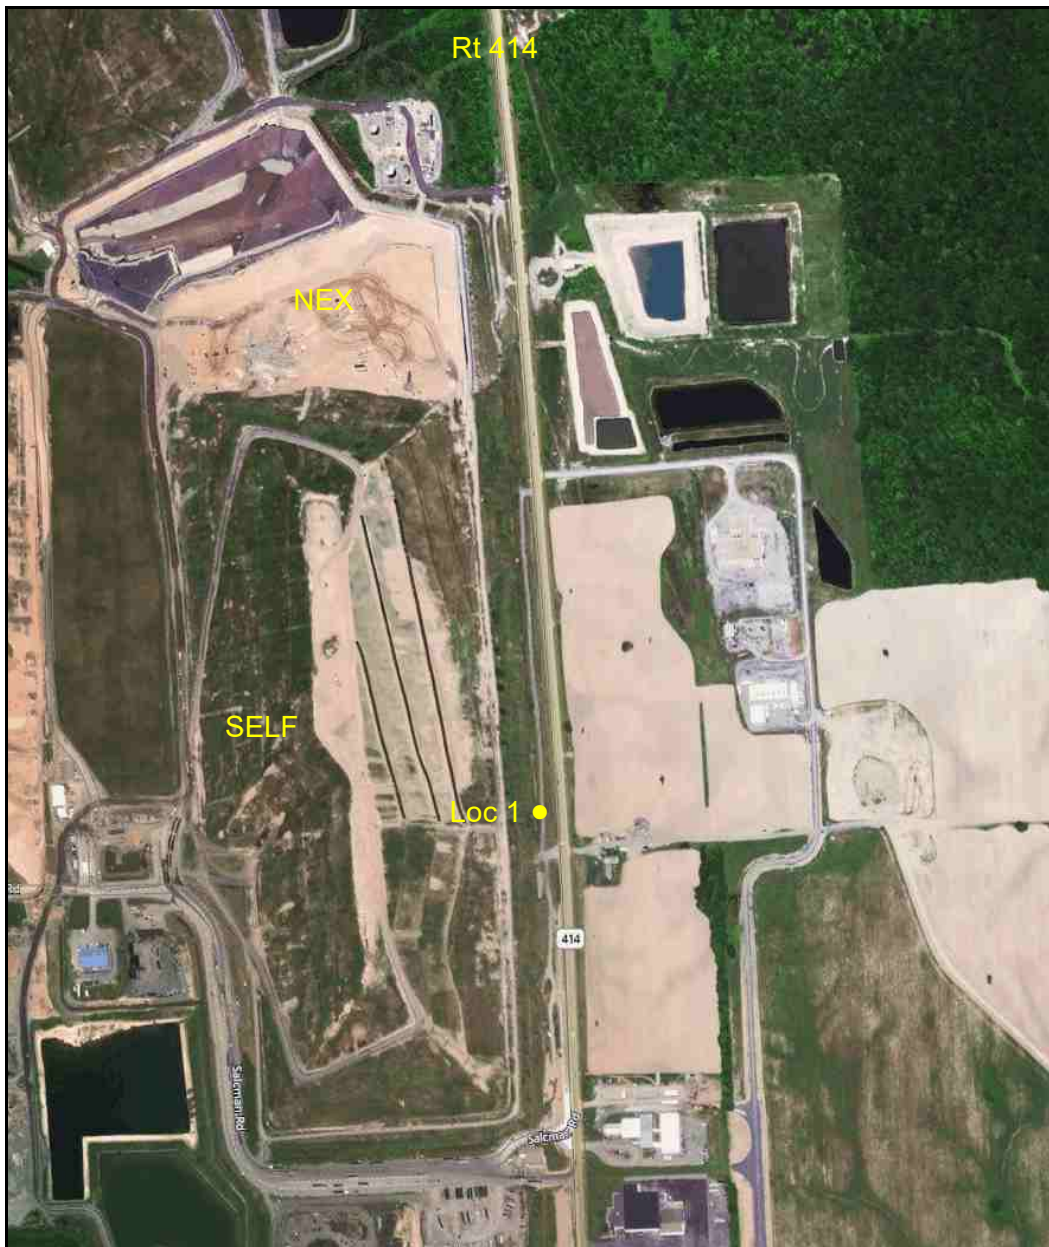
Noise levels received at survey Location 1 are predominantly generated by traffic on State Route 414, including sounds of vehicles accelerating and decelerating with jake brakes in the vicinity of Salcman Road. During surveys, leachate systems were being maintained on the eastern face of the SELF. The maintenance operations did not contribute to the measured sound levels. Sounds of landfill waste placement operations were not audible at Location 1. The Seneca Energy, Inc. gas-to-energy plant includes a number of engine-generators that are enclosed in buildings, and outdoor enclosed flares. The Seneca Energy II High BTU plant contains processing equipment and compressors that convert the landfill gas to pipeline grade renewable natural gas. Operations of the equipment at the facilities were perceptible between daytime traffic and in daytime evening periods after the afternoon peak traffic period. Construction activities at Stage 6 were not audible at Location 1.

Aerial view of Location 1 at east boundary of SELF landfill, opposite former residential-use properties on east side of Rt 414

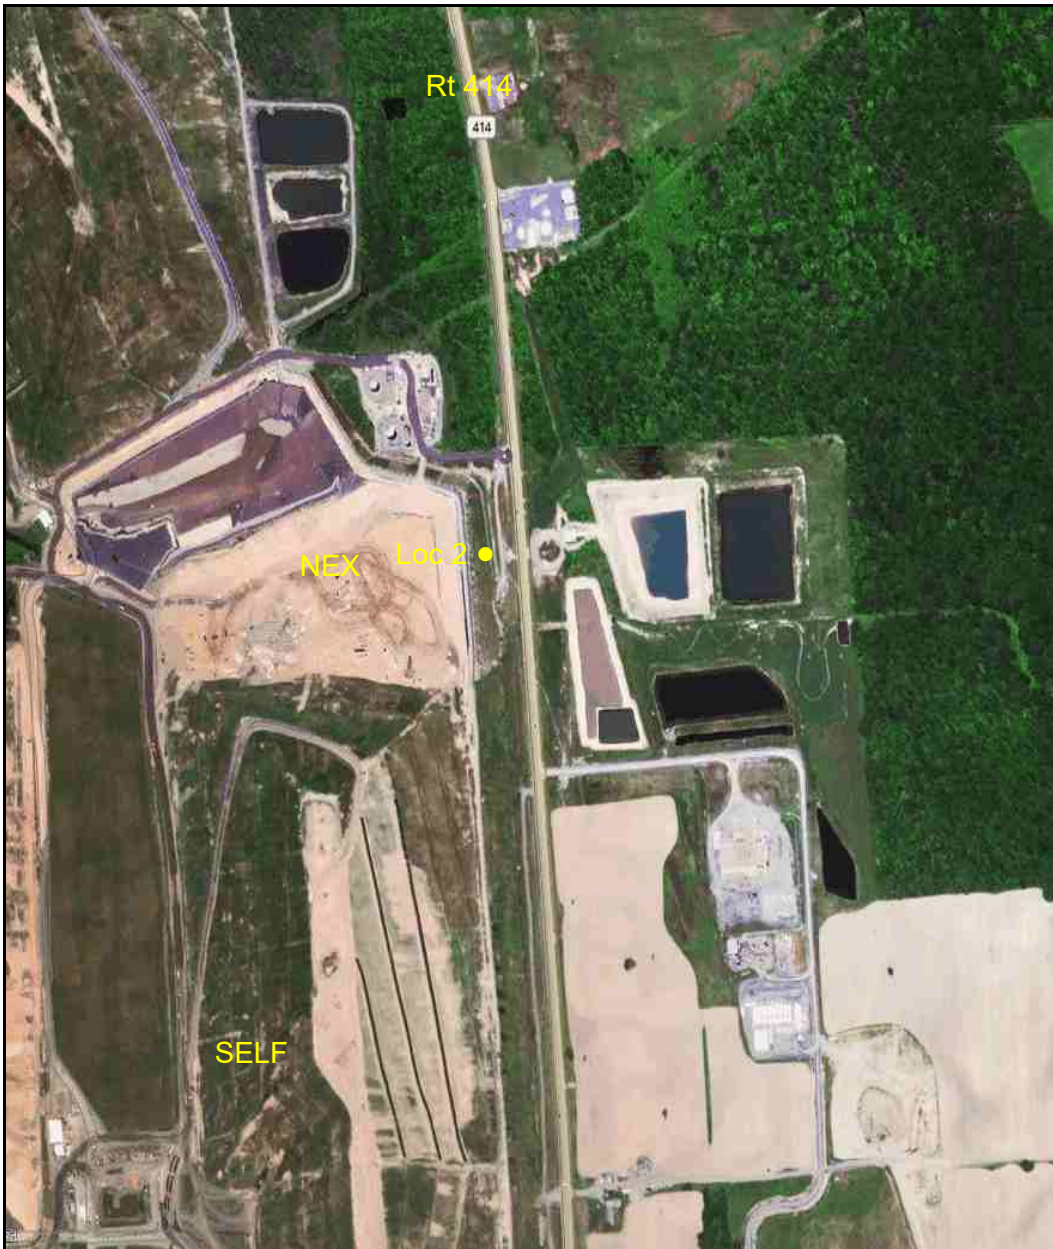
Aerial view of Location 2 adjacent to NEX landfill, opposite former residential property
