Re: SENECA MEADOWS LANDFILL 2020 ANNUAL REPORT  
209-4213087

## SENECA MEADOWS LANDFILL 2020 ANNUAL REPORT

CORNERSTONE ENGINEERING, GEOLOGY, AND LAND SURVEYING, PLLC

FEBRUARY 2021

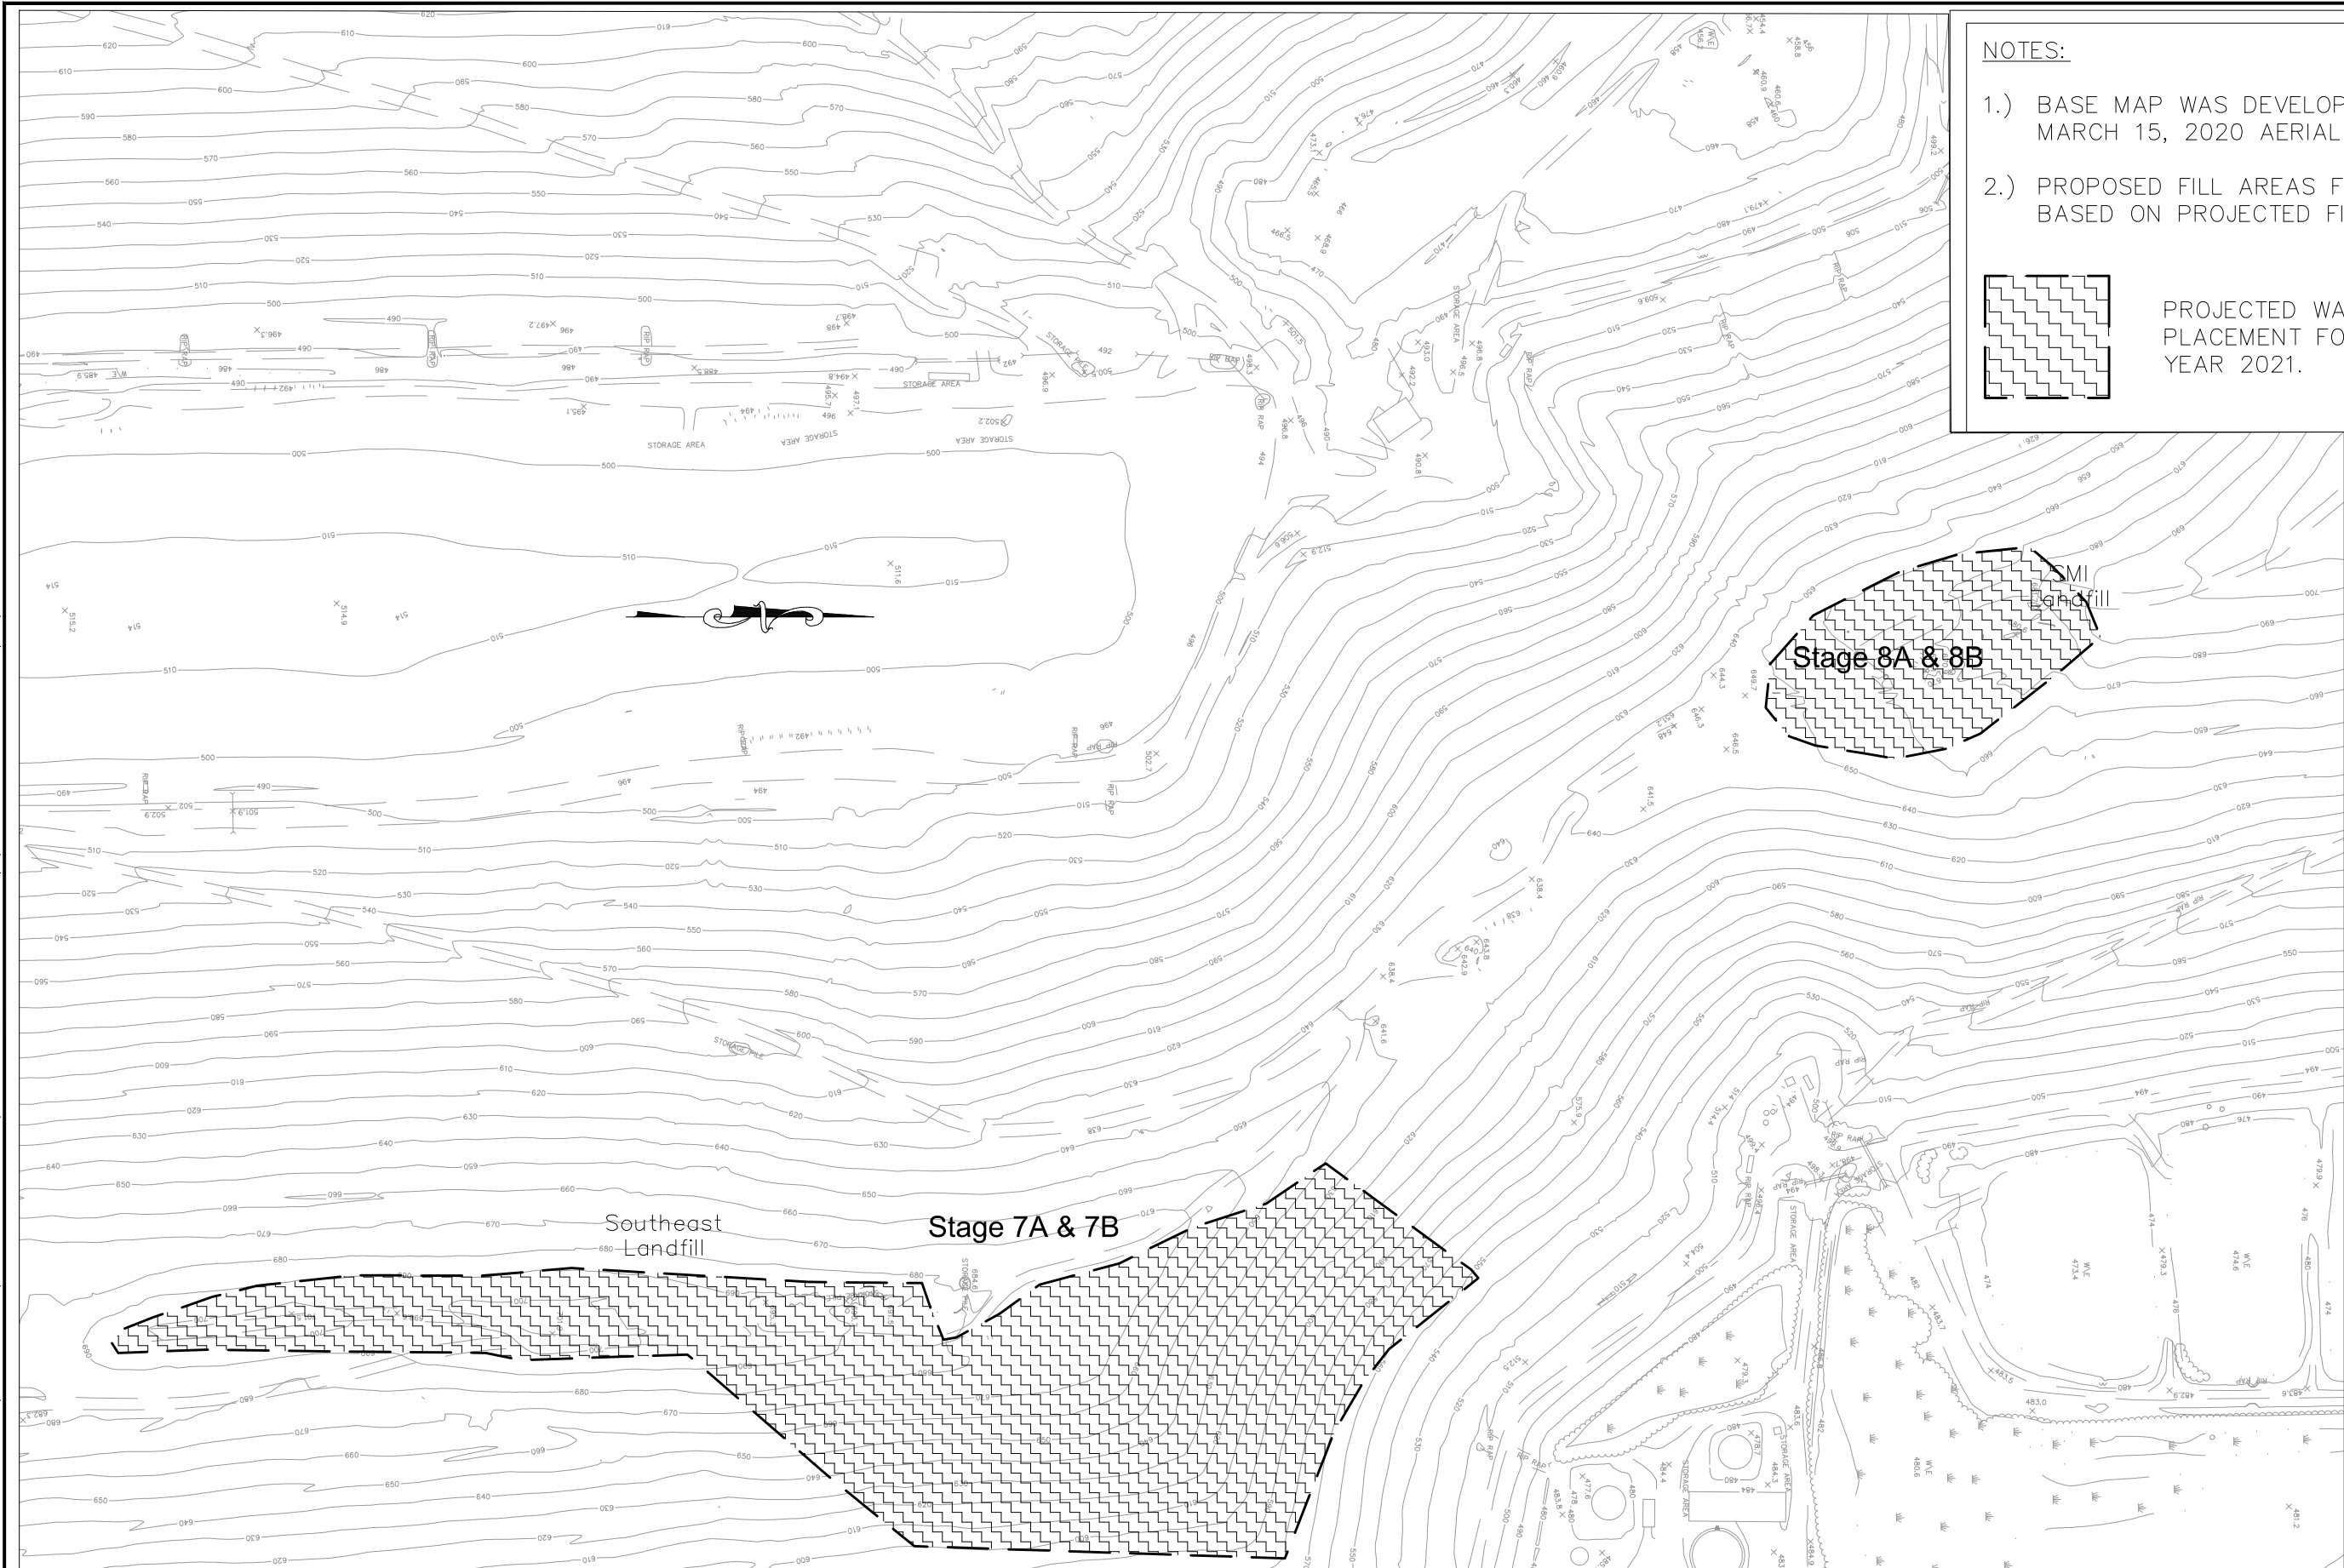
- 1.) BASE MAP WAS DEVELOPED FROM THE MARCH 15, 2020 AERIAL TOPOGRAPHY.
- 2.) PROPOSED FILL AREAS FOR 20210 ARE BASED ON PROJECTED FILL PROGRESSIONS.

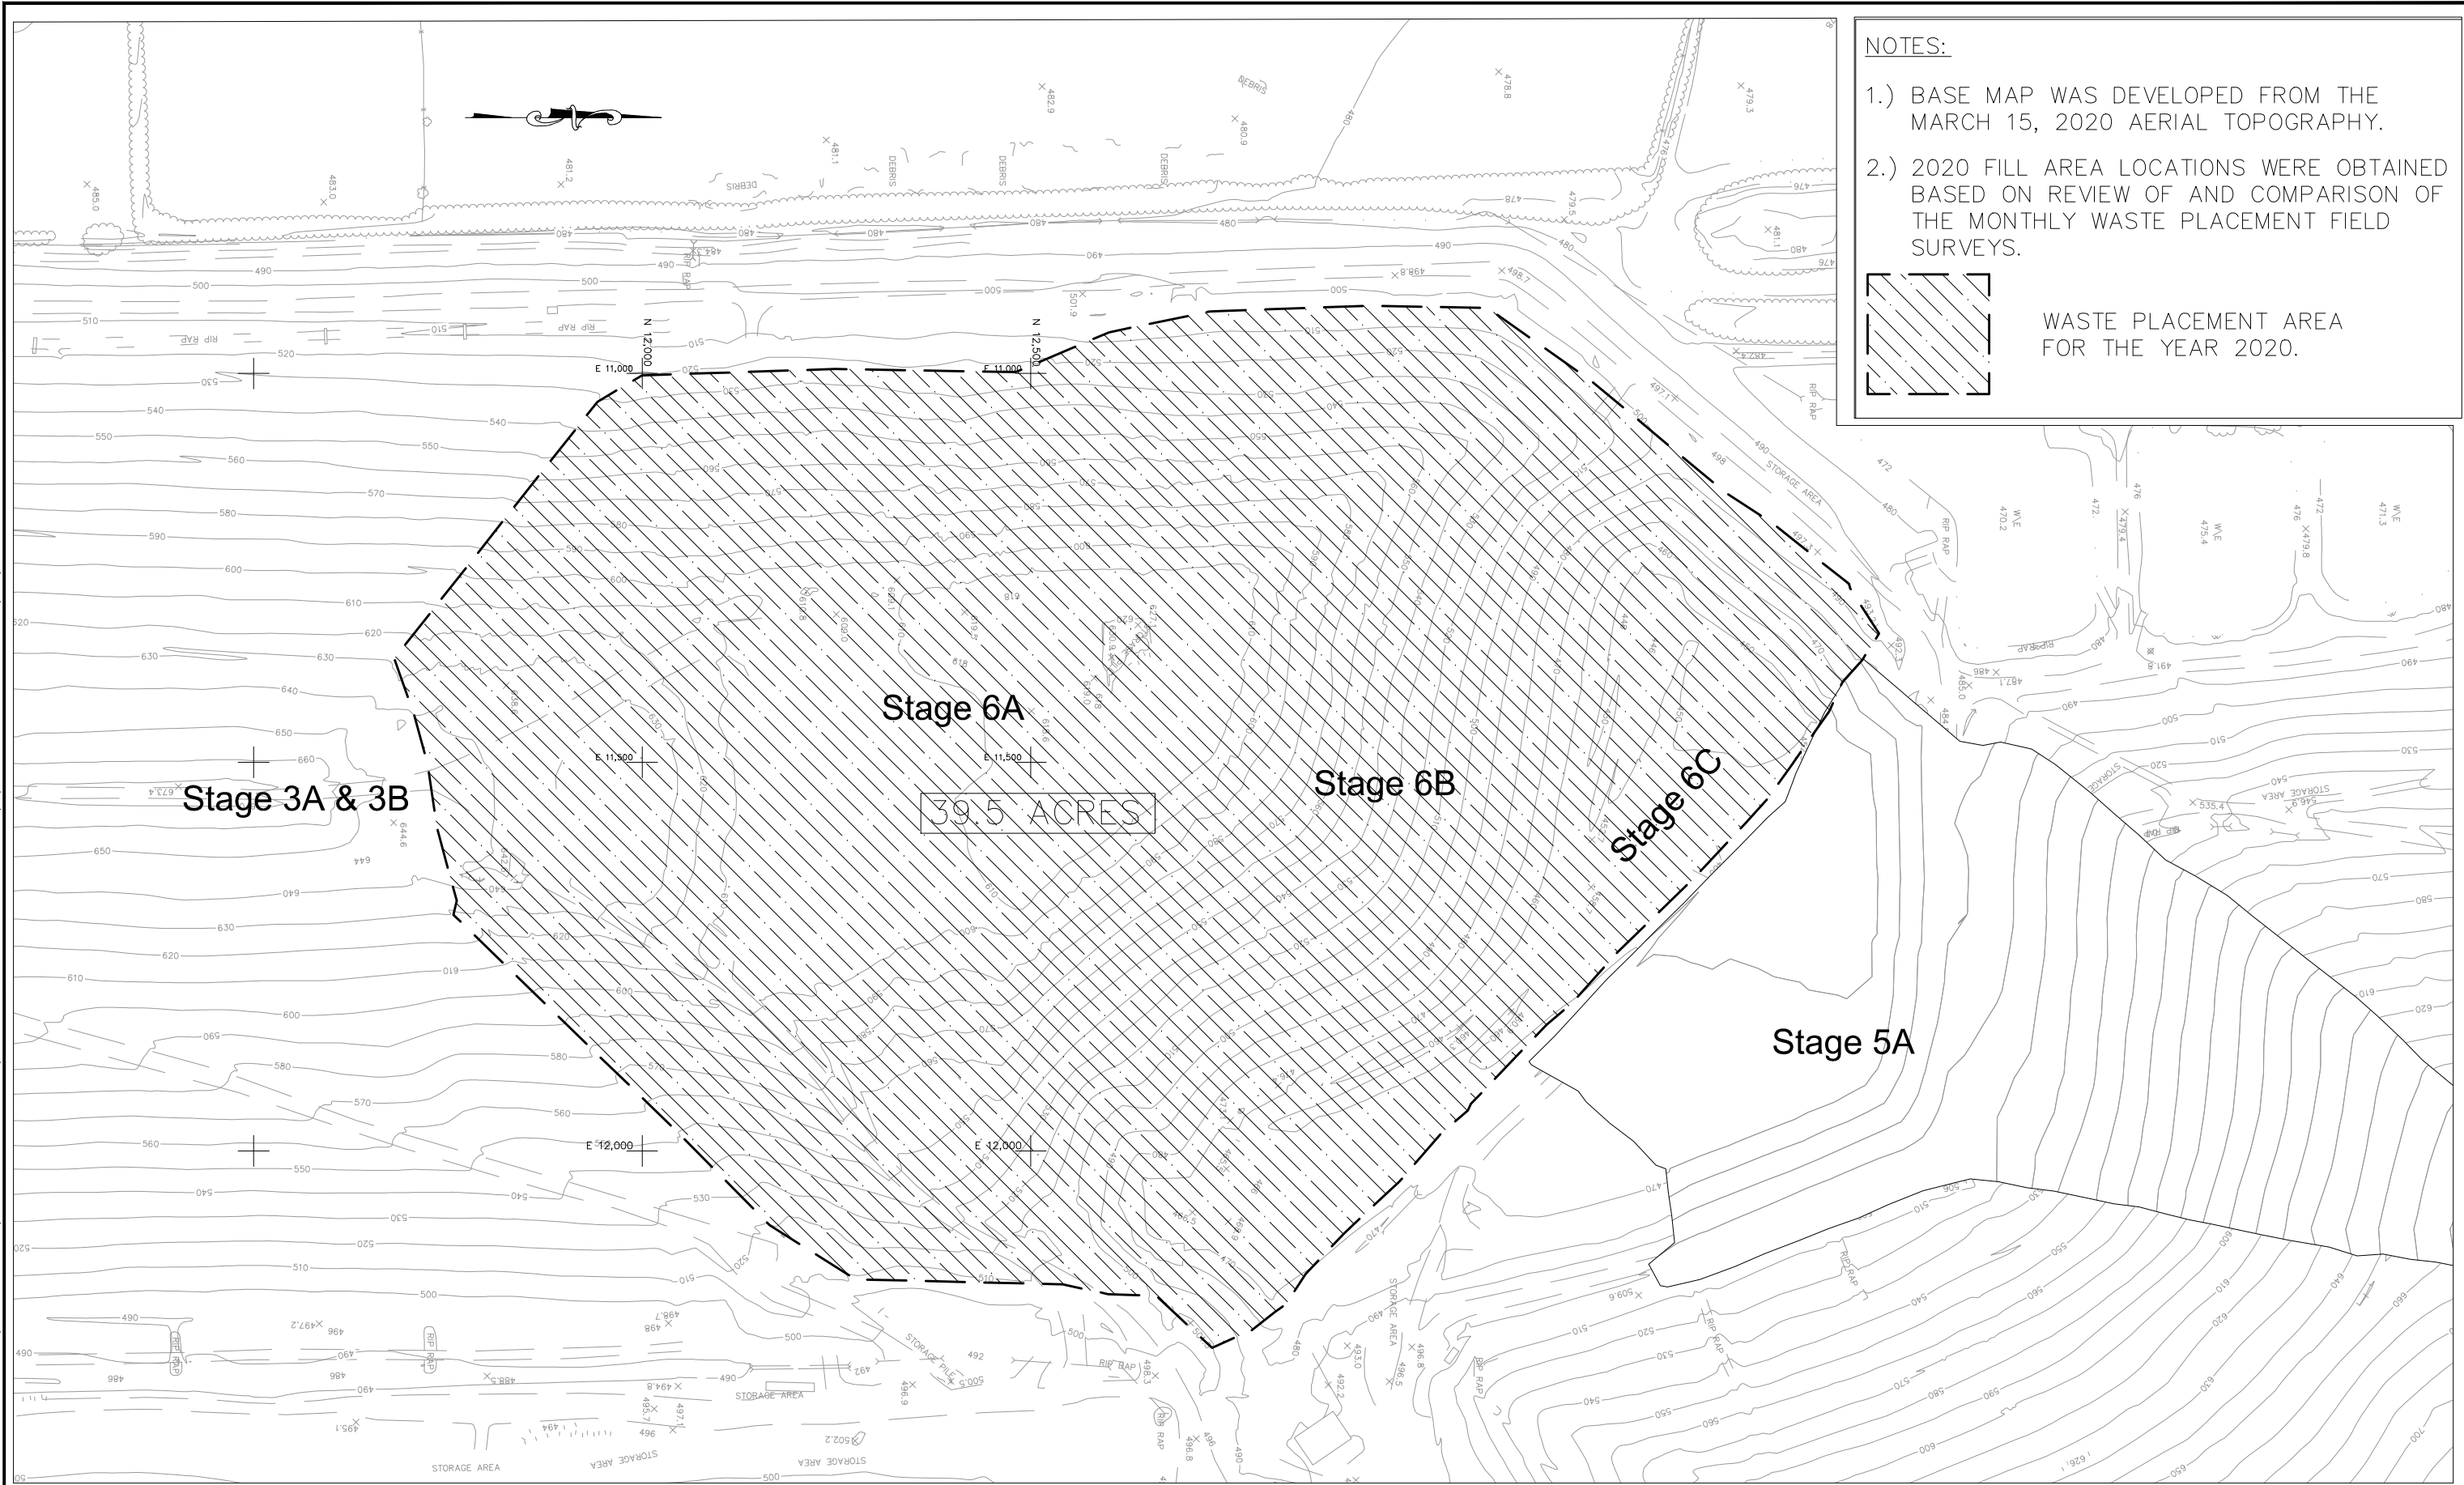
- 1.) BASE MAP WAS DEVELOPED FROM THE MARCH 15, 2020 AERIAL TOPOGRAPHY.
- 2.) 2020 FILL AREA LOCATIONS WERE OBTAINED BASED ON REVIEW OF AND COMPARISON OF THE MONTHLY WASTE PLACEMENT FIELD SURVEYS.

Near-term waste filling will continue within the constructed and certified landfill areas which include Stage 6A, 6B and 6C during 2020. The approximate locations of waste placement in the Stages 7/8, and Stage 6A/B are depicted on Figures 2-1, and 2-3, respectively. Additionally, it is noted that the SELF/EX-2 and NEX/EX-3 areas contain plateau and veneer fills that represent significant remaining air space that may be utilized for future waste placement. The specific locations of veneer fills that may be utilized will depend on operational considerations and will be determined at a later time.
