## Bridgehampton Wellfield PFAS Source Investigation Update

The agencies are completing a field investigation that began in June 2026 to determine potential sources of per- and polyfluoroalkyl substances (PFAS) in groundwater. This includes Perfluoropropionic acid also known as Perfluoropropanoic acid (PFPrA), which is an Ultra Short Chain (USC) PFAS (Figure 1), detected in recent water samples collected from the Bridgehampton Road Wellfield.

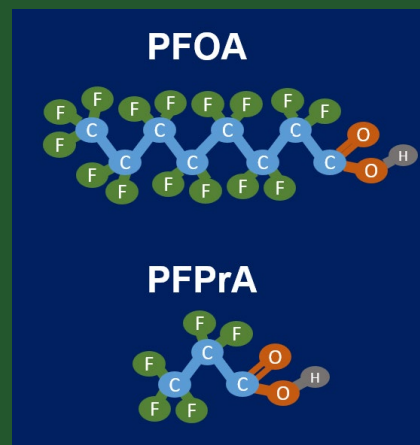
Figure 1: Structure of PFOA and PFPrA

PFAS are a group of chemicals that contain carbon chains with fluorine bonds (Figure 1). They have been used in a wide range of consumer products and industrial processes because they do not degrade easily. PFAS are classified based on the carbon chain length, with the two most commonly regulated PFAS (PFOA and PFOS) having eight carbon chains. Ultra short chain (USC) PFAS are typically classified as PFAS with less than four carbons. Shorter carbon chains lead to faster travel times in groundwater and soil, as short chain PFAS do not stick to soil particles as easily as longer chain PFAS.

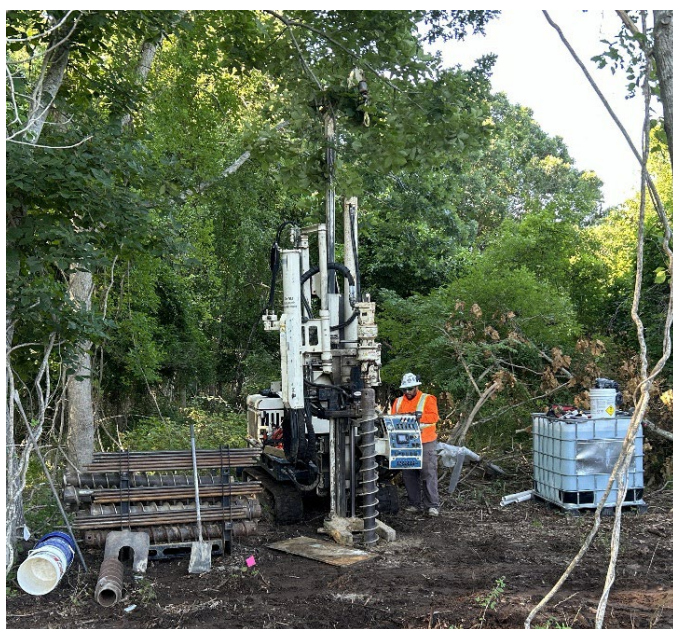
Figure 2: Monitoring well installation

To understand groundwater quality, DEC sampled seven existing National Grid monitoring wells and collected additional groundwater data alongside the Suffolk County Department of Health Services (SCDHS) at a total of 14 new groundwater monitoring wells through the investigation area (Figure 2). Additionally, to understand possible sources of PFAS contamination, DEC collected over 40 soil samples (Figure 3) at multiple depths from 12 locations. Sample locations are shown in the attached figures, and the status of sampling efforts is provided in Table 1 below. DEC also sent information requests to the EH BESS operators, to understand further details of the 2023 fire and fire response.

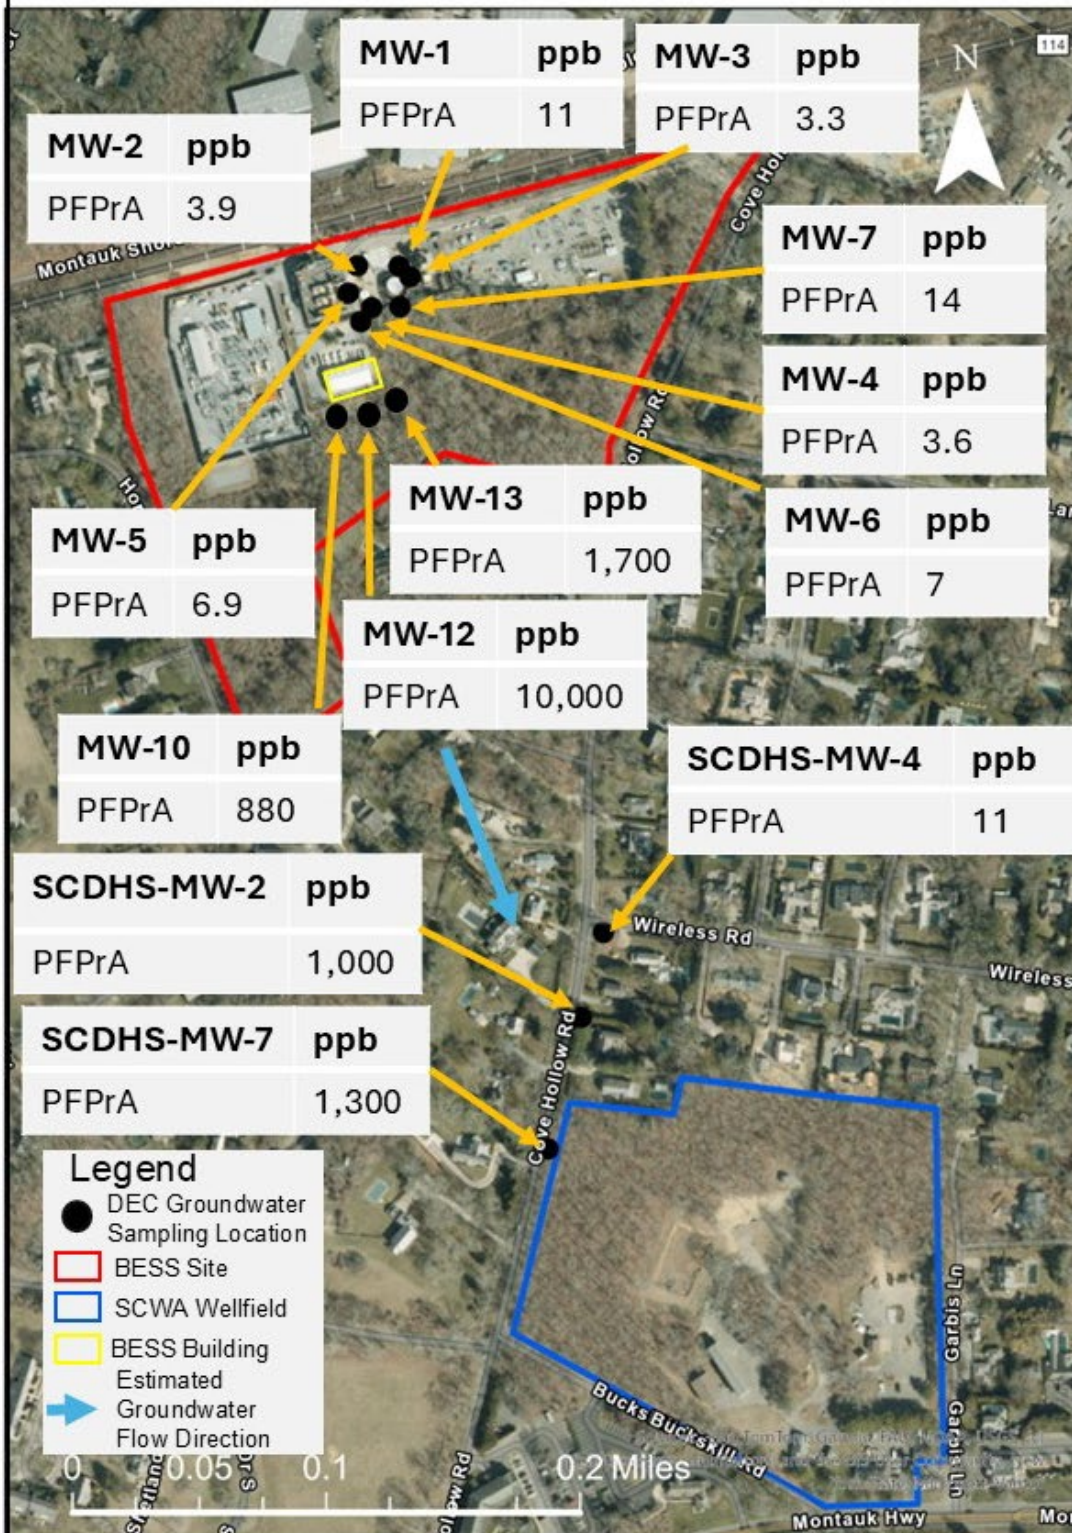
Figure 4: Groundwater Results

DEC completed initial reviews of available groundwater laboratory data for the groundwater wells sampled by DEC and SCDHS. The data is currently undergoing final data validation and will be made available in the final report DEC plans to release this fall. The preliminary data is shown in the attached figure (Figure 4). The maximum PFPrA concentration was detected adjacent to the EH BESS building. DEC has completed sampling the eight newly installed monitoring wells near the EH BESS building and expects to have additional laboratory results later in September.

Environmental data collected by DEC and SCDHS show elevated groundwater concentrations of PFPrA south of the EH BESS facility in the regionally downgradient groundwater flow direction.

DEC's investigation into the PFPrA source includes an evaluation of the East Hampton Battery Energy Storage System site that caught fire on May 31, 2023. A map of the BESS facility and the wellfield can be found on Figure 4.

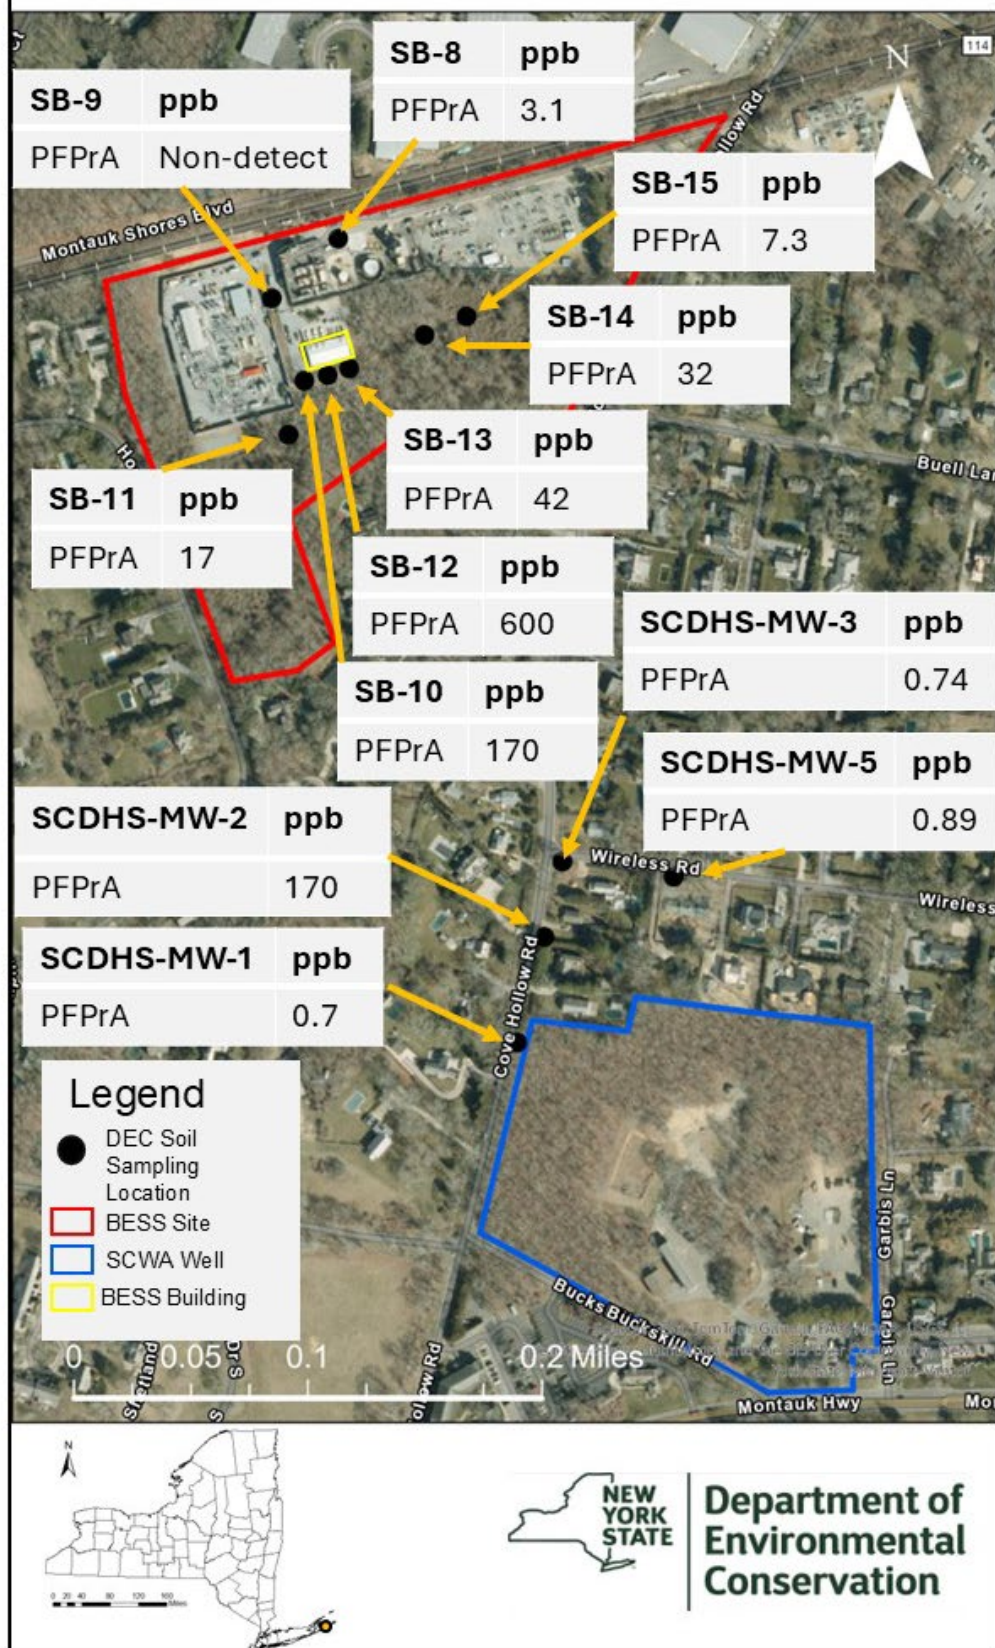
Figure 5: Soil Results 0-2 Inches Depth

The data is currently undergoing final data validation and will be made available in the final report. The preliminary data is shown below in the attached figure (Figure 5) and shows the highest PFPrA concentration was detected in the shallow soil sample collected adjacent to the EH BESS building.

Additionally, soil data collected by DEC exhibits elevated concentrations of PFPrA downgradient of the EH BESS building. This environmental data suggests a preliminary indication that the EH BESS facility may be a source of the PFPrA contamination due to the fire suppression system used.
