New York State Department of Environmental Conservation

Five Rivers Environmental Education Center

Draft Unit Management Plan

February 2007

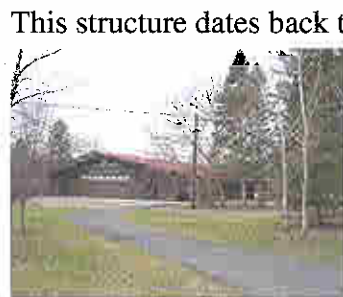
1. Visitors Center- Building No. 7 - 4600 sq. ft.

This structure dates back to at least the 1960's when it served as a cafeteria at the Albany State Office Building Campus. It was physically disassembled and re-located to the Five Rivers site in 1966. It is a wood-framed structure of approximately 4600 sq. ft. The exterior siding is wood and the metal roof appears relatively new. However, the roof utilizes framing that appears independent of the original roof structure creating,

- Deteriorating foundation condition that has caused relocation of frozen pipes in a previous winter.
- Non-compliant for ADA bathroom layout and fixtures
- Leaking roof in the large storage area
- Large storage area and occupied side of building do not have proper fire separation.
- The building is remote from the Visitors Center making it difficult to share resources, equipment, materials, etc.

It is our assessment that in order to achieve the programmatic goals in the most energy-efficient way, a new building to replace the current structure is strongly indicated. For energy efficiency and to eliminate duplication of services, integrate with the Guided School Program (see below).

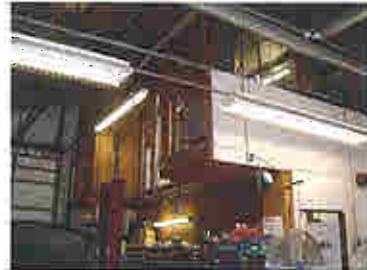
- No roof leaks apparent
- No structural problems apparent though there is impact damage to the siding at the lower sections, particularly near the overhead doors.
- There are two fuel pumps, one for diesel, the other for gasoline near the front entrance. These pumps are no longer in use.
- There is inadequate storage for the types of petroleum-based liquids used at this site.
- A forced air furnace is on the second floor loft space and is open to the first level where there are chemicals stored. The HVAC equipment cantilevers out over the workspace below.
- The bathroom in the second floor loft is not ADA compliant. It cantilevers out over the workspace below.

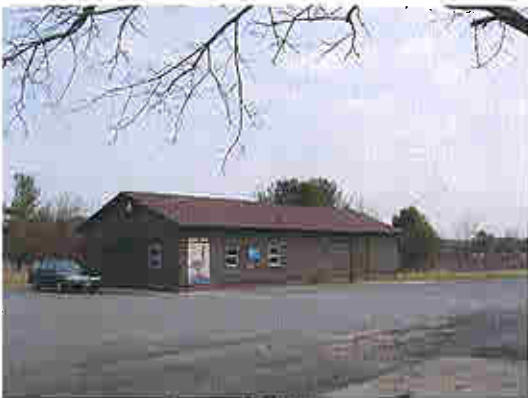
Goose Lodge – No. 2

Deficiencies of Goose Lodge – Overall, this building does not meet code requirements for the current program uses. The concrete block foundation is in very serious disrepair. There is no ventilation system, nor bathroom exhaust system. The bathroom layout and fixtures are not ADA compliant.

Conclusion – Because of the difficulty in upgrading this structure to modern office specifications, the OGS Study recommends that this structure be removed and its functions subsumed within the proposed new Visitor Center.

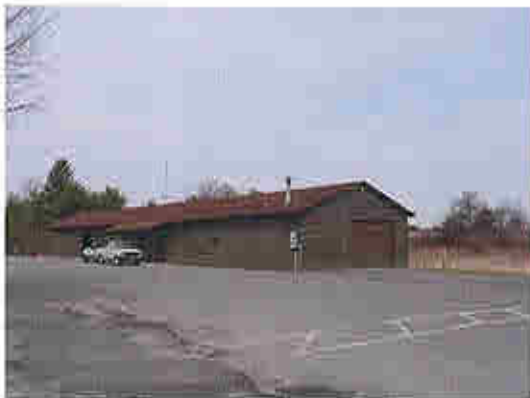
Operations – No. 3

Deficiencies – Deficiencies identified in Building 3 are a lack of sufficient interior lighting and a bathroom that is not ADA compliant. However, a major concern is the location of this facility. Truck traffic to and from the Operations Field Crew Headquarters negatively affects pedestrian traffic at a most vulnerable spot, where school buses currently unload and students cross over to the Goose Lodge.

Conclusion – The OGS Study recommends that a new Maintenance Facility be developed near the current Auto Repair Shop, integrating the functions of both buildings. The current Operations Field Crew Headquarters, Auto Repair Shop and Tire Barn would then be demolished.

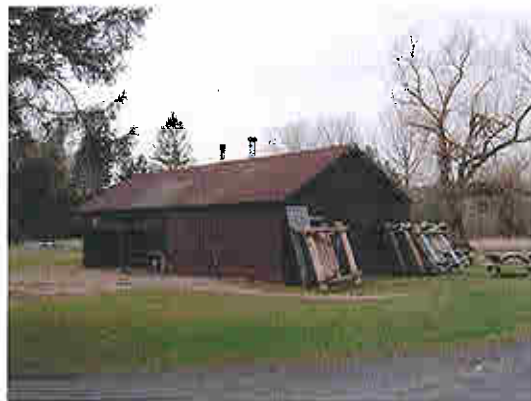
Bear Pen – No. 7A

Deficiency of the Bear Pen – Though structurally sound, this building is not heated and is poorly lit. Given the site configuration proposed in the OGS Study, the structure is in a very disadvantageous location.

Conclusion – The OGS Study recommends that the Bear Pen be removed and its current program and picnic use functions be relocated.
