Norton Basin/Little Bay Restoration Project: Historical and Environmental Background Report

November 2001

Barry A. Vittor & Associates, Inc., 656 Aaron Court, Building 6,
Willow Park Office Complex, Kingston, NY 12401

U.S. Army Corps of Engineers, New York District, CENAN-PL-ES,
26 Federal Plaza, New York, NY 10278

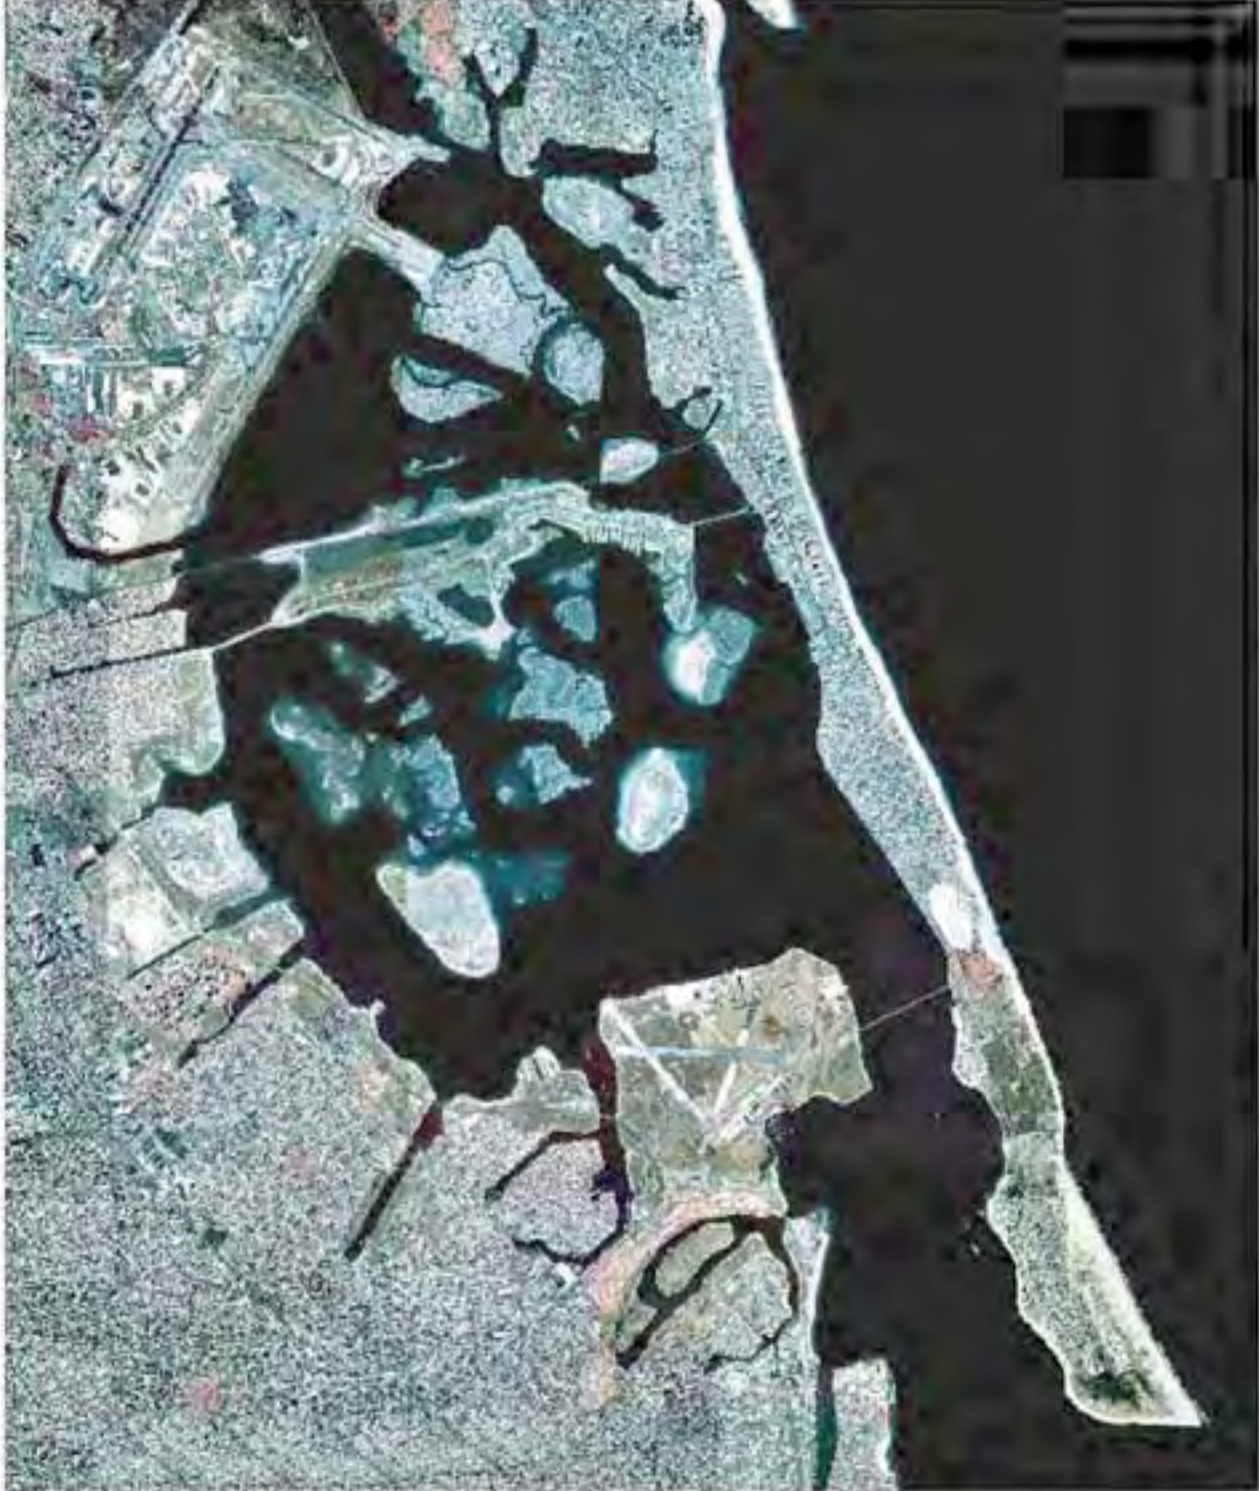
Figure 2.0.1. Aerial photograph of Jamaica Bay. Adapted from USGS aerial photograph, 1995.

Norton Basin and Little Bay are located on the Rockaway Peninsula of Jamaica Bay within the NY/NJ Harbor estuary (**Figure 2.0.1**). Jamaica Bay is a shallow bar-built estuary, approximately eight miles long, four miles wide and 26 square miles in area, located on the southwest corner of Long Island, NY. It represents a historic delta of the Hudson River (Grambo & Vega 1984) and drains a watershed of approximately 85,000 acres (USFWS 1997).

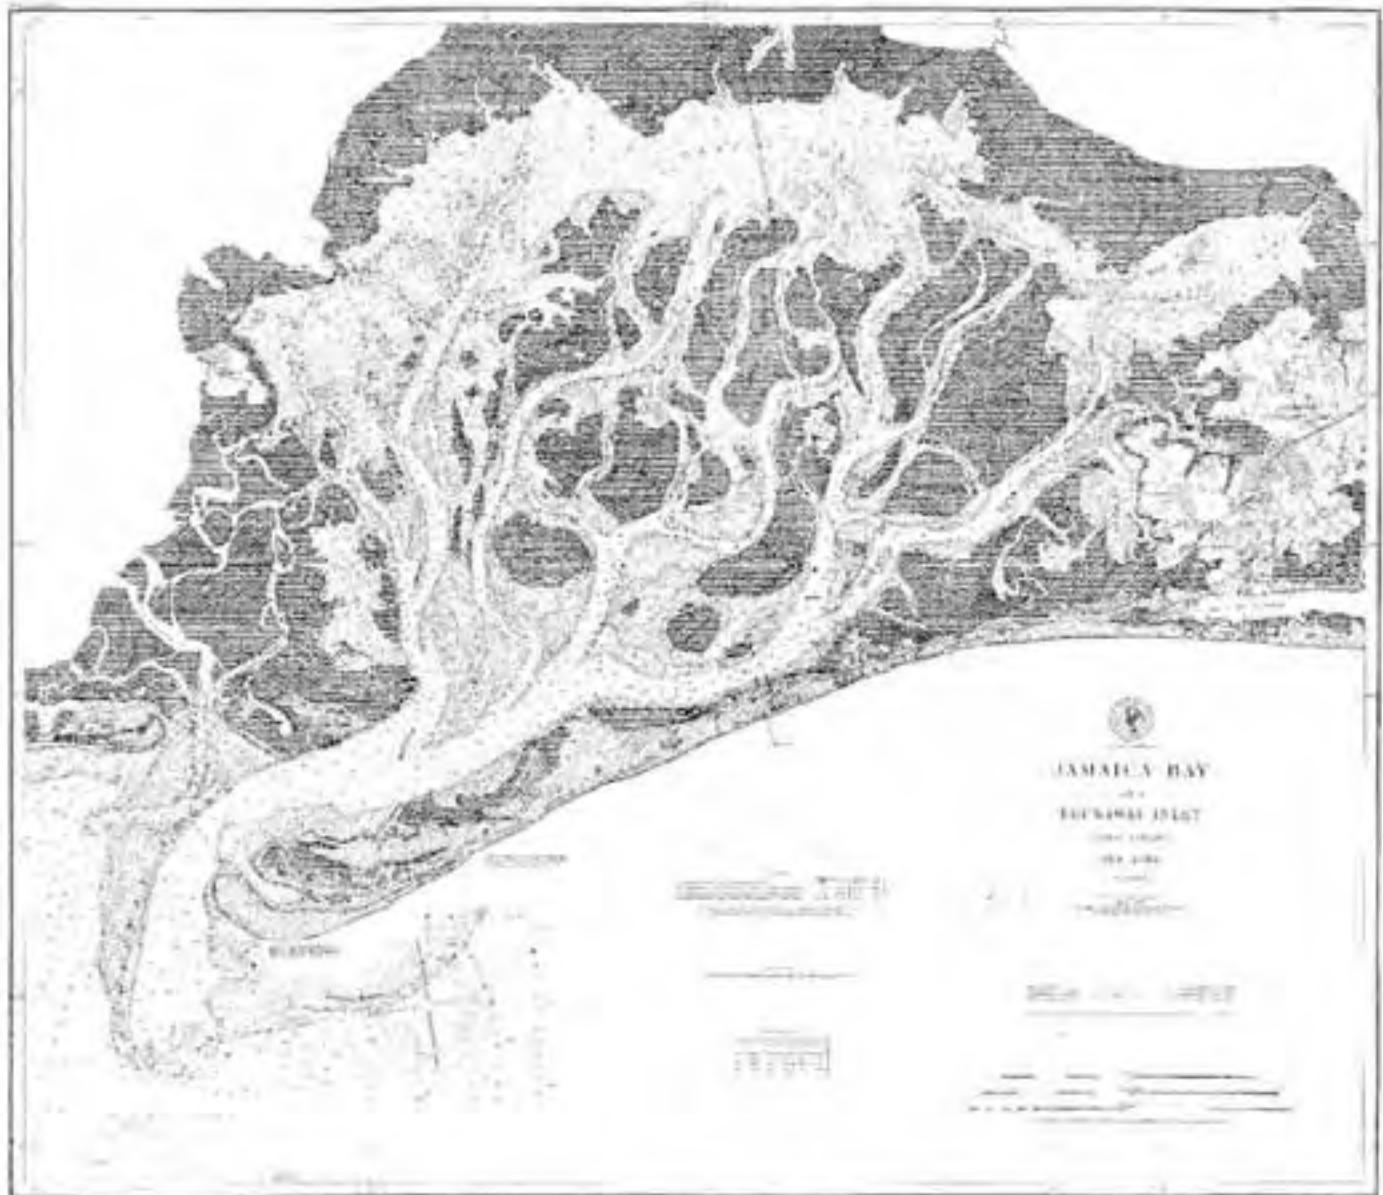
Figure 4.0.1. Topographic map of Jamaica Bay, 1899. U.S. Coast and Geodetic Survey, 1877-1878.

Figure 4.0.1 depicts a survey of Jamaica Bay completed by the U.S. Coast and Geodetic Survey of 1878. The Bay is dominated by intertidal marsh, reported as the dark areas of the map. By 1878, the first rail line transected the Bay and the town of Far Rockaway was a thriving tourist center. Focusing on Norton Basin and Little Bay (**Figure 4.0.2**), the basin now called Norton Basin was named "Aunt Sallie's Drain" and was 1-3 ft deep. Little Bay was 1-5.5 ft deep and connected to Aunt Sallie's Drain and directly to Grass Hassock Channel, which was 8-13 ft deep. Bass Channel was dredged for access from Far Rockaway to the rest of Jamaica Bay, was a 5-8 ft deep channel connecting to the Bay of Far Rockaway, where tourists entered the town by ferry from the city. The Rockaway

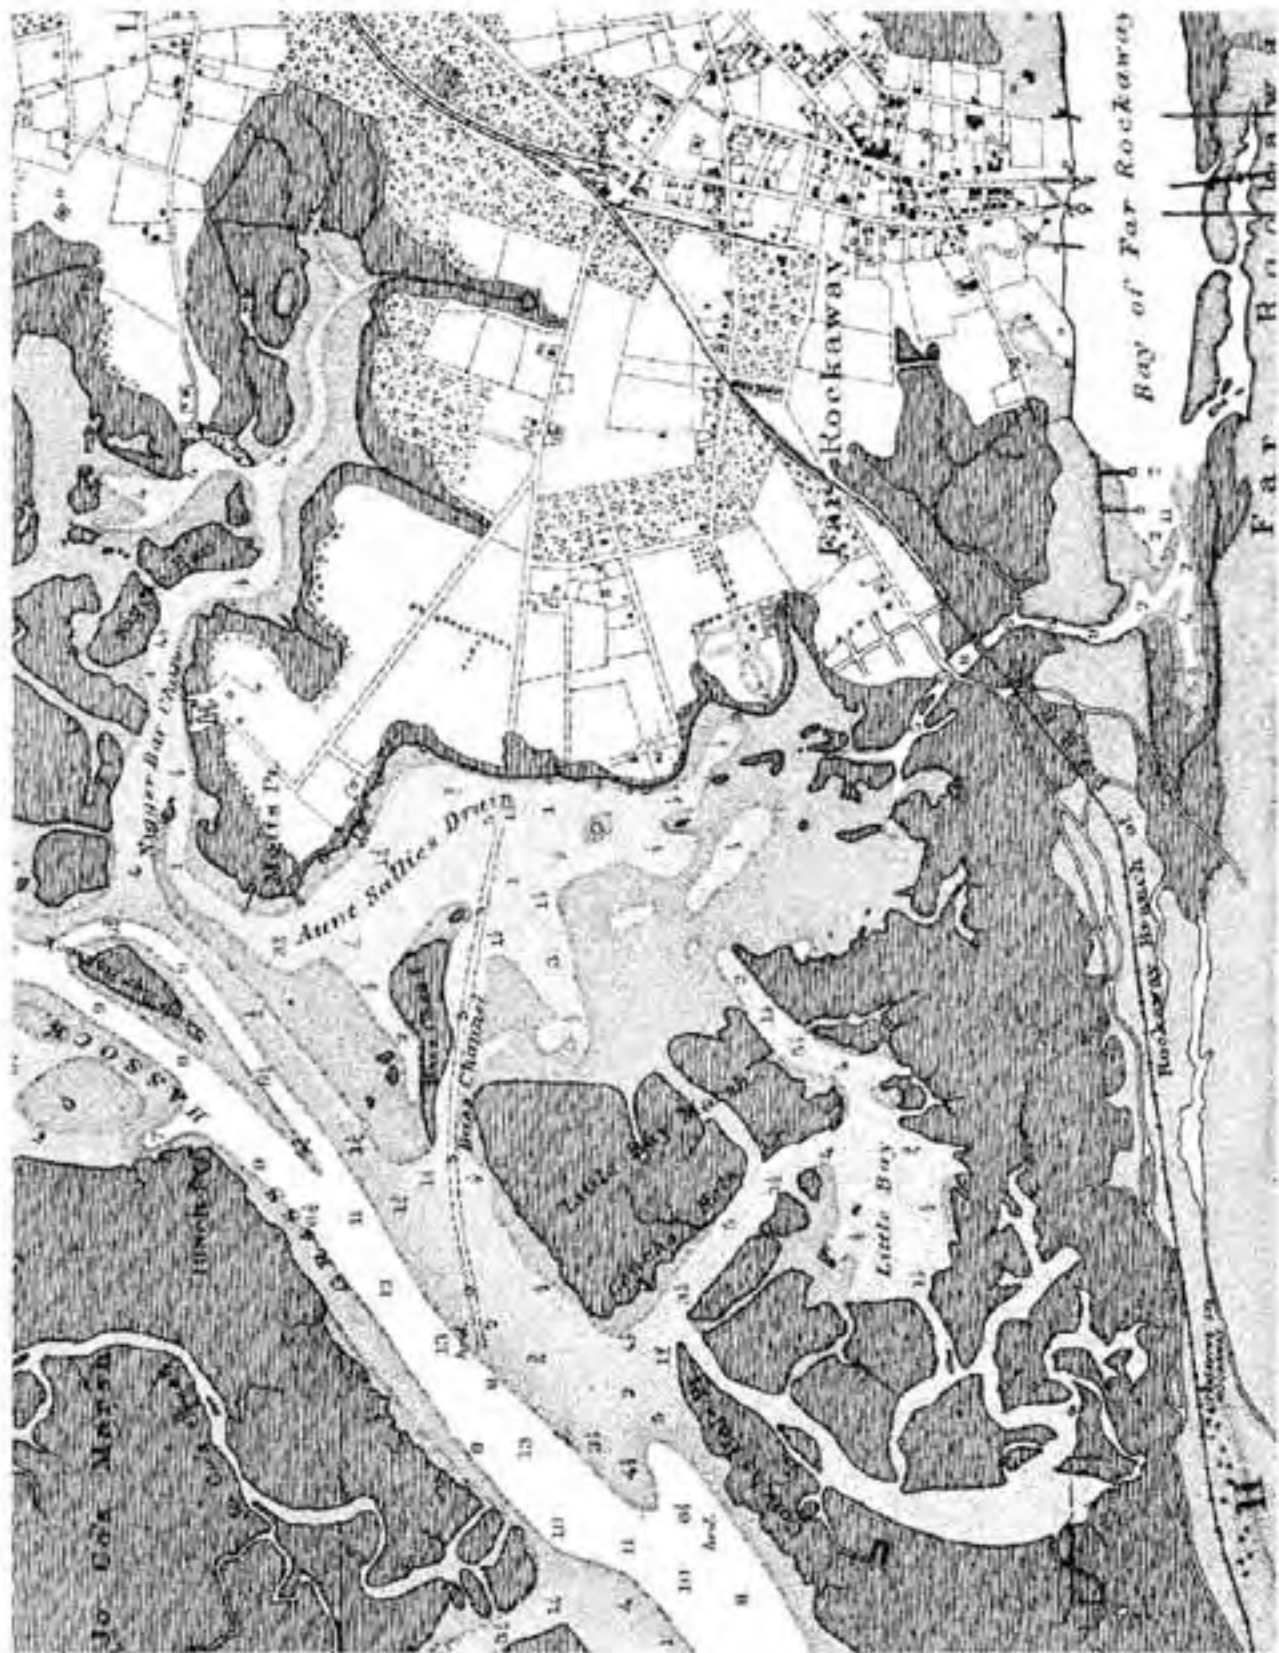
Figure 4.0.2. Topographic map of Norton Basin and Little Bay, 1899. U.S. Geodetic Coast and Geodetic Survey, 1877-1878.

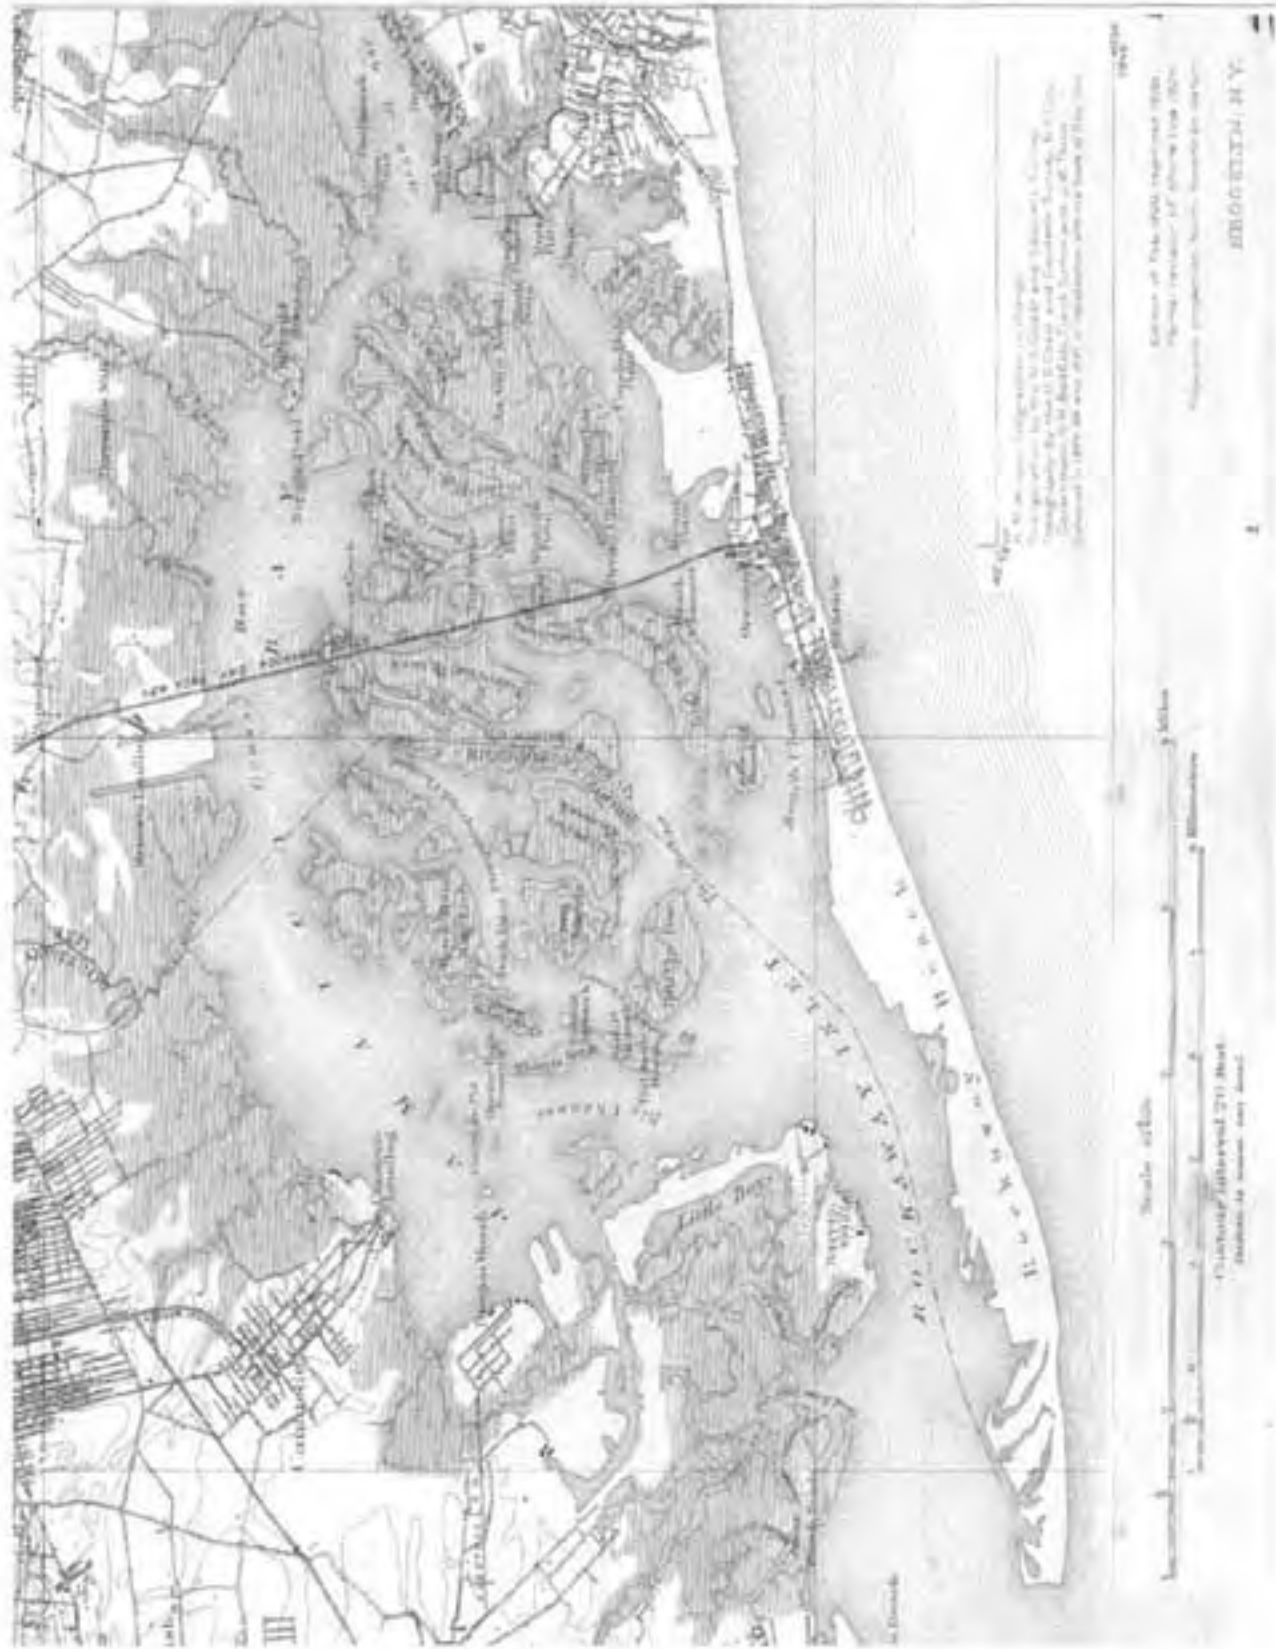
Figure 4.0.3. Topographic survey of Jamaica Bay, 1900. U.S. Coast and Geodetic Survey, 1888-1880, 1897.

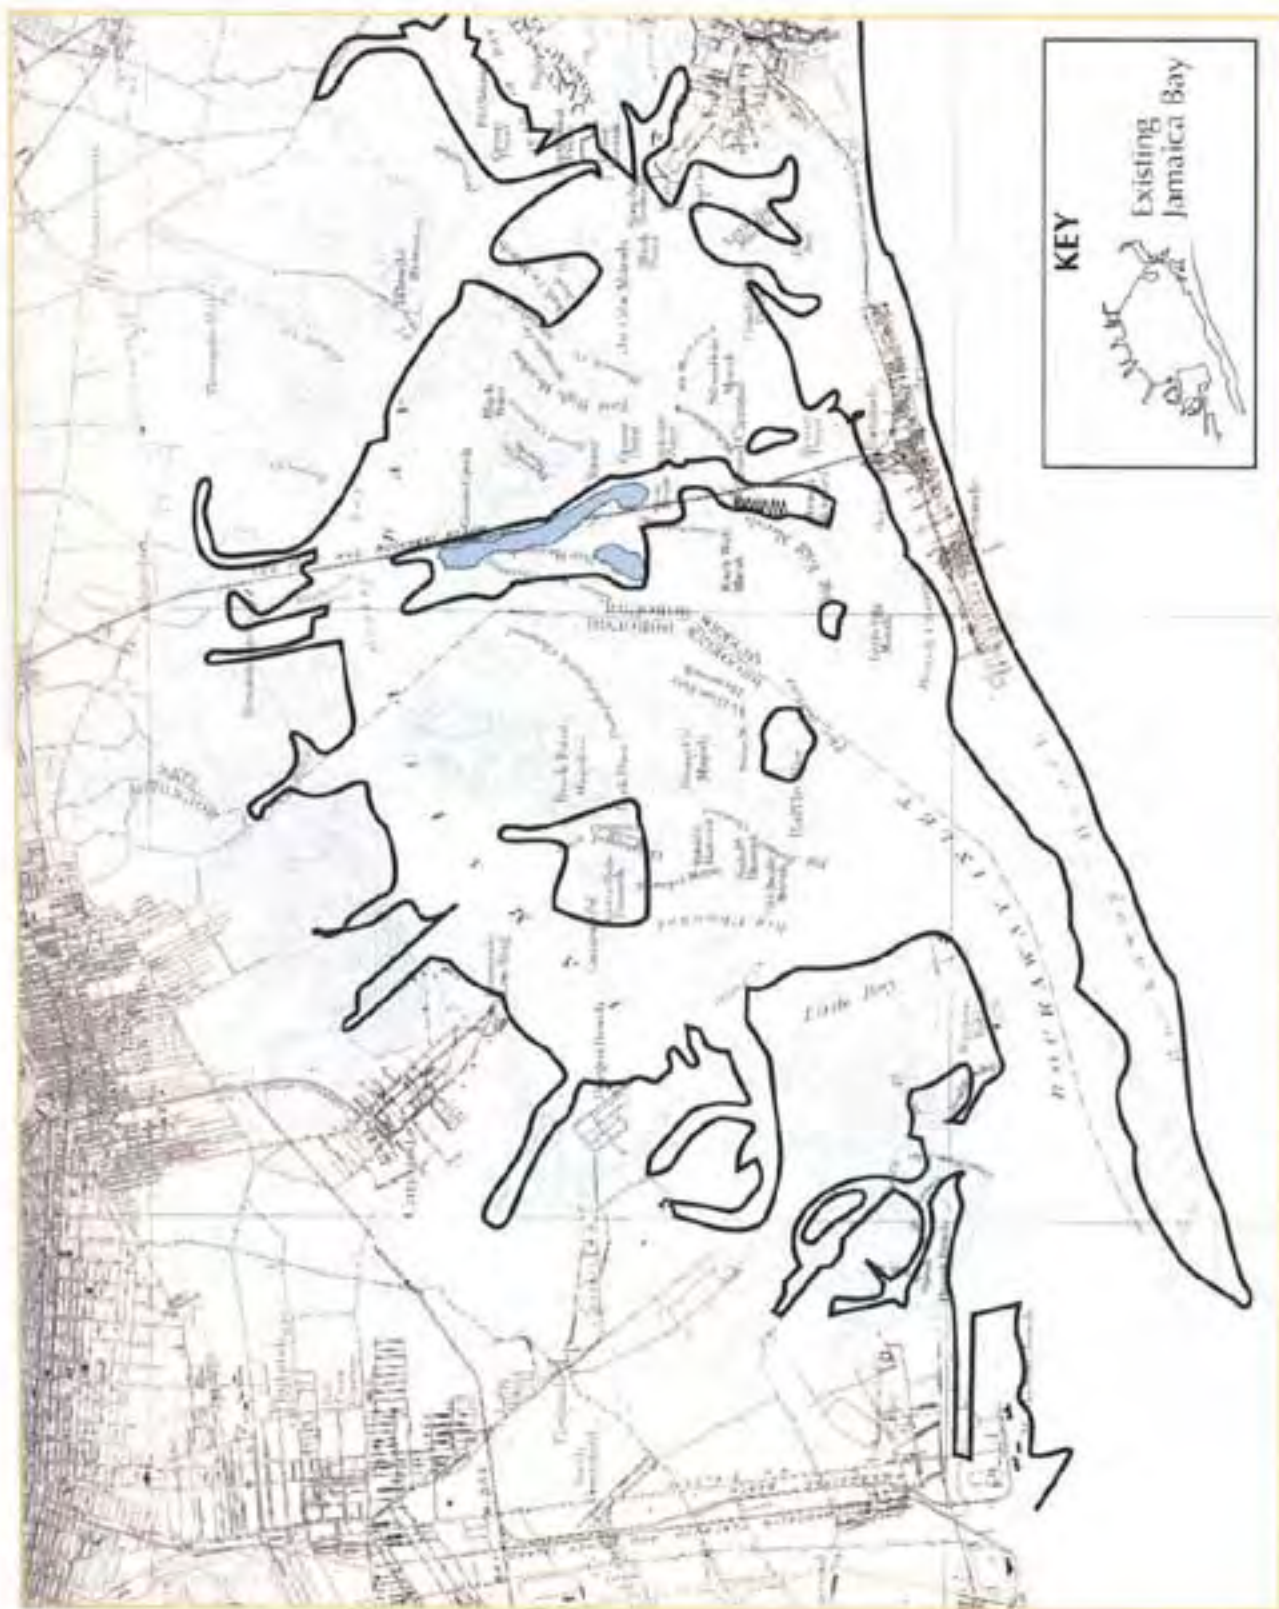
Figure 4-0.5. U.S. Coast and Geodetic Survey of Jamaica Bay (1900) overlaid with current (2000) upland boundaries of Bay. Blue areas are former intertidal marsh. Adapted from O'Brien and Gere, 2000.

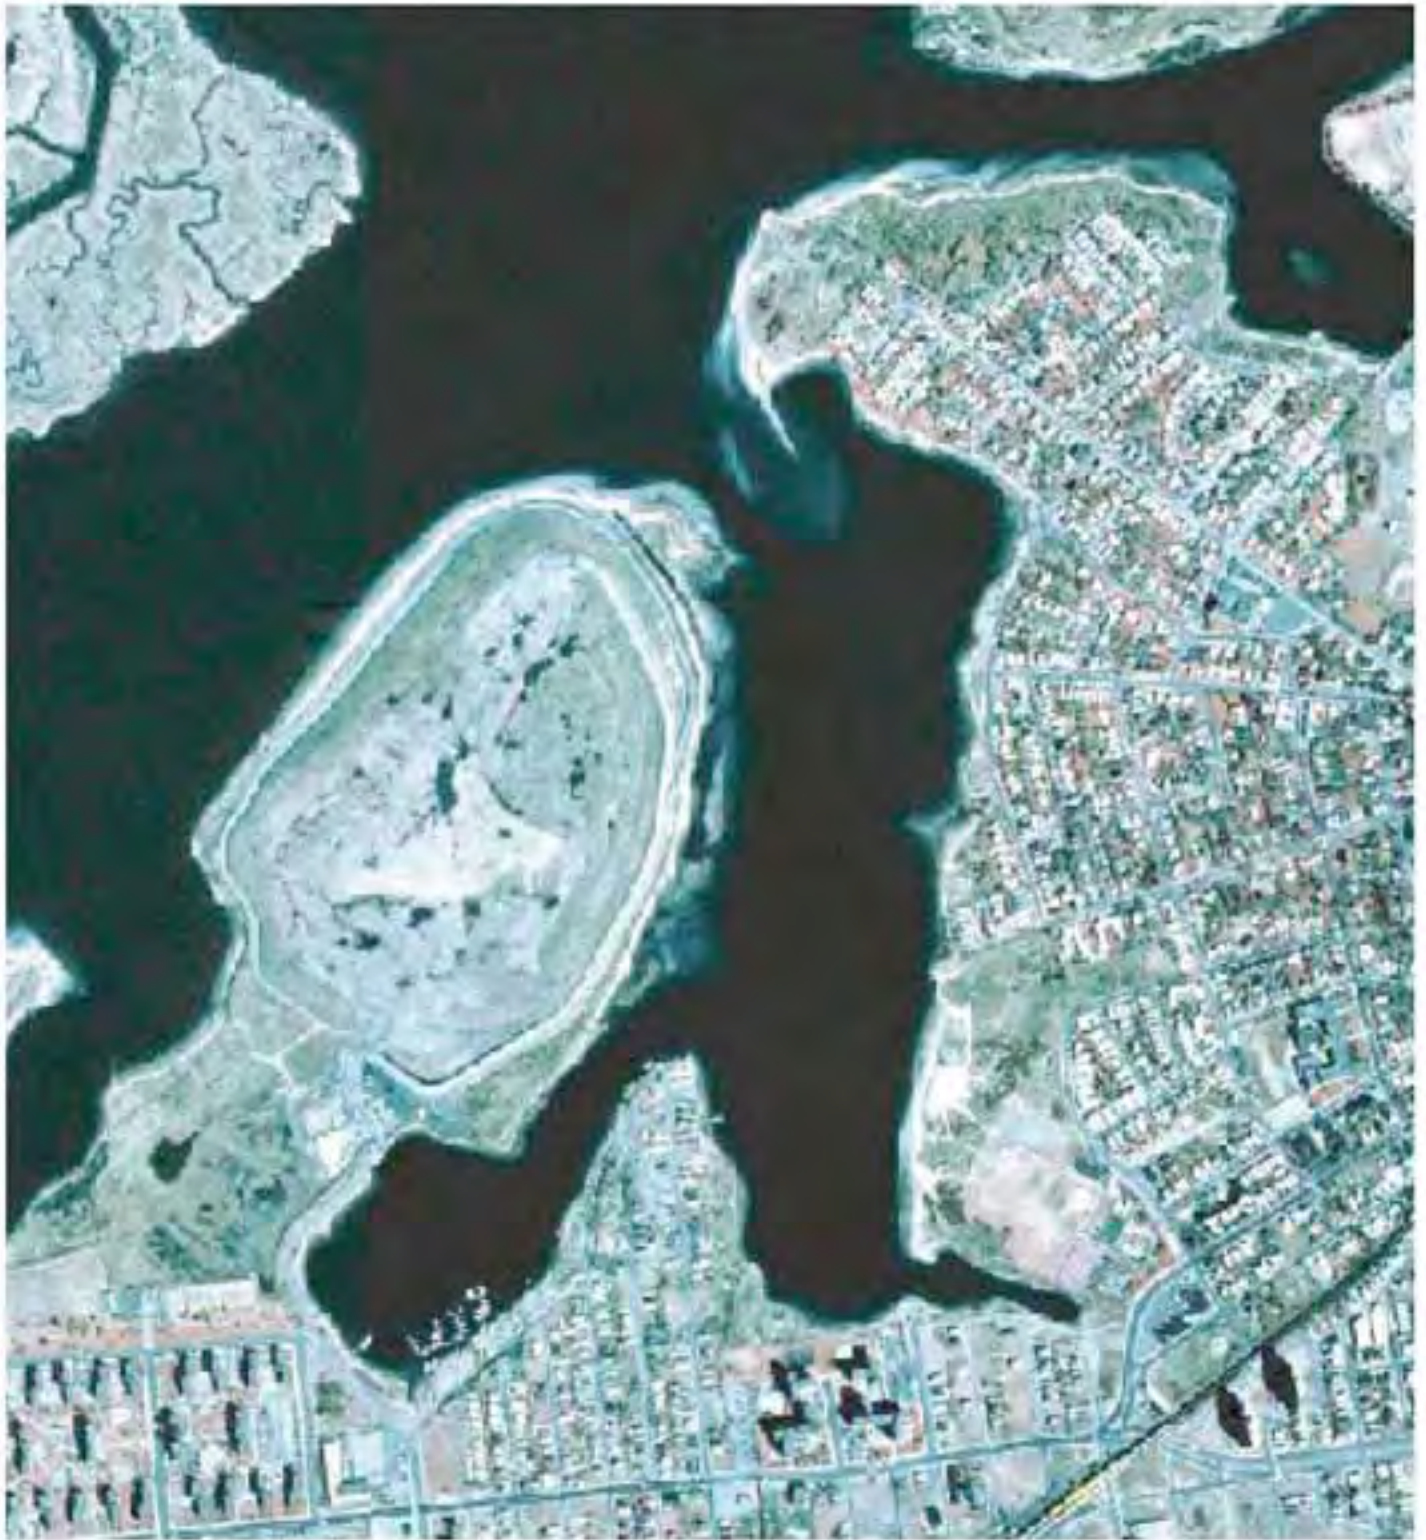
Figure 4.0.8. Aerial photograph of Norton Basin and Little Bay. Image adapted from USGS aerial photograph, 1995.

Figure 4.0.8 is a USGS aerial photograph of Norton Basin and Edgemere Landfill taken in 1995. The image shows the high level of development that has occurred around the basin over the last 150 years. Shallow sandbars are evident in the entrance channel and along the western edge of the basin. These sandbars will need to be removed if the proposed restoration proceeds in order to allow access by barges. Edgemere Landfill has been capped in this photograph, but remains the dominant feature of the immediate landscape. A small private marina has existed in the southernmost portion of Little Bay for several decades. Recent bathymetric investigations in Norton Basin and Little Bay have identified numerous boat hulls in the bottom of Little Bay (CR Environmental 2001). These boats are all less than 40 feet in size and do not immediately suggest any historic significance.

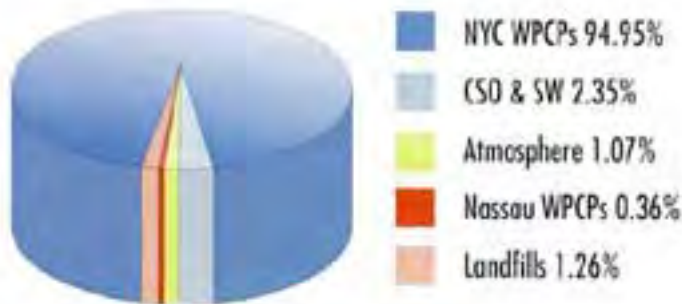
Figure 7.0.1. Sources of carbon, nitrogen, and phosphorus into Jamaica Bay. Calculated by O'Brien & Gere (2000) for the Jamaica Bay Eutrophication Study, NYCDEP.
