# Croton River Hydrilla Control Project

## 2021 ANNUAL UPDATE

New York State Department of Environmental Conservation  
Division of Lands and Forests  
Bureau of Invasive Species and Ecosystem Health  
CROTON RIVER HYDRILLA CONTROL PROJECT  
2021 ANNUAL UPDATE

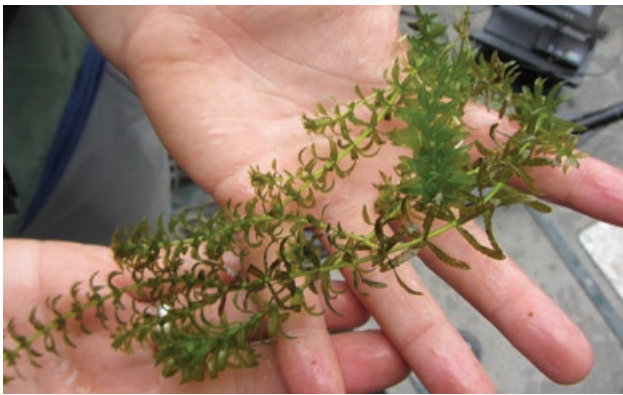
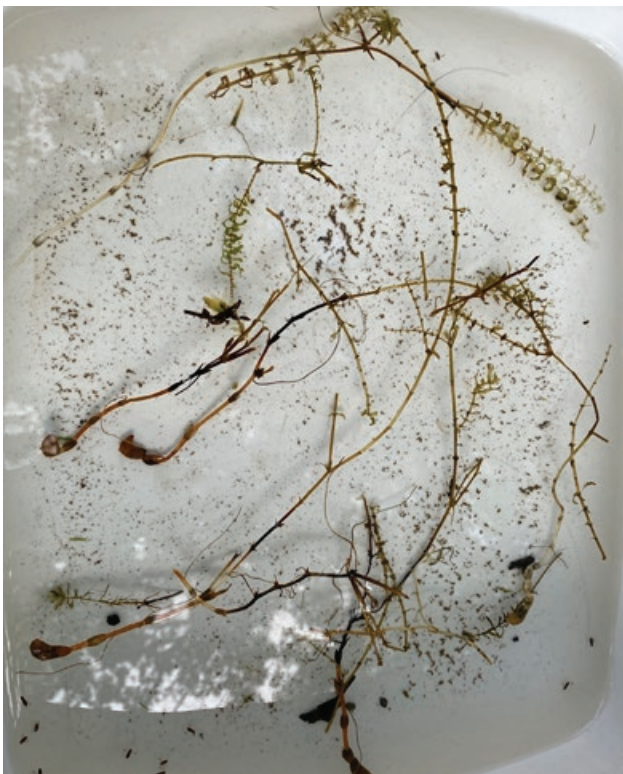
Figure 1: Healthy hydrilla in the Croton River in 2016 (top), and damaged, bleached hydrilla mid-treatment season in 2021 (bottom)

- DEC found a total of 10 hydrilla plants during several surveys throughout the entire Croton River in 2021.
- Hydrilla that was found by DEC staff and contractors showed significant signs of herbicide injury, reduced size, and impacts to plant health (see Figure 1).

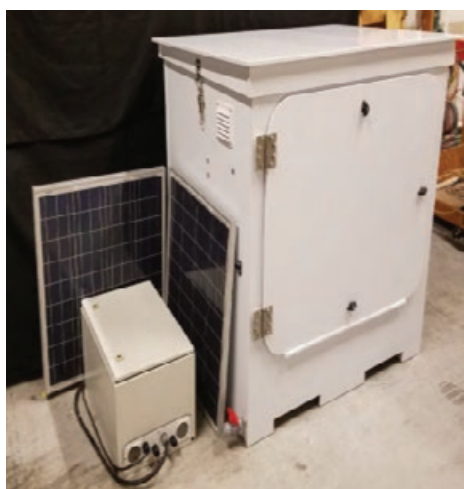
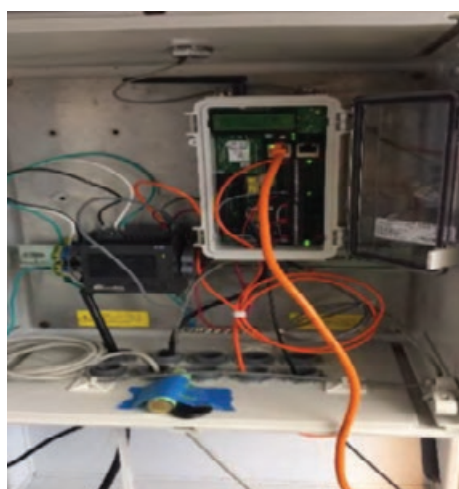
Figure 3: A fluridone injection unit (left), unit control dashboard (center), and cellular control device (right); credit: SePRO

The 2021 herbicide treatment involved injecting the aquatic herbicide fluridone (trade name: Sonar Genesis® [Environmental Protection Agency Reg. No. 67690-54]) into the Croton River at a concentration of 2.0–4.0 ppb for 70 days. Information about the efficacy of low-dose fluridone treatments of infested flowing waters can be found in the *Croton River Hydrilla Control Project Five-Year Management Plan*. Links to the plan and the NYS Special Local Needs Label for Sonar Genesis® can be found in Appendix A. Sonar Genesis® is a liquid herbicide (active ingredient: fluridone) that SÖLitude applied to the river using subsurface injection from remote-controlled (via cell phone) injection systems placed at two locations on the Croton River.

The first injection site was located just below the New Croton Dam and the second injection site was located approximately 1.1 miles downstream, near the concrete dam at Black Rock Park. Injection locations were selected to maximize treatment coverage and ensure product mixing (that the herbicide mixed with the water). Staff from SÖLitude and SePRO Corporation installed, calibrated, and maintained the units. A licensed pesticide applicator from SÖLitude filled and maintained the injection unit tanks.

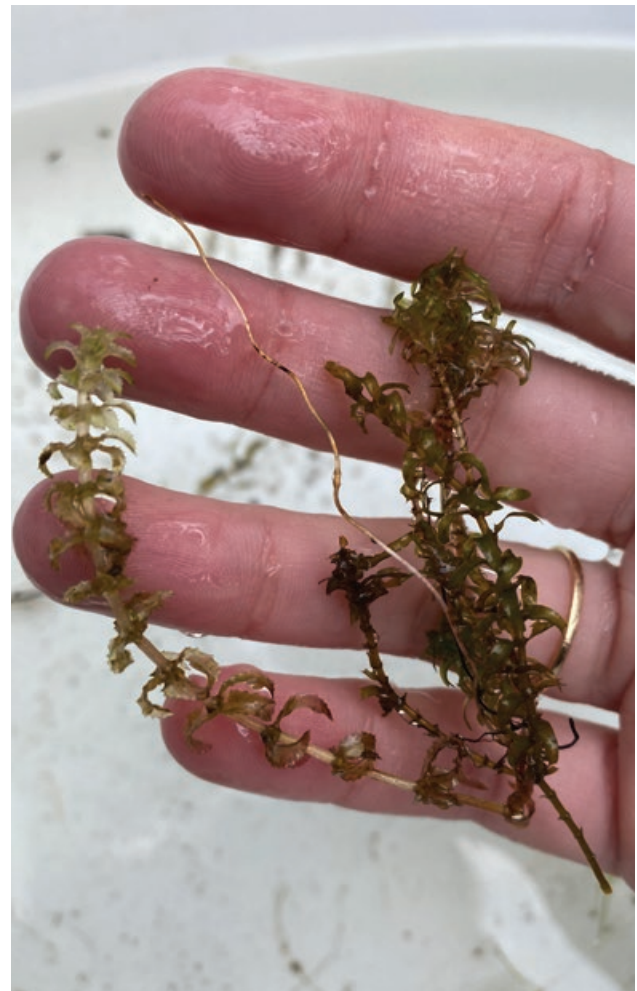
Figure 7. Invasive hydrilla (left) and native Elodea (right) collected on the same day in the Croton River. Hydrilla shows more bleaching from the treatment.

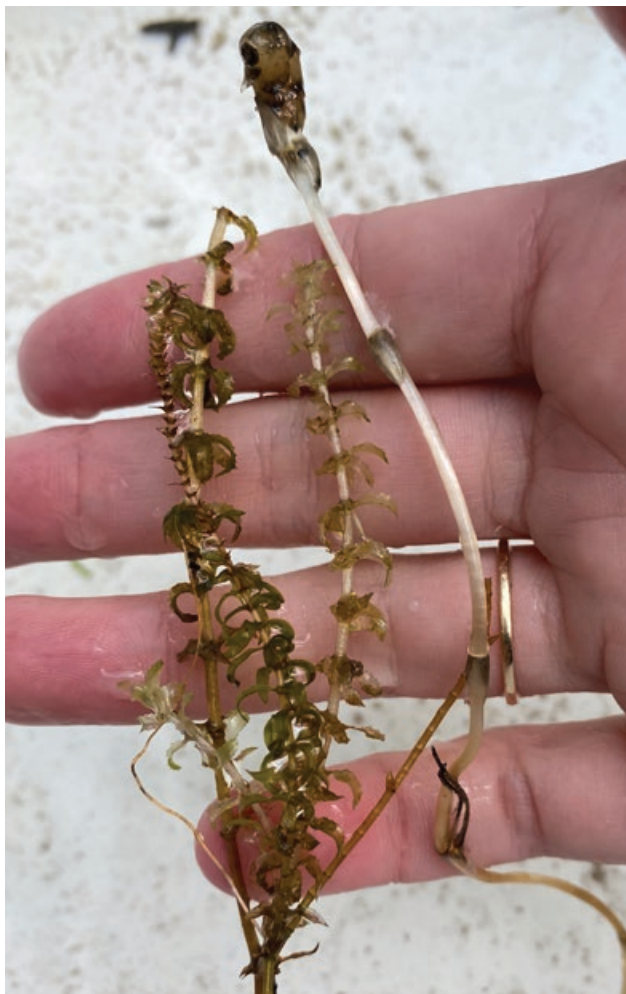
**Figure 8.** Croton River treated hydrilla plant showing bleaching and loss of leaves collected 7 weeks after treatment began.

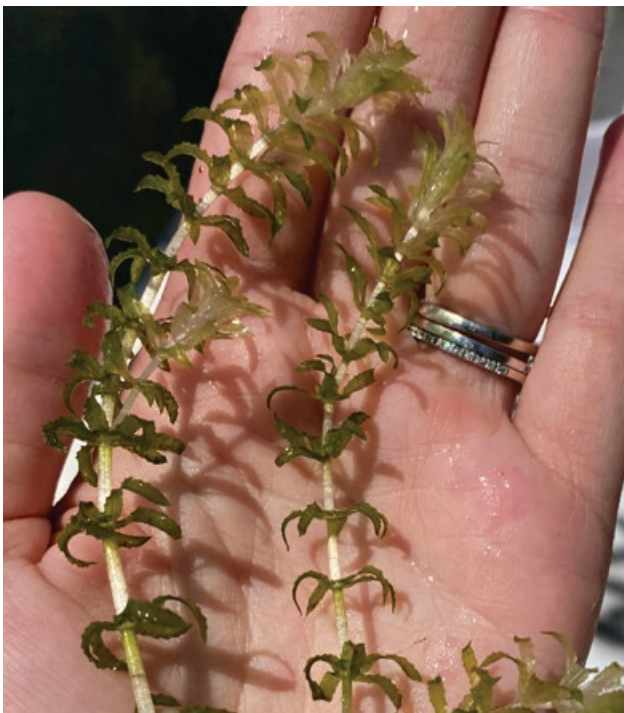
Figure 9: Treated hydrilla fragments from the New Croton Reservoir 1 week after treatment began in 2021.

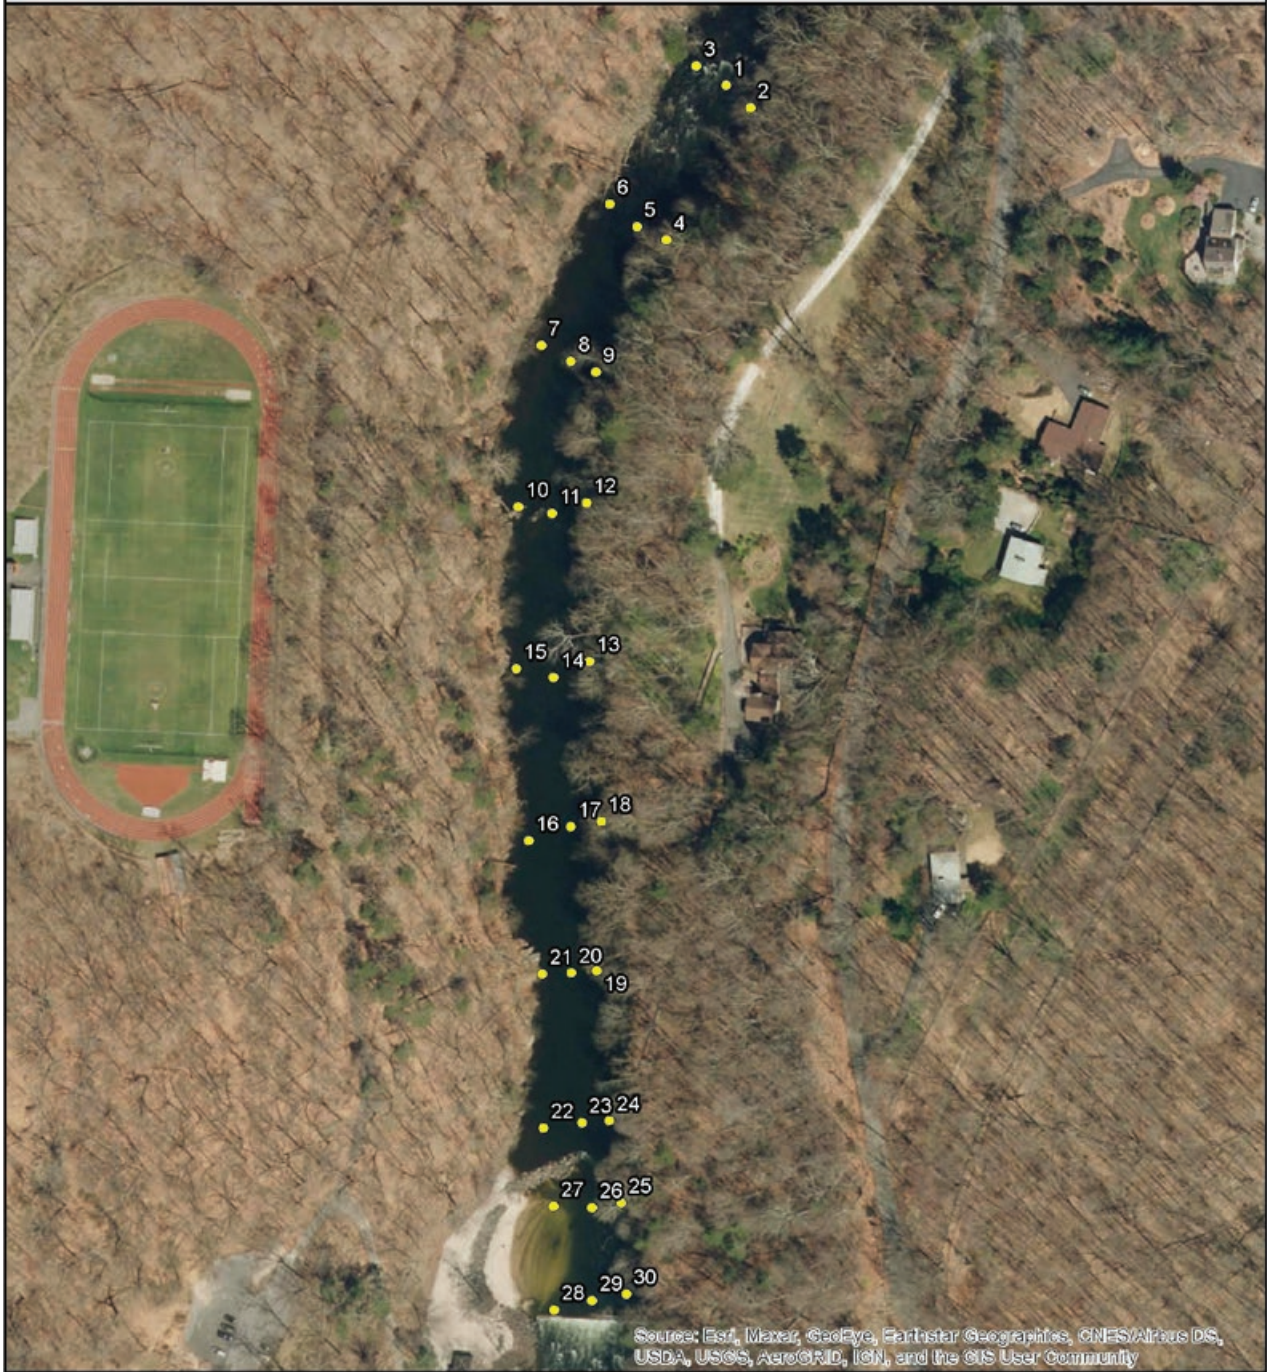
**CROTON RIVER**  
**SECTION B- SILVER LAKE BEACH**  
Aquatic Vegetation Survey  
October 12, 2021

Sampling Stations: 30

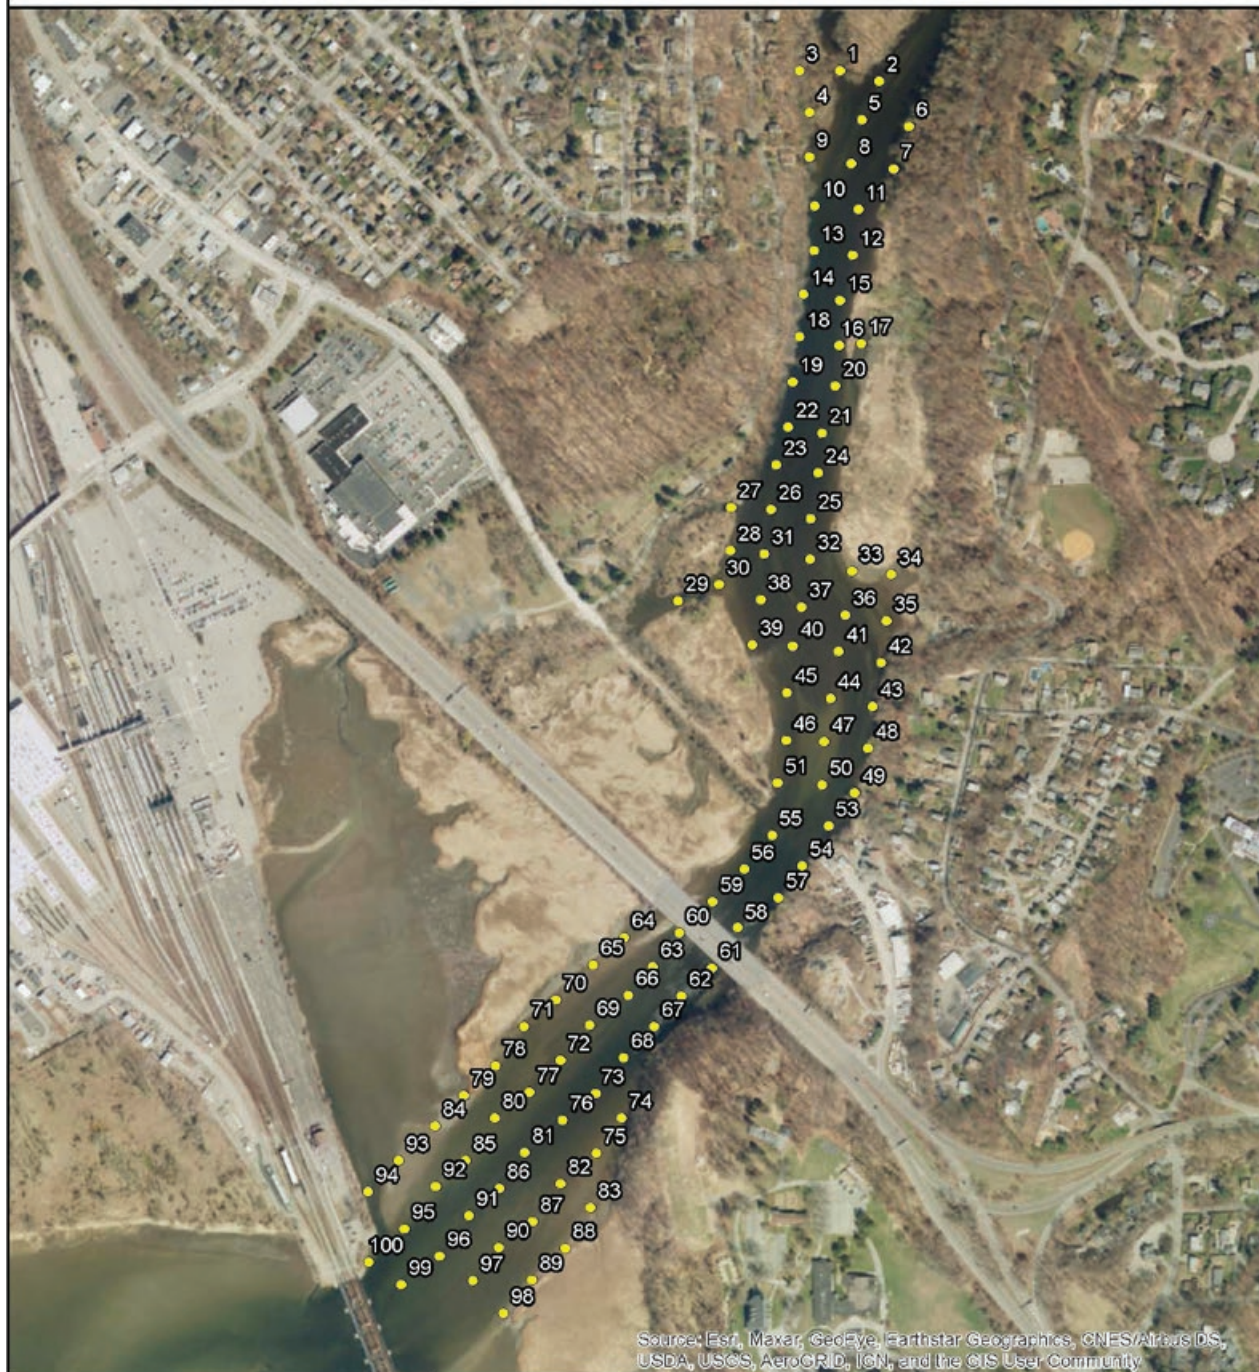
**CROTON RIVER**  
**SECTION D- LOWER RIVER**  
Aquatic Vegetation Survey  
October 4, 2021  
Sampling Stations: 100

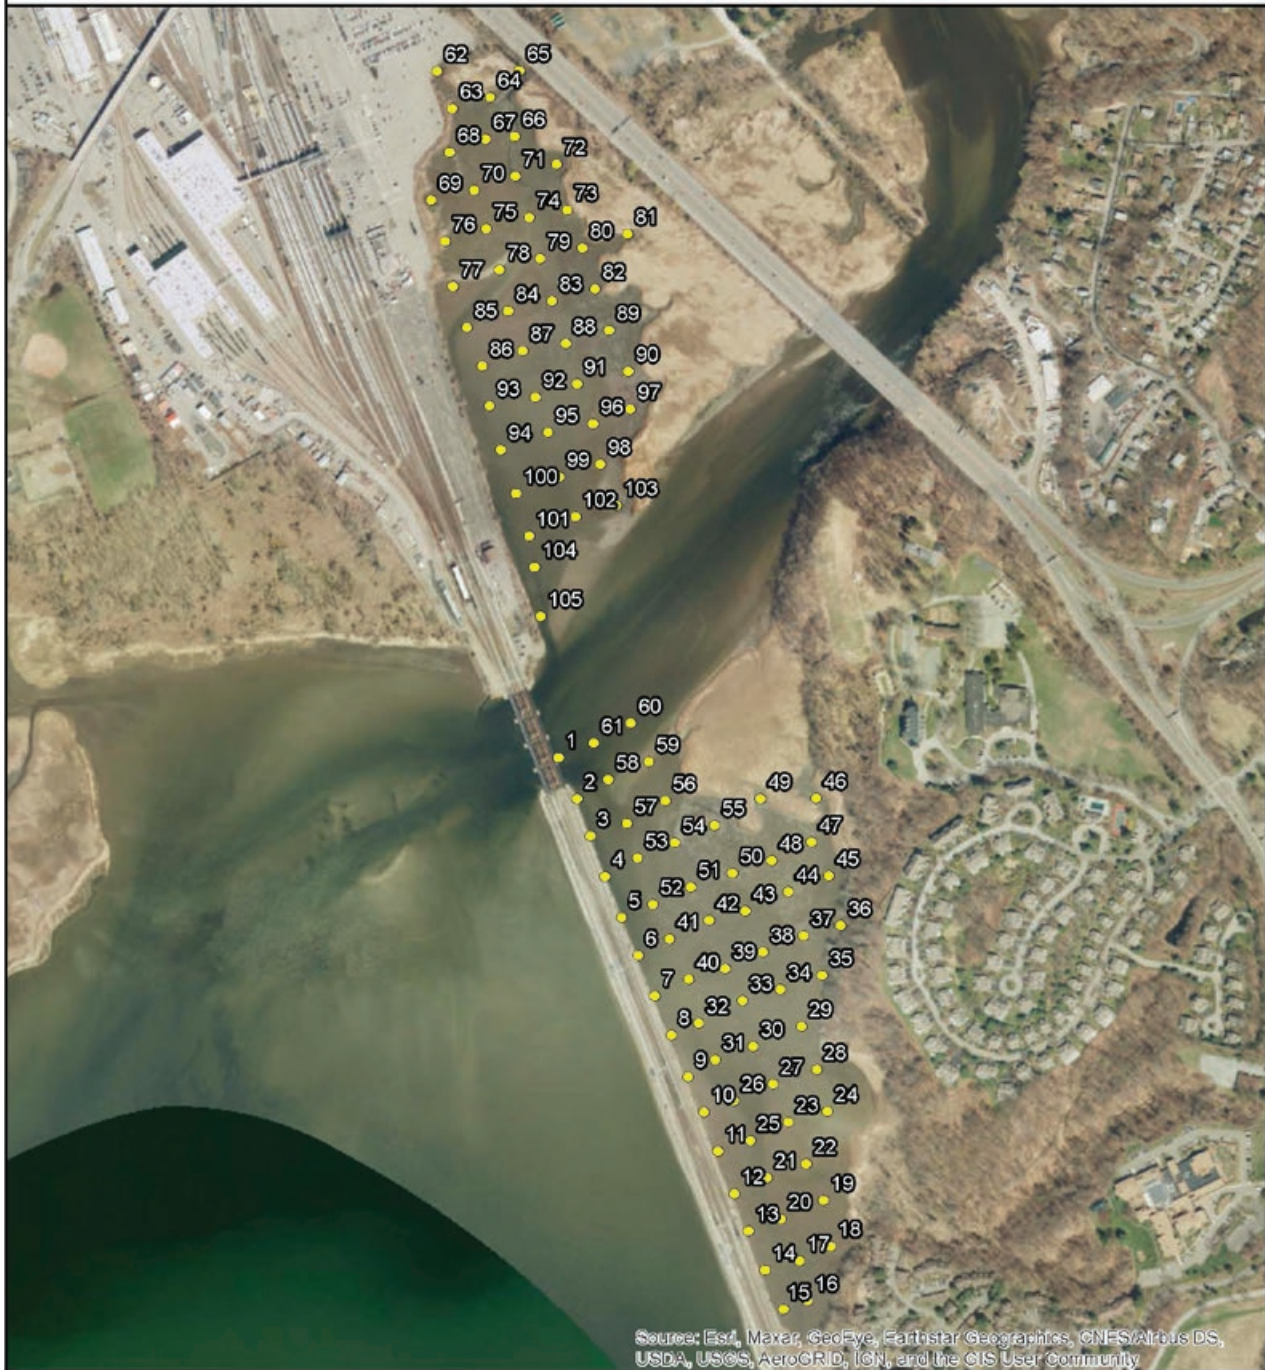
**CROTON RIVER  
SECTION E - LOWER COVES**  
Aquatic Vegetation Survey  
October 6, 2021

Sampling Stations: 105

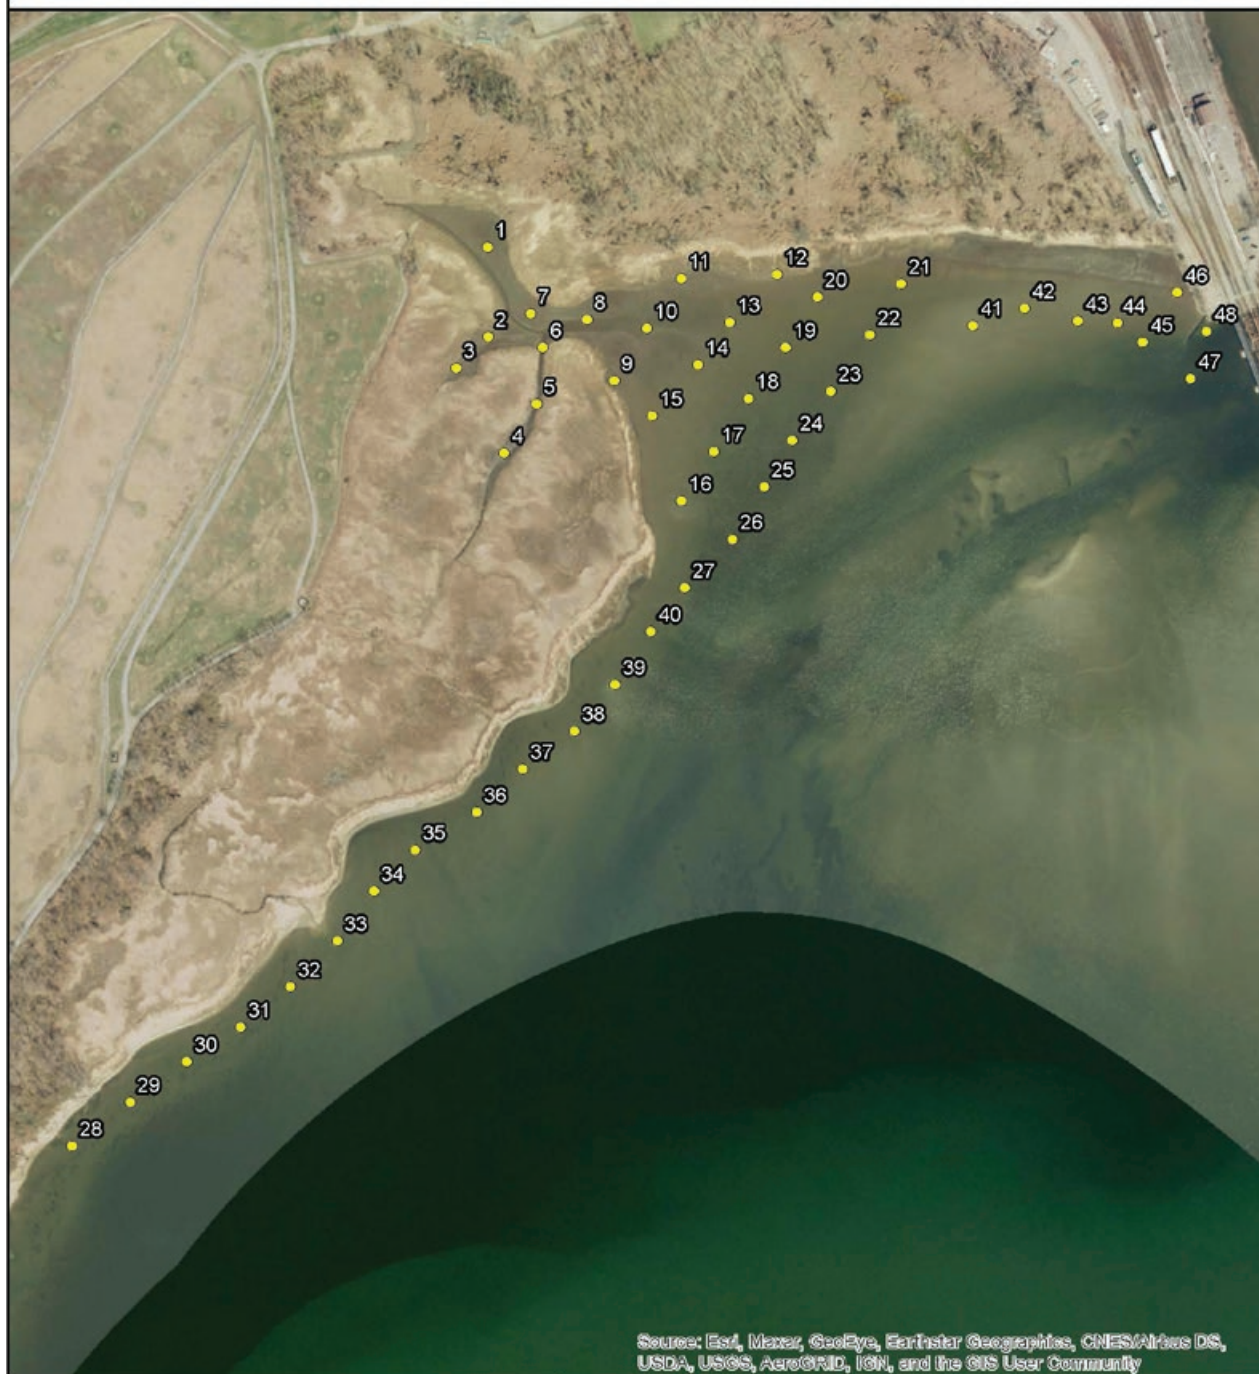
**CROTON RIVER  
SECTION F - CROTON BAY WETLANDS**  
Aquatic Vegetation Survey  
October 12, 2021

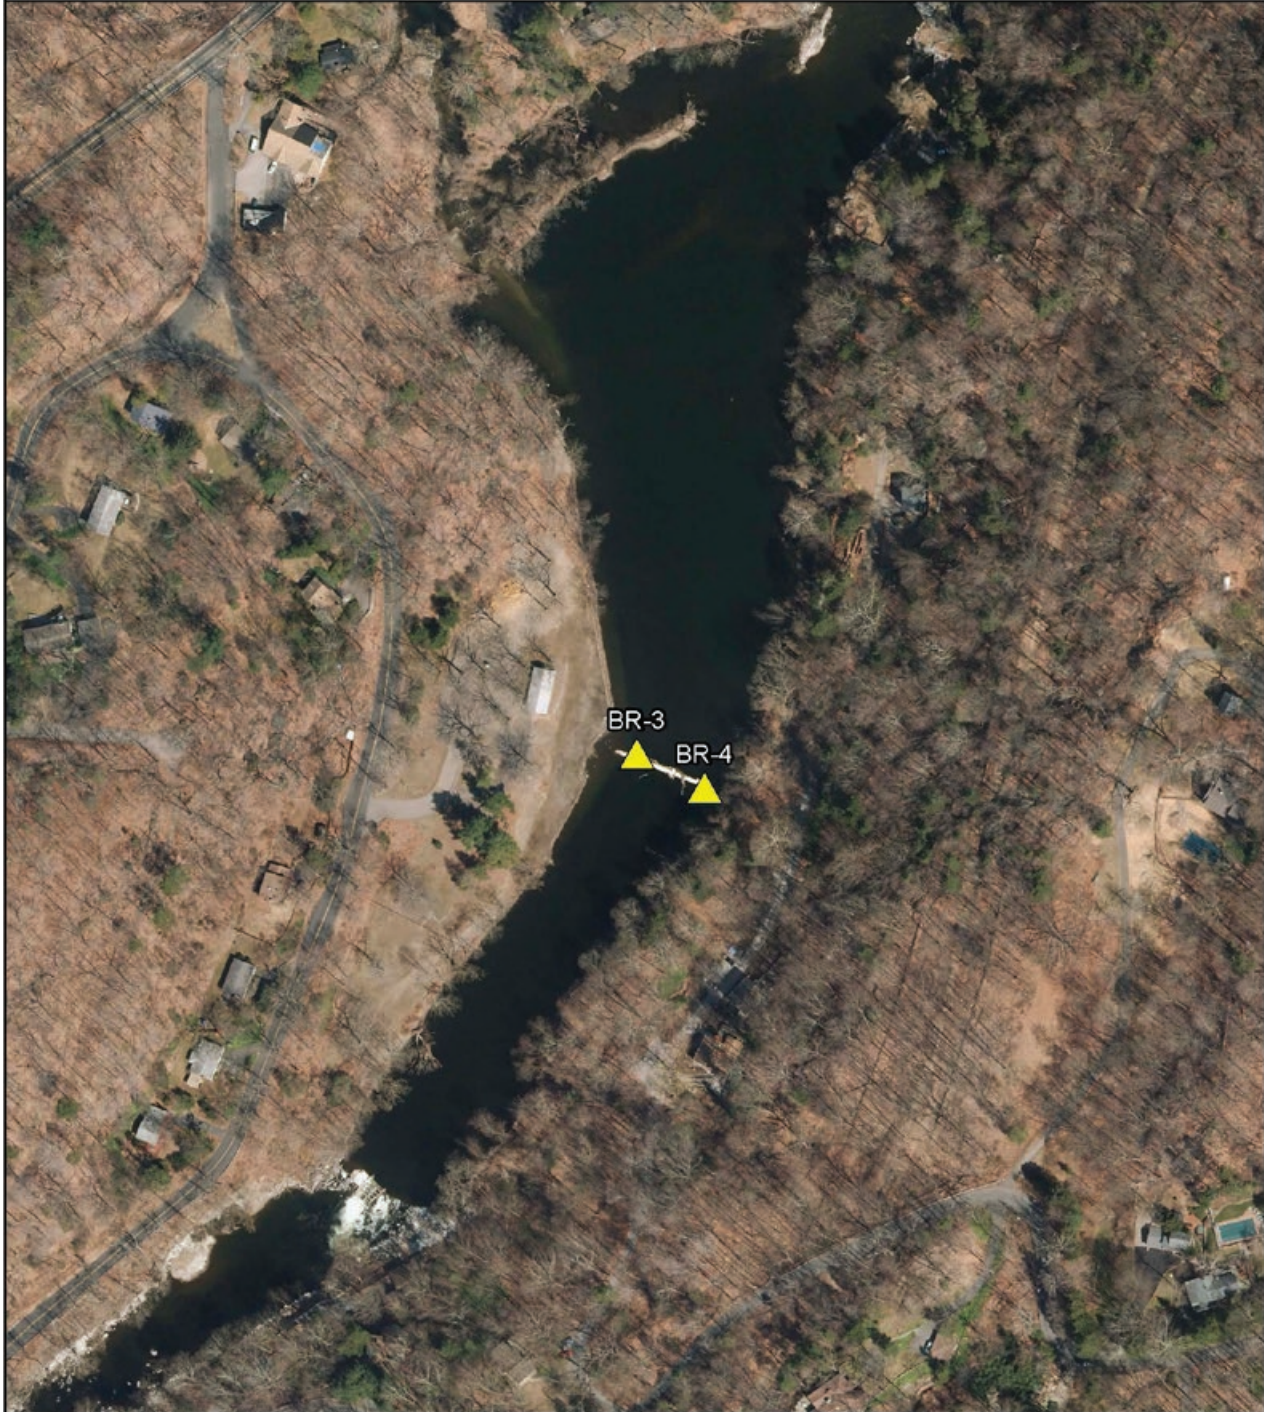
**BLACK ROCK PARK**  
Hydrilla Tuber Sampling Locations

**Hydrilla Tuber Sampling 2021**

DEC's contractor has conducted tuber surveys on the Croton River since 2016. On November 2 and 9, SÖLitude conducted hydrilla tuber monitoring for the 2021 treatment season. Tuber survey sites in the Croton River included Black Rock Park (BRP-3, BRP-4), Silver Lake Beach (SLB-1), and north and south of Paradise Island (CR-1, CR-2, CR--3, CR-4, and CR-5). Survey site maps can be found in Appendix B. Biologists from SÖLitude collected tubers using a modified post-hole digger. Tuber density was calculated and expressed in tubers/m<sup>2</sup> (meters squared).

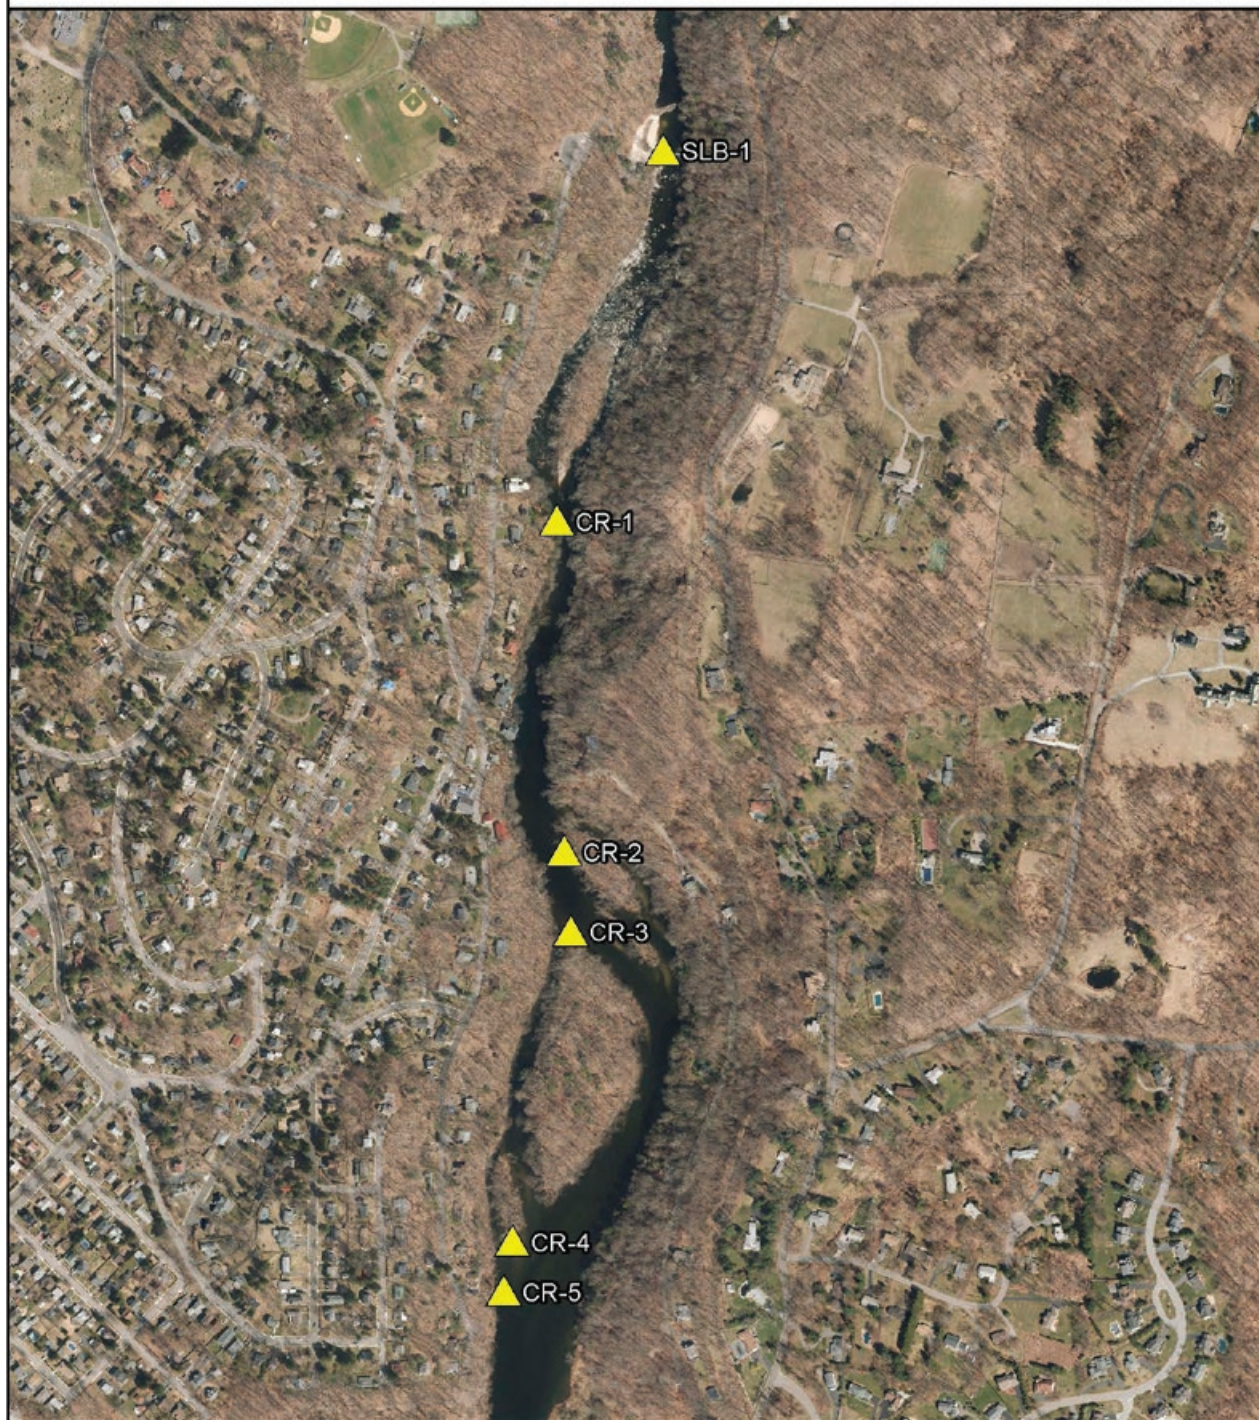
# SILVER LAKE BEACH & RIVER ISLANDS Hydrilla Tuber Sampling Locations

**Hydrilla Tuber Sampling 2021**
