CWM CHEMICAL SERVICES, LLC MODEL CITY, NEW YORK DRAFT ENVIRONMENTAL IMPACT STATEMENT	
POTENTIAL CLAY BORROW SOURCES	
	FIGURE 1

Wetland Delineation Report

# **CWM Landfill Expansion**

Town of Porter - Niagara County, New York  
**Wetland Delineation Report**  
 Figure 1: Regional Project Location

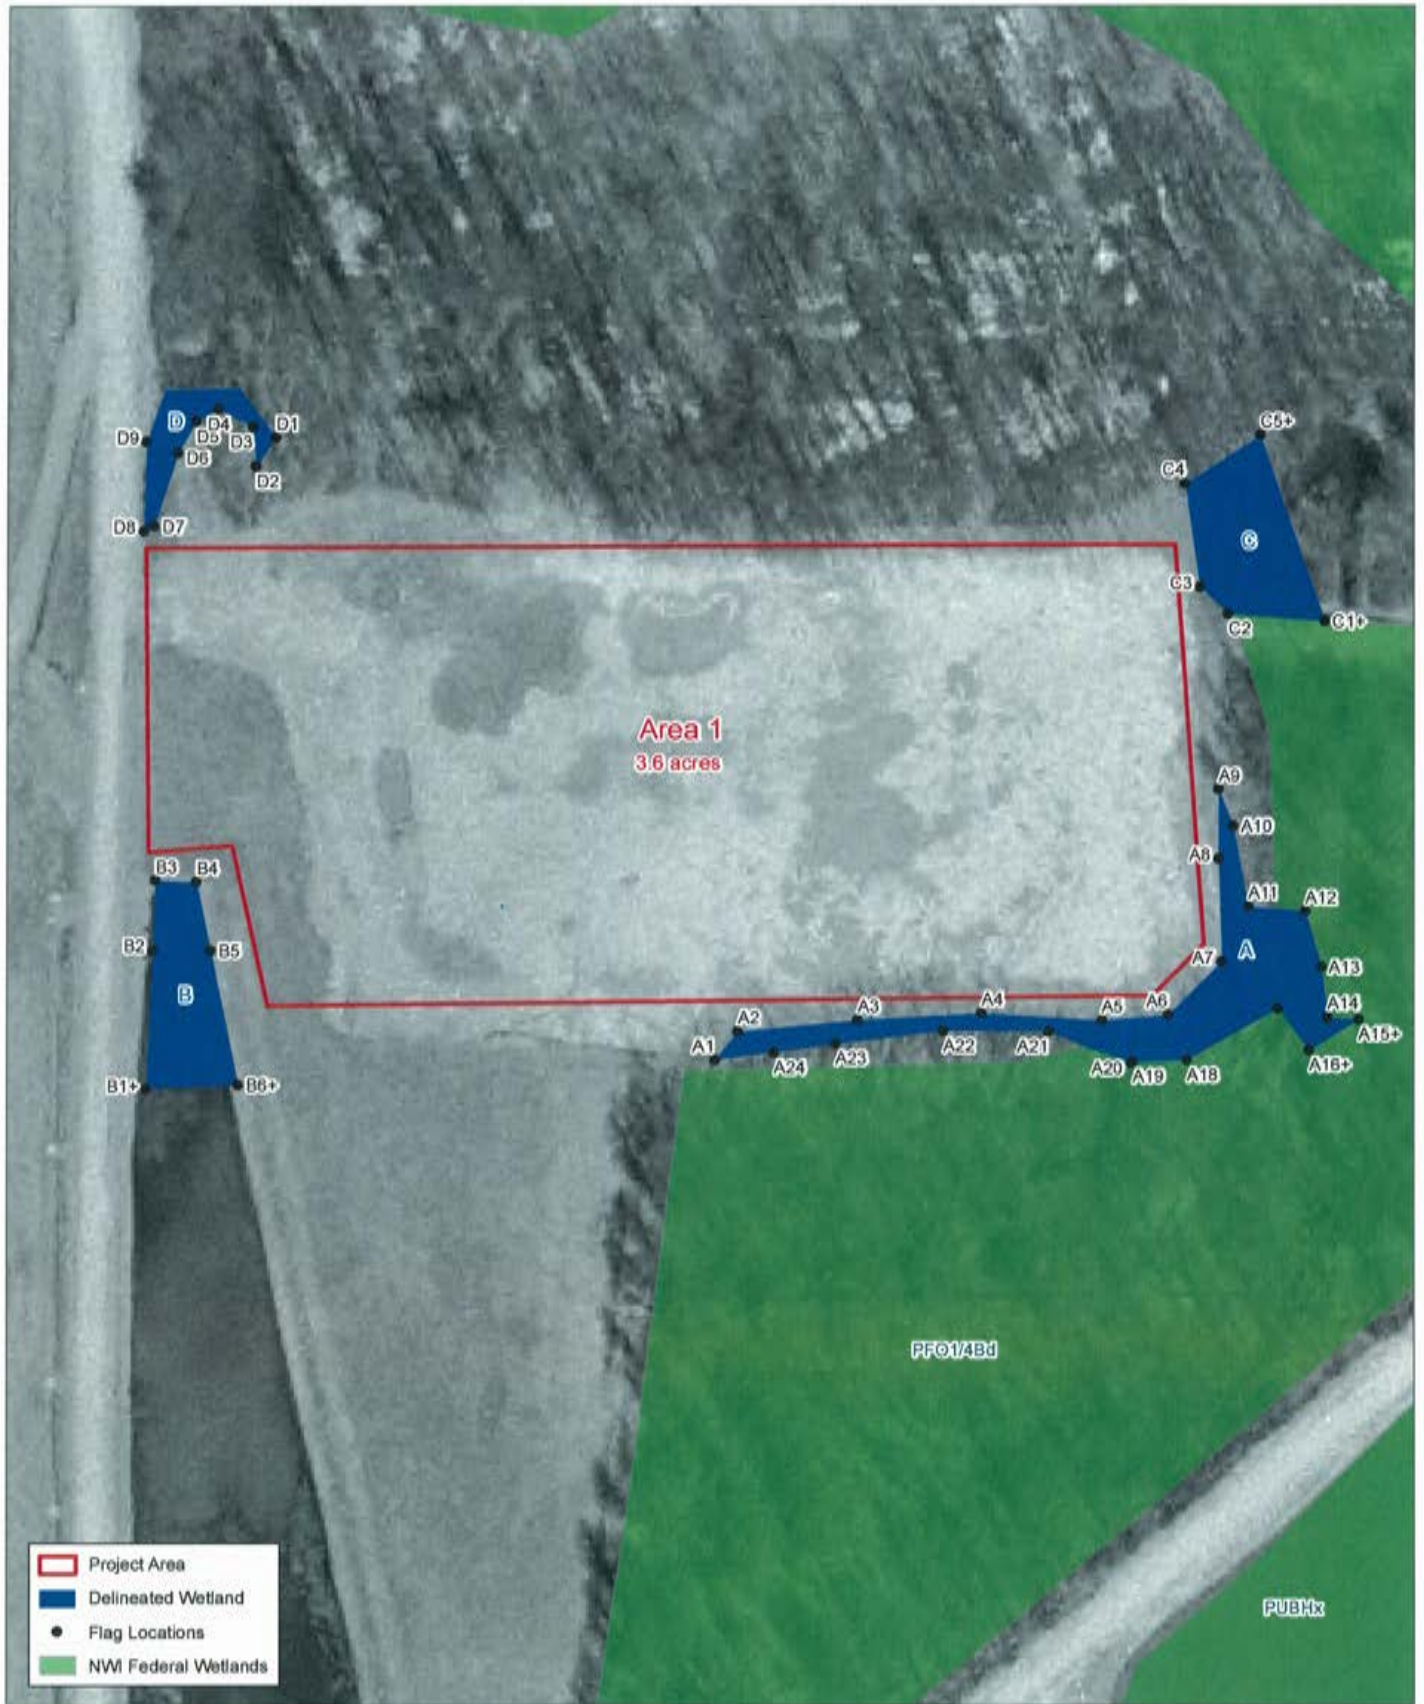
Notes:  
Data Source  
Base Map: DOQQ Orthophotography,  
Black and White, 2 ft. resolution, Year 2005.  
1. EDR Delineated Wetlands  
2. NWI Federal Wetland Survey,  
Ransomville Quadrangle.

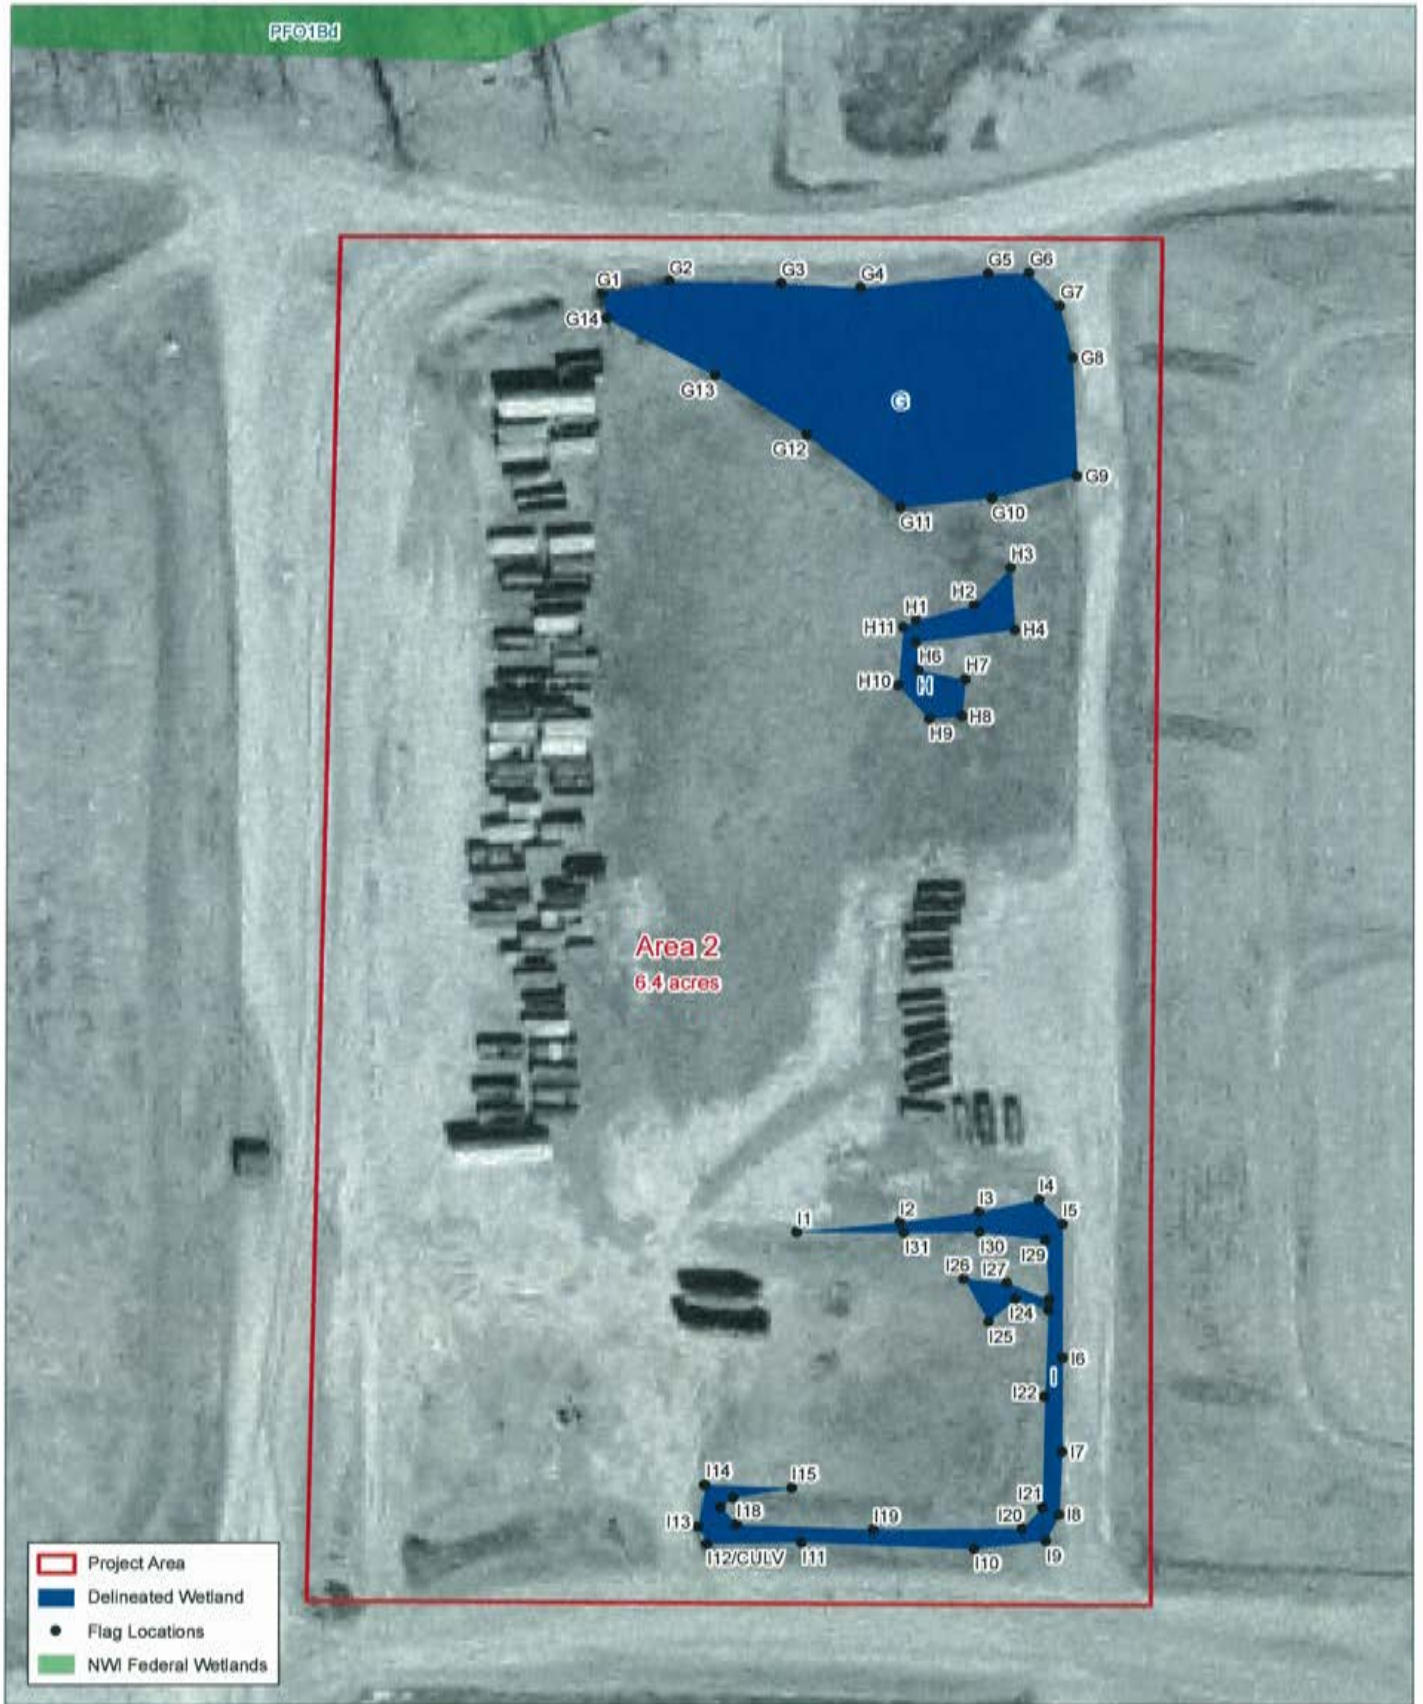
Notes:  
Data Source:  
1. EDR Delineated Wetlands  
2. NWI Federal Wetland Survey,  
Ransomville Quadrangle.

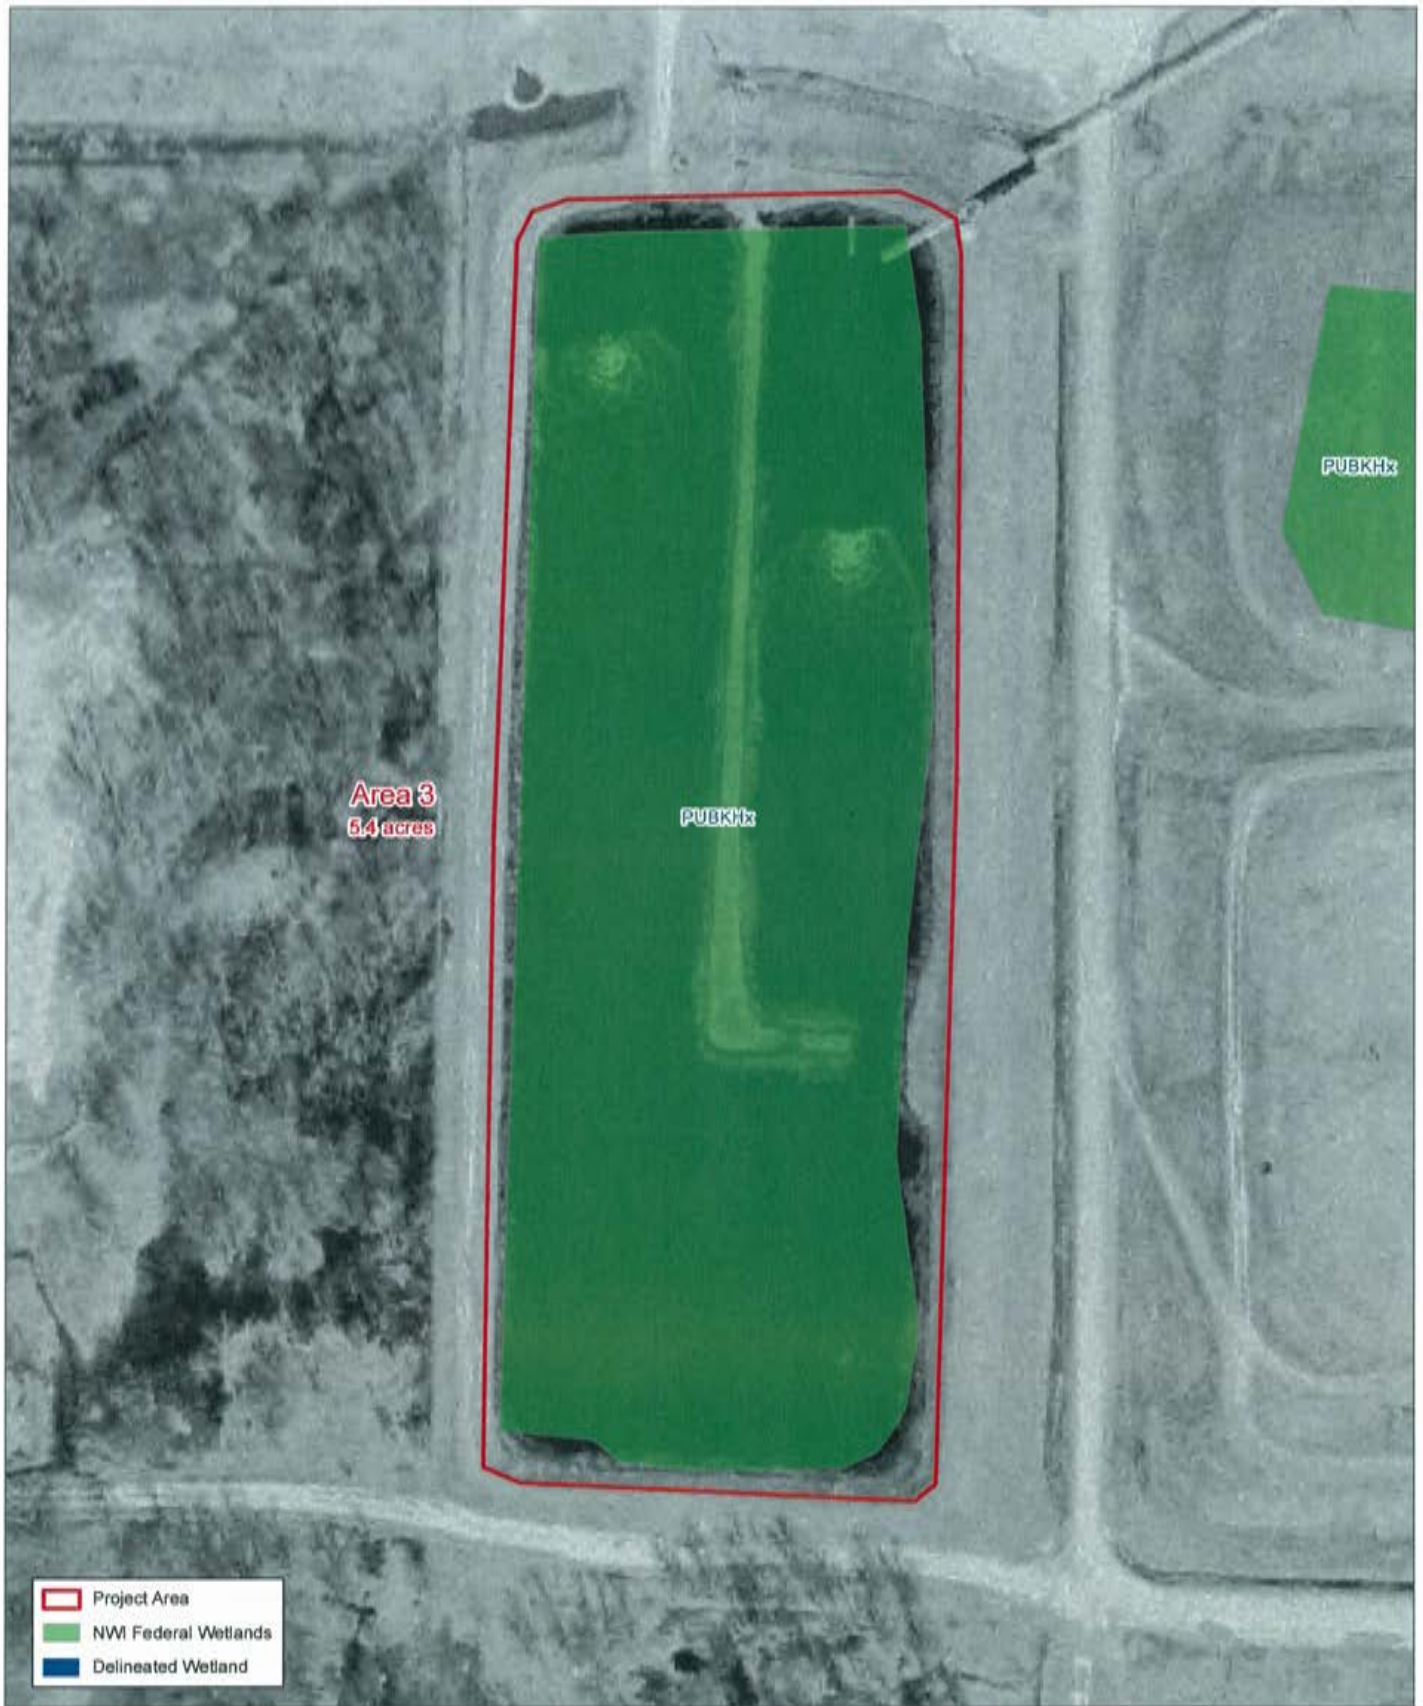
Notes:  
Data Source:  
Base Map: DOQQ Orthophotography,  
Black and White, 2 ft. resolution, Year 2005.  
1. EDR Delineated Wetlands  
2. NWI Federal Wetland Survey,  
Ransomville Quadrangle.
