Caroga Lake Public Campground

Unit Management Plan

October 2017

CAROGA LAKE PUBLIC CAMPGROUND SITE SPECIFIC - VOLUME II UNIT MANAGEMENT PLAN

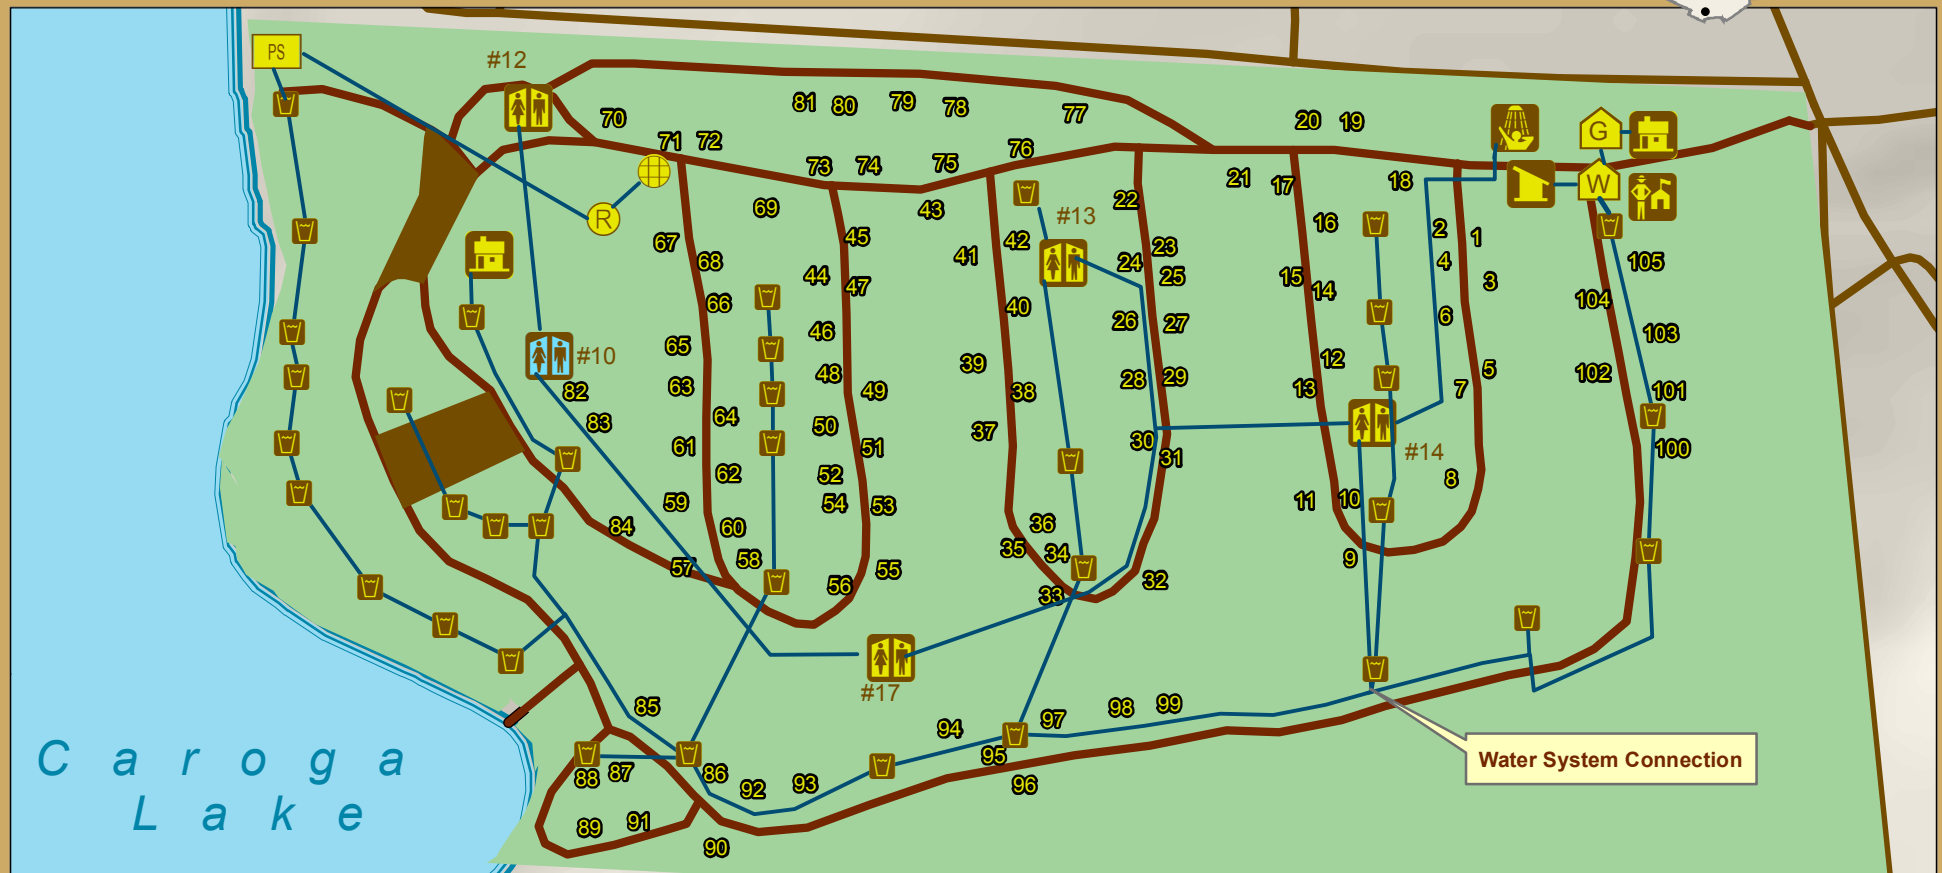
Exhibit # 5 - Existing Water Facilities Map

Staff Housing		Pumphouse		Garage		Wood Storage Bldg
	Rest Room		Vault Toilet		Shower Bldg		Recycling Bldg
	Well		Reservoir		Ticket Booth		Waterline

In 1993, a well was drilled to replace both the lake and spring water sources for the campground. The well is 395' deep with a 1½ HP submersible pump set at a 350' depth with a pumping capacity of 12 GPM. The water is pumped to a 10,000-gallon concrete potable water reservoir. From the reservoir, the water flows by gravity to a pump house where it is chlorinated. It is then pumped through 3,830' of pipeline to the 31 spigots, five comfort stations and five other buildings. The two water distribution systems, previously supplied by the lake pump and spring pump, are now one system and joined at a valve near site 99. (See Exhibit 5.)

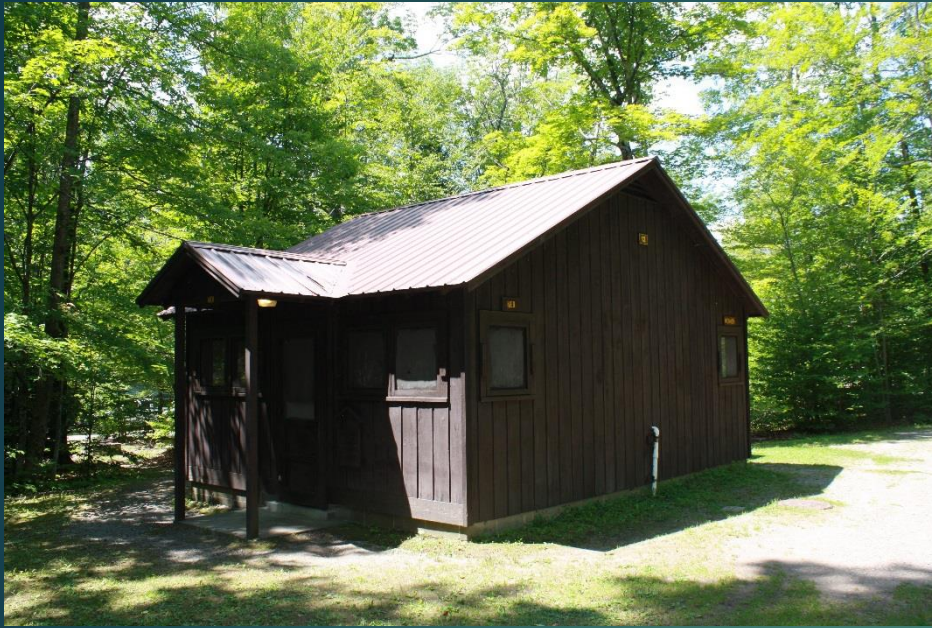
Comfort Station #4 (Bldg 13)

The existing toilet buildings contain older style toilets which require constant maintenance, and replacement parts are no longer available for the leaking flush valves. Toilet building #13 is located in the vicinity of the one existing ADA campsite and the proposed three converted universal sites. This area is level and best suited for an ADA-compliant toilet building. A new accessible toilet building will provide an efficient building to meet the needs of all campers. Toilet building #12 is used by both
