**Brownfield Cleanup Program  
Final Engineering Report  
For The  
111 Hydraulic Street Project  
Site No. C915235**

**Prepared For:**  
598 Main Street LLC  
726 Exchange Street Suite 825  
Buffalo, New York 14210

AFI Environmental  
PO Box 4049  
Niagara Falls, New York 14304

**APRIL 2011**

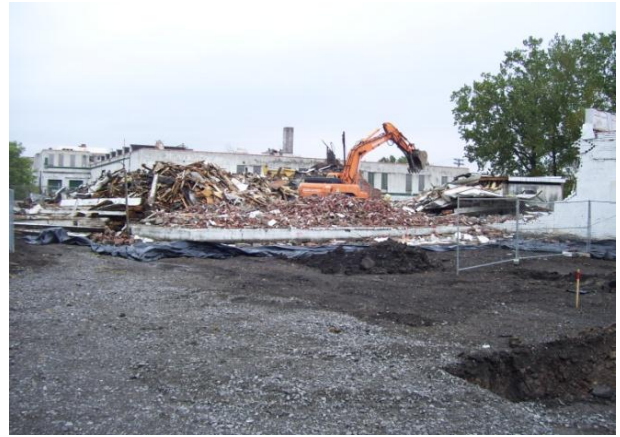
Photo 4 – Building Demolition

After the building demolition, and to gain access to the impacted soils, a concrete slab (former 'Door Store' building floor), footers, basement walls, and asphalt parking areas were removed. The concrete varied in thickness. The majority of the concrete was about 6-8 inches thick and was removed using a Komatsu 200LC excavator. Thicker areas of concrete (1-2 feet), which consisted primarily of old building footers and subsurface basement walls, were broken up with an excavator mounted rock buster, prior to removal from the site.

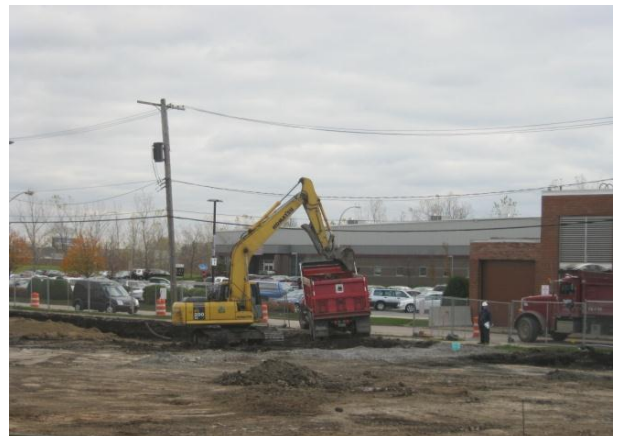
Photo 5 – Loading Contaminated Soils

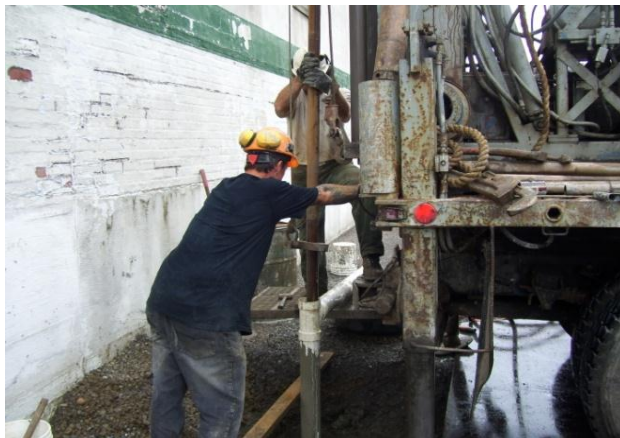
Photo 3 – Monitoring Well Installation

AFI personnel also provided oversight for the installation of four (4) onsite Bedrock Wells (BR-12, BR-15, BR-16, BR-17). BR-12 was completed on June 24, 2010, BR-15 on June 28, 2010, and BR-16 on June 29, 2010 which was prior to RI/IRM activities. BR-17 was installed on December 17, 2010 (to replace BR-16 which was damaged during IRM excavation activities).

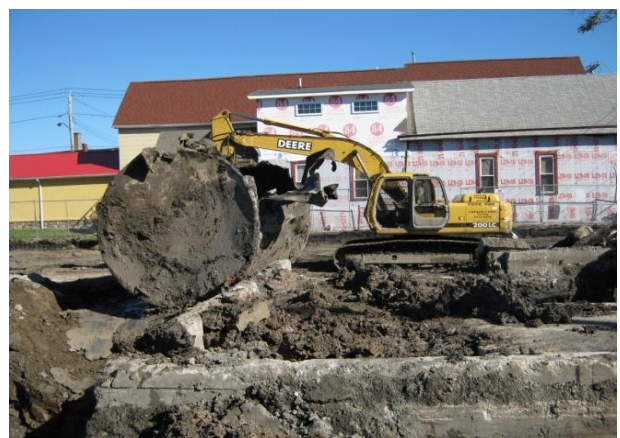
Photo 6 – UST Removal – Phase 3b

7. Testing, pumping and disposal of liquids and sludge from USTs by NOCO Recovery and Safety-Kleen;
8. Cleaning and removal of eleven (11) Underground Storage Tanks (USTs);

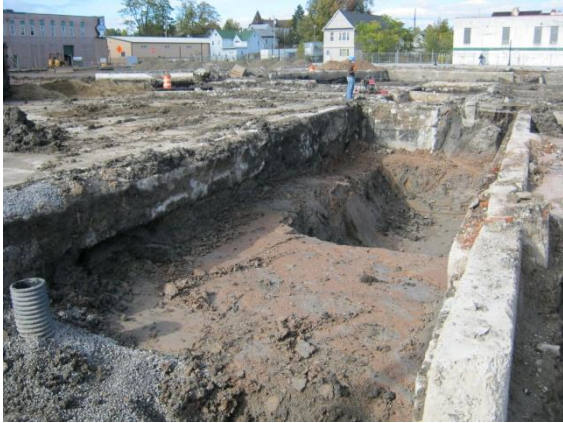
Photo 7 – UST #1 & 2 Tank Pit – After Removal

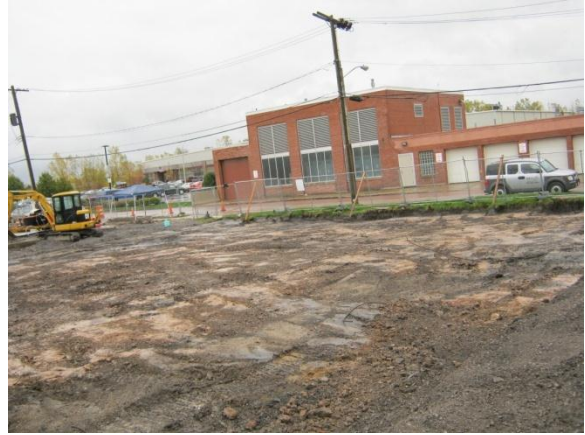
Photo 10 – Phase 1b – Excavated to Clean Soils

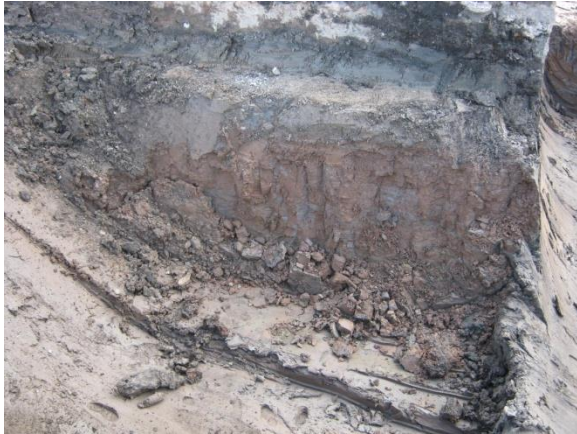
Photo 8 – UST #3 Tank Pit – After Removal

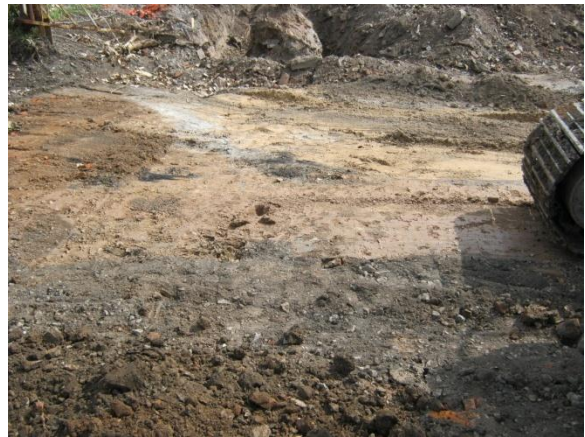
Photo 11 – Phase 2a – Excavated to Clean Soils

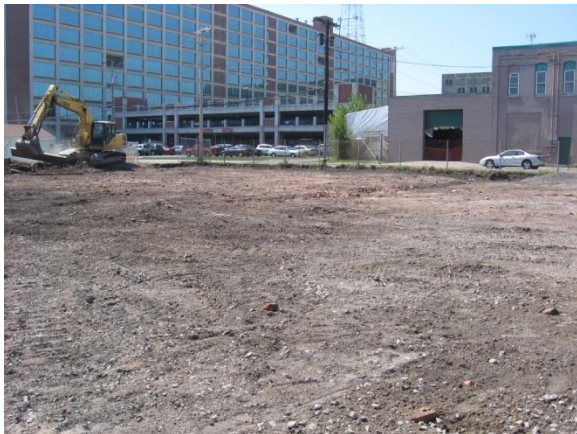
Photo 9 – Phase 1a – Excavated to Clean Soils

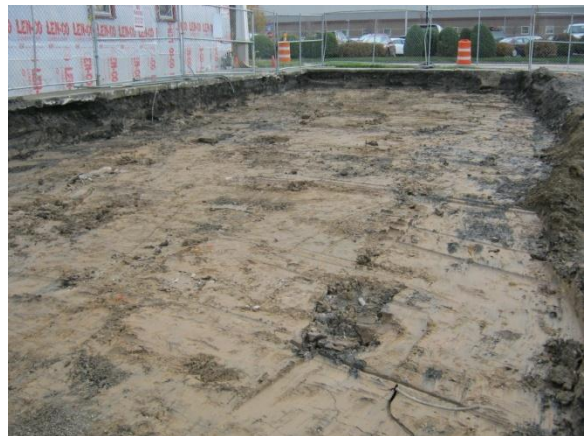
Photo 12 – Phase 2b – Excavated to Clean Soils

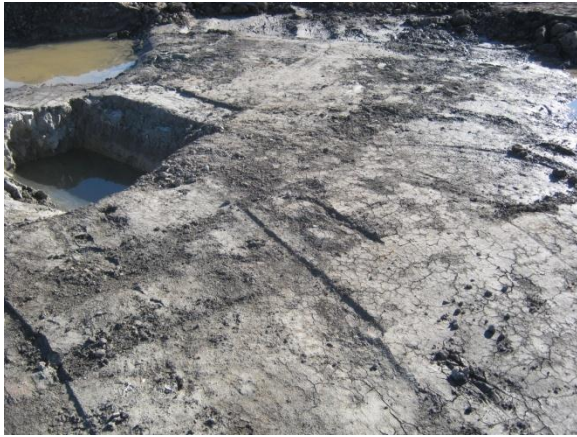
Photo 13 – Phase 3a - Excavated to Clean Soils

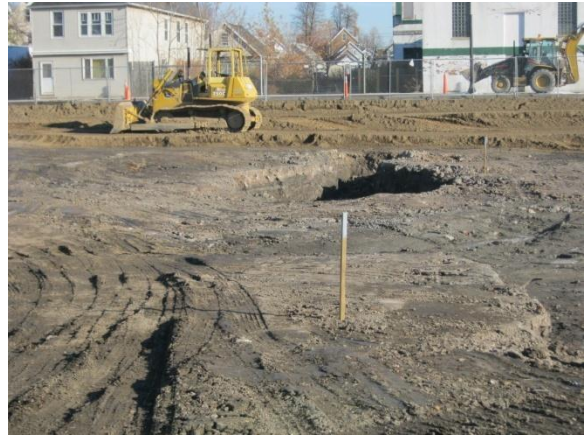
Photo 16 – Final Excavation Viewed from South

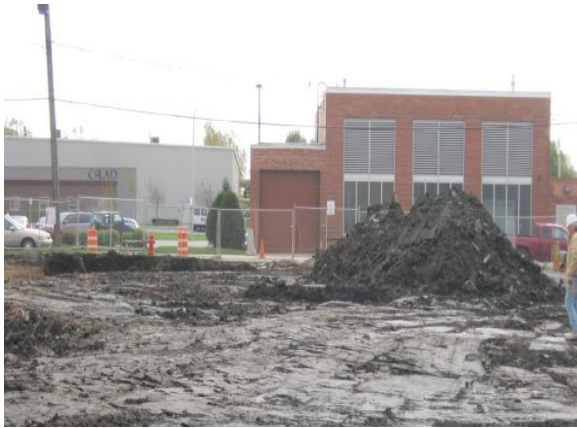
Photo 14 – Phase 3b – Excavated to Clean Soils

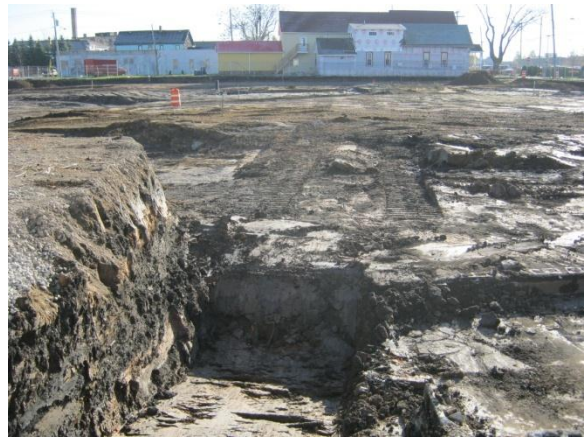
Photo 17 – Final Excavation Viewed from West

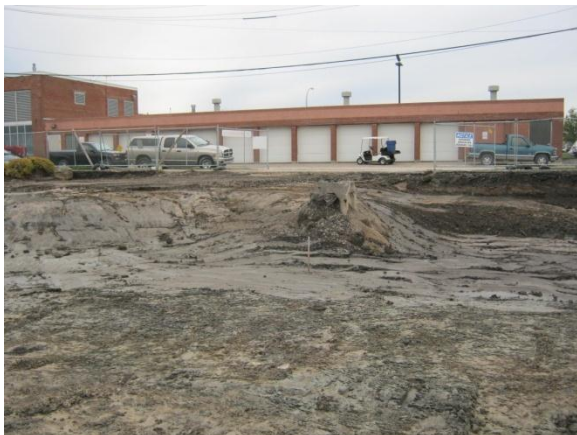
Photo 15 – Phase 4 – Excavated to Clean Soils

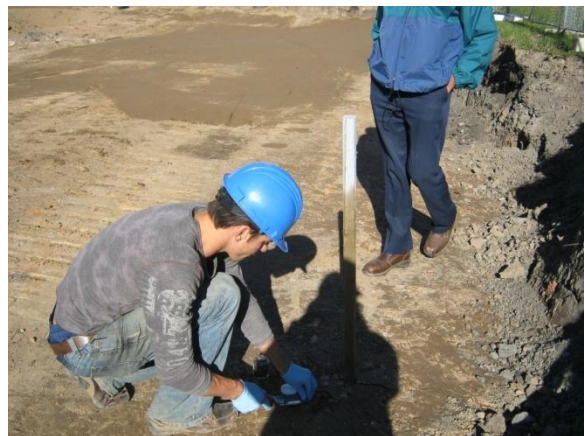
Photo 18 – Post Excavation Sampling

11. Upon completion of the excavation activities (exposing clean native clay) post excavation soil sampling was conducted. All post excavation soil samples were collected from the floor of the excavation utilizing a grid, approved by the DEC, to determine the location of confirmatory sampling locations. Additionally, discrete samples were collected for analysis from the walls of the excavation, (now located offsite) as per the DEC's direction (See Tables 3a and 3b respectively);
12. Placement and Compaction of approved backfill and establishment of temporary, positive drainage to reduce potential for pooling water in low areas.

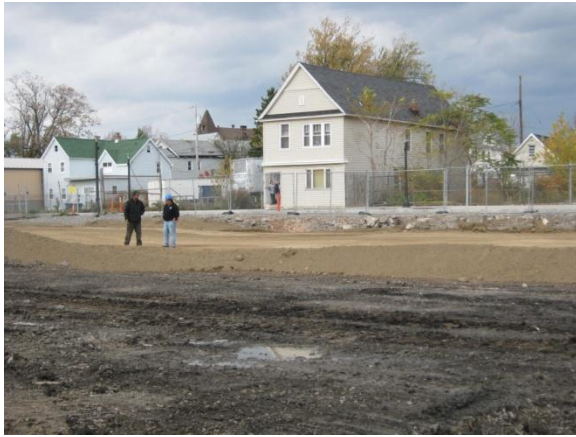
Photo 19 – Back Filling Site

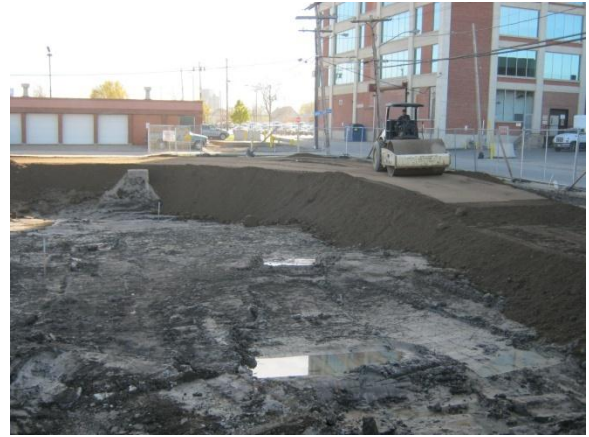
Photo 20 – Back Filling Site
