**REMEDIAL INVESTIGATION / INTERIM
REMEDIAL MEASURES AND ALTERNATIVES
ANALYSIS REPORT**

**BCP SITE No. C915302
1360 NIAGARA STREET SITE
CITY OF BUFFALO, ERIE COUNTY, NEW YORK**

C&S ENGINEERS, INC.

DECEMBER 2017

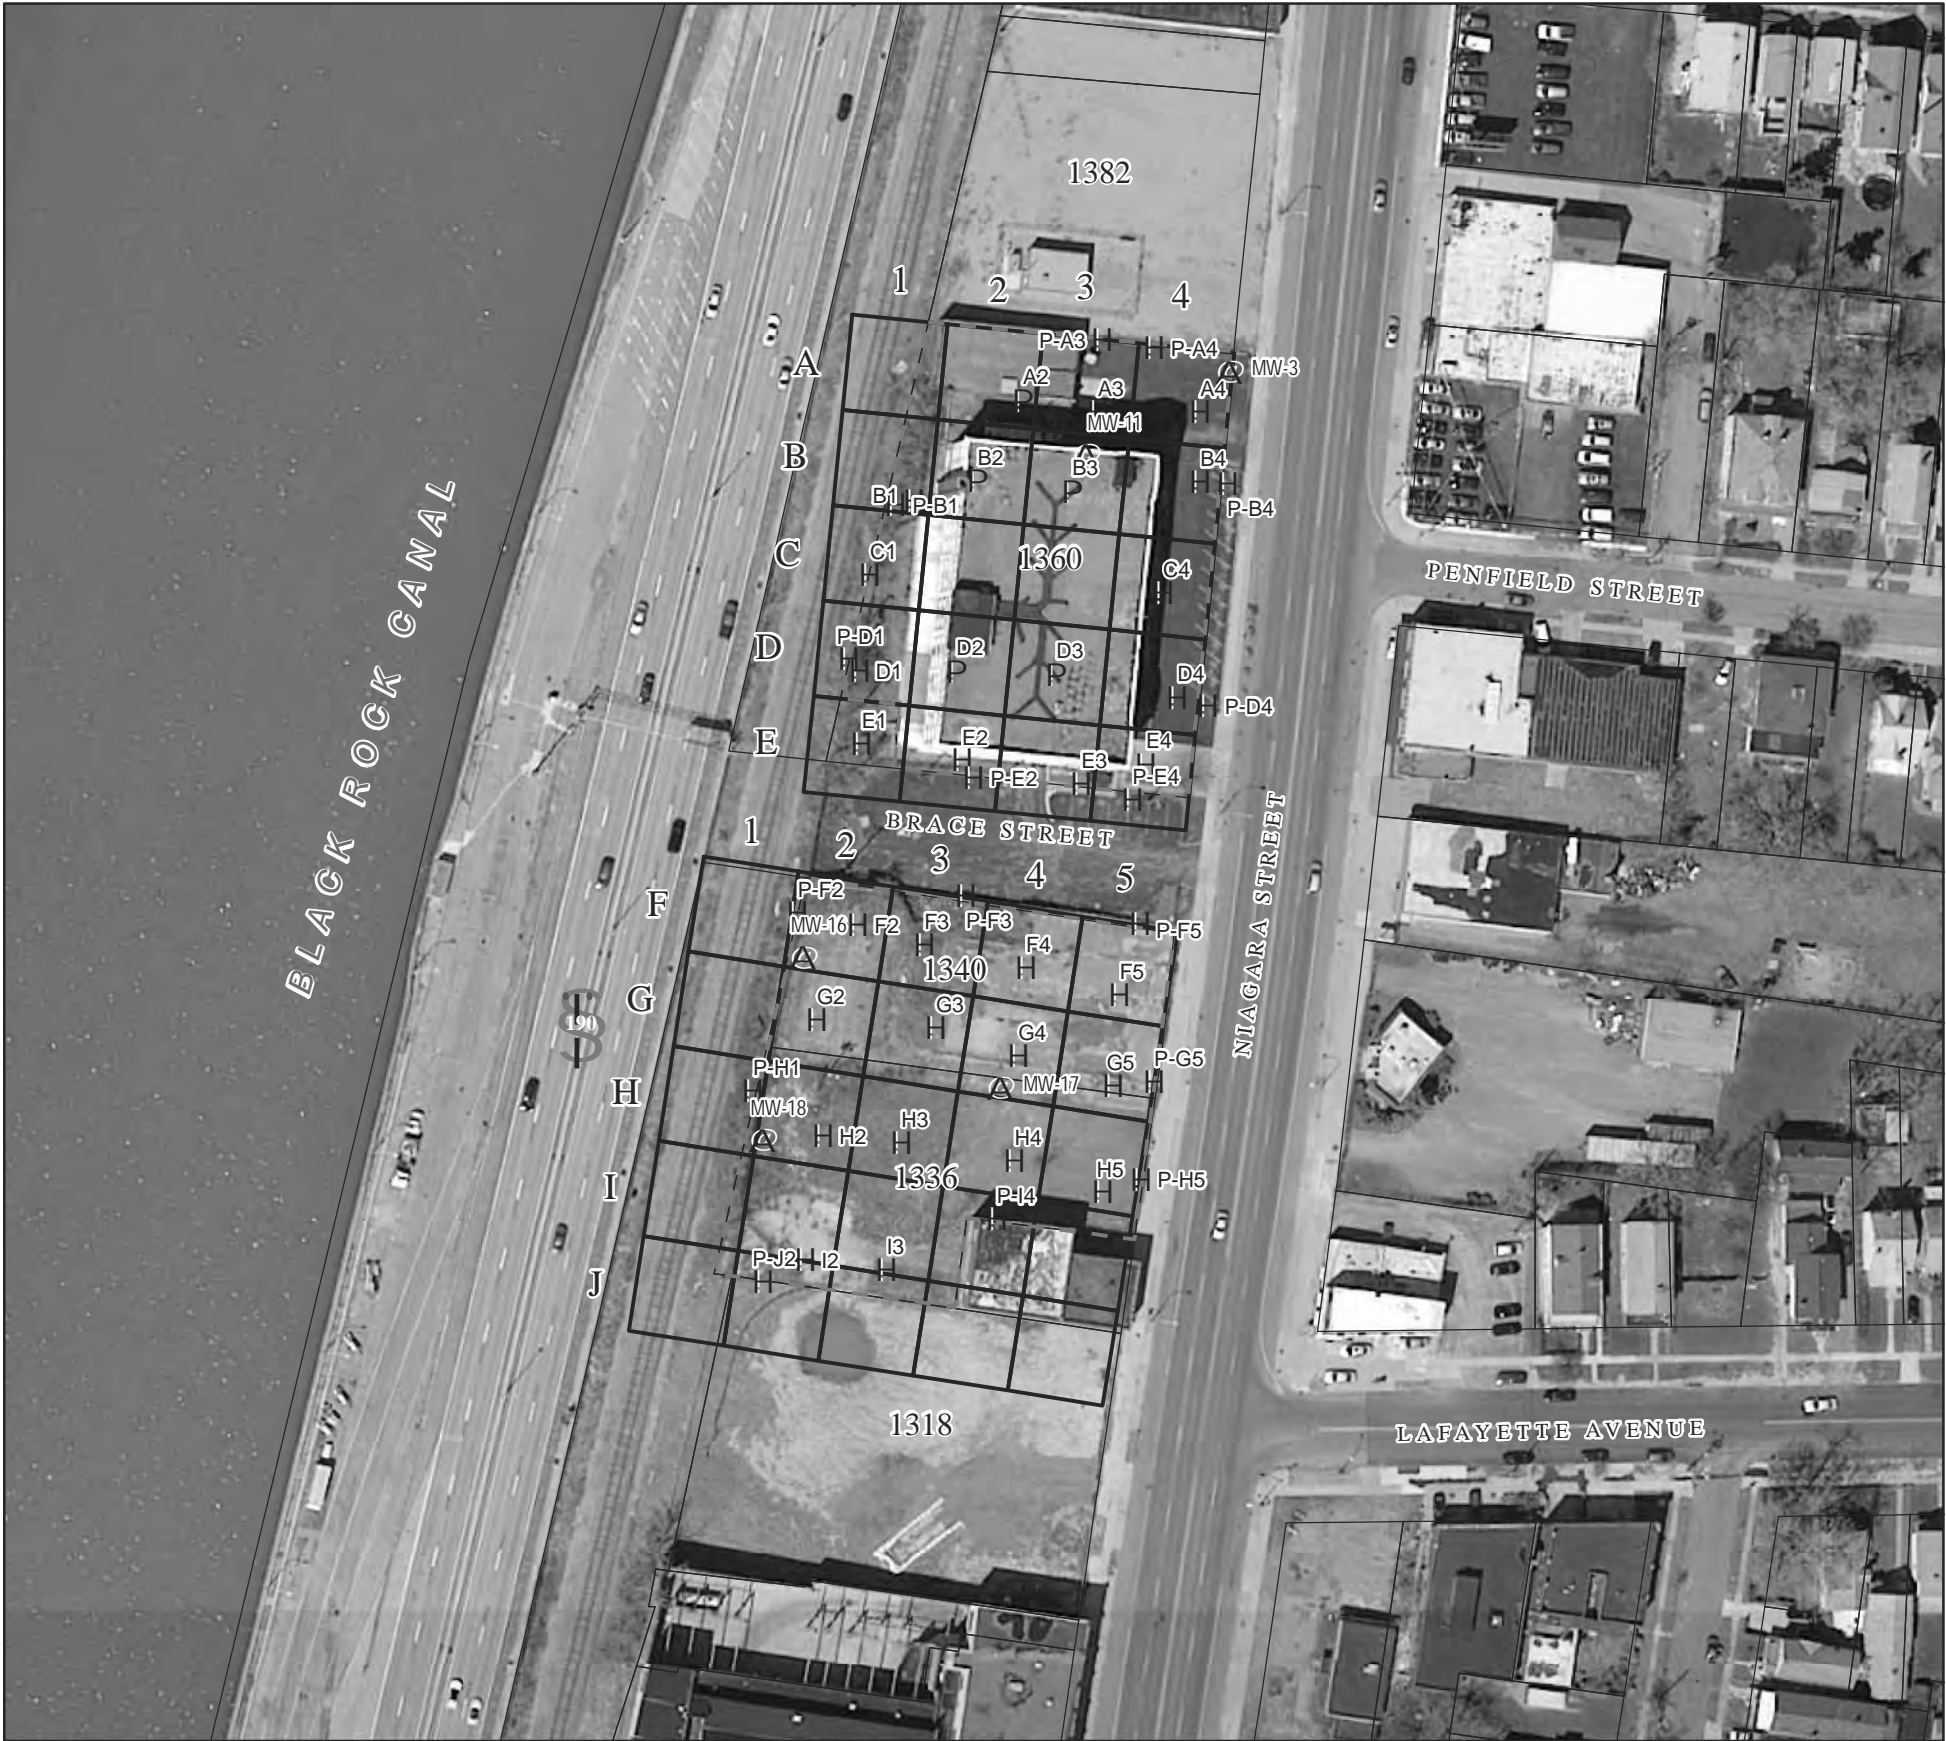
FIGURE 2

Soil borings were advanced across the Site to facilitate the characterization of native material and fill material. To ensure complete coverage of the Site, a 50-foot by 50-foot grid was established across the Site, as shown on **Figure 2**, resulting in 26 grid locations. From the borings, fill and native soil samples were collected to document Site conditions.

SAMPLING GRID
AND
LOCATIONS

Figure 1 shows the location of the Site and **Figure 2** shows the Site map and sample grid, including the Site boundaries.

To characterize groundwater conditions at the Site, five previously installed wells were sampled. The wells were distributed across the Site, as shown in **Figure 2**.

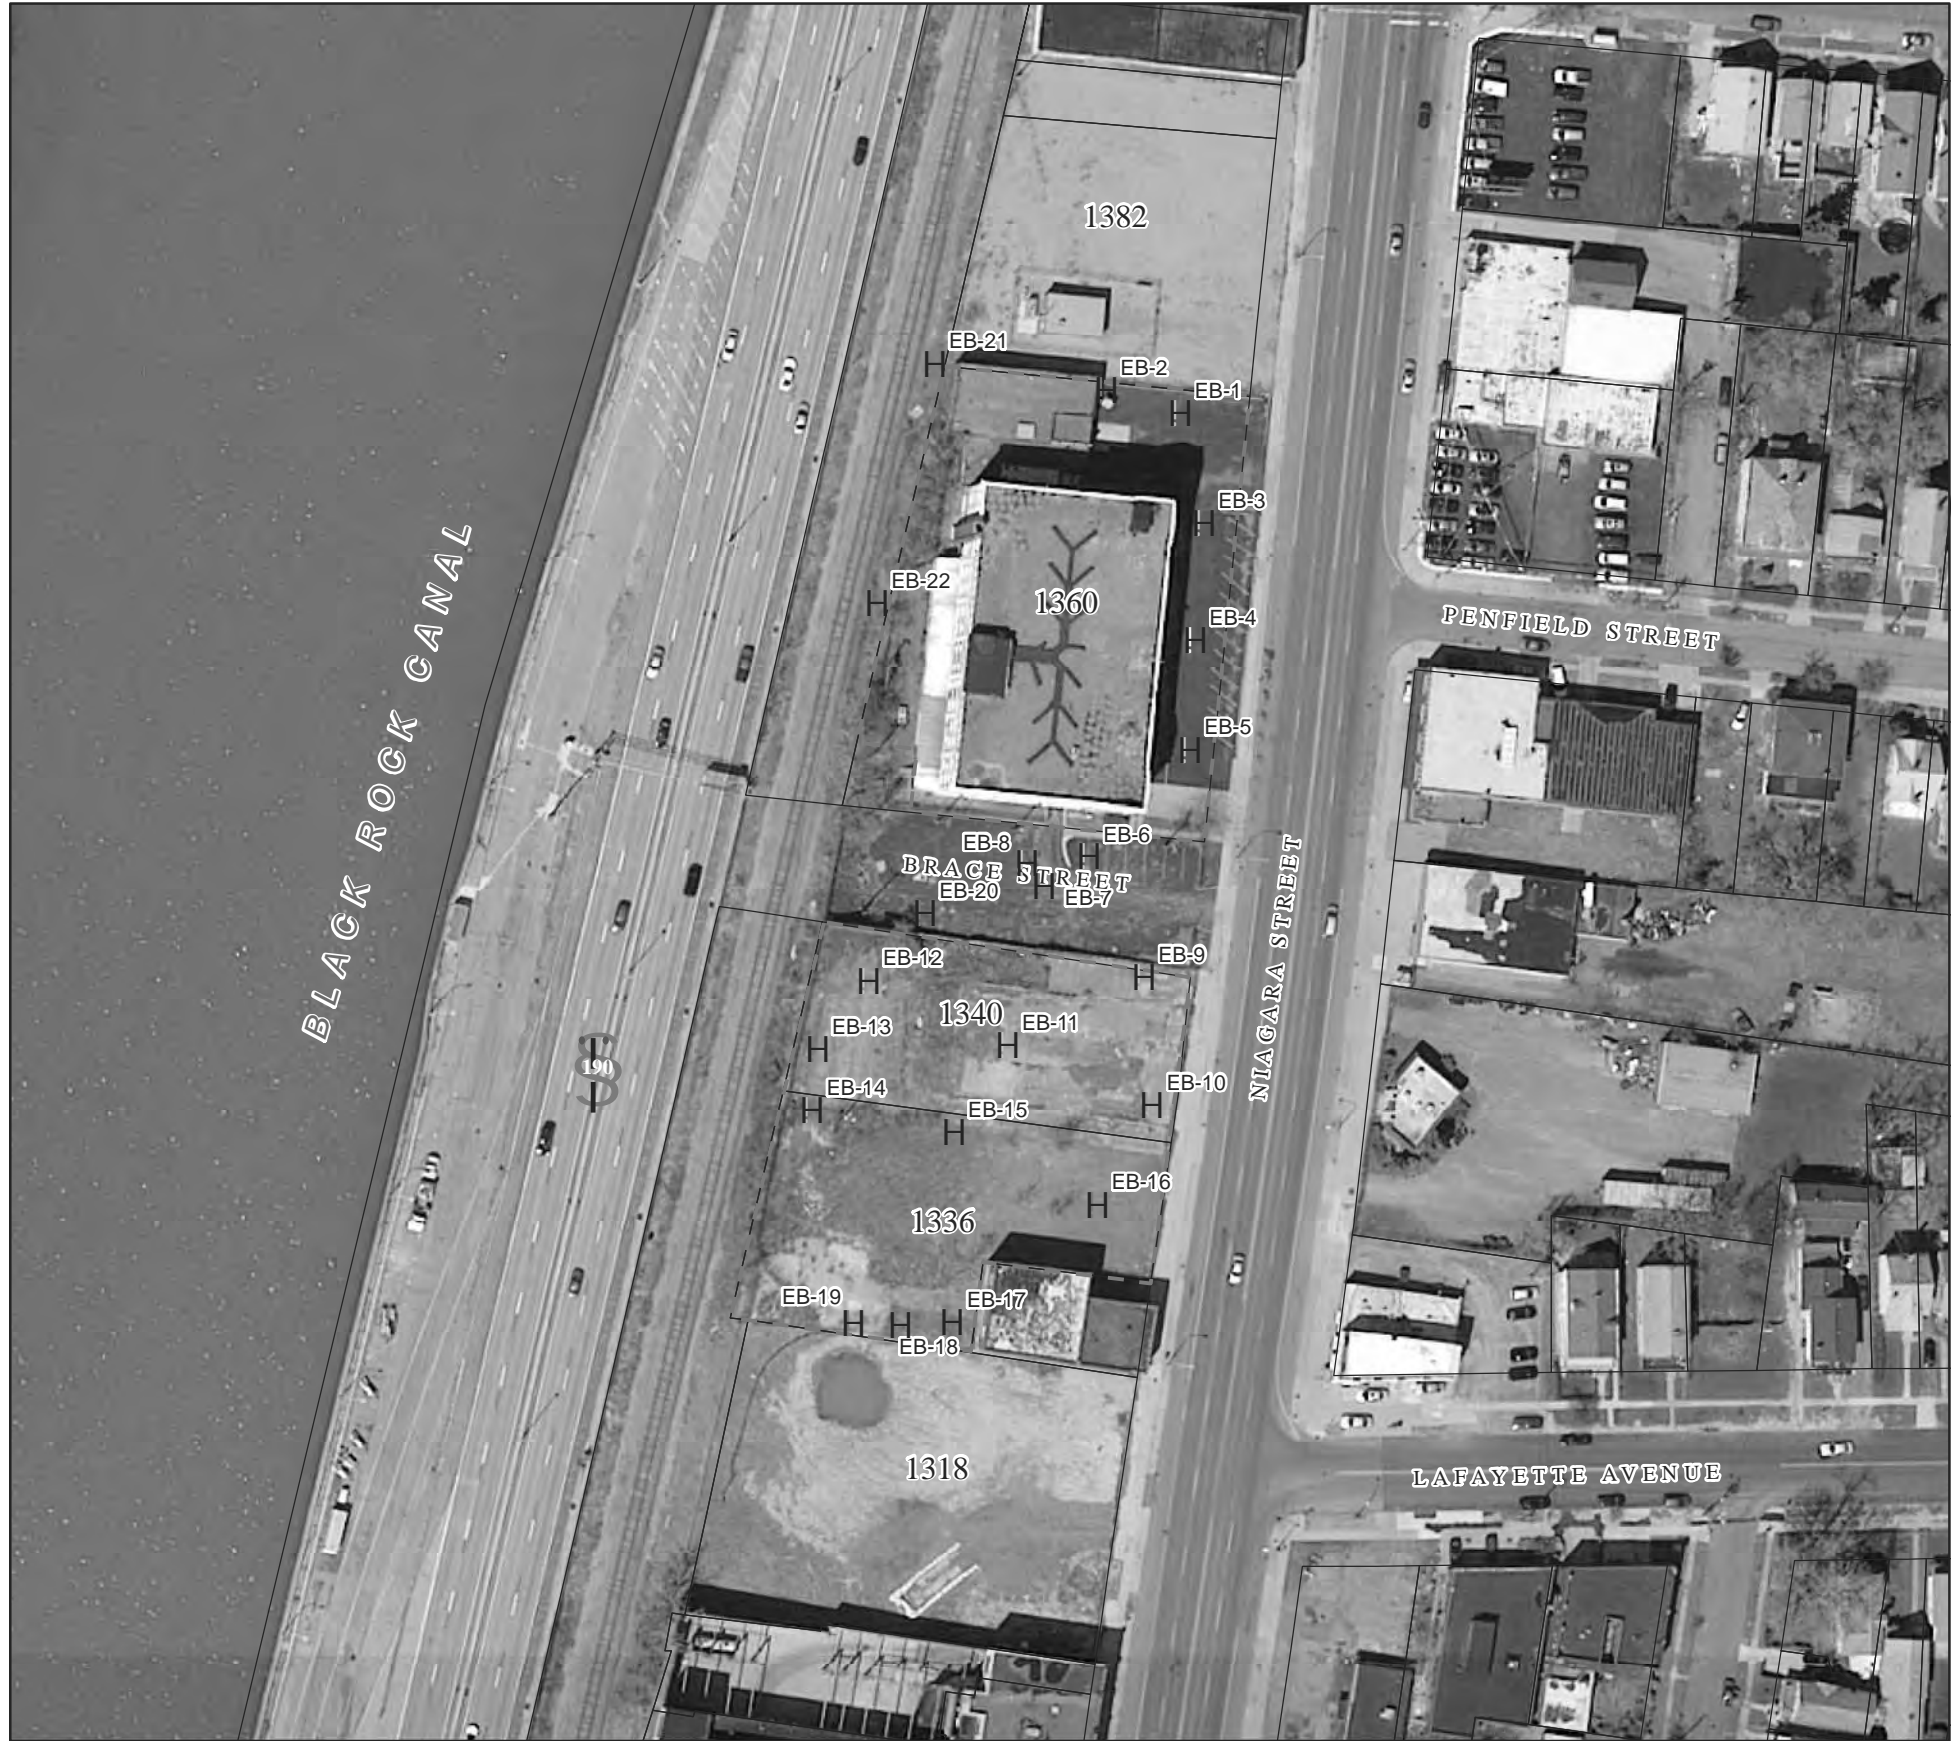
FIGURE 3

Asbestos and lead-based paint surveys were completed for the Site by AMD in 2015. A Phase I and Phase II ESA was completed for the Site by C&S in September 2015. The Phase I ESA indicated areas containing Recognized Environmental Conditions (RECs) under ASTM Standard E-1527-13 which were subsequently investigated in the Phase II ESA. The associated documents are summarized below and attached in **Appendix A**. **Figure 3** shows the site characterization results from 2015.

2015 SITE
CHARACTERIZATION

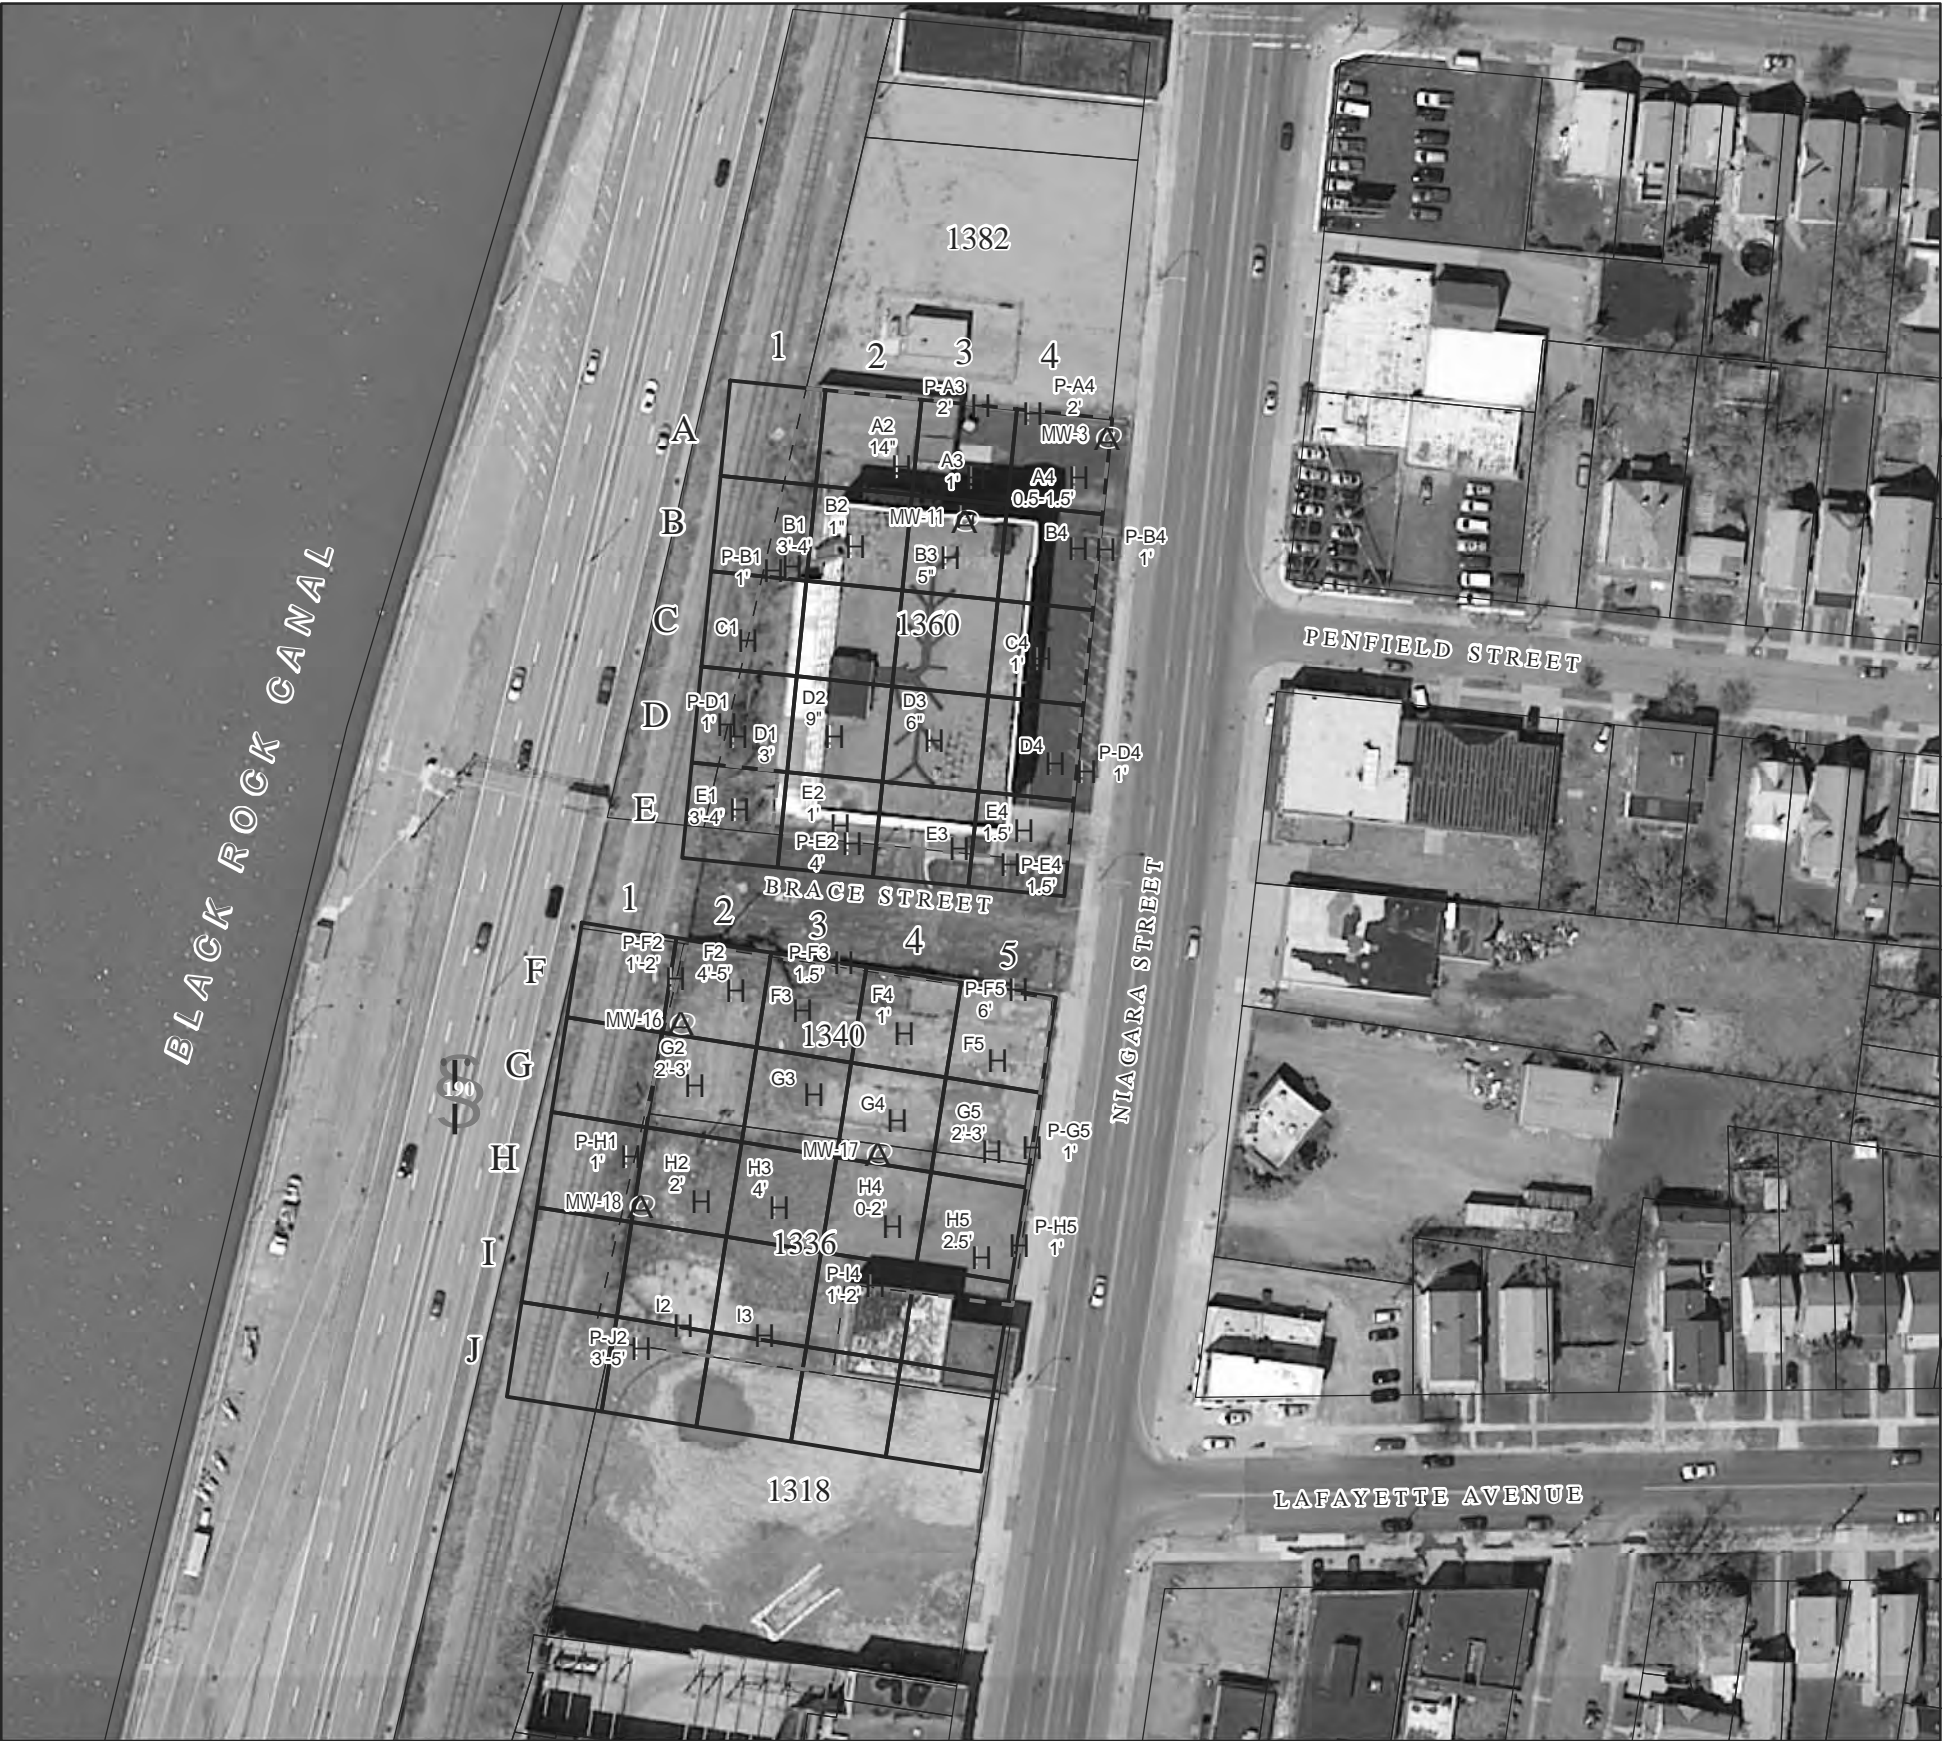
FIGURE 4

Fourteen fill samples were collected from the perimeter of the Site to characterize off-site conditions. Each of the samples were analyzed for TCL SVOCs and TAL metals. **Table 3** summarizes the analytical results, and **Figure 4** shows the sampling locations and results.

URBAN FILL
SAMPLING RESULTS

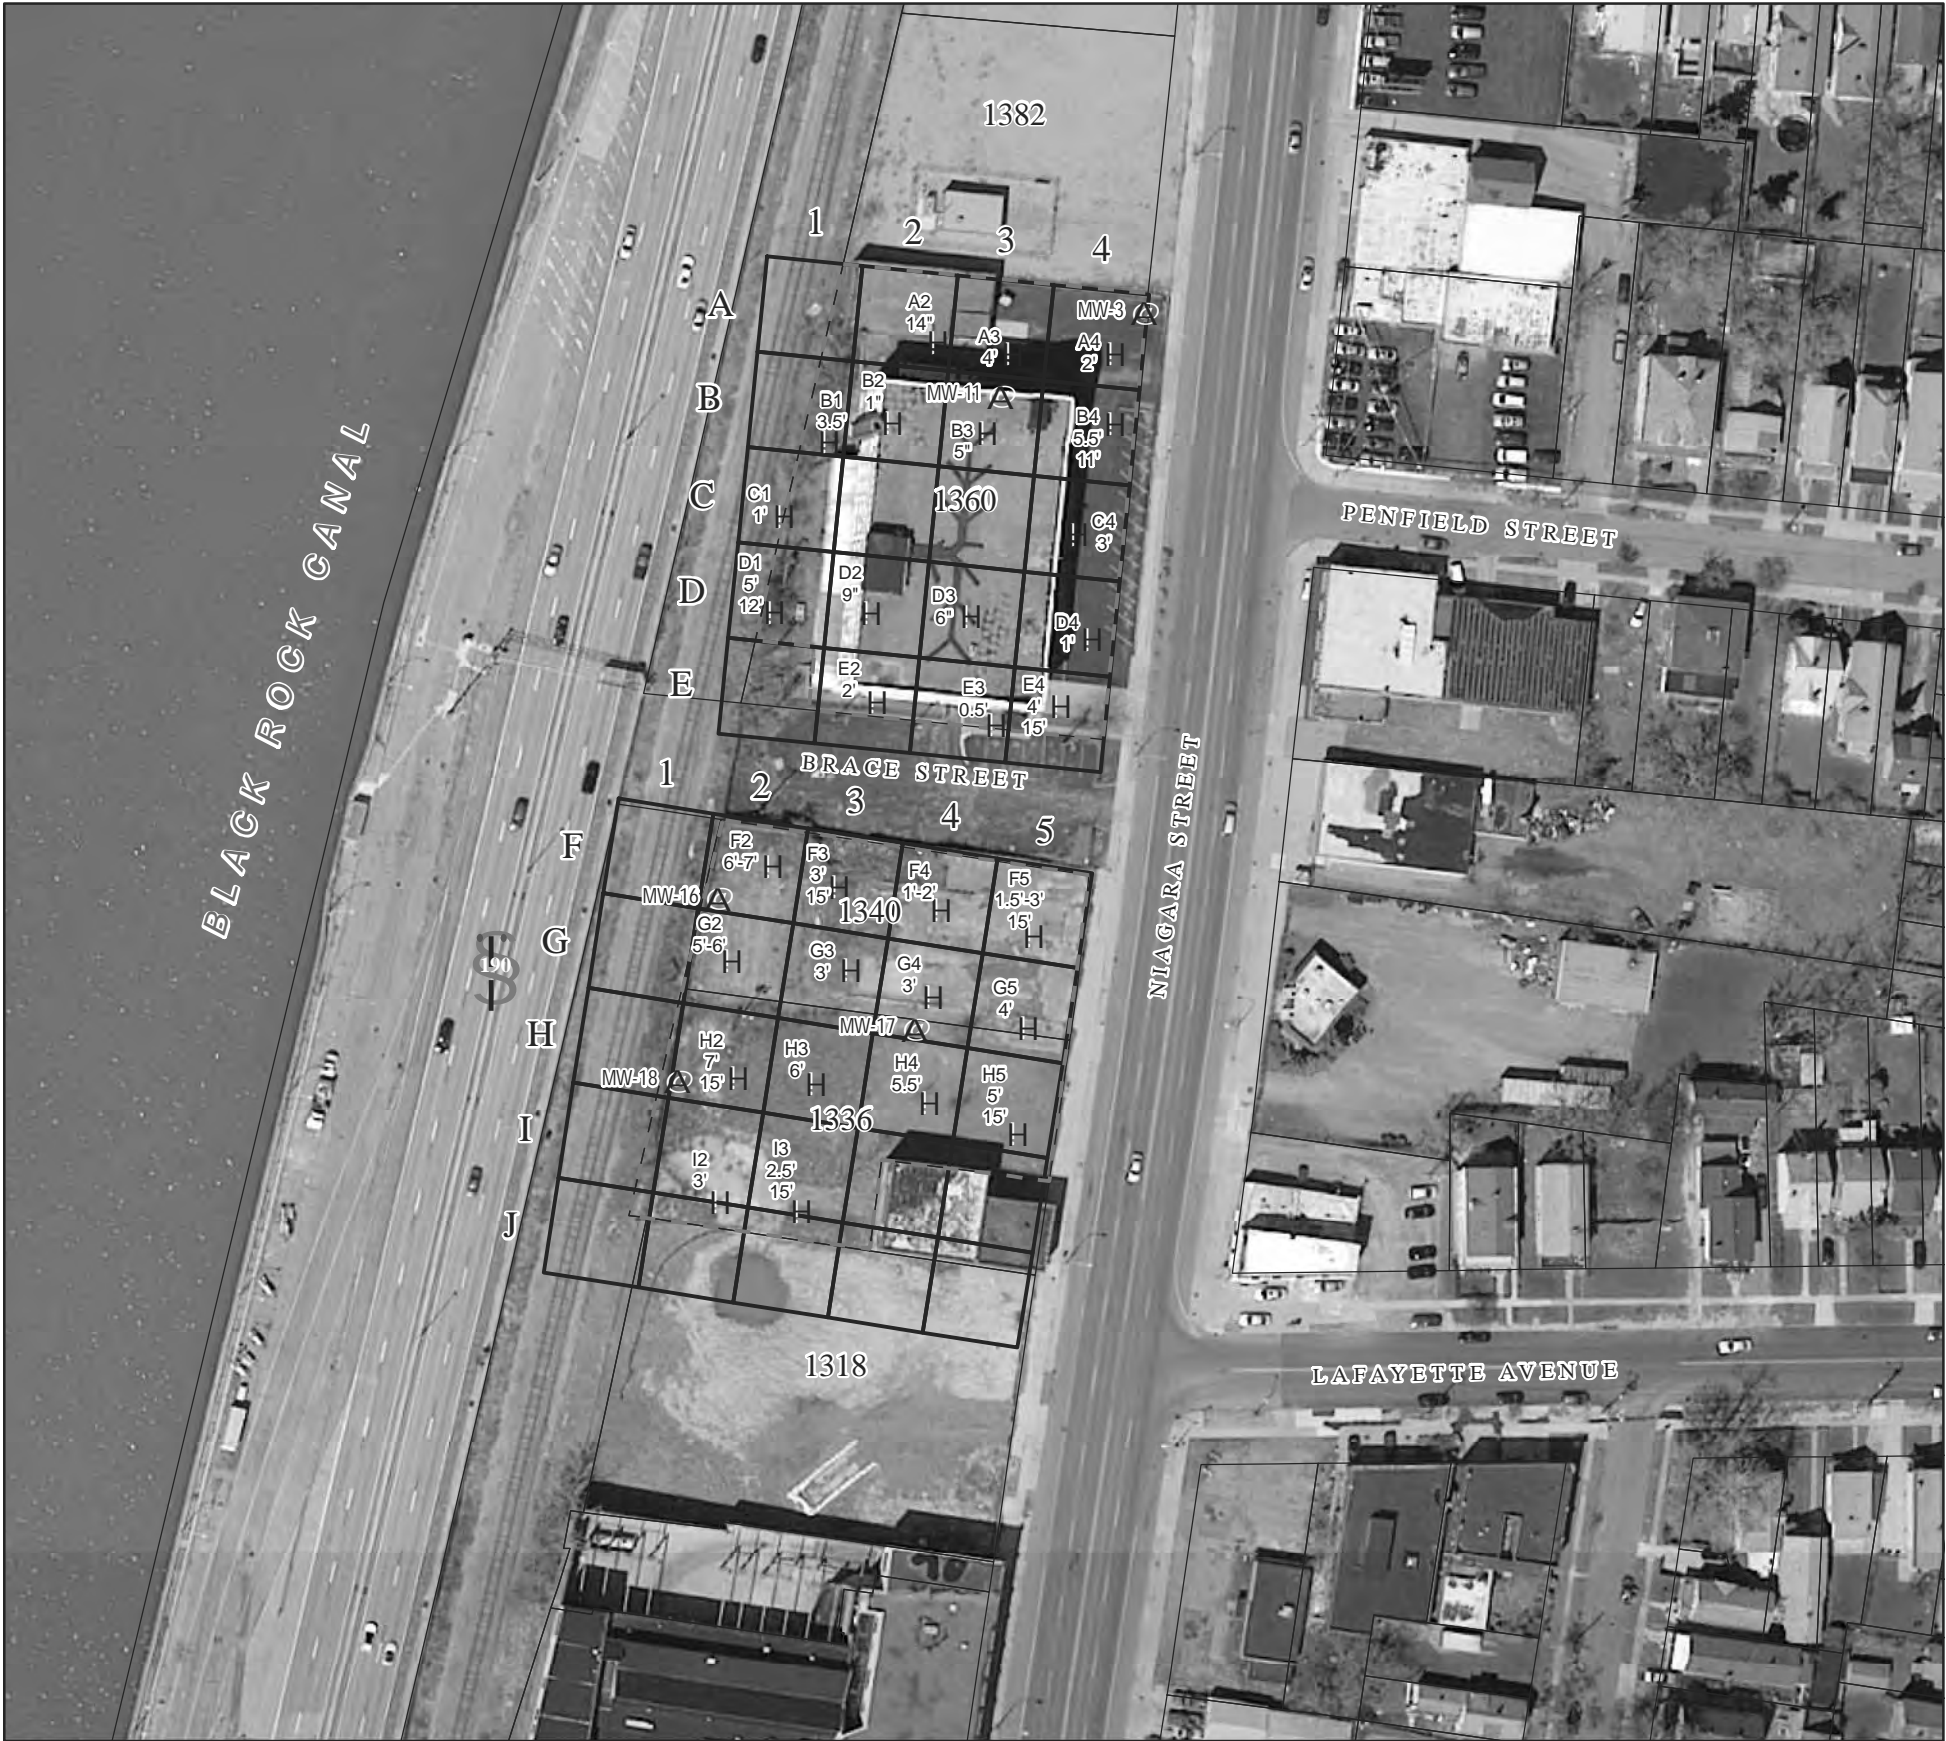
FIGURE 5

NATIVE SOIL
SAMPLING RESULTS
