**DRAFT REMEDIAL INVESTIGATION - INTERIM REMEDIAL MEASURES –
ALTERNATIVE ANALYSIS REPORT**

**BROWNFIELD CLEANUP PROGRAM
For
1550 HARLEM ROAD SITE
1550 Harlem Road, Cheektowaga, NY 14206
BCP # C915321**

Prepared For:
American Tire, Inc.
392 Ludington Street, Cheektowaga, NY 14206
WGS Project Number 18-102

October 25, 2018

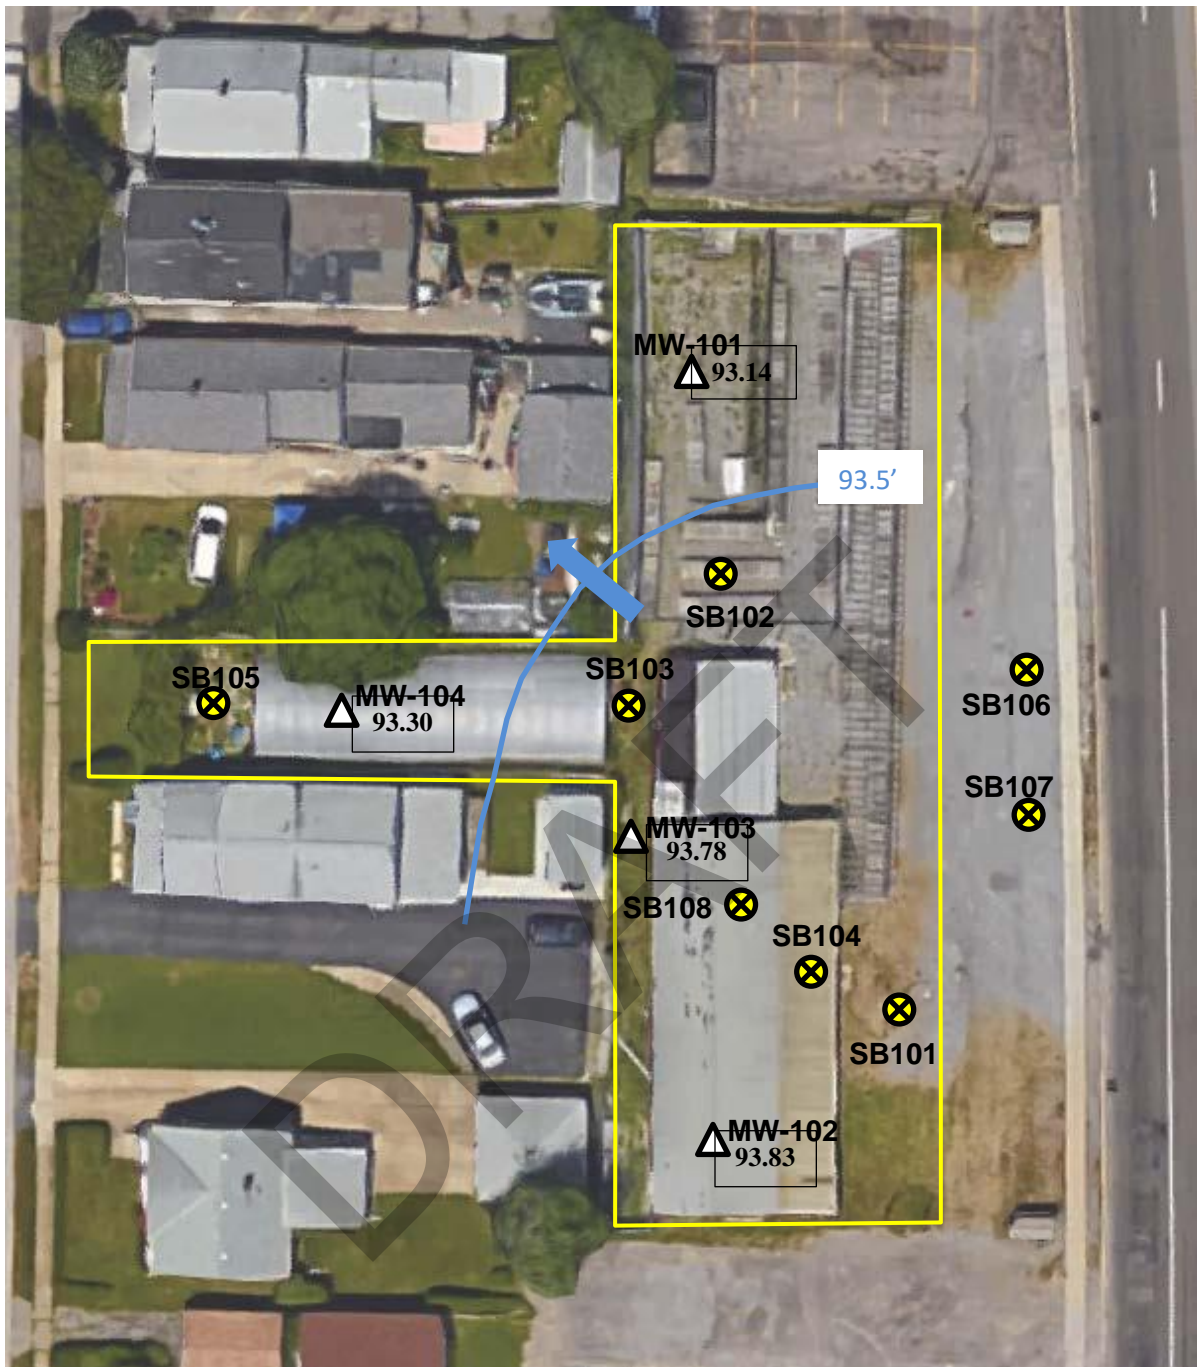
WITTMAN GEOSCIENCES, PLLC	Date: 10/2018	Groundwater Isopotential Map – Feb 2018 1550 Harlem Road, Cheektowaga, NY	Project: 18-102 Figure: 4a
	Scale: 1' = 40'

Monitoring well locations MW-101 to 104 were installed and initially measured in February 2018 and again in July 2018. Table 2 presents the relative groundwater elevation data. Groundwater depth was generally encountered 4 to 6 feet below grade in February and 6 to 8 feet in July. Figure 4a and 4b present the estimated groundwater flow direction, which generally appeared to be a westerly to northwesterly direction.
