NYSDEC Site # 516008
Saranac Lake Gas Co., Inc.
Saranac Lake, New York

OU3 Wetland Delineation Plan
Project 3611161193
Figure 3.4

APPENDIX A
WETLAND DETERMINATION DATA FORMS

Wetland Photographic Log	
Client: NYSDEC	Project Number: 3611161193.02
Site Name: Saranac Lake Gas Company	Site Location: Saranac Lake, New York.
Photographer: Charles Lyman

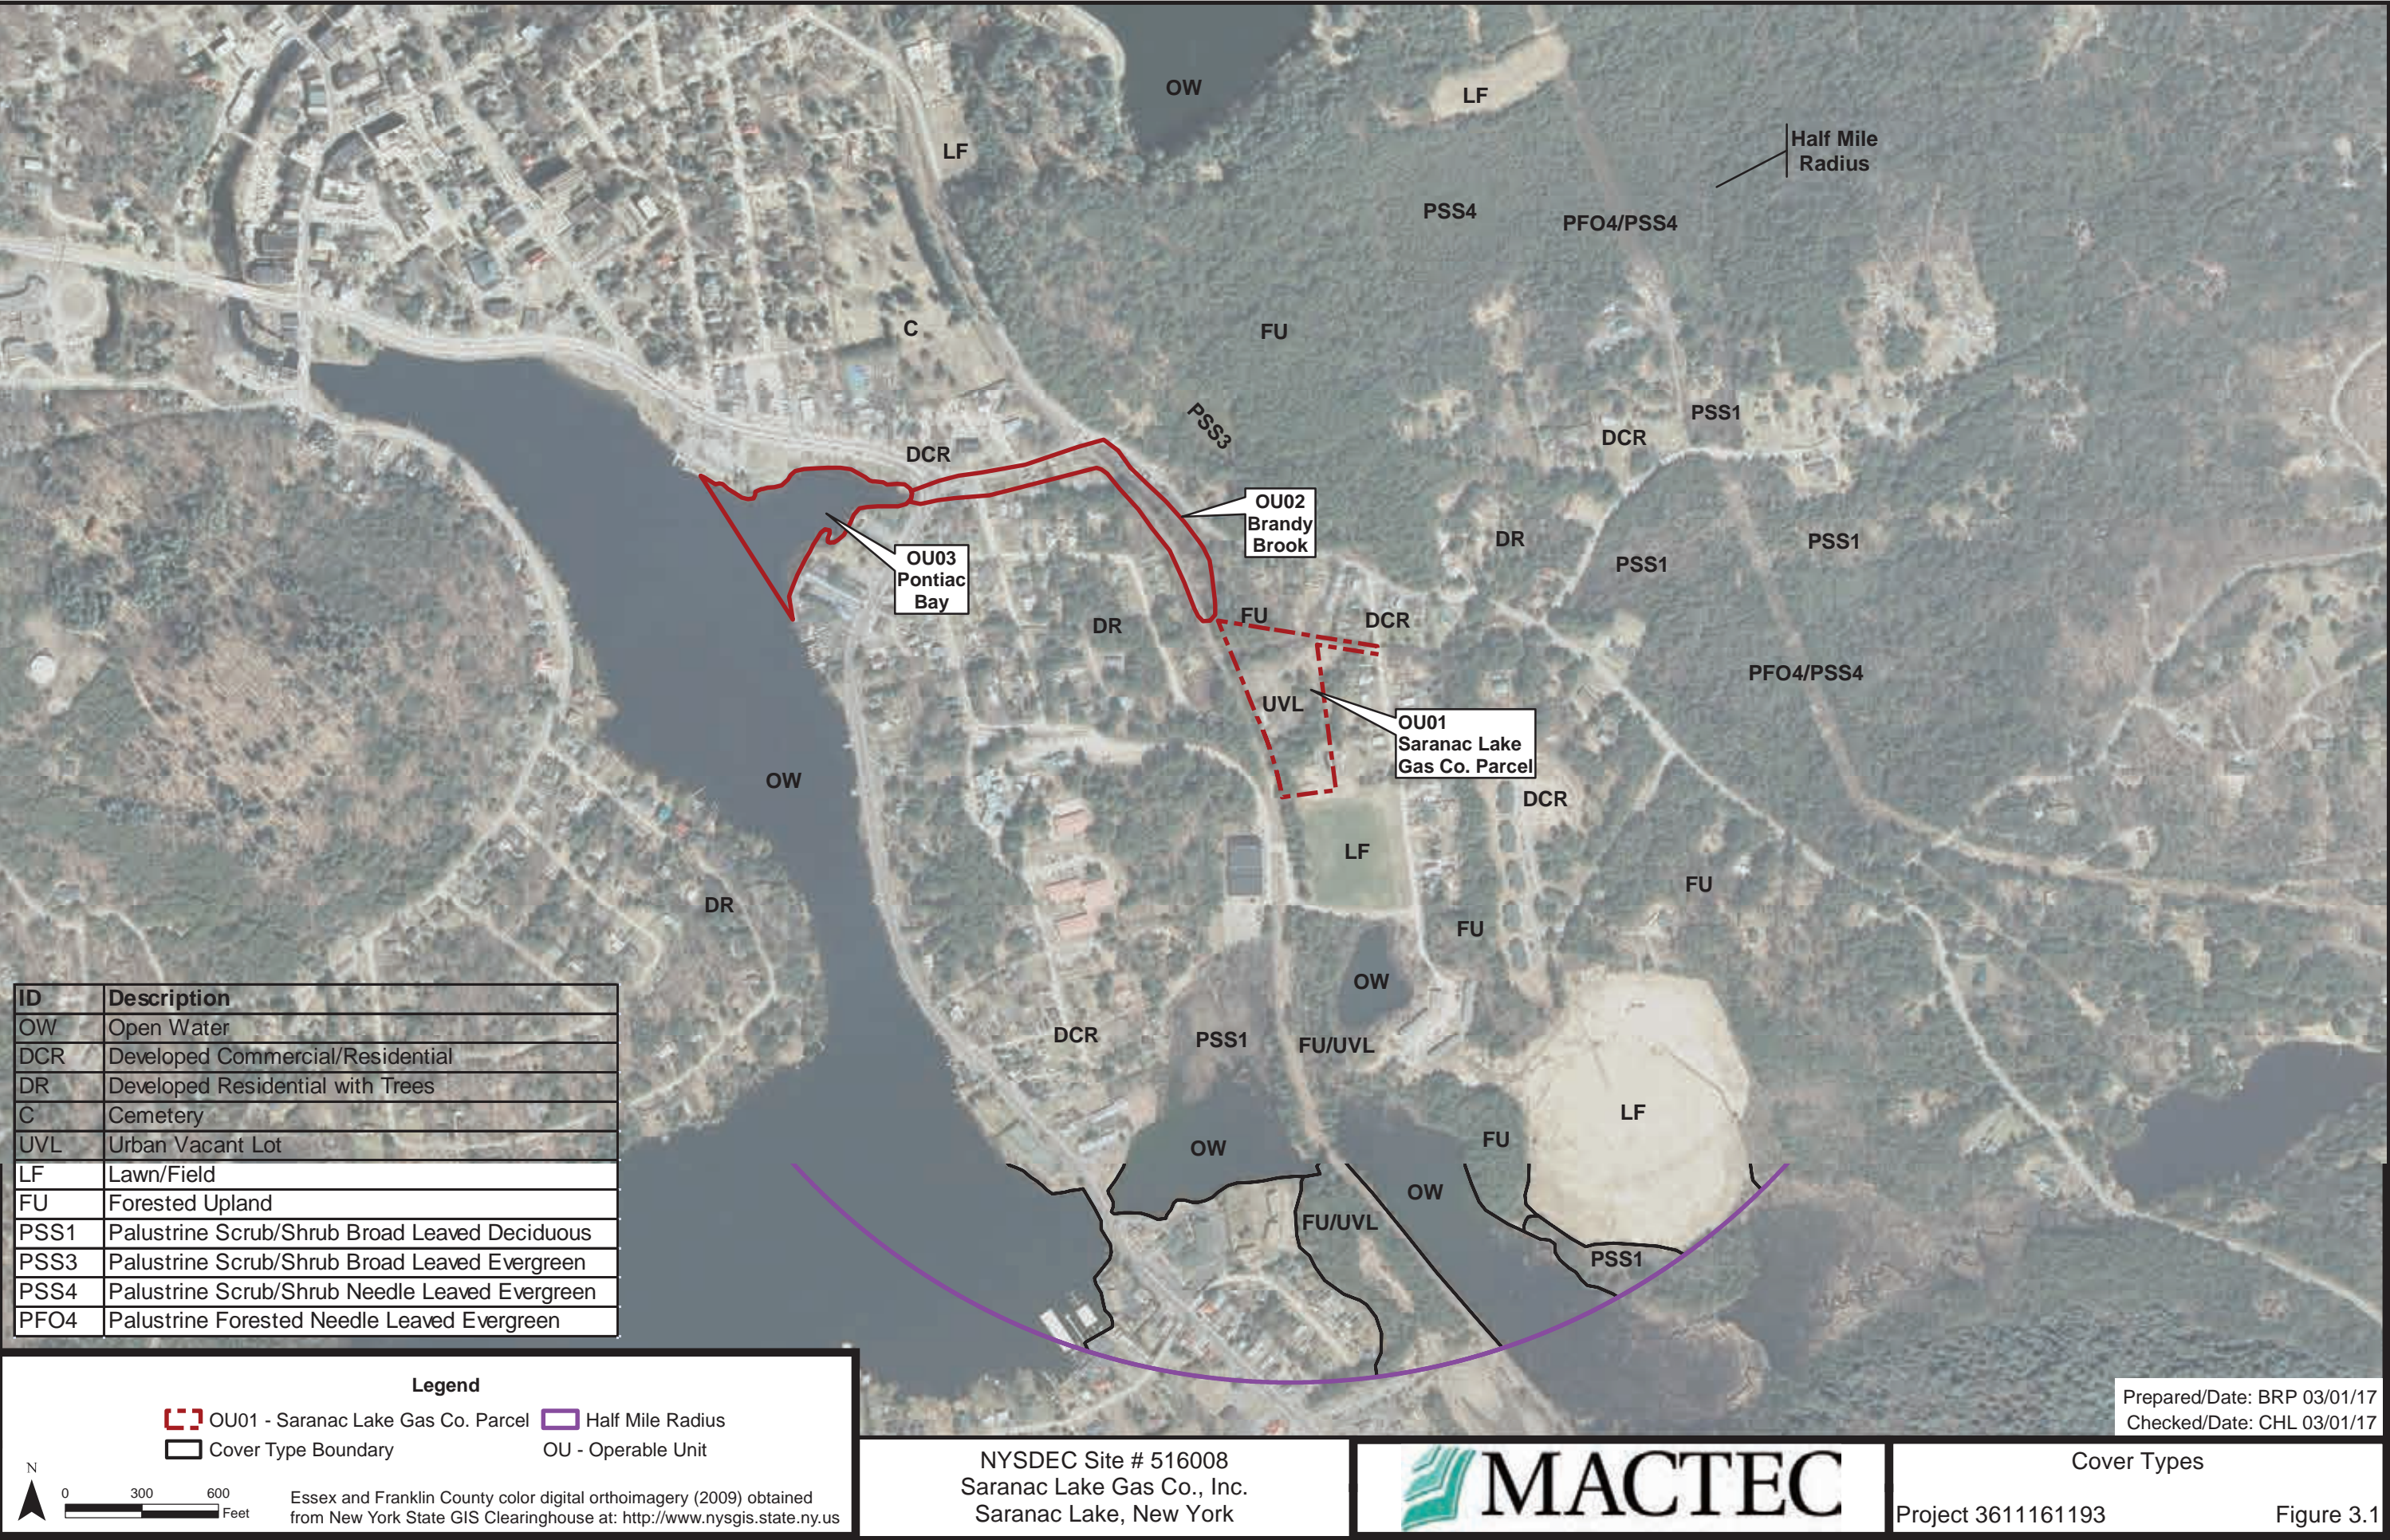
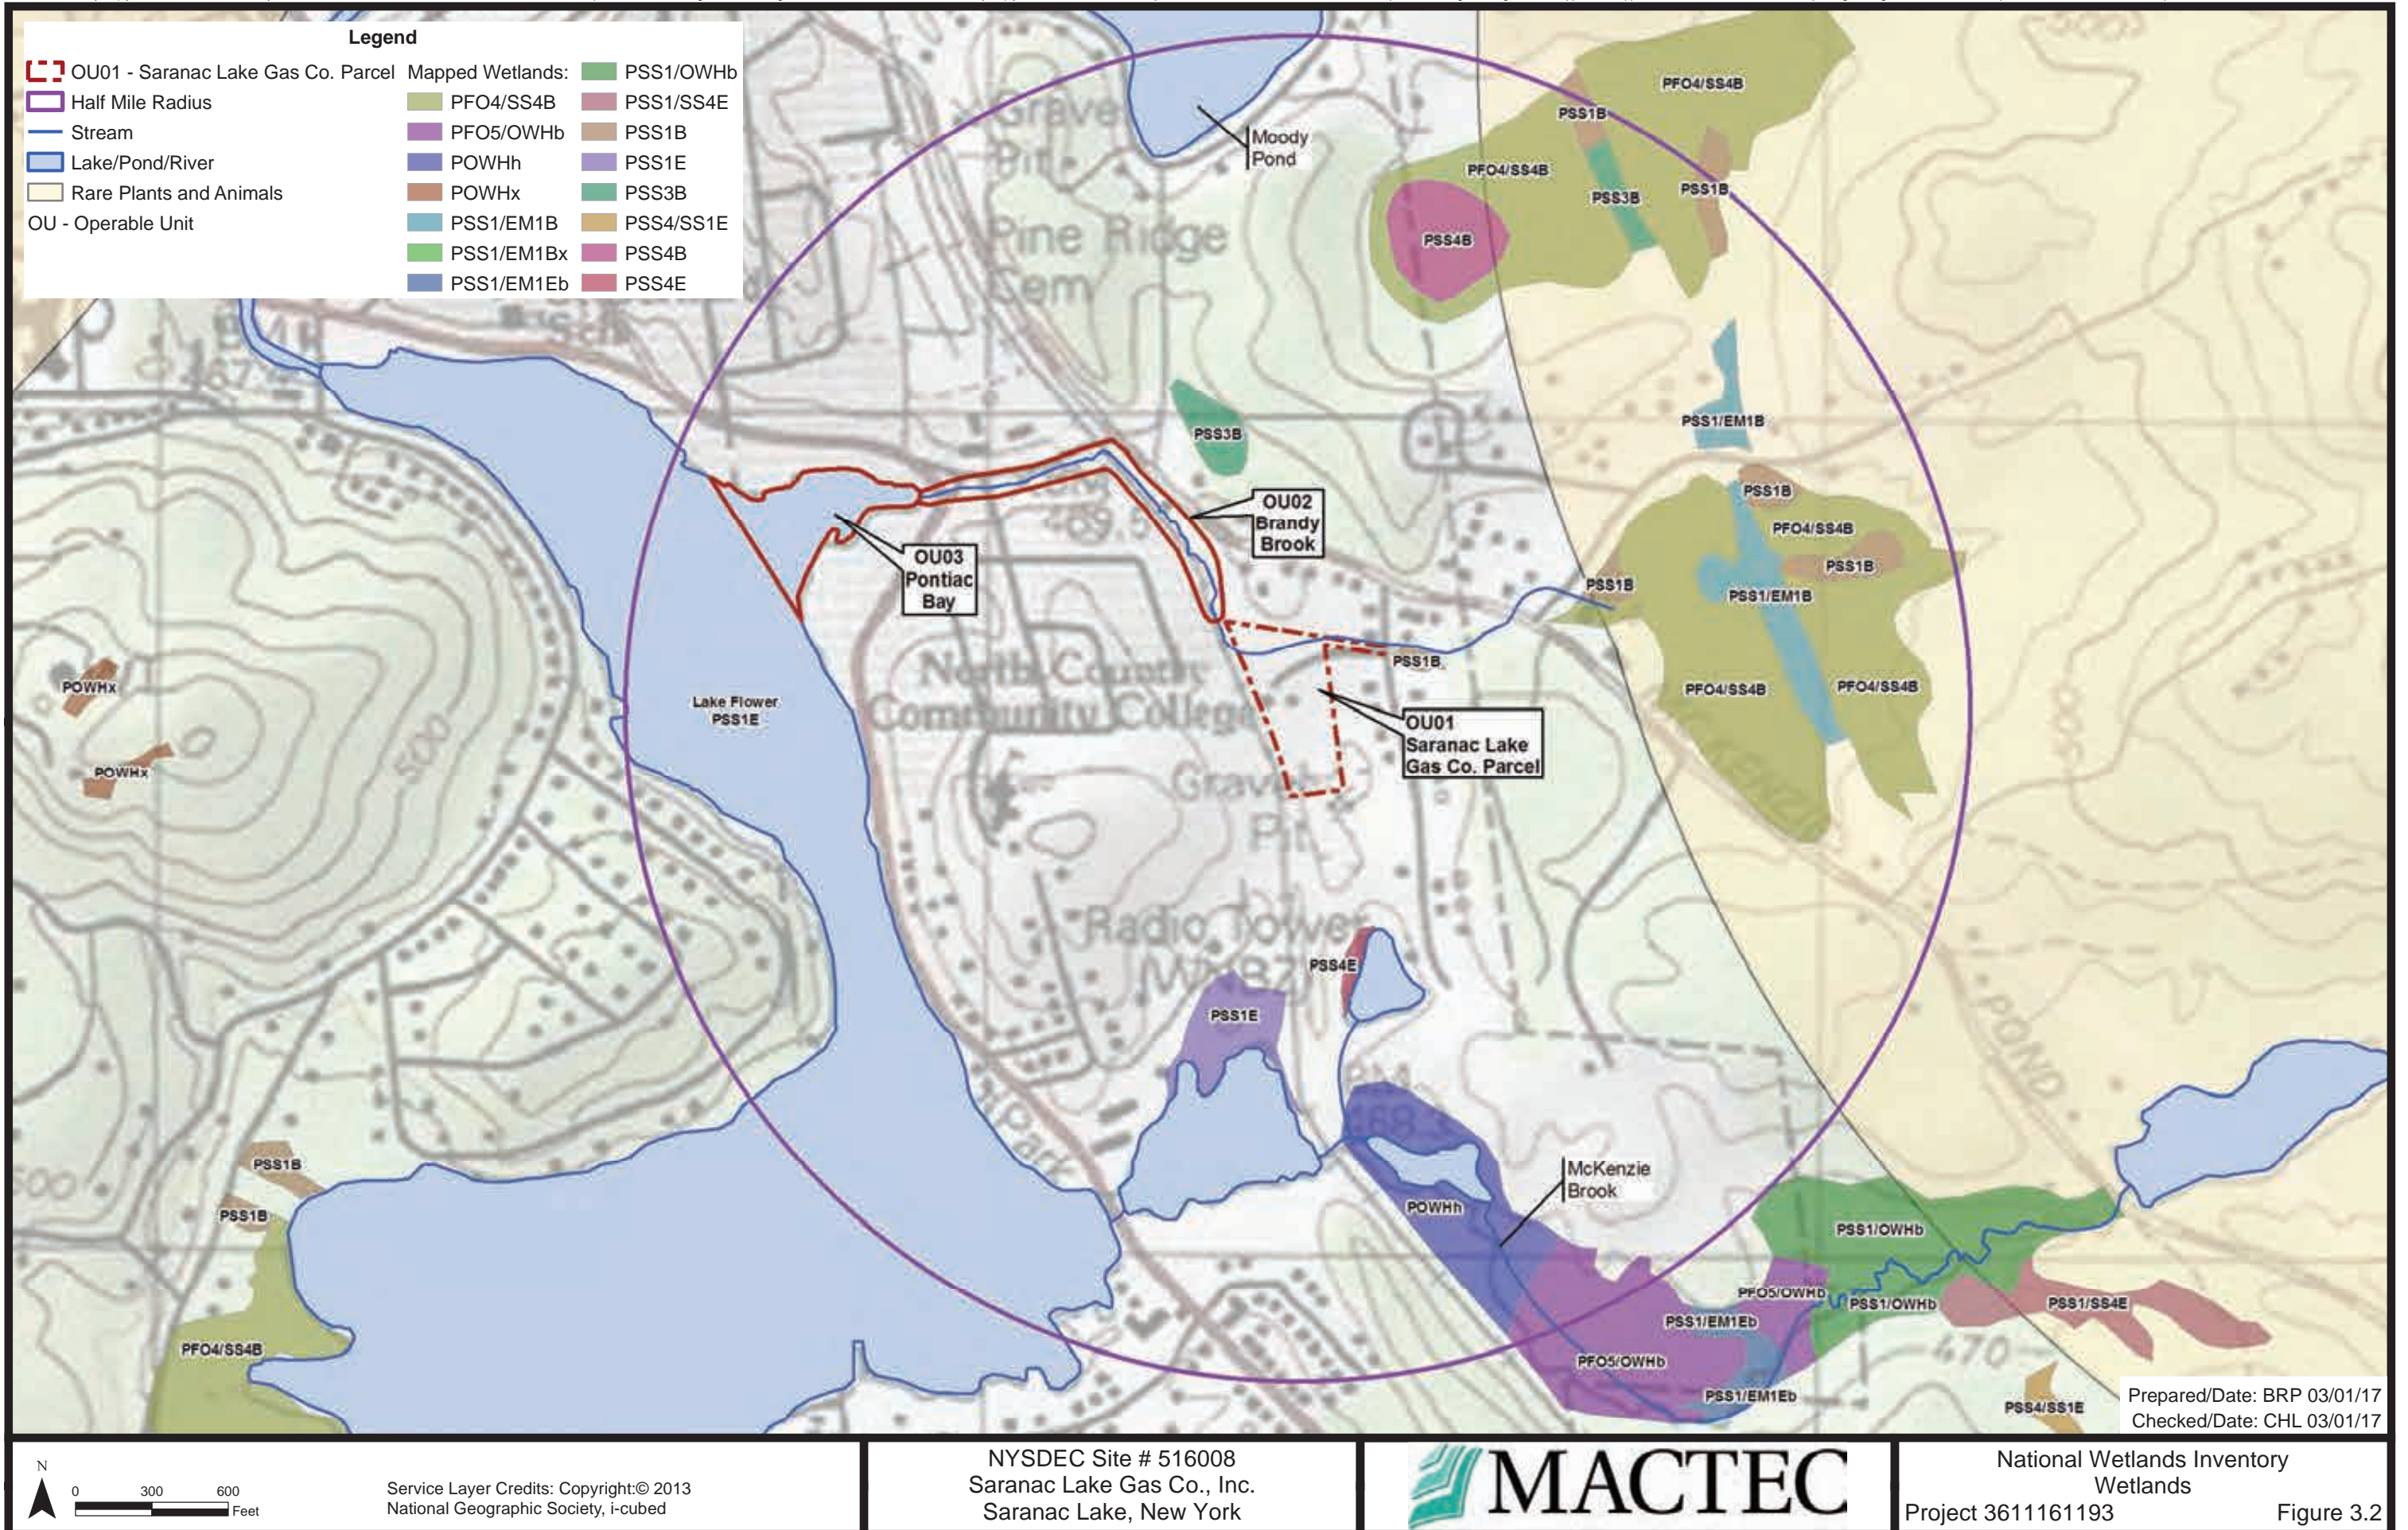
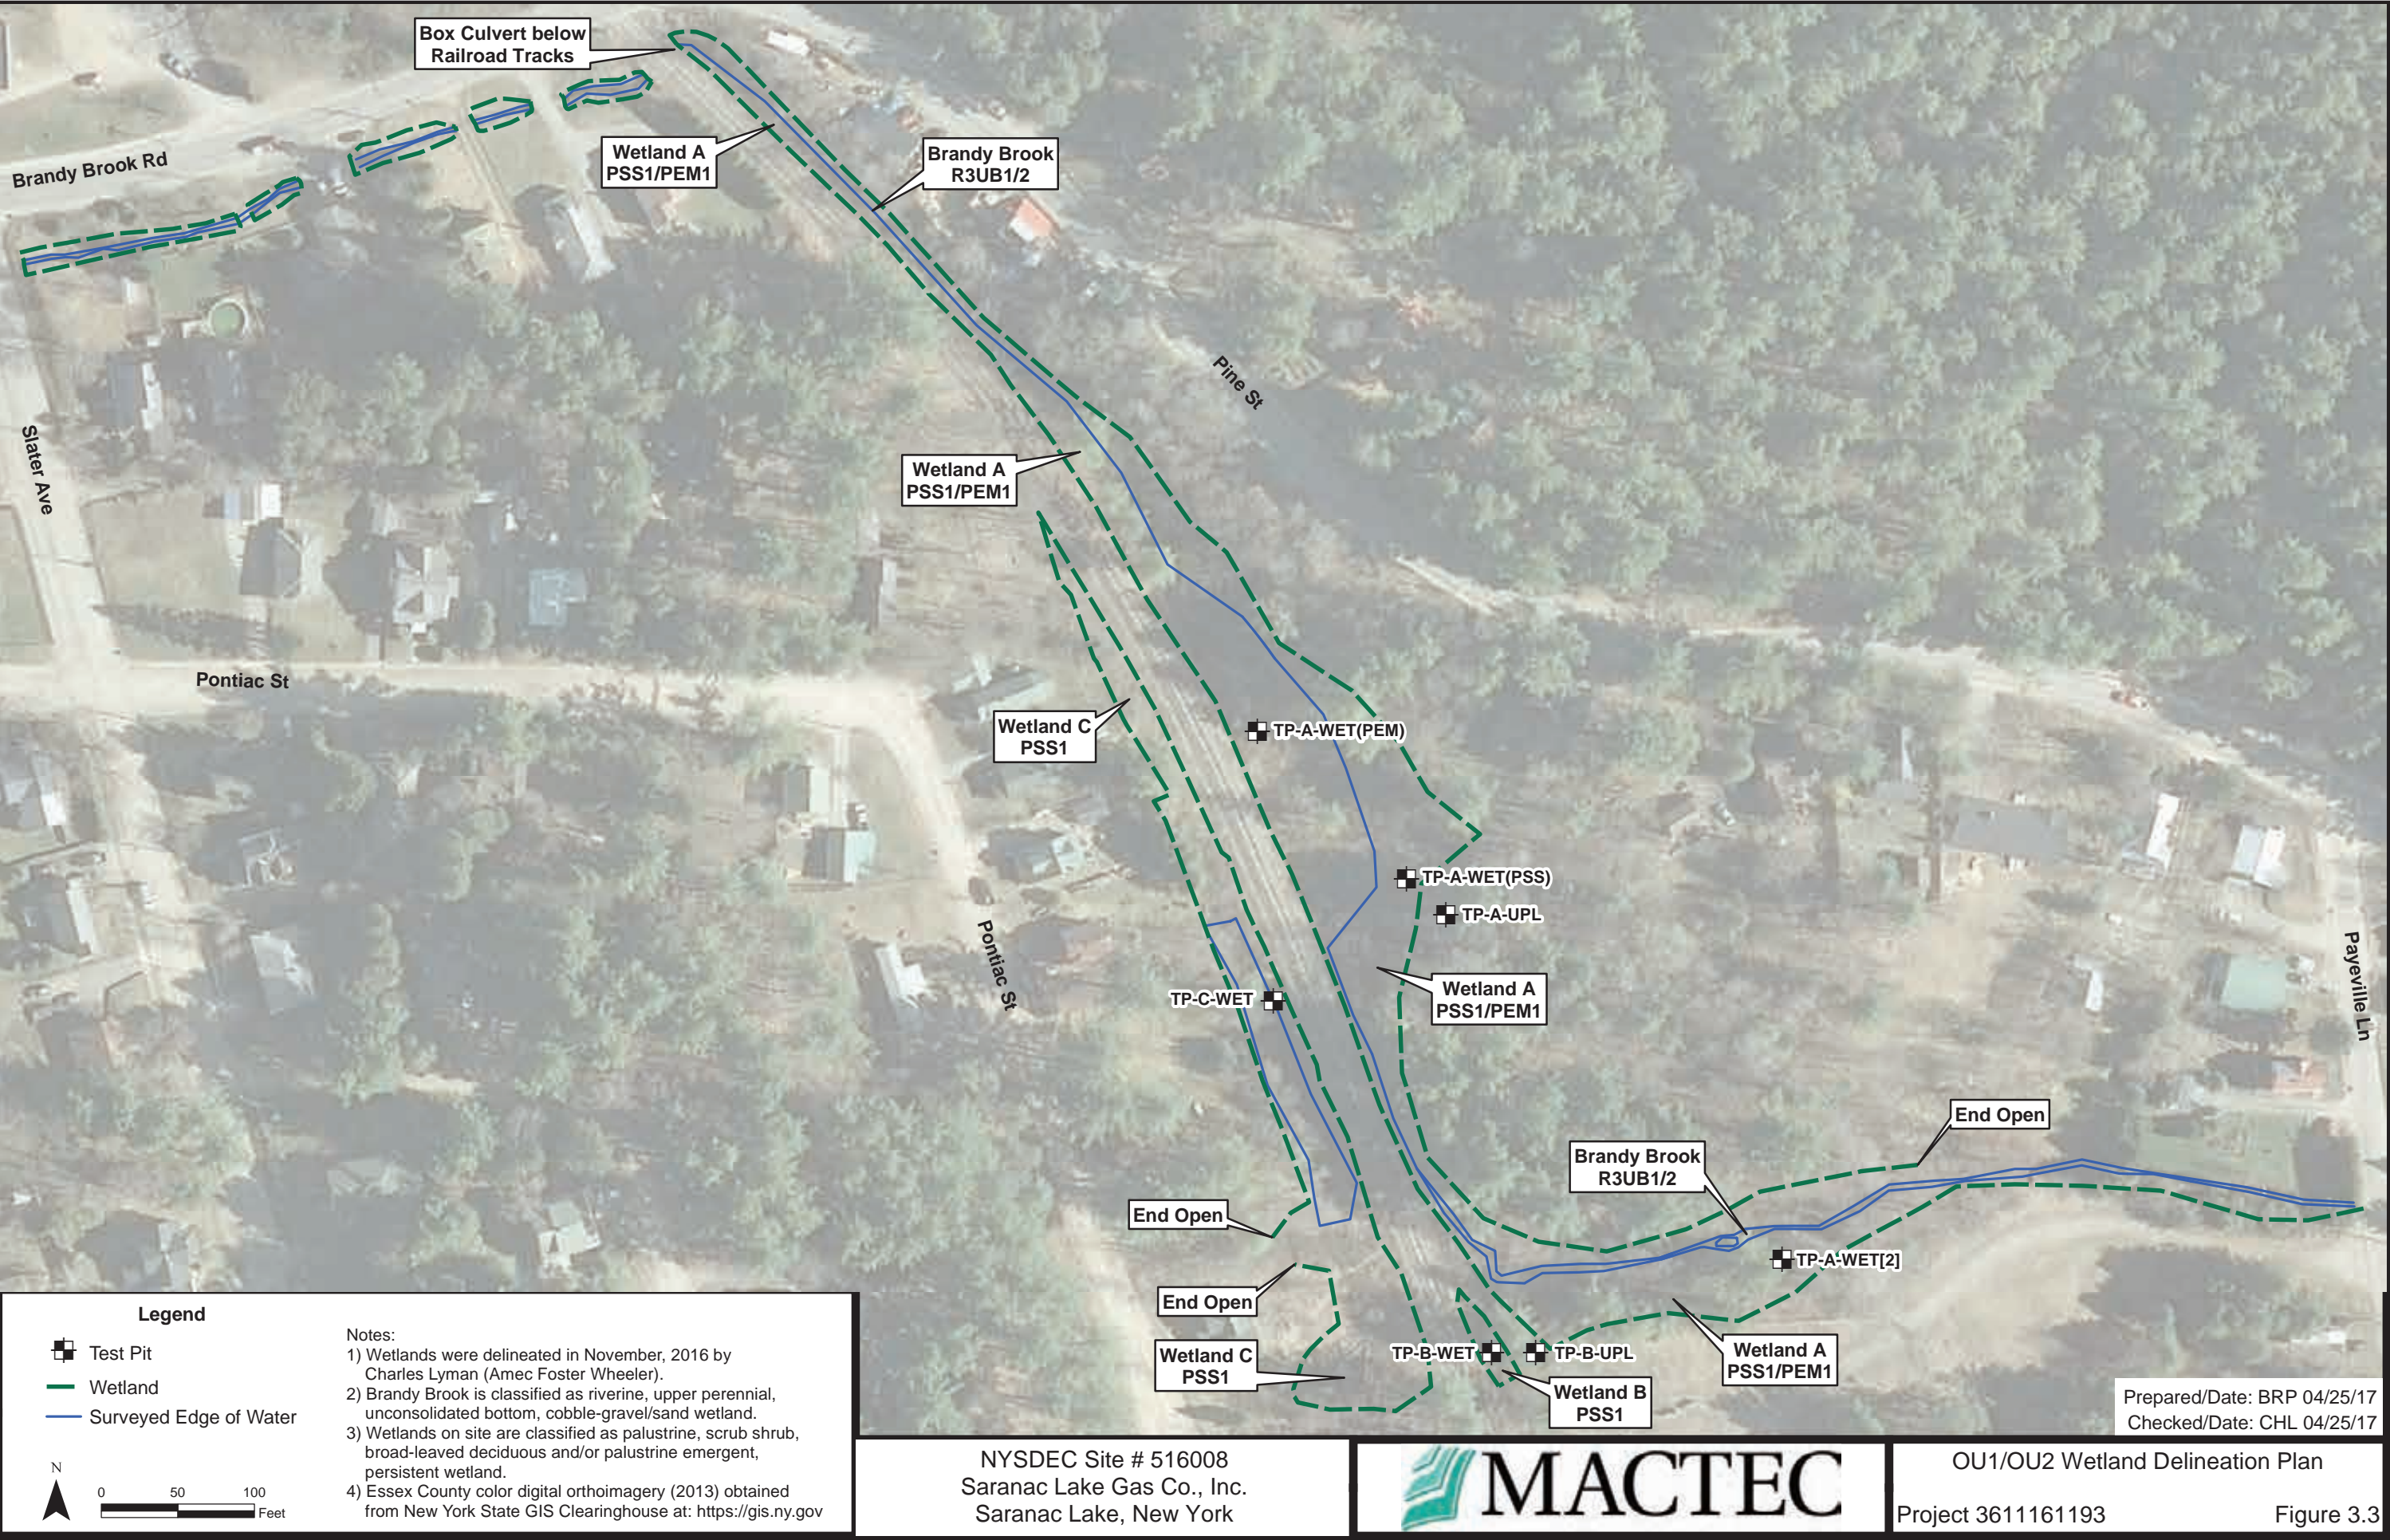
- Notes:
- 1) Lake Flower water level controlled by dam; spillway set at 1528'; lake level typically kept at 1528.5'.
 - 2) Bordering vegetated wetland absent along shore. Abrupt transition from upland to wetland. Wetland defined by edge of water.
 - 3) Pontiac Bay is classified as a lacustrine, limnetic, unconsolidated bottom, permanently flooded wetland (special modifier h = impounded added based on dam).
 - 4) Essex County color digital orthoimagery (2013) obtained from New York State GIS Clearinghouse at: <https://gis.ny.gov>

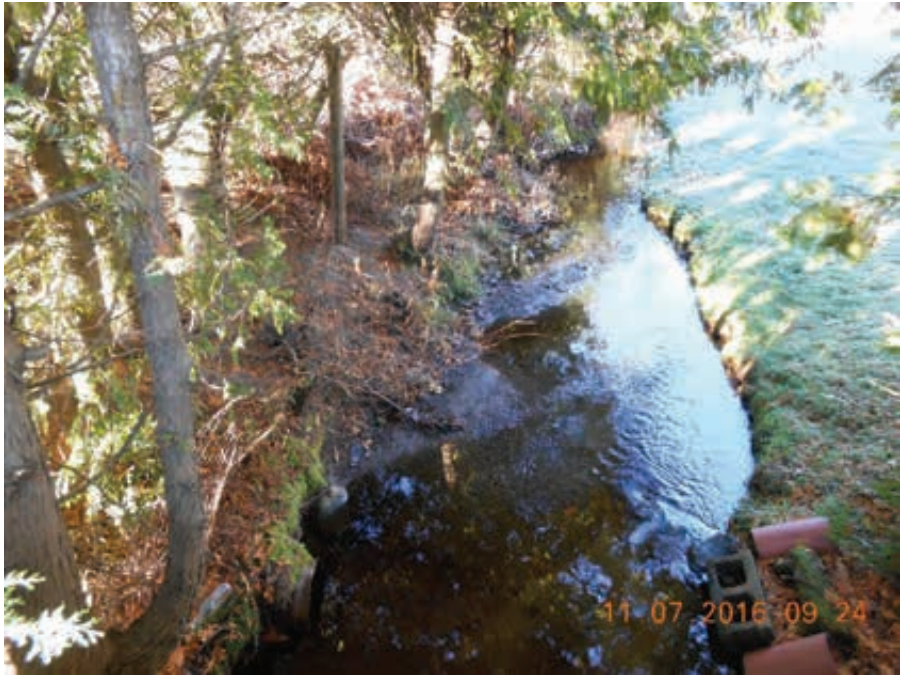
Date: November 7,8,9, 2016	
Photograph: 1	
Direction: West	
Description: View looking west at Brandy Brook from Payeville Lane. Note sand and gravel bottom.	
Photographer: Charles Lyman

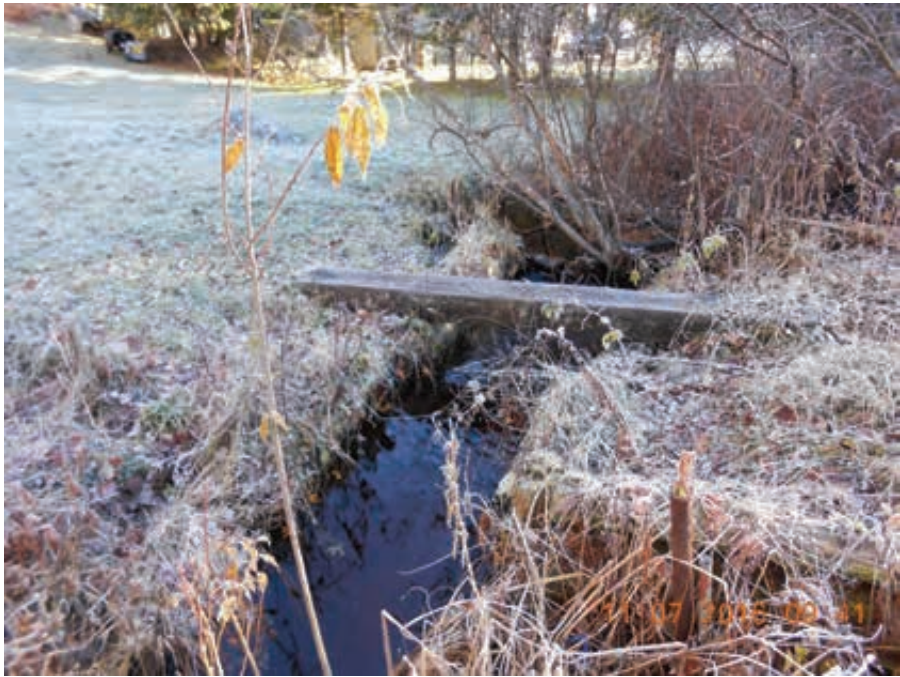
Date: November 7,8,9, 2016	
Photograph: 2	
Direction: Northeast	
Description: Brandy Brook north side of OU01, observed timbers along bank, like related to old foot bridge, note timber crossing creek.

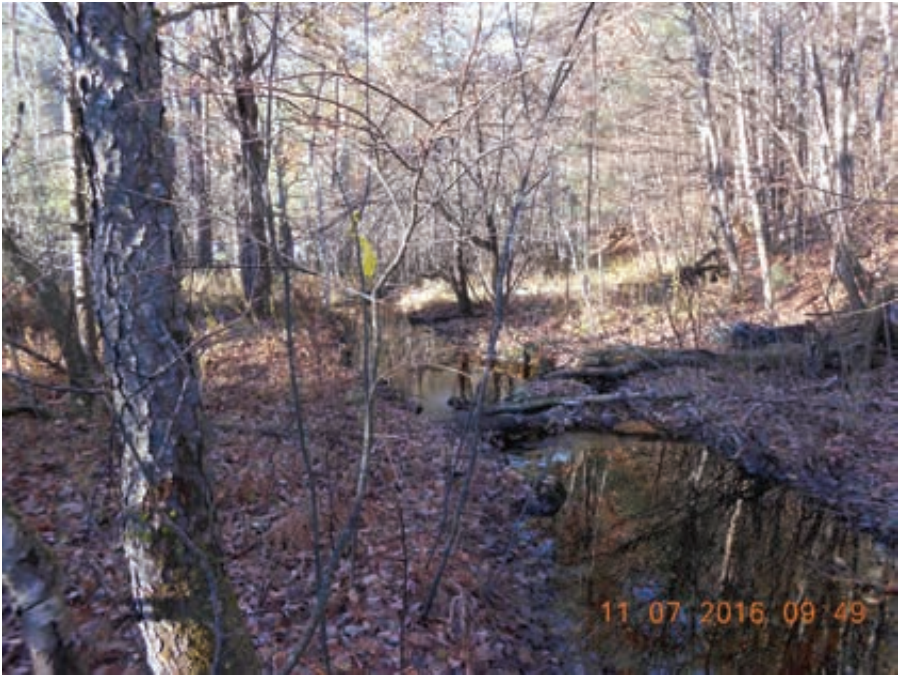
Date: November 7,8,9, 2016	
Photograph: 3	
Direction: West	
Description: View of Brandy Brook north side of OU01, note bordering Wetland A to south and upland to north.	
Photographer: Charles Lyman

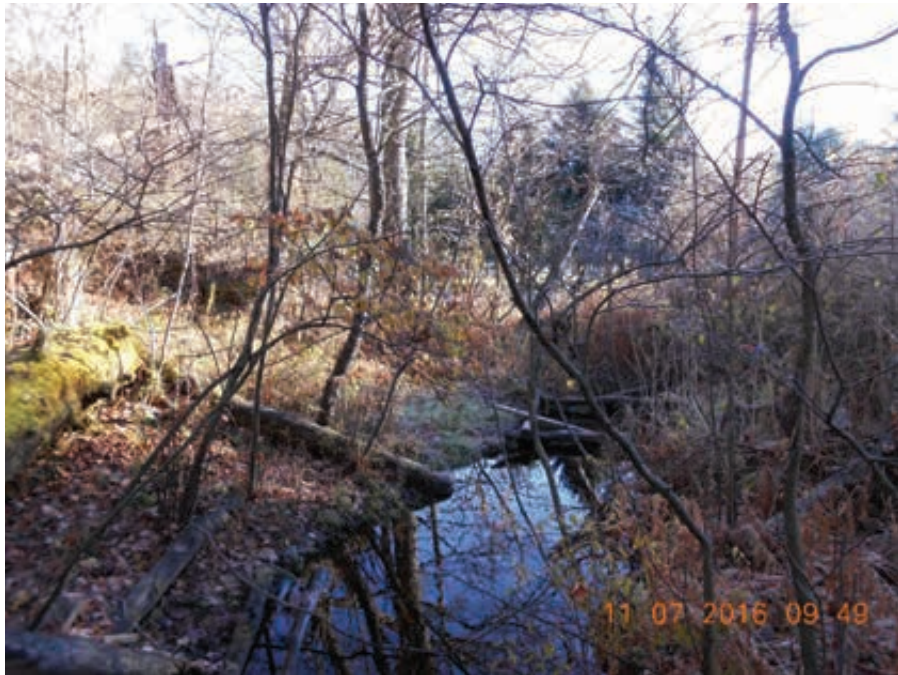
Date: November 7,8,9, 2016	
Photograph: 4	
Direction: East	
Description: Brandy Brook, note abrupt transition out of wetland based on topography.

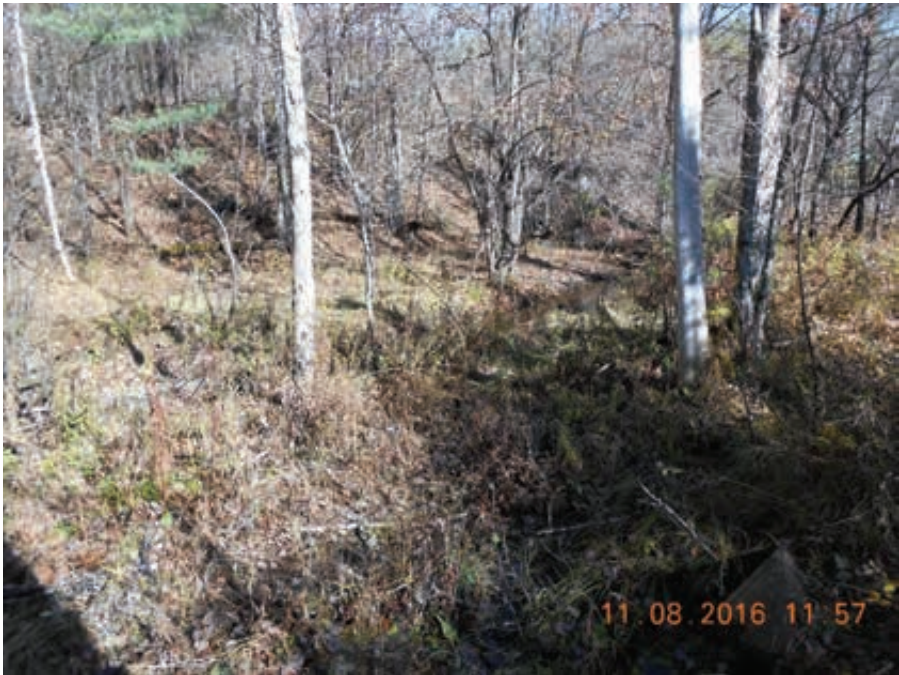
Date: November 7,8,9, 2016	
Photograph: 5	
Direction: East	
Description: View of Brandy Brook from former rail spur into site; Wetland A.	
Photographer: Charles Lyman

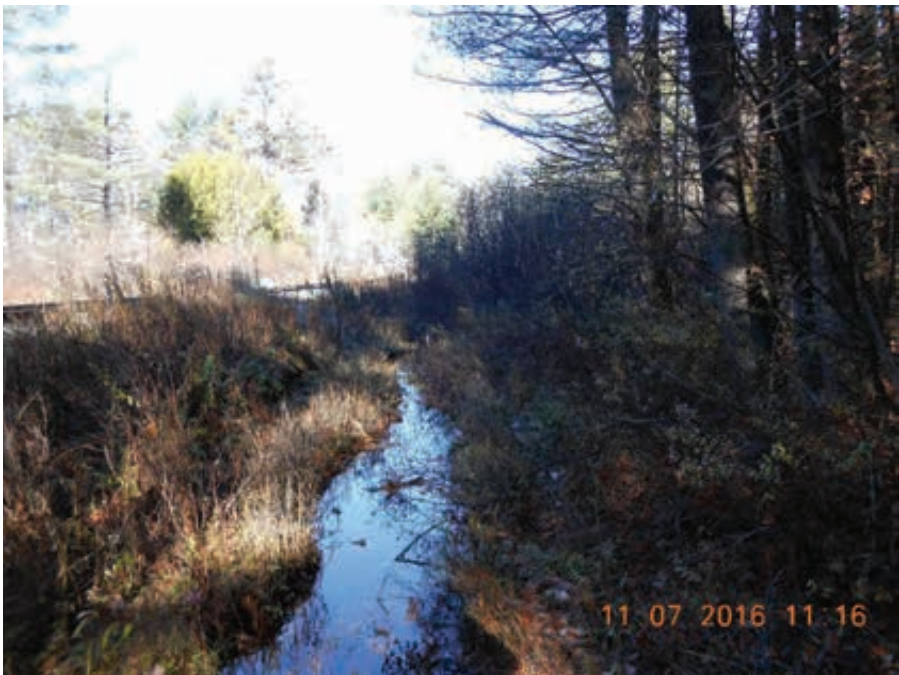
Date: November 7,8,9, 2016	
Photograph: 6	
Direction: North	
Description: View of Brandy Brook, note alder dominated PSS portion of Wetland A. Brook flows in low area between railroad tracks and upland hill to right of photo.

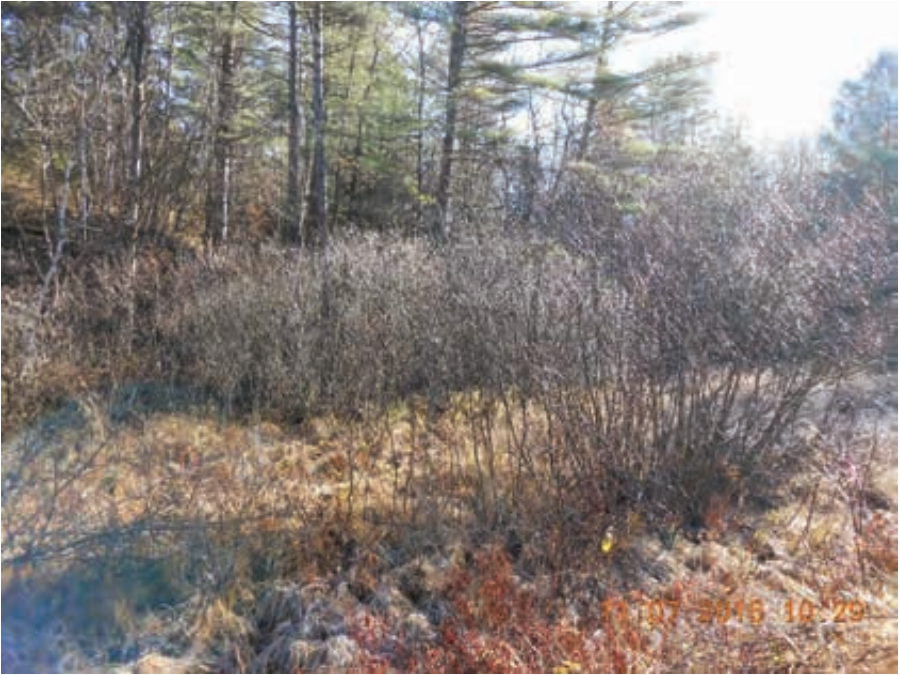
Date: November 7,8,9, 2016	
Photograph: 7	
Direction: South	
Description: Wetland A note PEM portions of wetland in foreground and upland hill in the background.	
Photographer: Charles Lyman

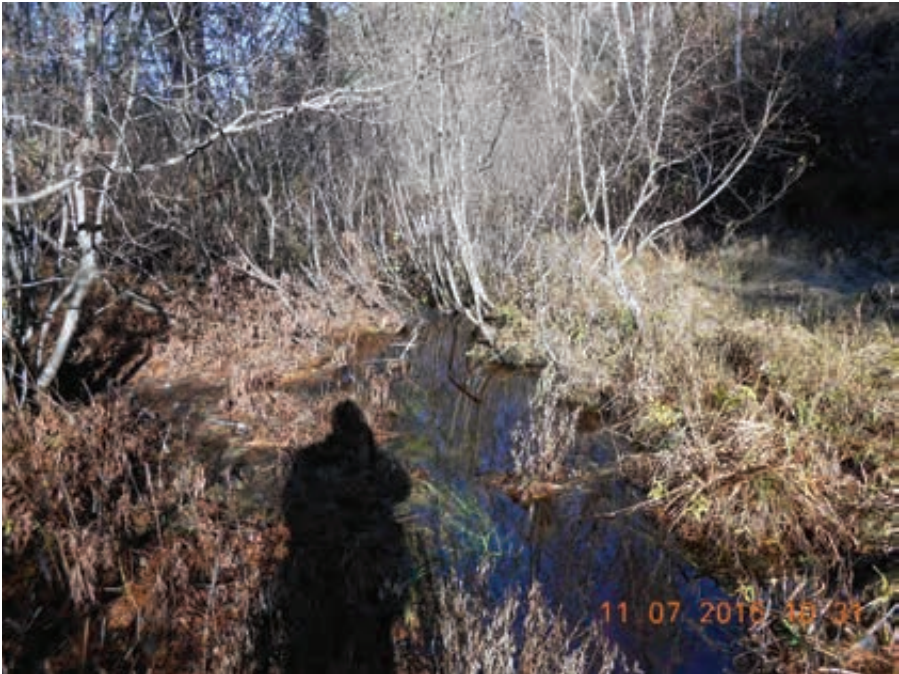
Date: November 7,8,9, 2016	
Photograph: 8	
Direction: North	
Description: Wetland A note transition from PEM to PSS.

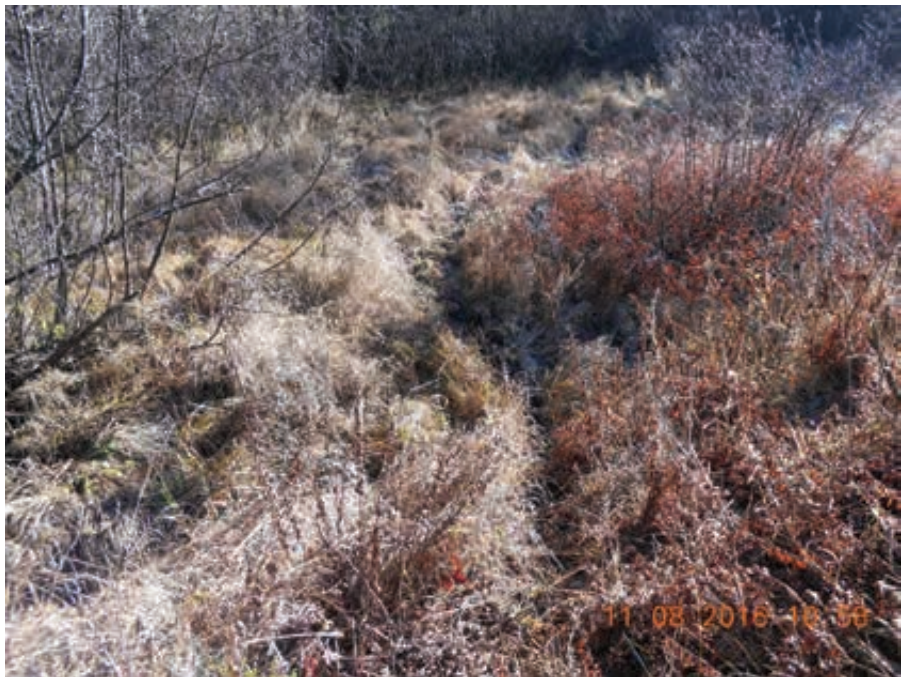
Date: November 7,8,9, 2016	
Photograph: 9	
Direction: Southeast	
Description: Wetland A east side of railroad tracks, note deer/game trail.	
Photographer: Charles Lyman

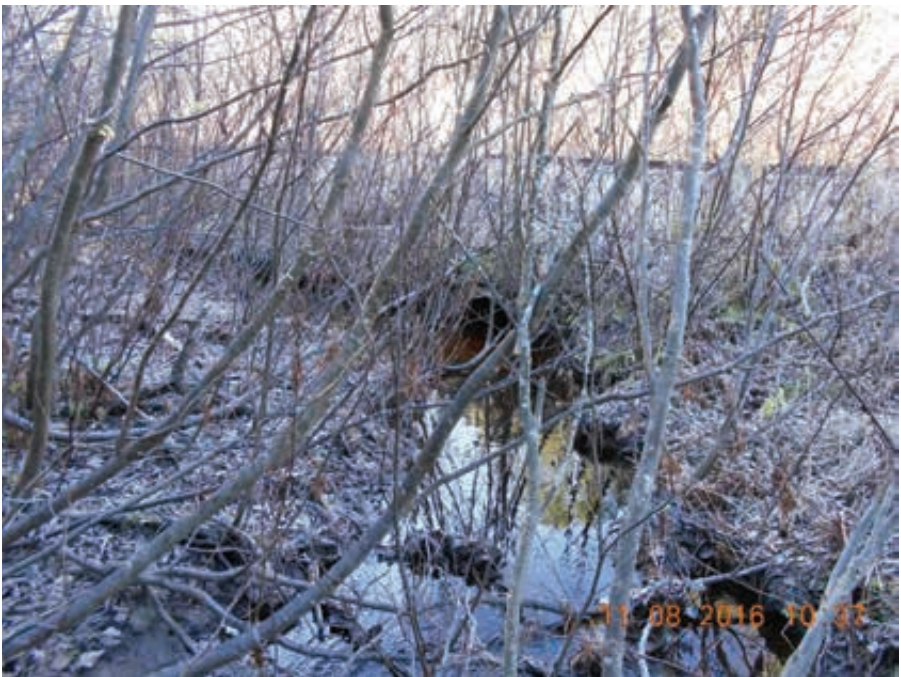
Date: November 7,8,9, 2016	
Photograph: 10	
Direction: Southwest	
Description: View of Brandy Brook and 24" culvert that connects to Wetland C.

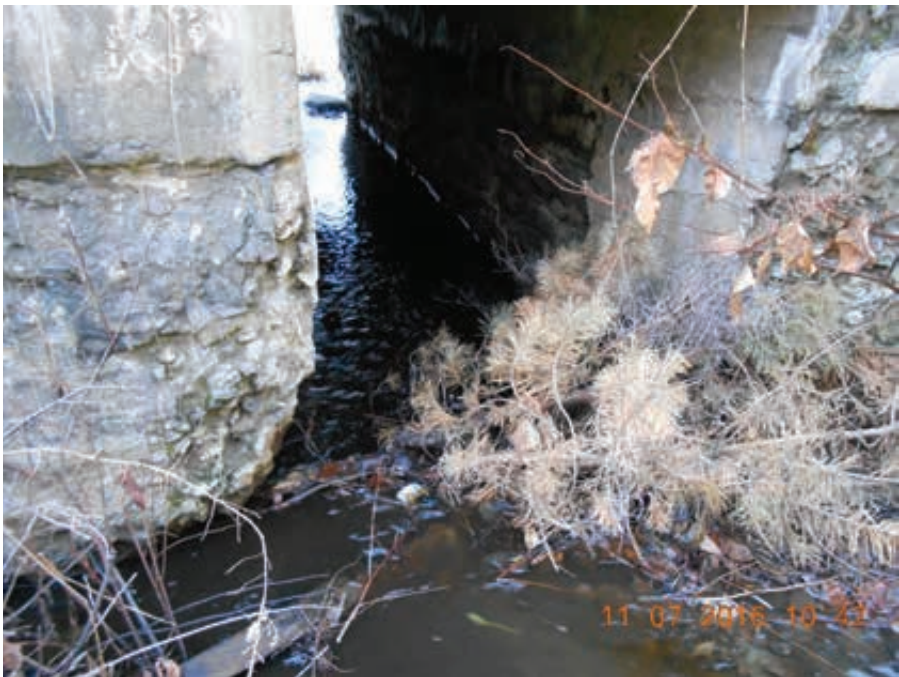
Date: November 7,8,9, 2016	
Photograph: 11	
Direction: West	
Description: View of Brandy Brook and box culver under railroad tracks.	
Photographer: Charles Lyman

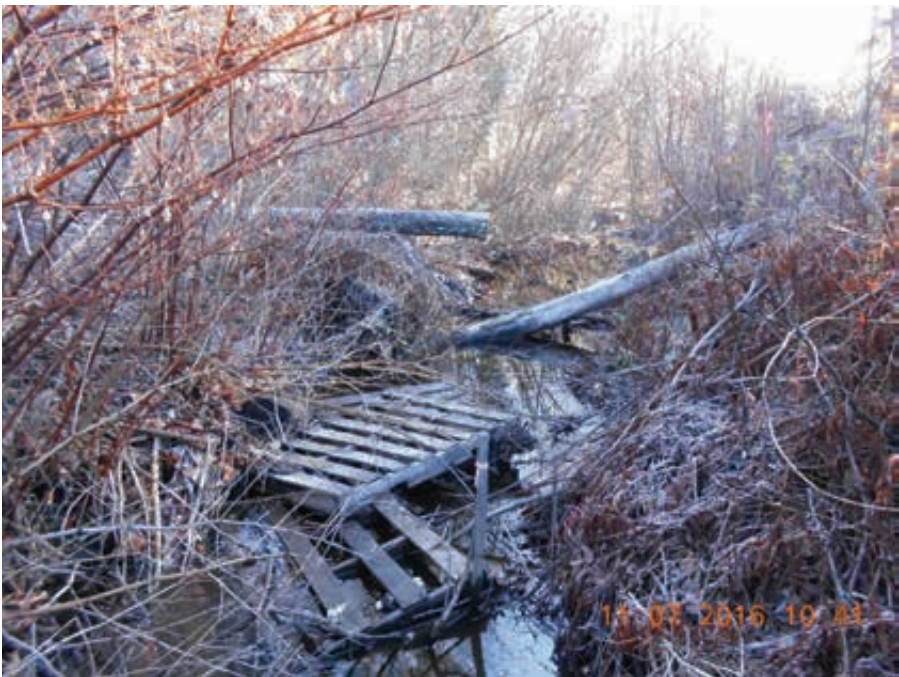
Date: November 7,8,9, 2016	
Photograph: 12	
Direction: Southeast	
Description: Brandy Brook looking upstream from box culvert under railroad tracks.

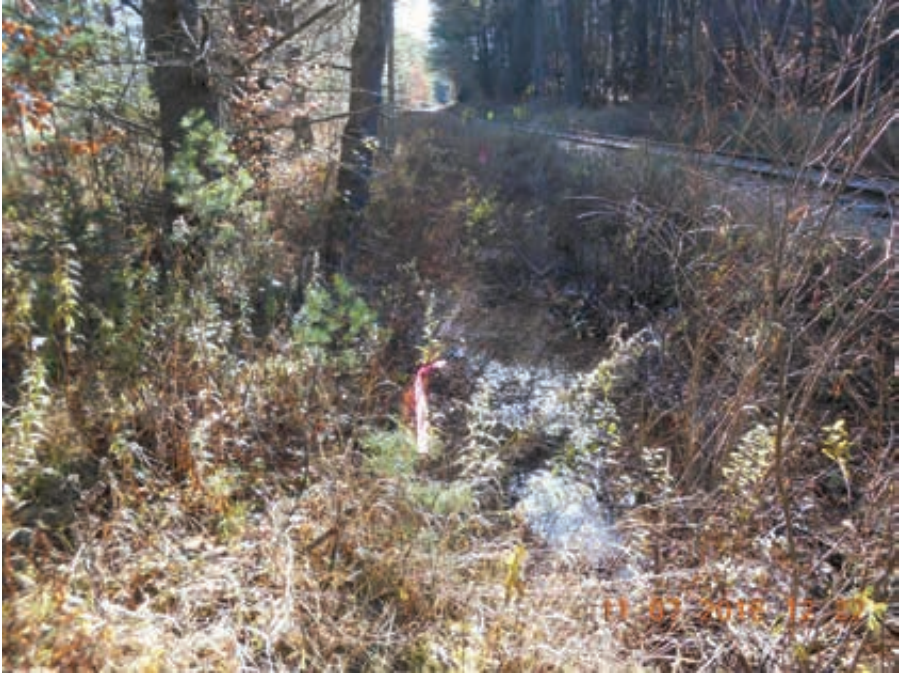
Date: November 7,8,9, 2016	
Photograph: 13	
Direction: South	
Description: Wetland B isolated wetland between active rail line and former spur to the site.	
Photographer: Charles Lyman

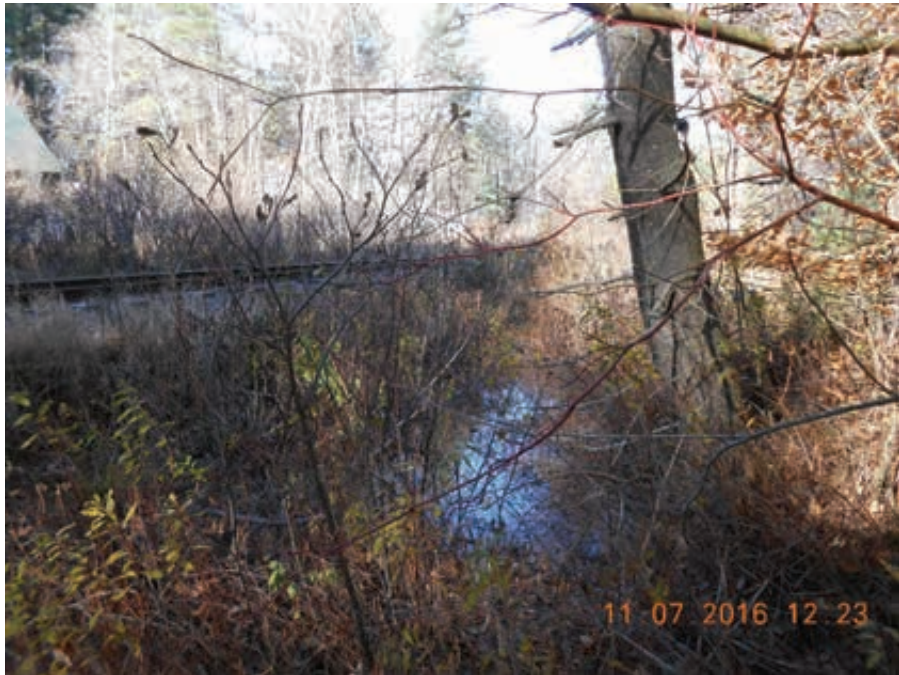
Date: November 7,8,9, 2016	
Photograph: 14	
Direction: North	
Description: Wetland B, note active rail line (left) and historic spur to sight (right).

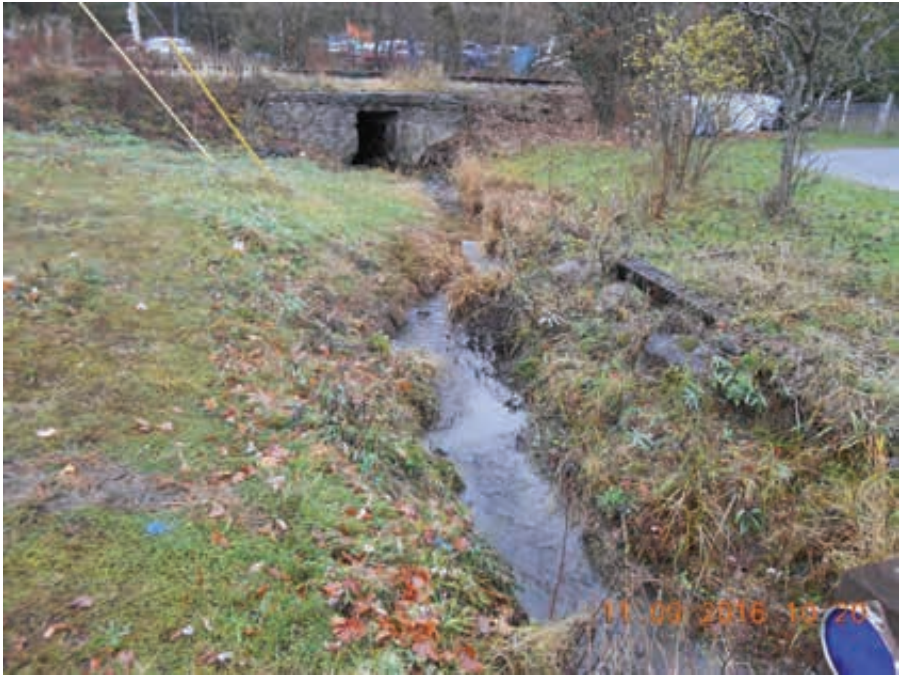
Date: November 7,8,9, 2016	
Photograph: 15	
Direction: East	
Description: Brandy Brook below box culvert under railroad tracks to first driveway crossing.	
Photographer: Charles Lyman

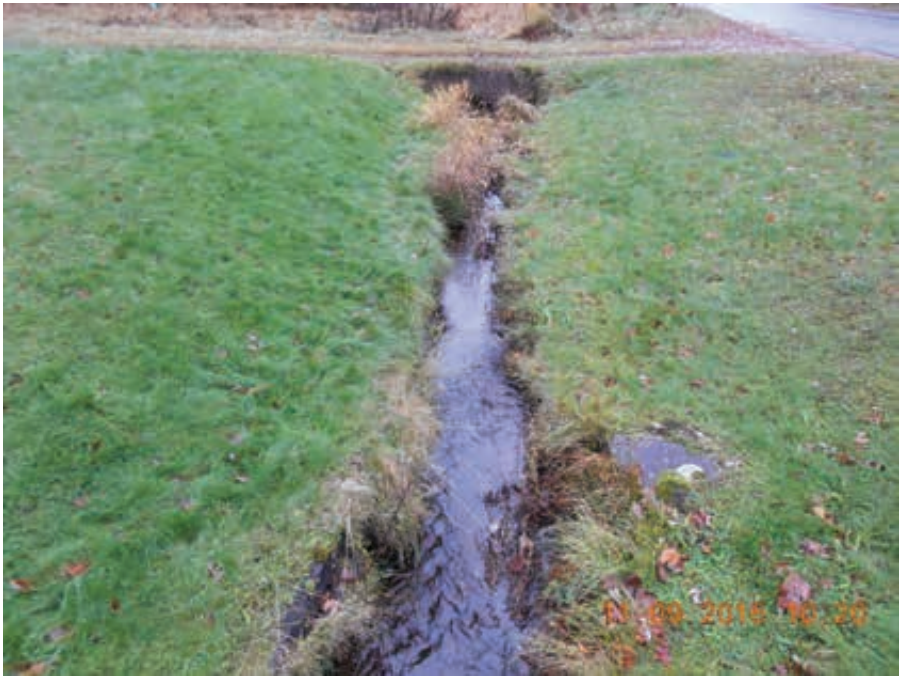
Date: November 7,8,9, 2016	
Photograph: 16	
Direction: West	
Description: Brandy Brook looking from driveway crossing; 30" corrugated metal pipe.

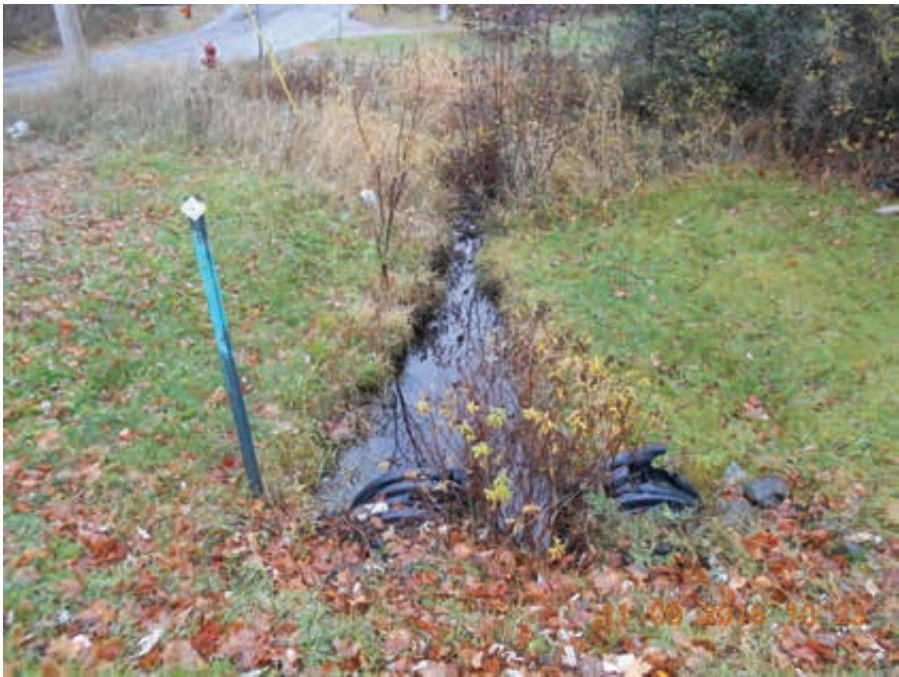
Date: November 7,8,9, 2016	
Photograph: 19	
Direction: East	
Description: Brandy Brook view from third driveway looking towards second driveway.	
Photographer: Charles Lyman

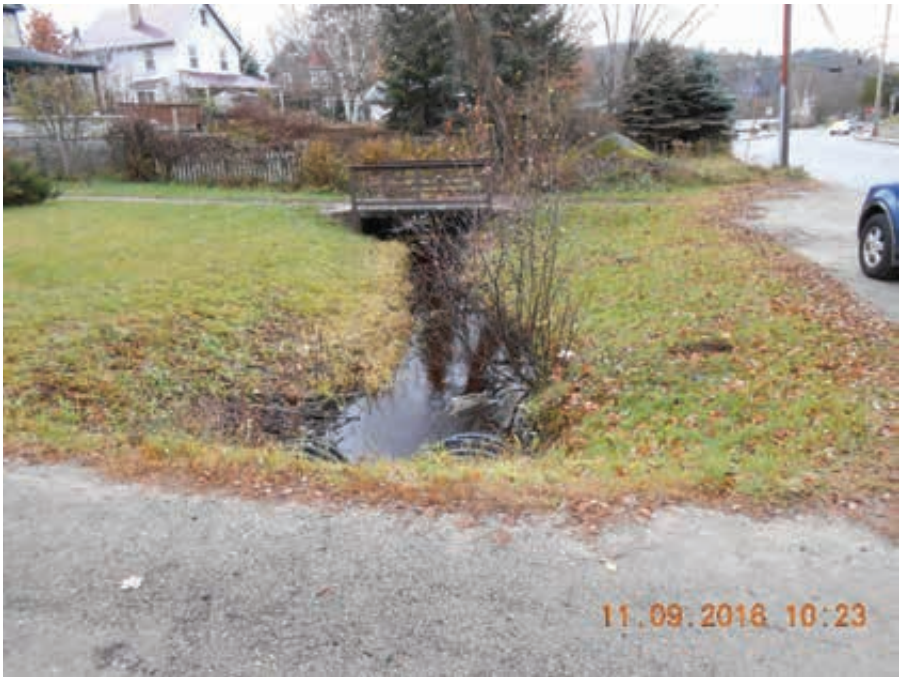
Date: November 7,8,9, 2016	
Photograph: 20	
Direction: West	
Description: Brandy Brook view from third driveway looking towards fourth driveway; (2) 24" corrugated plastic pipes.
