NYSDEC Site # 516008
Saranac Lake Gas Co., Inc.
Saranac Lake, New York

OU3 Wetland Delineation Plan
Project 3611161193
Figure 3.4

APPENDIX A
WETLAND DETERMINATION DATA FORMS

Wetland Photographic Log	
Client: NYSDEC	Project Number: 3611161193.02
Site Name: Saranac Lake Gas Company	Site Location: Saranac Lake, New York.
Photographer: Charles Lyman

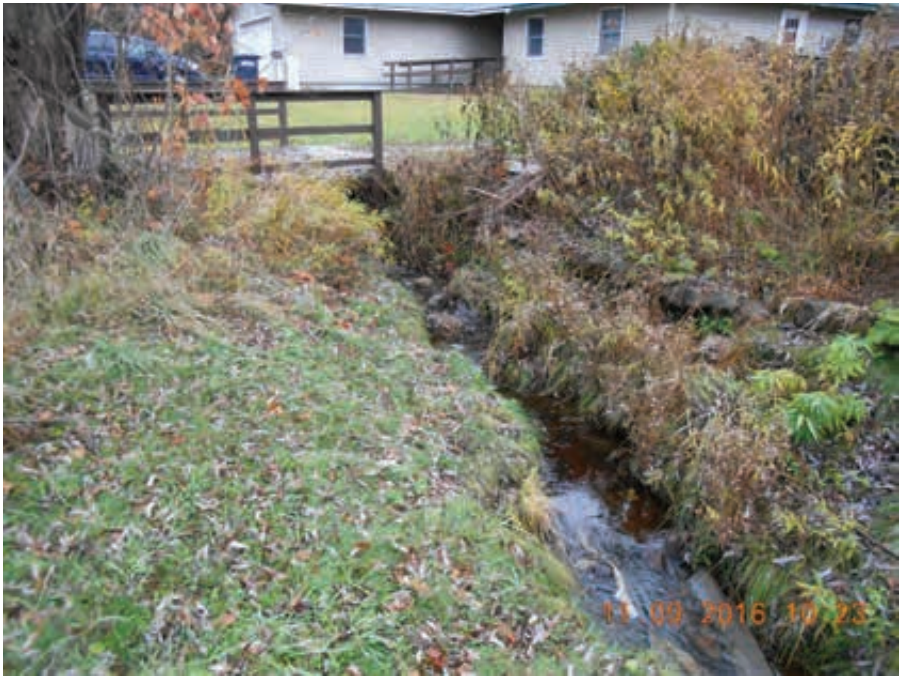
Date: November 7,8,9, 2016	
Photograph: 21	
Direction: East	
Description: Brandy Brook below fourth driveway crossing; note stone wall.	
Photographer: Charles Lyman

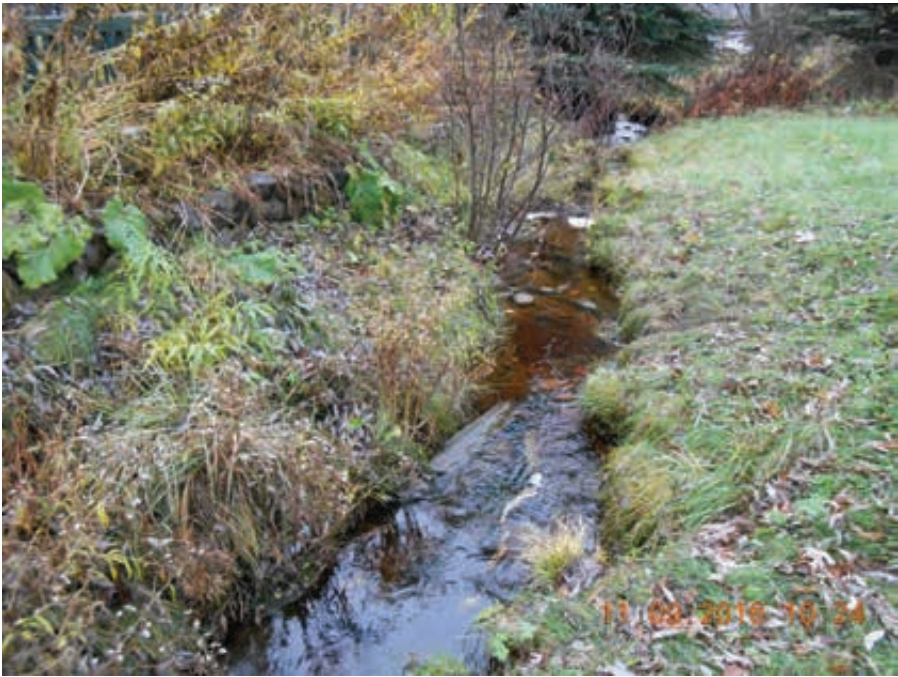
Date: November 7,8,9, 2016	
Photograph: 22	
Direction: West	
Description: Brandy Brook looking west below fourth driveway crossing.

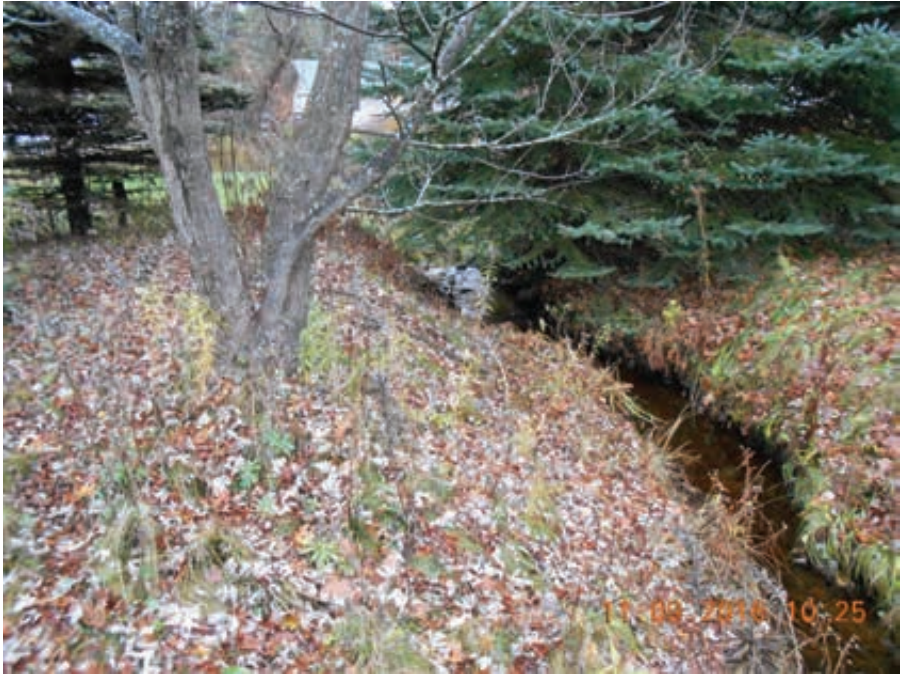
Date: November 7,8,9, 2016	
Photograph: 23	
Direction: East	
Description: Brandy Brook above headwall at Slater Ave.	
Photographer: Charles Lyman

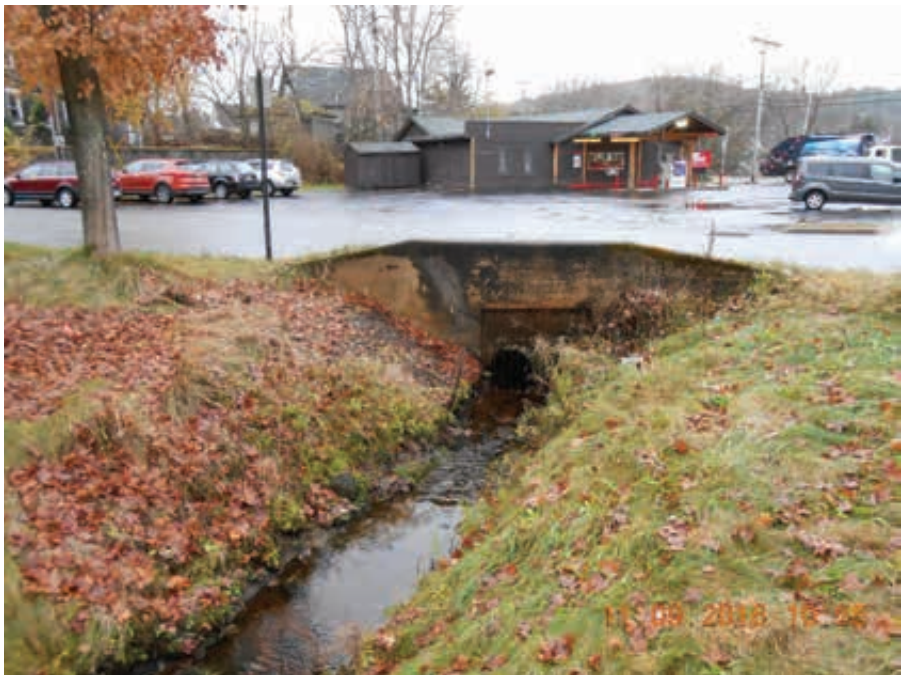
Date: November 7,8,9, 2016	
Photograph: 24	
Direction: West	
Description: Brandy Brook view of headwall and (2) 24" culverts that discharge to Pontiac Bay.

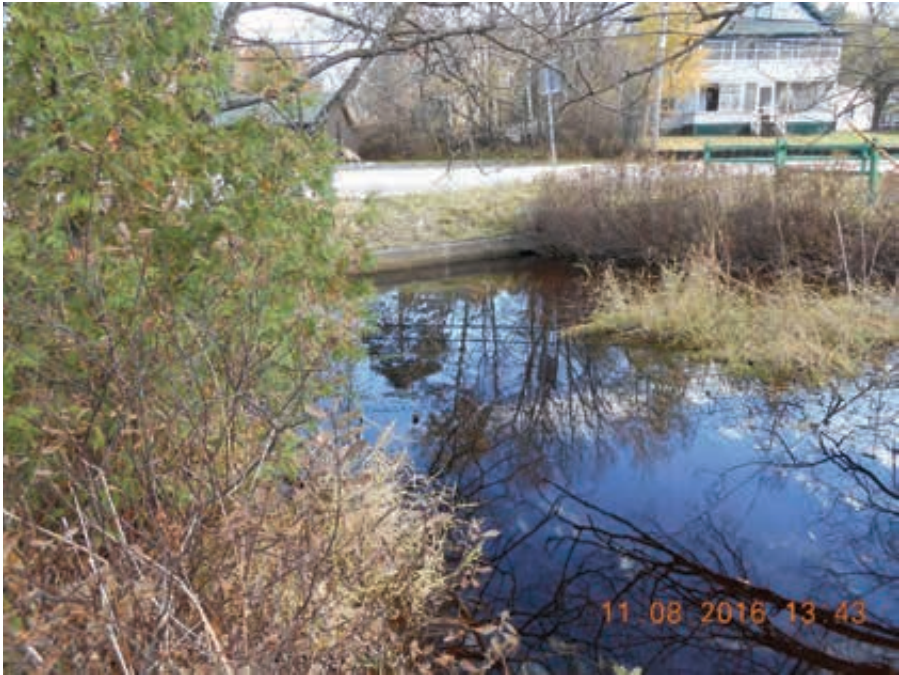
Date: November 7,8,9, 2016	
Photograph: 25	
Direction: Southeast	
Description: View looking at headwall where Brandy Brook culverts discharge to Pontiac Bay.	
Photographer: Charles Lyman

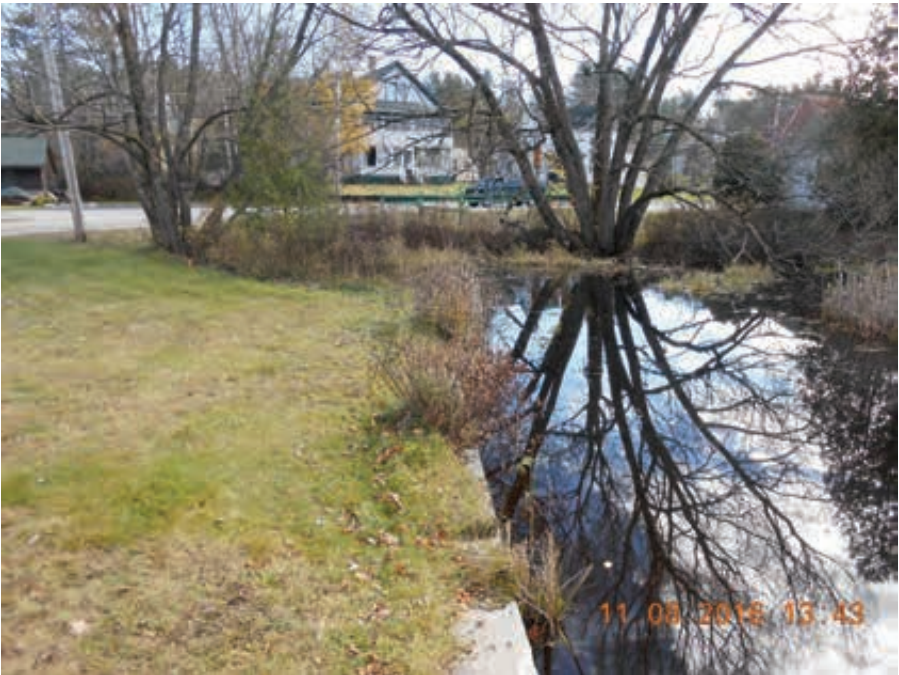
Date: November 7,8,9, 2016	
Photograph: 26	
Direction: North	
Description: View looking at second headwall at head of Pontiac Bay.

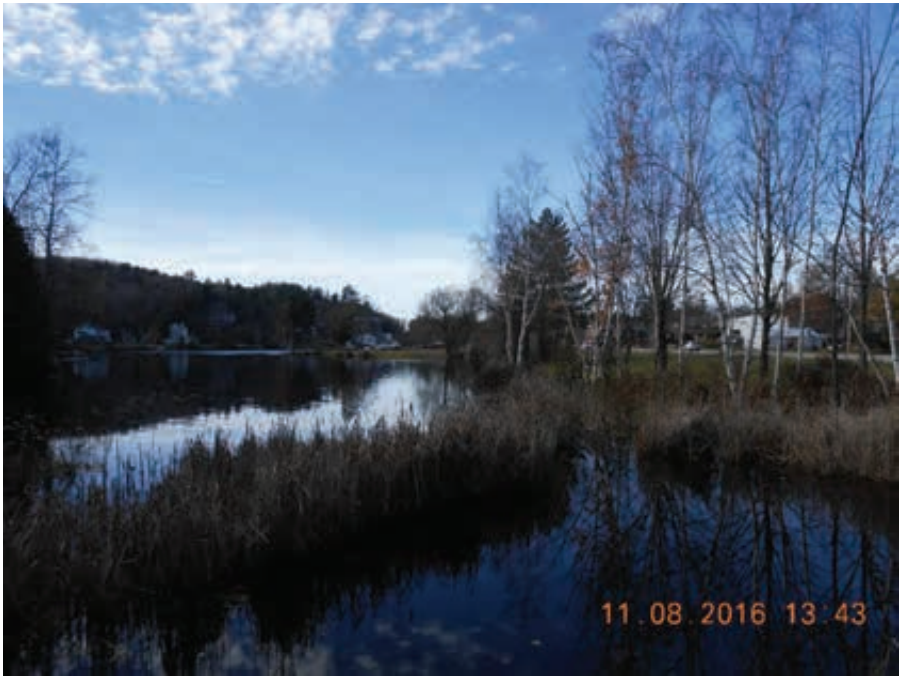
Date: November 7,8,9, 2016	
Photograph: 27	
Direction: west	
Description: View from head of Pontiac Bay, note park on right.	
Photographer: Charles Lyman

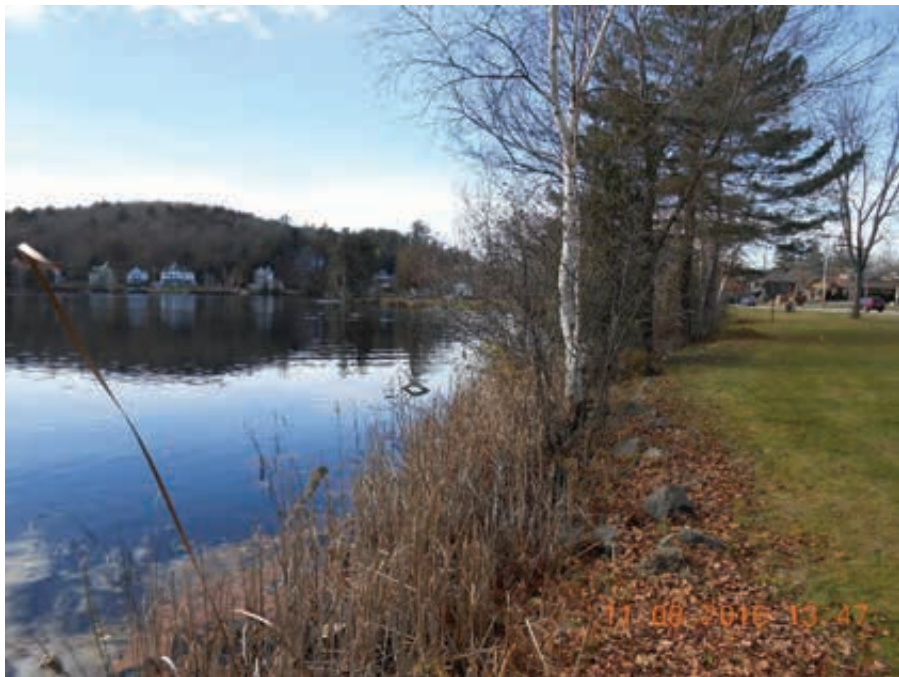
Date: November 7,8,9, 2016	
Photograph: 28	
Direction: West	
Description: View from top of bank along park, note overgrown rip rap bank.

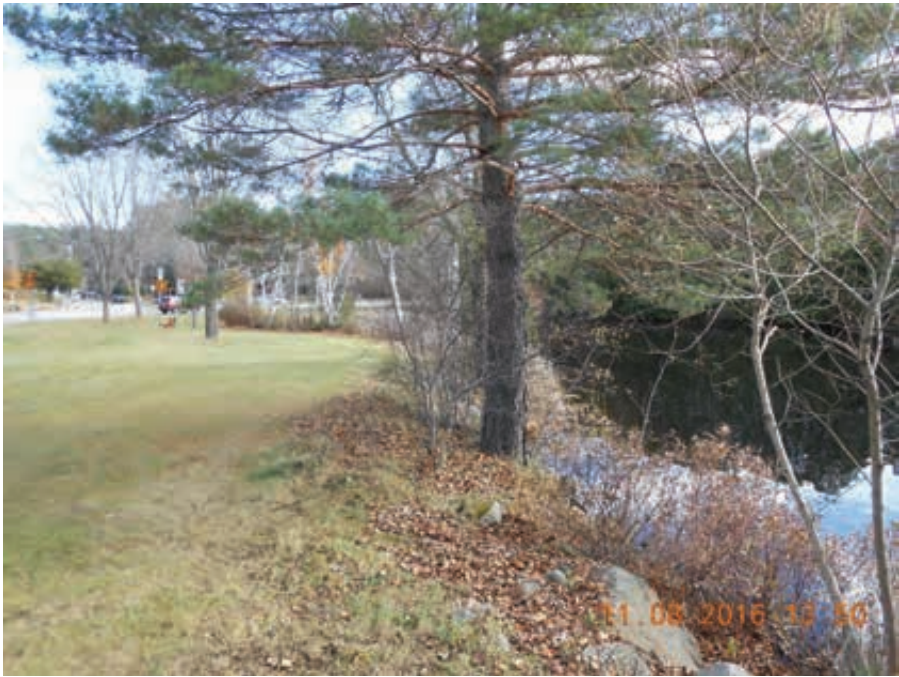
Date: November 7,8,9, 2016	
Photograph: 29	
Direction: East	
Description: View from top of bank, note overgrown rip rap/boulder bank	
Photographer: Charles Lyman

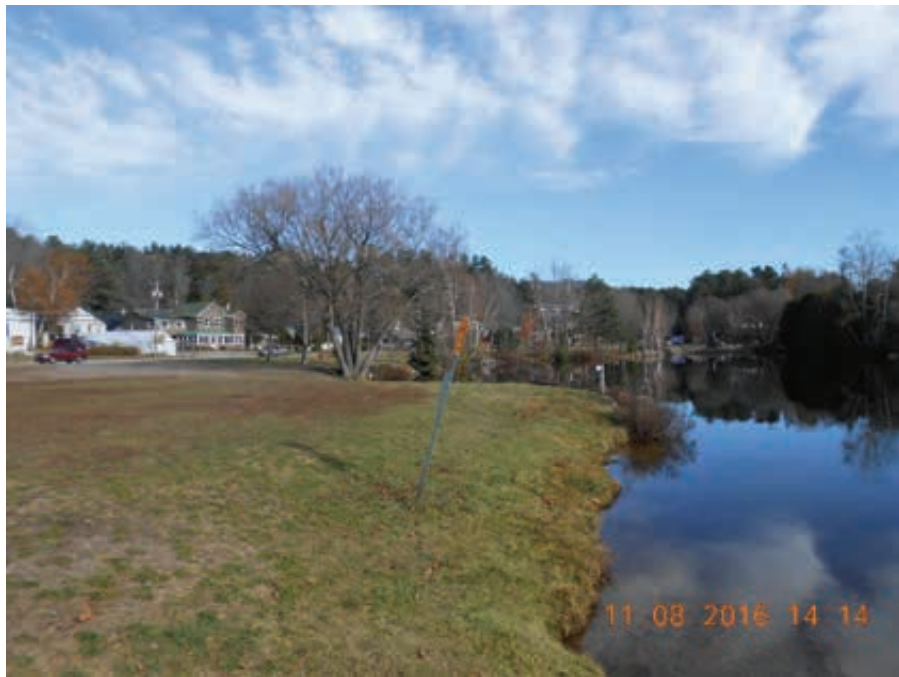
Date: November 7,8,9, 2016	
Photograph: 30	
Direction: East	
Description: View from top of bank looking back along Pontiac Bay.

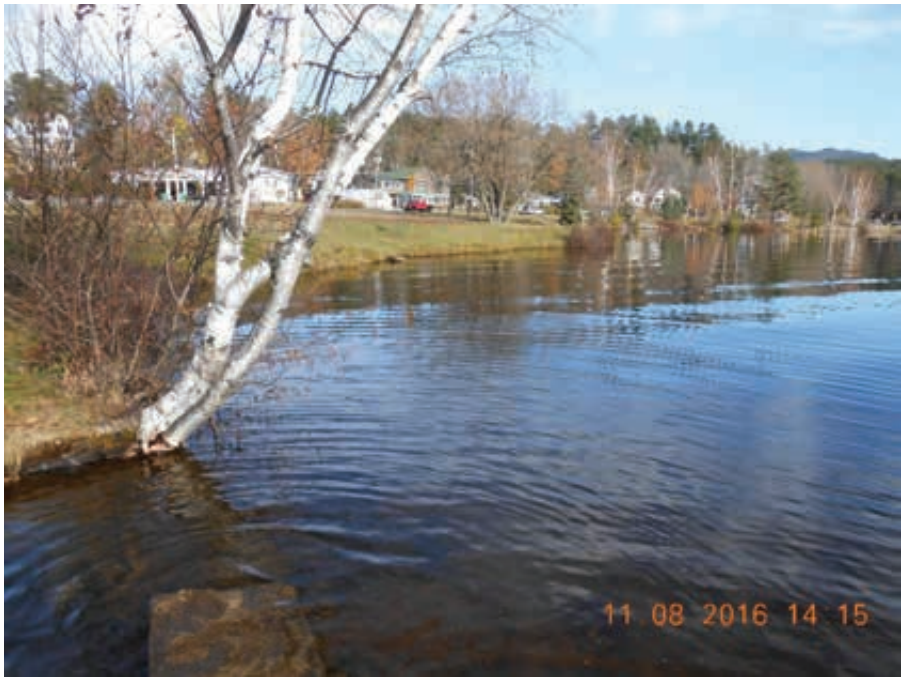
Date: November 7,8,9, 2016	
Photograph: 31	
Direction: East	
Description: View from boulder in Lake, showing bank along Pontiac Bay	
Photographer: Charles Lyman

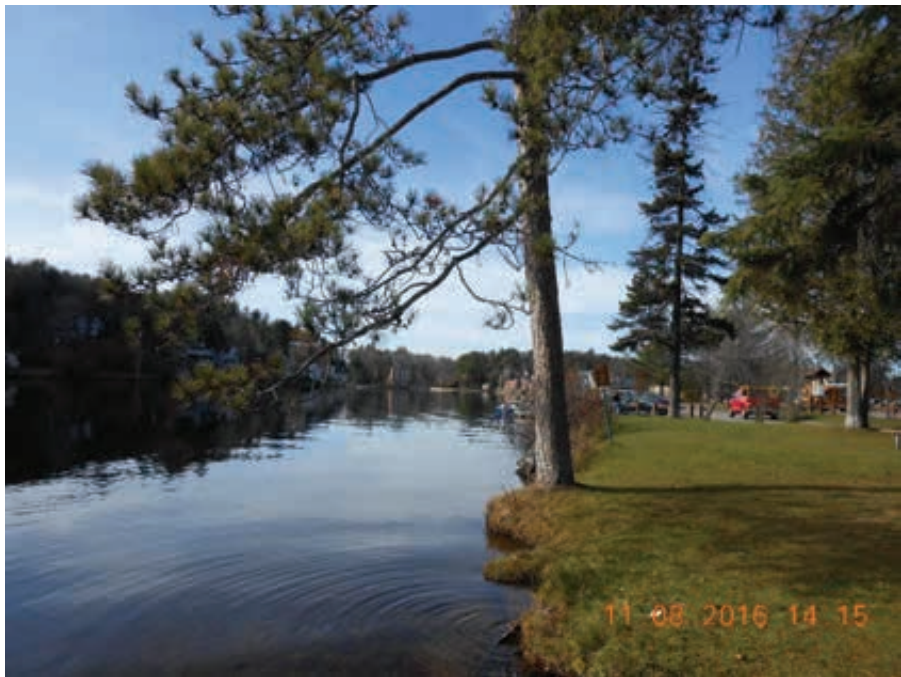
Date: November 7,8,9, 2016	
Photograph: 32	
Direction: North	
Description: View looking northwest towards Lake Flower dam, park and boat launch parking on the right.
