# FINAL ENGINEERING REPORT

## BROWNFIELD CLEANUP PROGRAM

Pierce Arrow Business Center

155-157 Chandler, Buffalo, New York 14207

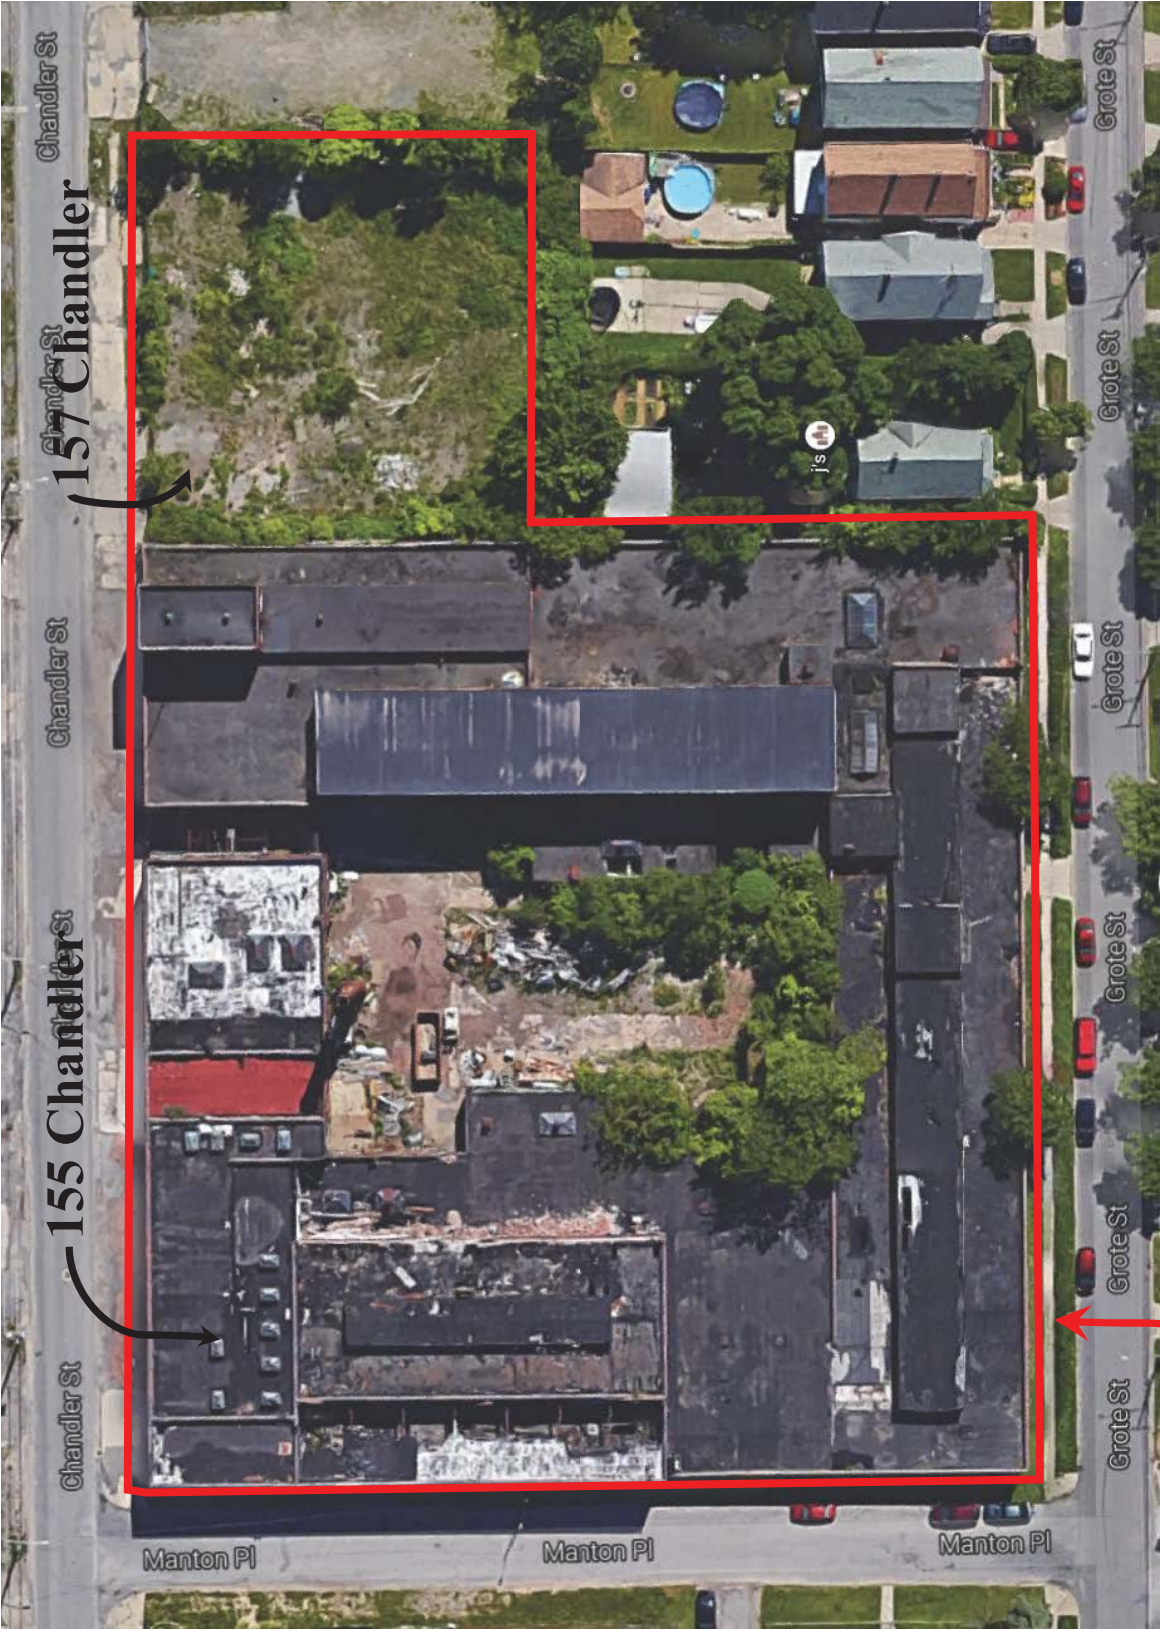
HAZARD EVALUATIONS, INC.			
Phase I/II Audits – Site Investigations – Facility Inspections			
SITE BOUNDARY LIMITS			
155 and 157 CHANDLER STREET			
BUFFALO, NEW YORK			
R & M LEASING LLC			
BUFFALO, NEW YORK			
DRAWN BY: LSH	SCALE: NOT TO SCALE	PROJECT: e1601	
CHECKED BY: EB	DATE: 11/17	FIGURE NO: 2

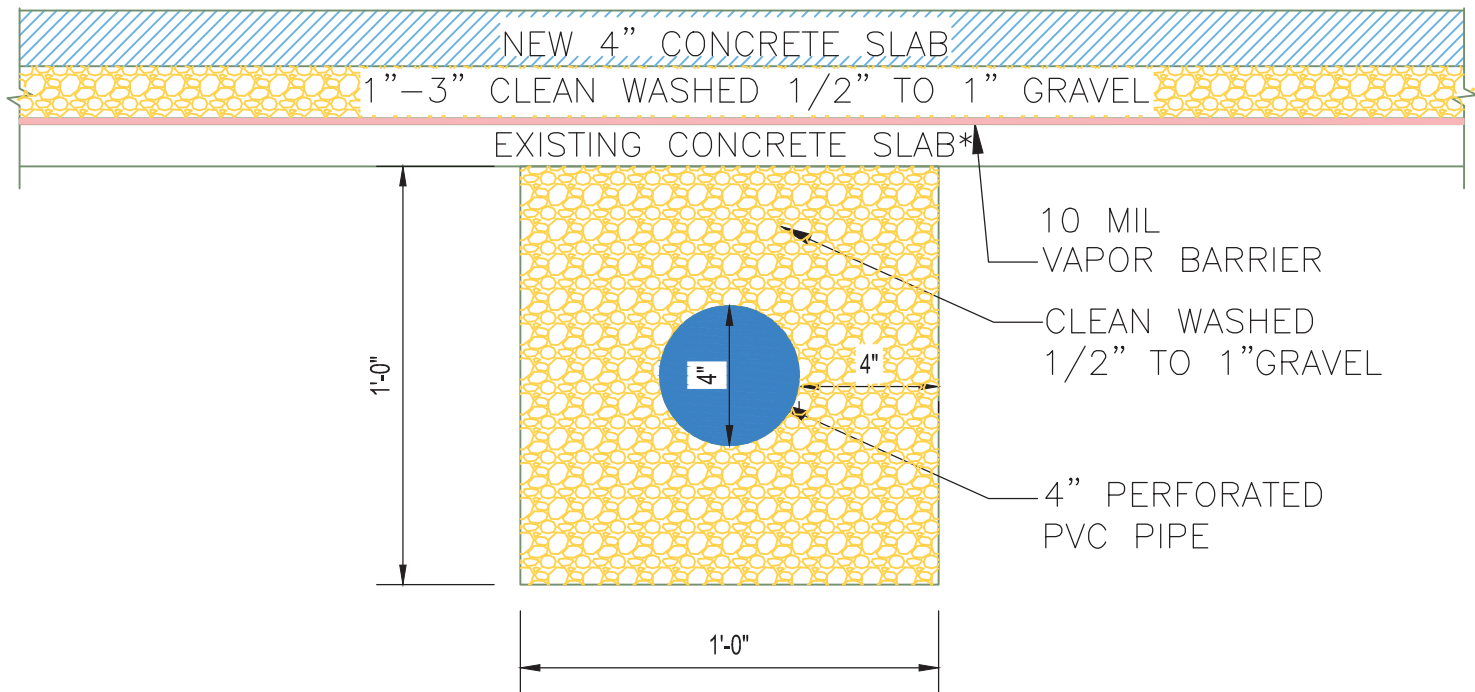
1  
SK-1

**TYPICAL CROSS-SECTION OF  
SSDS TRENCH AND PIPING**

\*NOTE: EXISTING  
CONCRETE SLAB MAY BE  
REMOVED IN SOME  
LOCATIONS AND REPLACED  
WITH 4" WASHED STONE

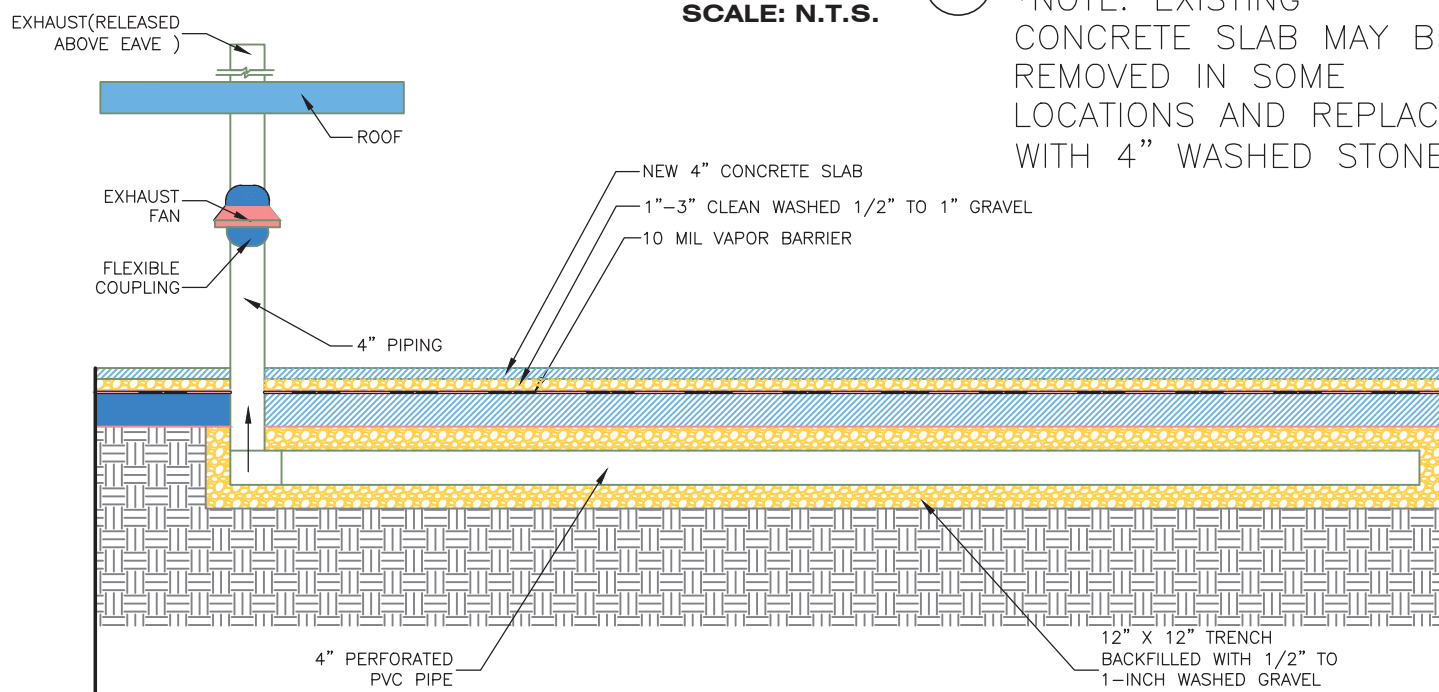
2  
SK-1

**TYPICAL SSDS TRENCH PROFILE**
