## National Fuel Gas Distribution Corporation

### Site Characterization Report

Former Buffalo Service Station – Off-Site

May 2013; Revised November 2013 and December 2015

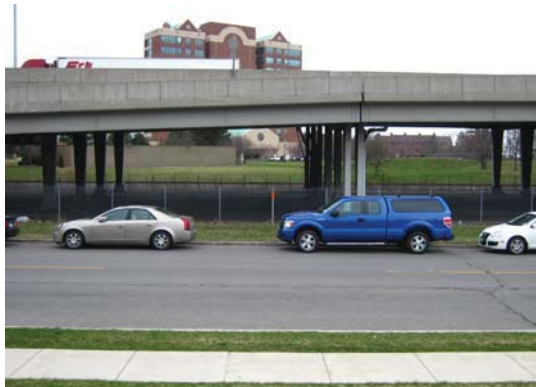
**Site, looking toward Lake Erie. Fourth Street in foreground and I-190 in background.**

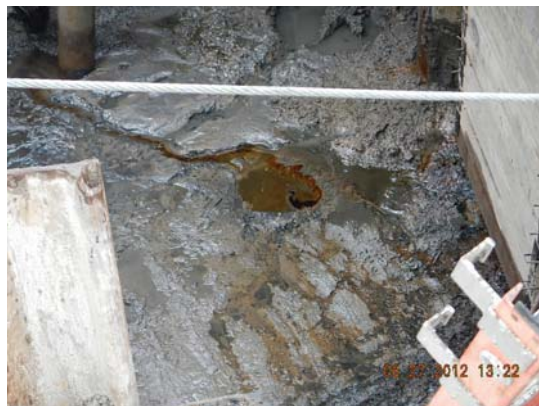
**Looking southeast. Coal tar entering excavation from beneath Fourth Street (on the right).**

At the base of the excavation (i.e. on top of the clay layer), at a gap in the sheet piling beneath the electrical conduit (where no sheet piling could be installed), a material resembling coal tar accompanied by a heavy sheen was observed entering the excavation from beneath Fourth Street. Some investigation by WSP revealed that there was no evidence of the coal tar-like material extending into the clay. With NYSDEC approval, WSP removed approximately 1-foot of clay across the bottom of the excavation area (total excavation depth of 19 to 21' bgs), then sampled the clay material to document that the remaining clay was not impacted. When the sample results showed that the clay layer was not impacted, WSP filled the excavation from the top of the clay layer up to approximately elevation 576' (approximately 6' bgs) with flowable fill material. The remainder of the excavation area was backfilled with clean overburden material that had been staged onsite.

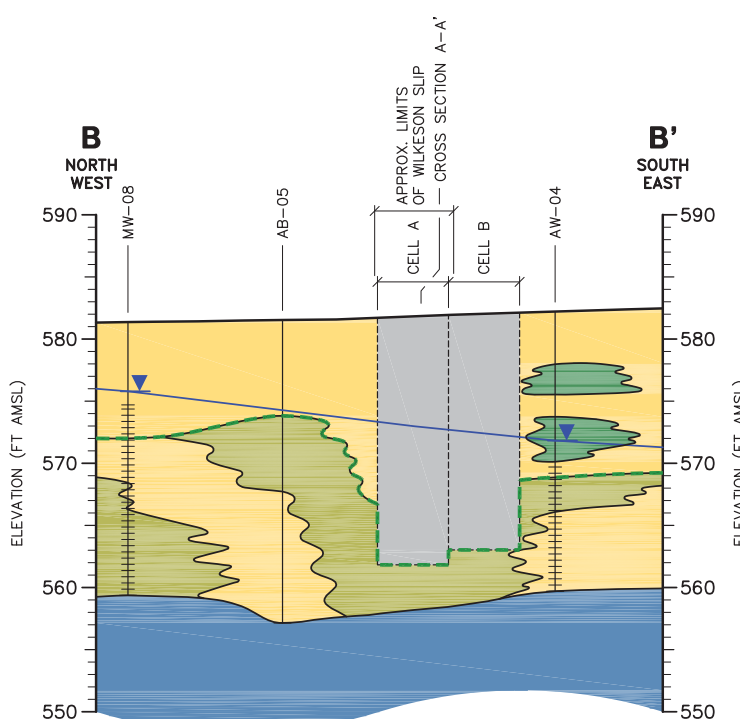
FIGURE 4

WELL OR BORING ID  
— GROUND SURFACE  
— GROUNDWATER ELEVATION (2/18/13)  
— LITHOLOGIC CONTACT (DASHED  
WHERE INFERRED)  
— FILL AND NATIVE SOIL CONTACT  
SCREEN  
BOTTOM OF BORING
