## **SECTION 6 FINDINGS**

### **6.2 ESTIMATED CONSTRUCTION AND OPERATION COSTS OF TYPICAL SWIMMING FACILITIES**

### **6.3 SWIMMING SITES FEASIBLE FOR DEVELOPMENT**

### 6.3.1 Category A: Potential Improvements to Existing Swimming Sites

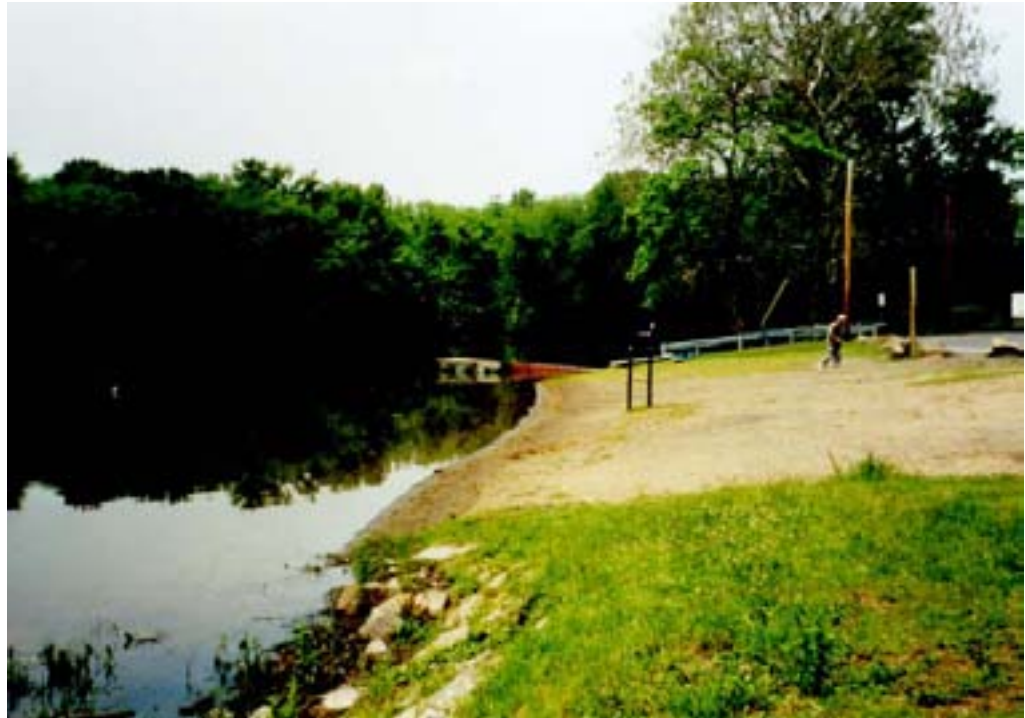
A small impoundment is created by a dam on the Esopus Creek, which keeps the water level constant, though Creek currents maintain good water circulation. Sand, augmented by occasional replenishment provides a good beach surface. Slopes are moderate, marked as 9 feet to 12 feet depths, though no diving is permitted from floats anchored approximately 125 feet off shore. There is one lifeguard station at this “one-bay” beach. No entrance control is provided at this small Park. Those learning to use small, non-motorized boats also use the park in the off-season and to access the Creek by canoe and kayak.

Village representatives indicate that there is an occasional weed control problem, though this condition was not observed at the time of this study. What was apparent, however, is that the Park's bathhouse will require rehabilitation in the near future, to keep the facility operating. Additionally, the bathhouse and some of the other facilities could use cosmetic improvements and nearby landscaping to increase the overall attractiveness of the Park, which is located at the South entrance to downtown. Additionally, the impromptu parking off Route 9W could be redesigned so that the use of these few spaces will not contribute to traffic problems along this busy route. Angle parking that can only be entered in a southbound direction may be a solution for this road front section of the Park.

**Beach Conditions:** The Village of Saugerties has a small and popular park and beach on a tributary to the Hudson, the Esopus Creek, only a few hundred feet West of the tidal river. The beach, located two blocks from the Village center, is a logical destination, especially for youth, who can walk or bicycle to the facility from home. It is a guarded beach, with a small, old bathhouse and a designated sand beach, with a roped swimming enclosure with floating docks. Access is from Route 9W and from local streets. While parking at the site can only accommodate approximately 30 cars, local street parking can provide for overflow. Family groups use the park on weekends and senior citizens frequent the Park, to enjoy the outdoors and to watch children at play. The facility is ideally located to provide an important community service.

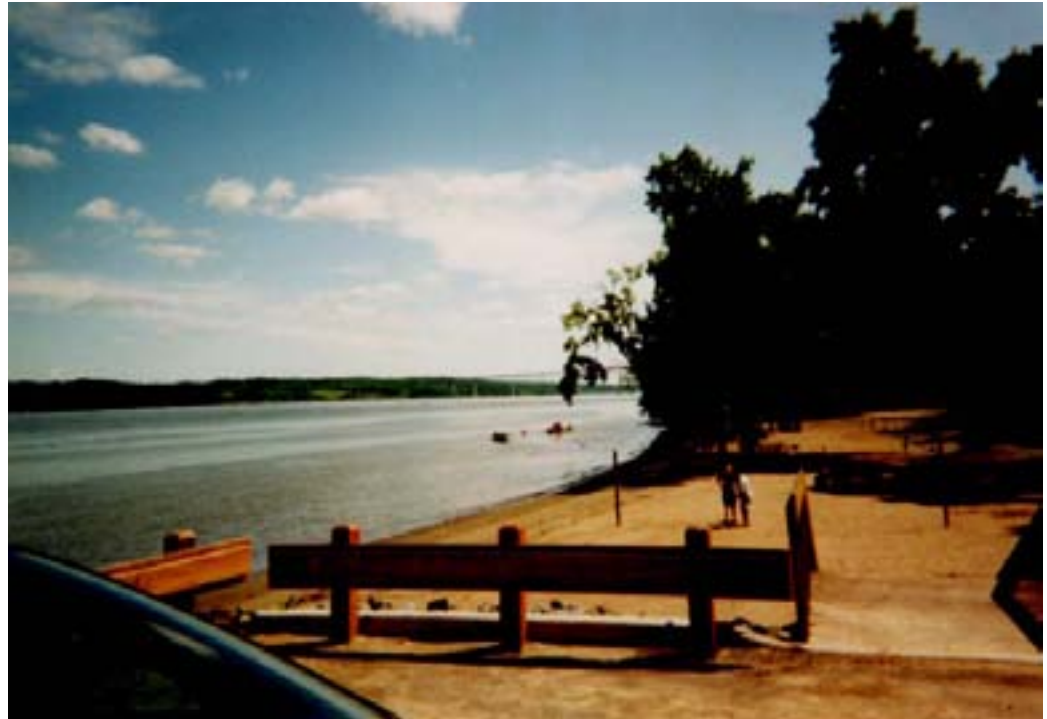
A row of very popular parking places along the shoreline road offers direct access to the picnic sites. These parking activities may have caused root compaction stressing the row of shoreline trees that provide shade for the picnic sites. This combined with erosion from the waves hitting the River shoreline may have contributed to shoreline retreat, beach loss and the loss of shade trees. Another potential problem exacerbating beach erosion may be a vertical wall constructed near shore to help retain the paved area and support facilities in front of the bathhouse. Engineering proposals have been solicited by the County to protect the

shoreline and row of shade trees. The consultants working with this study suggested further consideration of the recommendations received to date, to assure that the best measures are found to protect this important beach and shoreline. Staff from several agencies contacted during these initial efforts indicated an interest in providing help in solving this erosion problem.

The shoreline configuration, and near shore contours may offer more clues regarding the erosion problem and it's potential solutions. Significant shoals composed of fine-grained sand are located a few hundred feet to the north and to the south of the eroding beach and shoreline. This material may provide another clue regarding the erosion at the beach and may provide sand for replenishment if such action is indicated as needed, feasible and environmentally compatible.

**Beach Conditions:** The beach is located on clean sands from dredged material placement on this shore several decades ago. The Ship Channel, the Barrytown Navigation Reach, is located only approximately 500 feet off shore, so wakes have important effects on the beach. The lifeguards take special notice of ships and barges that can create unusual wave action, and may even ask small children to come nearer to shore on the infrequent occasion when this creates a temporary risk. Large, long period, waves caused by larger ships erode sections of the shore and can move debris on to the beach, which must be periodically cleaned. In contrast, the wave washed beach looks clean and inviting, free of silts and mud.

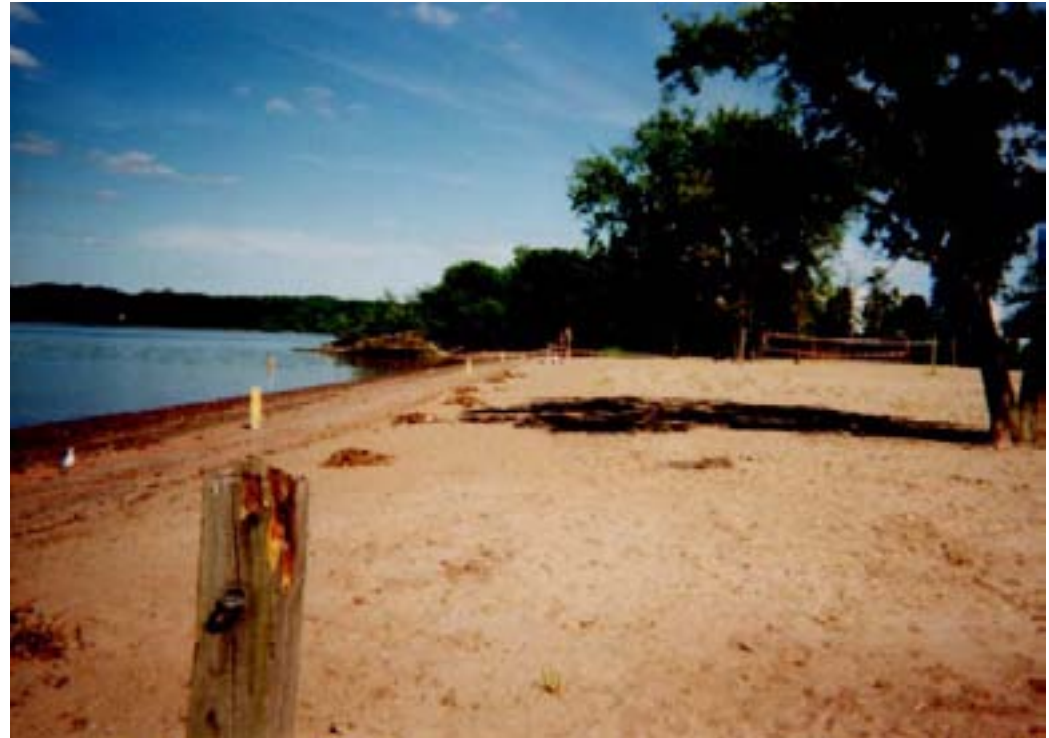
While Kingston Point Park features the beach as the centerpiece of Hudson Riverfront rejuvenation, the parking, bathhouse and its concession area, next to the beach indicate the need for update. The layout of the parking lot could be improved. The small building used as a contact station and parking lot entrance,

located at the western end of the parking lot, also needs improvement. The bathhouse interior shows signs of aging and heavy use. Improved services for the handicapped may also be advisable. These features may be updated at modest cost, but their improvements can change the marketable appearance of this major regional tourist destination.

A wide upland sand beach provides excellent areas for sunning and other beach activities, including the launching of sailboards in the off seasons. Two bays are provided for swimming, marked by lemon-lines, each protected by a lifeguard station. A short, heavy timber wall separates the end of the beach from a substantial, paved parking area west of the wall. A contact station, staffed in season, marks the end of Delaware Avenue, which also serves as the entrance road to the Park, and the abrupt beginning of the paved rectangular parking field serving the Park.

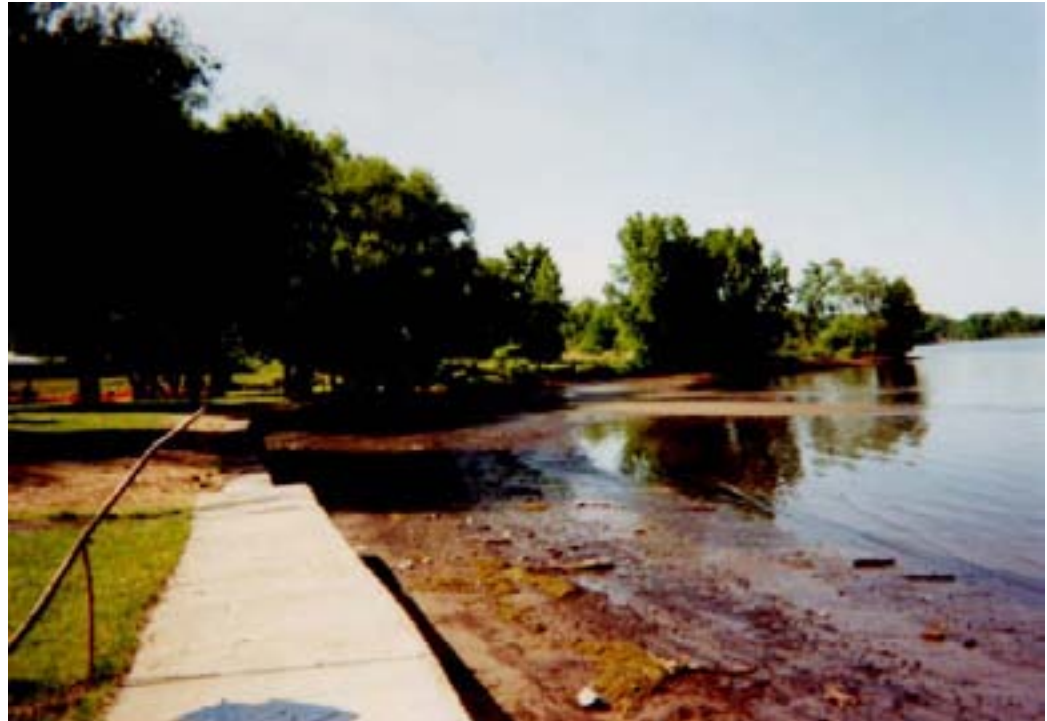
Though a guarded swimming facility was open at this beach, water chestnut invaded the shallow bay, making operations difficult. Harvesting of the aquatic weed has been attempted, and is still being run by volunteers in an attempt to bring the bay back to its earlier condition. It is unclear if these harvesting operations will prove successful. The shallow, protected bay, nutrient rich sediments and the aggressive nature of water chestnut may be too difficult to surmount. Without control of the aquatic plant problems, it is unlikely that the swimming area can be opened again.

**Other Potential Site Uses:** A peninsula and protective works for a marina form the southern boundary of this beach. A small park was developed at this beach by the municipality, including a combination bathhouse comfort station, a concession building, fields and courts used for sports and games and a group picnic shelter. Shade trees, landscaping and the parking provided are simple, but suitable for the scale of operations at the Park.

**Beach Conditions:** The hamlet of Port Ewen, located south of Roudout Creek, has much of its Hudson River shoreline on a bay formed by the protective peninsula built at the mouth of the Creek and harbor. The bay is very shallow, with mud flats underlying only one foot of water one half mile from shore. Stable, fine-grained sand, black in color, forms a beach, with somewhat deeper offshore water near the end of Parsell Street.

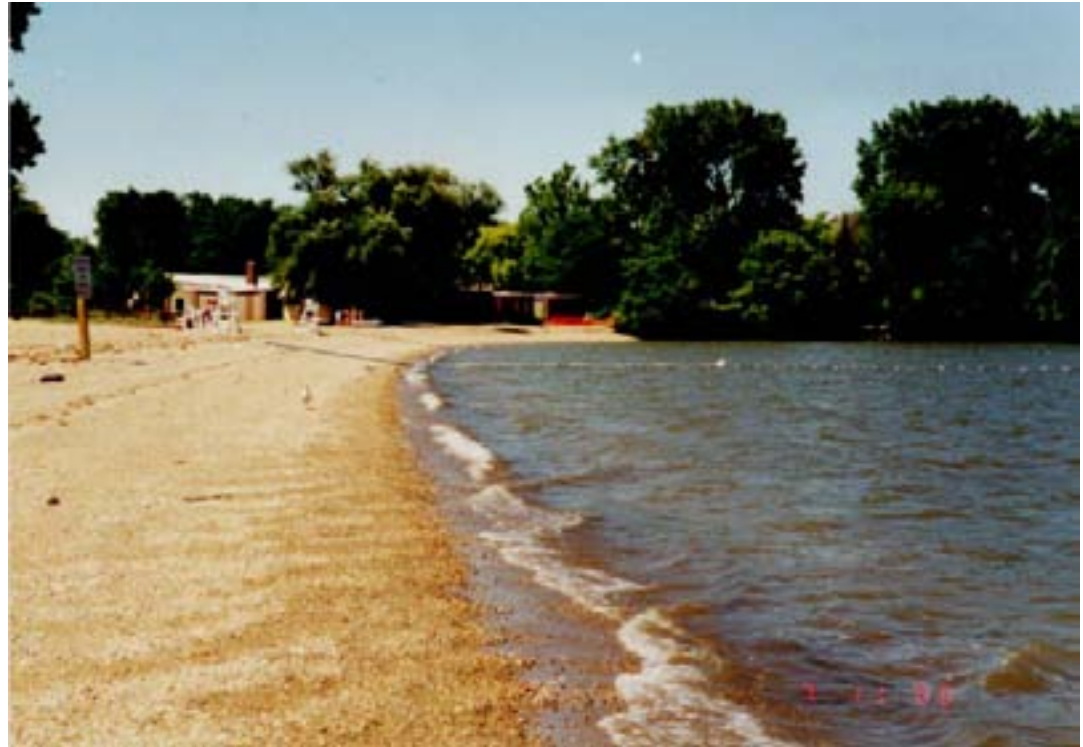
Park operations at Croton Point included a public beach during the mid-20<sup>th</sup> Century. A very large bathhouse complex and an architecturally interesting concession building served the patrons in this section of the Park. The bathhouse is still in use, supporting existing beach operations, but sections of the bathhouse building and the entire concession structure have been virtually abandoned. The open sections show significant deterioration and possibly vandalism. The entire Park operates out of a construction trailer.

It is apparent that the supporting buildings for this important park and beach must be fully evaluated. Modern practices, brought about by the use of quick-drying swimming suits have made some of these large bathhouse operations obsolete at other beaches. It is uncertain if this cinderblock building is worth rehabilitation with a number of uses being added to its bathhouse function, or if a smaller modern structure would be a better solution for the beach and Park. Other buildings and infrastructure in this area of the Park may also have to be evaluated for future uses.

**Beach Conditions:** The beach faces north, and receives ebb-tidal littoral drift, forming a fine half mile long natural beach that extends well upland as well as underwater. The slopes of the beach are excellent. Water quality and currents at the beach location have not posed any problem during the past decade. Lemon-lines and a second set of warning lines designate two guarded beach sections and buoys have been established to keep small boats out of the swimming area. Non-powered boats are allowed to use sections of the beach outside of the swimming area and in the off-season. Water currents bring in floating debris that is periodically raked and removed. The availability of trained lifeguards and operating budgets has been a problem at this popular beach and at similar parks.
