Department of
Environmental
Conservation

LAKE GEORGE BEACH

Pollution Source Investigation

April 2017

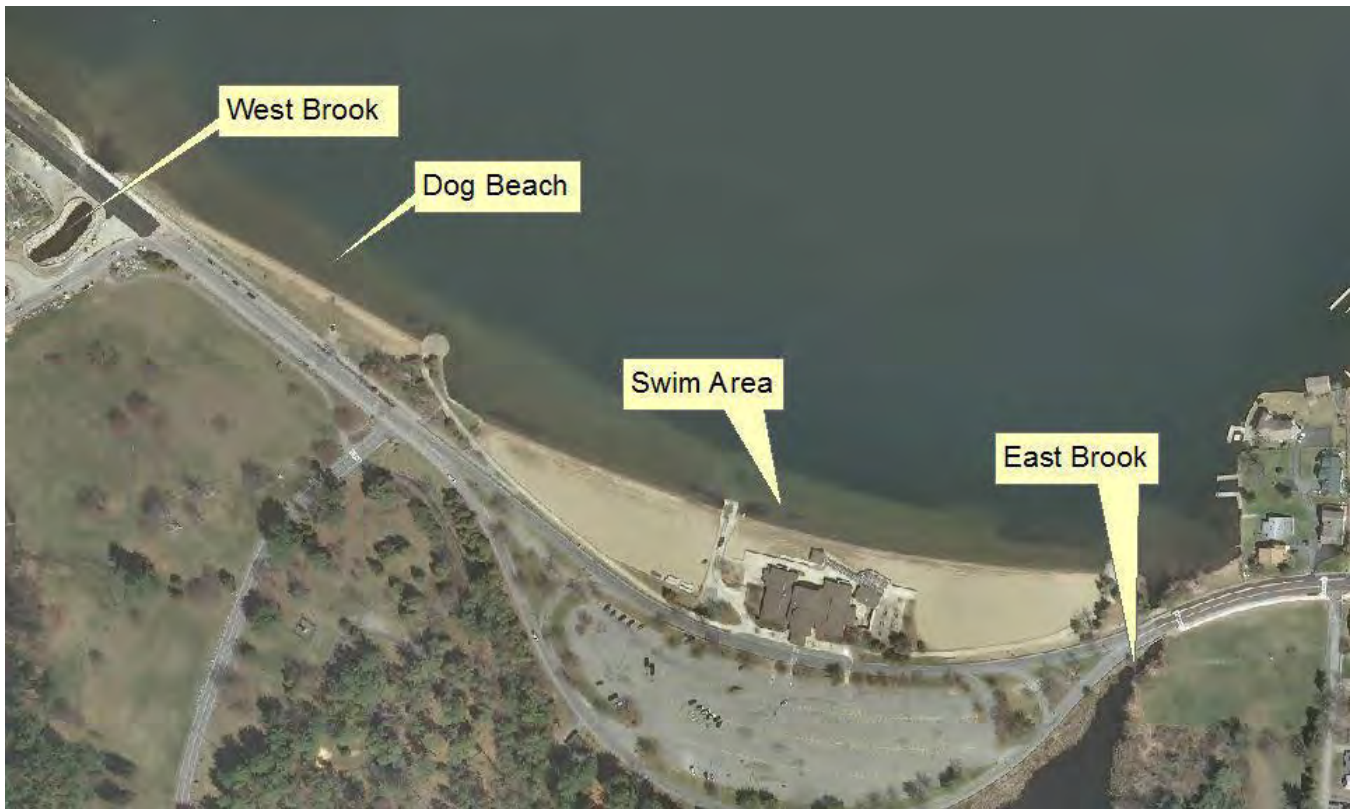
Figure 1. Map of Lake George Beach and surrounding area

Two tributaries, East Brook and West Brook, enter the lake in close proximity to the beach. East Brook flows into the lake approximately 150 yards from the eastern edge of the swim area, while West Brook enters the lake approximately 300 yards from the western edge of the swim area (Figure 1). A portion of the Lake George shoreline located west of the swim area is operated as a “dog beach,” where dogs are allowed access to the water and sand. Swimming is not permitted at any time at the dog beach.

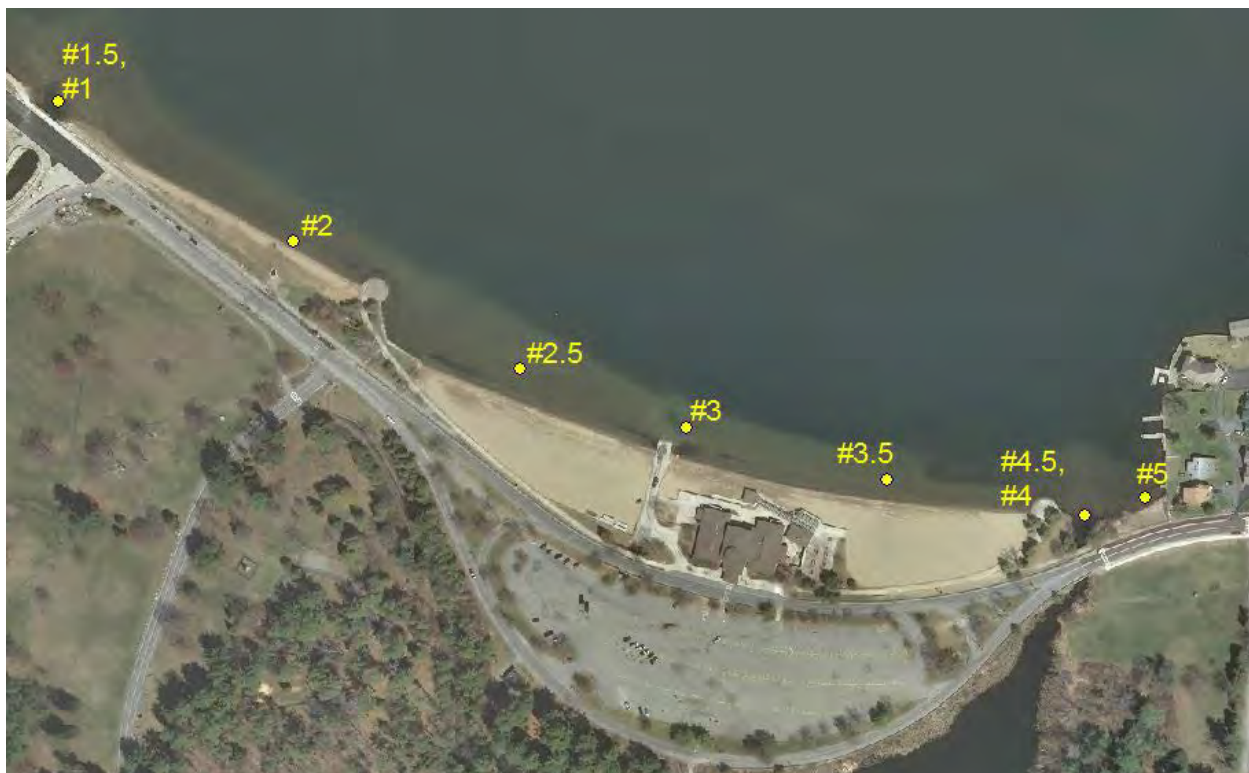
Figure A1. Map of shoreline sampling locations

Site ID	Site Description	Sampling Depth
#1	Confluence of West Brook and Lake George	Shallow water
#1.5	Confluence of West Brook and Lake George	At Depth (3 feet)
#2	Dog Park Beach	Shallow water
#2.5	Left of Swim Area (facing Lake George)	Shallow water
#3	Middle Swim Area	Shallow water
#3.5	Right of Swim Area (facing Lake George)	Shallow water
#4	Confluence of East Brook and Lake George	Shallow water
#4.5	Confluence of East Brook and Lake George	At Depth (3 feet)
#5	100 feet East of Confluence of East Brook	Shallow water

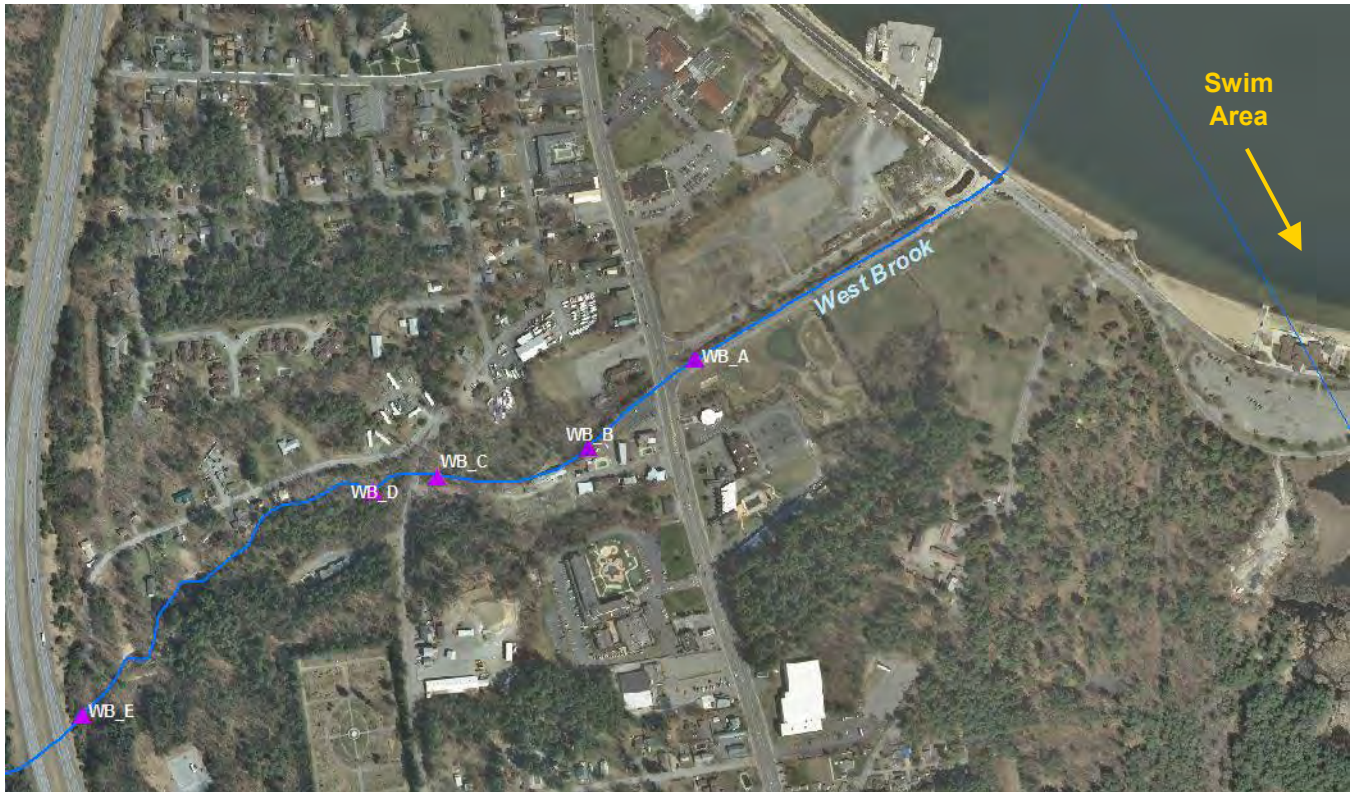
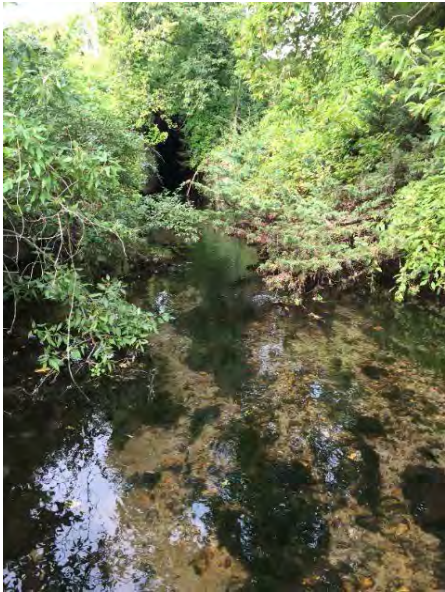
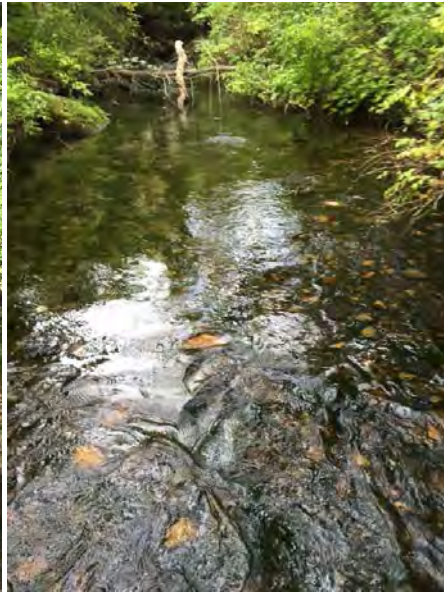
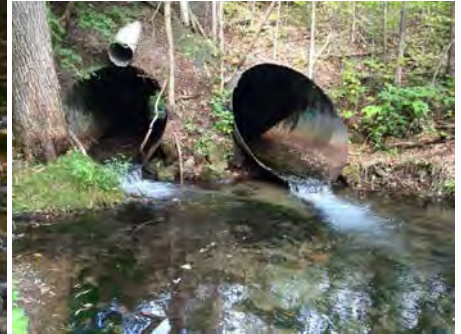
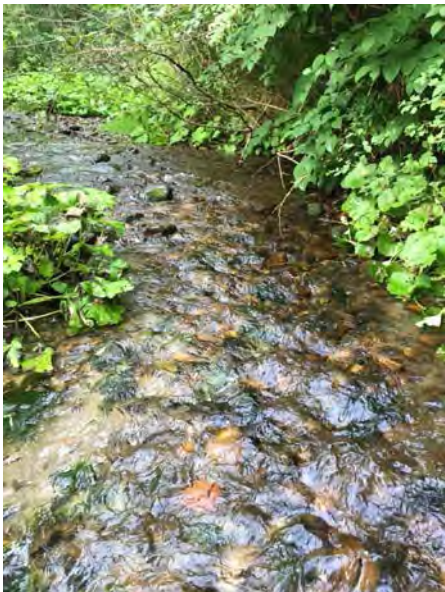
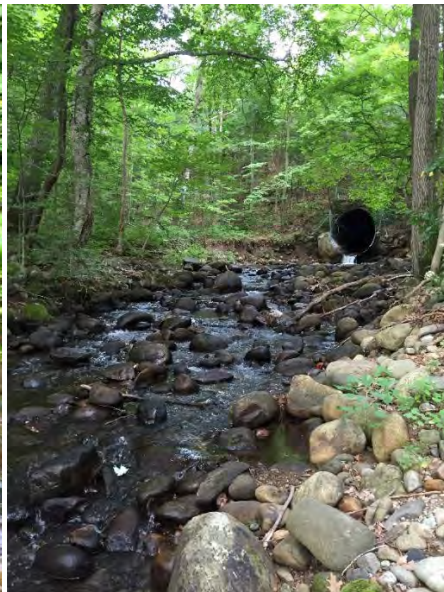
Figure A2. West Brook sampling site locations

West Brook. Samples were collected from five sample sites (Figure A2, Figure A3). Water quality parameters, visual observations, and *E.coli* results are listed in Table A4. All samples showed levels of *E.coli* well below the single sample standard. Water clarity was excellent at all sites and no physical indicators (odor, color, wildlife) of bacterial sources were observed.

Figure A3. Photographs of West Brook sample sites

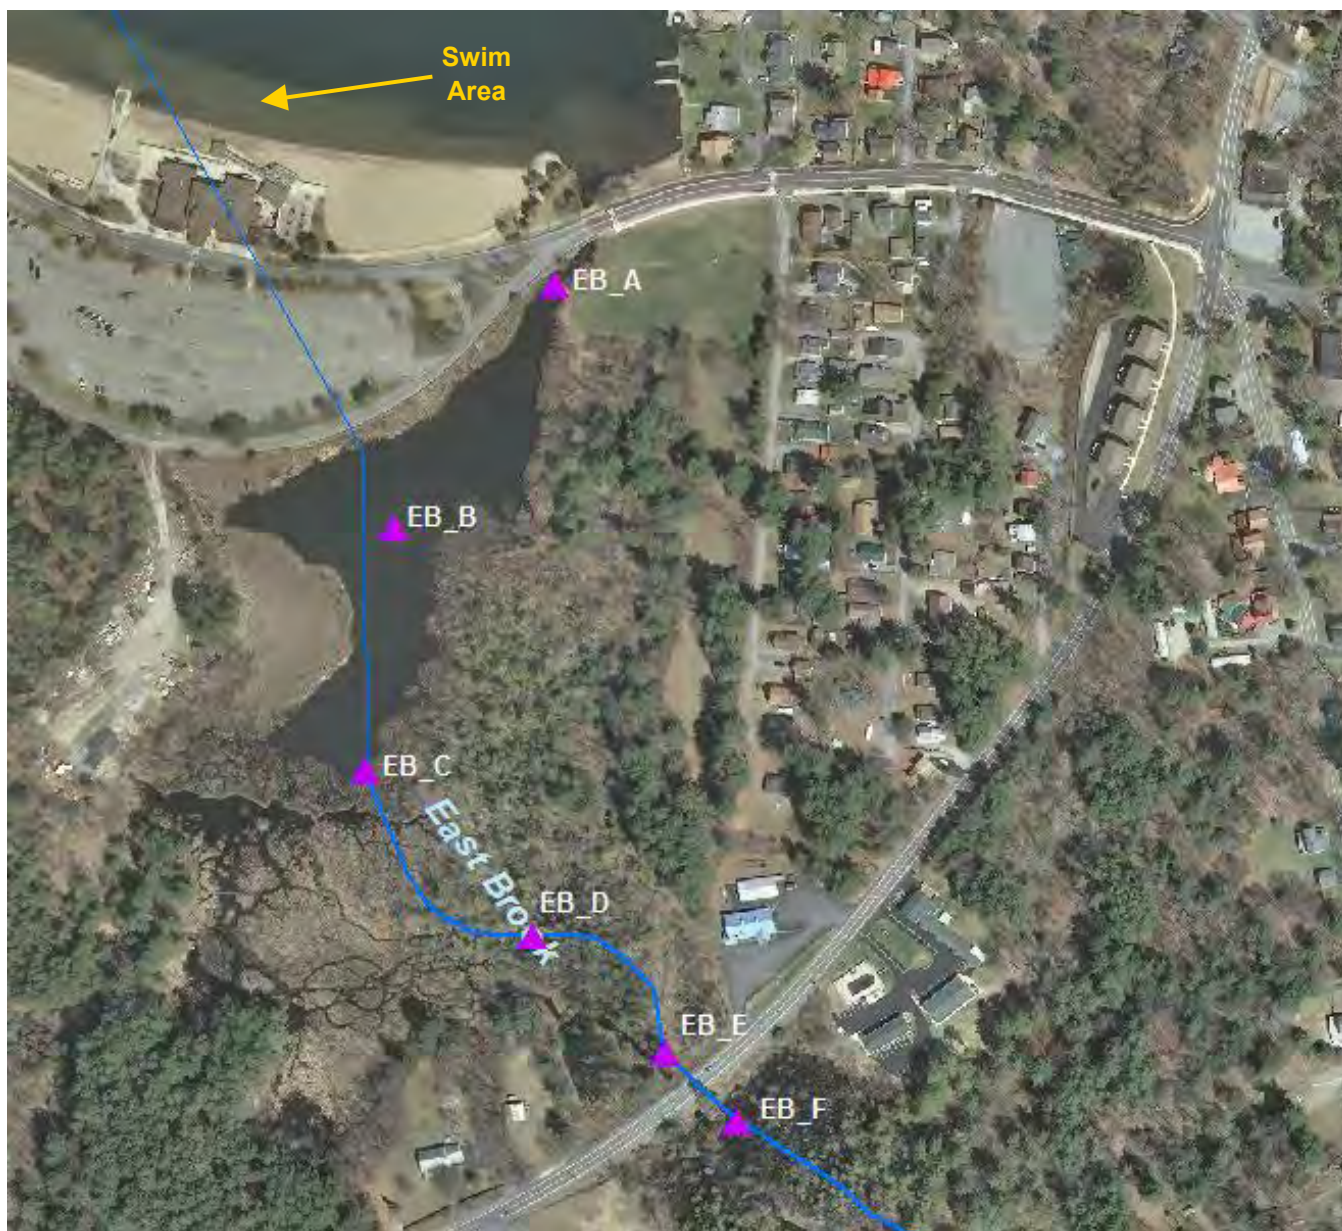
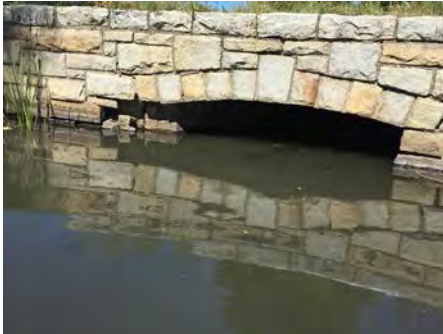
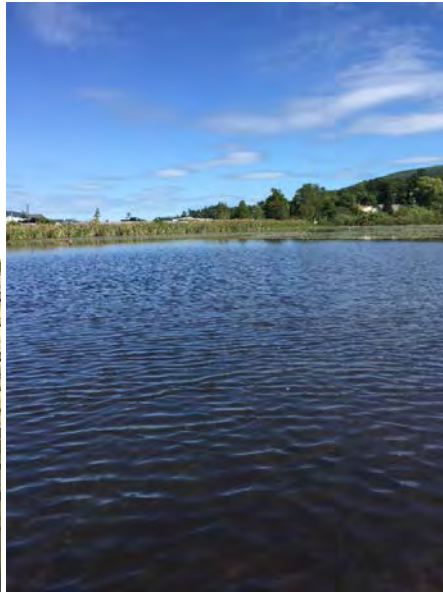
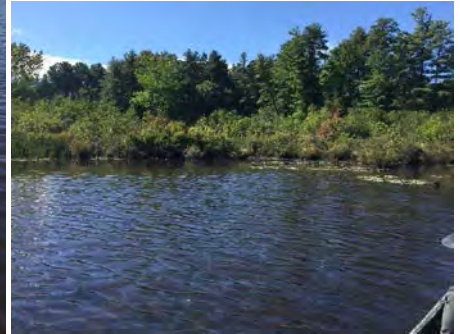
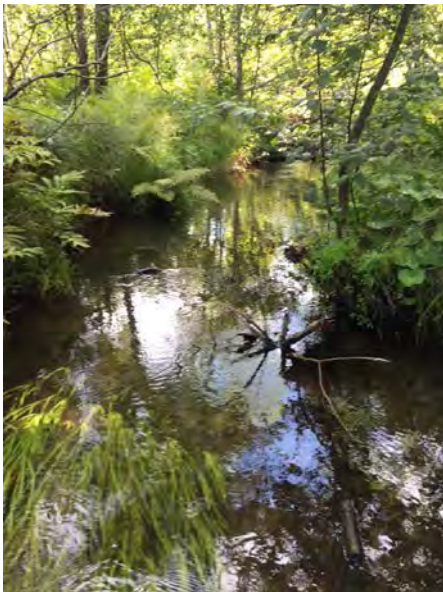
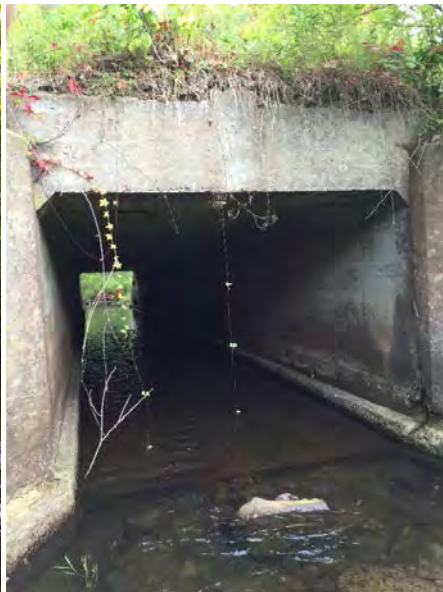
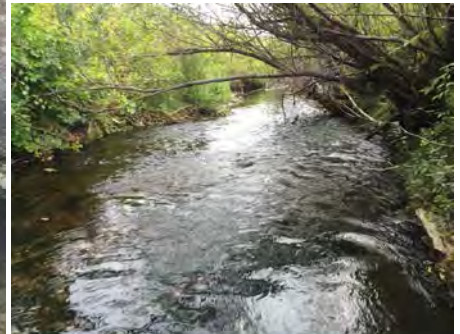
Figure A4. East Brook sampling sites locations

East Brook. Samples were collected from six sample sites (Figure A4, Figure A5). Water quality parameters, visual observations, and *E.coli* results are listed in Table A5. Sample Site EB-A contained very high levels of *E.coli*, and the water was observed as opaque. A corrugated metal pipe was observed in close proximity to the sample location. Sample Site EB-B and EB-C showed elevated levels approaching or slightly above the single sample standard, but no other physical indicators of bacterial sources were observed.

Figure A5. Photographs of East Brook sample sites

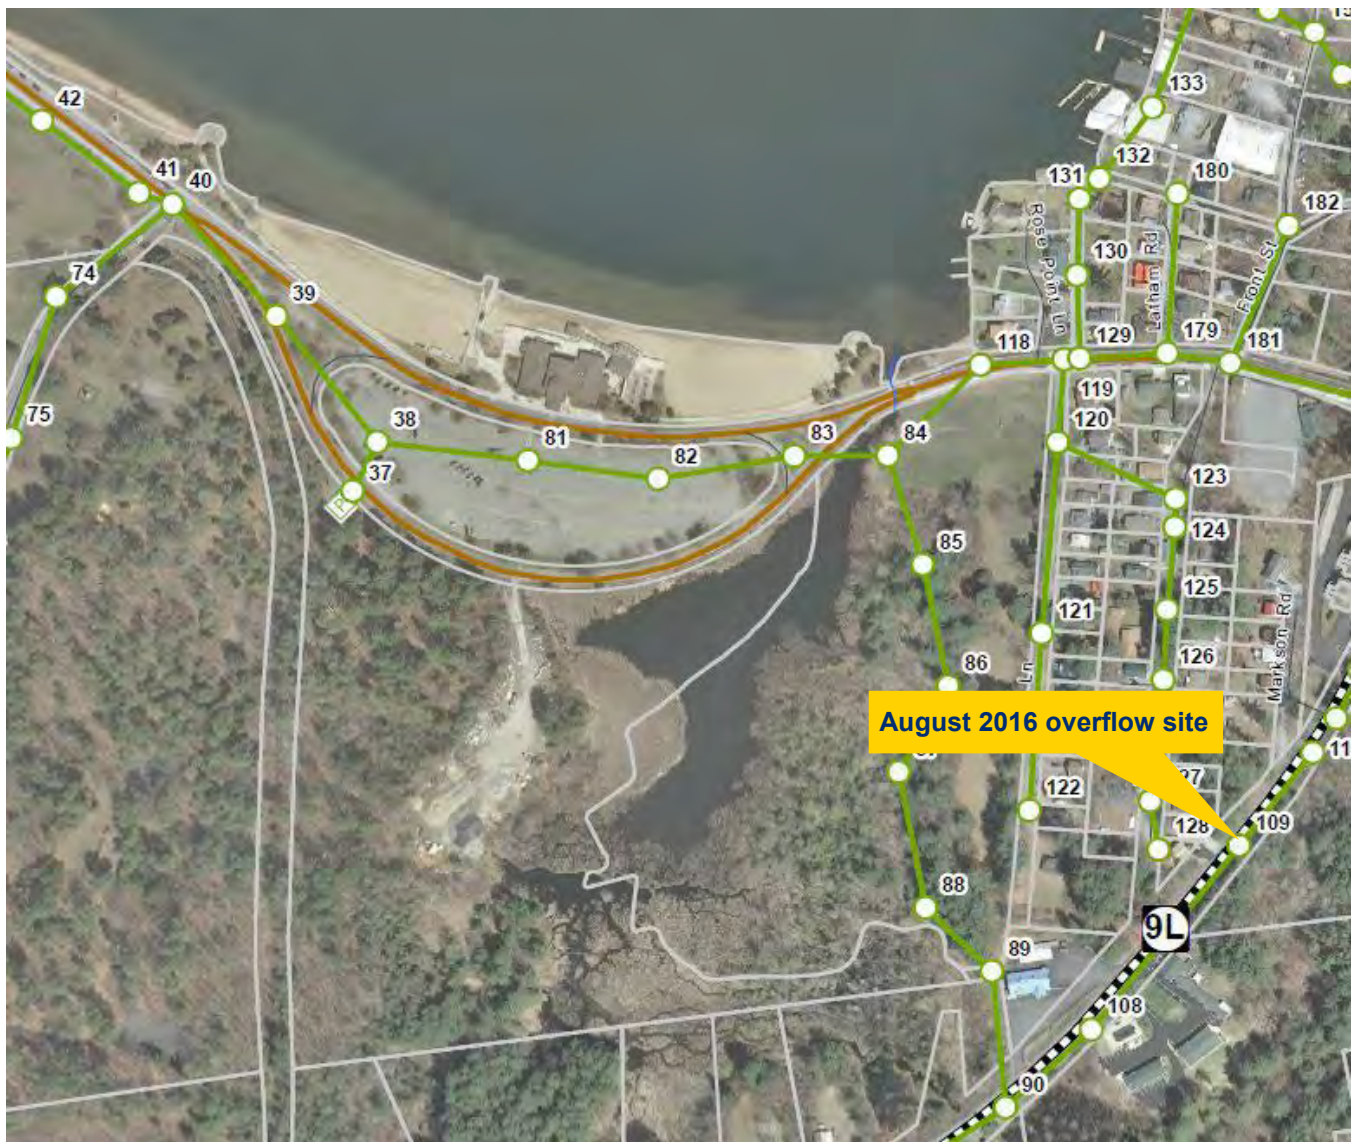
Figure B3. Map of Caldwell Collection System and August 25, 2016 overflow site

occurred in August 2016 did not appear to reach East Brook, nor impact the beach. A second overflow that occurred from the same system in December 2016 did discharge to East Brook. A Notice of Violation issued by DEC to the Town of Lake George in response to the second overflow required additional investigative and maintenance work on the sanitary sewer system. On February 28, 2017, the Lake George Association, working with the Town of Lake George, conducted dye tests of the sanitary sewer system to determine if any cross connections with the storm sewer system existed. This testing did not identify any cross connections or leakage from the sanitary sewer into the storm sewer system.

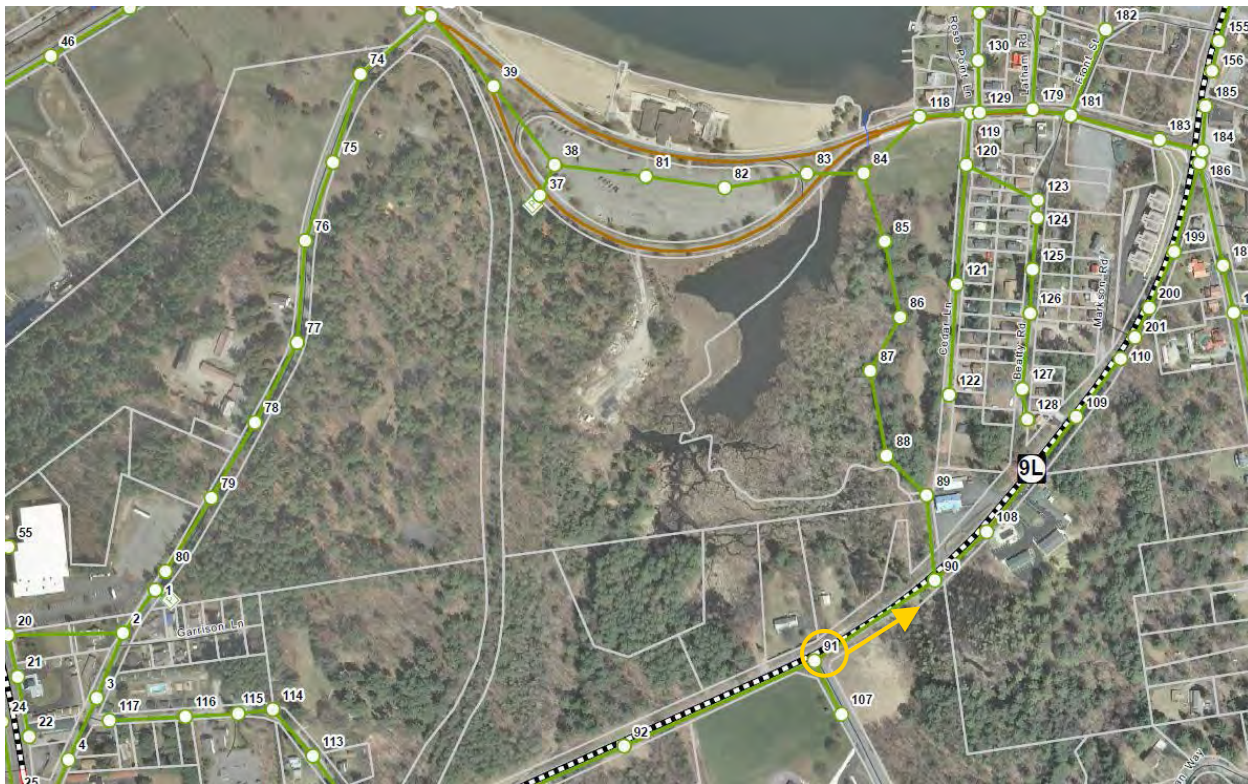
Figure B4. Map of Caldwell collection system and December 29, 2016 overflow site

On December 29, 2016, DEC received a report of another overflow of the sanitary sewer on Route 9L. A follow-up inspection found sanitary sewage discharging from an unmarked manhole (MH #90A) and running into a stormwater drainage ditch into East Brook, as noted on Figure B4. In response, DEC issued a second NOV to the Town of Lake George Caldwell Sewer District requiring additional investigative and maintenance work for the sanitary sewer system. In response to the NOV, the town has retained an engineer and committed to a schedule for further investigative work on the condition of the sanitary sewer system, as depicted in Figure B5.

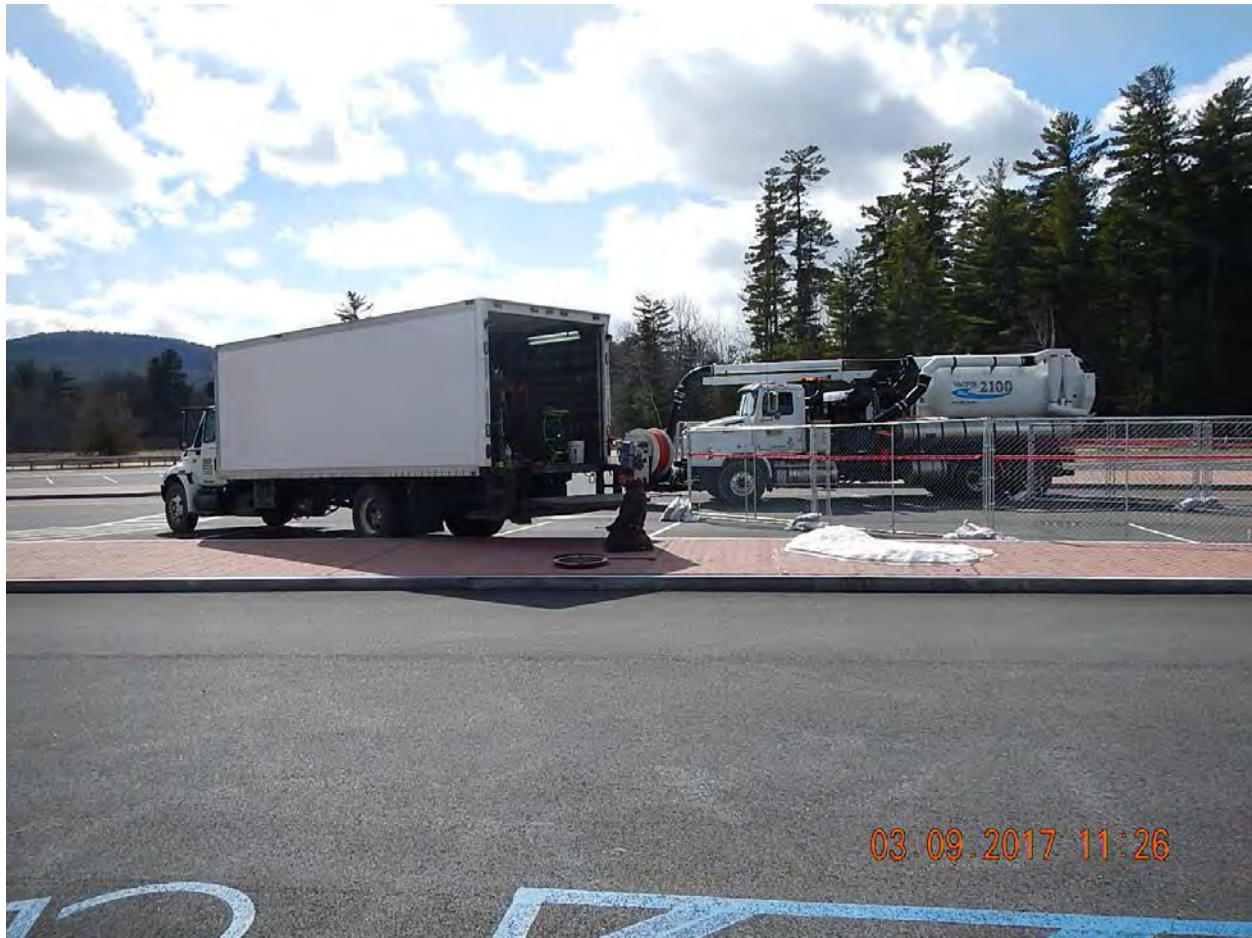
Figure B6. Photo of video inspection crew

In early 2017, DEC hired a contractor to video-inspect the condition of all DEC -owned storm and sanitary sewers that service Lake George Beach State Park, Lake George Battleground, and Lake George Battlefield. All lines and connections were reported to be in good condition with no evidence of exfiltration of sanitary sewage.

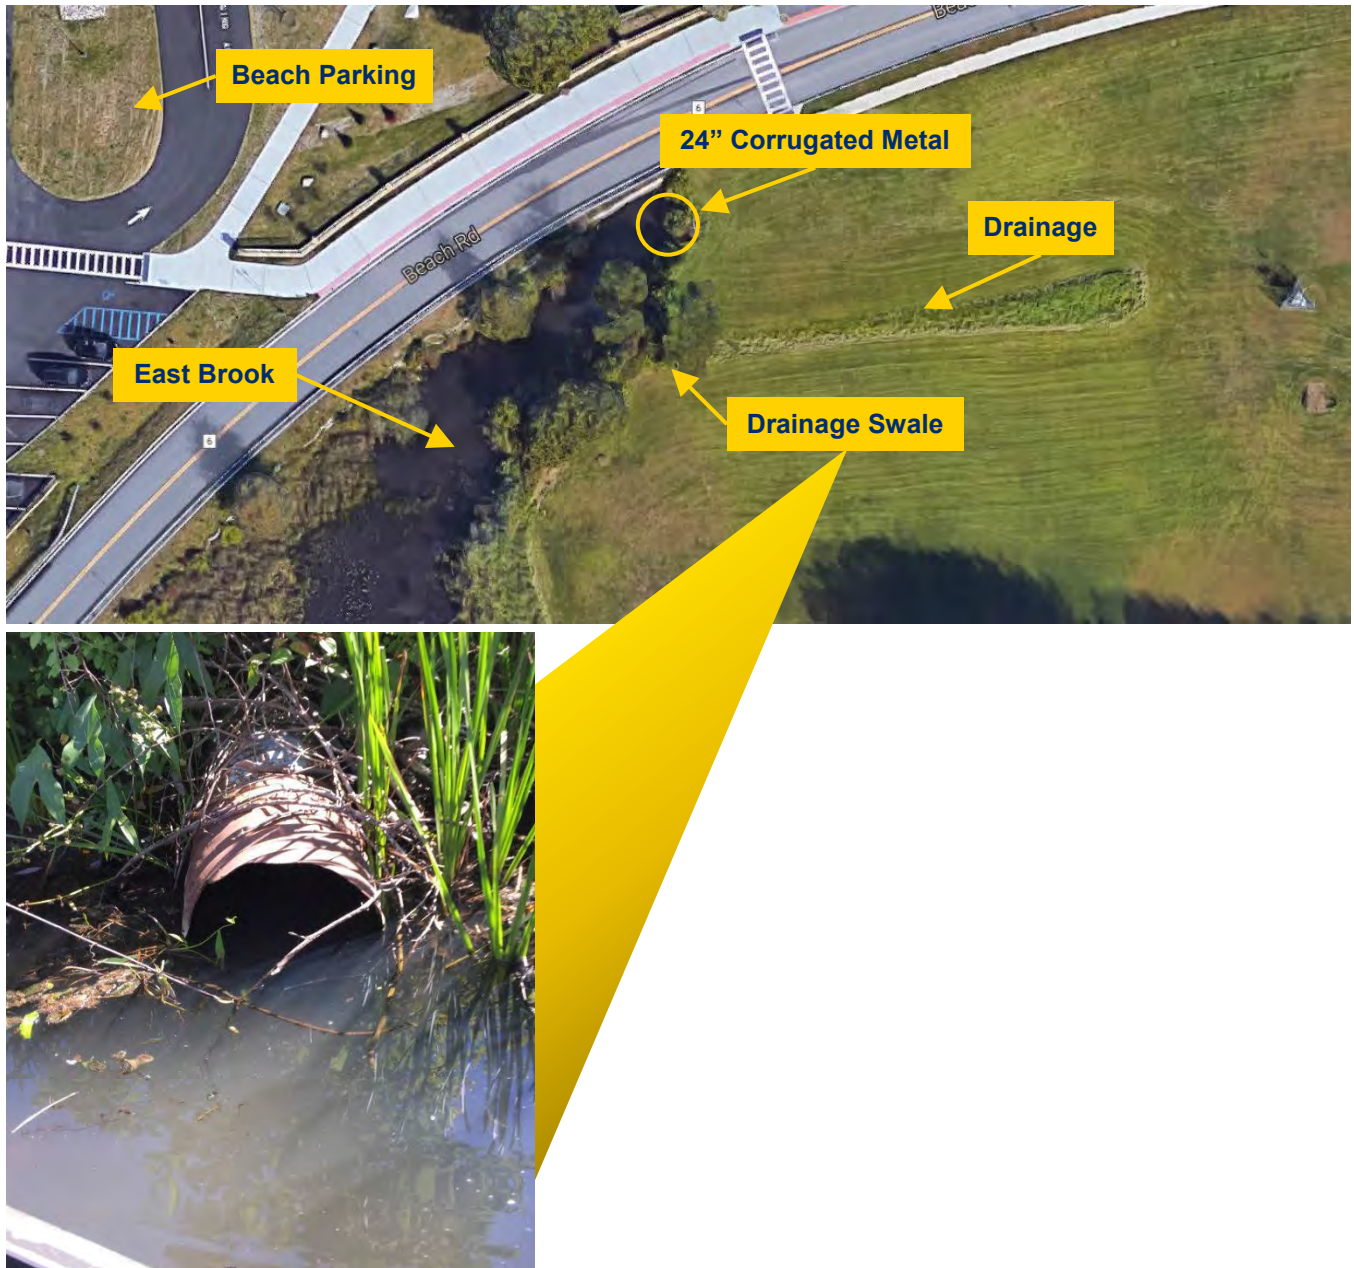
Figure B7. Photos of 24" corrugated metal stormwater pipe and drainage swale located near East Brook and Beach Road

During the tributary sampling event on September 6, 2016, a potential stormwater outfall was identified near Sample Site EB-A. A 24" corrugated metal pipe was observed adjacent to the stone arch culvert that conveys flows from East Brook under Beach Road into the lake. A drainage swale channel was also observed in an overgrown area within the East Brook wetland area, as identified on Figure B7.

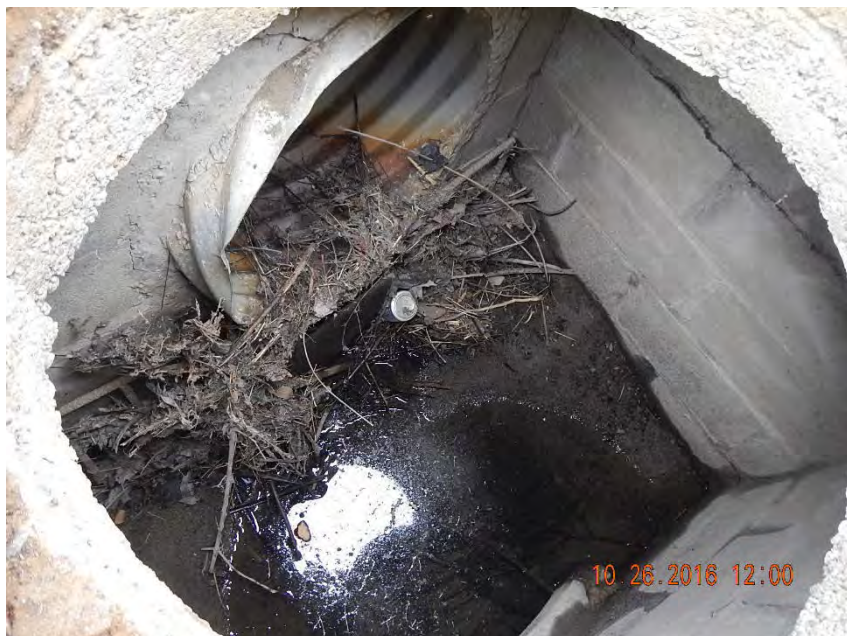
Figure B9. Photo of Cedar Lane Manhole with 24" corrugated metal pipe

Dye testing performed by DEC on January 30, 2017, confirmed that during low flow periods, the drainage channel to the east of the Cedar Lane manhole discharges through the 24" corrugated metal pipe near the mouth of East Brook. A secondary outlet (shown in Figure B9) with an invert elevation ~1 foot above the inlet at the Cedar Lane manhole conveys high flows to a stone-lined channel that also discharges to East Brook (Figures B8, B9).

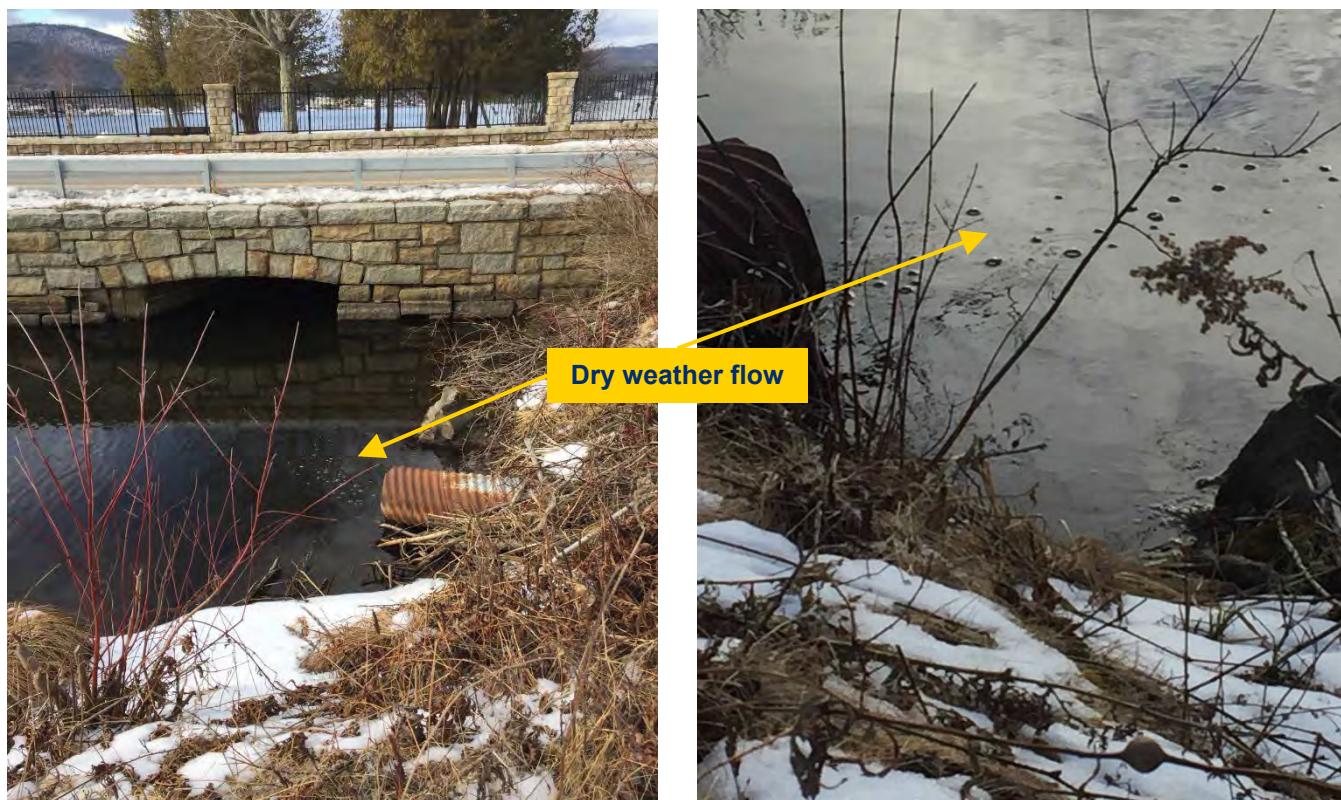
Figure B10. Photos of dry weather flows from 24" corrugated metal pipe into East Brook (photos taken January 28, 2017)

Dry weather discharges were observed from the 24" corrugated metal pipe outlet into East Brook (Figure B10).

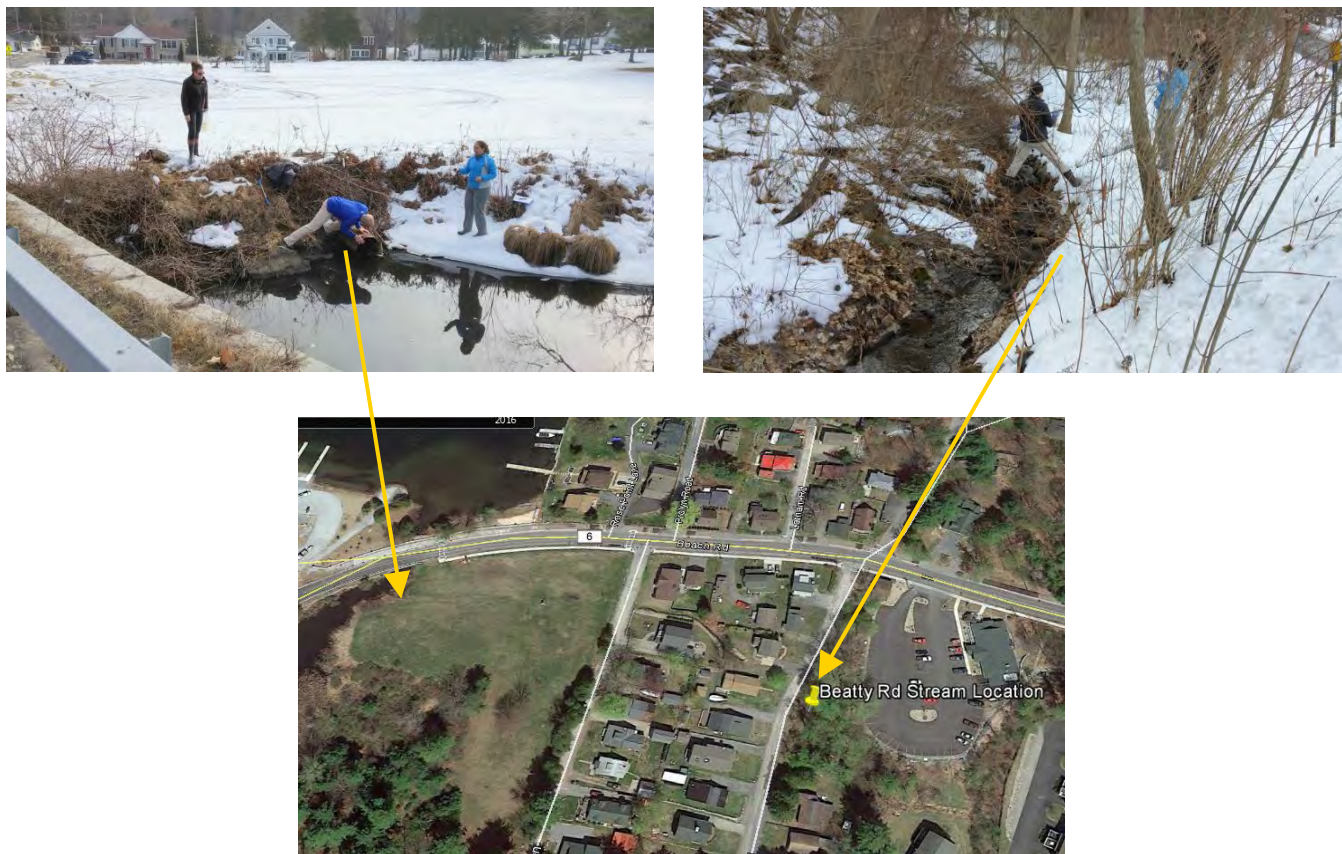
Figure B11. Photos from February 22, 2017 sampling effort

Although there were no physical indicators of pollutants in the discharge observed from the 24" corrugated metal pipe, DEC worked with the Lake George Association, the Village of Lake George, and the Town of Lake George to further investigate the potential for illicit discharges in this area. On February 22, 2017, the Lake George Association, working in partnership with the Town and Village of Lake George, collected samples for fecal coliform at the 24" pipe and within a tributary near Beatty Lane. The results of this testing showed fecal coliform levels below the single sample threshold value (1,000 col./100 ml for freshwater) at both the 24" outfall (115 col./100 ml) and within the tributary (1 col./100 ml).

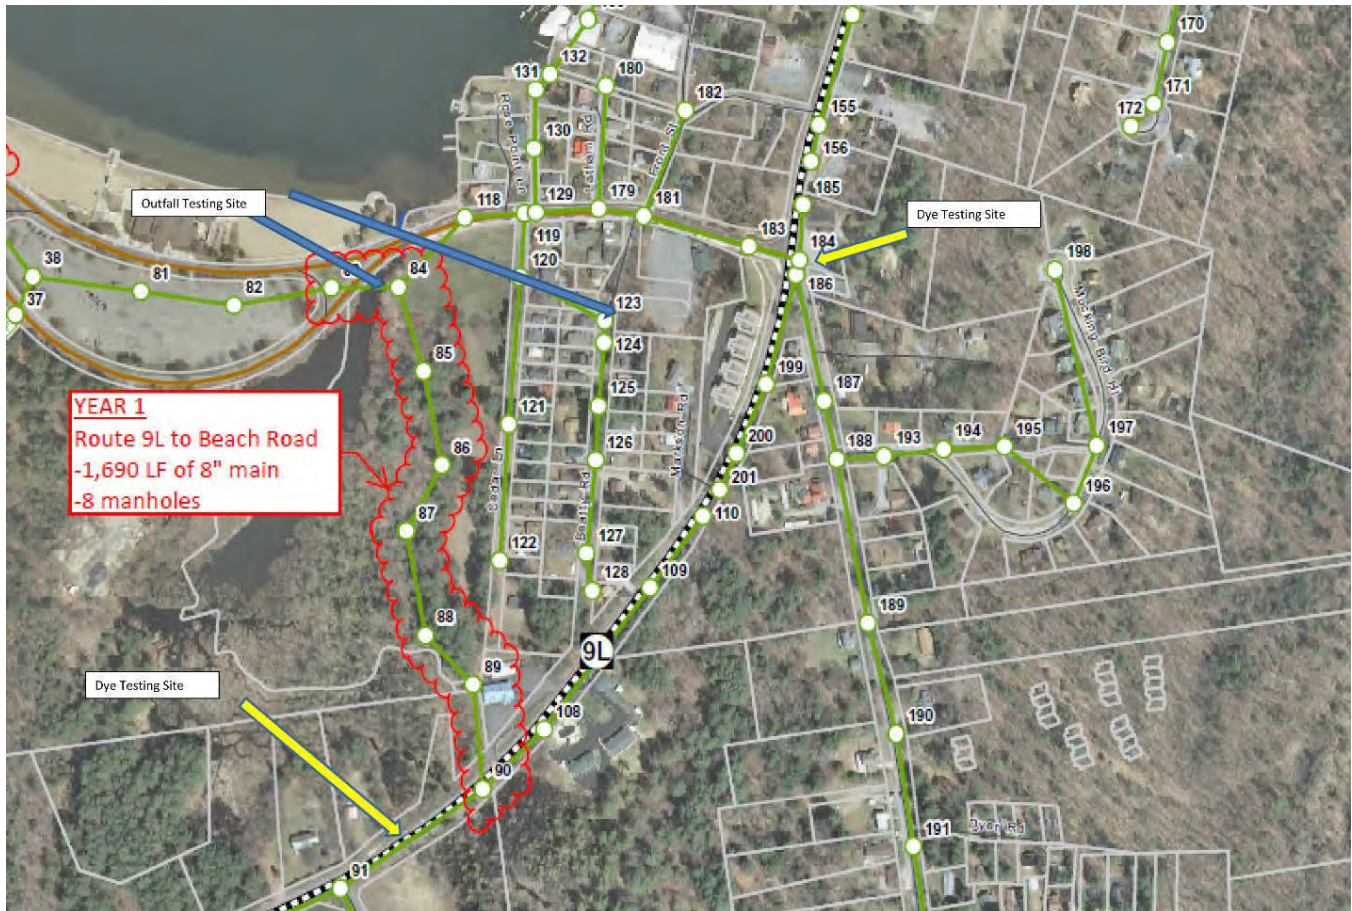
Figure B12. Dye testing locations

On February 28, 2017, the Lake George Association working with the Town of Lake George conducted dye tests of the sanitary sewer system to determine if there were any cross connections with the storm sewer system. This testing did not identify any cross connections or leakage from the sanitary sewer into the storm sewer system. The town plans to further investigate the condition of the sanitary sewer lines using closed circuit television beginning in the spring of 2017 (Figure B5).
