# FLOOD MITIGATION & RESILIENCE REPORT

## Blind Brook - SD 969 mod 1

New York State Department of Environmental Conservation,  
in cooperation with the New York State Office of General Services

November 2022

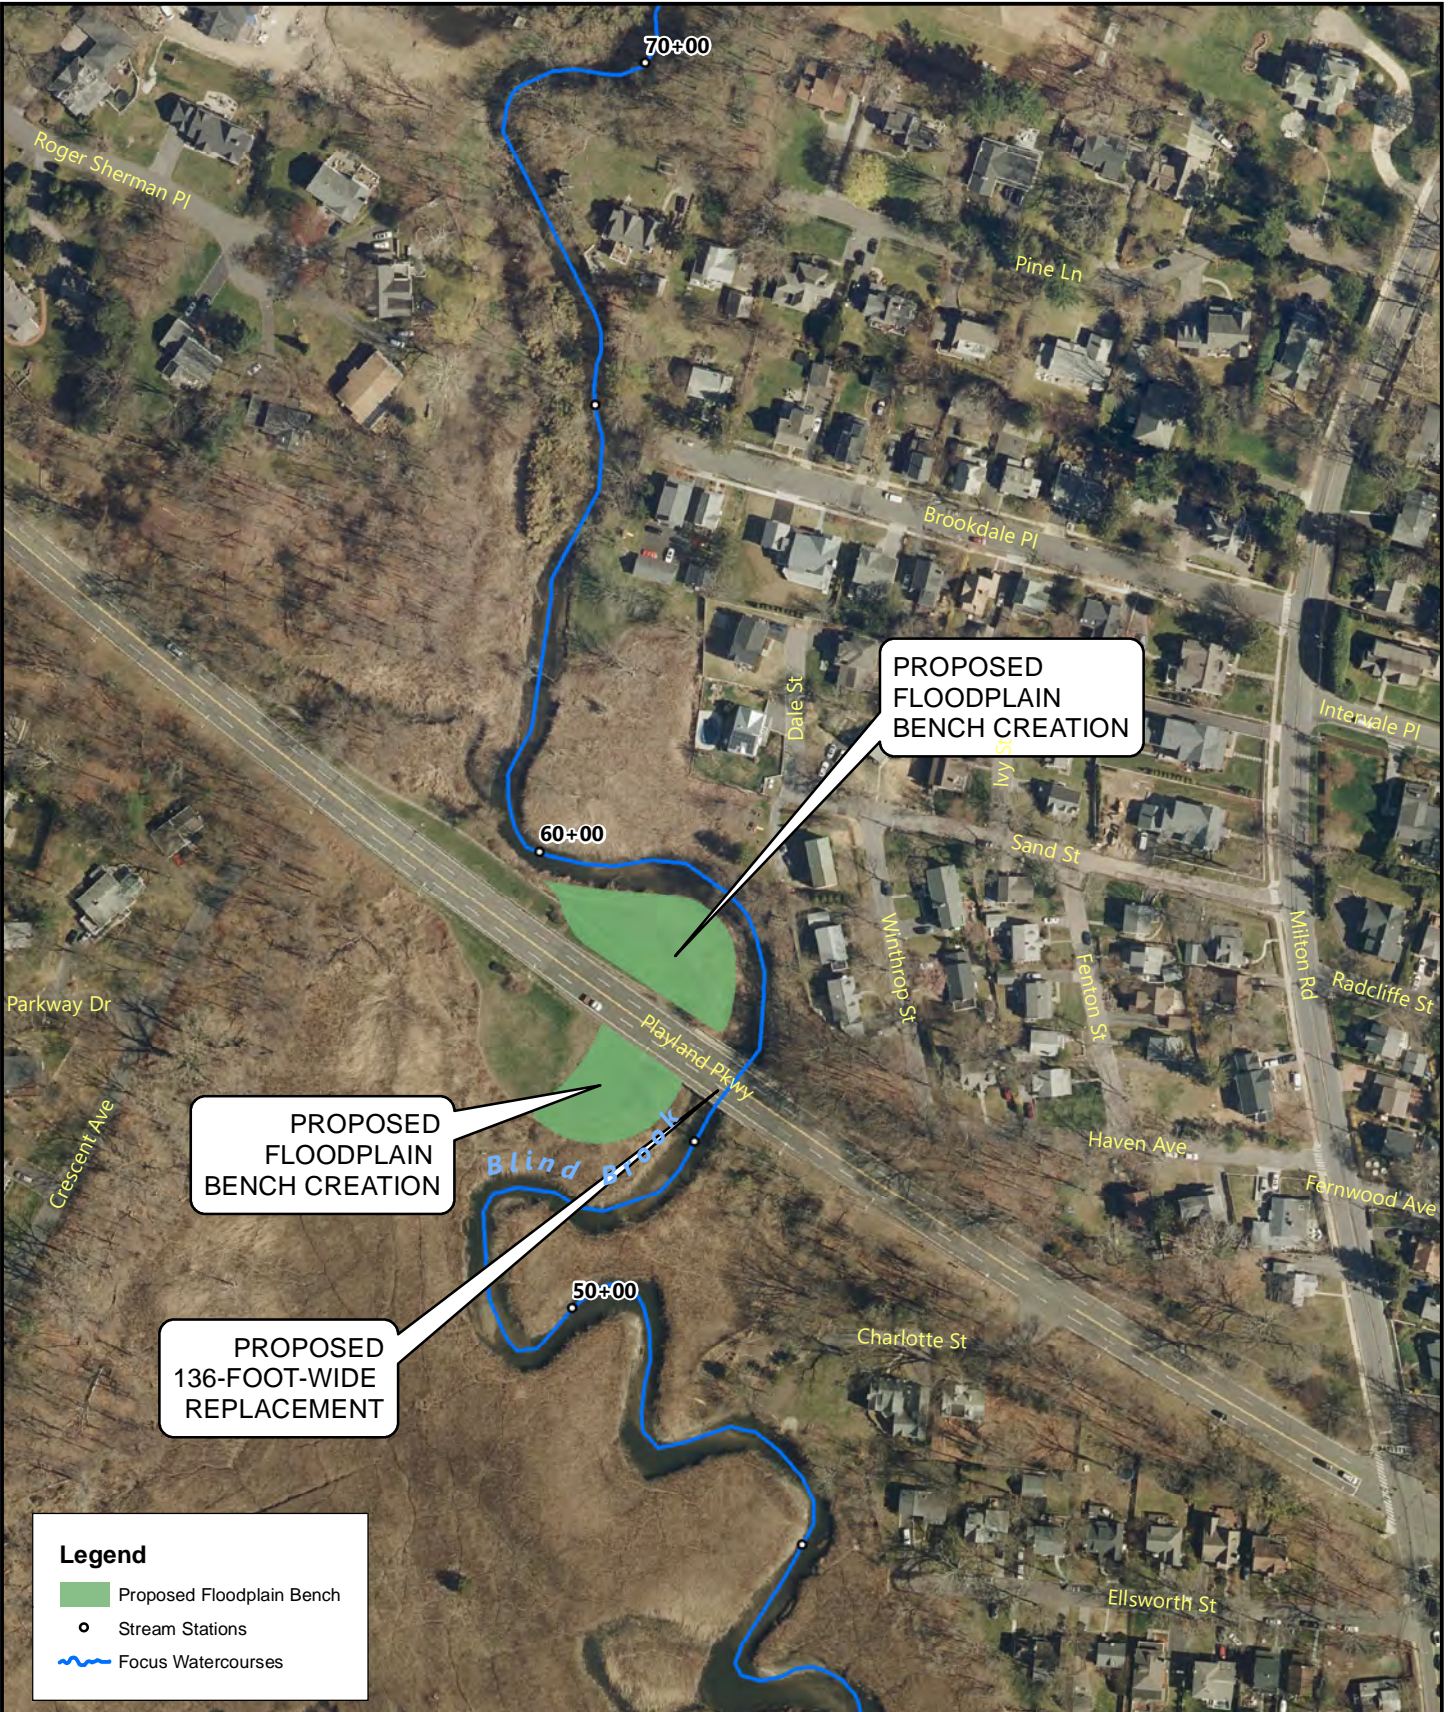
SCALE	1" = 200'
DATE	7/22/2022
PROJ. NO.	6511.0018
<b>FIG. 4-4A</b>

Avenue, a 45-foot-wide, approximately 215-foot-long, and 7-foot-deep floodplain bench was added to the model upstream of the bridge along the right bank (Figure 4-4A). A 180-foot-wide, 360-foot-long, and 5-foot-deep floodplain bench was modeled upstream and downstream of the upsized Playland Parkway bridge along the right bank (Figure 4-4B). Due to the severely constrictive nature of the existing bridges, implementing the proposed floodplain benches alone without modifying the structures themselves is unlikely to produce meaningful flood reduction benefits. Floodplain benches are being recommended here since upsizing the bridges would introduce the opportunity to reconstruct the reach with a properly sized multistage channel and reclaimed floodplain. Together, the bridge replacements and floodplain bench creation would provide substantial reductions of flood depths and lateral flood extents at the neighborhoods upstream of these structures along the left bank from STA 20+00 to STA 50+00 and STA 56+40 to STA 70+00. With the recommended larger spans, both bridges would pass the existing 100-year storm event, although the upsized Playland Parkway bridge would still not pass the future 100-year. Flood reductions under the 10-year flood event are illustrated in Figure 4-4 (existing conditions) and Figure 4-5 (with proposed upsized bridges). Flood reductions during the 50-year flood event are illustrated in Figure 4-6 (existing conditions) and Figure 4-7 (proposed conditions). Flood reductions during the 100-year flood event are illustrated in Figure 4-8 (existing conditions) and Figure 4-9 (proposed conditions). The flood mitigation benefits of the proposed floodplain and bridge replacements are limited by the tailwater control of Milton Harbor and Blind Brook's shallow slope within the approach reach.

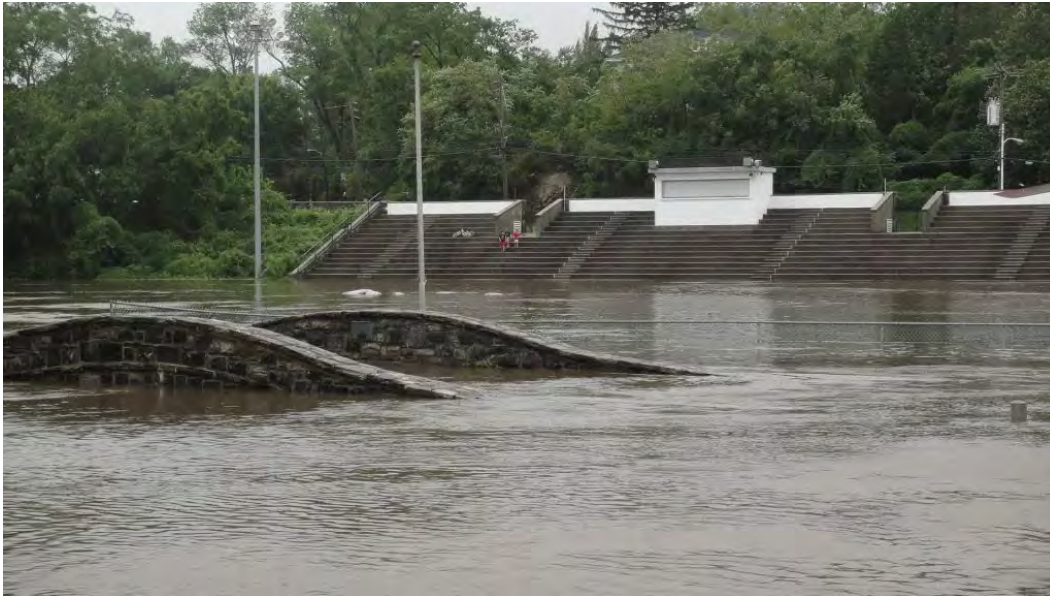
**Figure 4-11 Rye High/Middle School football field flooded during Hurricane Irene 2011. The masonry stone arch bridge over Blind Brook is seen underwater (center left). Photo Courtesy of Patch.com News Report.**

Two small bridges and a low-head inline dam span Blind Brook near the Rye Middle/High School building and sports field. The structures are shown to be marginally influenced by tidal and sea level rise conditions. The school football field to the east of Blind Brook is located within the floodplain and floods regularly (Figure 4-11). Across from the football fields to the west, the Rye school building is shown to be situated outside of the 100-year floodplain although it is mapped within the FEMA 500-year flood hazard zone. City of Rye officials reported that the school building has flooded in the past.

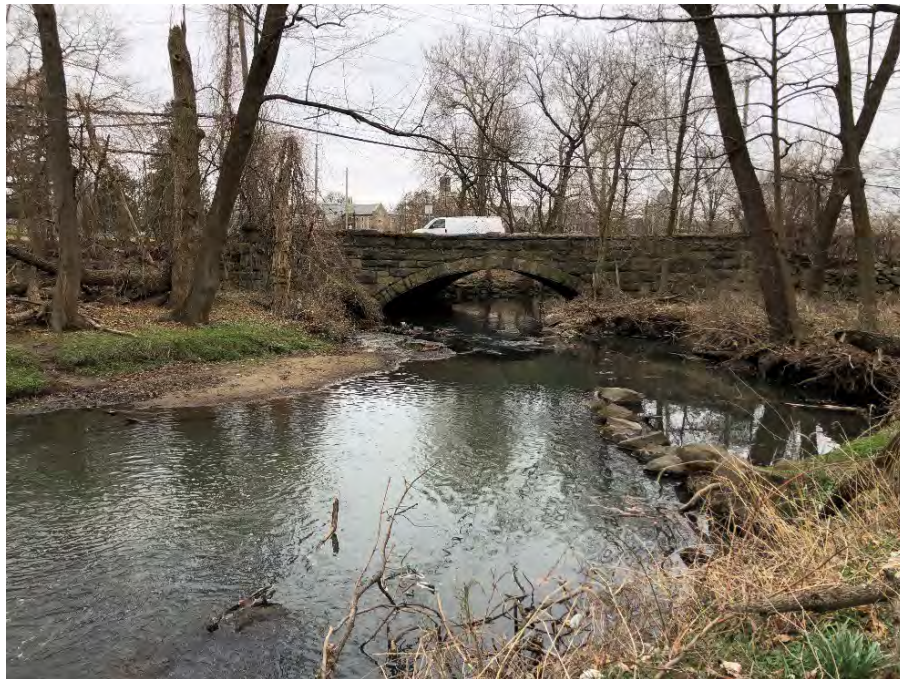
**Figure 4-14: Looking downstream at the Boston Post Road bridge inlet over Blind Brook**

Boston Post Road is carried over Blind Brook by a masonry arch bridge (Figure 4-14) built in 1934 (STA 83+79). The open-bottom deck bridge measures 32 feet wide by 8.5 feet high. The approach roadway embankments to the right (southwest) and left (northeast) severely encroach on the brook's floodplain, limiting flood flow conveyance and causing impounding of floodwaters upstream of the bridge. Hydraulic modeling shows the existing structure being flank to its right starting at the 10-year flood event. Shallow sheet flow over the southwestern approach is projected to occur during the 50- and 100-year flood events. The bridge backwater increases water surface elevations as much 1.7 to 2.0 feet during the 50- and 100-year flood events, respectively, impacting the portion of Blind Brook between the upstream bridge face and STA 100+00. Development on the brook's banks within this reach is sparse, although homes along the right bank near STA 95+00 would benefit from improvements at the bridge. Moreover, approximately 350 feet upstream of Boston Post Road, the Rye Nature Center driveway bridge (STA 92+54) would also benefit from reductions in surface elevations although the crossing itself is also severely undersized, as discussed below.

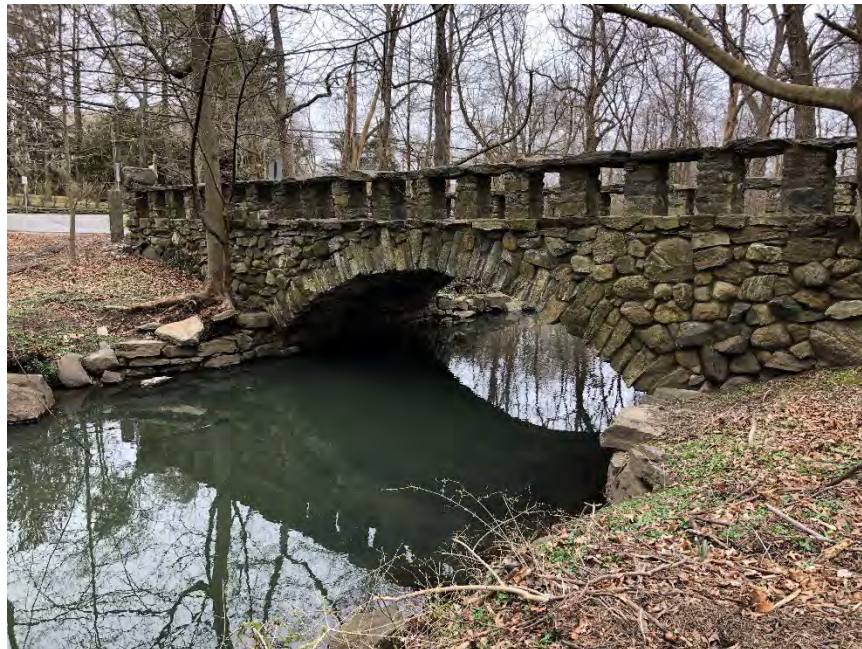
The driveway to the Rye Nature Center is carried over Blind Brook at STA 87+26 by a masonry arch bridge built in 1870 (Figure 4-21). NYS Parks, Recreation, and Historic Preservation (OPRHP) deemed this bridge eligible for listing in the NYS historic repertoire by DOT Historic Bridge Inventory 2022 under Criterion C: *“Possessing high artistic values and demonstrates pattern or feature common to a particular bridge type.”* The structure is reported to have flooded during Hurricane Irene, Tropical Storm Lee, and Hurricane Sandy. The bridge has been closed numerous times after floods due to concerns with scour under the structure, consequently interrupting community access to the nature center for extended periods. The bridge has a 32-foot-span and an 8.5-foot-high vertical opening. It has a hydraulic capacity of less than the estimated existing 10-year flood event and creates a backwater that can be traced all the way upstream to just below the Central Avenue bridge at STA 100+00. Without a tailwater influence from the downstream bridge at Boston Post Road, the bridge is still incapable of passing the existing 10-year flood event, with hydraulic modeling showing the right (northeastern) approach road to the bridge under 1 to 2 feet of water.

**Figure 4-21: Looking downstream at bridge over Blind Brook to the Rye Nature Center**

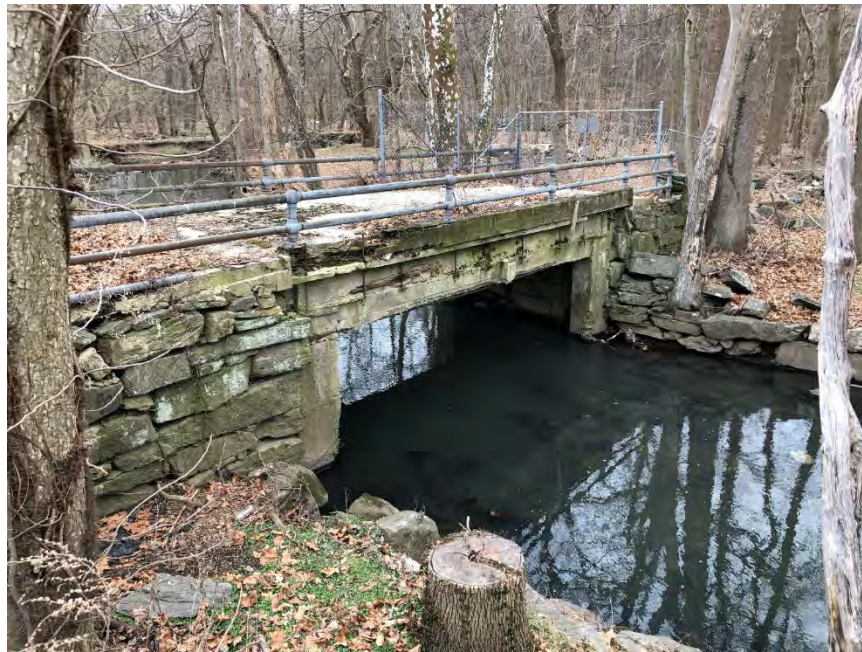
**Figure 4-22: Looking downstream at pedestrian bridge inlet over Blind Brook. The bridge has been posted and fenced off on both sides to prevent passage.**

pedestrian bridge. This implies that the bridge is impeding flood flow conveyance and raising water surface elevation upstream anywhere between 1.5 to 1.3 feet in the 10- and 100-year flood events.

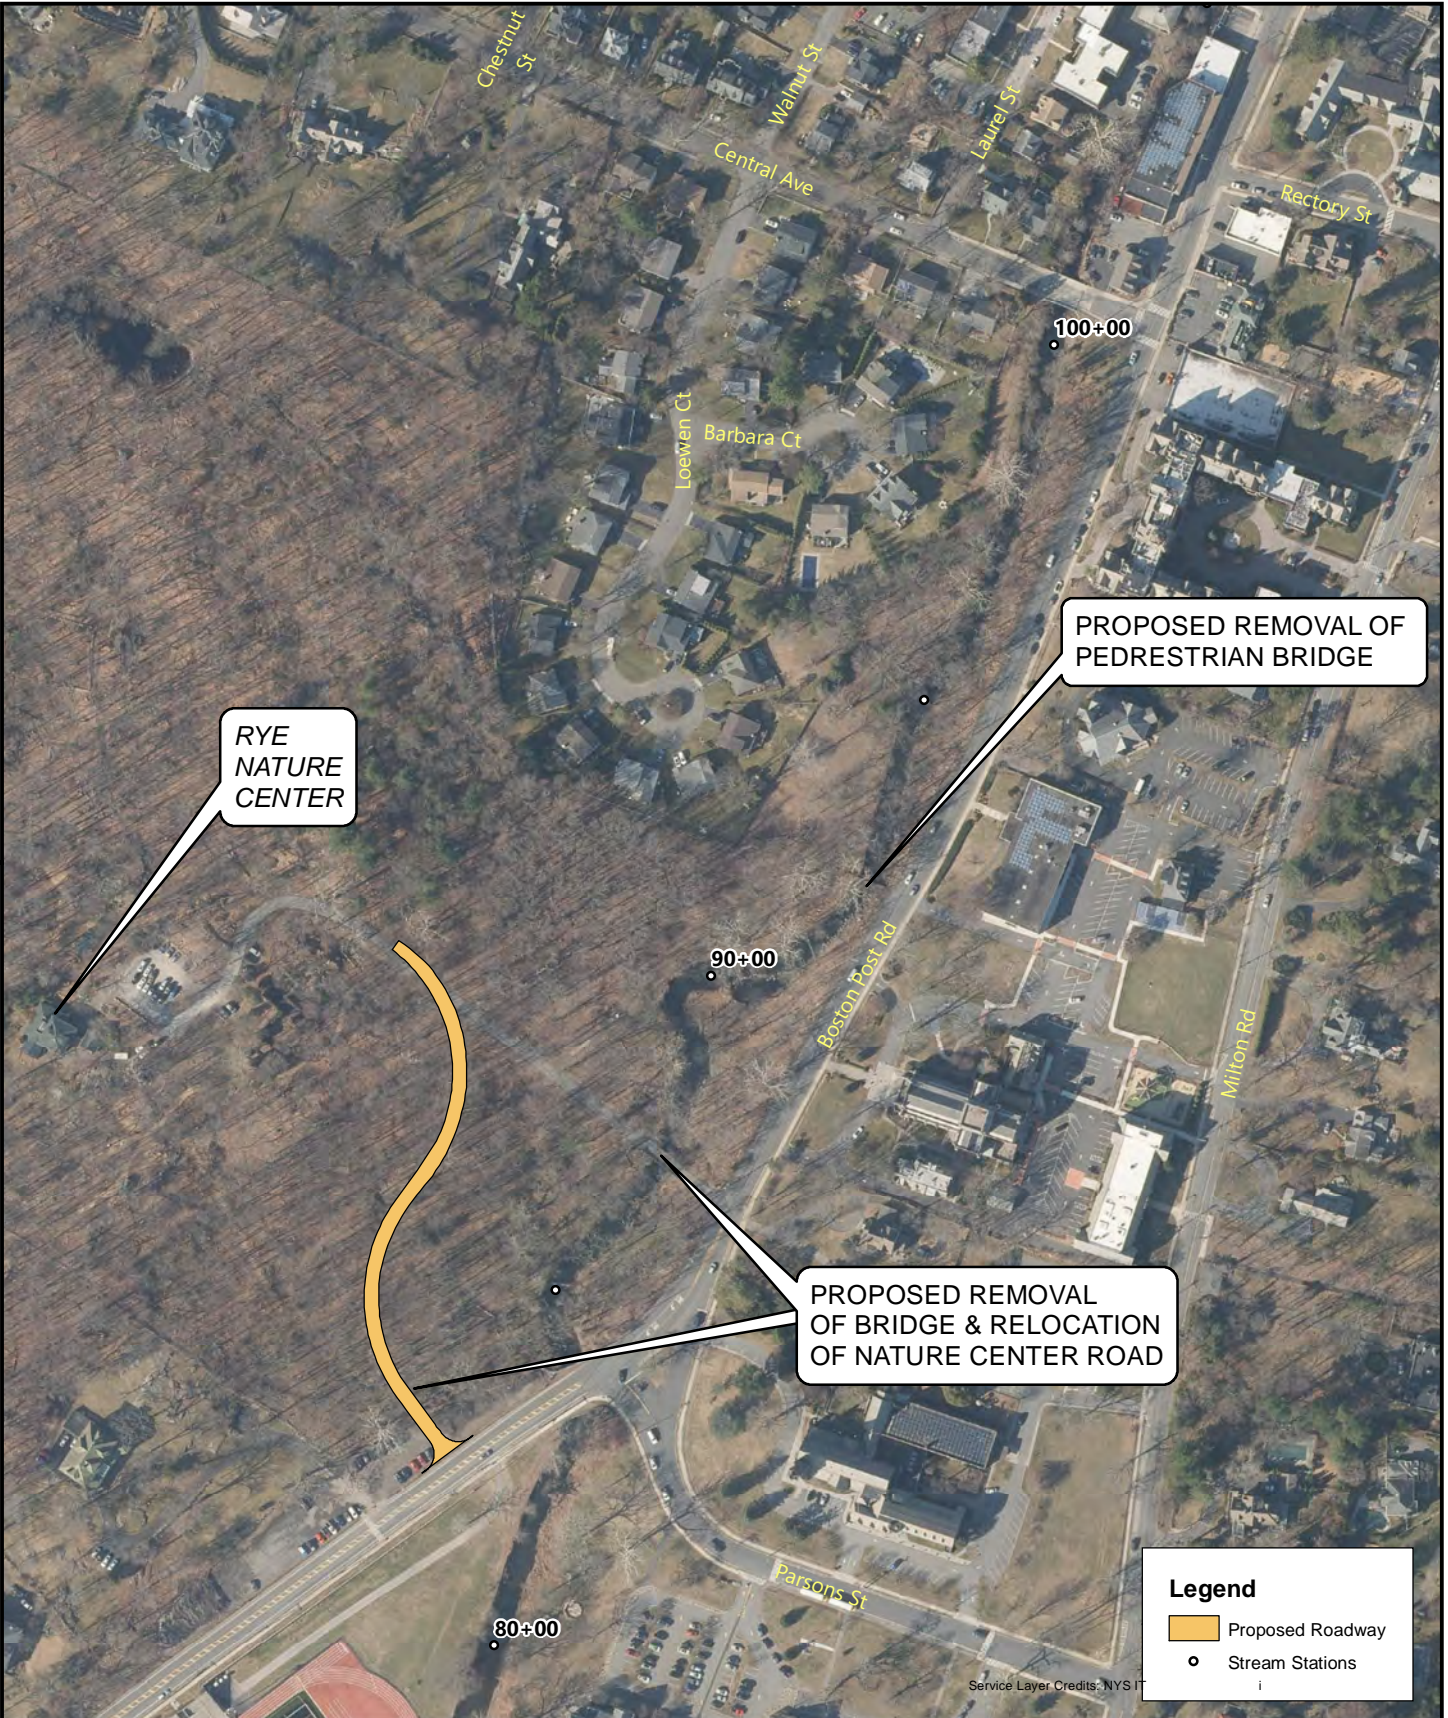
**FIG. 4-24**

Figure 4-24 (existing conditions) and Figure 4-25 (proposed conditions) depict flood depths for the 10-year flood event. Figure 4-26 (existing conditions) and Figure 4-27 (proposed conditions) show depths for the 50-year flood event. 100-year flood event mapping is shown in Figure 4-28 (existing conditions) and Figure 4-29 (proposed conditions).

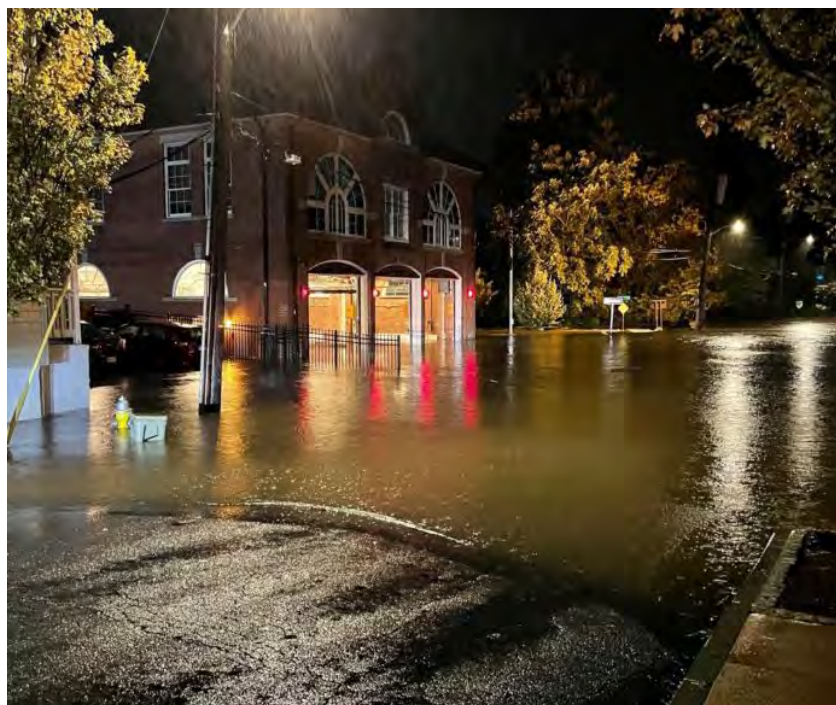
**Figure 4-31: City of Rye firehouse inundated with several inches of water from the remnants of Tropical Storm Ida 2021. Photo taken on Locust Avenue near intersection with Purchase Street, looking southwest toward Blind Brook. Photo courtesy of MyRye.com News Report.**

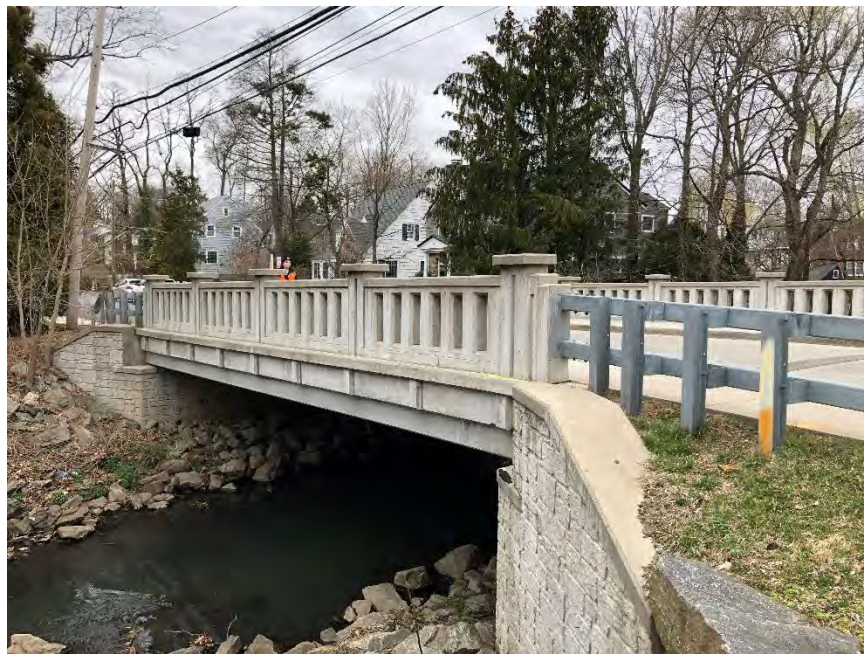
**Figure 4-33: Looking upstream at the Central Avenue bridge. The crossing at this location was replaced in 2013 with a larger span bridge.**

At the downstream-most margins of HRA 2 near STA 100+72 is the Central Avenue bridge over Blind Brook (Figure 4-33). The bridge was replaced in 2013, substituting the former 30-foot-wide structure with a 40-foot-wide bridge. The hydraulic model predates the bridge replacement; therefore, measurements collected in the field were used to update this crossing in the model. The existing bridge is shown to only pass the existing 10-year flood event and does not pass the future 10-year flood event. During flood events, the bridge is indicated to flank to its right (northwest), inundating a topographically low area near the intersection with Laurel Street and several buildings situated along the right overbank upstream of Central Avenue.

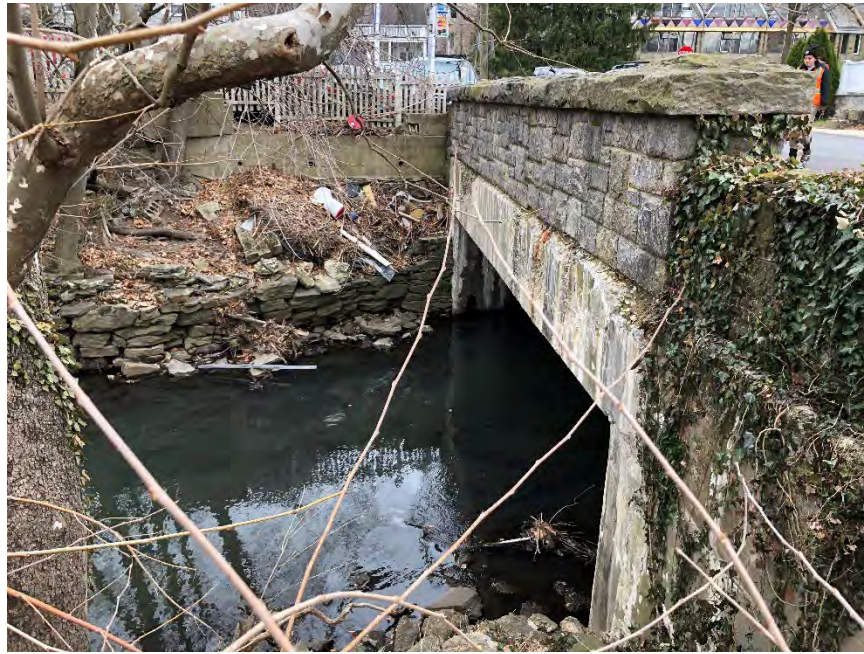
**Figure 4-34: Looking at the Orchard Avenue upstream bridge face**

shown to flank to its right (northwest) as early as the current 10-year flood event. During the Tropical Storm Ida flood, the bridge indeed was flanked, and floodwater damaged the sidewalk and the bridge parapet to the right as shown in Figure 4-35. The backwater effect from the bridge extends up to the Locus Avenue bridge at STA 115+00. Homes situated to the north of Orchard Avenue, as well as the Rye YMCA parking lot, are shown to inundate starting at the 10-year flood event.

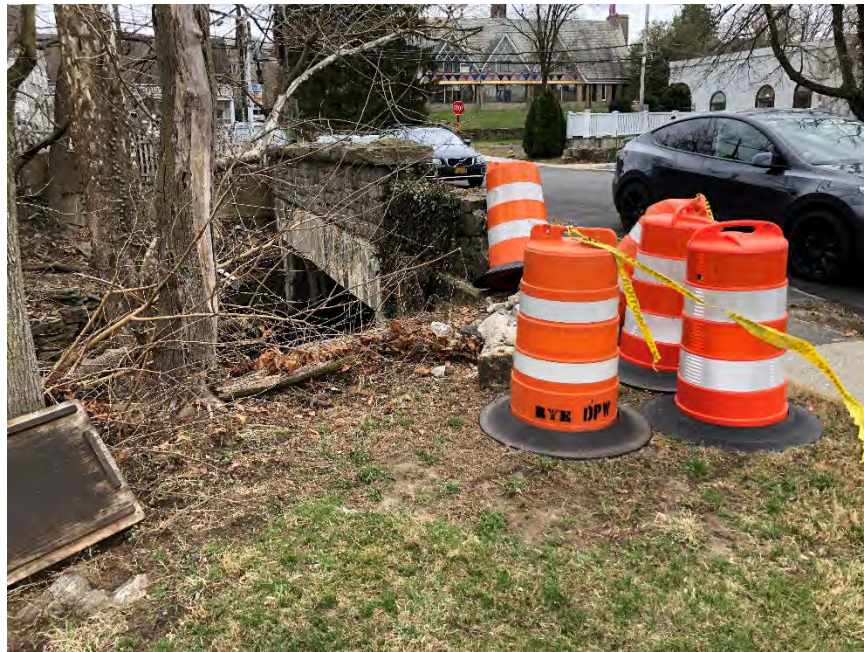
**Figure 4-35: Looking at sidewalk damage and collapsed portion of the bridge parapet at the upstream bridge face**

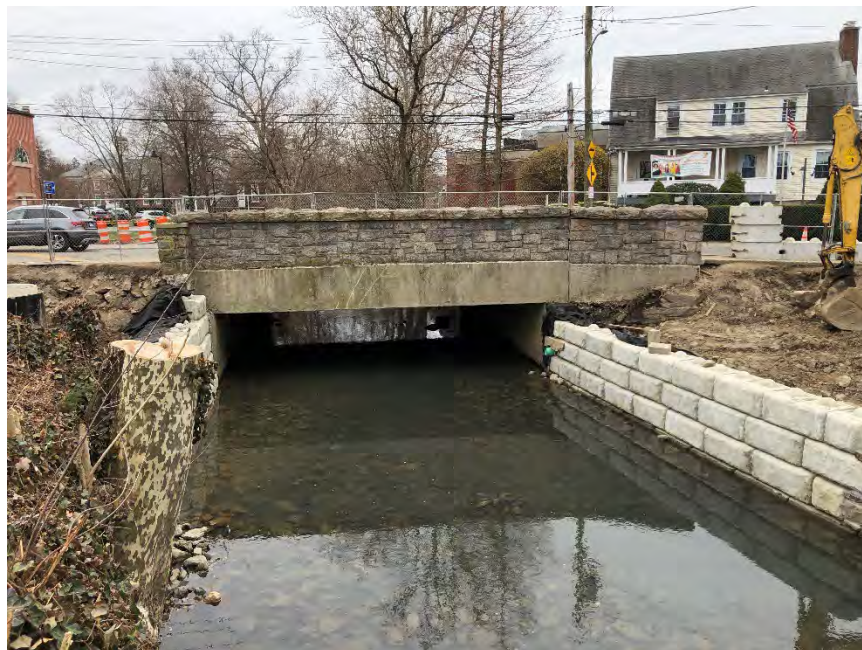
Figure 4-36: Looking downstream at the Locust Avenue bridge

Possibly the most hydraulically undersized bridge in HRA 2 is the Locust Avenue bridge near STA 115+00 (Figure 4-36). Floodwaters are known to flank the bridge on either side and erode sidewalks on the downstream side of the structure. Hydraulic modeling indicates that this open-deck concrete bridge, built in 1928, is overtopped as frequently at the 10-year flood event and suggests over a foot of water over the right (western) approach. According to the NYSDOT bridge inventory report, the Locust Avenue bridge was last inspected in March 2021 and has been denoted as being in “poor condition.” At the time of this report, the City of Rye was conducting a sewer line replacement project on the upstream side of the bridge, although no work was being performed on the Locust Avenue bridge itself.

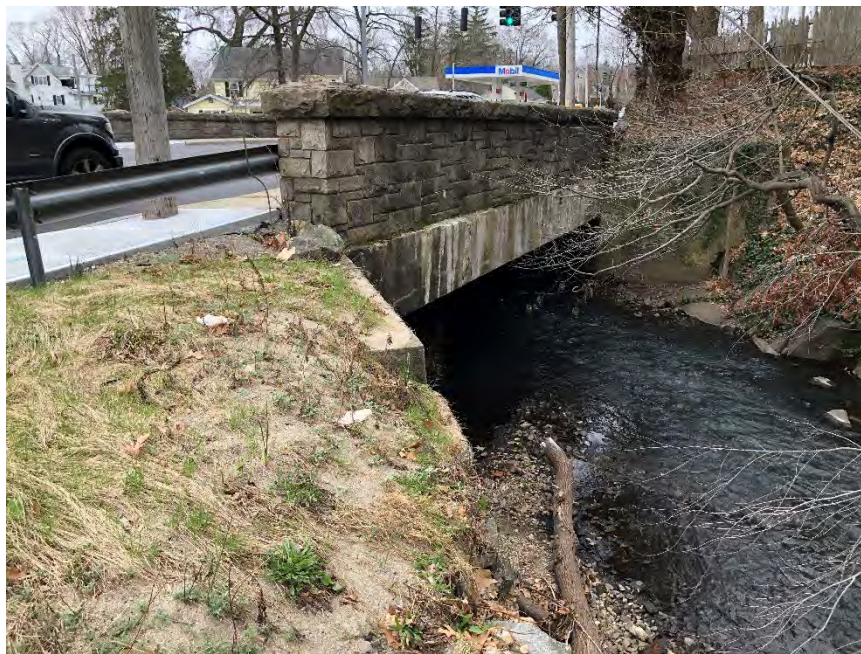
The bridge carrying Theodore Fremd Avenue over Blind Brook at STA 121+95 is a 1928 open-deck bridge that measures approximately 30 feet wide by 7 feet high (Figure 4-37). The brook makes a sharp bend as it approaches the bridge and then again after passing underneath it. Upstream of the bridge, Blind Brook is narrowly pinched between the Metro-North railroad embankment to the north and the roadway and parking lots to the south. This location is notorious for repeatedly scouring during flood events from water that outlets from the MTA/I-95 crossing. On the downstream side of the Theodore Fremd Avenue crossing, a 9-foot-high by 22-foot-wide rectangular channel transports the brook between Elm Place to the north and residential development to the south. At approximately 130 feet downstream of the Theodore Fremd Avenue bridge, there is a private pedestrian bridge that does not pass any of the peak modeled flood events. The private bridge appears to be in poor condition and exhibits signs of damage from past floods (Figure 4-38).

Figure 4-37: Looking downstream at the Theodore Fremd Avenue bridge

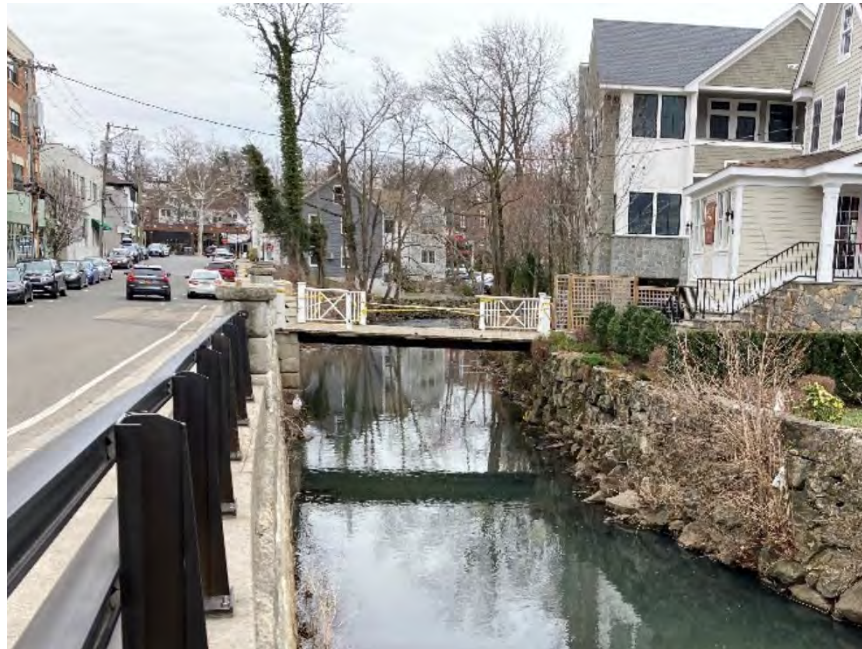
**Figure 4-38: Looking downstream at the walled-in section of Blind Brook and the private pedestrian bridge that spans over it. The bridge is missing portions of the guardrail, and yellow caution tape has been added around the structure.**

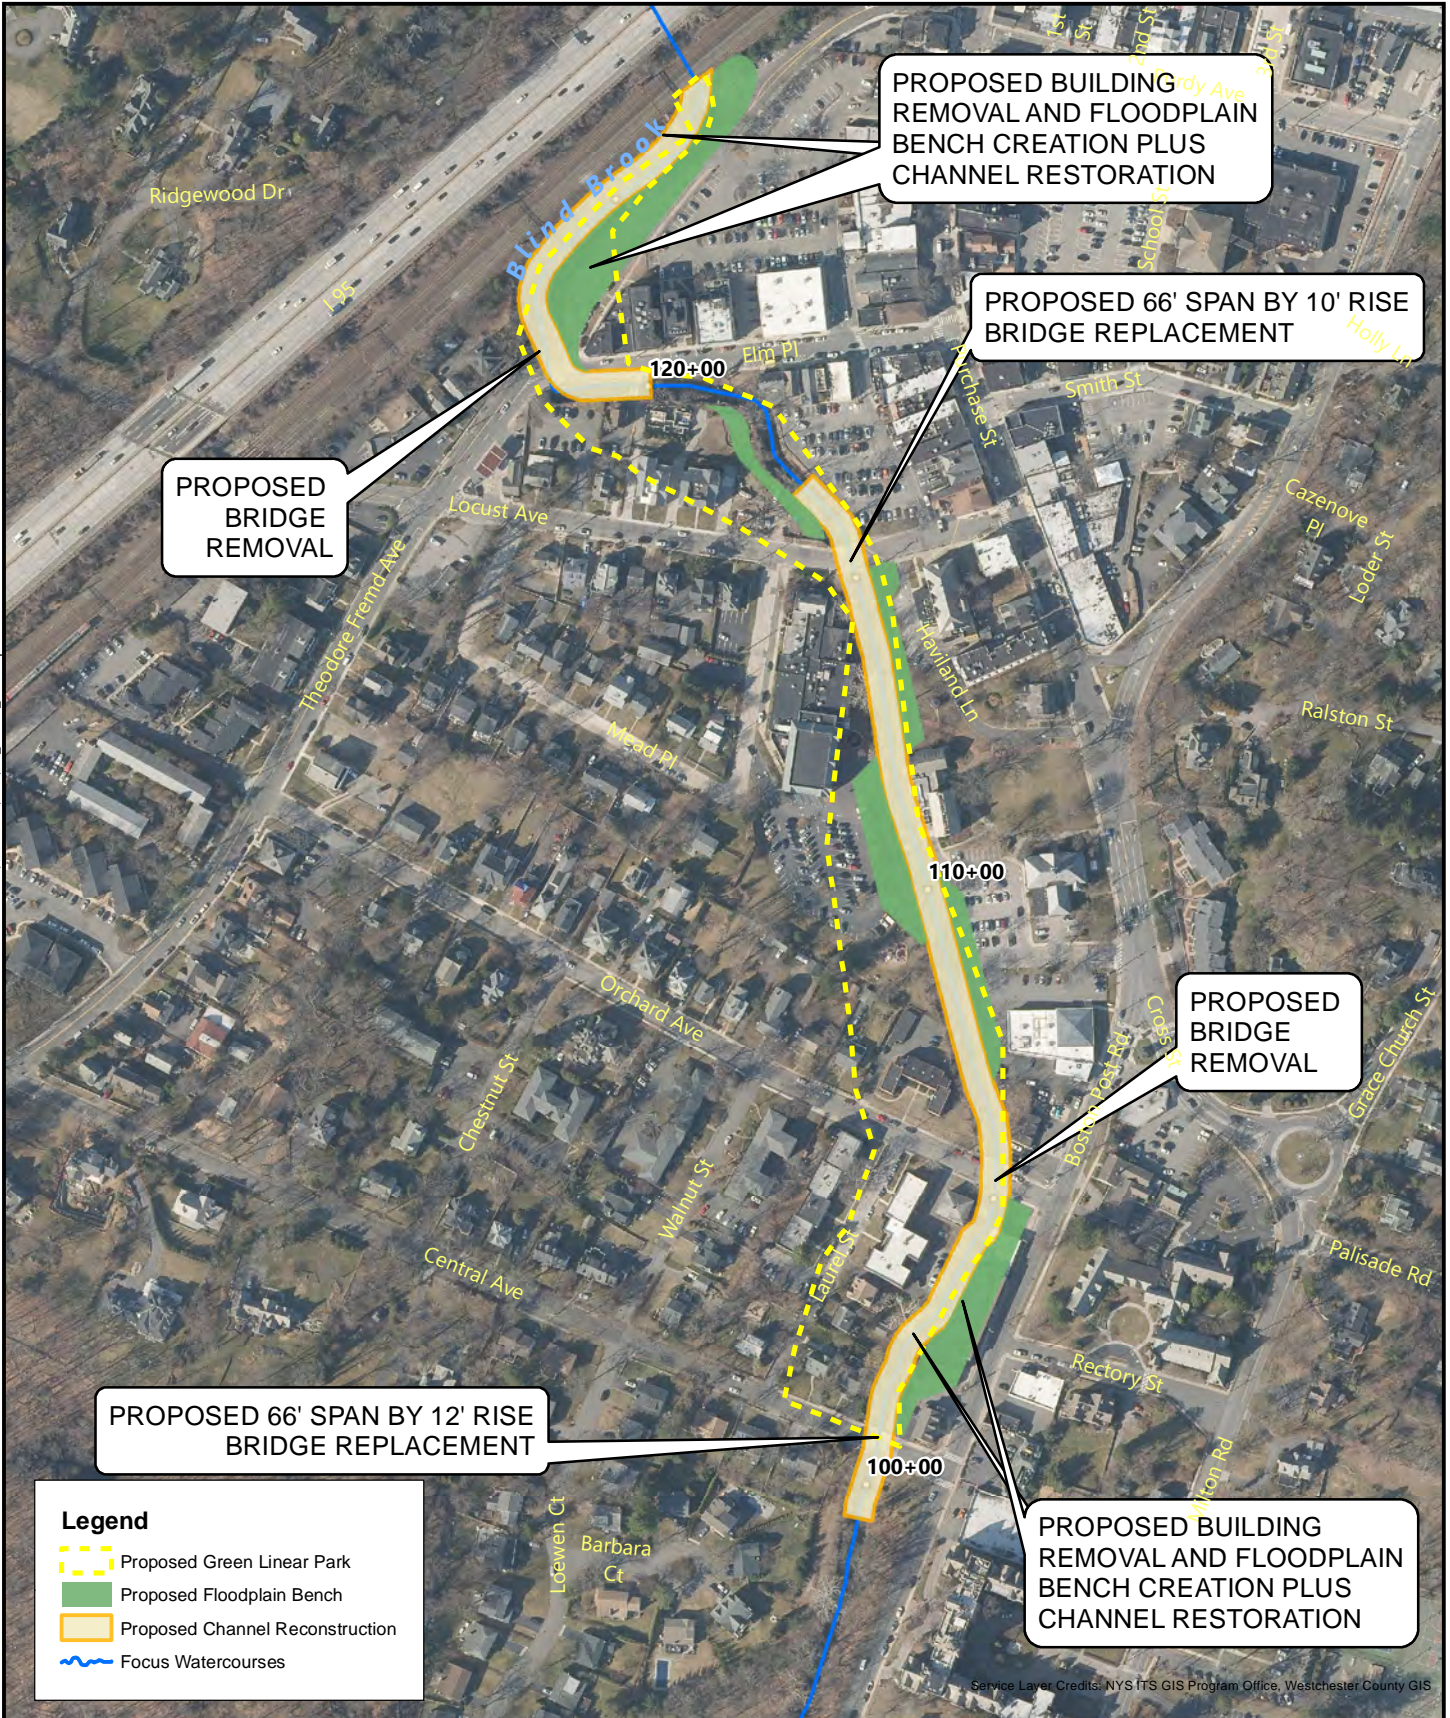
**FIG. 4-39**

The concept map on Figure 4-39 illustrates the recommended floodplain bench locations and replacement bridges that were assessed. The long-term recommendation to create a linear riparian park along Blind Brook is indicated in concept by the dashed lines on Figure 4-39.

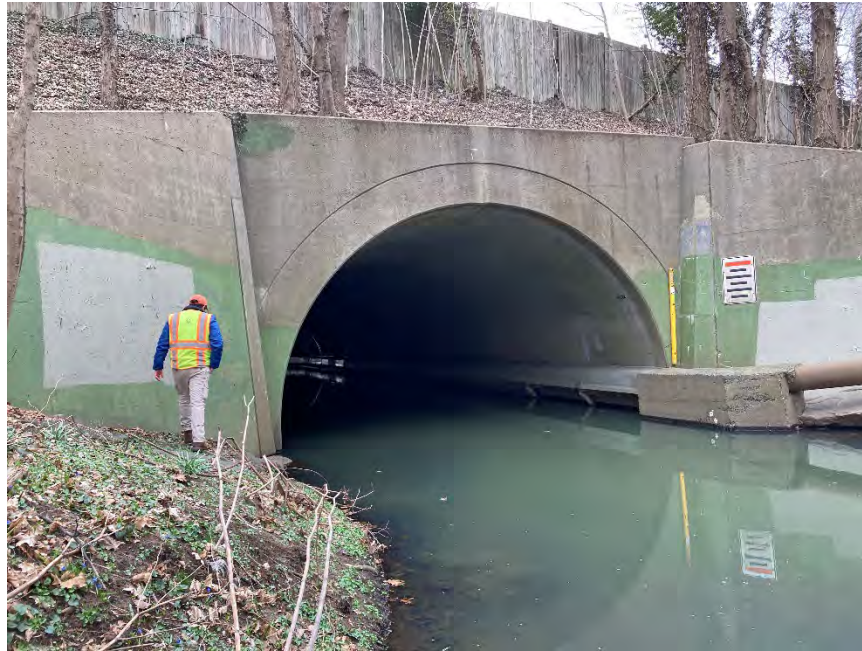
The structure transporting Blind Brook under the Metro-North (MTA) railroad and I-95 at STA 129+00 is a single concrete arch bridge approximately 25 feet wide by 16 feet high (Figure 4-47). The Metro-North railroad tracks have been in operation since the late 1840s, serving commuters as part of the New York-New Hampshire transportation line. The NYS I-95 highway crossing was installed in the 1950s immediately upstream of the rail line, and the arch bridge carrying Blind Brook was extended an additional 115 feet to the north.

**Figure 4-47: Looking downstream at the Metro-North/I-95 bridge**

The railroad and roadway top sits over 20 feet above the top of the arch bridge and are not overtopped in even the largest modeled flood events. Rather, the crossing and its embankments are shown to back up and impound water, resulting in water surface elevations ranging from 3.5 feet to 6.8 feet higher than the unobstructed 10-year and 100-year flood events, respectively. This backwater impact is shown to carry upstream for approximately 1 mile before it fully diminishes. Inundation of homes adjacent to Blind Brook begins at the modeled 10-year flood event and is shown to engulf several of the homes off Highland Road to the west and Wappanocca Avenue to the east during the 50-year and 100-year flood events. Under future flow conditions, flooding is modeled to be more severe at homes currently mapped within the 100-year floodplain and would extend to other homes currently mapped near the fringes.

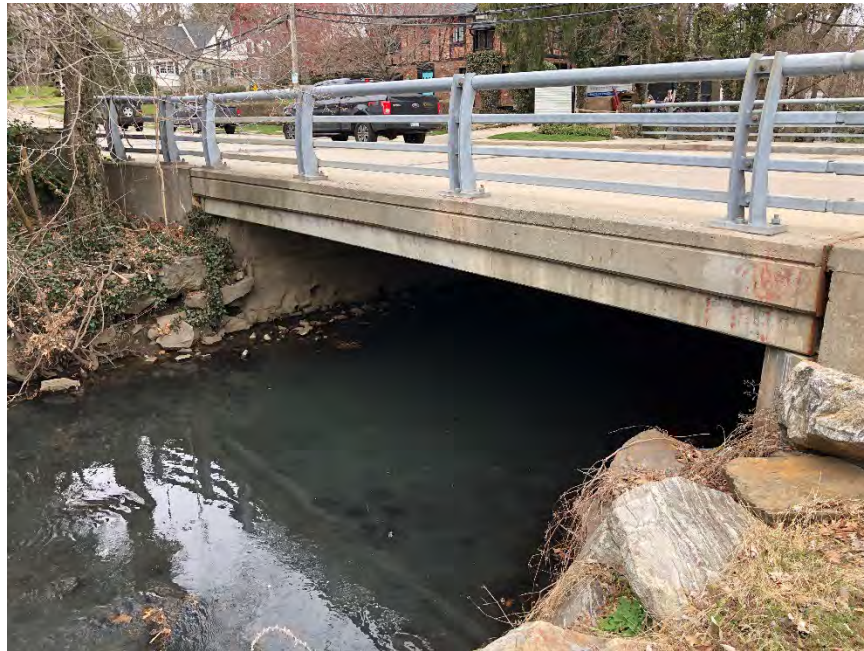
**Figure 4-54: Looking upstream at the Highland Avenue bridge**

The structure carrying Highland Avenue over Blind Brook at STA 137+06 is a 31-foot-wide by 7-foot-high open-deck bridge built in 1989 (Figure 4-54). In its current configuration, with a tailwater influence from the downstream MTA/I-95 arch bridge located 700 feet downstream, it is only able to pass the existing 10-year flood event with no freeboard. The bridge is shown to overtop in the future 10-year flood event with about a foot of water. The Highland Avenue bridge sees little benefit from the removal of the tailwater condition downstream, indicating that the bridge itself is hydraulically inadequate to convey flood flows on Blind Brook and acts as a constriction. Assuming no tailwater influence from the MTA/I-95 crossing (i.e., assuming the MTA/I-95 arch bridge has been replaced with an adequately sized span), the Highland Avenue bridge increases upstream water surface elevations by 1.2 feet in the existing 10-year flood event and 2.2 feet in the existing 100-year flood event. The backwater from the bridge extends upstream until reaching the bridge under Purchase Street at STA 165+00.

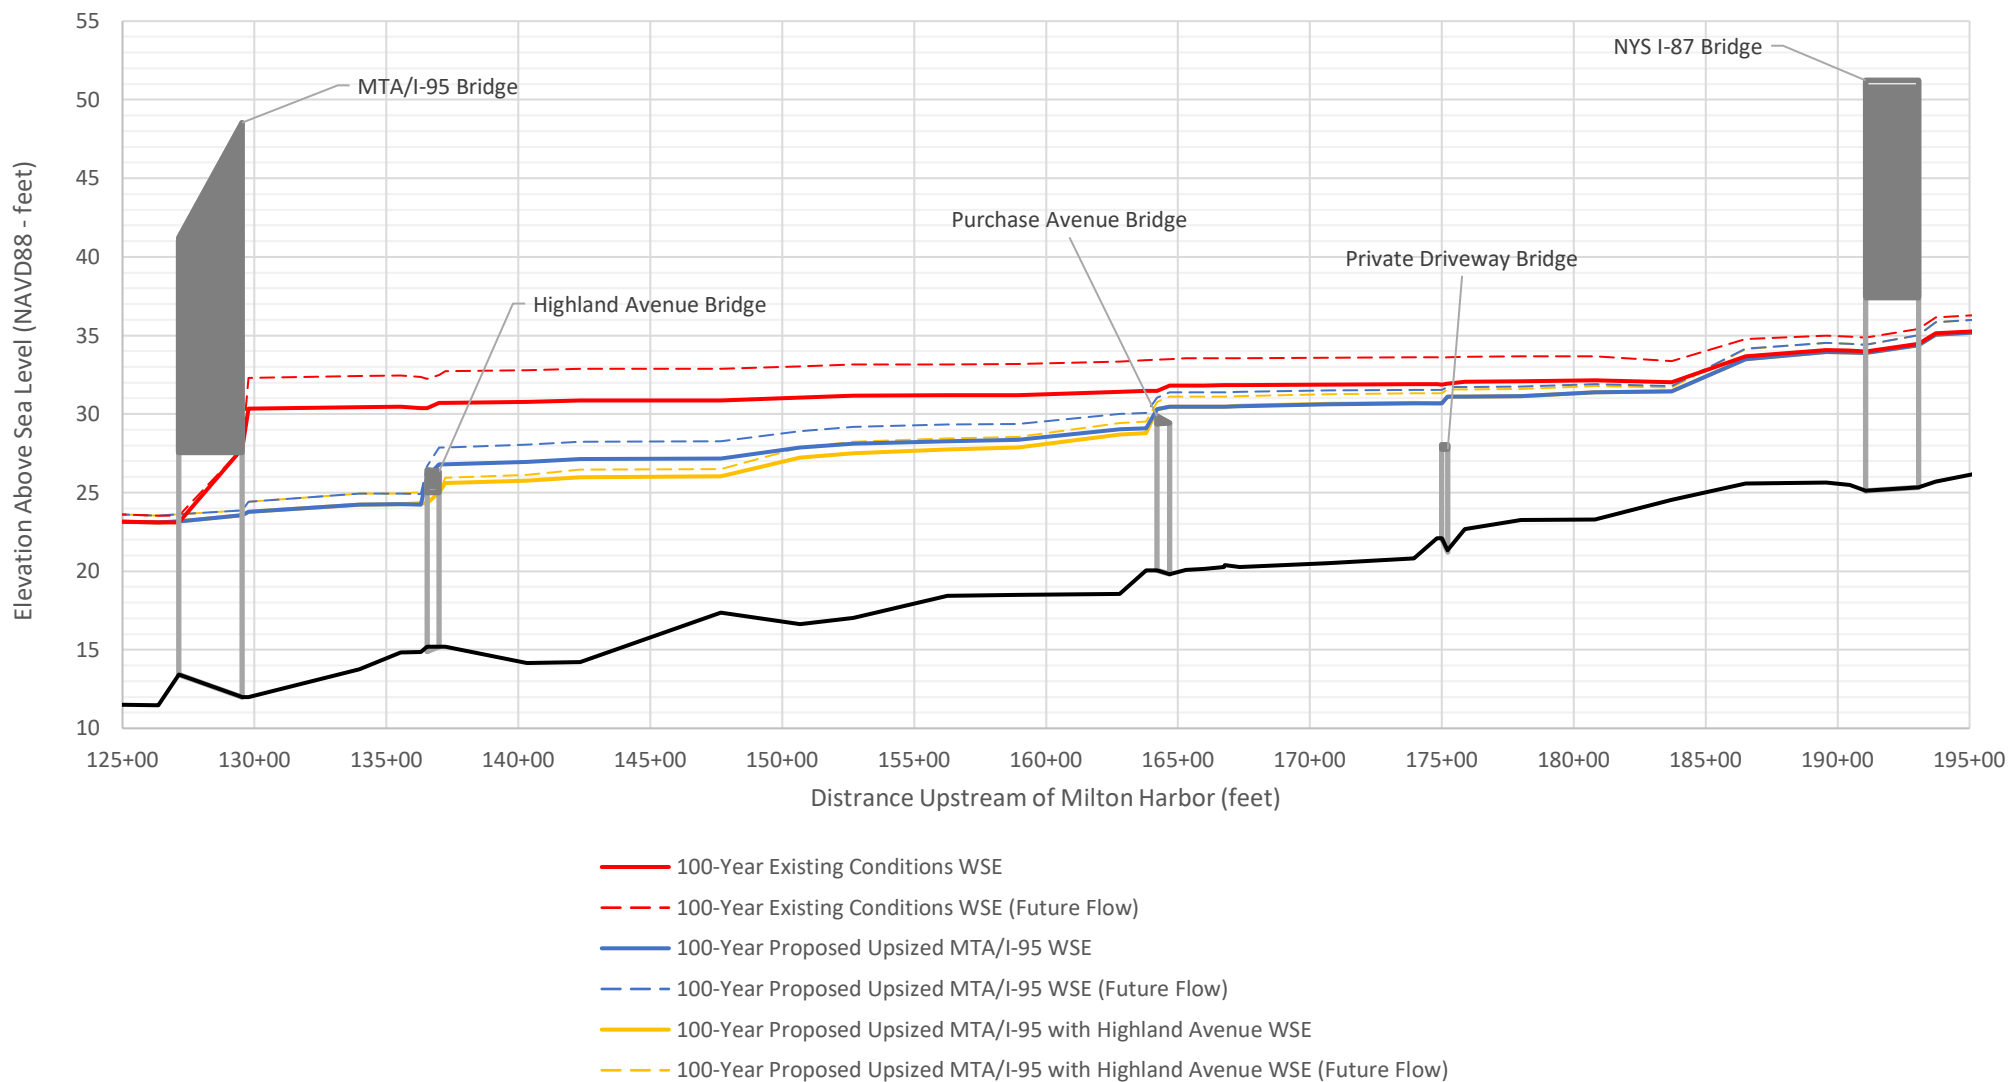
**Figure 4-59: Blind Brook Profile for 50-Year Flows Under Current Conditions and After Adjusting Structures Through HRA 3**

A longitudinal profile with water surface elevations in HRA 3 during the 50-year flood event is shown on Figure 4-59. A profile with water surface elevations during the 100-year flood event is shown on Figure 4-60. In both profiles, water surface elevations are shown 1) under existing conditions; 2) with the replacement of the MTA/I-95 arch bridge with a 60-foot-wide bridge; and 3) with the replacement of the MTA/I-95 arch bridge with a 60-foot-wide bridge and the replacement of the Highland Avenue crossing with a 45-foot-wide bridge.

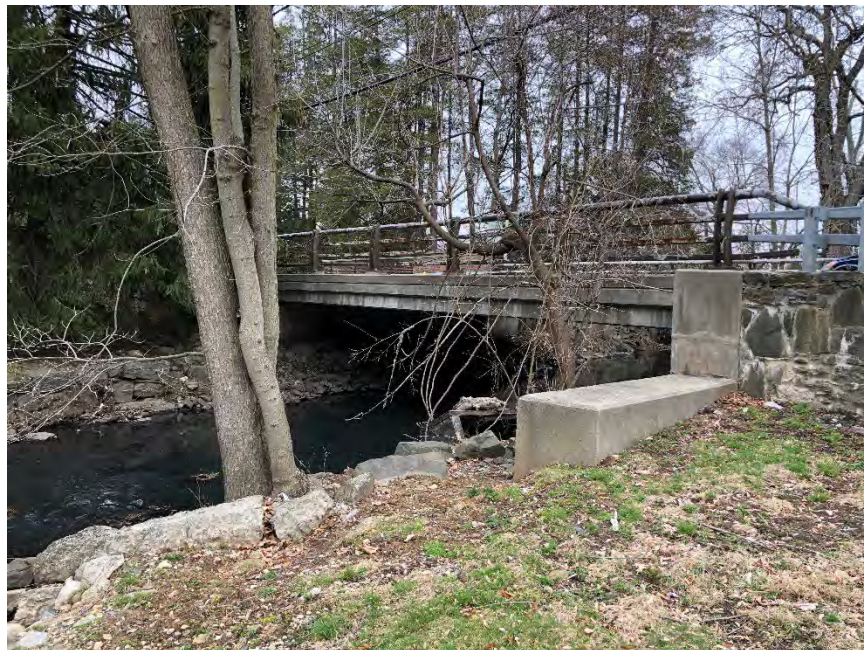
Figure 4-61: Looking upstream at the Purchase Street bridge

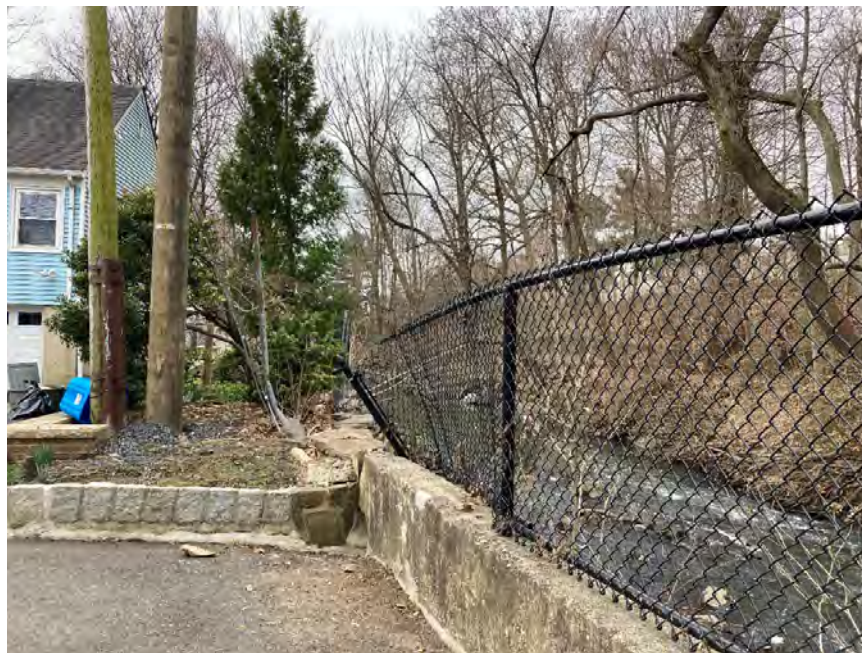
**Figure 4-62: Blind Brook as it flows adjacent to Wyman Street**
