# FLOOD MITIGATION & RESILIENCE REPORT

## Blind Brook - SD 969 mod 1

New York State Department of Environmental Conservation,  
in cooperation with the New York State Office of General Services

November 2022

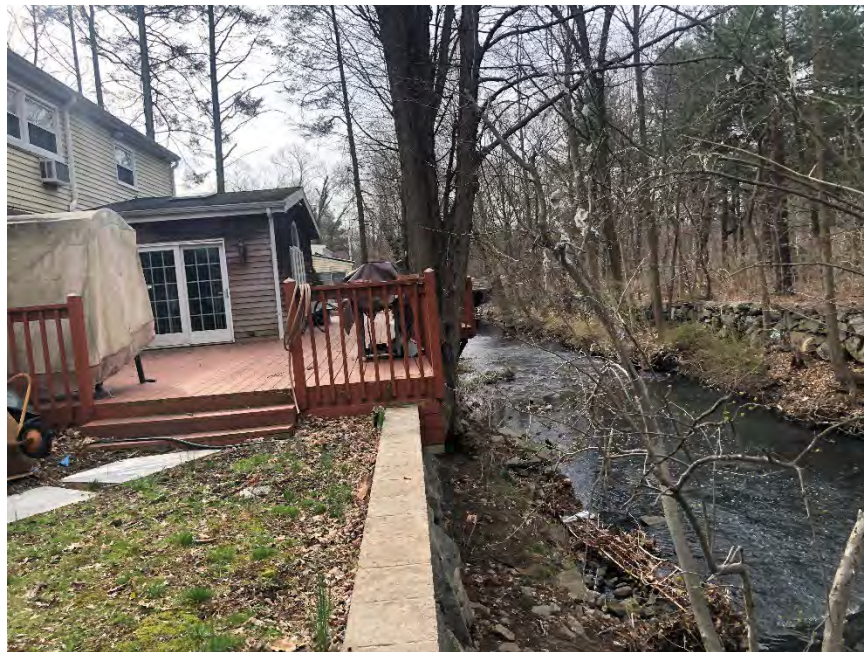
HRA 4 encompasses the section along Blind Brook between STA 240+00 and STA 265+00 in the village of Rye Brook and the town of Harrison. The brook flows through a trapezoidal channel for most of this section and is tightly squeezed between backyards on the east (Figure 4-64) and a parking lot to the west. Flooding was assessed at the Brook Lane neighborhood, which accounts for 20 percent of documented repetitive losses in the village of Rye Brook. Many of the homes along the left bank of the brook have been severely flooded, most recently being from the remnants of Tropical Storm Ida in 2021, where residents had to be rescued from their flooded homes by local emergency services. Brook Lane residents and village officials, in collaboration with NRCS, are working to explore flood mitigation action alternatives, including the potential for property buyouts and a floodplain bench reclamation project. SLR conducted a site walk of the neighborhood with representatives from the village and NRCS to step through their vision and document past flood damage. The Westchester Avenue bridge at STA 241+55 was also evaluated for hydraulic competency and its effect on flooding at the upstream community. A map of HRA 4 is illustrated in Figure 4-65.

**Figure 4-64: Blind Brook as it flows adjacent to homes on Brook Lane**

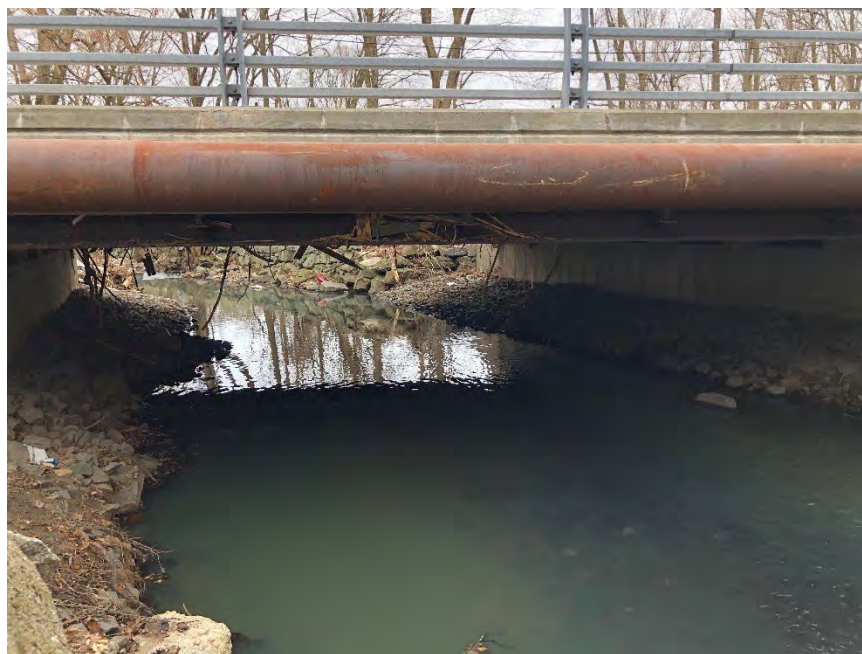
The Westchester Avenue bridge spanning Blind Brook (STA 241+55), shown in Figure 4-66, is an open-deck bridge that measures 40 feet wide and has a vertical opening of about 7 feet. The bridge was built in 1997. In the hydraulic model, this structure is shown to pass all modeled current and future storm events without overtopping. The model indicates that a foot of freeboard would exist in the current and future 10-year flood events. Floodwaters would encounter the bridge's low chord starting at the existing 50-year flood event. The bridge is shown to be a moderate constriction during the 100-year flood event by increasing upstream water surface elevations by 2 feet. According to the observations made during a site visit, flooding at the Brook Lane neighborhood during Tropical Storm Ida resembled the severity and flooding extent of a 500-year storm event. Several of the homes immediately adjacent to the brook experienced over 3 feet of flooding at spots, and a few homes to the east of Brook Lane also experienced shallow flooding. This flooding condition is only observed during a 500-year event and therefore was also considered in the evaluation of mitigation design alternatives.

**Figure 4-66: Looking downstream at the Westchester Avenue bridge over Blind Brook. A significant amount of woody debris is seen underneath the bridge deck, indicative of flood flows reaching the bridge's low chord.**

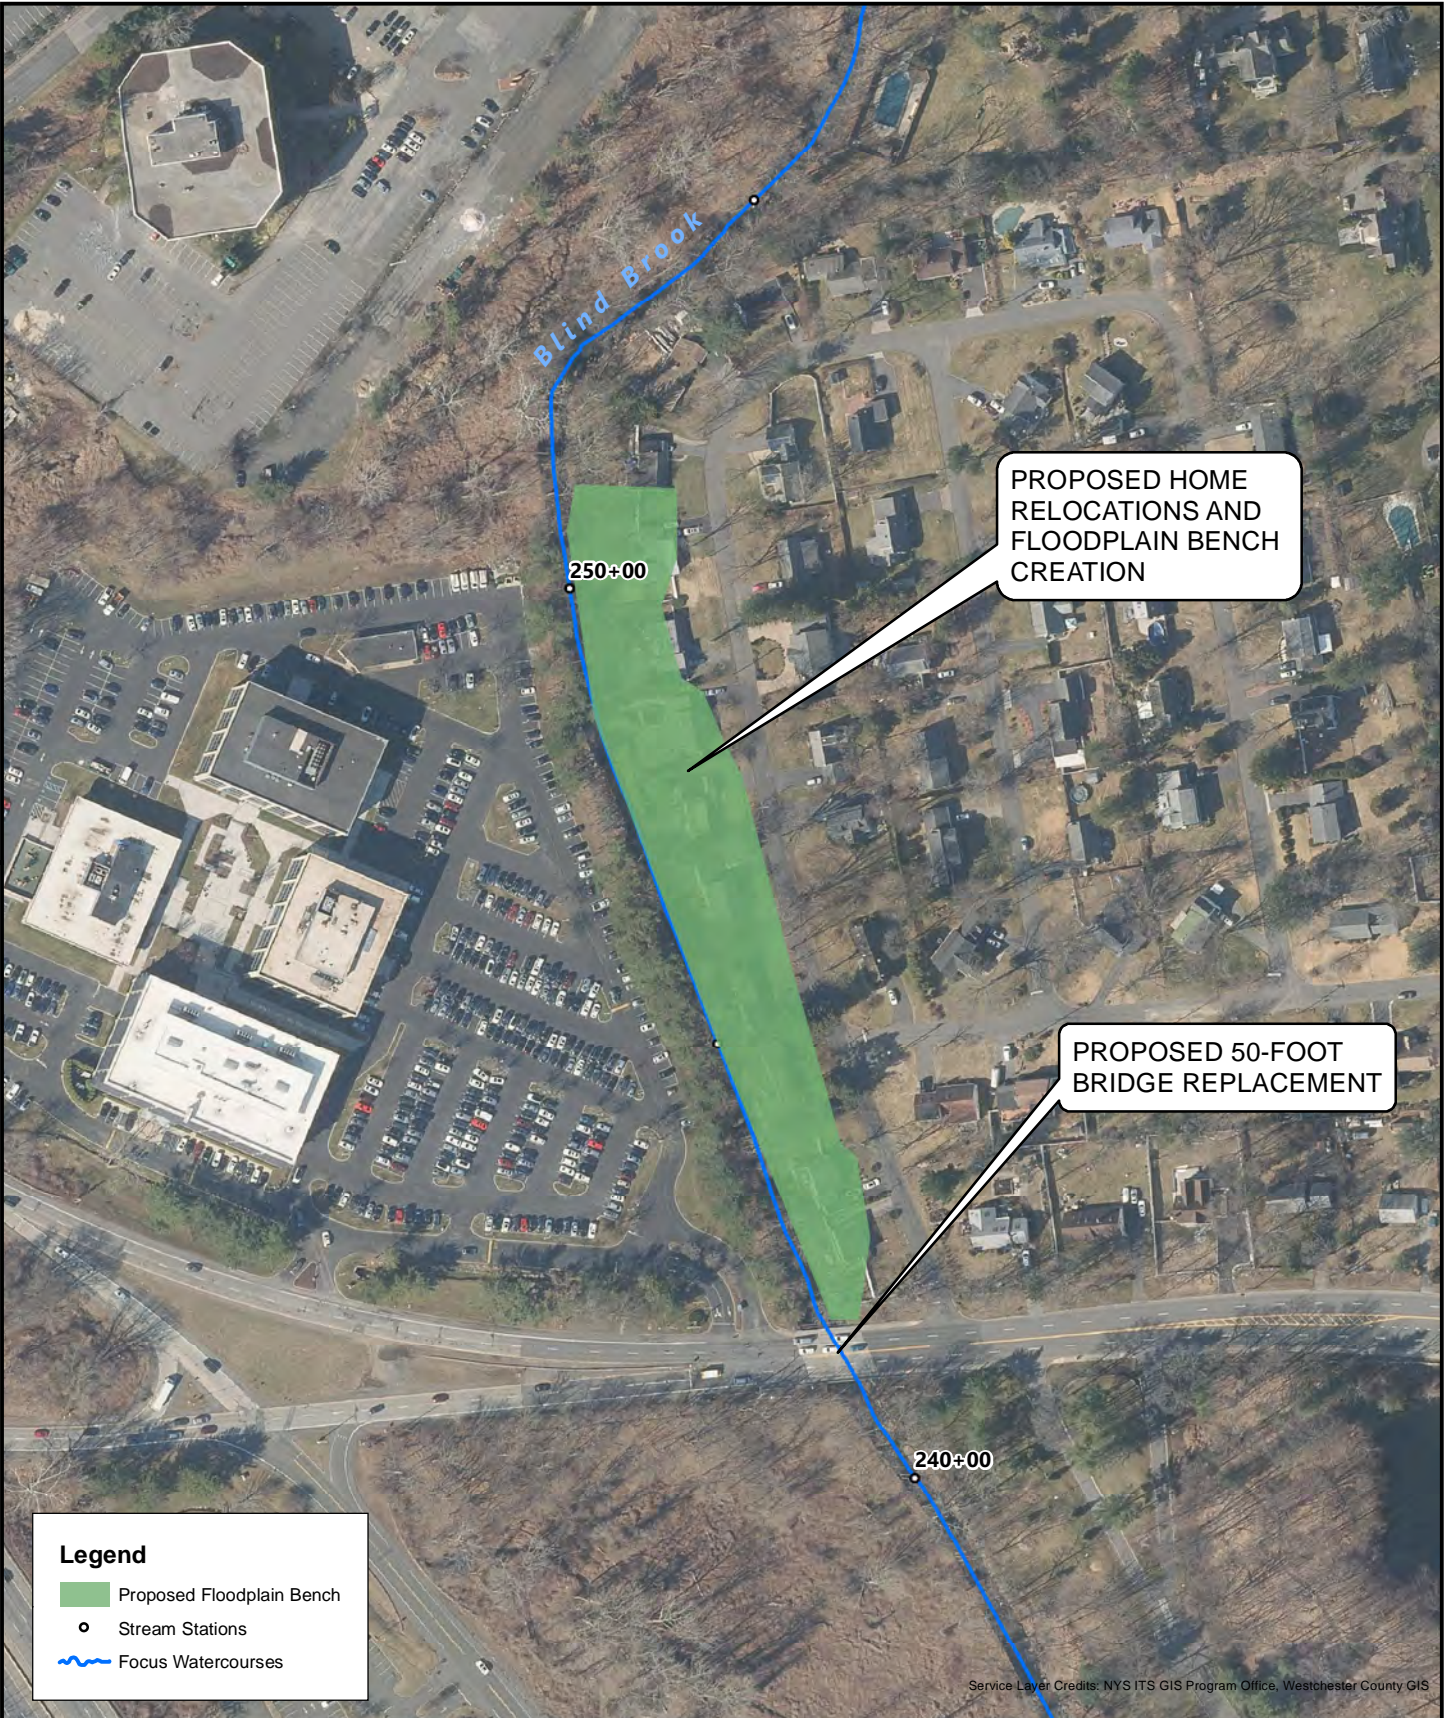
**FIG. 4-67A**

Alternatively, a floodplain bench along the river right bank across from the Brook Lane neighborhood was investigated. The proposed floodplain would measure approximately 130 feet at its widest, 731 feet long, excavated between 1.5 to 5.0 feet below existing ground. The floodplain bench would consume a portion of a commercial parking lot within the town of Harrison. Assuming replacement of the Westchester Avenue bridge, the resulting flood reductions are almost identical to the floodplain bench scenario discussed above. Although flooding is shown to be reduced, it would not eliminate flooding at three to five homes next to Blind Brook. This suggests that a floodplain bench on the river right bank, in conjunction with replacement of the Westchester Avenue bridge, can potentially reduce the number of home buyouts by nearly half that are required for a floodplain bench on the river left to achieve the same outcome. This alternate floodplain bench concept is presented in Figure 4-67A.

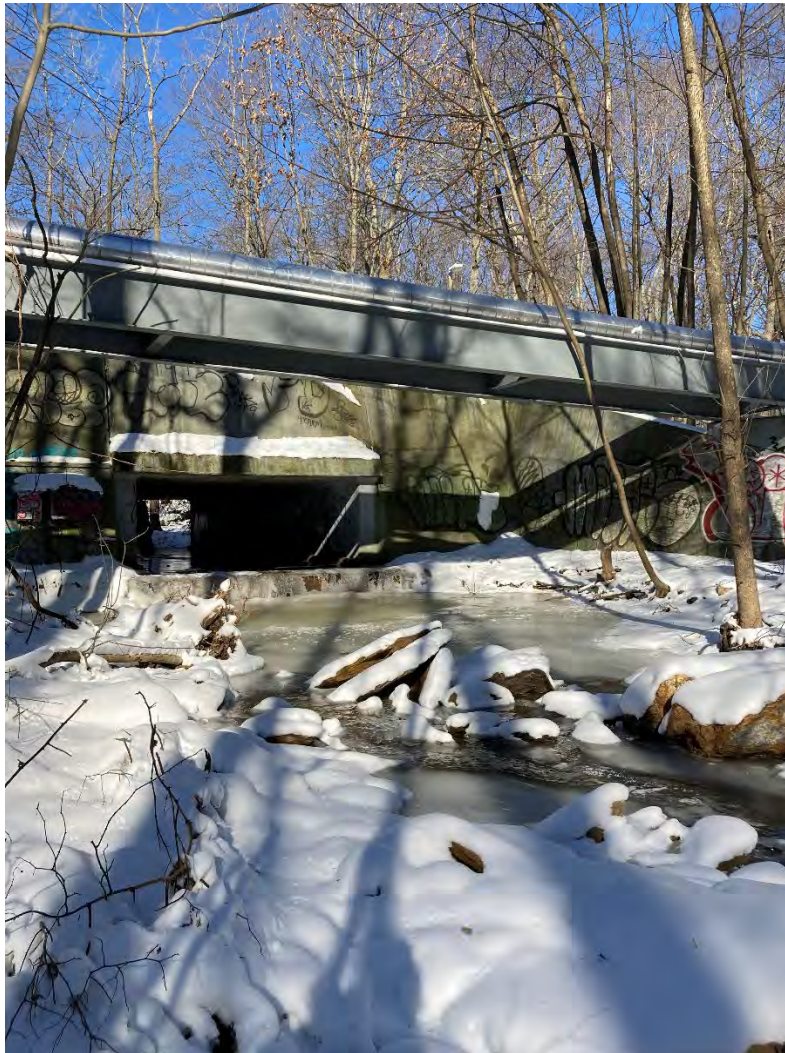
**Figure 4-74: Looking upstream at the Salter Drive culvert. A water line for the SUNY Purchase College Campus Thermal Energy Storage Project runs on the downstream side of the structure.**

The culvert under Salter Drive on Blind Brook is a four-sided concrete box culvert that spans approximately 21 feet and has a 5.5-foot-high opening. At approximately 235 feet upstream, the structure carrying Lincoln Avenue is comprised of four separate corrugated metal pipes that each measure 3 feet in diameter. According to the hydraulic model, the Salter Drive culvert is shown to pass all modeled storm events while the Salter Drive culverts have a capacity of less than the existing 10-year storm event. The model does indicate that the Lincoln Avenue culverts flank to the left (east) and would divert water away from the main channel during a flood.

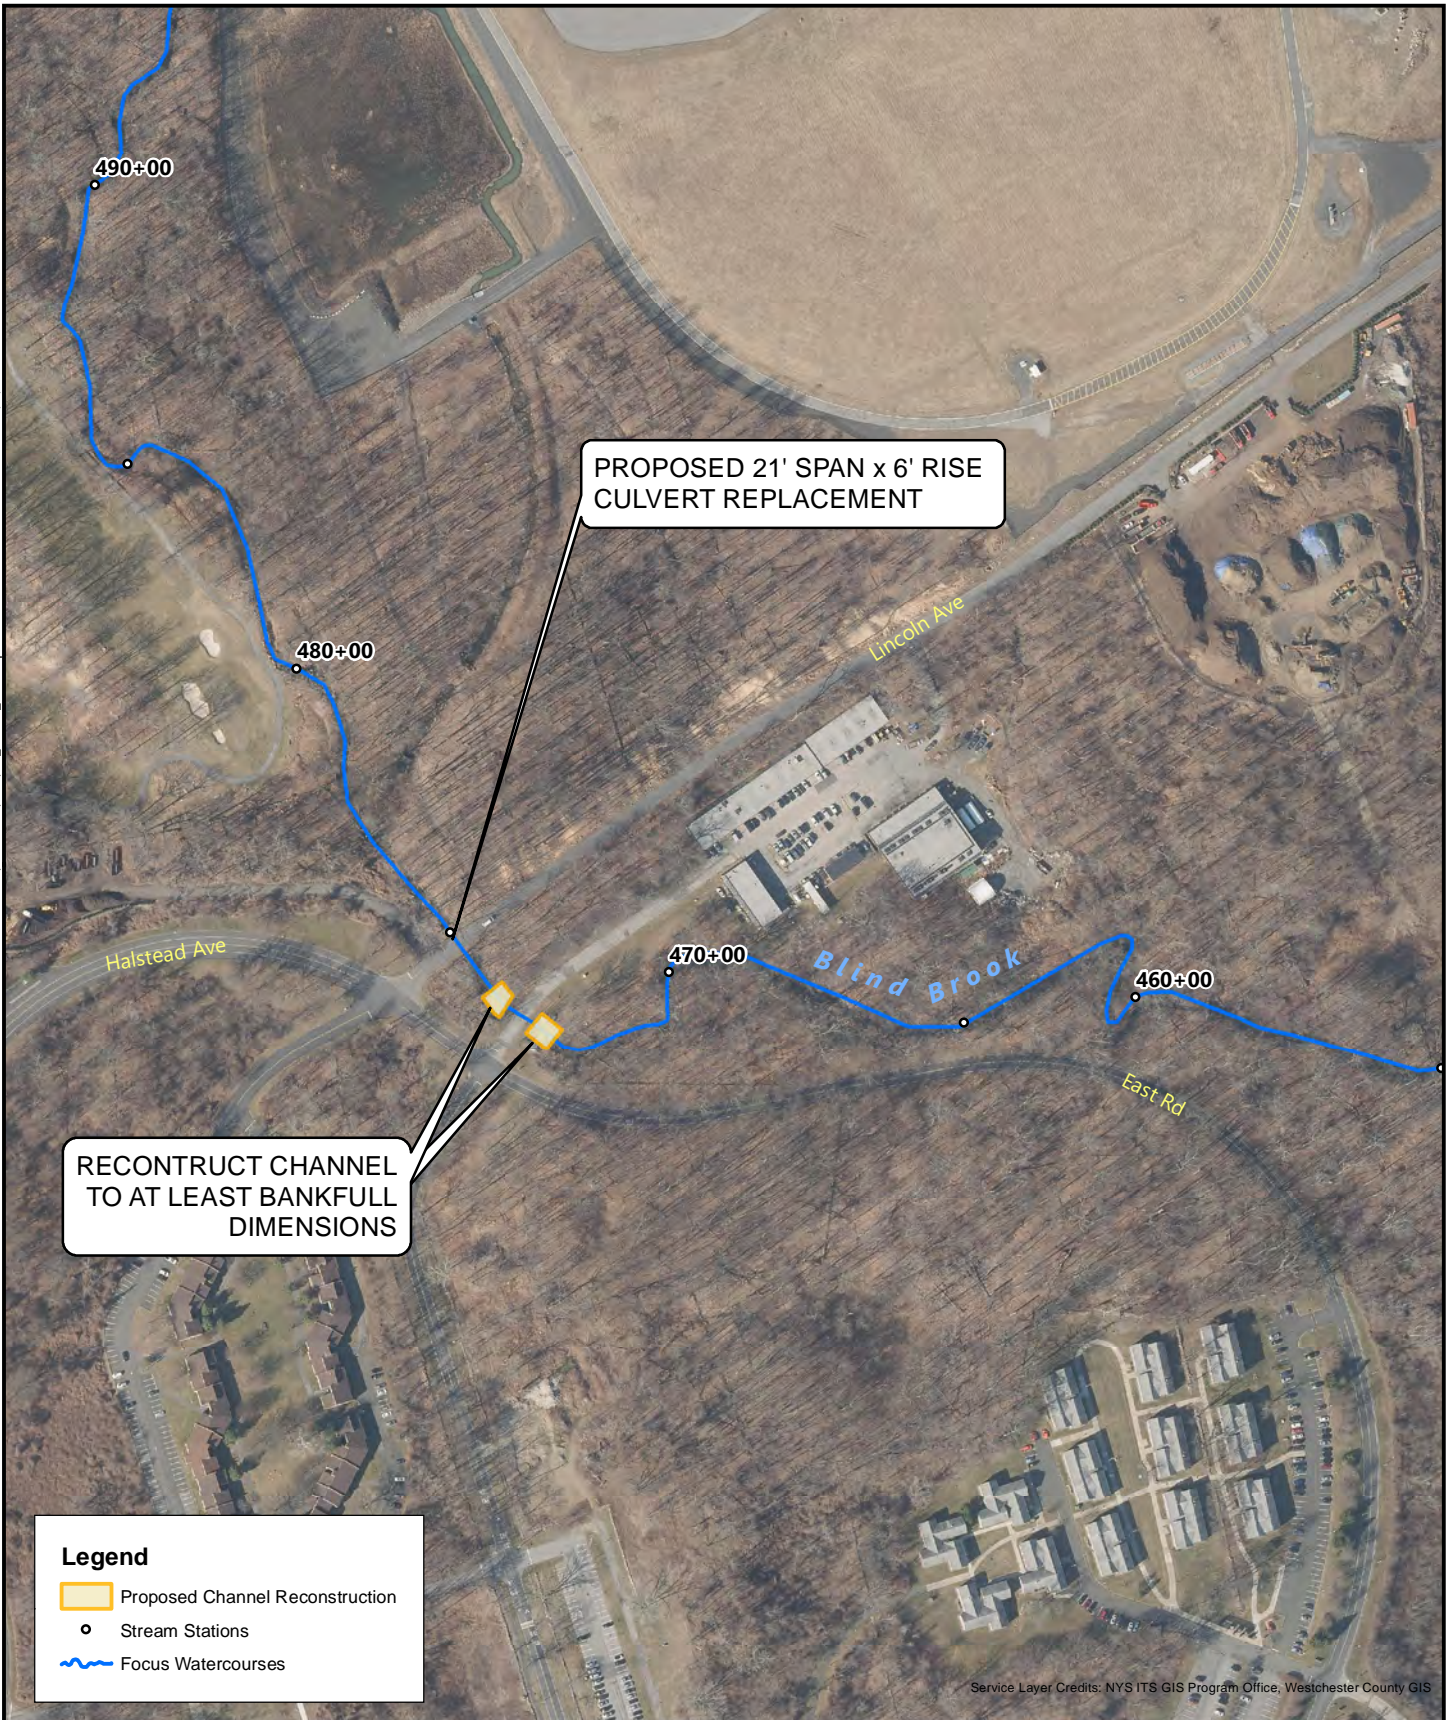
Replacing the culverts under Lincoln Avenue with a single 21-foot-wide by 6-foot-high concrete box would convey the existing and future 100-year storm events. Furthermore, reconstruction of the channel reaches immediately upstream and downstream of Salter Drive to at least bankfull dimensions would lower water surface elevations at the culvert and further contain floodwaters within the channel. The Salter Drive culvert itself does not appear to exacerbate flooding, and inspection and maintenance of the structure is proposed until due for replacement. A rigorous hydrologic and hydraulic analysis is recommended for each structure in HRA 5 when it is due for routine replacement to ensure that each bridge is adequately sized to convey flood flows and does not contribute to flooding of the SUNY Purchase College buildings. Furthermore, it is recommended that a stormwater runoff feasibility study be undertaken to explore stormwater mitigation techniques that will reduce flooding caused by excess upland runoff and inadequate roadside drainage along Lincoln Street. Figure 4-76 illustrates a concept map for HRA 5.

RECONSTRUCT CHANNEL  
TO AT LEAST BANKFULL  
DIMENSIONS

PROPOSED 21' SPAN x 6' RISE  
CULVERT REPLACEMENT

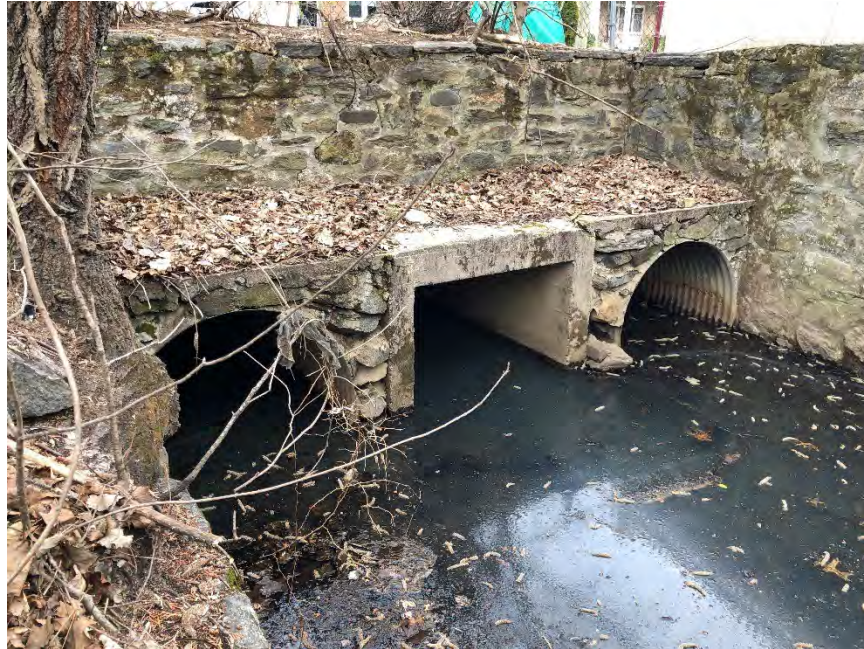
The structures under Argyle Road (STA 60+90) and Betsy Brown Road (STA 65+80) are both comprised of three separate conduits. Argyle Road contains a 4-foot by 4-foot concrete box culvert at its center and two 3-foot-diameter corrugated metal pipes on either side (Figure 4-78). Carrying Betsy Brown Road over East Branch Blind Brook are two 4-foot-diameter corrugated metal pipes and a partially collapsing stone box culvert that is approximately 3 feet wide by 4 feet high (Figure 4-79). Two lengthy 6-foot-diameter corrugated metal pipes run under Acker Drive (Figure 4-80). The Acker Drive culvert outlet is located near STA 72+45 and extends upstream for about 270 feet to its inlet at STA 75+00. Based on hydraulic analysis, all culverts are shown to overtop in the current 10-year flood event.

Figure 4-78: Looking upstream at the culvert structure under Argyle Road

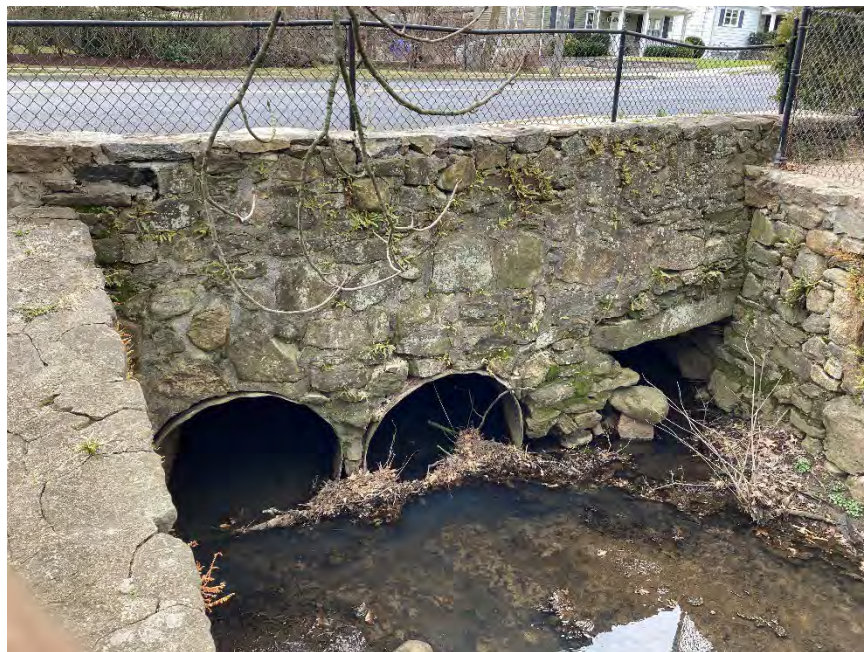
Figure 4-79: Looking downstream at the culvert structure under Betsy Brown Road

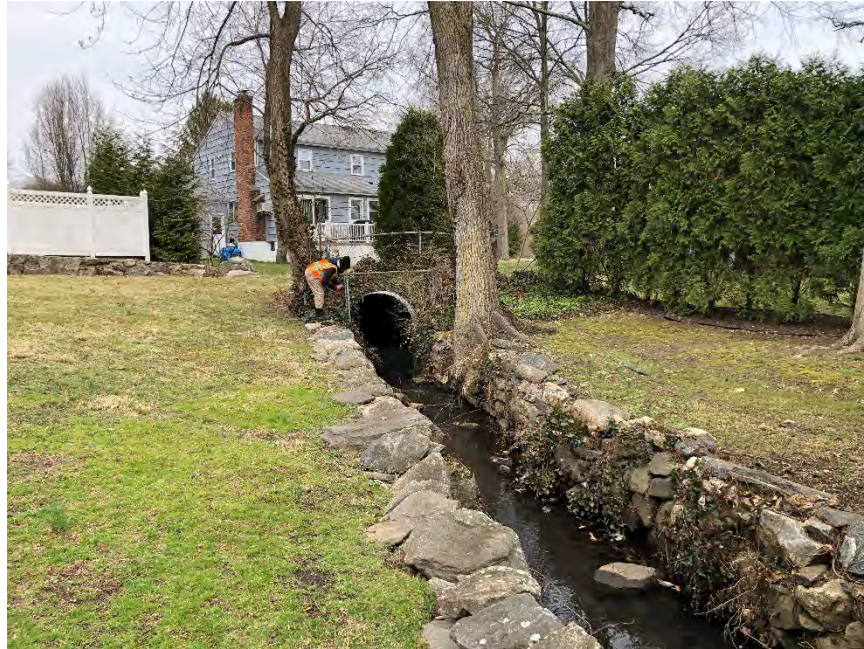
**Figure 4-80: Looking upstream at the outlet of the culverts that run under Acker Drive. The stream is channelized behind the backyards of homes for most of its length as depicted.**

Given the length of the Acker Drive culvert, it is also suggested to daylight the stream channel where it is not required to run underground. Daylighting the structure would include, at minimum, physically uncovering the culvert, removing it, and restoring the channel. Channel restoration would include excavation of a properly sized, multistage channel and floodplain, installation of grade control structures and/or scour protection measures along the restored channel to prevent channel incision and protect upstream infrastructure, and installation of native plantings.
