Flood Mitigation Report East Branch Delaware River SD 060

Delaware County, New York
January 2021

MMI #7160-01-04

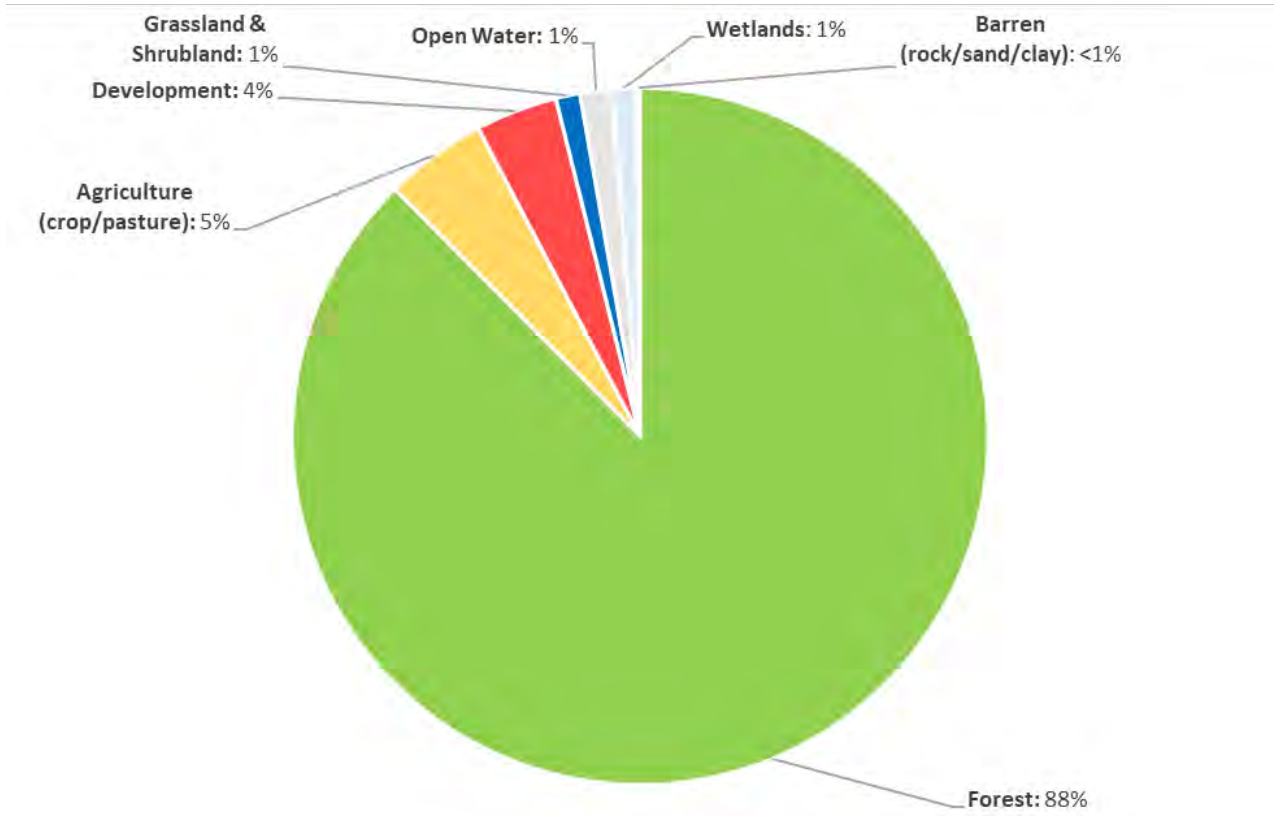
Figure 2-3: Land Cover within the EBDR Watershed

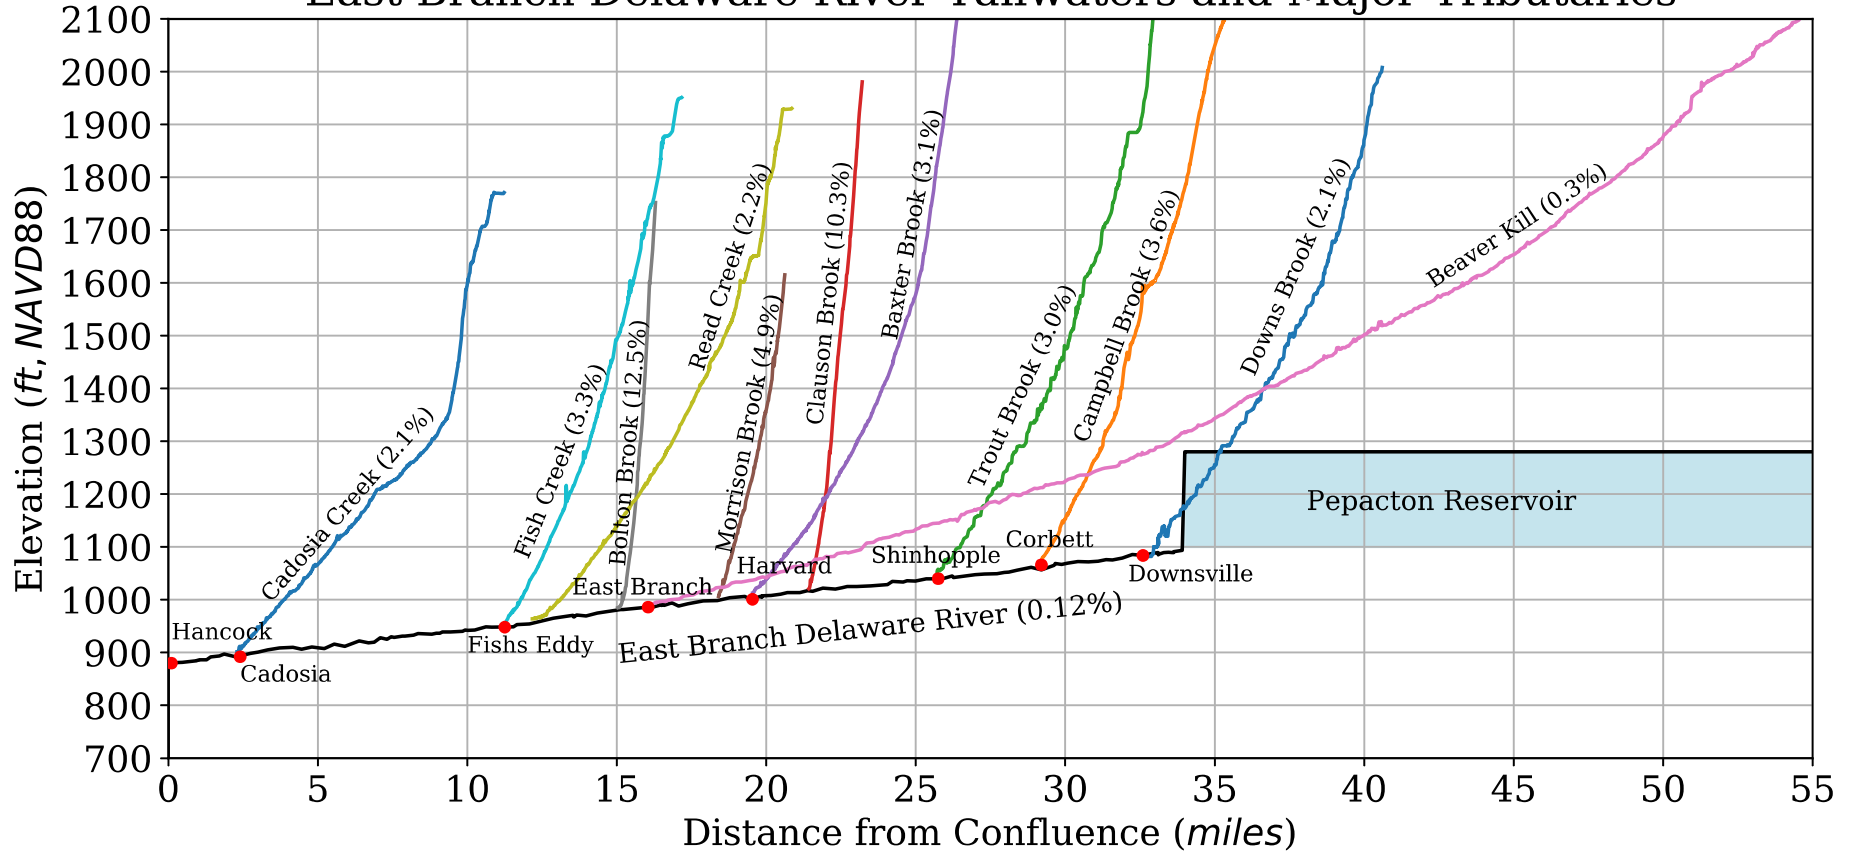
EBDR LONGITUDINAL PROFILE
 EAST BRANCH DELAWARE RIVER FLOOD STUDY - DS060
 FIGURE 2-5

The EBDR channel between Pepacton Reservoir and Hancock has a relatively mild slope, averaging 0.12 percent, or 6.3 feet per mile. Between Downsville and Hancock, a number of steep-gradient tributaries drain into the EBDR. These tributaries have a cobble or boulder substrate and, while small in size, comprise a large percentage of the cumulative length of the EBDR watershed stream network. These tributaries can act as sediment and debris reservoirs wherein coarse sediment and wood are episodically transported to the EBDR channel through erosion and bank failures. These processes can be especially dramatic during flood events. Figure 2-5 depicts the longitudinal profile of the low-gradient EBDR along with the profiles of several steep-gradient tributaries. Encroaching development and infrastructure are susceptible to damage by flooding on the EBDR as well as these dynamic, highly energetic tributaries.

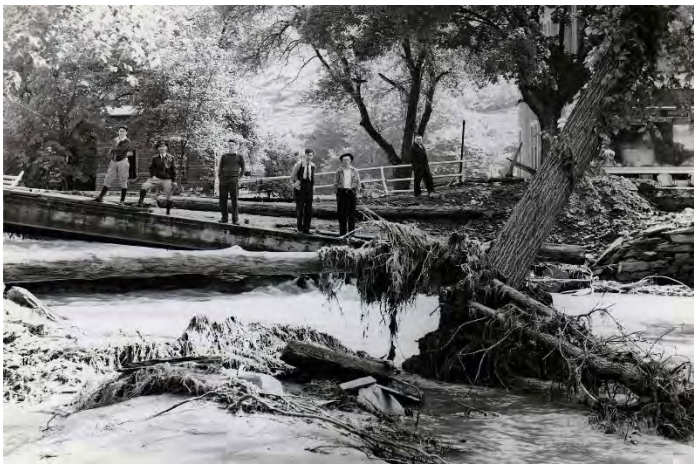
Photo 3-1
Damaged bridge during 1942 flood in Downsville. Courtesy
of Colchester Historical Society, Downsville, New York

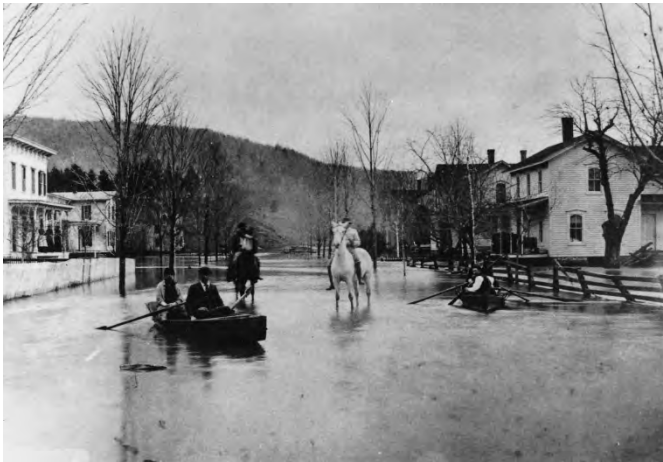
Photo 3-2
Flooding in Downsville, April 1895. Courtesy of Colchester Historical Society, Downsville, New York

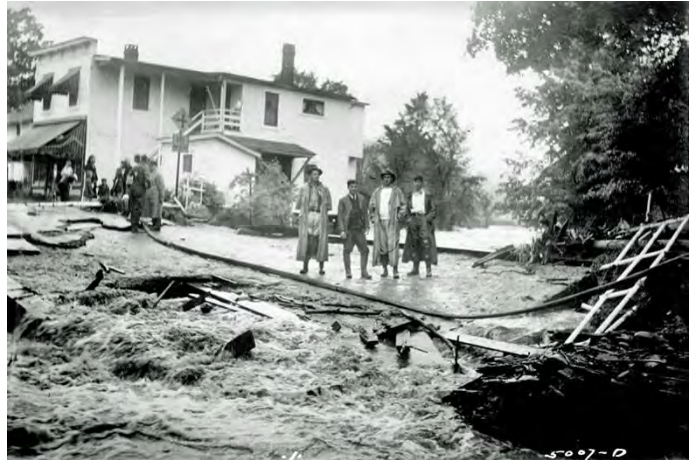
Photo 3-3
Flooding in Downsville, 1942. Courtesy of Colchester Historical Society, Downsville, New York

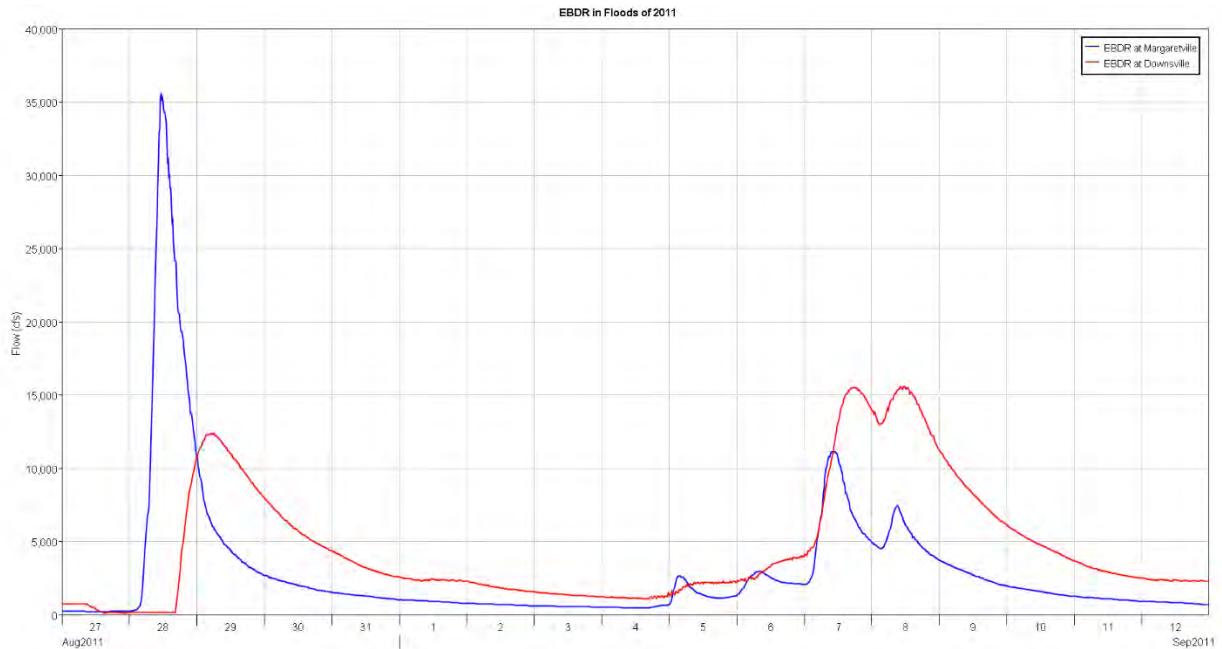
Figure 4-2:
Flow Hydrographs for the EBDR at Margaretville and Downsville during Tropical Storms Irene and Lee, 2011

The graphics presented in Figures 4-2 and 4-3 were created using data from USGS gauging stations and postflood analyses (USGS Scientific Investigations Report 2014–5058, Floods of 2011 in New York, and USGS Open-File Report 2009–1063, Flood of June 26–29, 2006, Mohawk, Delaware, and Susquehanna River Basins, New York). They include hydrographs from USGS gauges located upstream (at Margaretville) and downstream (at Downsville) of the Pepacton Reservoir and demonstrate the dampening of peak flows due to the attenuating effect of the reservoir. Note that these gauged flood hydrographs are only part of the total; in its analysis, the USGS also accounted for the contributions of the several tributaries that meet the EBDR upstream of the dam but downstream of the Margaretville gauge, including those that empty directly into the reservoir. Figure 4-2 is from late August and early September 2011 when Tropical Storms Irene and Lee passed through the region. At the onset of high flows resulting from Tropical Storm Irene, the Pepacton Reservoir was filled to 94.8 percent of its capacity, meaning that the spillway of the dam at the reservoir outlet was not spilling, and there was substantial void space in the reservoir. This available void resulted in a 64 percent attenuation of peak flows. When Tropical Storm Lee arrived in the region 10 days later, the Pepacton Reservoir was full, and as a result, the attenuating effect of the reservoir on EBDR flows was not as great as it had been during Tropical Storm Irene.

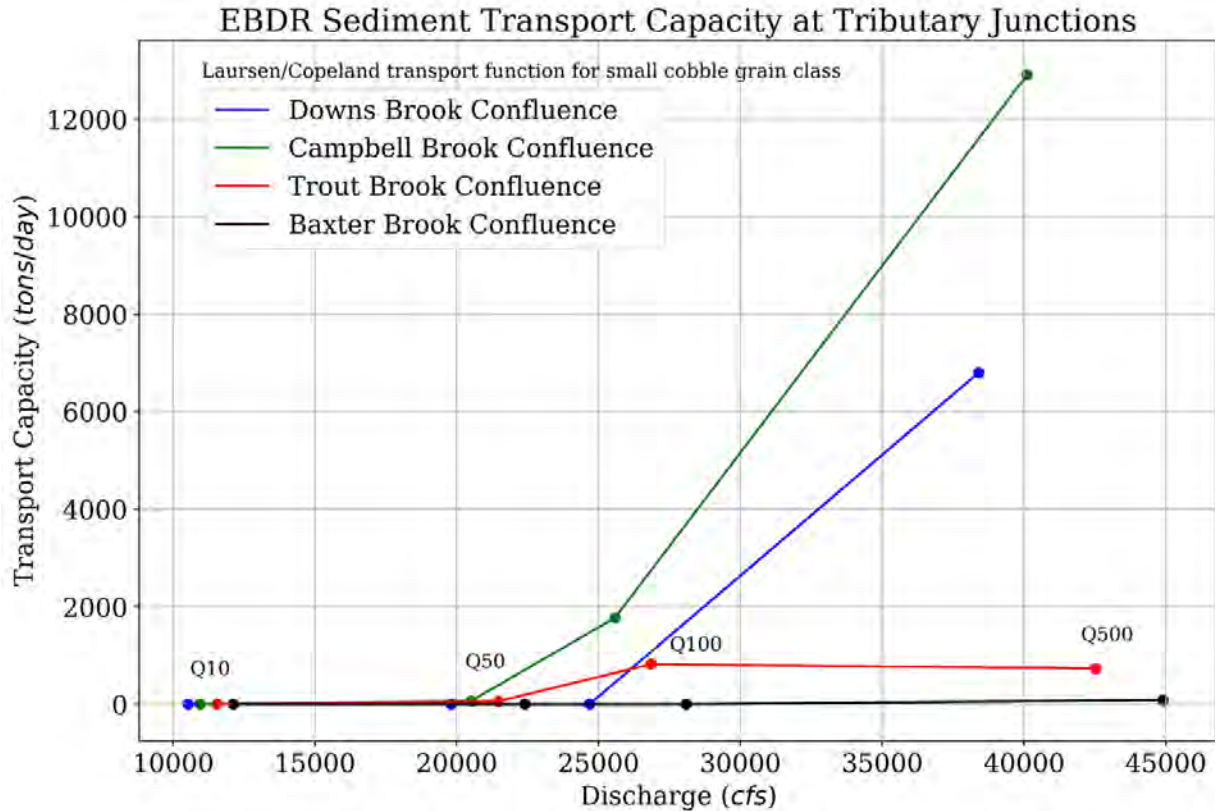
Figure 4-4: Transport capacity of small cobble grain class for the EBDR at representative tributary junctions based on FEMA modeling. Channel and valley characteristics result in some variability in competence in the most severe floods; however, at the reach scale, these coarse particles are essentially immobile in up to the 50-year flood.

Overall, the coarse material within the aggradational features in the EBDR is relatively stable on decadal timescales, which is the case both upstream and downstream of the Pepacton Reservoir. Fundamentally, this is because the river's substrate is nonalluvial in origin, having been delivered to the valley by glacial processes several thousand years ago. Today, these sediments continue to be delivered to the valley floor by tributaries with more unit energy than the EBDR can achieve in the wide, shallow valley it has inherited. Analysis of historical aerial imagery and mapping reveals that the river's anabranch planform and many of the depositional features within the channel have been relatively unchanged over the past 70 to 80 years. The growth of new depositional features unrelated to tributary inputs is generally limited to the slack waters downstream of bridge piers.

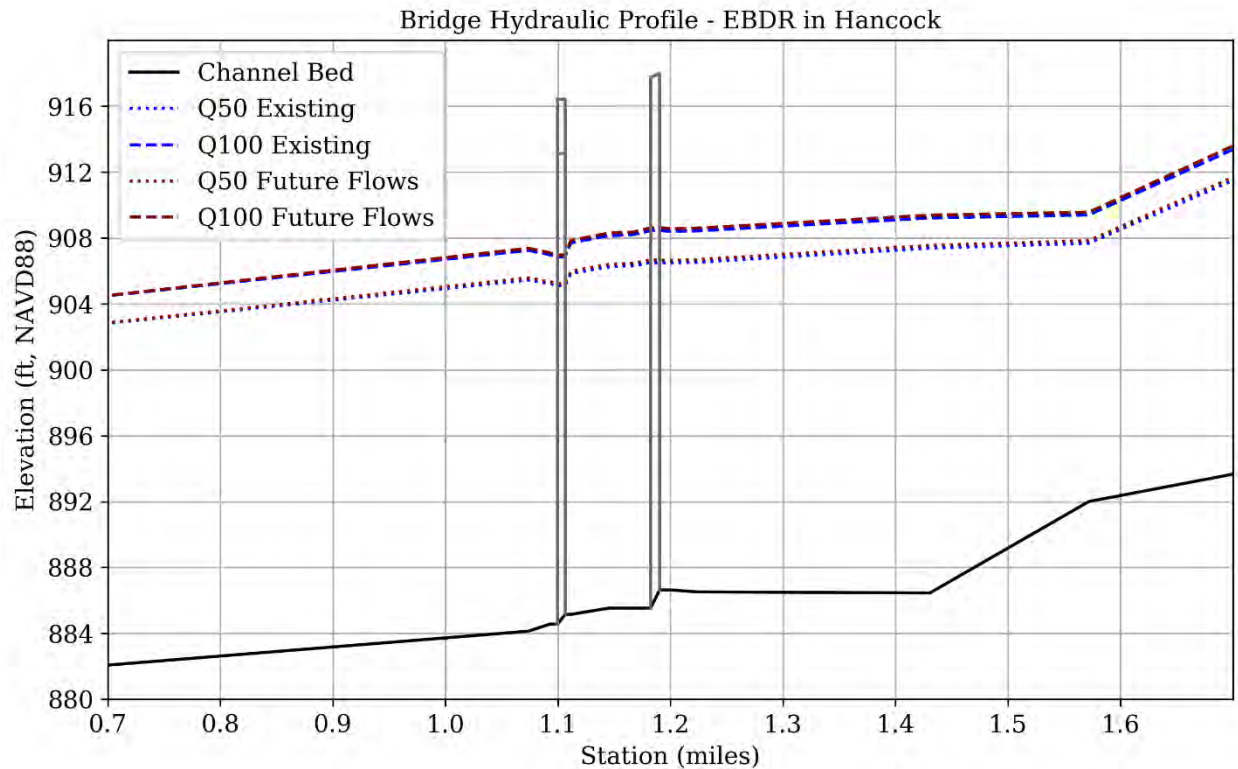
Figure 4-5: 50- and 100-year flood profiles at the Route 97 and NYSW railway bridges in Hancock. Existing and projected future flow scenarios are plotted.

Two bridges span the EBDR in Hancock. The Route 97 bridge, at STA 1.2, (BIN 1035490) was constructed in 2005 and is owned by the NYSDOT. The NYSW Railway Corporation owns a crossing just downstream at STA 1.1. FEMA modeling indicates that neither the Route 97 bridge nor the NYSW railroad bridge contributes to backwater flooding up to the 100-year flood. Both structures are significant hydraulic constrictions in the modeled 500-year flood. La Barre Street and Route 97/Stockport Road are expected to be inundated in the 100-year flood. East of the village, several sections of Peas Eddy Road are also modeled as overtopping in this event. This may leave residents stranded.

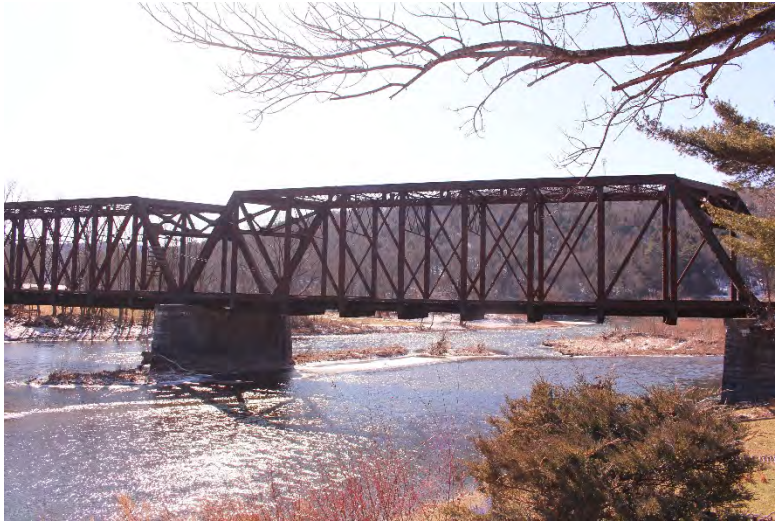
Photo 4-2
Railroad Bridge over the EBDR in Hancock

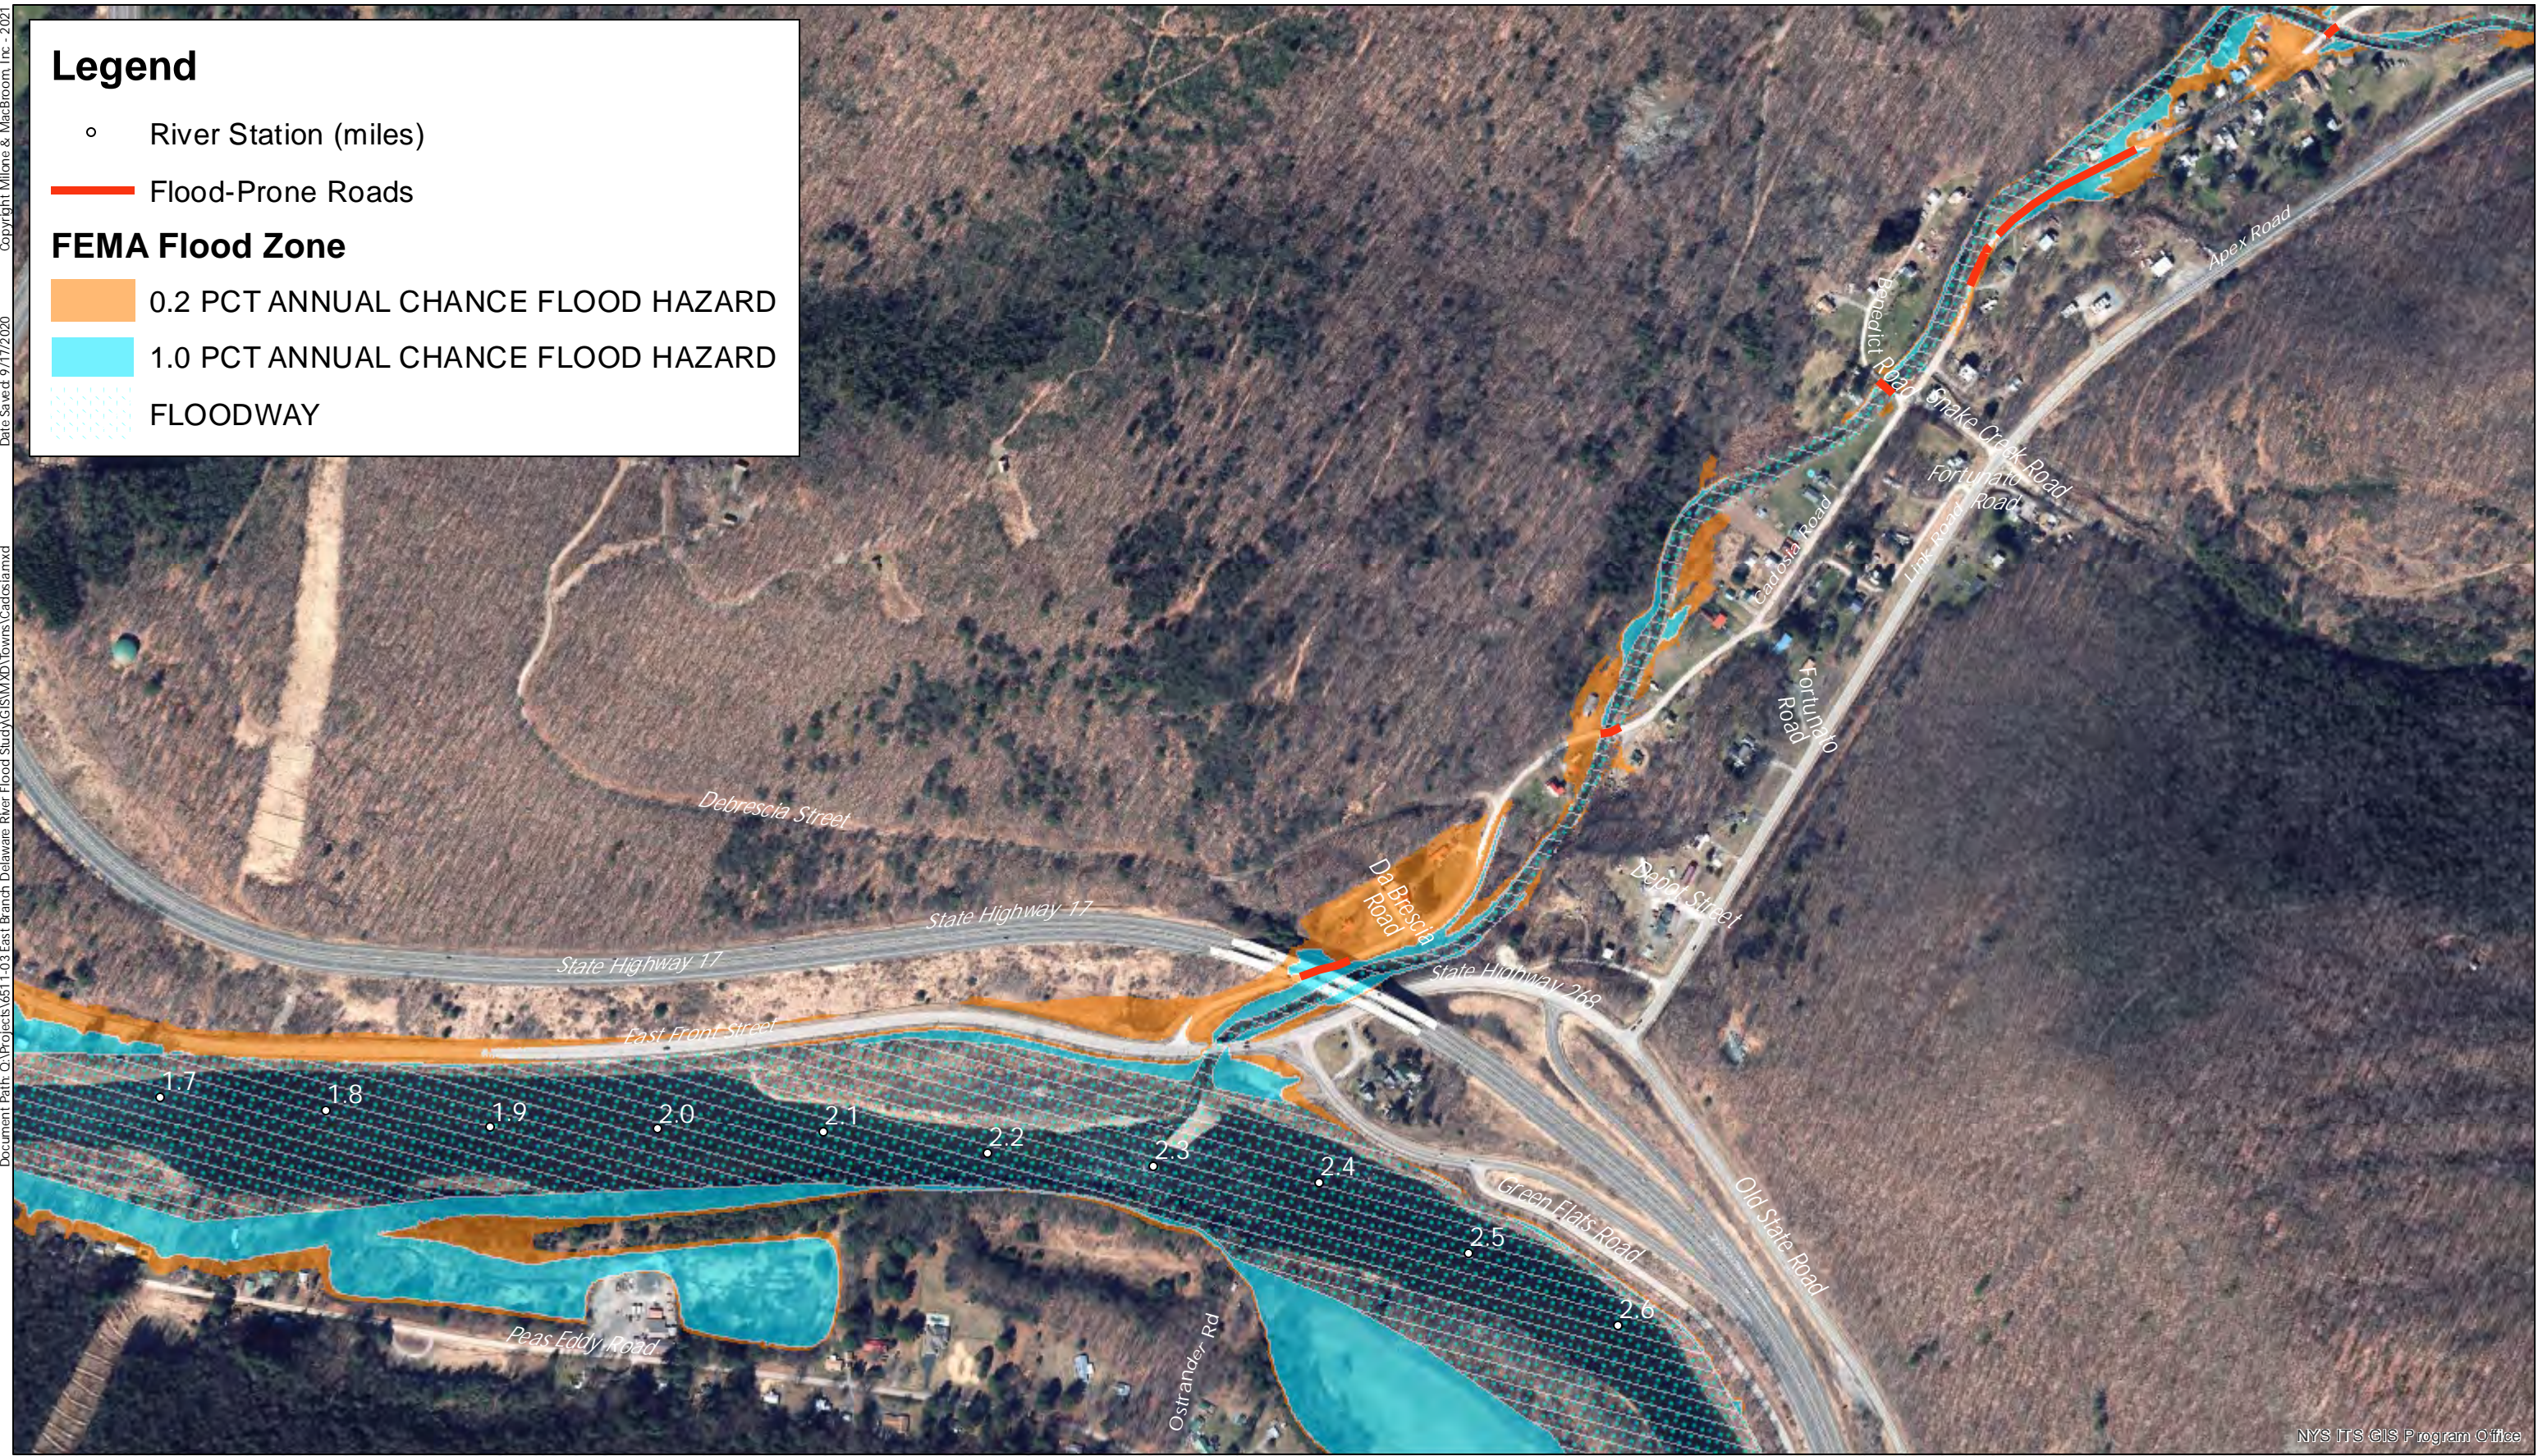
FIGURE 4-8

HIGH RISK AREA #2 - CADOSIA (EBDR & CADOSIA CREEK)

Cadosia is a hamlet located in the town of Hancock where Cadosia Creek meets the EBDR. This is a small crossroads area consisting of residential structures, a few businesses, lodging establishments, and rental cabins. Unlike many of the small communities along the EBDR, Cadosia is situated within the tributary valley rather than upon depositional alluvial features within the EBDR valley. Thus, flooding of the EBDR itself does not pose a direct hazard to most of the hamlet although flooding of Cadosia Creek may still result in substantial damages. Severe ice jamming in 1981 reportedly extended 3 miles up the tributary from the EBDR. Cadosia Creek drains an approximately 18-square-mile watershed, measured at its confluence with the EBDR. Here, the EBDR's watershed covers 820 square miles. Figure 4-8 shows the Cadosia area.

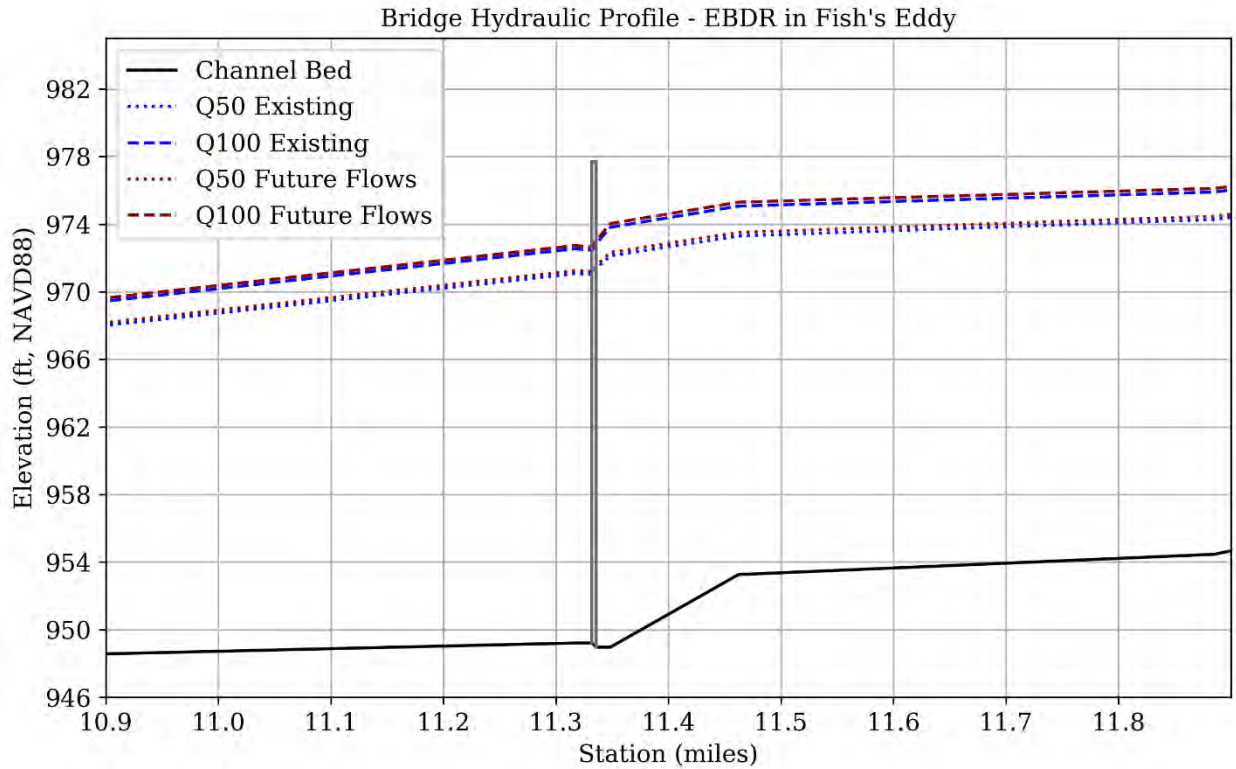
Figure 4-10: 50- and 100-Year Flood Profiles at the Route 28 Bridge in Fish's Eddy. Existing and projected future flow scenarios are plotted.

Route 28 crosses the EBDR as a single lane on a three-span through-truss bridge at STA 11.3, originally constructed in 1901 for the O&W Railroad and converted to a highway bridge following abandonment of the rail line in the 1950s (BIN 3352620). The structure is currently owned by Delaware County. FEMA modeling indicates that this bridge contributes to some backwater flooding, but modeled floodwater elevations remain below the low chord of the deck up to the 500-year flood. A historical photograph shows that the "Pumpkin Flood" of 1903 left this bridge with very little freeboard, if any. At its estimated peak discharge at this location, this was roughly a 100-year flood. The road formerly crossed the EBDR just upstream; this can be seen on the right side of the historical photograph. The relic abutments and central pier footing remain in place but are not represented in FEMA modeling. It is recommended that additional channel cross sections be surveyed near these structural features for incorporation into the existing hydraulic model to assess whether these archaic bridge components contribute to flooding in Fish's Eddy.

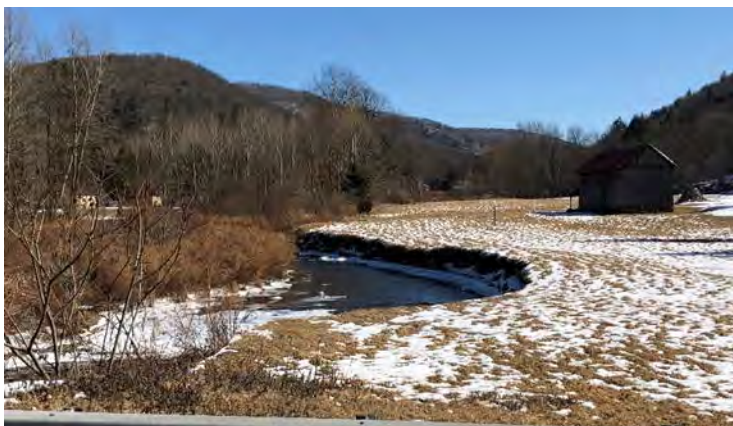
Just upstream of the Bodoit Road crossing of Fish Creek, the stream is undergoing lateral migration, with an active failure of the left (southern) bank, seen in the photo below. Over time, this realignment may threaten the stability of the Bodoit Road bridge as well as adjacent property. Establishing a riparian buffer with bank-stabilizing plantings may be beneficial in this and other cases of bank erosion and mass failures occurring where shallow-rooted vegetation, such as

**Photo 4-3
Bank Failure Upstream of Bodoit Road Crossing of Fish Creek**

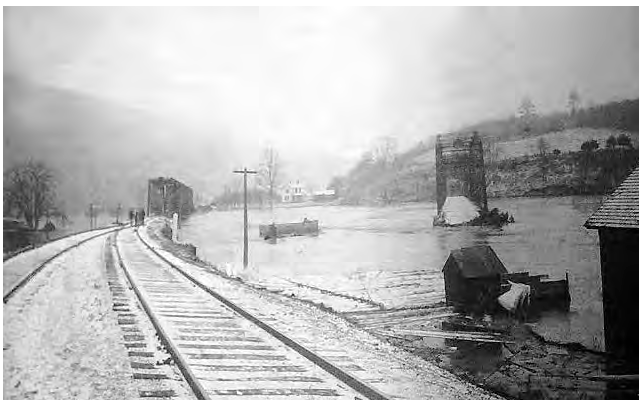
Photo 4-4
Fish's Eddy in 1903 flood. The railroad bridge is now the single-lane Route 28 bridge. The former road bridge is visible to the right; only substructural features remain today. Courtesy of Colchester Historical Society, Downsville, New York

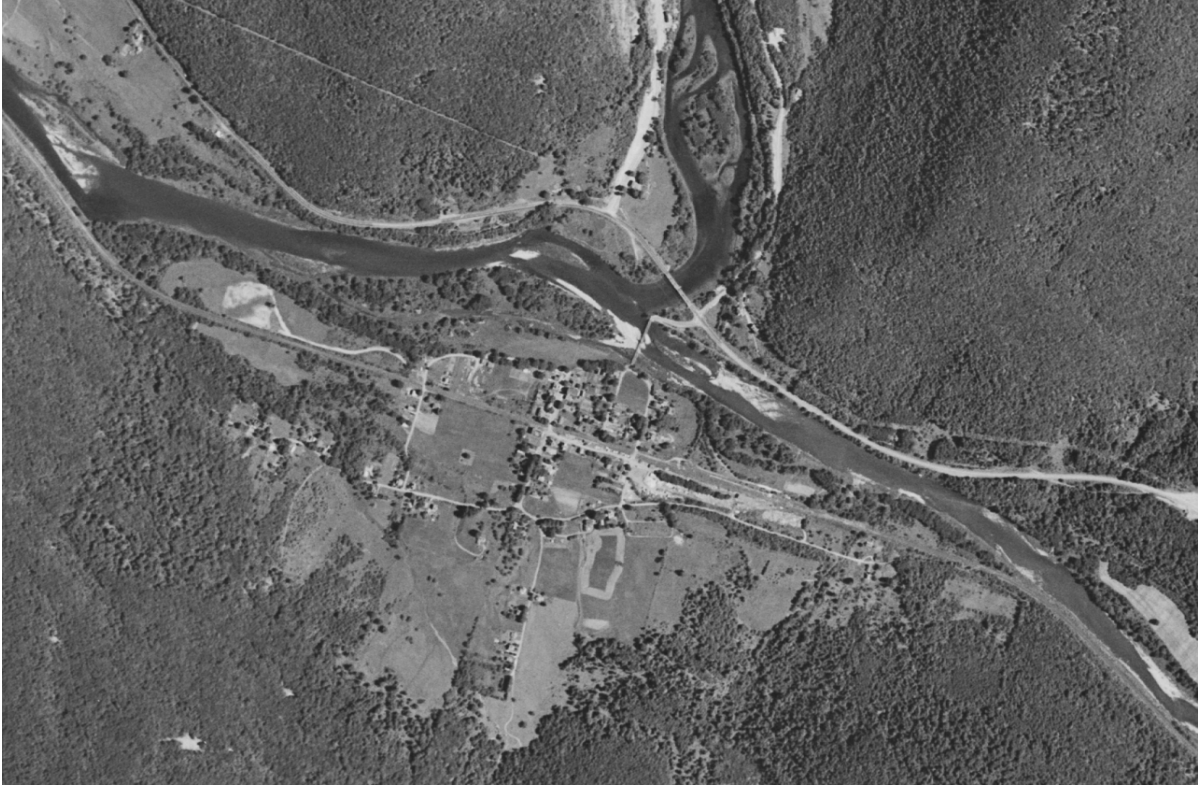
Photo 4-5

Portion of aerial photograph acquired in July of 1958, prior to construction of the East Branch levee and the new Route 17. Note the Bridge Street bridge has been relocated since this time. Retrieved from the USGS Earth Resources Observation and Science Center's *EarthExplorer* online service.

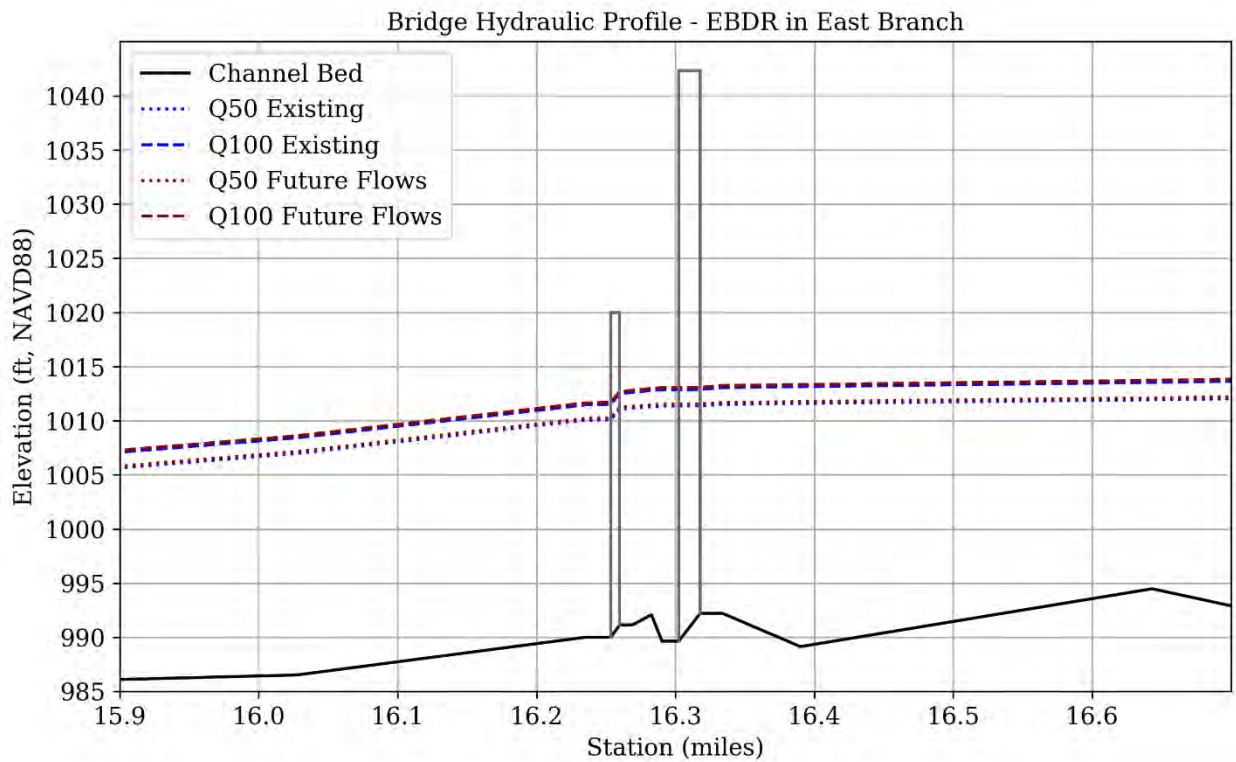
Figure 4-13: 50- and 100-year flood profiles at the old and new Route 17 bridges across the EBDR in East Branch. Existing and projected future flow scenarios are plotted.

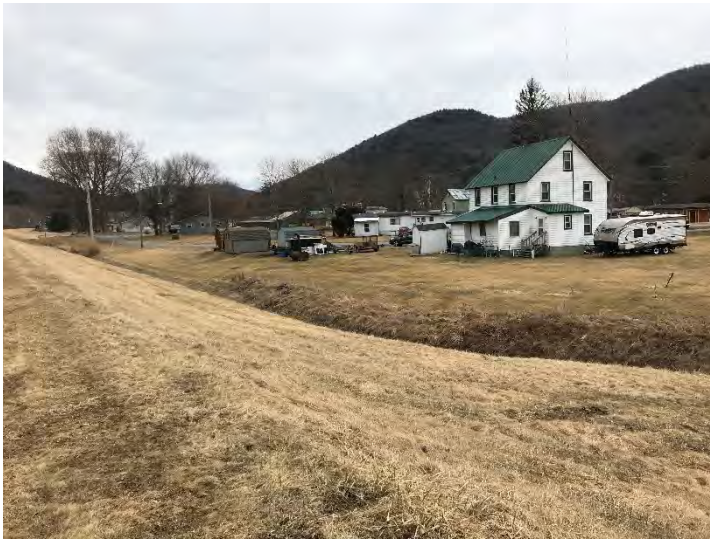
Photo 4-6
Levee in East Branch. View is from the levee crest, roughly to the southeast. Ponding area is out of frame to the photographer's right. EBDR is to the left. Outlet culvert with flap gate is behind photographer.

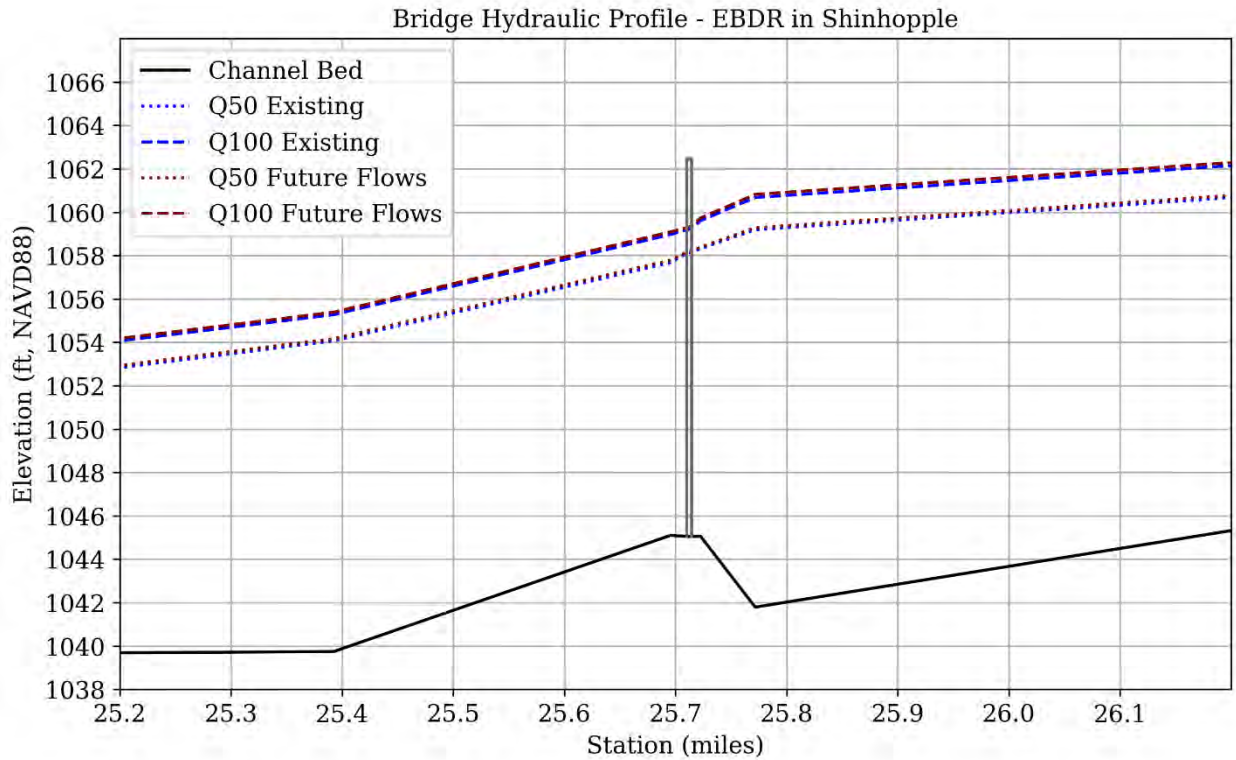
Figure 4-21: 50- and 100-year flood profiles at the River Road bridge across the EBDR in Shinhopple. Existing and projected future flow scenarios are plotted.

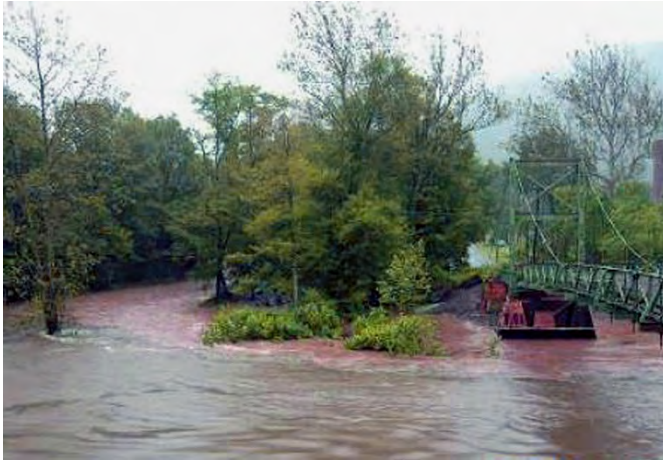
Photo 4-8
Corbett bridge during 2006 flood. Courtesy of Colchester
Historical Society, Downsville, New York

Campbell Brook Road is frequently damaged by flooding of its namesake watercourse. Intermittent sidecast berms line the stream banks, and the remains of former mill dams and other man-made structures persist in the channel. This has left Campbell Brook in an impaired state that is susceptible to instabilities that are likely to cause damage to the adjacent roadway over time.

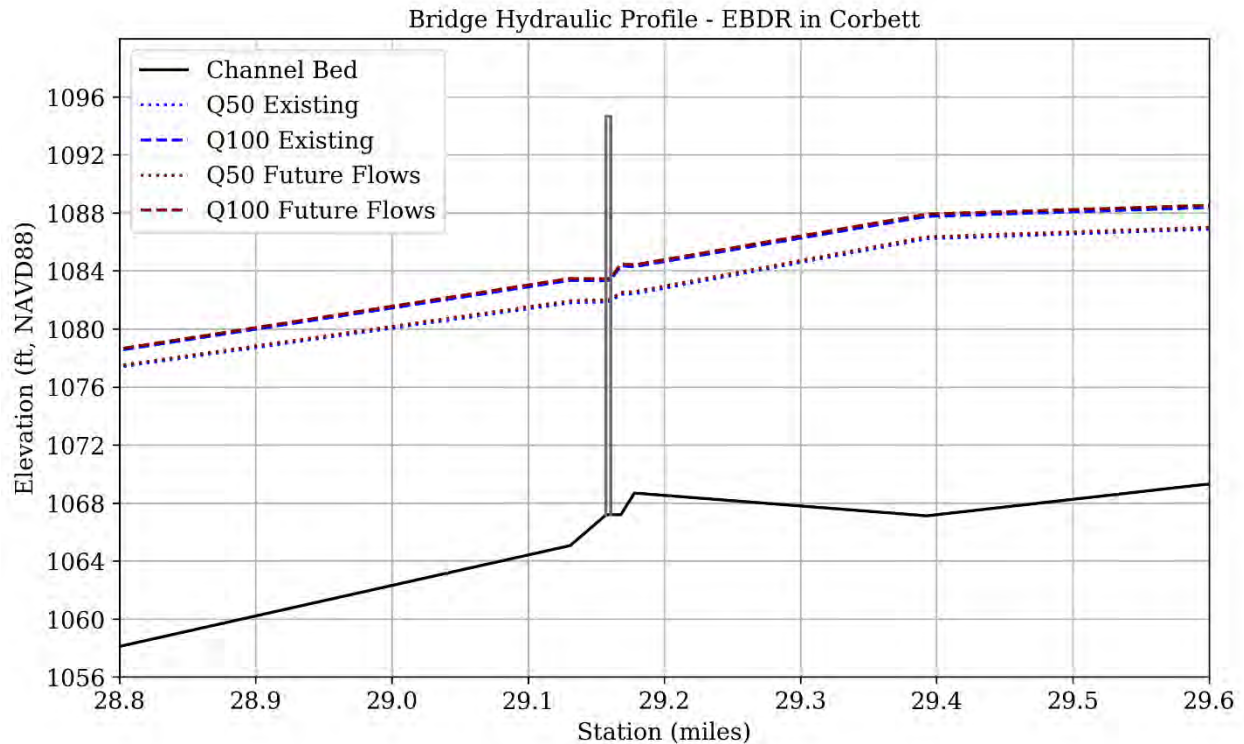
Figure 4-24: 50- and 100-year flood profiles at the Corbett Road suspension bridge across the EBDR in Corbett. Existing and projected future flow scenarios are plotted.

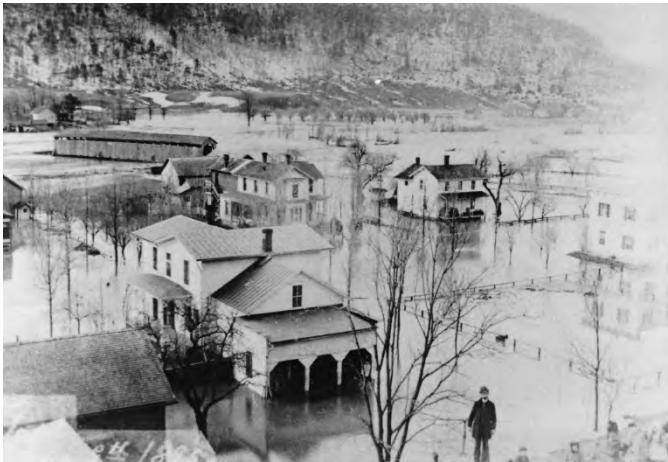
Photo 4-9
Flooding in Downsville, 1895. Covered bridge at top left of photograph. Courtesy of Colchester Historical Society, Downsville, New York

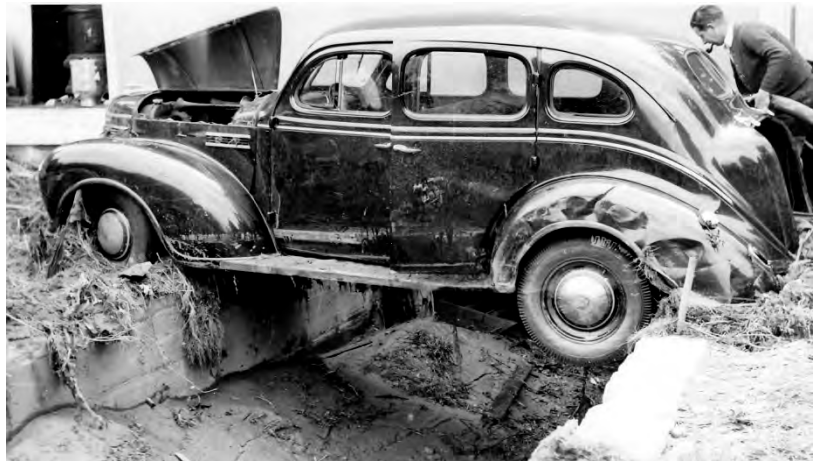
Photo 4-10
Flood damage in Downsville, 1942. Courtesy of Colchester Historical Society, Downsville, New York

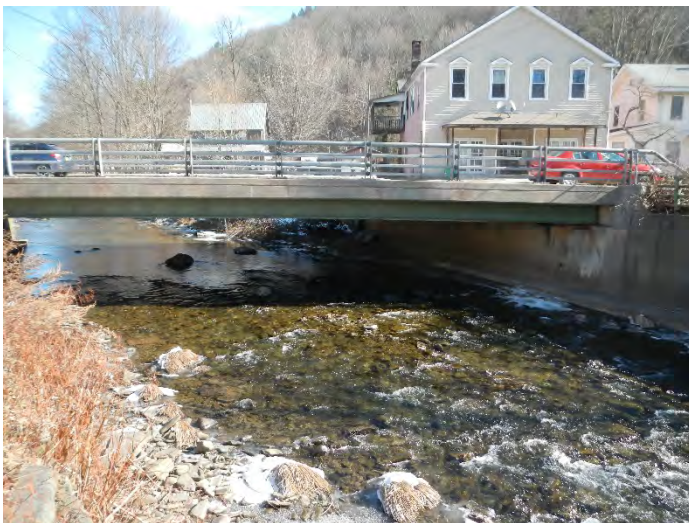
Photo 4-11
Routes 30/206 bridge over Downs Brook, Downsville
