FLOOD MITIGATION & RESILIENCE REPORT

Great Chazy River - SD119

> SLR #142.16511.00011.0040 June 2022

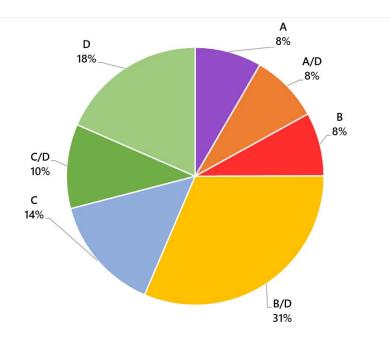
Figure 2-4: Hydrologic Grouping of Soils within the Great Chazy River Watershed

During a rainfall event, the proportion of rainfall that runs off directly into rivers and streams or that infiltrates into the ground is greatly influenced by the composition of soils within a watershed. Soils are assigned a hydrologic soil group identifier, which is a measure of the infiltration capacity of the soil. These are ranked A through D. A hydrologic soil group A soil is often very sandy, with a high infiltration capacity and a low tendency for runoff except in the most intense rainfall events; a D-ranked soil often has a high silt or clay content or is very shallow to bedrock and does not absorb much stormwater, which instead is prone to run off even in small storms. A classification of B/D indicates that when dry the soil exhibits the properties of a B soil, but when saturated, it has the qualities of a D soil. Approximately 42 percent of the mapped soils in the Great Chazy River watershed are classified as hydrologic soil group C, C/D, or D, indicating a low capacity for infiltration and a high tendency for runoff (Figure 2-4). A large portion of the mapped soils are B/D (31 percent), which indicates a tendency for runoff in high-magnitude rainfall events.

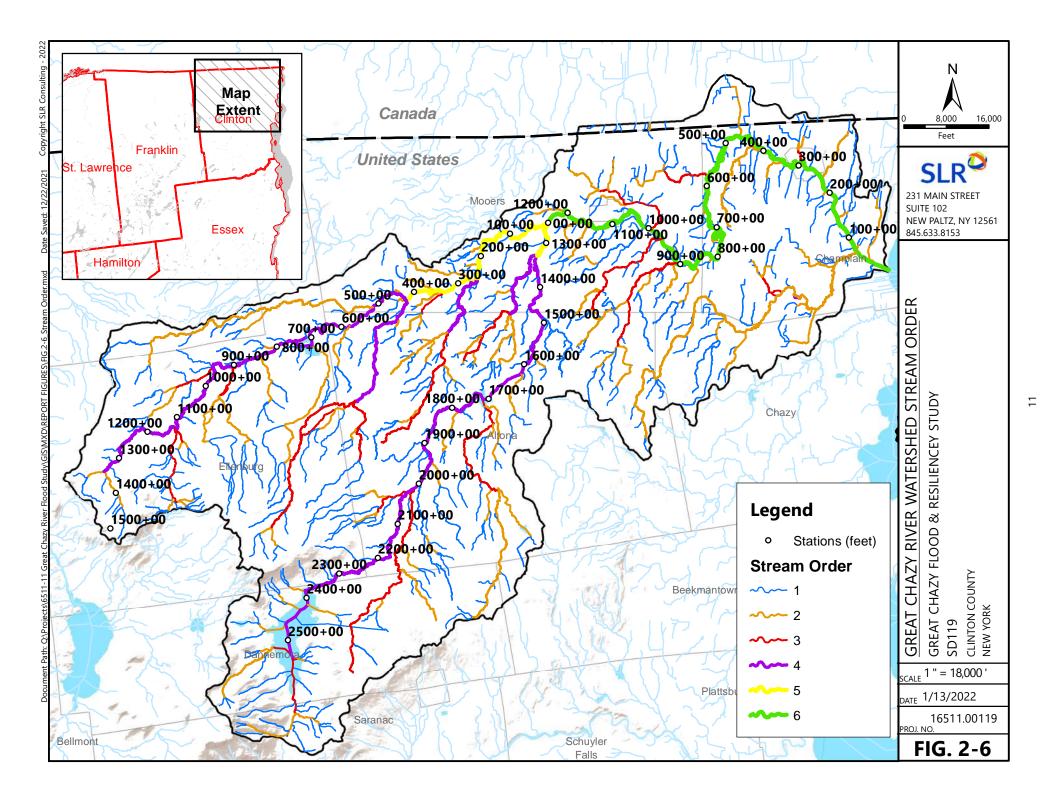
Stream order provides a measure of the relative size of streams by assigning a numeric order to each stream in a stream network. The smallest tributaries are designated as first-order streams, and the designation increases as tributaries join. The main stem of the Great Chazy River can be characterized as a sixth-order stream at its outlet where it discharges to King Bay and as a fourth-order stream for most of its length. Larger tributaries such as the North Branch of the Great Chazy River are fifth order. Fourth-order streams include Corbeau Creek and Park Brook. Third-order streams include Bullis Brook and Sperry Brook. Second-order stream examples include Brandy Brook and Deer Pond Brook. Many of the first-order streams are unnamed. Figure 2-6 is a map depicting stream order in the Great Chazy River watershed.

Characteristics of each order of stream (total length, average slope, and percentage of overall stream network) are summarized in Table 2-1. In the Great Chazy River watershed, first- and second-order streams account for most of the overall stream length (77 percent), and first-order streams are steeper in slope than higher order streams.

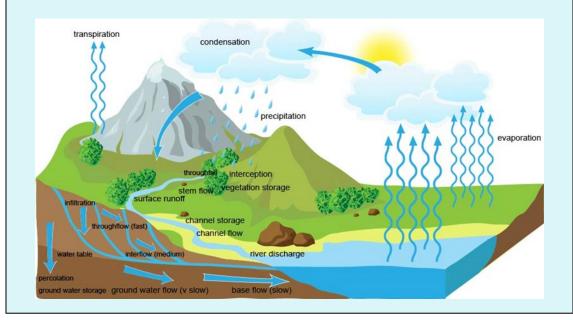
Figure 2-7: Diagram of Simplified Hydrologic Cycle

A simplified diagram of the hydrologic cycle is presented in Figure 2-7.

Along with the location, duration, and intensity of a storm, the flooding that may result from a rainfall event can vary widely depending on the unique hydrology of each basin. Characteristics of local topography, soils, vegetation cover and type, bedrock geology, land use and cover, river hydraulics and floodplain storage, ponding, wetland, and reservoir storage, combined with antecedent conditions in the watershed such as snowpack or soil saturation, can impact the timing, duration, and severity of flooding.

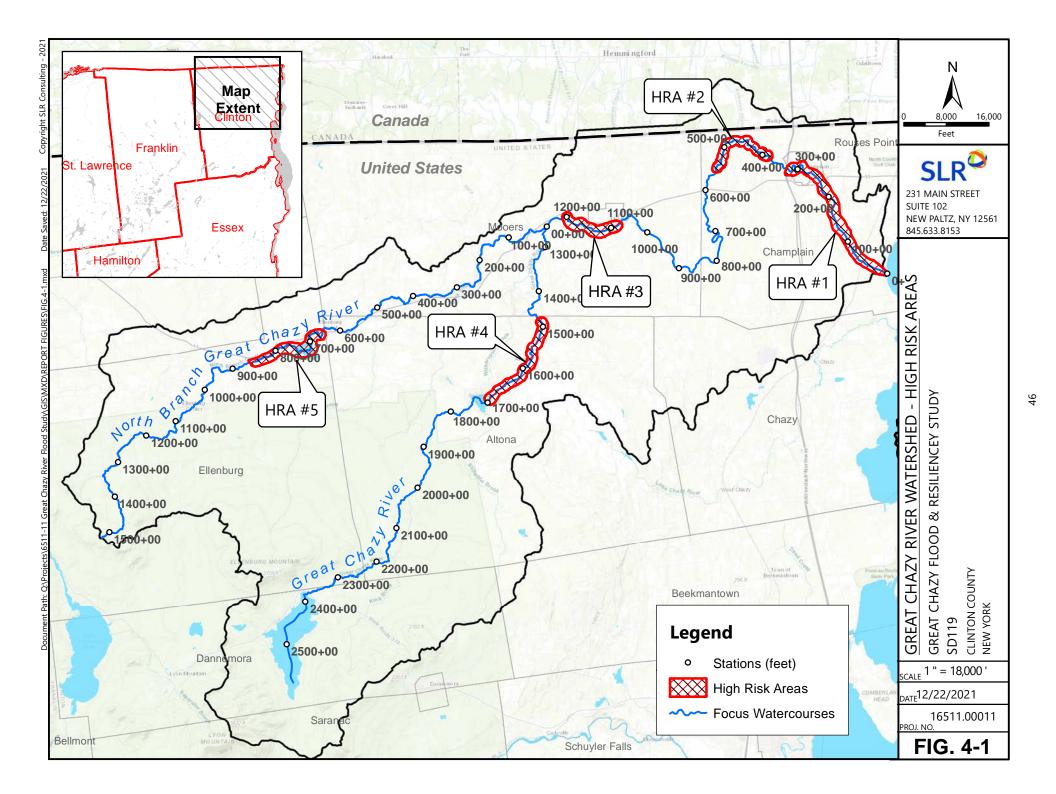
Figure 4-1 shows the locations of HRAs within the Great Chazy River watershed.

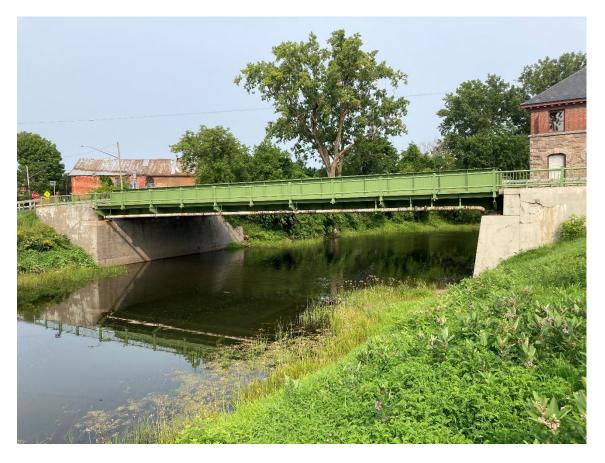
Figure 4-3C: Elm Street bridge over Great Chazy River, looking upstream from the left (north) bank. Samuel de Champlain Museum is visible at right.

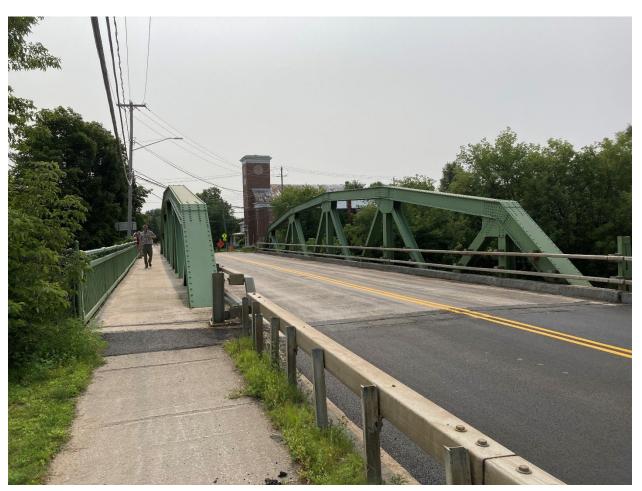
Figure 4-3D: US-9 bridge crossing of Great Chazy River; view from the left bank looking east toward the downtown of the Village of Champlain. Flow is right to left in image.

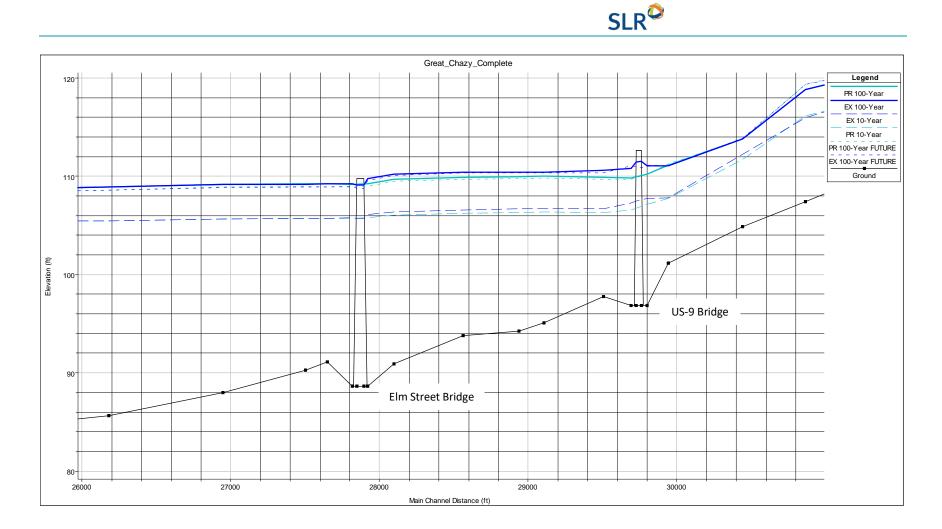
Figure 4-5: Flood Profiles under Existing and Proposed Clear Water Flood Conditions in the Village of Champlain with Lake Champlain at Corresponding Flood Stages

WATER SURFACE ELEVATION (FEET NAVD88)				
FLOOD (YEAR)	US-11 Bridge		Elm Street Bridge		
	Existing	Proposed	Existing	Proposed	
10	107.74	107.16	106.09	105.78	
25	109.07	108.41	107.55	107.18	
50	109.84	109.29	108.35	108.16	
100	111.09	110.25	109.73	109.22	
100 +	111.12	110.19	109.57	108.95	
500	112.71	112.44	111.93	111.90

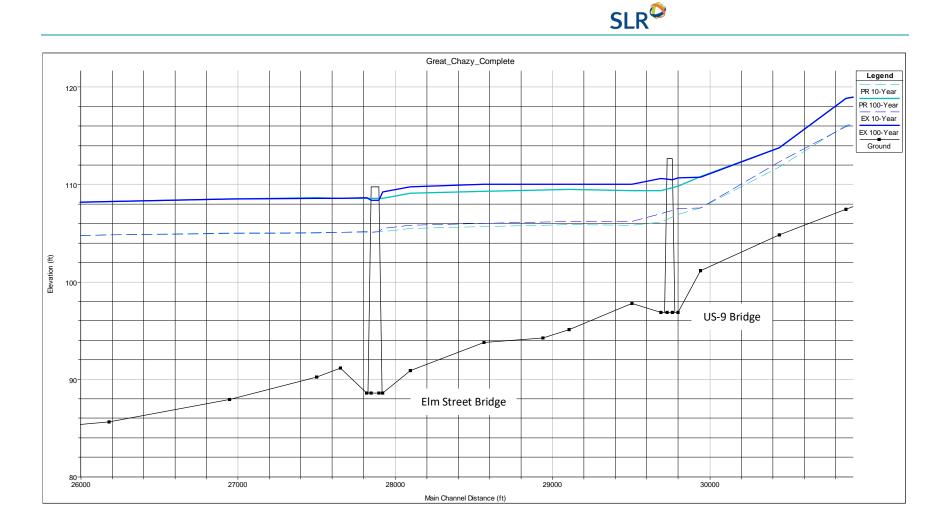
Figure 4-6: Flood Profiles under Existing and Proposed Clear Water Flood Conditions in the Village of Champlain with Lake Champlain at Median April Stage

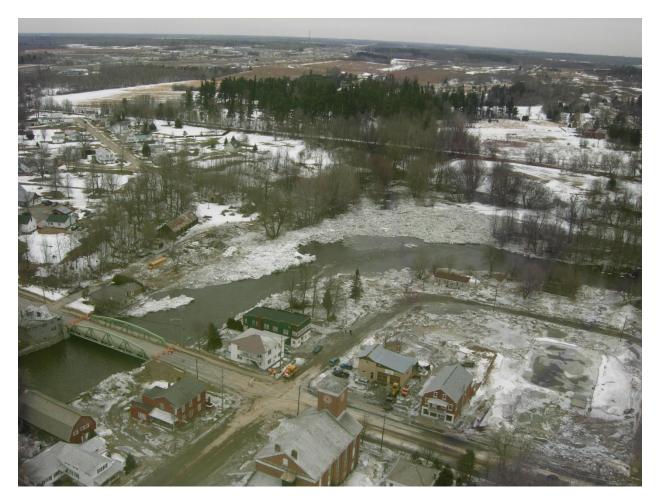
Figure 4-7: Ice buildup in the village of Champlain. Note US-9 bridge at center left is closed, and ice rafts had deposited in developed overbank areas. Orientation is northwest, with flow left to right in image. Image is provided by Clinton County Department of Emergency Services.

When ice formed and accumulated upstream, including behind Whiteside Dam, is released, it moves downstream toward the village of Champlain. The US-9 and Elm Street bridges are undersized and prone to jamming, which can be exacerbated by both the excess ice generated behind the dam upstream, the Great Chazy River's sinuous path through the downtown area, as well as accumulation at the thick, solid layer of ice that forms in Lake Champlain's tailwater. This is demonstrated in aerial photographs collected by the Clinton County Department of Emergency Services in March 2007, shown in Figures 4-7, 4-8, and 4-9.

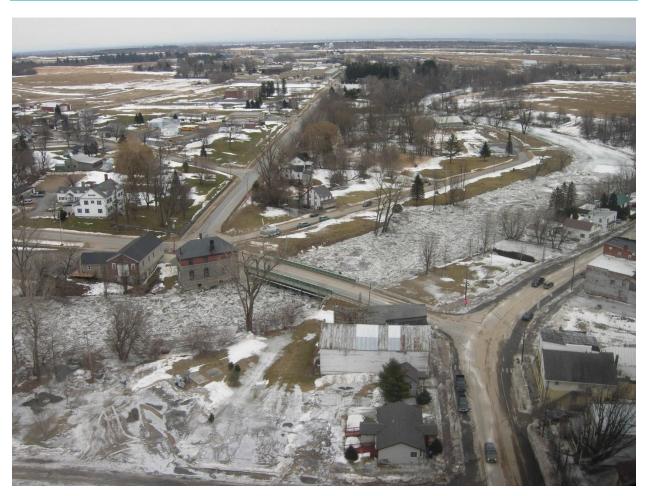
Figure 4-8: Ice jamming in village of Champlain; view is to the east, looking downstream toward Lake Champlain. Elm Street bridge is in center. Breakup ice accumulates at Lake Champlain tailwater ice at center right of image. Image is provided by Clinton County Department of Emergency Services.

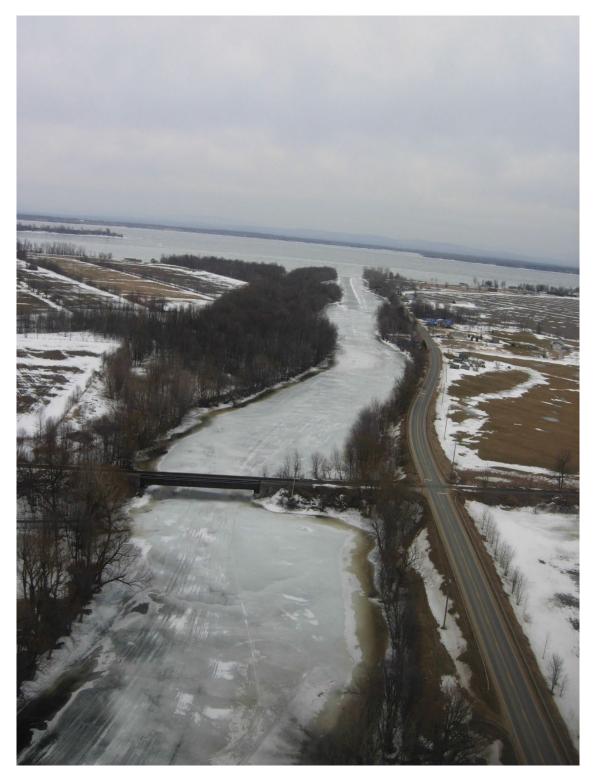
Figure 4-9: Solid ice formed in Lake Champlain's tailwater extends down the Great Chazy River from the village of Champlain to the lake. View is to the southeast, looking downstream. Canadian Pacific railroad bridge is in image center; CR-22 parallels the river on the right. Image is provided by Clinton County Department of Emergency Services. Wide-river ice jamming and dynamic-bridge ice jamming were simulated in the HEC-RAS hydraulic model developed for this study. Based on input parameters gleaned from descriptions and photographs of past ice jams, flooding was simulated under the conditions described above. In the village of Champlain, 10-year flood depths increase by about 8 feet throughout the developed area, with development of a 6-foot-thick ice jam extending from the Lake Champlain tailwater ice to upstream past the US-9 bridge, which is simulated as being overtopped by ice floes along with the Elm Street bridge.

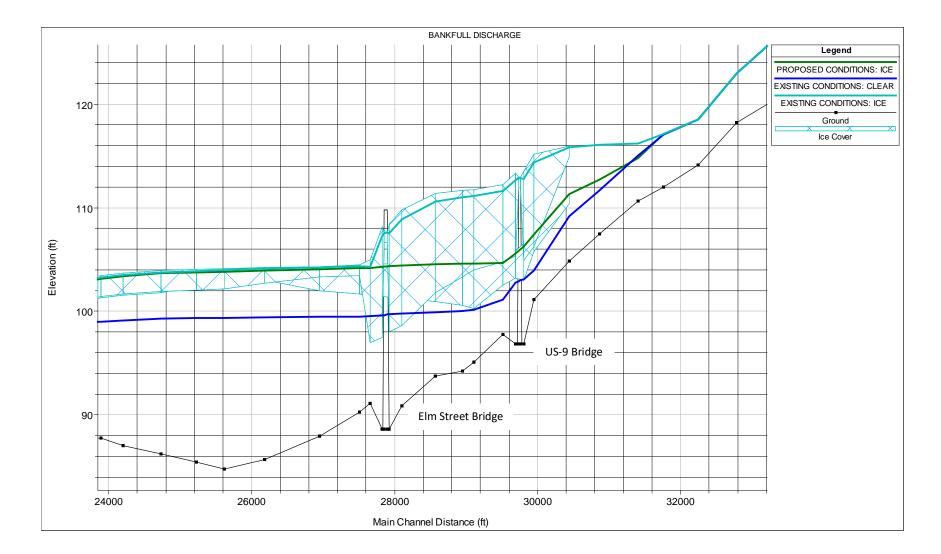
Figure 4-10: Profile of modeled bankfull flow through the Village of Champlain under ice jamming scenarios comparing existing and proposed conditions. Clear water bankfull flow is shown for reference.

With the proposed Elm Street and US-9 bridges and floodplain enhancements described above, the consequences of ice jam events can be significantly mitigated due to alleviation of the bridge constrictions and provision of overbank relief for ice rafting. In the scenario described above, an ice-affected bankfull flow with Lake Champlain at EL 98 feet (NAVD88), flooding depths in the village of Champlain are reduced by up to 6.9 feet compared to the same ice jam under existing conditions, shown in Figures 4-10, 4-11, and 4-12 and Table 4-4. In an ice-affected 10-year flood with the lake at this same level, ice and water depths in the village are reduced by up to 4.4 feet.

ICE- AFFECTED FLOW EVENT	ICE & WATER SURFACE ELEVATION (FEET NAVD88)			
	US-11 Bridge		Elm Street Bridge	
	Existing	Proposed	Existing	Proposed
Bankfull	112.79	106.26	107.51	104.35
10-Year Flood	117.53	112.77	114.12	112.54

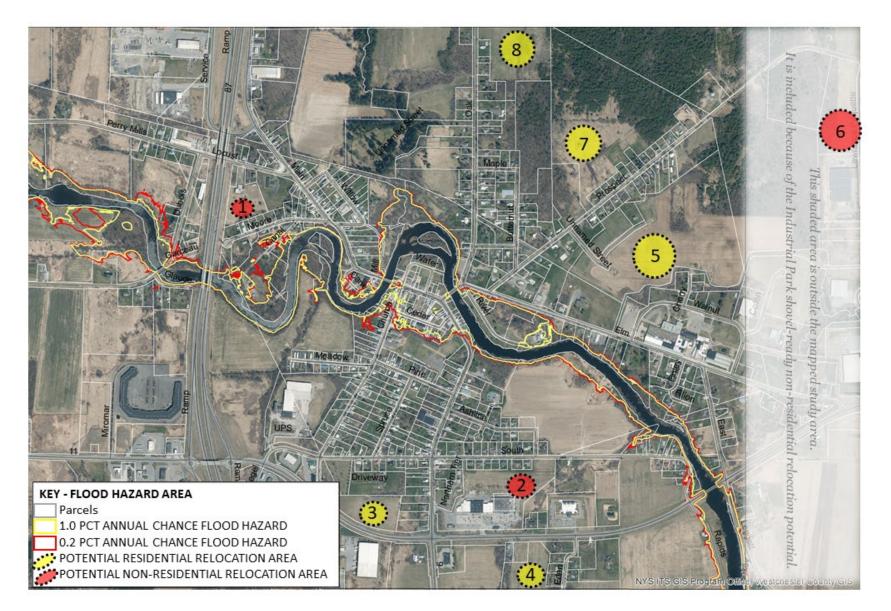
Figure 4-13 Conceptual relocation mapping for HRA 1. See inset on previous page for details.

Voluntary relocation of affected flood-prone property owners in the proposed floodplain reclamation area depicted in Figure 4-4 is recommended, thus facilitating recommended floodplain enhancements and bridge replacements along this reach, which are expected to be most beneficial during ice jamming events. Depending on the ultimate extent of floodplain reclamation, the park and gardens may remain as is or simply be set at a lower elevation where they would remain accessible other than during significant floods and ice-rafting events.
