# FLOOD MITIGATION & RESILIENCE REPORT

## Sparkill Creek - SD115

SLR #142.16511.00010.0040

January 2022

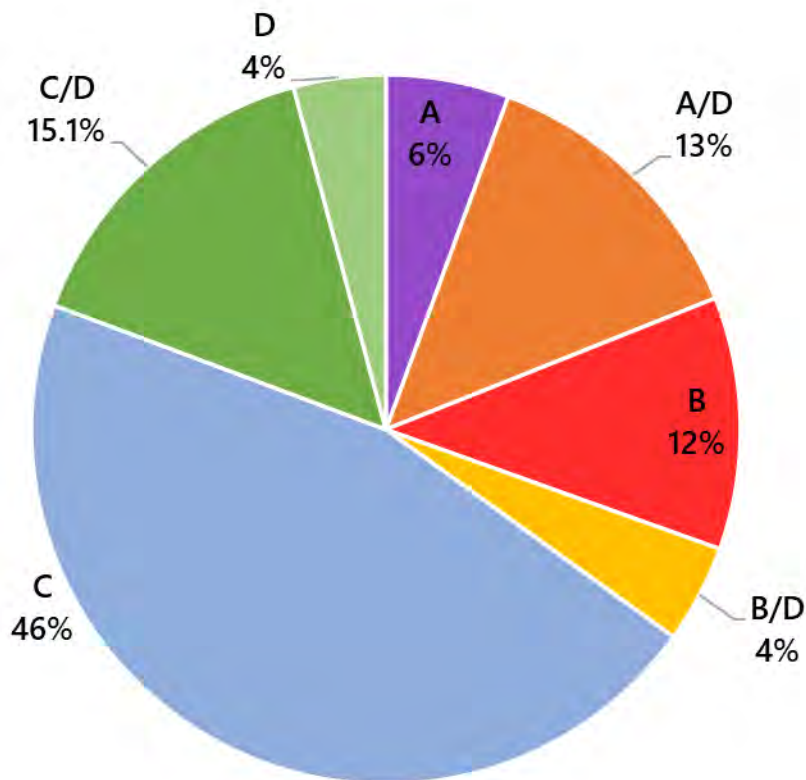
**Figure 2-4: Hydrologic Grouping of Soils within the Sparkill Creek Watershed**

During a rainfall event, the proportion of rainfall that runs off directly into rivers and streams or that infiltrates into the ground is greatly influenced by the composition of soils within a watershed. Soils are assigned a hydrologic soil group identifier, which is a measure of the infiltration capacity of the soil. These are ranked A through D. A hydrologic soil group A soil is often very sandy, with a high infiltration capacity and a low tendency for runoff except in the most intense rainfall events; a D-ranked soil often has a high silt or clay content or is very shallow to bedrock and does not absorb much stormwater, which instead is prone to run off even in small storms. A classification of B/D indicates that when dry the soil exhibits the properties of a B soil, but when saturated, it has the qualities of a D soil. Over 65 percent of the mapped soils in the Sparkill Creek watershed are classified as hydrologic soil group C, C/D, or D, indicating a low capacity for infiltration and a high tendency for runoff (Figure 2-4). This contributes to flash flooding in the watershed as rainfall runoff moves swiftly into streams rather than gradually seeping through the soils.

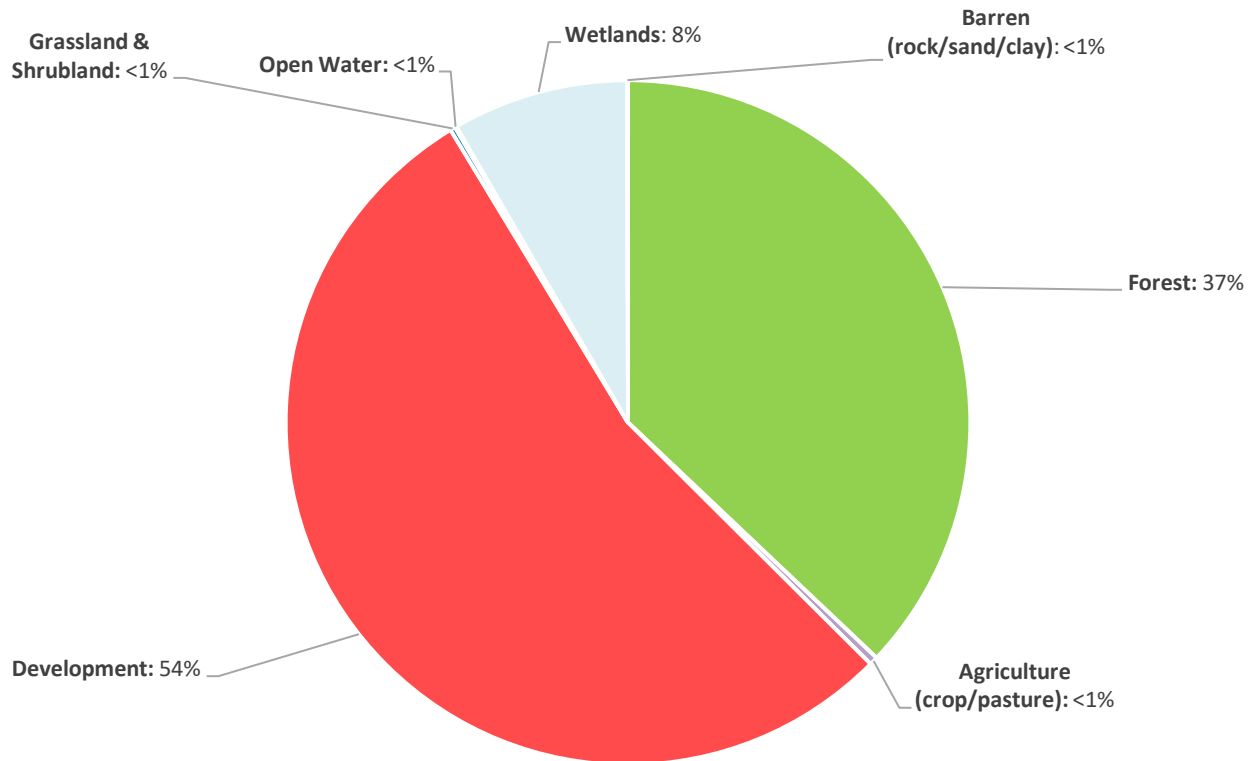
**Figure 2-5: Land Cover within the Sparkill Creek Watershed**

Land cover is another important factor influencing the runoff characteristics of a watershed. Rockland County is located a dozen miles north-northwest of New York City and is part of the New York Metropolitan Area. Land cover within the Sparkill Creek watershed can be characterized using the 2016 Multi-Resolution Land Characteristics National Land Cover Database for Southeast New York State and is shown graphically in Figure 2-5. Developed land is the most common land cover, representing 54 percent of the watershed. Forested land consists of deciduous, coniferous, and mixed forest types and makes up

37 percent of the land cover in the watershed. Open water and wetlands make up 8 percent of the land cover. The remaining land cover consists of agricultural land, grassland and shrubland, and barren land, each making up less than 1 percent of the watershed.

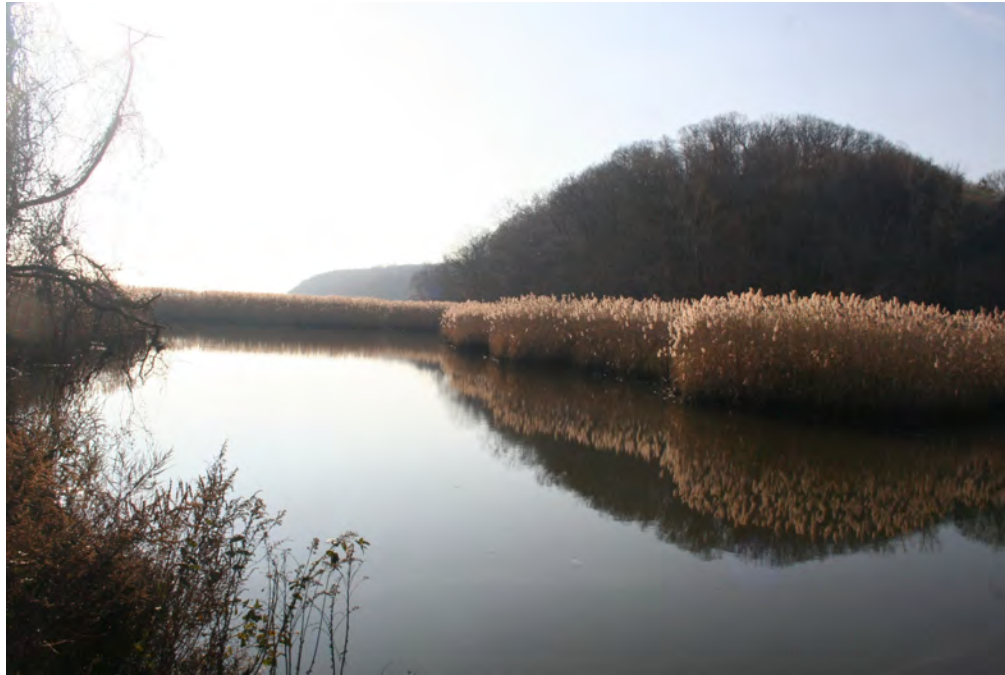
**Figure 2-6: Piermont Marsh, a 1,000-Acre System of Brackish Tidal Marsh, Shallows, and Intertidal Flats at the Edge of the Village of Piermont Where Sparkill Creek Meets the Hudson River Estuary**

Parkway just south of Sparkill. Piermont Marsh, a 1,000-acre system of brackish tidal marsh, shallows, and intertidal flats, is located at the edge of the village of Piermont where Sparkill Creek meets the Hudson River Estuary (Figure 2-6). Coastal wetlands such as Piermont Marsh help to protect coastal communities from flooding and erosion by acting as a buffer to storm surges.

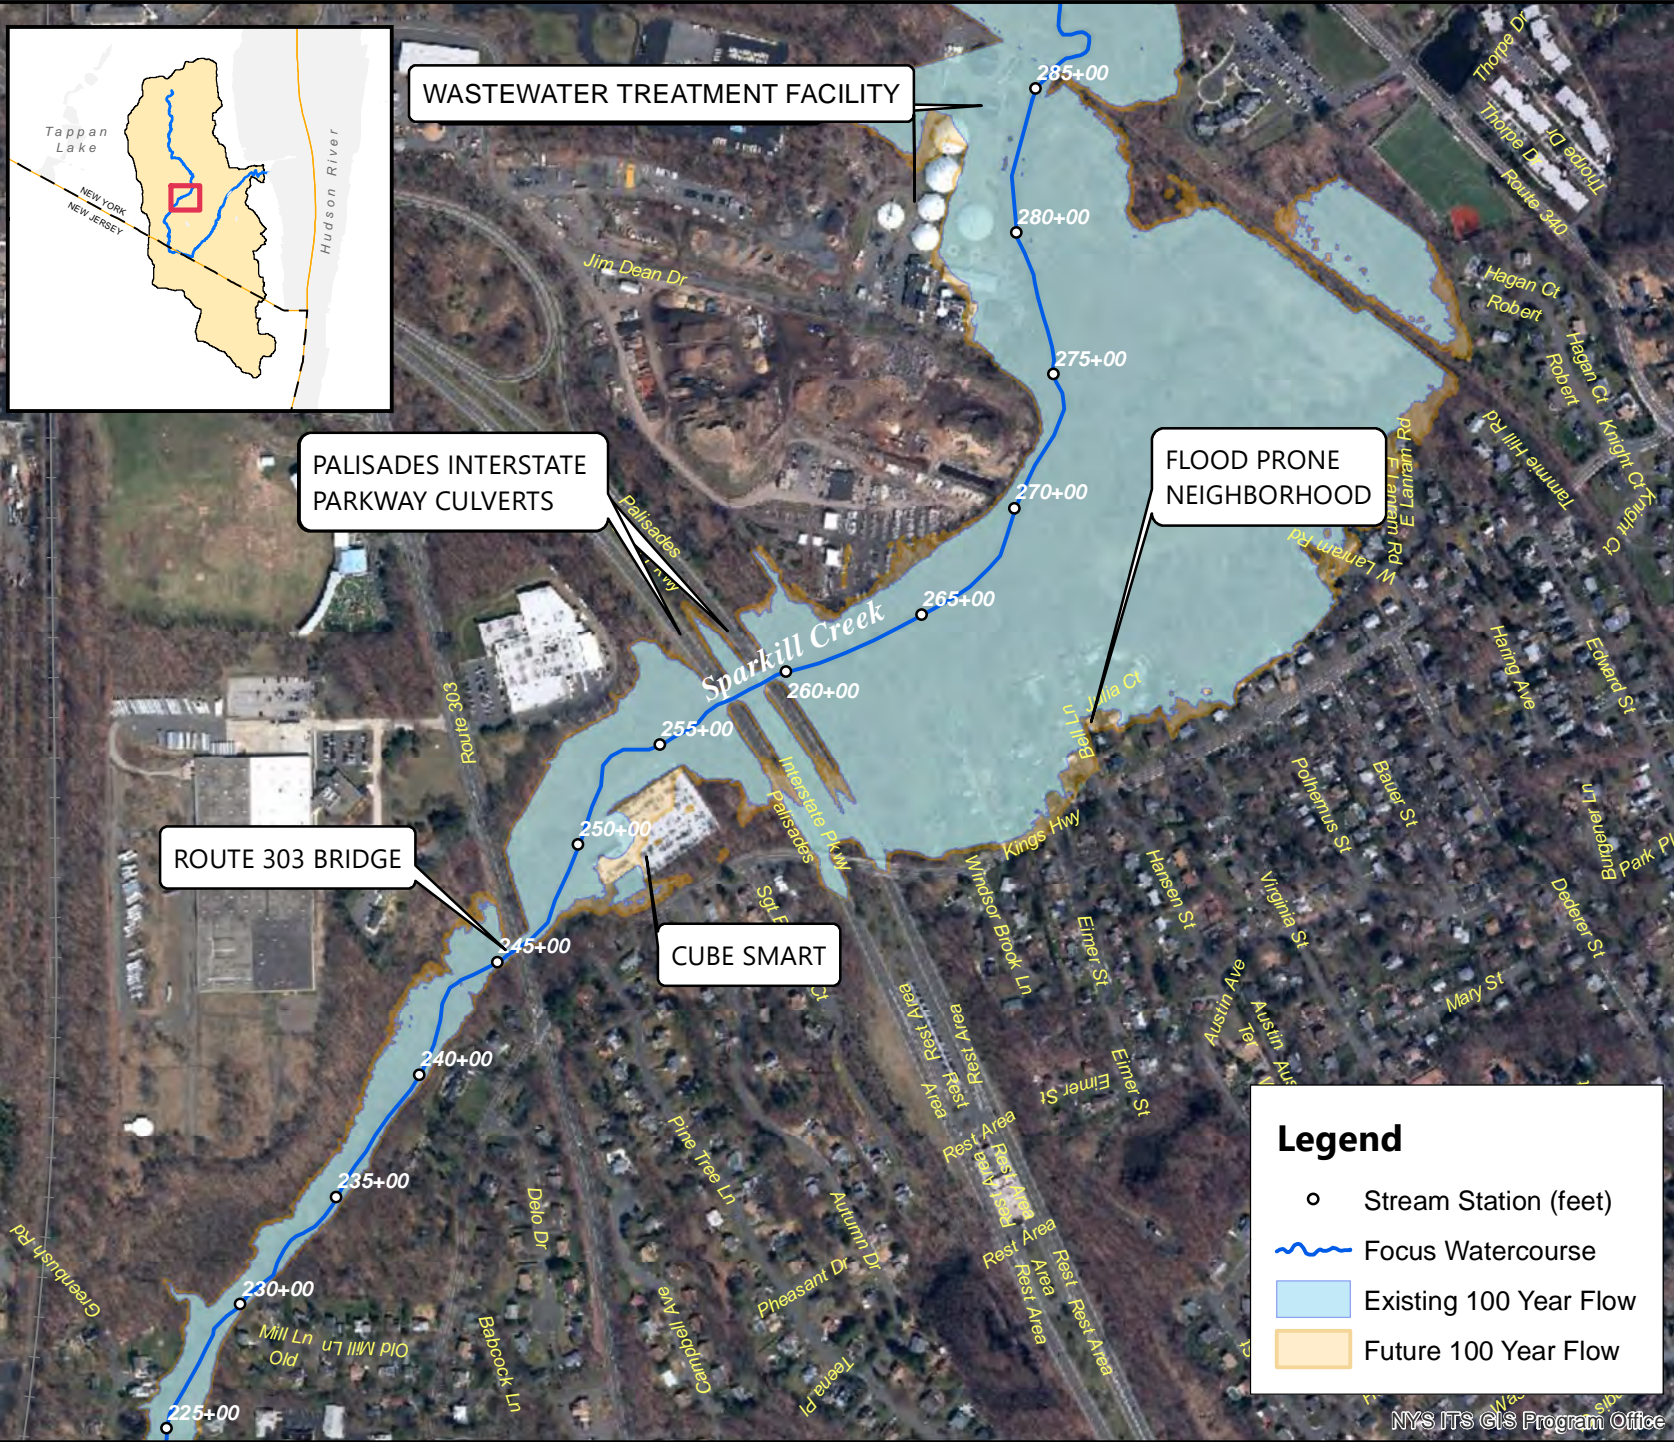
**FIG. 3-6**

**HIGH RISK AREA #5 - FEMA MAPPING**  
 SPARKILL CREEK FLOOD & RESILIENCE STUDY  
 SD115  
 ROCKLAND COUNTY  
 NEW YORK

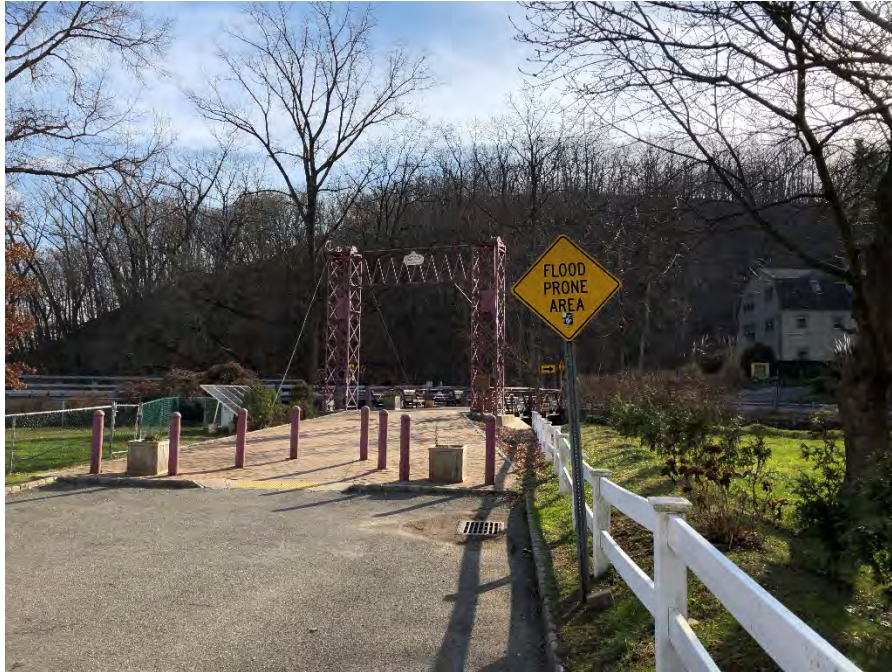
**Figure 4-3** The historic Bridge Street bridge spans the Sparkill Creek as a pedestrian bridge just upstream of the Ferdon Avenue bridge.
