HRA #1 - CONCEPT MAP
 SPARKILL CREEK FLOOD & RESILIENCE STUDY
 SD115
 ROCKLAND COUNTY
 NEW YORK

4.2 HIGH RISK AREA #2 – HAMLET OF SPARKILL

SPARKILL CREEK FLOOD & RESILIENCE STUDY
SD115
ROCKLAND COUNTY
NEW YORK

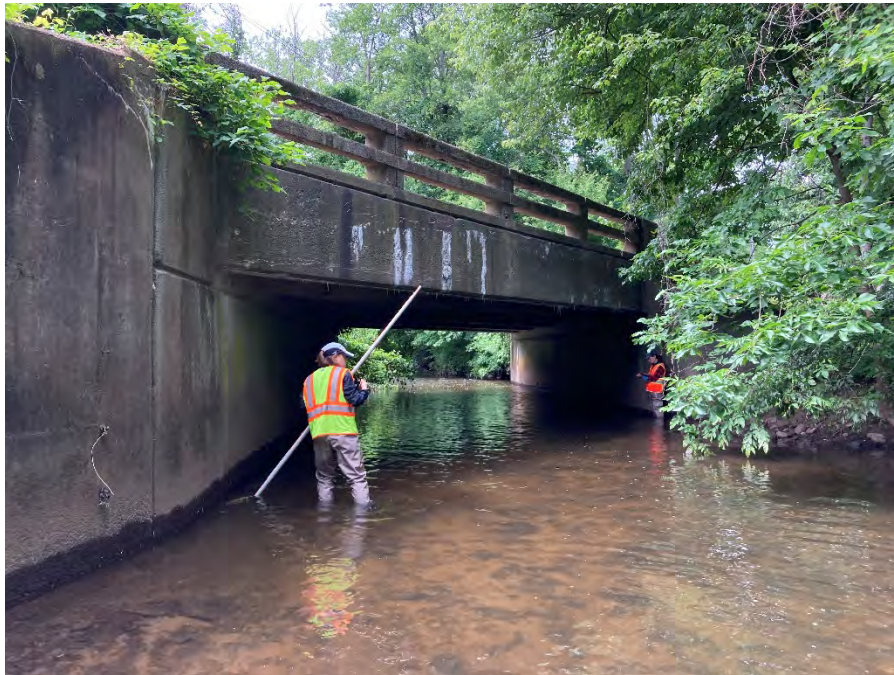
Figure 4-15: William Street Bridge

A sanitary pump station is located in Sparkill and is reportedly prone to flooding, resulting in loss of power and pump inoperability. A Rockland County-owned bridge with a span of 29.5 feet crosses the creek at William Street (Figure 4-15); its NAACC crossing code is xy4102879173926036, and it received an aquatic passability score of 0.91 out of 1.0: an *insignificant barrier*. There has been reported flooding at the adjacent Sparkill Palisades Fire Department, including during Tropical Storm Irene when flooding depths of 2 to 3 feet were reported at the firehouse, extensively flooding the first floor (Figure 4-16). Flooding also occurred along Route 340 near the intersection with Van Terrace (Figure 4-17). About 175 feet downstream from William Street, at Valentine Avenue, an NYSDOT-owned bridge with a span of 27.5 feet crosses the creek. The NAACC crossing code is xy4102912473925550 with an aquatic passability score of 0.89 out of 1.0, an *insignificant barrier*.

Hydraulic modeling was used to evaluate the William Street and Valentine Avenue crossings separately to identify the effect each structure has on flooding. The William Street bridge is hydraulically undersized and contributes to the flooding described above, including at the Sparkill Palisades Fire Department, a critical facility. If the William Street bridge were to be replaced with a new structure with a span of approximately 60 feet, a lateral reduction in flood extent of almost 70 feet would result during the 50-year flood. This reduction would pull the fire department out of the projected flood extents, as seen in the flood depth images in Figure 4-18 (50-year flood event under existing conditions) and Figure 4-19 (50-

The replacement of the William Street bridge is recommended.

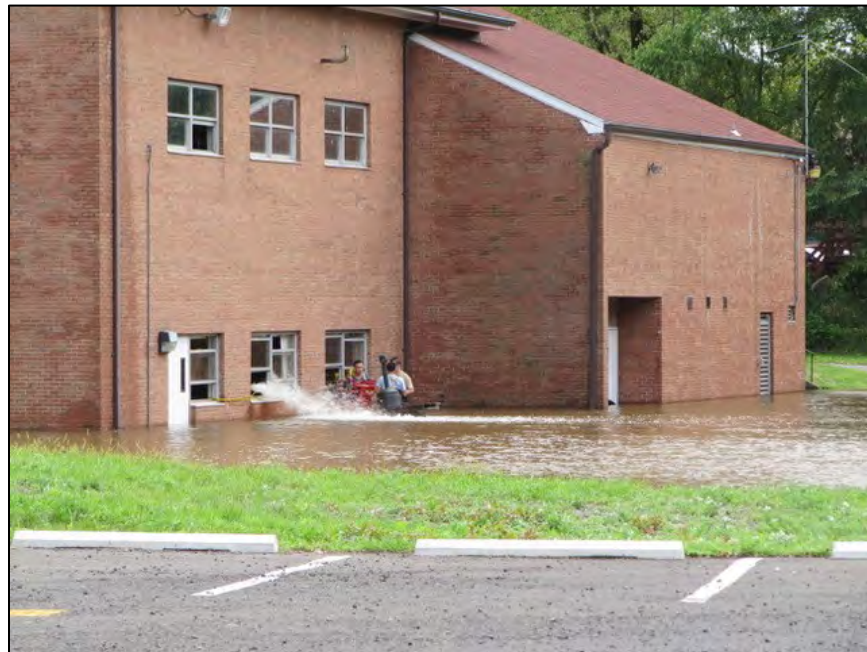
Figure 4-16: Sparkill Palisades Fire Department, a Critical Facility, during Tropical Storm Irene in 2011 (photo provided by Lawrence Vail)

The William Street bridge is hydraulically undersized and contributes to flooding upstream of the bridge, including at the Sparkill Palisades Fire Department, a critical facility.

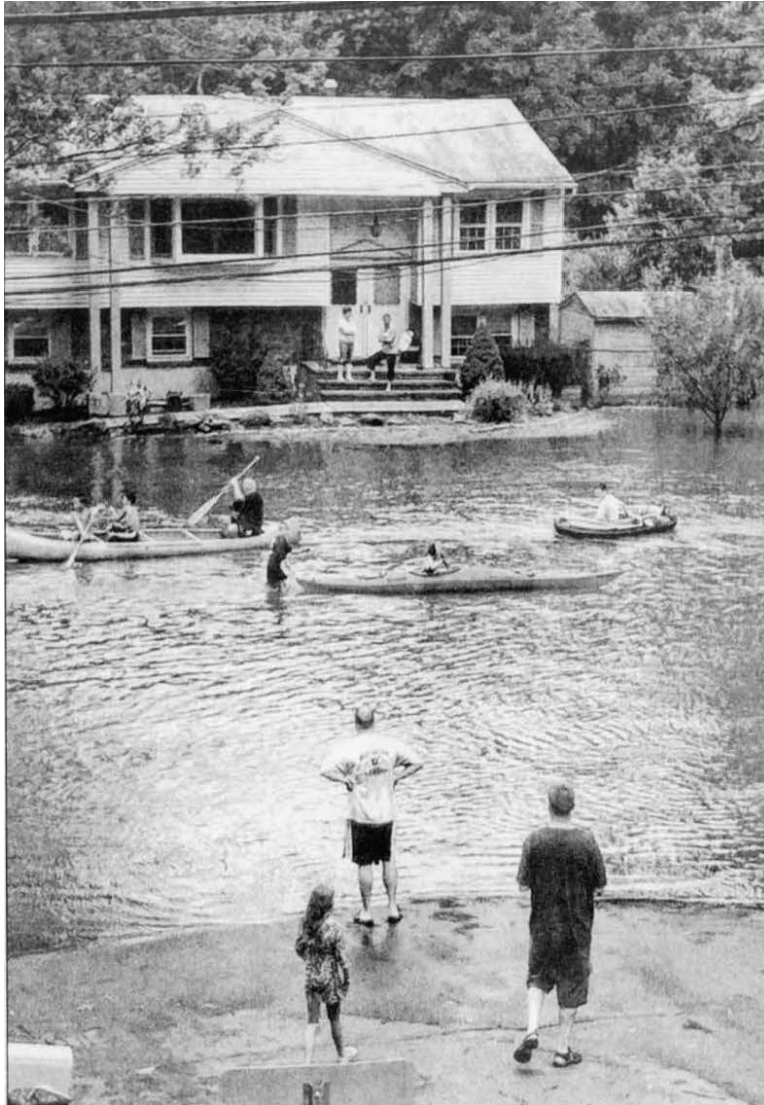
Figure 4-17: Photograph Taken during Tropical Storm Irene of Flooding along Route 340 near the Intersection with Van Terrace

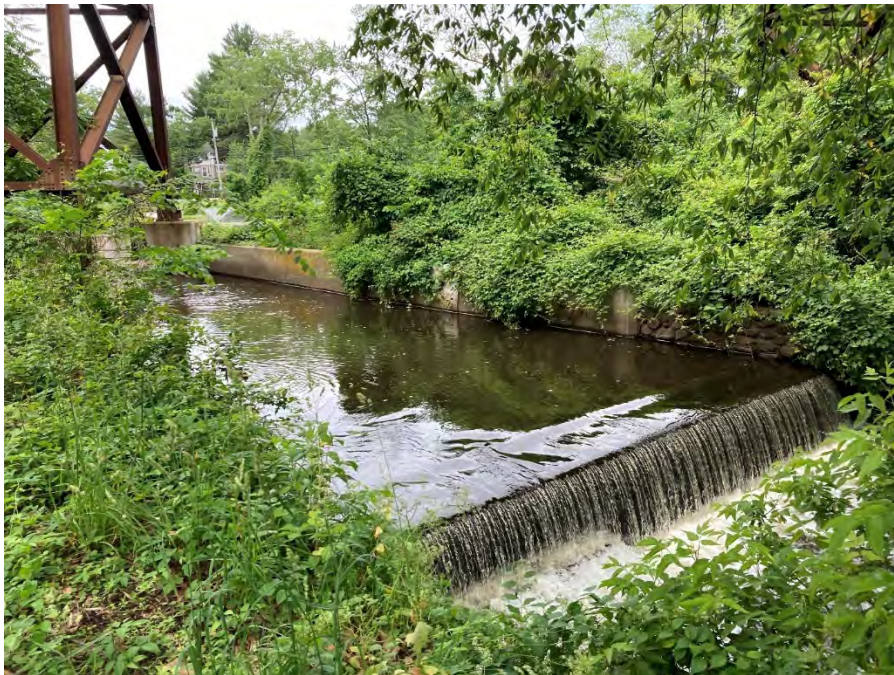
Figure 4-22: Boss Pond Dam Spillway

Approximately 415 feet downstream of Valentina Avenue is a 5-foot-high concrete dam spanning Sparkill Creek. The structure has an 8-foot-wide active spillway (Figure 4-22). This dam is registered in the NYSDEC dam inventory under the name of Boss Pond Dam. Constructed in 1814, the hazard code A or low hazard class dam is included in the hydraulic model as an inline structure that spans the active channel and extends across the left overbank, forming the adjacent impoundment at Eleanor Stroud Park. Removing the entire structure and restoring the immediate river reach upstream to more natural conditions would reduce water surface elevations at the spillway by approximately 3.4 feet and 2.6 feet during the 10-year and 100-year storms, respectively. The reductions in water surface elevations extend 690 feet upstream and have minimal influence on the performance of the Valentina Avenue and William Street bridges. Nonetheless, the dam serves no apparent function and creates an ecological barrier for aquatic organism passage; its removal should be considered.

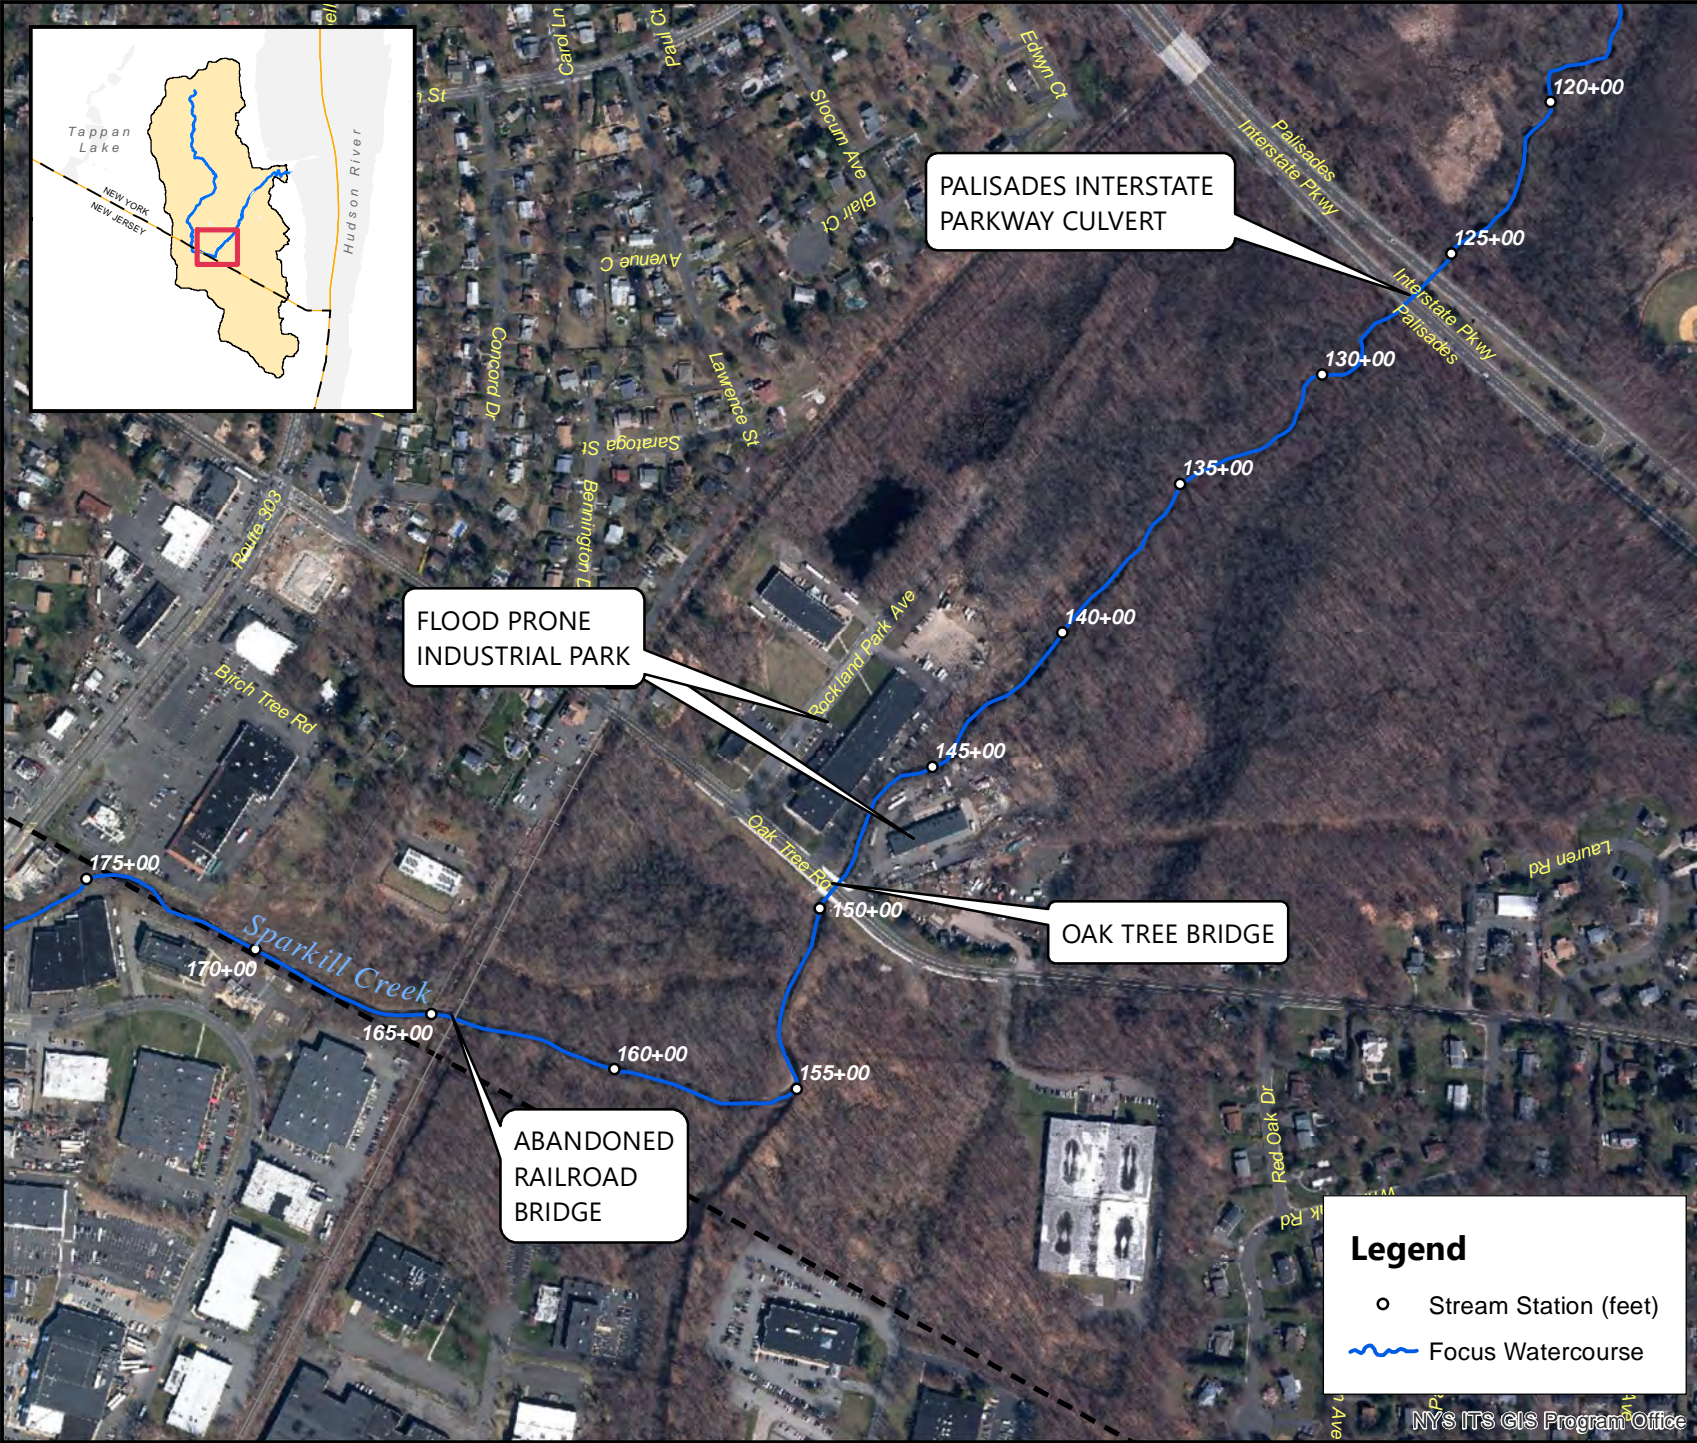
FIG. 4-24

PALISADES INTERSTATE PARKWAY CULVERT

OAK TREE BRIDGE

ABANDONED RAILROAD BRIDGE

HIGH RISK AREA #3 - OAK TREE ROAD & PIP
 SPARKILL CREEK FLOOD & RESILIENCE STUDY
 SD115
 ROCKLAND COUNTY
 NEW YORK

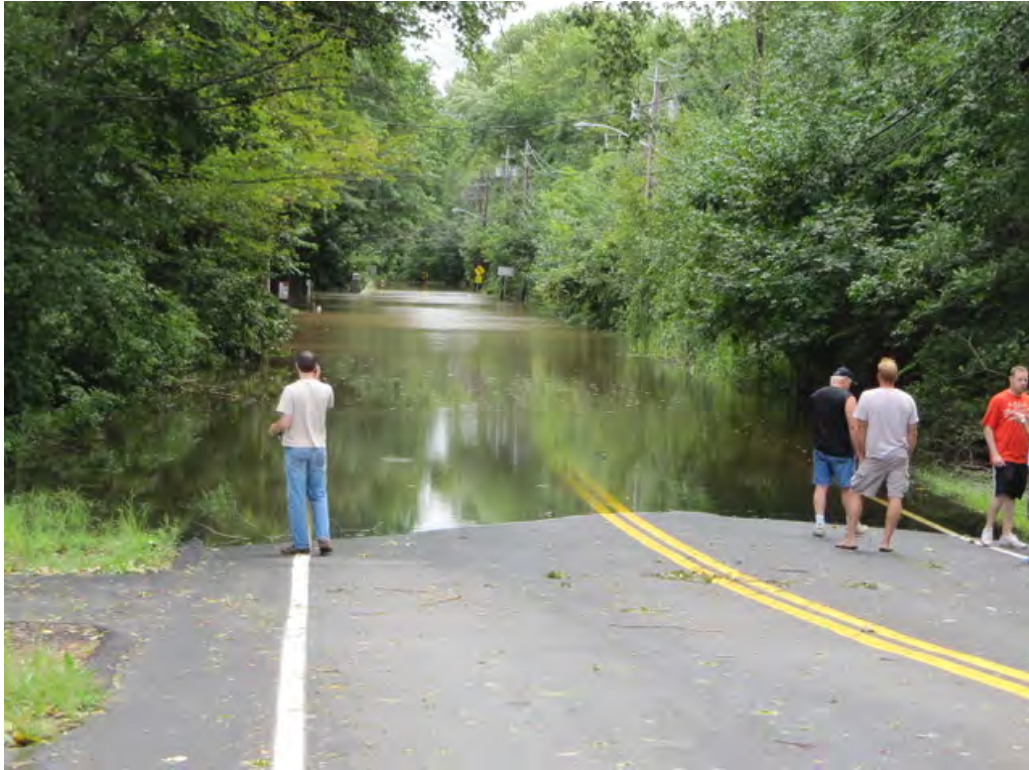
Figure 4-25: Oak Tree Road Bridge during Tropical Storm Irene (photo provided by Lawrence Vail)

Oak Tree Road was flooded during Tropical Storm Irene in August 2011 (Figure 4-25). The Oak Tree Road bridge spans 29.5 feet and does not currently pass even the 10-year flows. This is due in part to the backwater from the 21.7-foot-wide culvert under the PIP, just downstream. The hydraulic performance at the Oak Tree Road bridge is reduced during flood conditions because of the tailwater condition caused by the undersized culvert that carries the PIP over Sparkill Creek. Hydraulic modeling was used to evaluate a scenario in which the current PIP crossing is replaced with a new structure with a 60-foot span, the Oak Tree Road bridge is replaced with a span of 73 feet, a floodplain is created on the right bank at the current location of a business, and the channel is regraded and increased in size downstream of Oak Tree Road. The floodplain bench simulated in the hydraulic model had a bench width ranging from 70 to 170 feet and extended for approximately 900 linear feet along the right bank, from STA 139+00 to STA 148+00. Excavation depths ranged from 2 to 6 feet below existing grade. The channel was adjusted to accommodate the replacement bridges. Relocation of the business on the right bank of Sparkill Creek, downstream of Oak Tree Road, would be required. This conceptual layout is illustrated in Figure 4-26. Under this scenario, water surface elevations would be reduced by almost 2 feet for the 100-year flows, and the Oak Tree Road crossing would pass up to the 50-year flows, as depicted in the profiles in Figures 4-27a and 4-27b. Existing and proposed flood depths for the current 50-year storm are shown in Figure 4-28 and Figure 4-29, respectively. Existing and proposed flood depths for the current 100-year storm are shown in Figure 4-30 and Figure 4-31, respectively. A summary of the proposed replacement structures and the findings of the hydraulic analysis, evaluated under current conditions and under future conditions projecting for changes in hydrology due to climate change, are listed on Table 4-1.

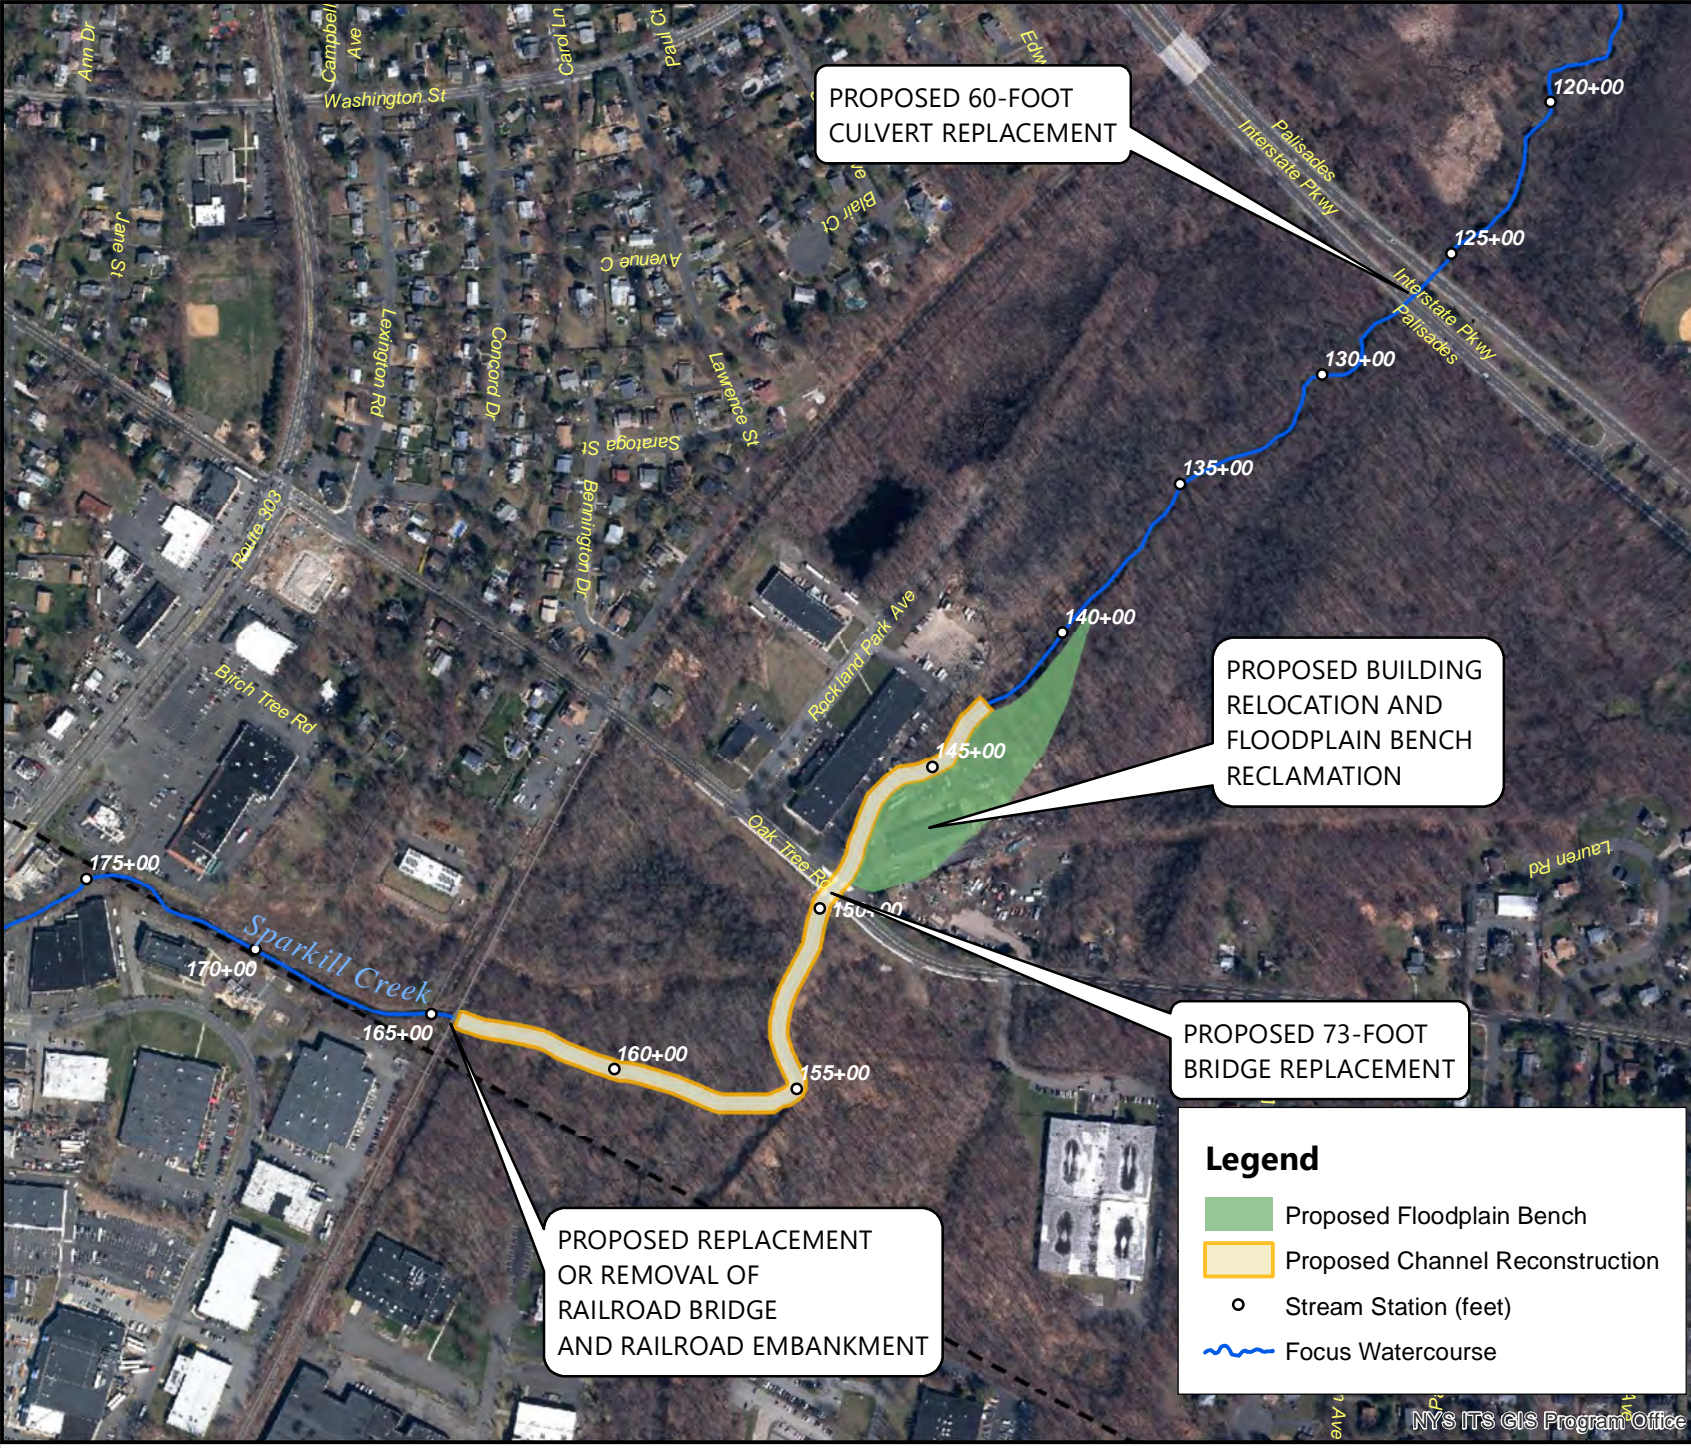
FIG. 4-26

HRA #3 - CONCEPT MAP
 SPARKILL CREEK FLOOD & RESILIENCE STUDY
 SD115
 ROCKLAND COUNTY
 NEW YORK

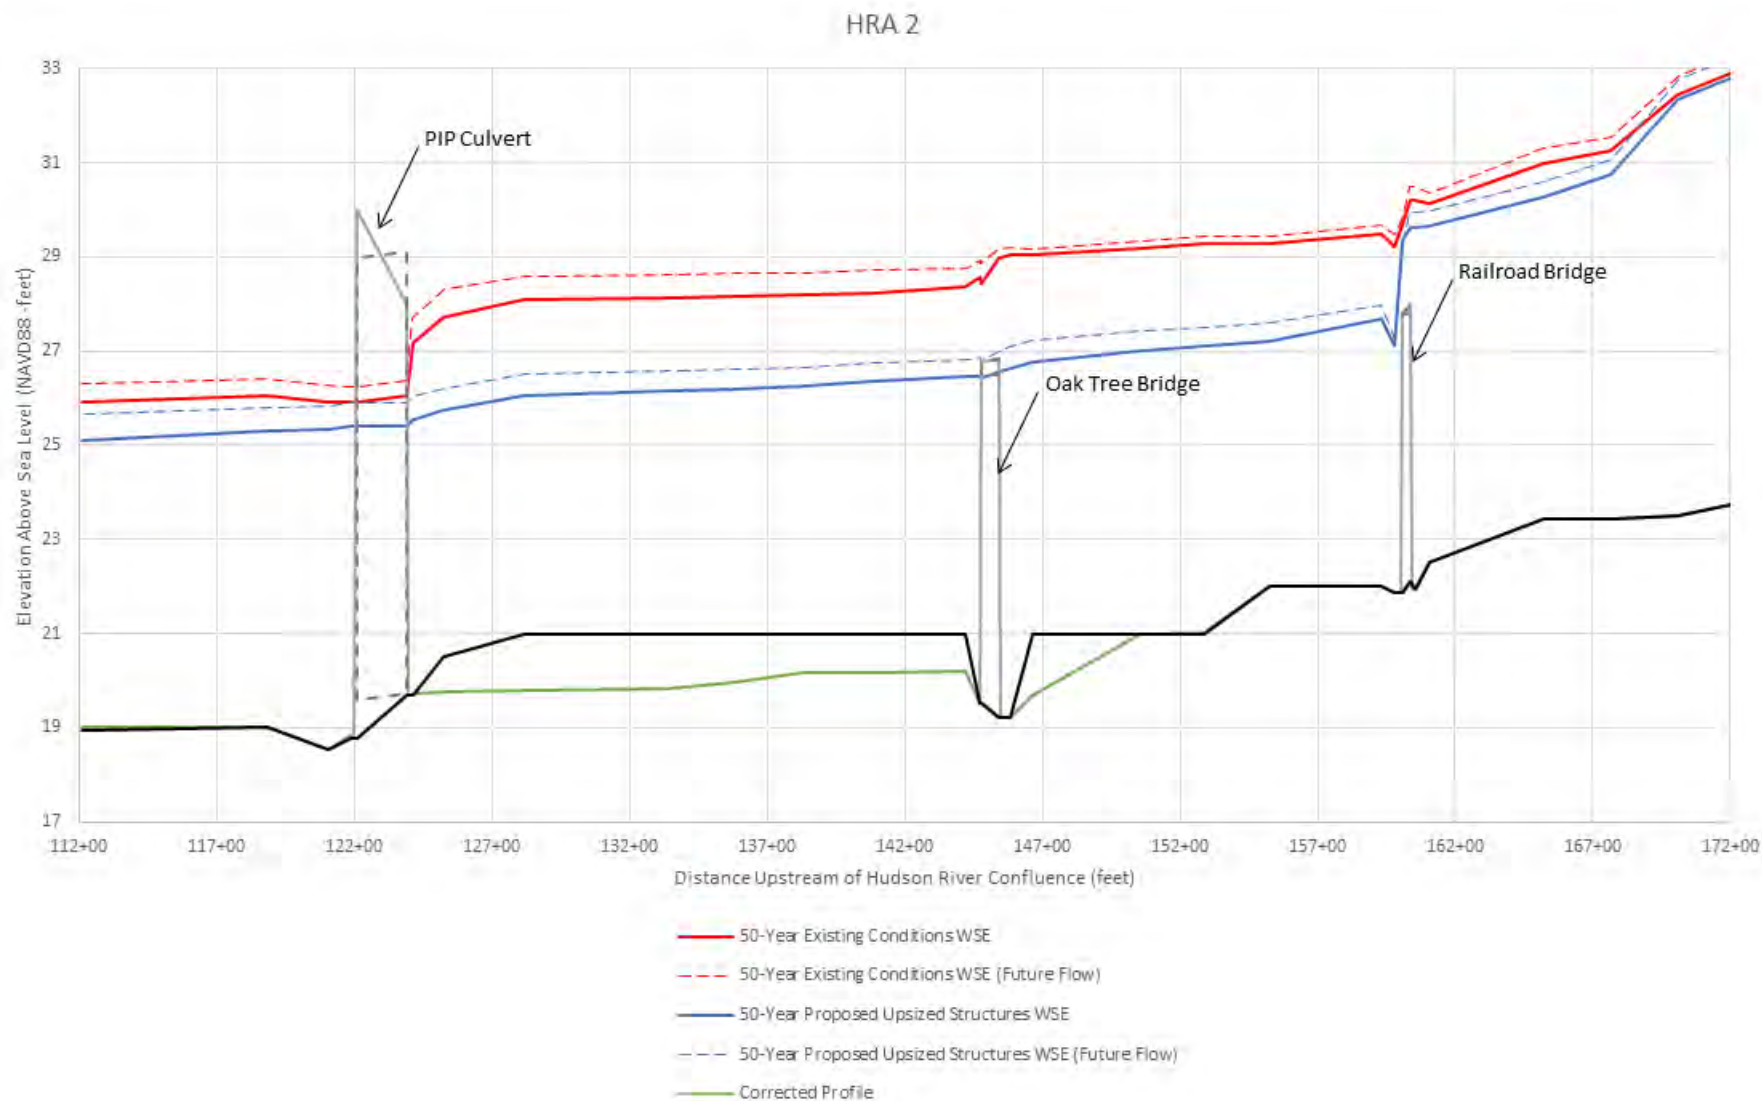
Figure 4-27a: Reach Profile for 50-Year Flows Under Current Conditions and After Adjusting the Channel and Structures Through HRA 3

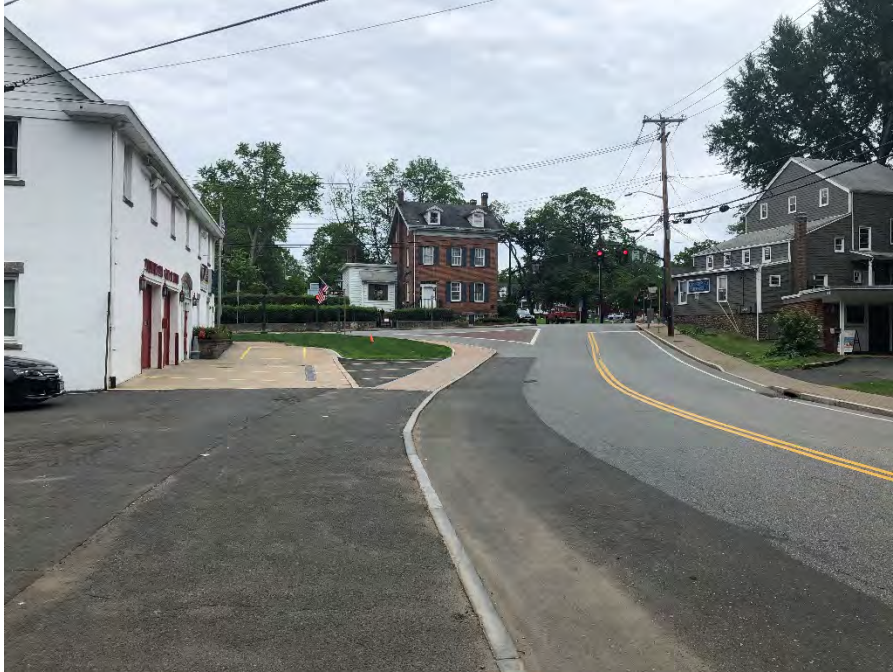
Figure 4-33: Volunteer Fire Association of Tappan, a Critical Facility adjacent to Sparkill Creek

HRA 4 runs along Sparkill Creek from STA 200+00 to STA 220+00 and includes from the Kings Highway bridge, south to the Oak Tree Road bridge, in the hamlet of Tappan (Figure 4-32). The watershed of Sparkill Creek at this location is over 5 square miles. Within HRA 4 is the Volunteer Fire Association of Tappan, a critical facility located adjacent to Sparkill Creek at 123 Washington Street (Figure 4-33). Data collected by FEMA indicates that, as of 2019, multiple properties within HRA 4 in Tappan were identified as repetitive loss or severe repetitive loss, including on Washington Street, Oak Tree Road, Van Ward Place, and Kings Highway.

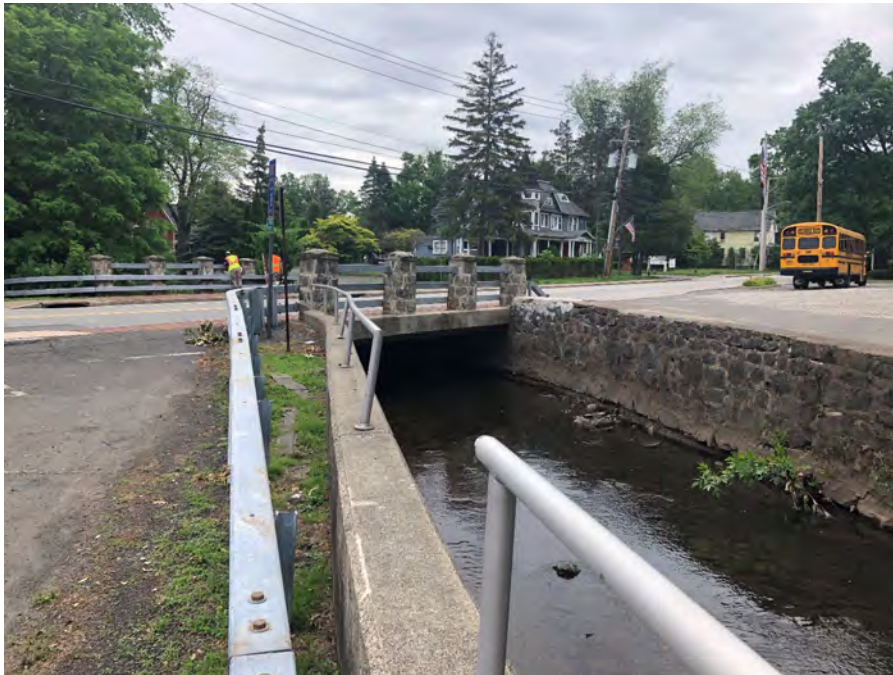
Figure 4-34: Washington Street Bridge and Channelized Section of Sparkill Creek

Beginning at the upstream end of HRA 4, Sparkill Creek passes under the Kings Highway bridge, which has a span of 22 feet. Moving downstream, Sparkill Creek becomes highly channelized as it flows between vertical stone masonry and concrete walls. An 18-foot-wide Rockland County-owned bridge crosses the creek at Washington Street (Figure 4-34). Sparkill Creek then passes through Tappan Memorial Park, where it flows adjacent to a small pond and takes a hard, near 90-degree bend to the left, followed by another hard bend to the right. A small pedestrian bridge spans the channel at 27.4 feet within the park. Continuing downstream, a 40-foot-wide county-owned bridge crosses the creek at Oak Tree Road.

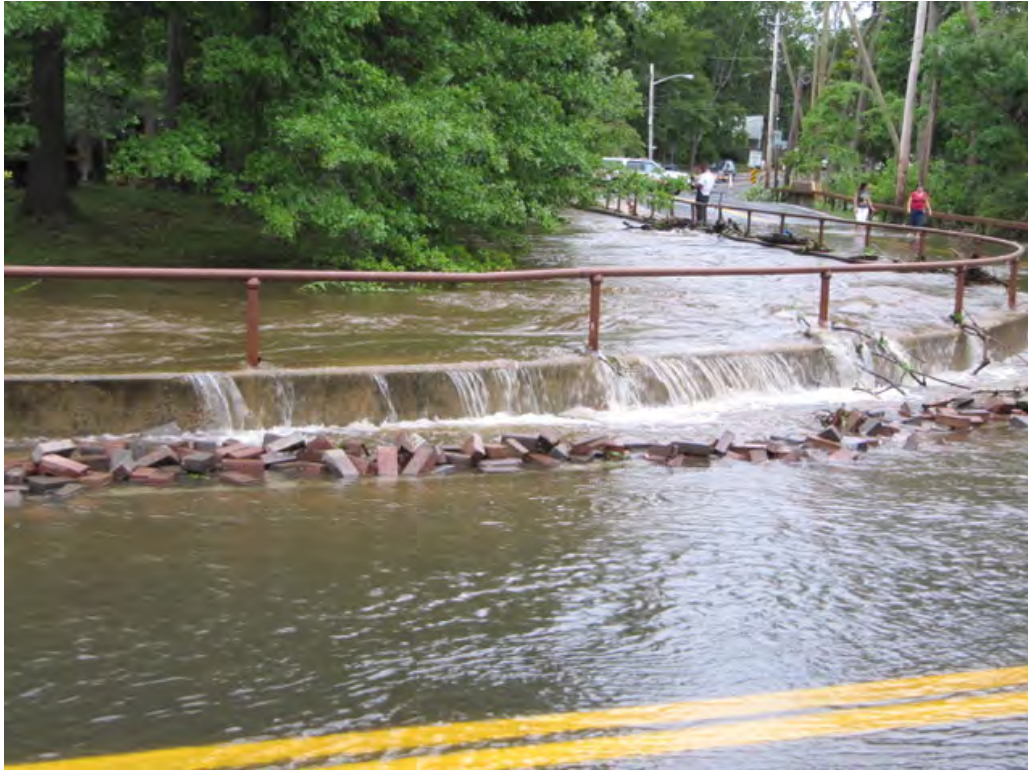
Figure 4-35: Flooding on Sparkill Creek along Oak Tree Road at Van Wardt Place during Tropical Storm Irene (Photo provided by Lawrence Vail)

HRA 4 was extensively flooded during Tropical Storm Irene in 2001 (Figure 4-35). Based on hydraulic analysis, field assessment, and comparison of each structure's span to the channel's bankfull width, it was determined that all structures within HRA 4 are inadequately sized and are unable to convey even the 10-year flood event. The channelized sections of the creek are also hydraulically undersized and contribute to flooding in Tappan.

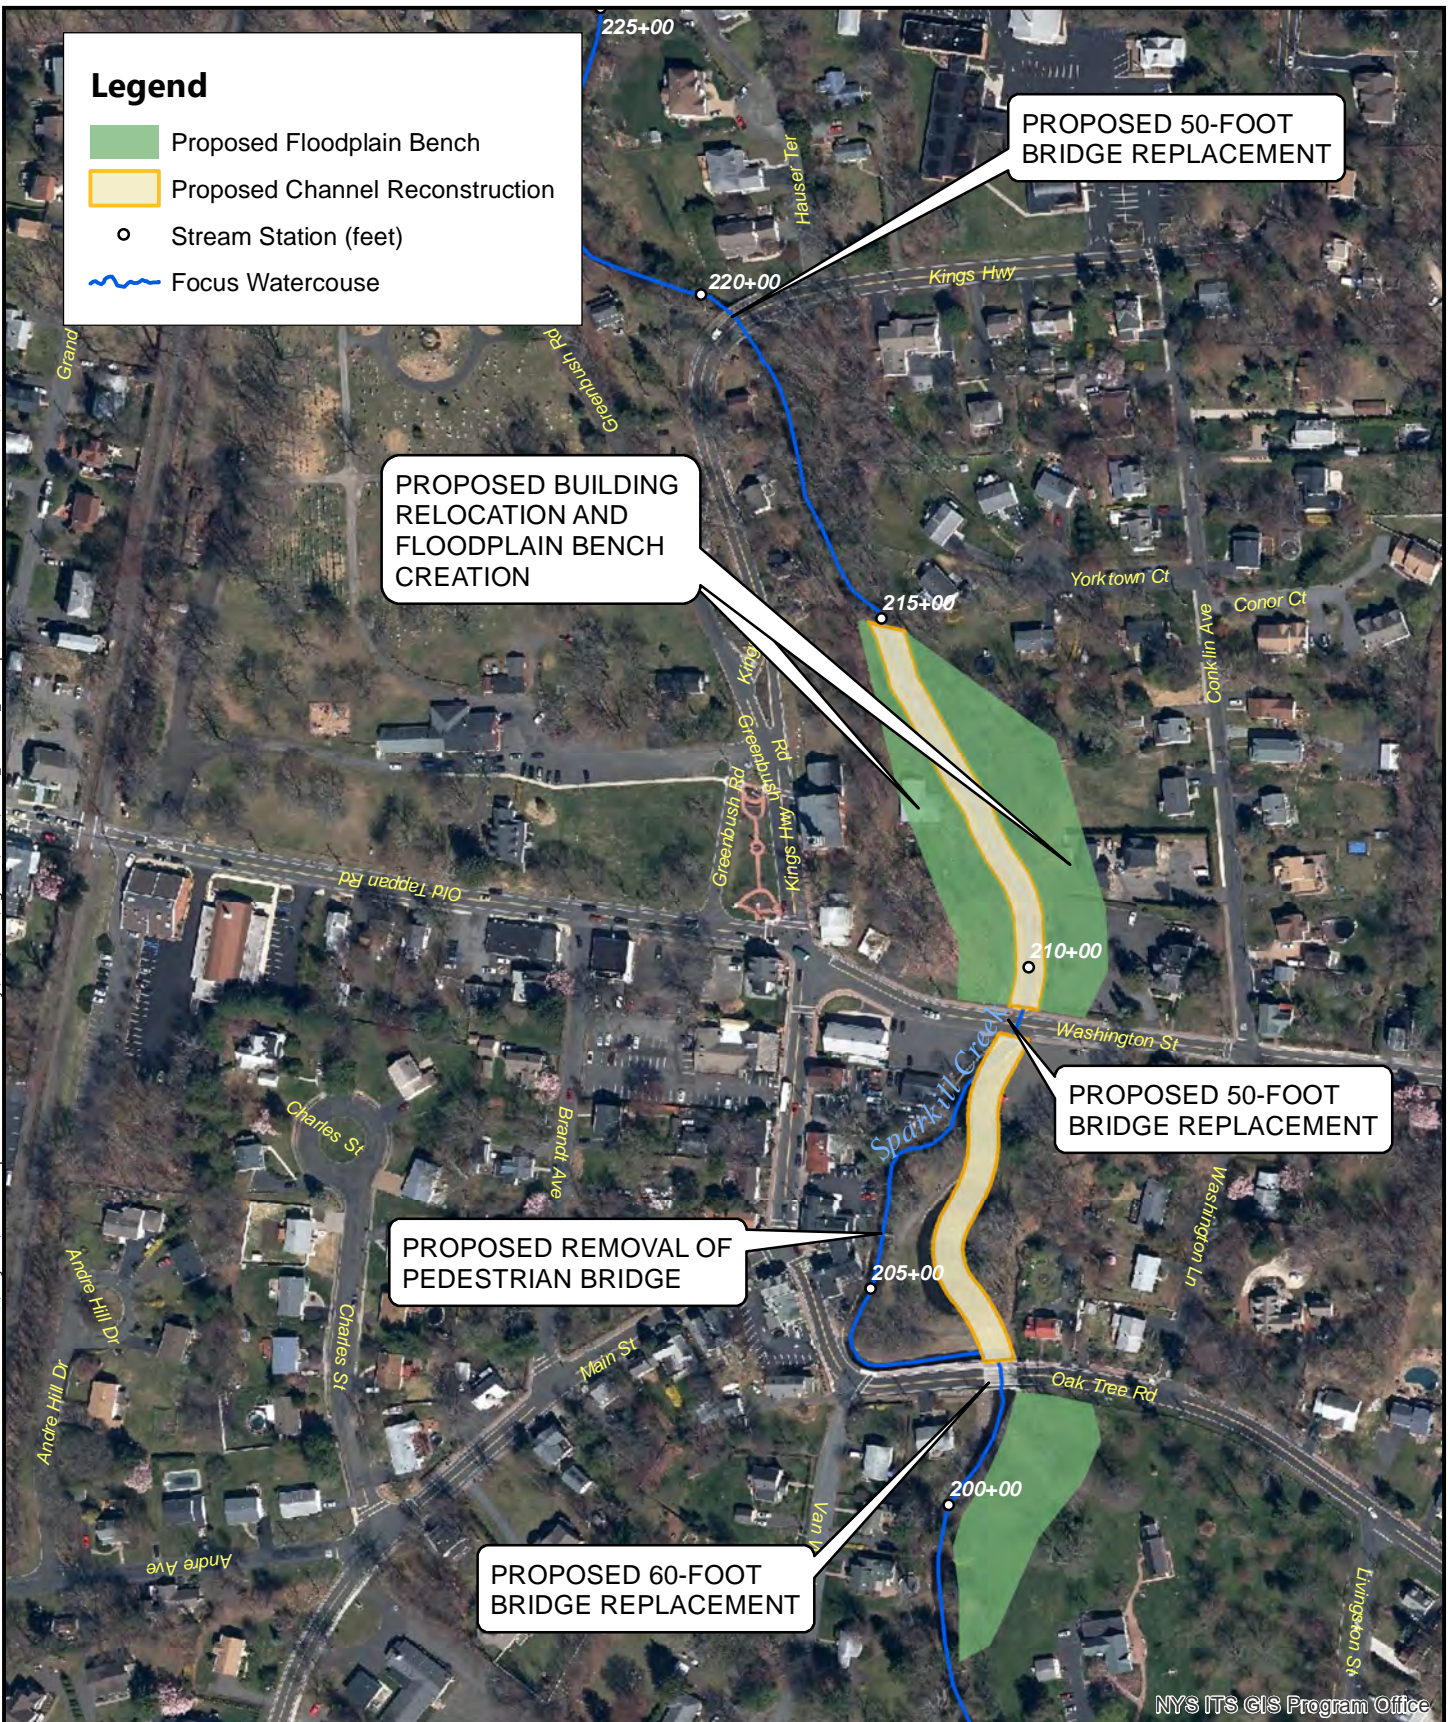
FIG. 4-36

PROPOSED 50-FOOT BRIDGE REPLACEMENT

PROPOSED BUILDING RELOCATION AND FLOODPLAIN BENCH CREATION

PROPOSED REMOVAL OF PEDESTRIAN BRIDGE

PROPOSED 60-FOOT BRIDGE REPLACEMENT

HRA #4 - CONCEPT MAP

A proposed set of flood reduction improvements was evaluated. Under this scenario, the Kings Highway bridge and the Washington Street bridge would be replaced with adequately sized structures, each with a span of 50 feet. The Oak Tree Road bridge would be replaced with a new bridge with a span of 60 feet. Floodplain would be enhanced along both sides of Sparkill Creek in key areas, requiring the relocation of several structures immediately adjacent to the creek. Floodplain benches upstream of Washington Street along the right and left banks would measure approximately 550 feet long and would extend from STA 209+50 to STA 215+00. Floodplain bench widths would range from 65 to 115 feet and would be excavated 4 to 6 feet below the existing grade. The channel restoration between Washington Street and Oak Tree Road, from STA 202+00 to STA 209+08, would include floodplain benches along the left and right banks. Floodplain bench widths would range between 40 and 115 feet and would be excavated from 3.5 to 7.0 feet below the existing ground. Downstream of Oak Tree Road, the floodplain bench along the left bank would extend from STA 197+95 to STA 201+70, measure 150 feet at its widest, and on average be 3 feet below existing grade. Undersized and channelized sections of the Sparkill Creek channel would be widened to the bankfull width of 39 feet, and Sparkill Creek through Tappan Memorial Park would be realigned to eliminate the two hard bends and better align the channel with the Oak Tree Road bridge, leaving the existing channel through the park to act as an overflow during large flood events. The pedestrian bridge in the park would no longer be necessary and would be removed. A conceptual layout showing the improvements described above is depicted in Figure 4-36.

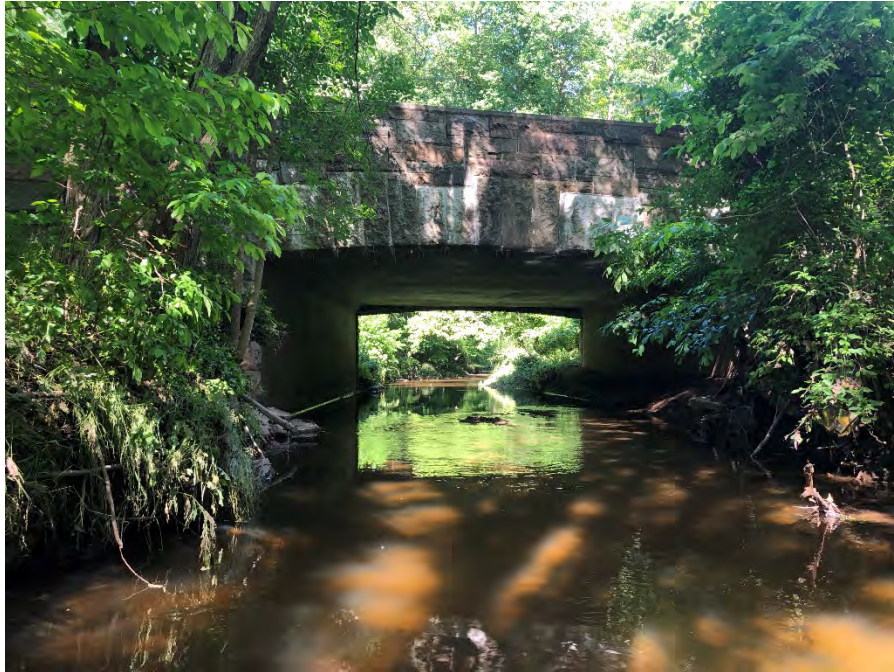
Figure 4-44: Looking Upstream at Northbound Palisades Interstate Parkway Bridge Outlet

Each of the two culverts that span the northbound and southbound lanes of the PIP (owned by Palisades Interstate Parkway Commission) has a span of 27 feet (Figure 4-44). Their NAACC crossing code is xy4103207773941537, and their aquatic passability score is 0.89 out of 1.0, an *insignificant barrier*. The State Route 303 crossing (owned by NYSDOT), north of the intersection with Kings Highway, is carried by twin-barrel concrete box culverts that measure 10 feet wide and 8 feet high (Figure 4-45). The NAACC crossing code for the culverts is xy4102990773944169, and they were assigned a score of 0.89 out of 1.0 for aquatic passability: *insignificant barriers*. The structures currently pass up to the 500-year flows.

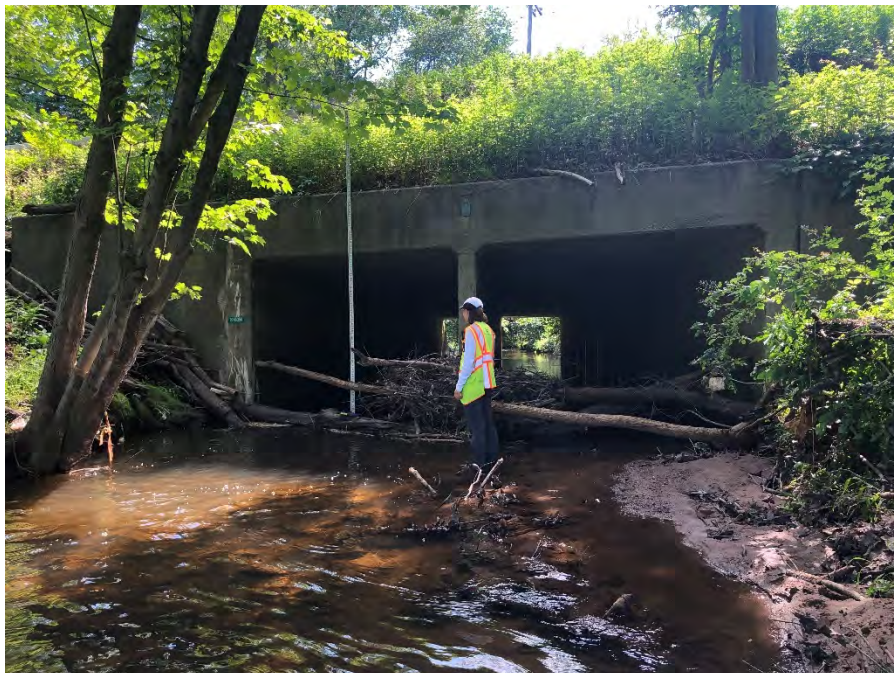
Figure 4-45: Looking Downstream at Route 303 Culvert Inlets

The State Route 303 crossing can pass up to the 500-year flood event without overtopping. Similar to the PIP culverts described above, the State Route 303 culvert creates a backwater that influences upstream
