HRA #5 - 100-YEAR PROPOSED CONDITIONS FLOOD DEPTHS
SPARKILL CREEK FLOOD & RESILIENCE STUDY
SD115
ROCKLAND COUNTY
NEW YORK

4.6 HIGH RISK AREA #6 – RAIL TRAIL

HIGH RISK AREA #6 - RAIL TRAIL
 SPARKILL CREEK FLOOD & RESILIENCE STUDY
 SD115
 ROCKLAND COUNTY
 NEW YORK

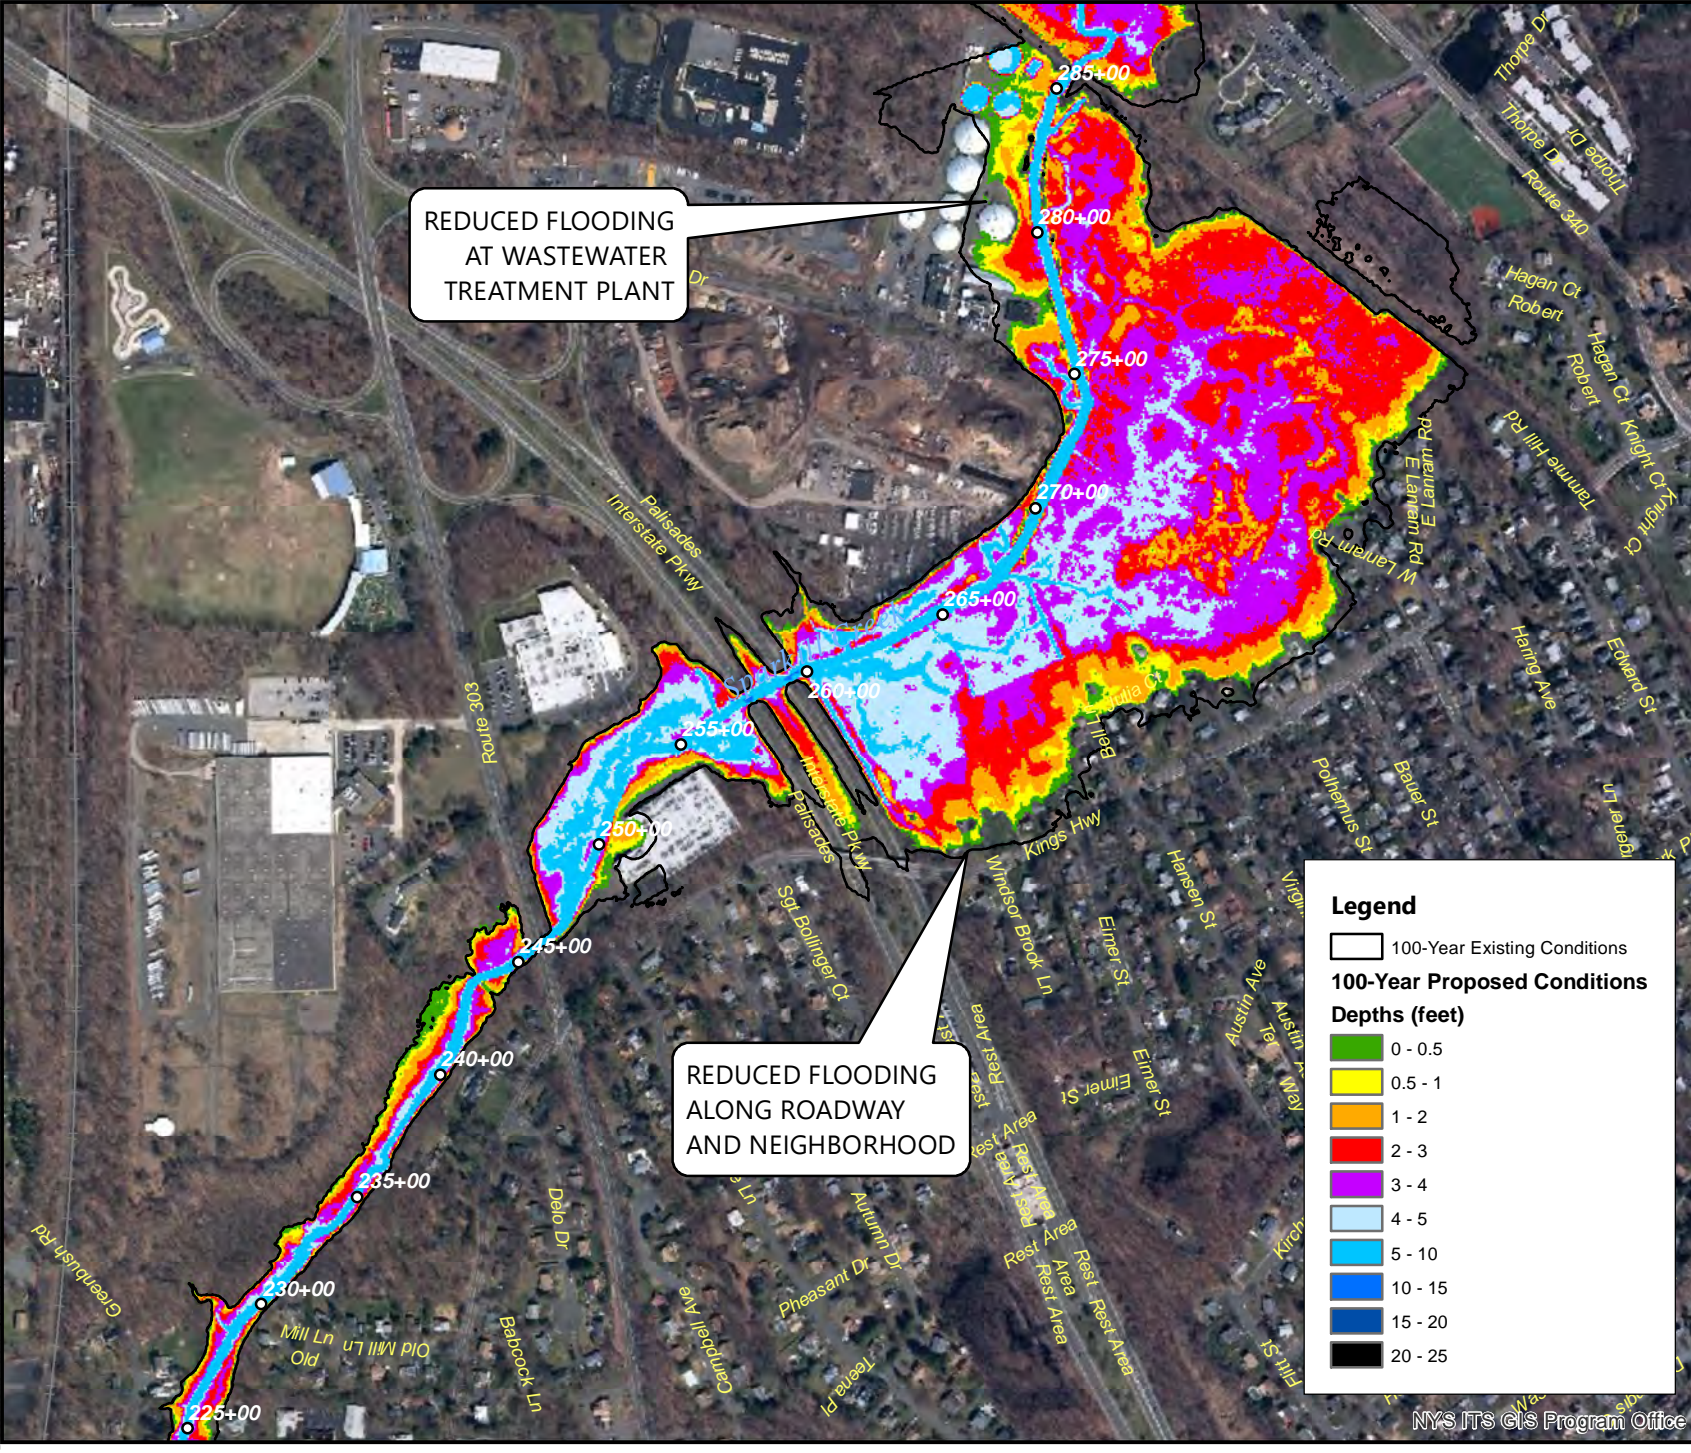
FIG. 4-47

REDUCED FLOODING
AT WASTEWATER
TREATMENT PLANT

REDUCED FLOODING
ALONG ROADWAY
AND NEIGHBORHOOD

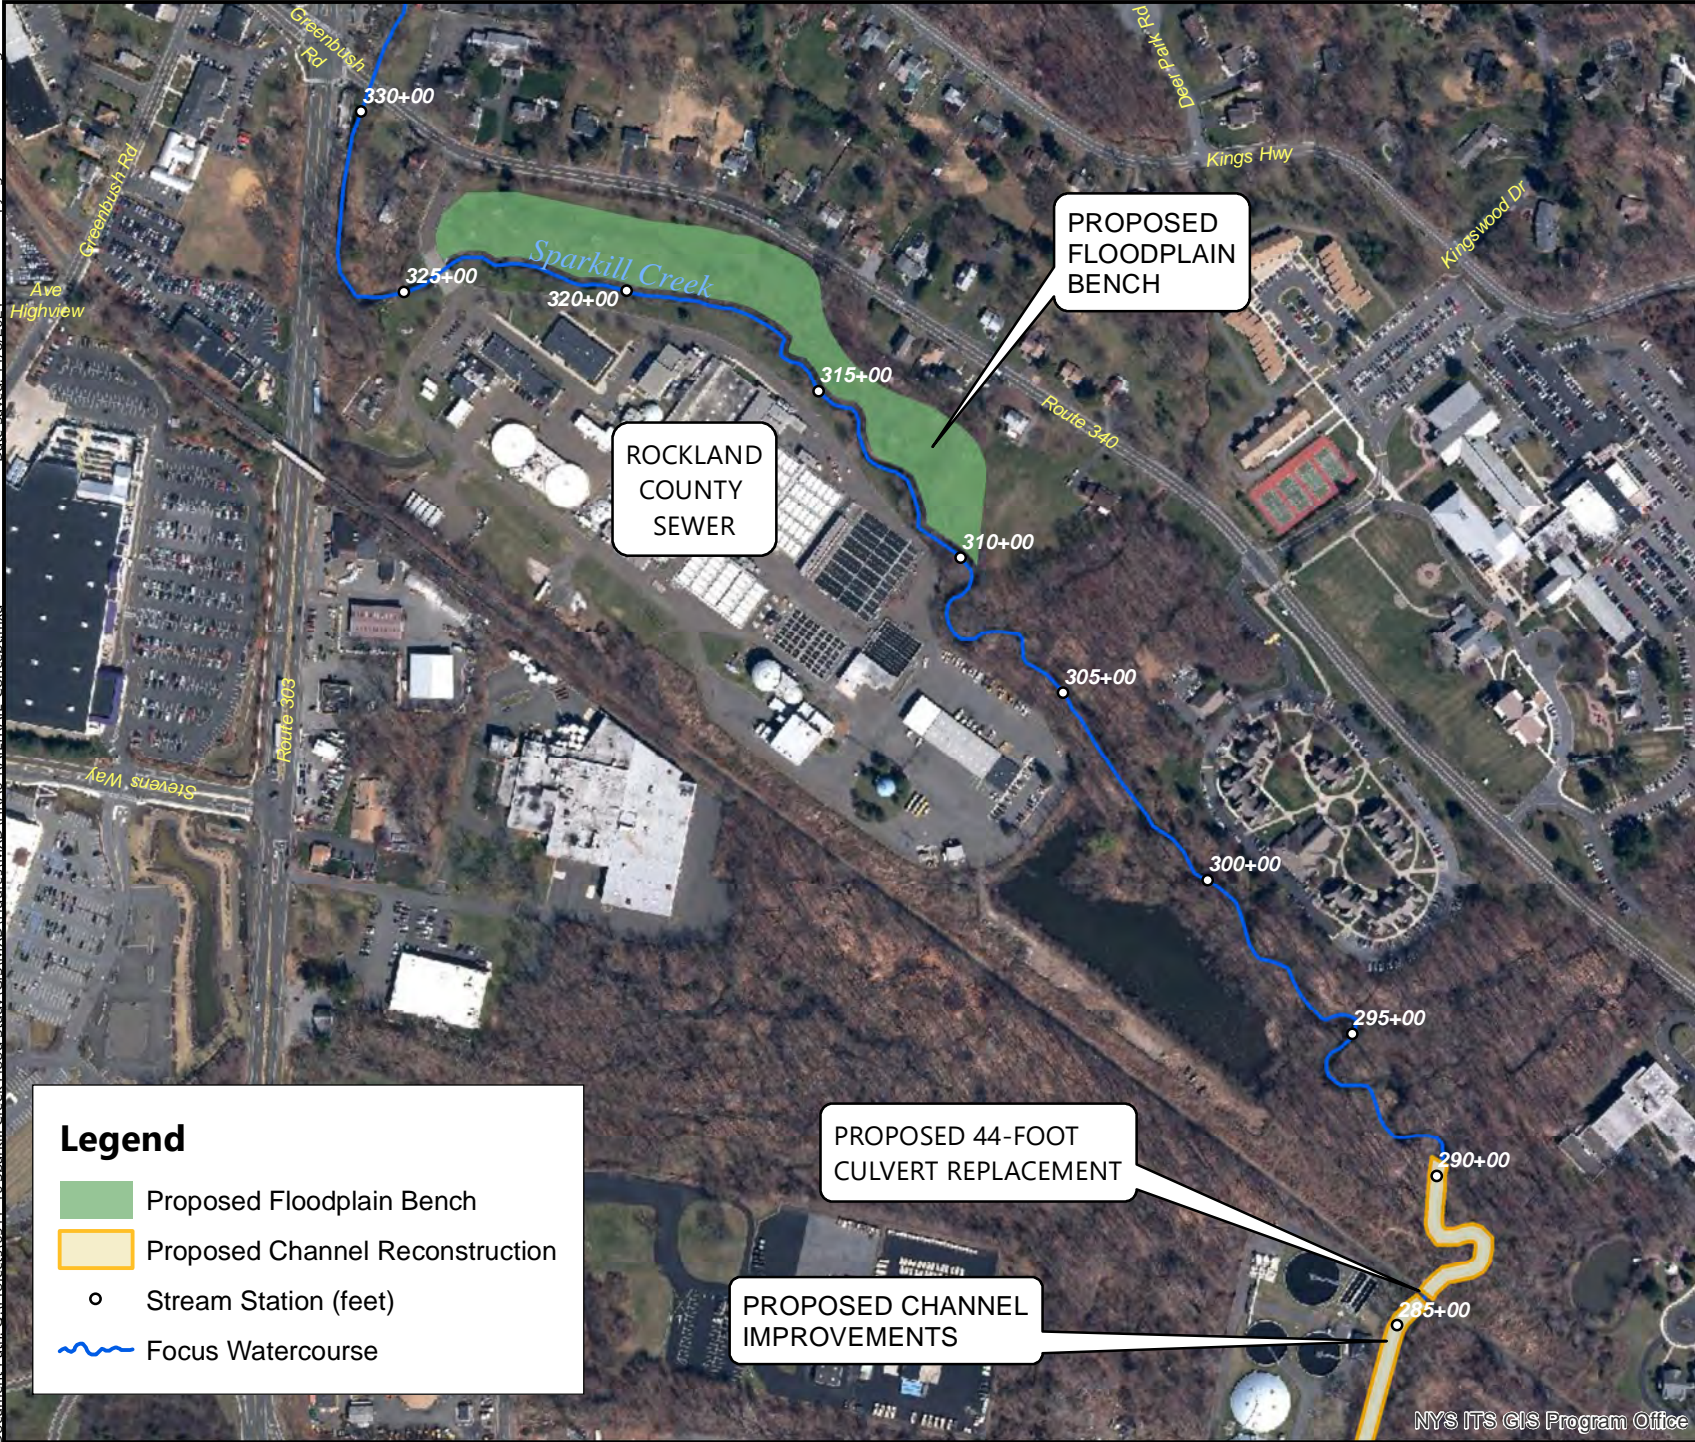
FIG. 4-50

HRA#6 - CONCEPT MAP
 SPARKILL CREEK FLOOD & RESILIENCE STUDY
 SD115
 ROCKLAND COUNTY
 NEW YORK

Replacement of the rail trail bridge with a new structure with a span of at least 44 feet, removal of the railroad embankment to accommodate the larger span, widening of the Sparkill Creek channel to a bankfull width of 34 feet, and widening the floodplain immediately upstream and downstream of the crossing would result in reduced flooding depths and extent upstream of the crossing, including a reduction in depth and frequency of flooding at the Rockland County Sewer Facility. Floodplain creation would run along the left bank from STA 309+69 to STA 323+92 or approximately 1,400 linear feet. This floodplain bench would have varying widths, measuring 77 feet at its most narrow point and 140 feet at its widest. Excavation depths would range from 1.0 to 7.5 feet below existing grade.

The improvements described above are depicted in concept in Figure 4-50. Flood reductions during the 10-year flood event are illustrated in Figure 4-51 (existing conditions) and Figure 4-52 (proposed conditions). Flood reductions during the 50-year flood event are illustrated in Figure 4-53 (existing conditions) and Figure 4-54 (proposed conditions). Flood reductions during the 100-year flood event are illustrated in Figure 4-55 (existing conditions) and Figure 4-56 (proposed conditions).
