# **SUSQUEHANNA RIVER**

## **Biological Stream Assessment**

## **BIOLOGICAL STREAM ASSESSMENT**

Lower Susquehanna River  
Broome and Tioga Counties, New York  
Susquehanna River Basin

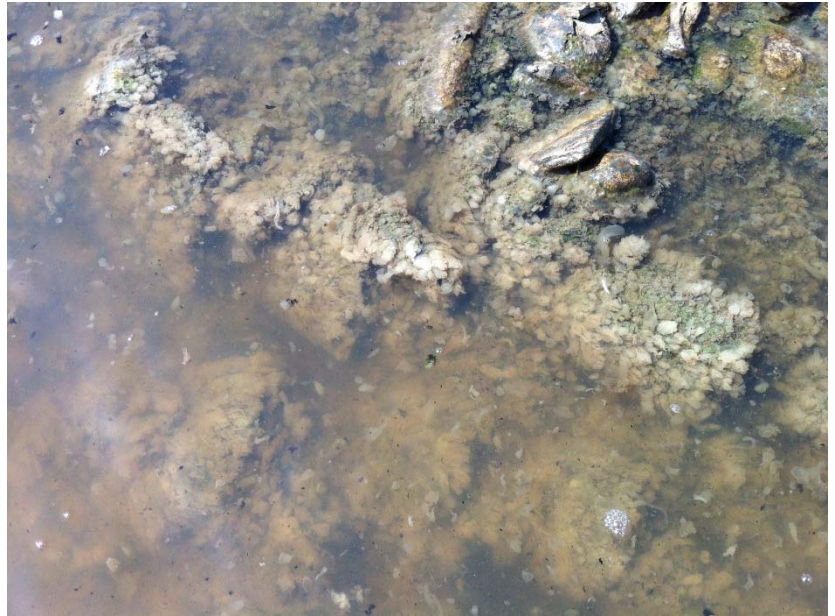
Figure 3a. Sewage fungus mat covering substrate - Station SUSQ-03; 0.1 mile downstream from Binghamton -Johnson City Sewage Treatment Plant

SUSQ-03, (Figure 2) is the first site downstream (0.1 mile) from the BJCSTP. The sample was collected at a riffle that is formed at the confluence of the outfall tributary, Fuller Hollow Creek. In clear contrast with the upstream location, this site was visibly degraded with dense sewage fungus mats covering all substrate surfaces (Table 1, Figures 3a-c). There was a noxious odor present. In slack water at edges of the riffle and in stagnant pools on the backside of the riffle there were areas of dense anoxic sludge. Fungus flocculent was also evident in the water column.

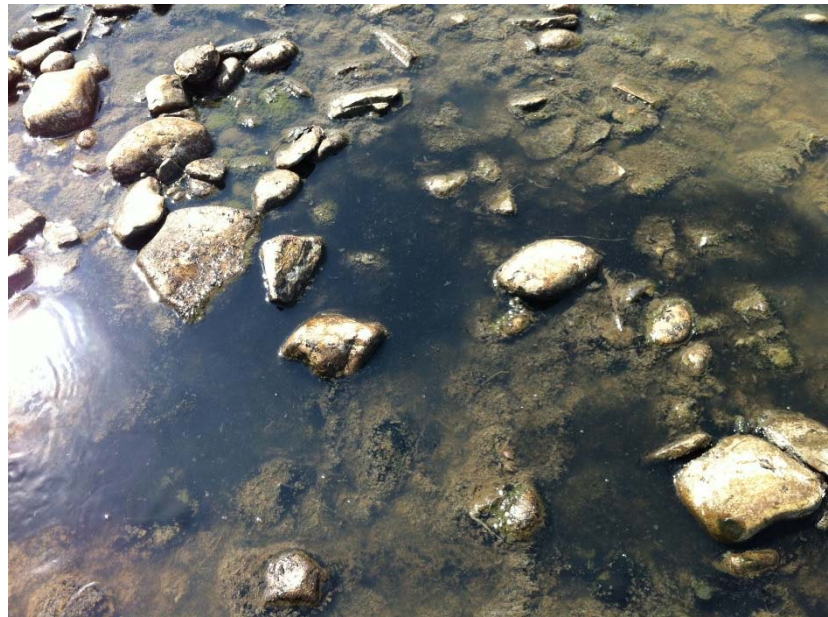
Figure 3b. Anoxic sludge -SUSQ-03

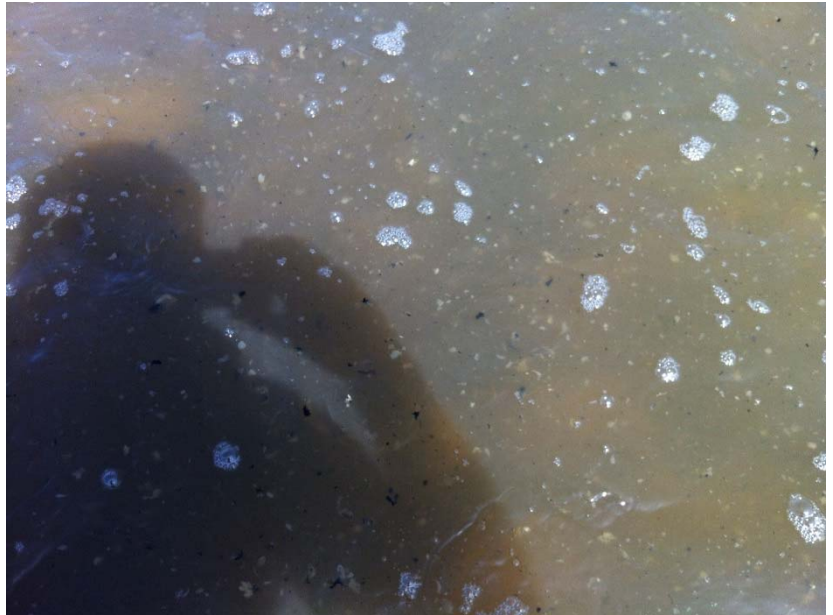
Figure 3c. Fungus flocculent in water column – SUSQ-03

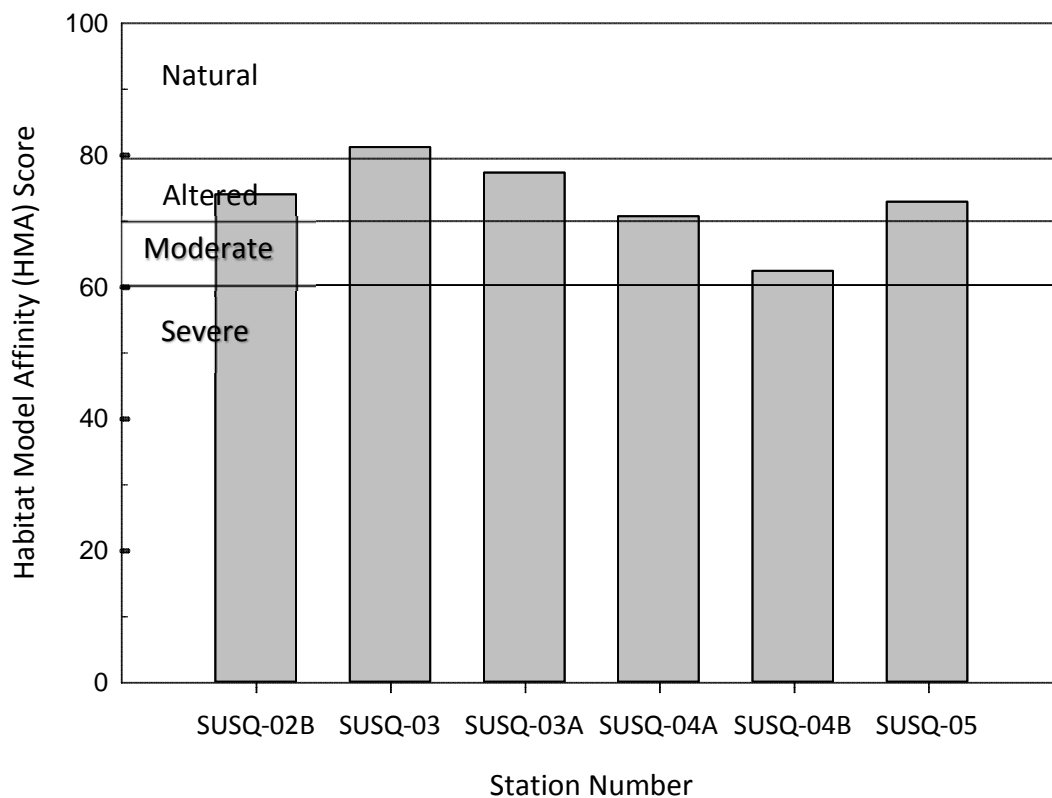
Figure 5. Habitat assessment scores for each sampling location on Lower Susquehanna River, 2014.

At survey site location, SUSQ -04A; 6.9 miles below the BJCSTP (Figure 2c), recovery from the effect of the sewage effluent was evident. Sewage fungus and algal mats were not observed at the kick sample site and the noxious odor was no longer detectable. Benthic community metrics showed a measurable improvement compared to SUSQ-03A (Figure 4). Overall water quality was assessed near the threshold between slightly impacted and non-impacted water quality with a BAP score of 7.2. The macroinvertebrate community transitioned to dominance by Ephemeroptera represented by clean water species such as *Maccaffertium mediopunctatum*, *Leucrocuta* sp. and *Rhithrogena* sp. (Table 5). Data from this site should be considered with the following caveat; the site is in an area that is braided with channels between small islands so that any effluent plume may be diffused or redirected away from the actual sample site (Figure 2c, Table 1). Impact source determination was inconclusive (Table 2). The scoring of physical habitat attributes reflected an altered to moderately altered area of the river impacted by higher sediment deposition, low riffle frequency, and low assessments for bank stability and bank vegetation (Table 3, Figure 5).

Full recovery of the benthic community to a condition similar to the site upstream of the treatment plant was evident at the last site surveyed, SUSQ-05, 11.9 miles downstream of the BJCSTP (Figure 2e, Table 1). All macroinvertebrate community metrics except NBI-P supported the improvement in water quality to non-impacted (BAP 8.26) at this site (Figure 4). A diverse mixture of clean water indicator species were present. Of particular note is the reappearance of the stoneflies, *Agnatina capitata* and *Paragnetina media*, generally indicative of non-impacted water quality (Table 5). The NBI-P score that shows slightly enriched condition at this point in the river, nearly twelve miles downstream from the BJCSTP, may now be as much attributable to non-point source contributions of nutrients as to any single point source. This phosphorus enrichment likely accounts for the vigorous green algae cover on the substrate at this site. Impact source determination was not warranted with the return to non-impacted condition. Habitat Model affinity scoring shows an altered habitat because of low riffle frequency and low riparian width due to proximity to the highway (Figure 5).
