Flood Mitigation Report West Branch Delaware River SD 060

Delaware County, New York
January 2021

This document was prepared for the New York State Department of Environmental Conservation, in cooperation with the New York State Office of General Services.

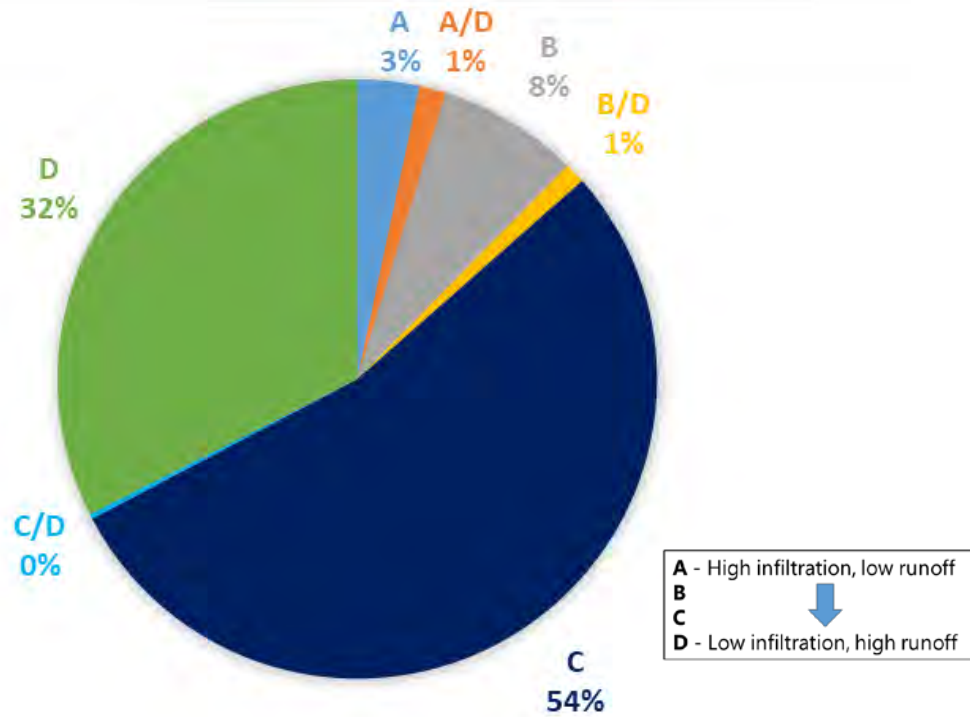
Figure 2-2: Hydrologic Grouping of Soils within the WBDR Watershed

During a rainfall event, the proportion of rainfall that runs off directly into rivers and streams or that infiltrates into the ground is greatly influenced by the composition of soils within a watershed. Soils are assigned a hydrologic soil group (HSG) identifier, which is a measure of the infiltration capacity of the soil. These are ranked A through D. An HSG A soil is often very sandy, with a high infiltration capacity and a low tendency for runoff except in the most intense rainfall events; a D-ranked soil often has a high silt or clay content or is very shallow to bedrock and does not absorb much stormwater but instead is prone to runoff even in small storms. A classification of B/D indicates that when dry the soil exhibits the properties of a B soil, but when saturated, it has the qualities of a D soil. Over 85 percent of the mapped soils in the WBDR watershed are classified as HSG C, C/D, or D, indicating a low capacity for infiltration and high tendency for runoff (Figure 2-2). This contributes to flash flooding in the watershed as rainfall runoff moves swiftly into streams rather than gradually seeping through the soils. This is mitigated to some degree by the large areas of forest in the watershed, which tend to encourage infiltration and reduce runoff.

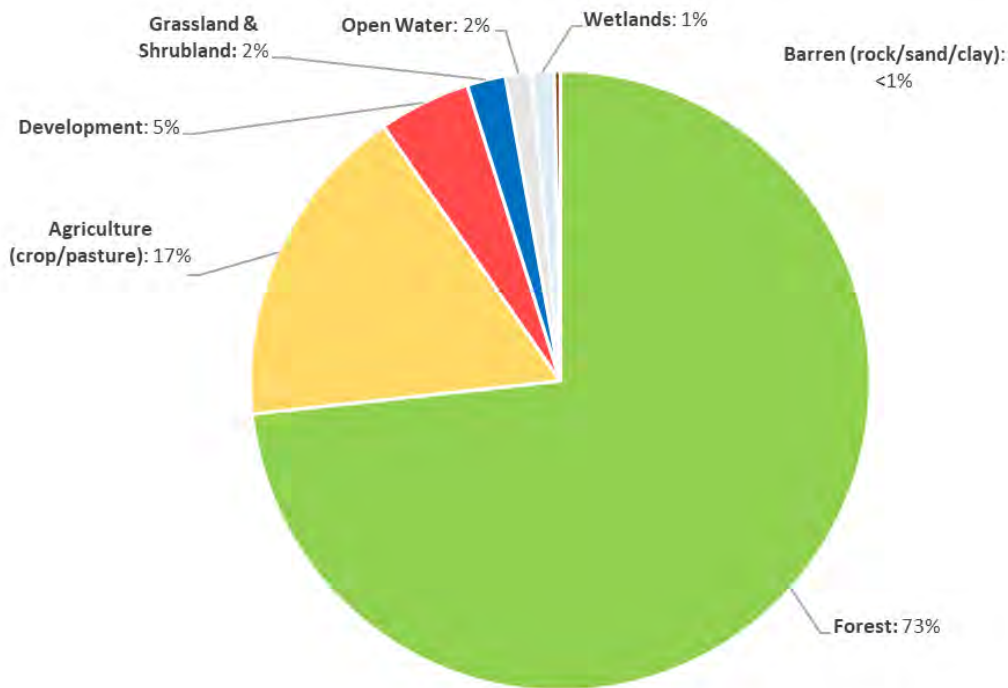
Figure 2-3: Land Cover within the WBDR Watershed

Land cover within the WBDR watershed can be characterized using the 2016 Multi-Resolution Land Characteristics National Land Cover Database for Southeast New York State (Figure 2-3). Forested land consists of deciduous, coniferous, and mixed forest types and makes up 73 percent of the land cover in the watershed. Agricultural lands, including hay, pasture, and cultivated crops, make up 17 percent. Developed land represents 5 percent of the land cover. The remaining 5 percent of the land cover consists of grassland, shrubland, wetlands, open water, and barren land.

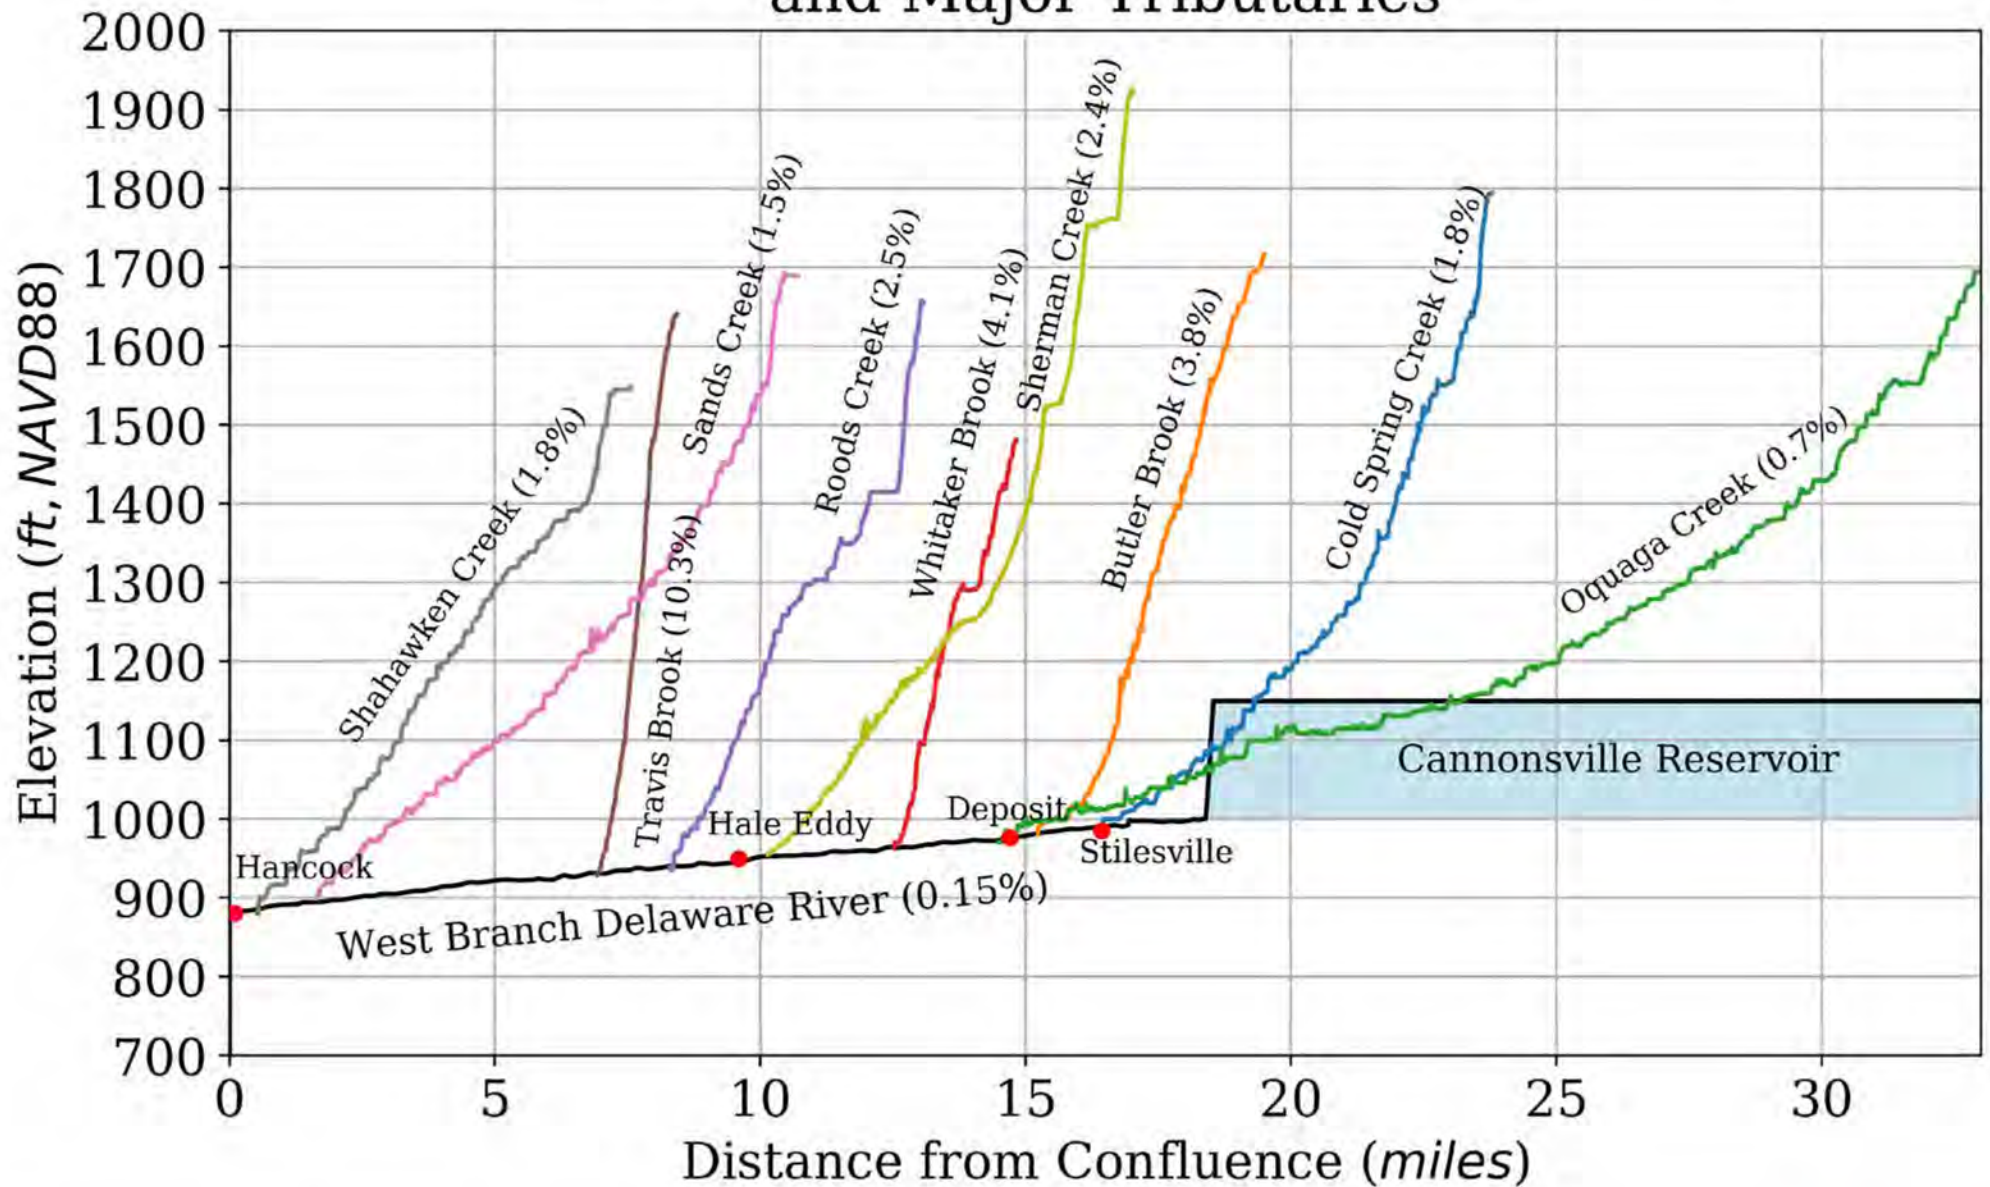
FIGURE 2-5

WBDR LONGITUDINAL PROFILE

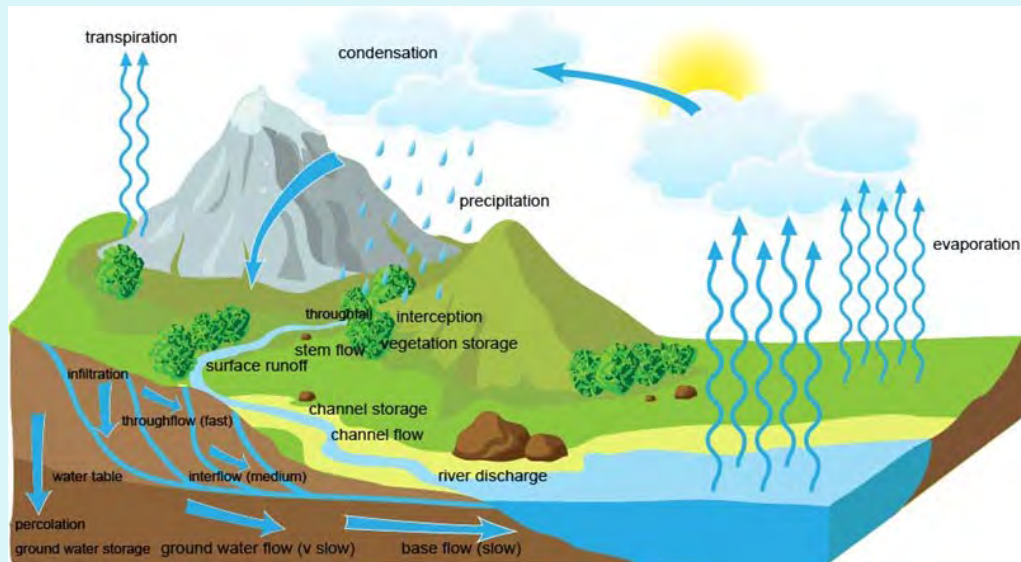
Figure 2-7: Diagram of Simplified Hydrologic Cycle

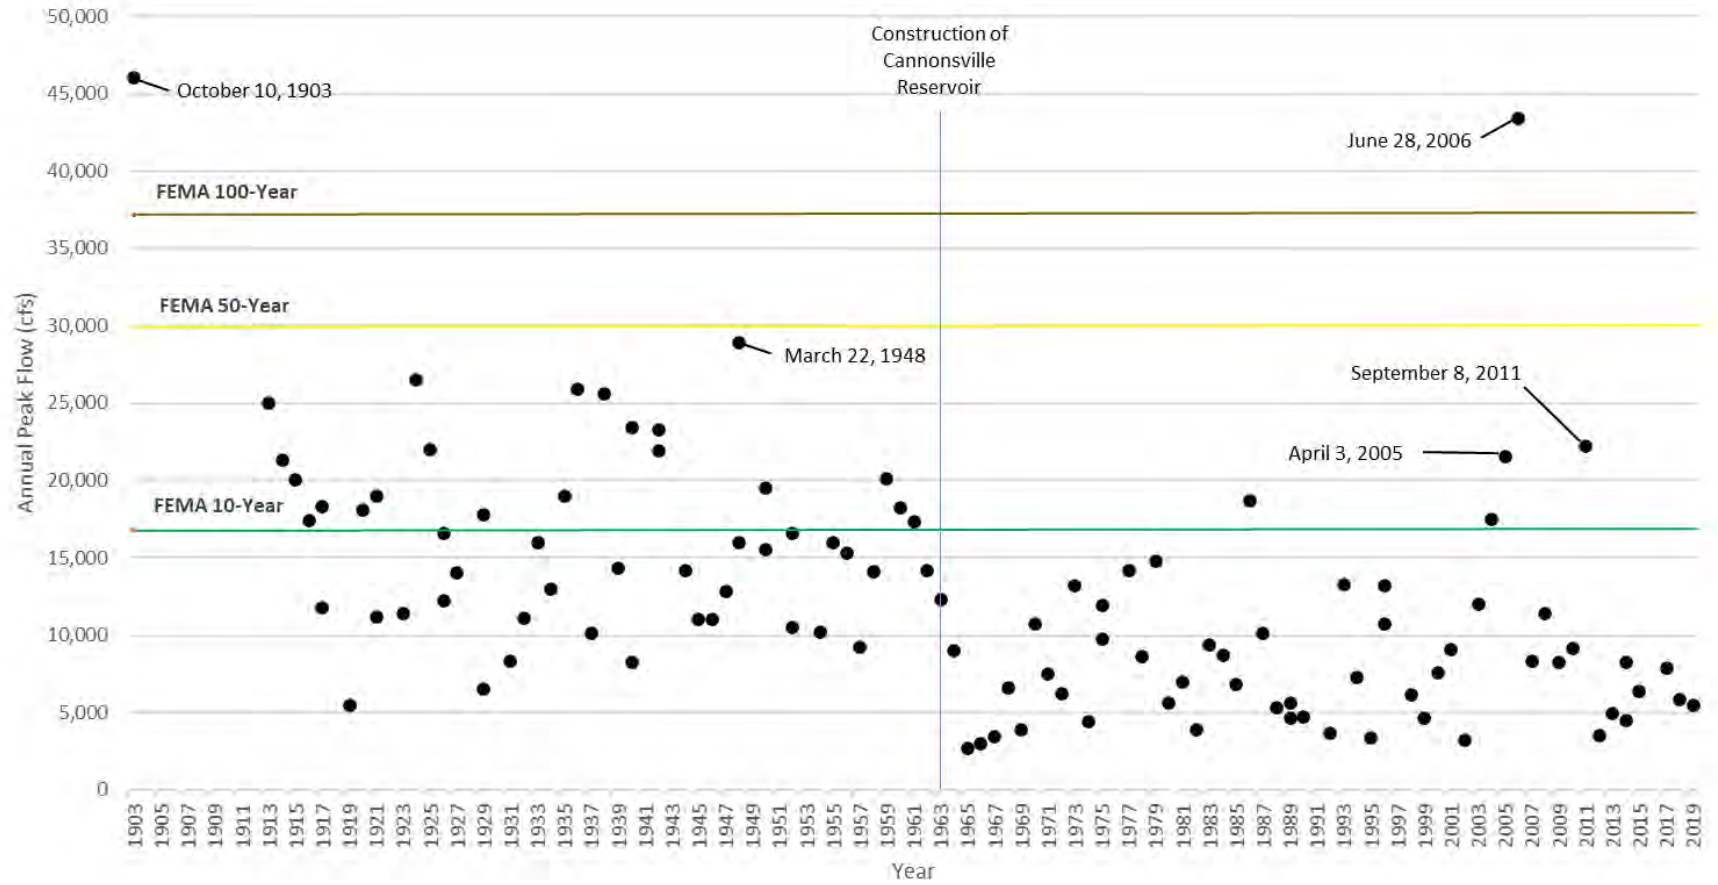
Figure 3-1
Hydrograph of Annual Peak Flow on the WBDR at Hale Eddy
1903 - 2019

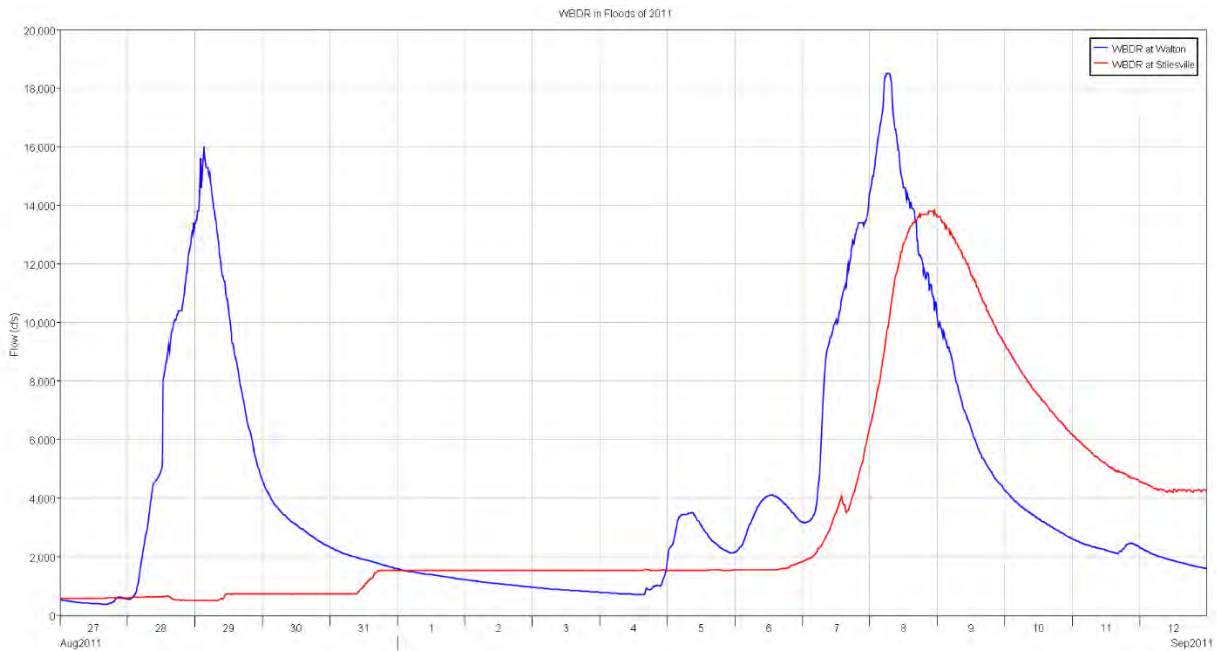
Figure 4-1: Flow Hydrographs for the WBDR at Walton and Stilesville during Tropical Storms Irene and Lee, 2011

flood hydrographs are only part of the total; in its analysis, the USGS also accounted for the contributions of the several tributaries that meet the WBDR upstream of the dam but downstream of the Walton gauge, including those that empty directly into the reservoir. Figure 4-1 is from late August and early September 2011 when Tropical Storms Irene and Lee passed through the region. At the onset of high flows resulting from Tropical Storm Irene, the Cannonsville Reservoir was filled to 84.6 percent of its capacity, meaning that the spillway of the dam at the reservoir outlet was not spilling, and there was substantial void space in the reservoir. This substantial void resulted in complete attenuation of the flood wave. When Tropical Storm Lee arrived in the region 10 days later, the Cannonsville Reservoir was at 96.8 percent capacity, and as a result, the attenuating effect of the reservoir on WBDR flows was not as great as it had been during Tropical Storm Irene.

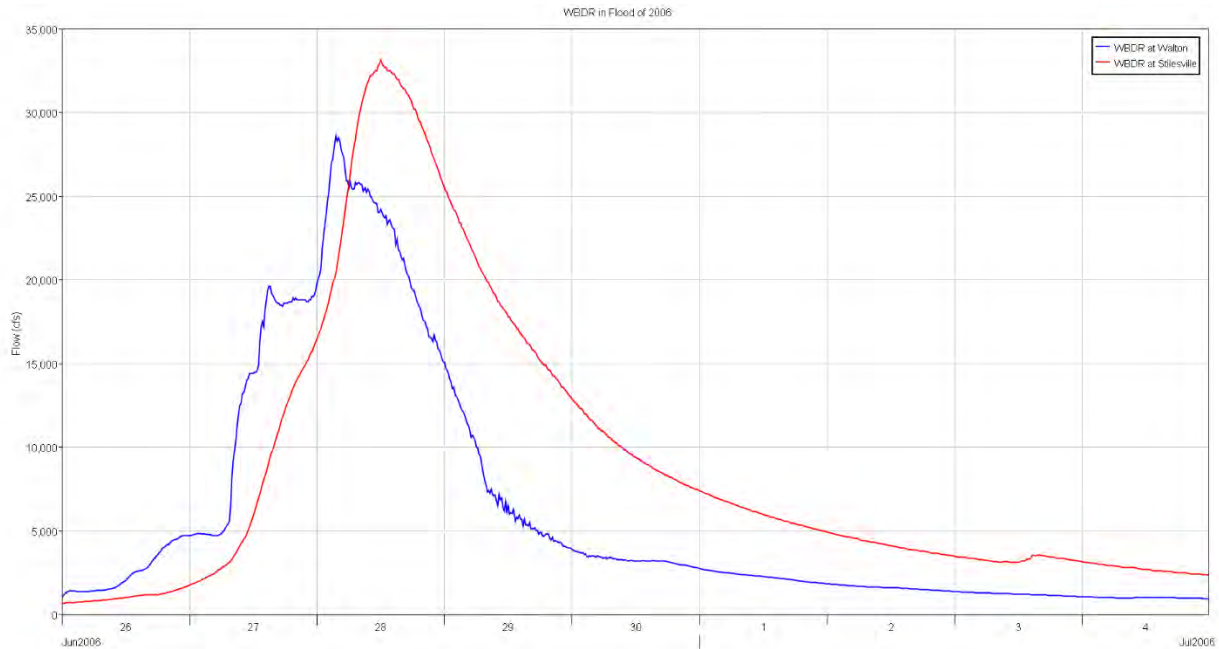
Figure 4-2: Flow Hydrographs for the WBDR at Walton and Stilesville during the 2006 Flood

At the onset of the June 2006 flood, the Pepacton Reservoir was filled to capacity and spilling, with no void (Figure 4-2). In contrast to the 64 percent attenuation seen during Tropical Storm Irene, the reservoir resulted in a 28 percent attenuation of peak flows during the 2006 flood.

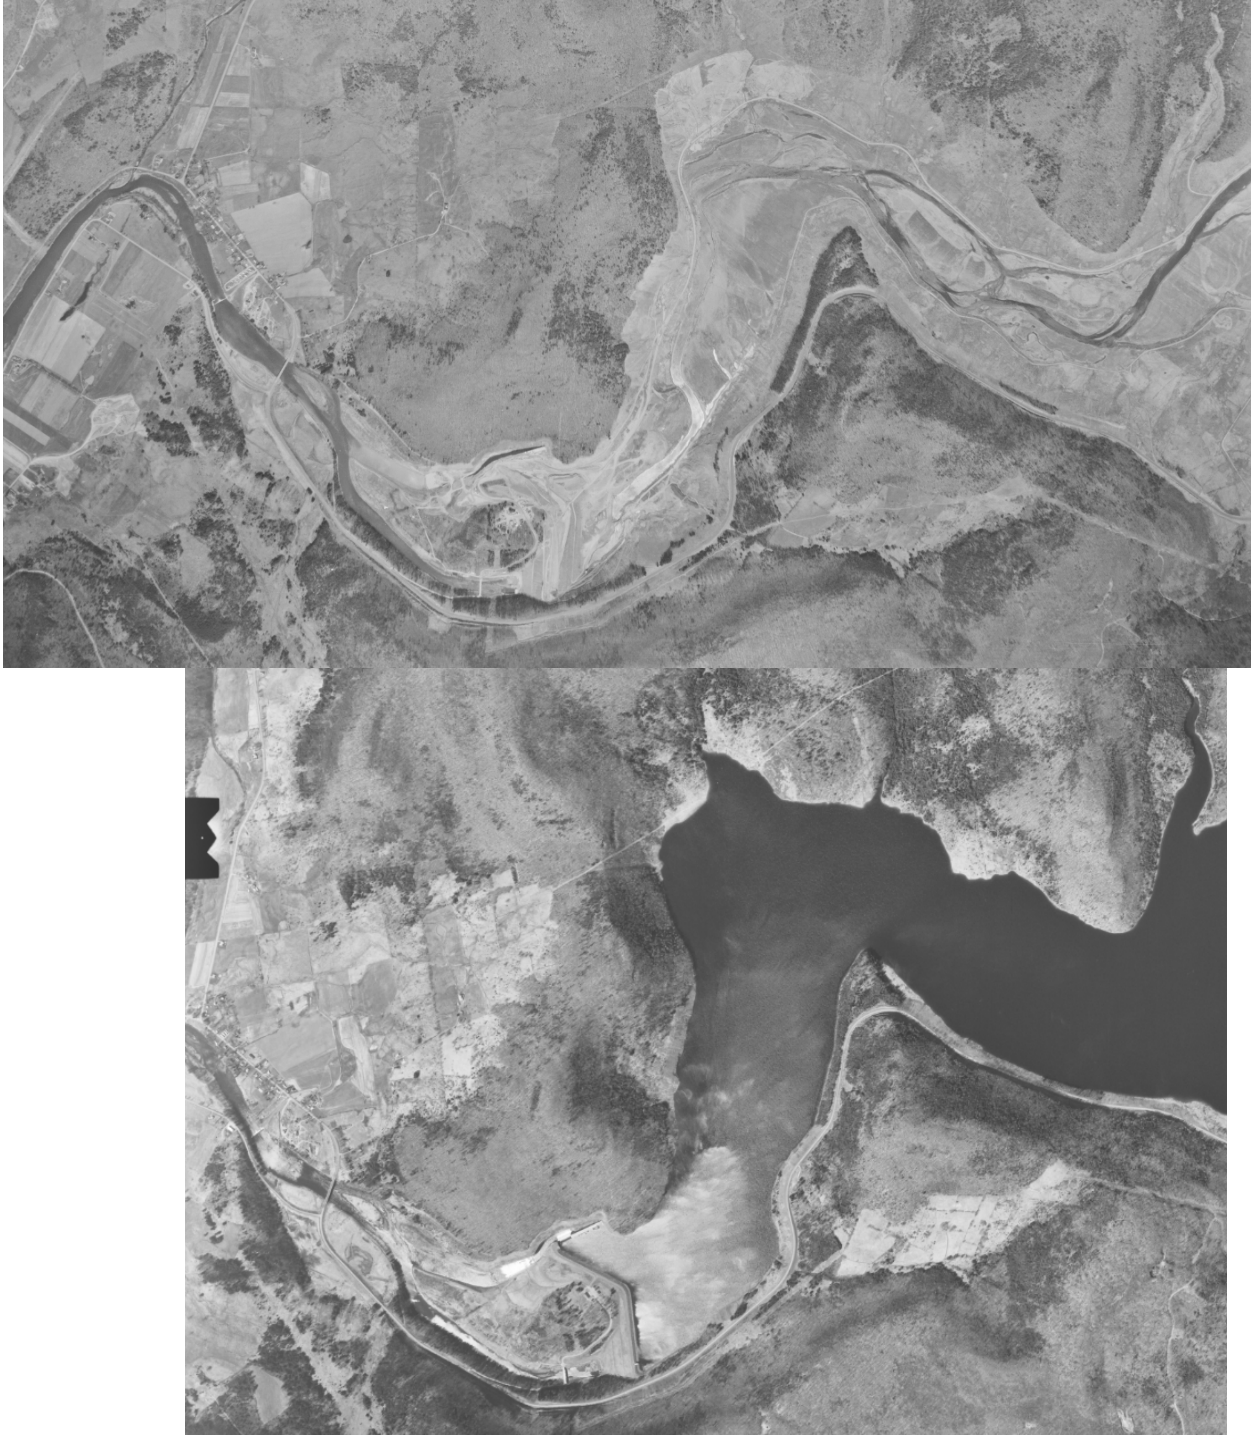
Photo 4-1: Portions of aerial photograph acquired in April 1963 during construction of the Cannonsville Dam (above) and in April 1973 after the reservoir had filled (below). The hamlet of Stilesville is visible on the left side of the images. The bridge over the WBDR in Stilesville has since been relocated approximately 3,500 feet downstream. Retrieved from the USGS Earth Resources Observation and Science Center's *EarthExplorer* online service.

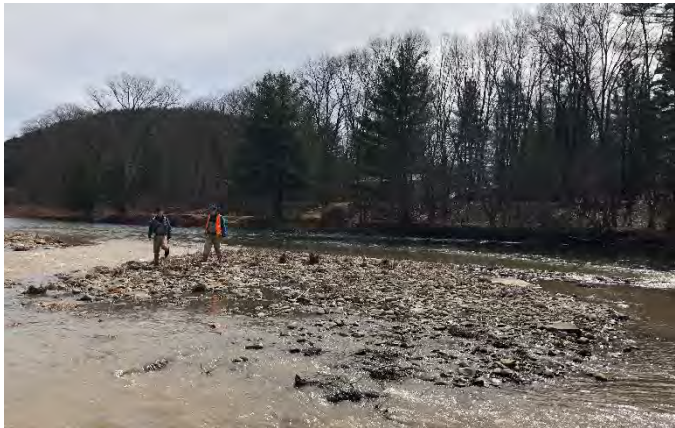
Photo 4-2: Sediment bar along the WBDR

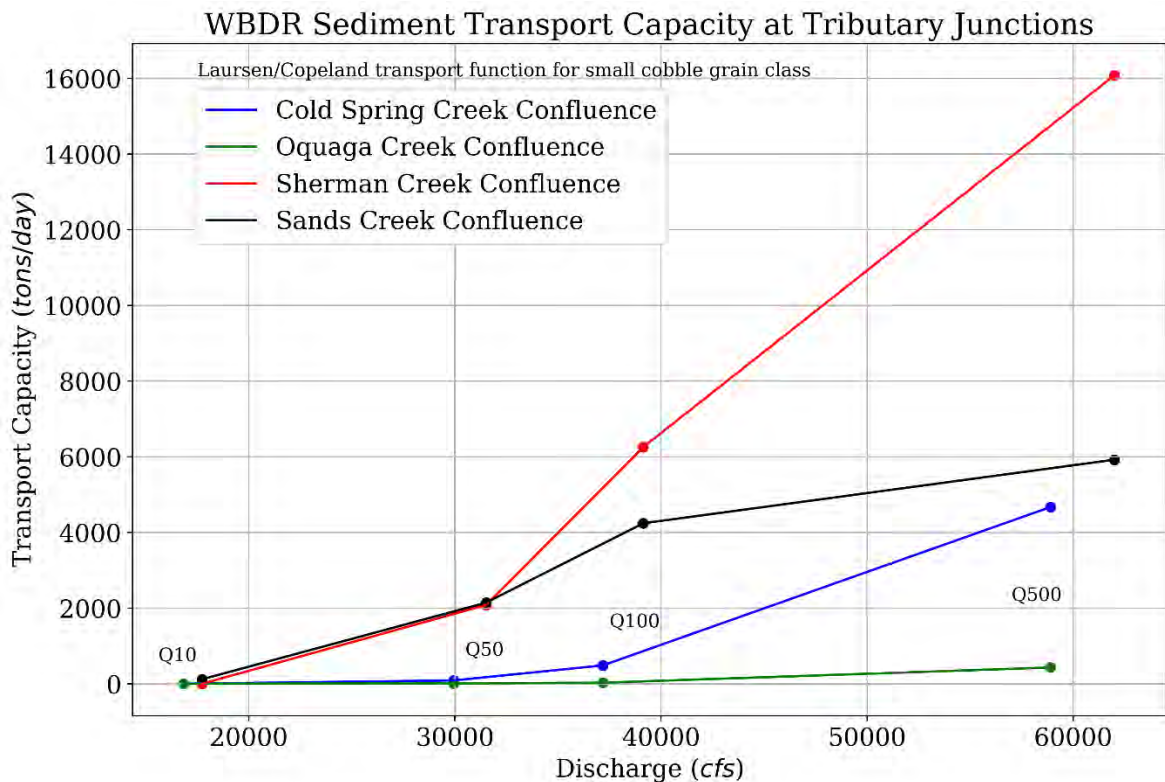
Figure 4-3: Transport capacity of small cobble grain class for the WBDR at representative tributary junctions based on FEMA modeling. Channel and valley characteristics result in some variability in competence in the most severe floods; however, at the reach scale, these coarse particles are essentially immobile in up to the 10-year or 50-year floods.

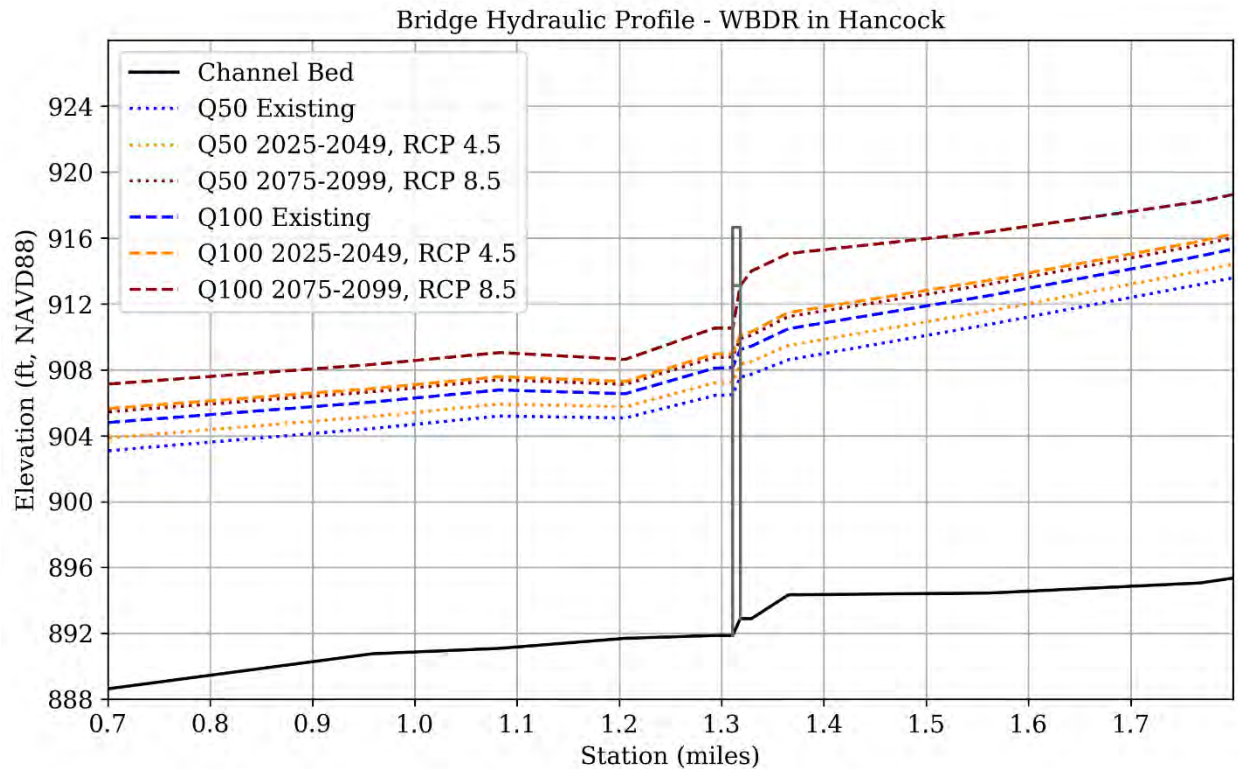
Figure 4-5: Hydraulic profiles of the WBDR at the Route 191 bridge in Hancock. Current and projected future flow profiles are shown.

The Route 191 bridge (BIN 1091700) that crosses into Pennsylvania was constructed in 1937 and is the final crossing of the WBDR before the confluence with the EBDR. This bridge is a moderate hydraulic constriction, causing as much as 1 foot or more of backwater inundation in the 10-, 50-, and 100-year floods and up to 1.7 feet of additional depths in the 500-year flood. A substantial aggradational feature has developed upstream of this bridge and appears to occlude the majority of the opening of the right (western) span of the crossing. This aging bridge is likely due for replacement in the coming decades. An upgraded structure should be accompanied by new hydrologic and hydraulic analyses that represent the conditions the bridge is likely to face over its design life.

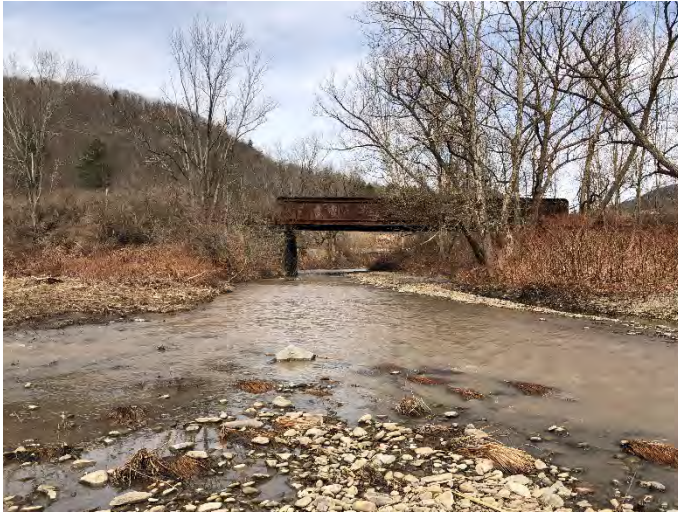
Photo 4-3: Railroad crossing of Sands Creek at its confluence with the WBDR. Note the cobble bar in the foreground.

West of the village between Hancock and Hale Eddy, the NY Susquehanna & Western (NYSW) Railroad is modeled as overtopping in the 50-year flood. Sands Creek Road (Route 67) crosses Sands Creek several times as it follows the tributary up its valley. The Sands and Cadosia Creek Watershed Assessments conducted by LandStudies in 2009 identified a number of conceptual flood mitigation and stream restoration alternatives. Updated hydraulic modeling of Sands Creek would enable quantitative assessment of these strategies and prioritization of infrastructure upgrades and stream rehabilitation projects.

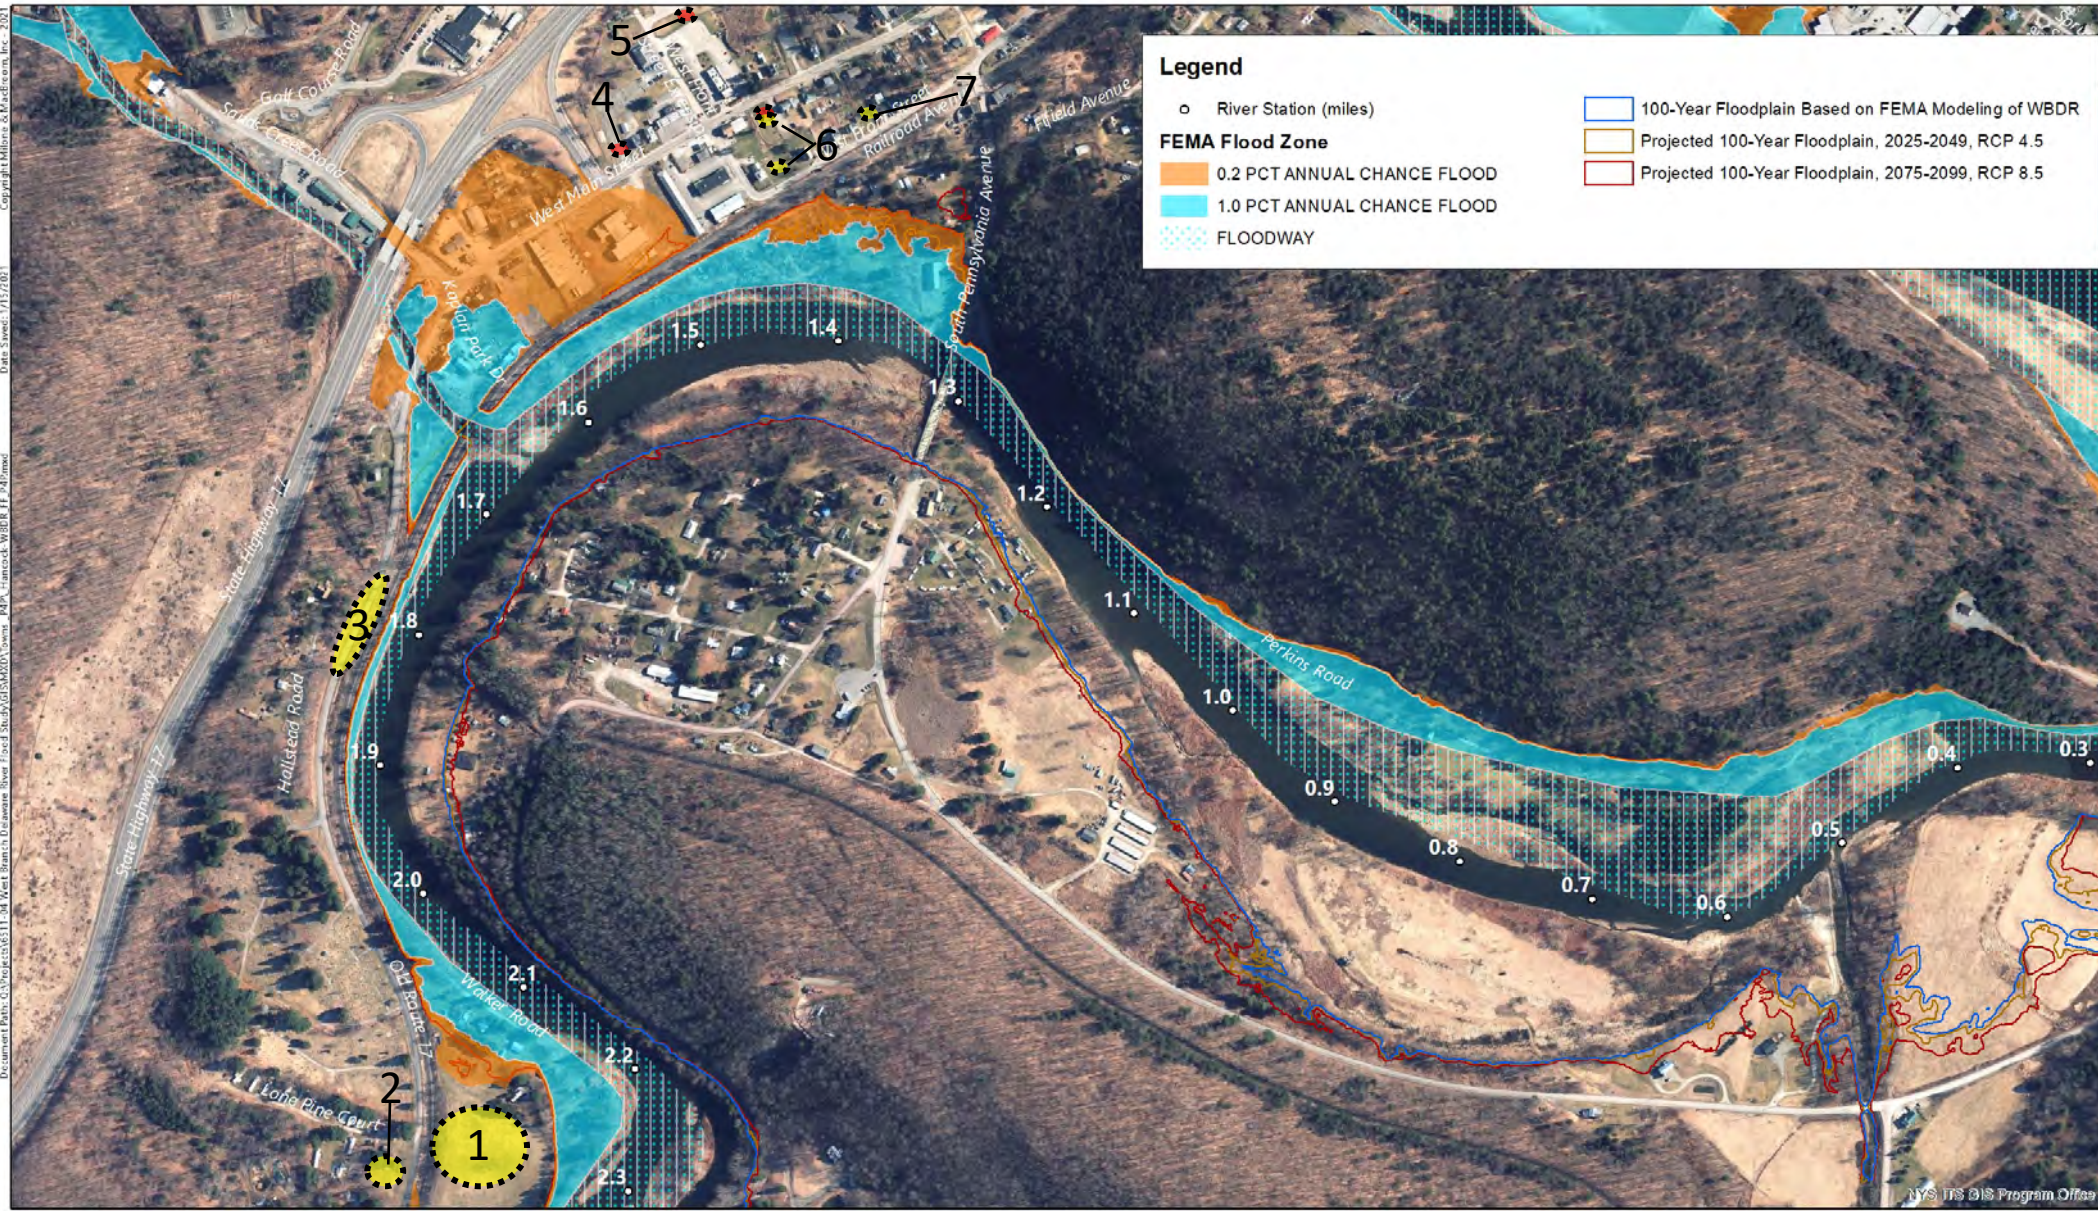
- River Station (miles)
- 100-Year Floodplain Based on FEMA Modeling of WBDR
- Projected 100-Year Floodplain, 2025-2049, RCP 4.5
- Projected 100-Year Floodplain, 2075-2099, RCP 8.5
- 0.2 PCT ANNUAL CHANCE FLOOD
- 1.0 PCT ANNUAL CHANCE FLOOD
- FLOODWAY

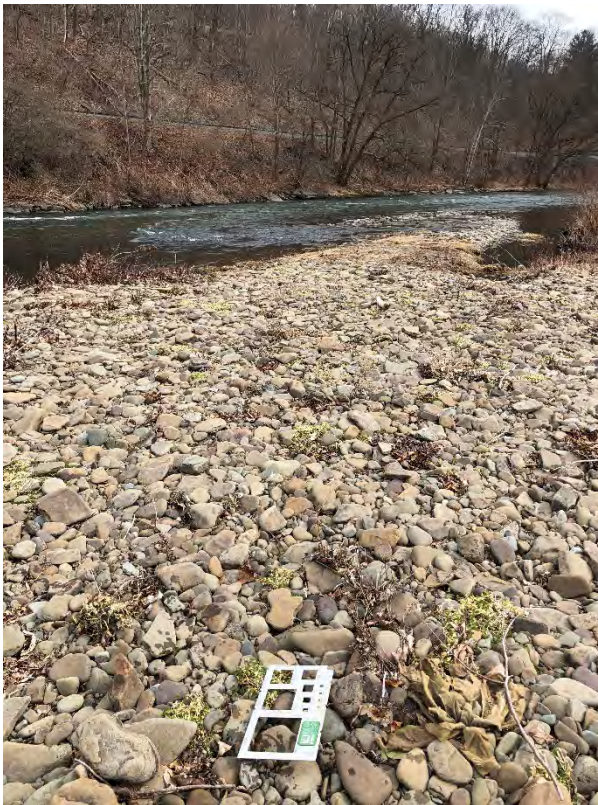
Photo 4-4: Coarse sediment aggradation at the confluence of Sherman Creek with the WBDR

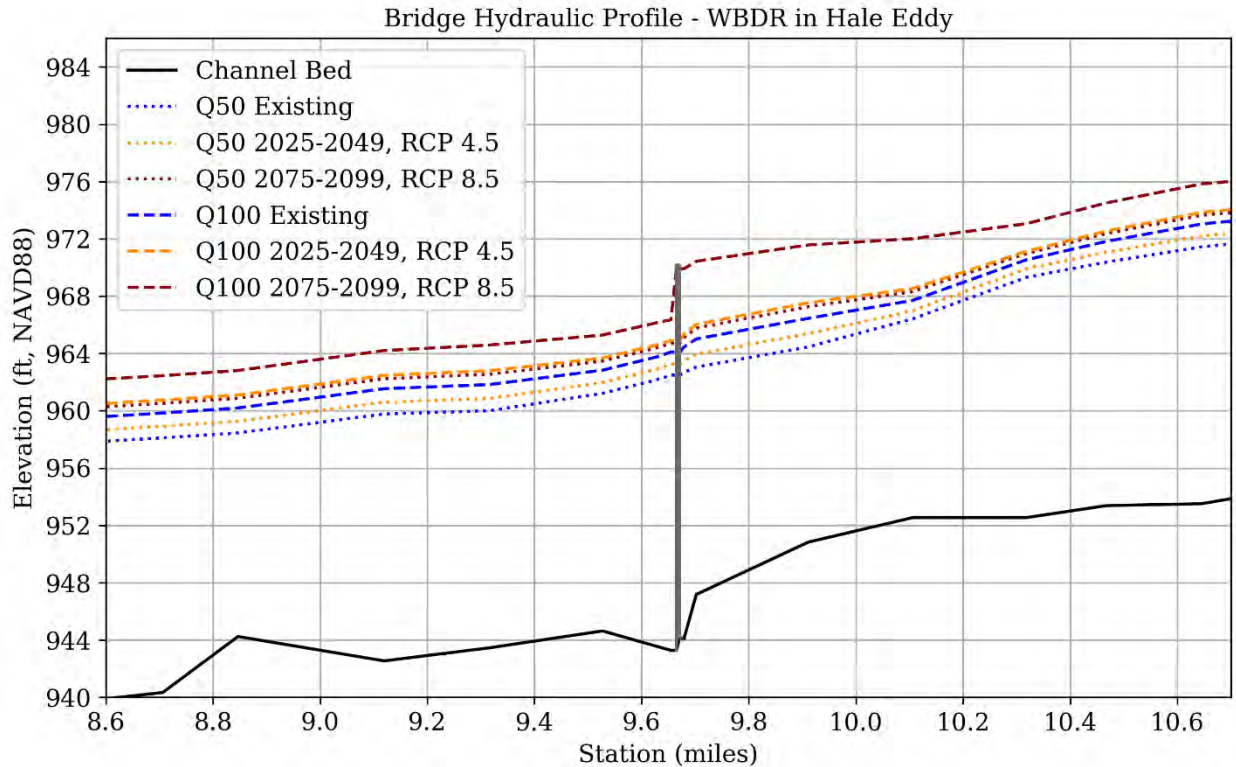
Figure 4-7: Hydraulic profiles of the WBDR at the Hale Eddy bridge. Current and projected future flow profiles are shown.

The Hale Eddy bridge (BIN 3352290) carries Route 56/River Road/Sherman Creek Road/Hale Eddy-Broome County Line Road across the WBDR. This bridge was built in 2000 and is adequate to pass up to the current 100-year flood although over 2.5 feet of backwater develops at this structure in the 500-year flood. Depending on which of the projected future flow scenarios discussed in Section 2.3 bears out, it is possible that this structure would no longer pass the 100-year flood by the end of its design lifetime.

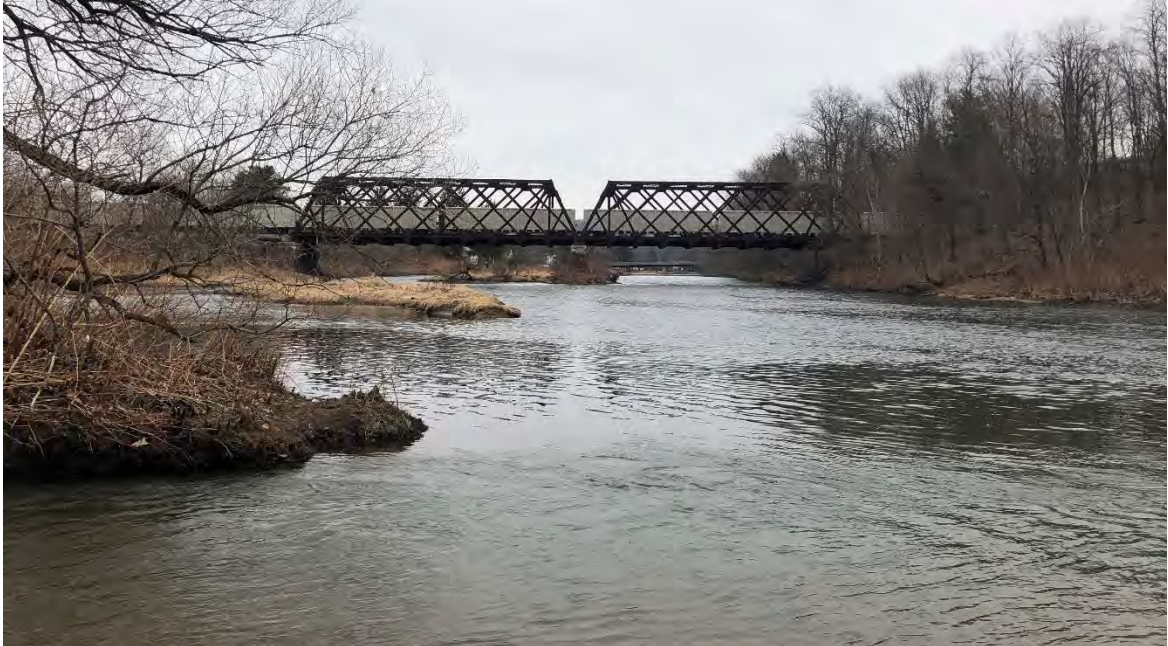
Photo 4-5: View looking upstream on the WBDR from the confluence of Oquaga Creek (lower left of image). The Pine Street/Oak Street bridge can be seen in the distance underneath the left (viewer's right) span of the NYSW railroad bridge.

The village features a historic district along the right bank of the WBDR, much of which is mapped in the river's regulatory floodway according to FEMA's preliminary FIS. South of the village corporate limits, several homes line the WBDR on its left bank along with an industrial area. Here, the effective regulatory flood zones are delineated based on the most recent FIS for Delaware County (36025CV001B). These properties on Airport Road all lie within the floodway and are expected to be impacted by flows exceeding the 10-year flood. Anecdotal reports confirm that this area is prone to frequent flooding that restricts access.

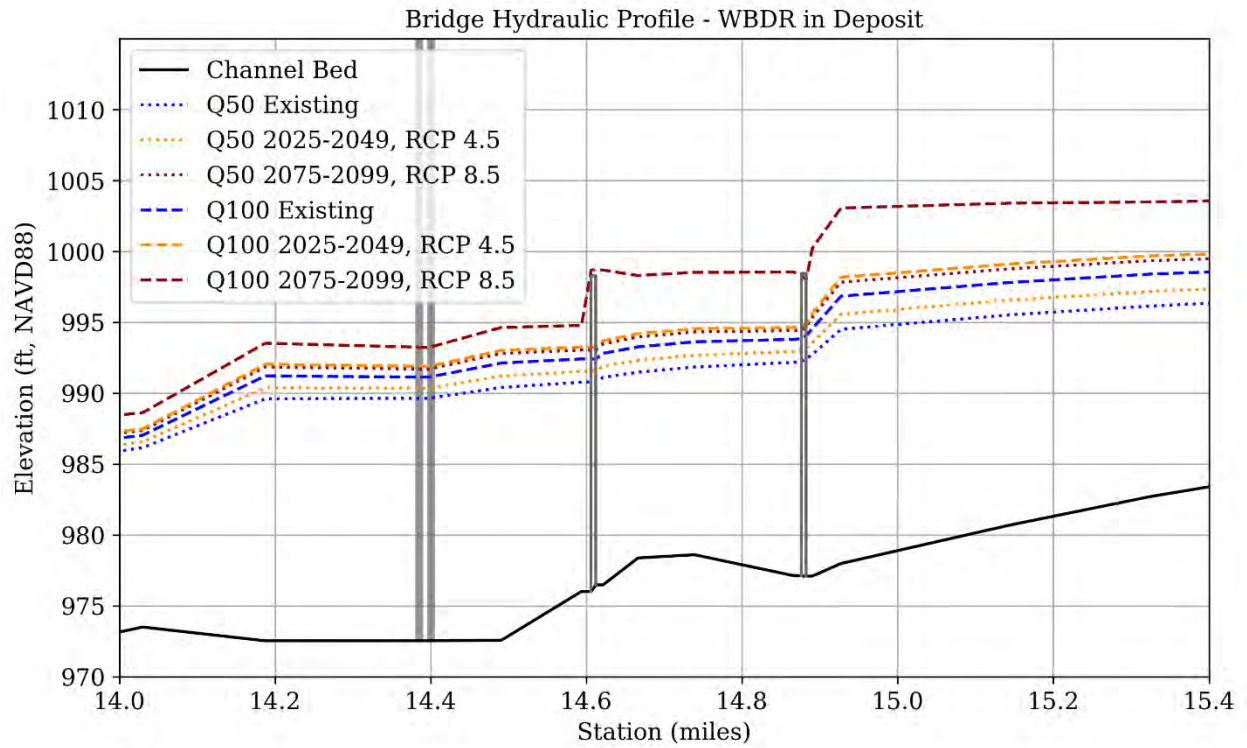
Figure 4-9: Hydraulic profiles of the WBDR in Deposit, showing the Route 17, NYSW Railway, and Oak Street bridges. Current and projected future flow profiles are shown.

Preliminary FEMA modeling indicates that the Pine Street/Oak Street bridge (BIN 1007640) over the WBDR, built in 1990, will pass the 10-year flood, but the 50-year event will overtop the approach roadway and flood downtown Deposit. However, this bridge does not cause significant additional backwater flooding in the village except in the modeled 500-year flood. A NYSW railroad bridge spans the WBDR about 1,400 feet downstream of the Pine Street/Oak Street bridge. This crossing causes slight backwaters but does not significantly increase flooding extents except in the 500-year flood wherein it may result in more than a 4-foot increase in upstream water surface elevation. A depositional bar has developed at this bridge's central pier. Both of these bridges are predicted to become hydraulically inadequate in modeled future flow scenarios. The Route 17 bridges (Westbound BIN: 1013331; Eastbound BIN: 1013332) are unconventionally represented in the FEMA hydraulic model but are not expected to significantly contribute to backwater flooding. These were built in 1961.

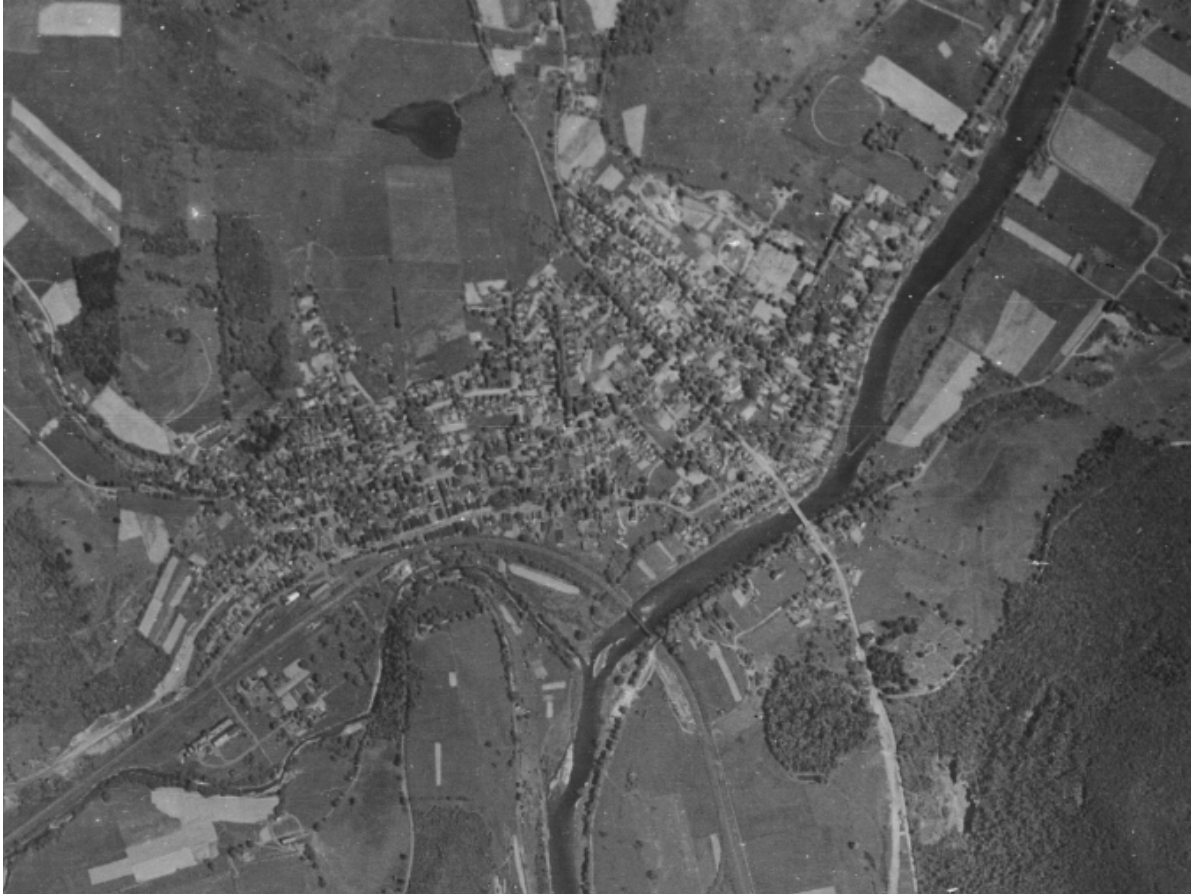
Photo 4-6: Portion of an aerial photograph acquired in May 1942, showing the village of Deposit. Note aggradation at the center pier of the railroad bridge over the WBDR and at the confluence with Oquaga Creek. These features were present long before construction of the Cannonsville Reservoir. The new Route 17 had not yet been constructed. Retrieved from the USGS Earth Resources Observation and Science Center's *EarthExplorer* online service.

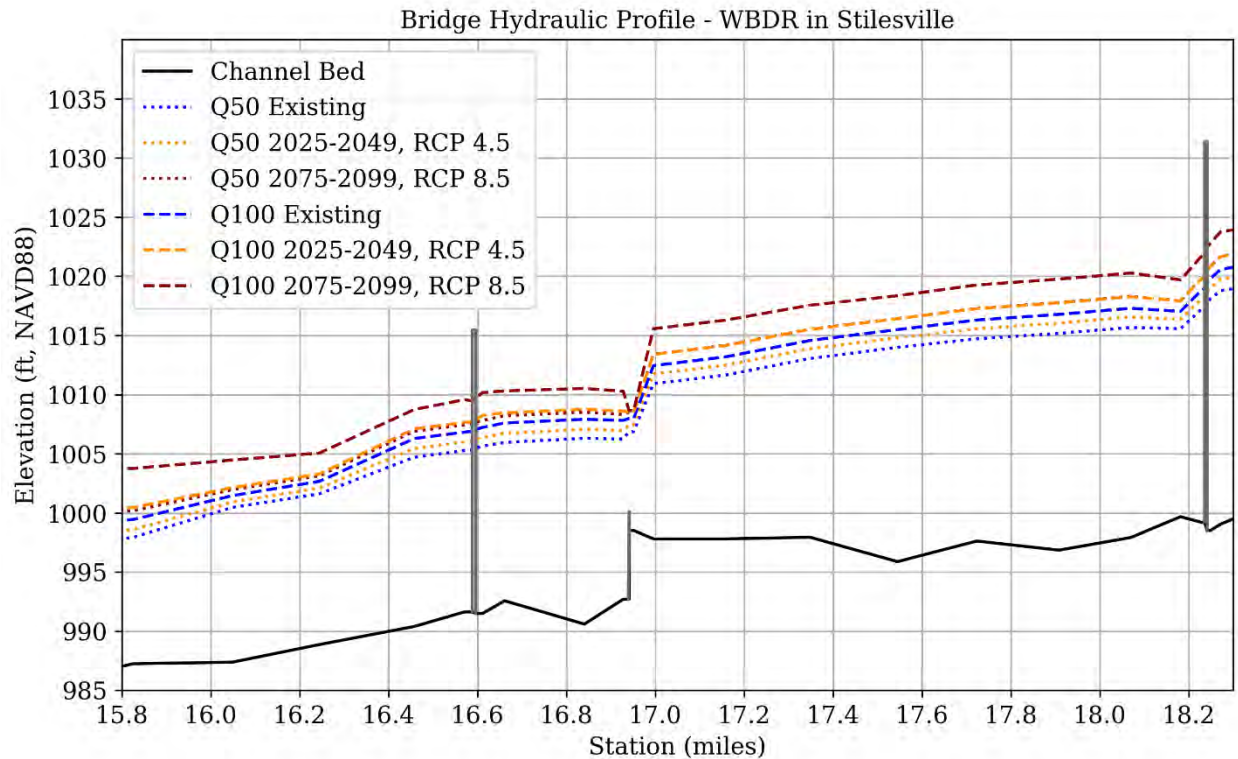
Figure 4-11: Hydraulic profiles of the WBDR in Stilesville, showing the Route 8 bridge. Current and projected future flow profiles are shown.

According to FEMA modeling, the NYCDEP access road bridge over the WBDR immediately downstream of the Cannonsville Dam does not appear to be a significant hydraulic constriction and does not contribute to flooding in Stilesville. This bridge is projected to have freeboard in the modeled 500-year flood event. The Route 8 bridge (BIN 1007660) constricts the channel somewhat but is still modeled as passing the 100-year flood with only minimal influence on floodwater surface profiles; the four-span bridge was built in 1990. The approach roadway and parts of the bridge deck are expected to overtop in the 500-year flood but not result in significant additional inundation depths. A depositional bar has developed at this bridge's central pier.
