Flood Mitigation Report West Branch Delaware River SD 060

Delaware County, New York
January 2021

This document was prepared for the New York State Department of Environmental Conservation, in cooperation with the New York State Office of General Services.

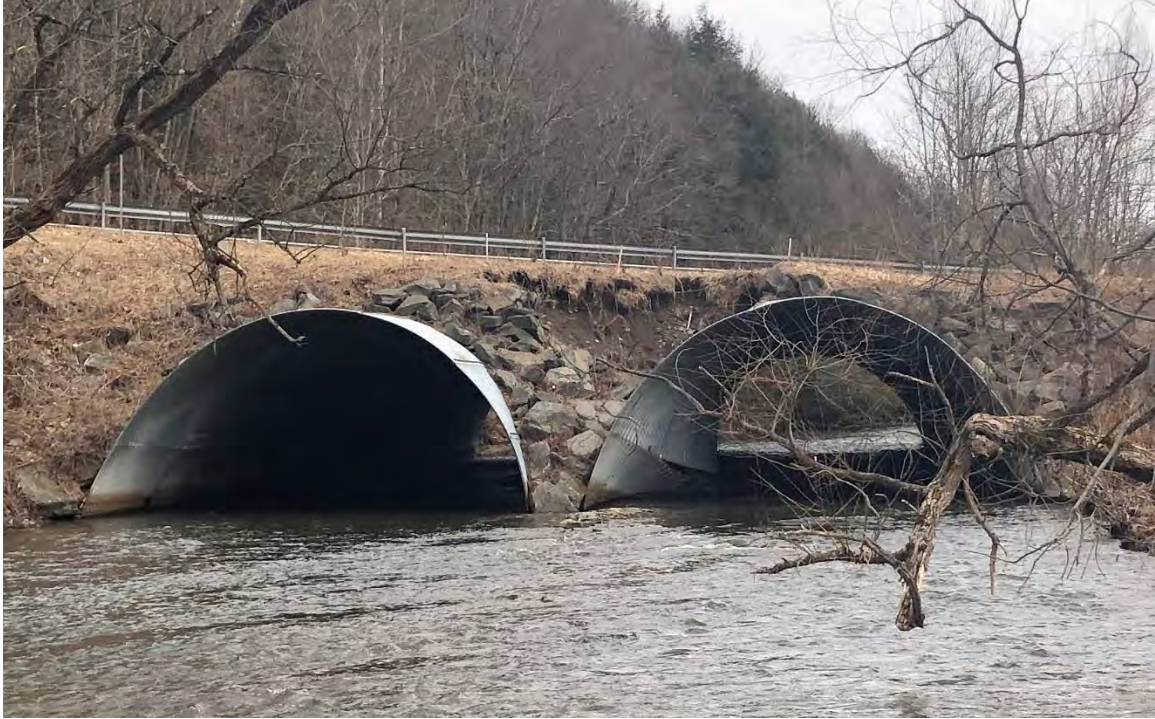
Photo 4-7: Damaged culvert carrying Dug Road over Cold Spring Creek at its confluence with WBDR. View looking upstream. Corrugated arch panels in east barrel have separated, and cover fill is eroding into the creek. Also note sediment aggradation in intermediate slack water.

Route 8 follows Cold Spring Creek and subsequently its East Branch up the valley to the north and east; Route 20 follows the creek's main stem to the north. These roads are critical detour routes in case of flooding in the WBDR valley and are susceptible to damage by these energetic tributary streams. Inundation of low-lying sections of Schofield Road and washouts of Michigan Hollow Road have been reported.
