**LIMITED SITE DATA DOCUMENT**

**BATAVIA IRON & METAL COMPANY, INC.**

**CITY OF BATAVIA, GENESEE COUNTY, NEW YORK**

**SITE NO. 819018**

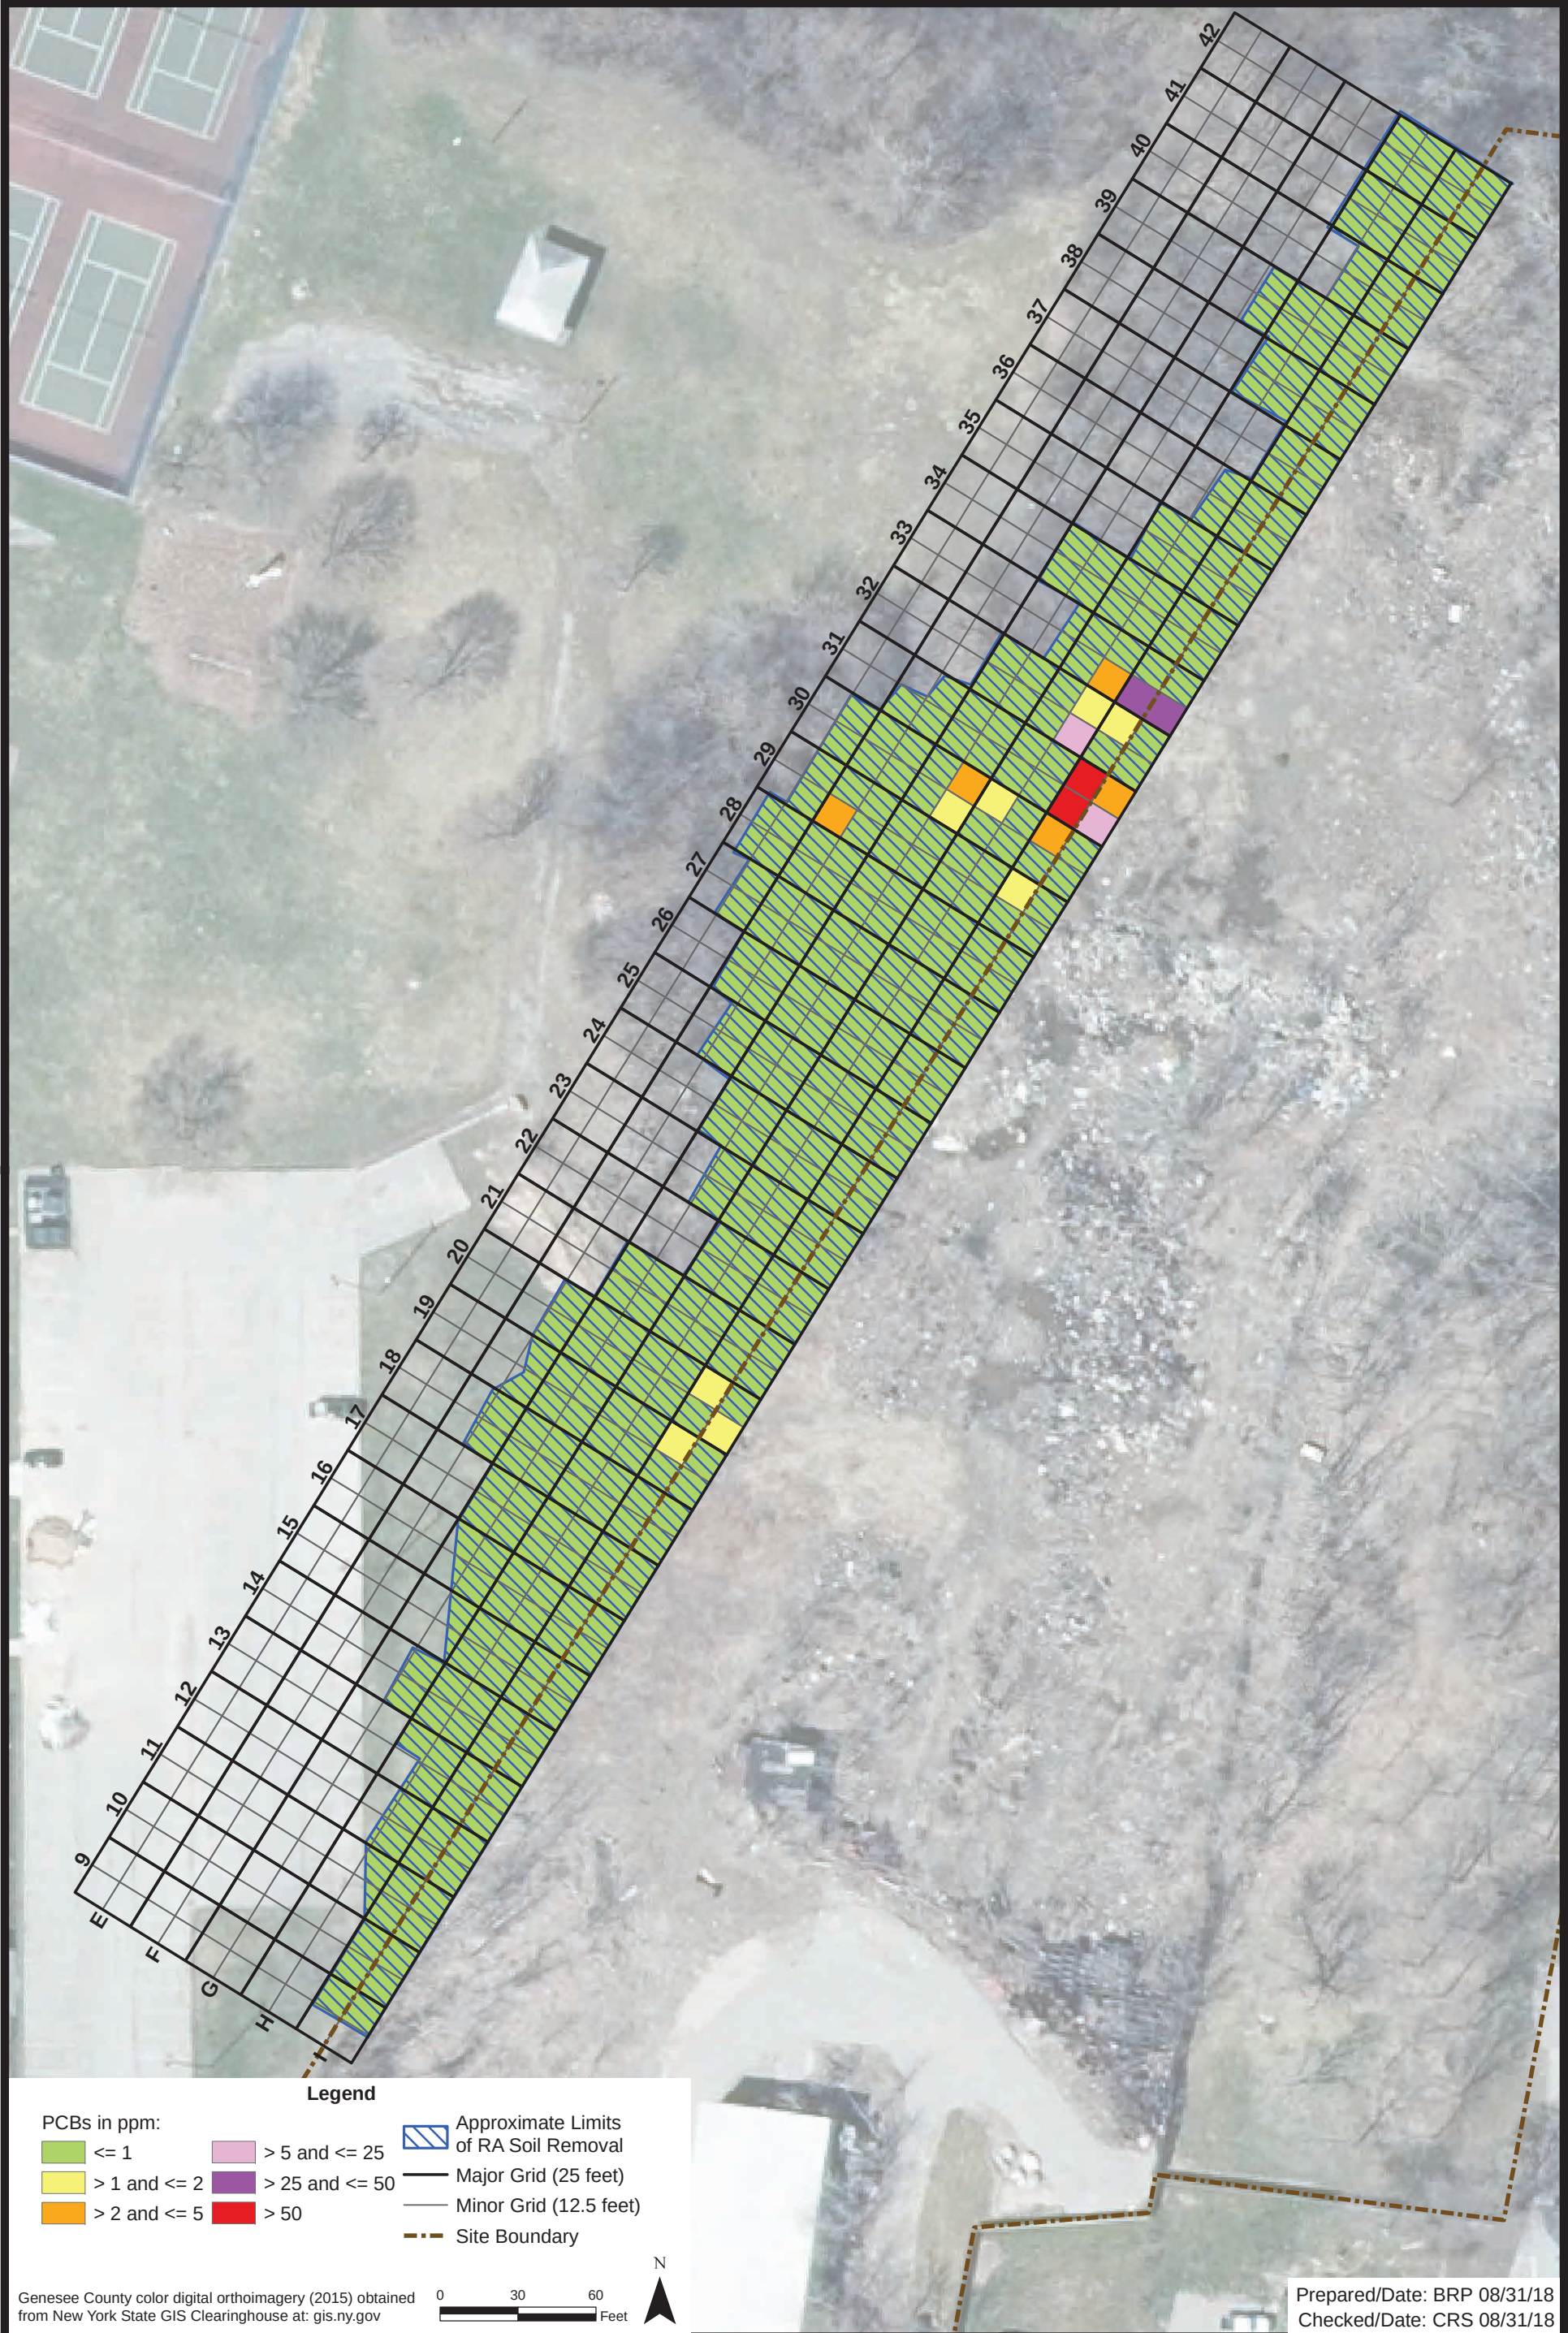
Figure 2.1 – Post-IRM Excavation Limits and Exceedances  
From Phase 1 Pre-Design Investigation Report (MACTEC, 2019)

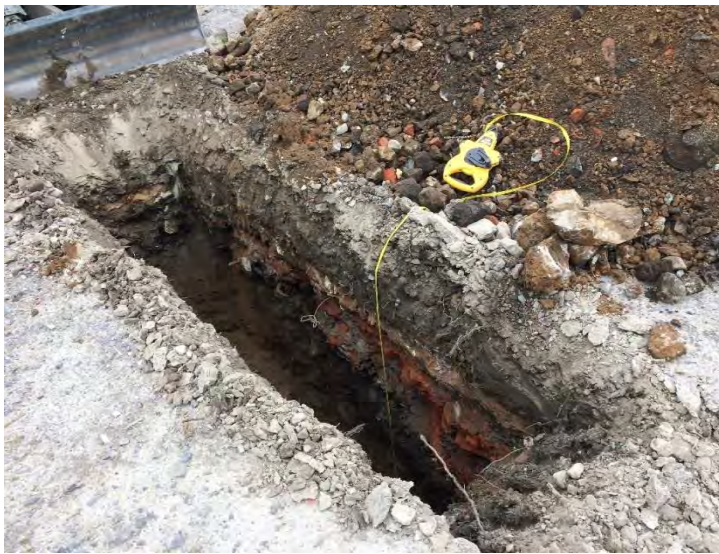
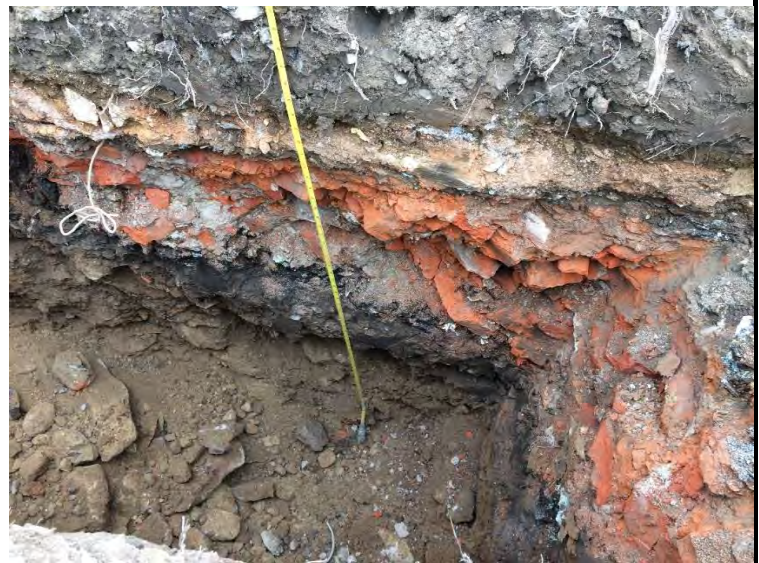
| Sample Information | | | Monitoring | | | | Sample Description and Classification | USCS Group Symbol | Remarks |
|---|---|---|---|---|---|---|---|---|---|
| 0 | | | 0.0 | 0.5 | | | Moist, soft, brown, SILT, little f sand and fmc gravel, some metal, little ceramics. No odor | FILL | |
| 1.5 | | | NA | NA | | | Hard, moist, medium dark brown, fm SAND, mostly bricks, some CD, no odors. | FILL | |
| 4.5 | | | 0.0 | 0.8 | | | Moist, soft, brownish black, SILT, little fine sand and organics, noncohesive, slight organic odor. | ML | |
| 5.5 | | | 0.0 | 0.7 | | | Soft, moist, medium brown, FM SAND, little fmc subrounded gravel, some subrounded to subangular cobbles, no odors. | SW | |

Sample 0-0.2, 2.3 (SVOC), 4.5, 7.0

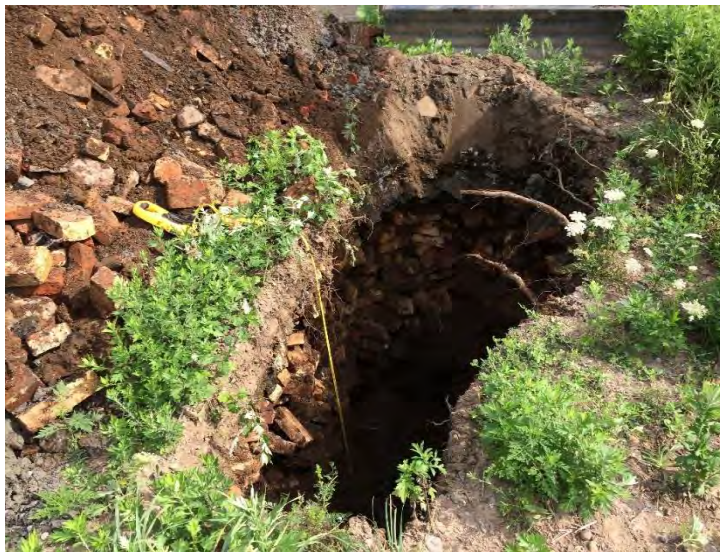
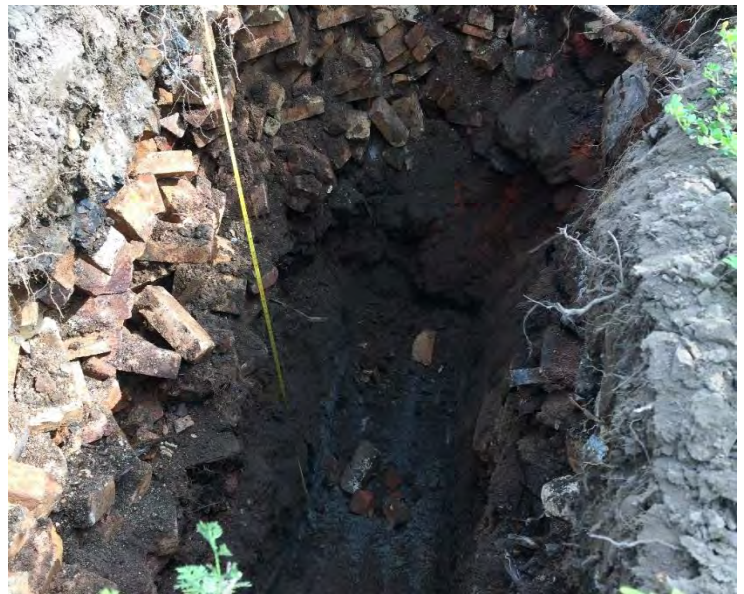
Sample 0-0.2, 2.5 (SVOC), 5.0, 8.5

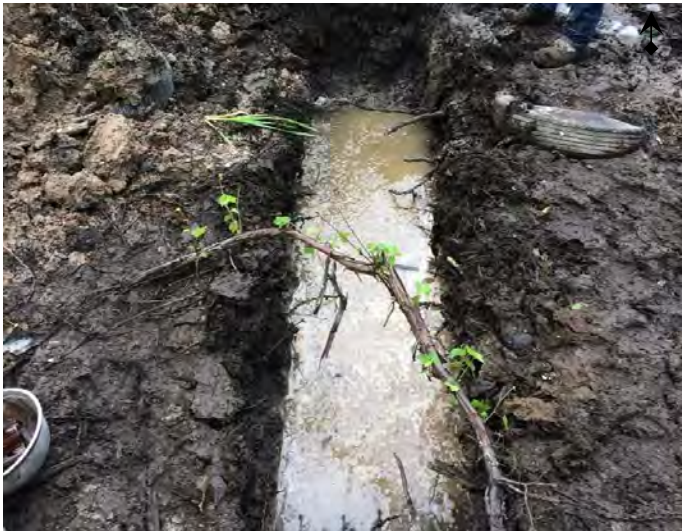
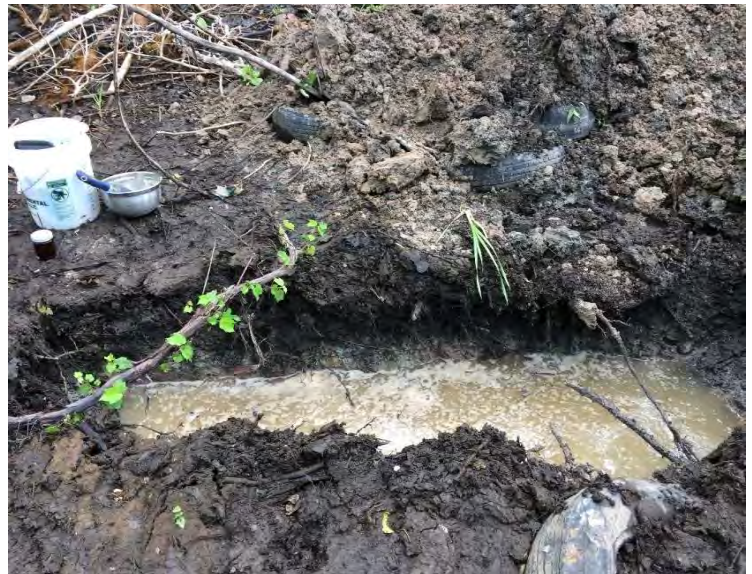
| Sample Information | | | Monitoring | | | | Sample Description and Classification | USCS Group Symbol | Remarks |
|---|---|---|---|---|---|---|---|---|---|
| 0 | | | 0.0 | 0.4 | | | Wet, soft, brownish black, CLAY, some organic debris, slightly plastic, no odor or staining. | CL | |

Sample 0-0.2, 1.0 (bottom of fill), 2.2 (bottom of excavation)

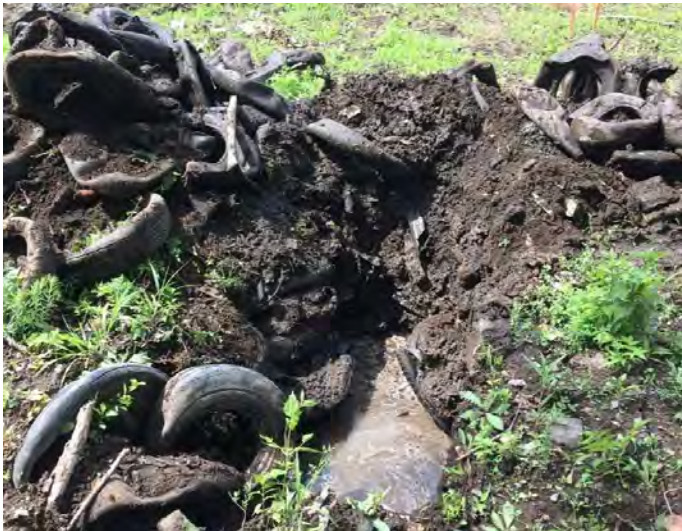
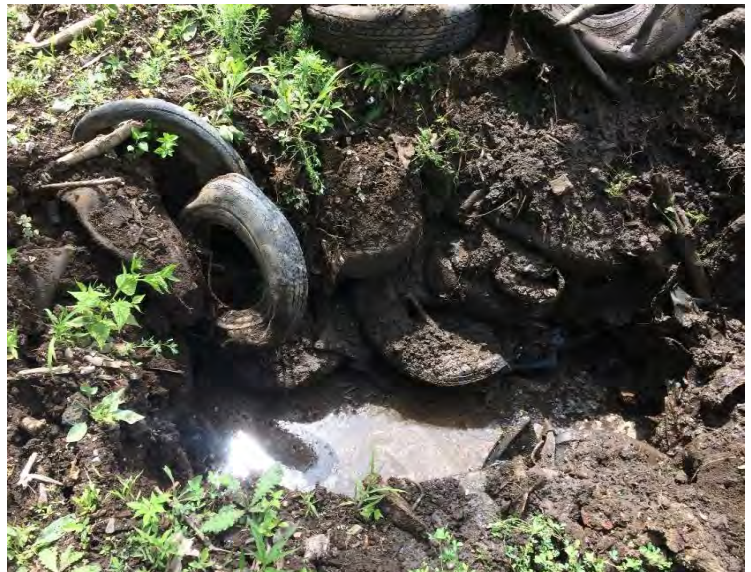
Sample 0-0.2, 1.5 (mid of fill), 3.9 (D/MS/MD) (bottom of excavation)

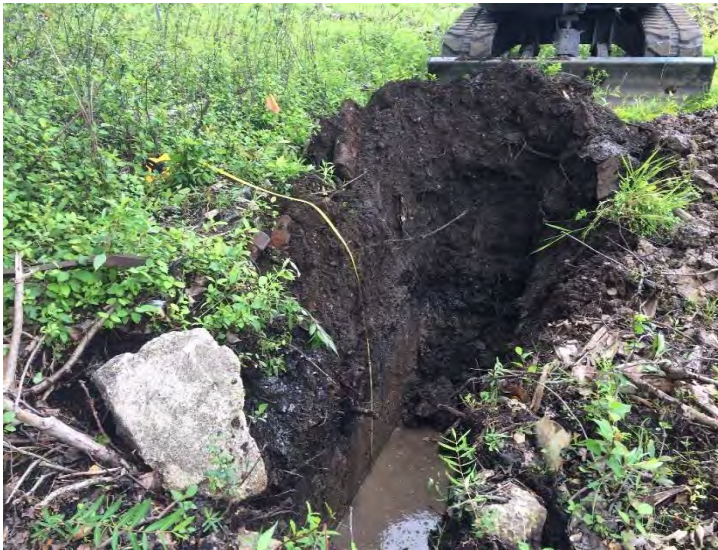
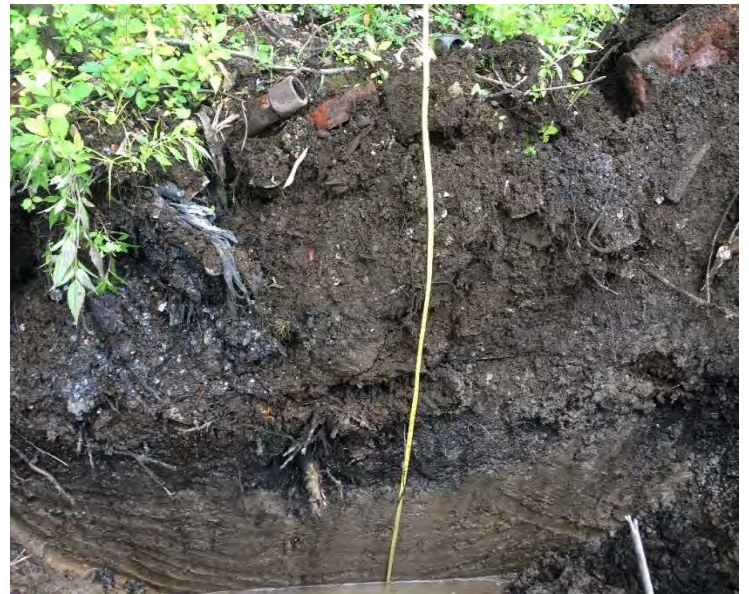
Sample 0-0.2, 2.5, 5.0

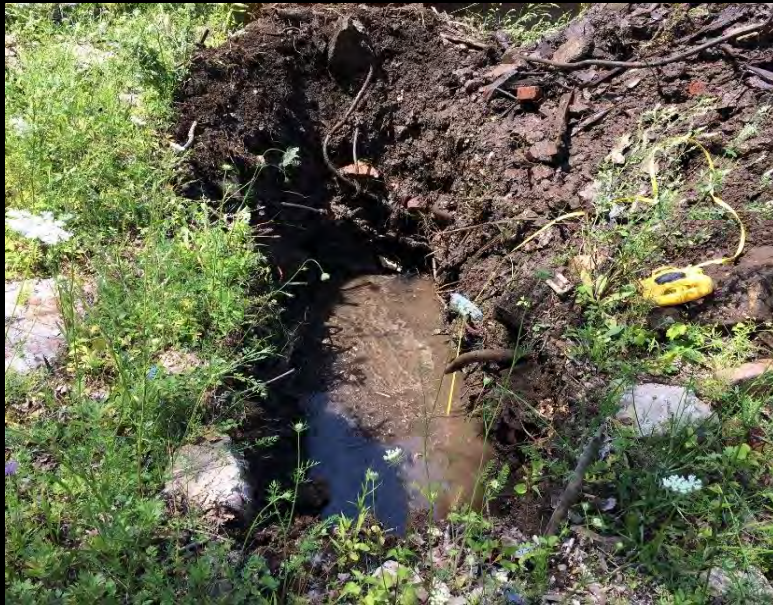
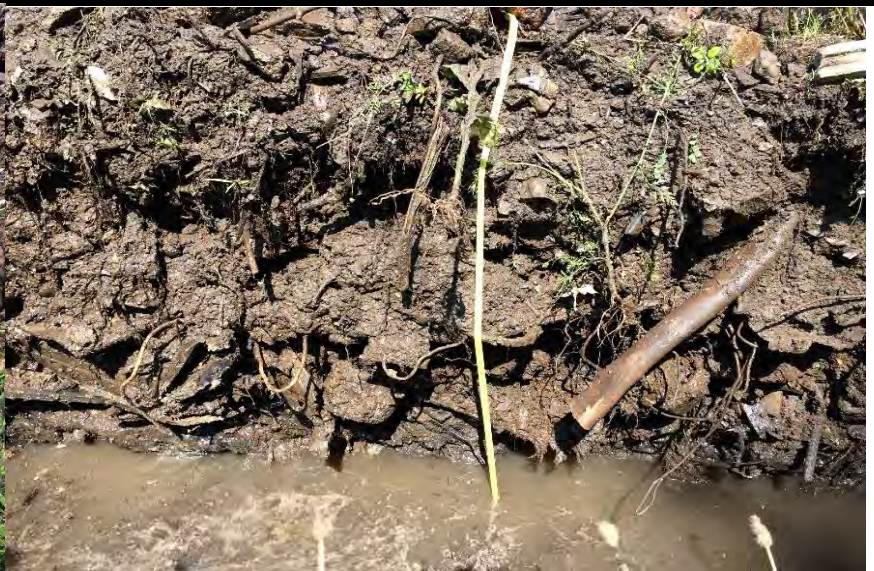
1 - metals, mercury, PCBs, TCLP metals  
2 - metals, mercury, PCBs, TCLP metals  
3 - metals, mercury, PCBs

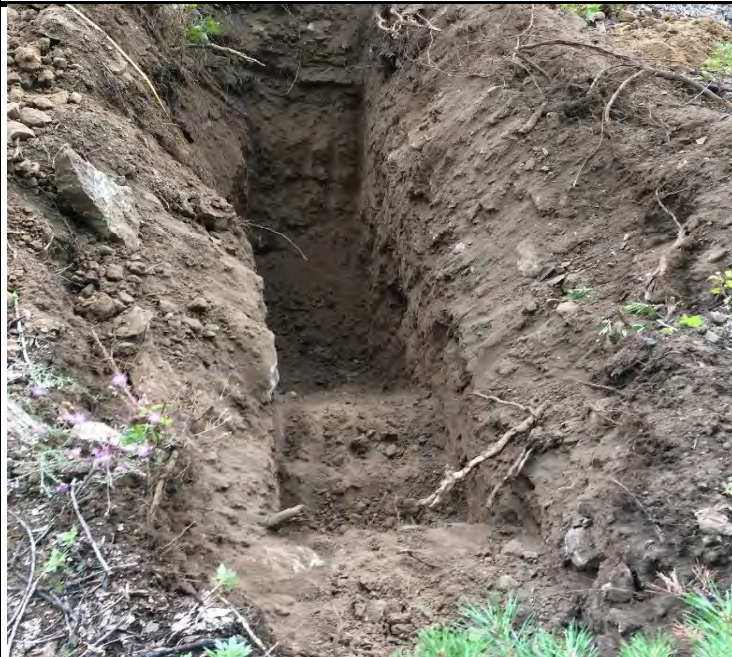
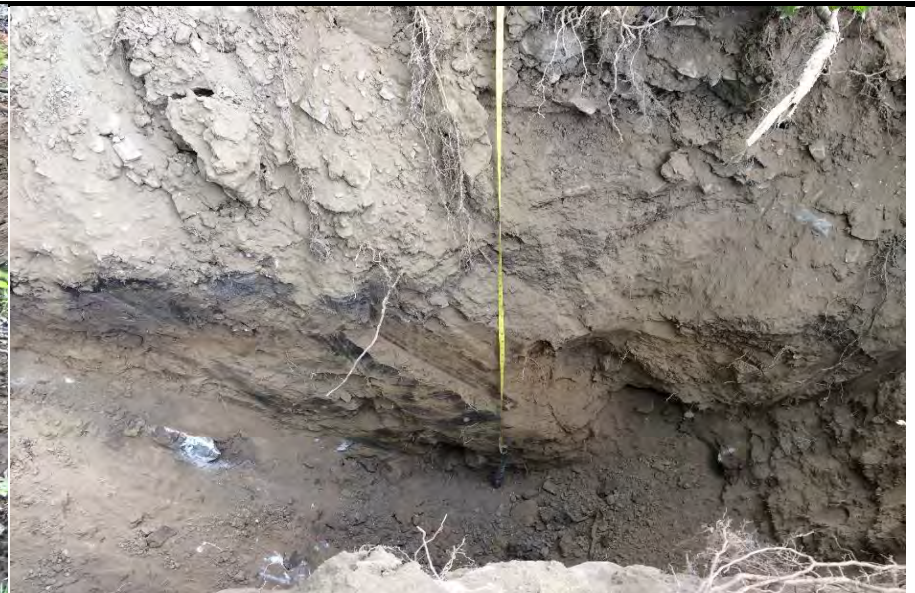
1 - PCBs, metals, mercury (Duplicate , MD, MSD collected)

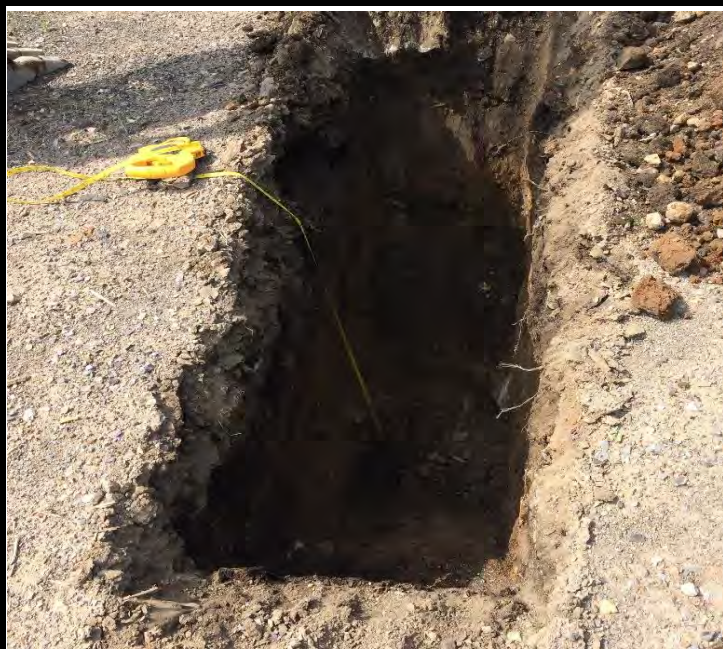
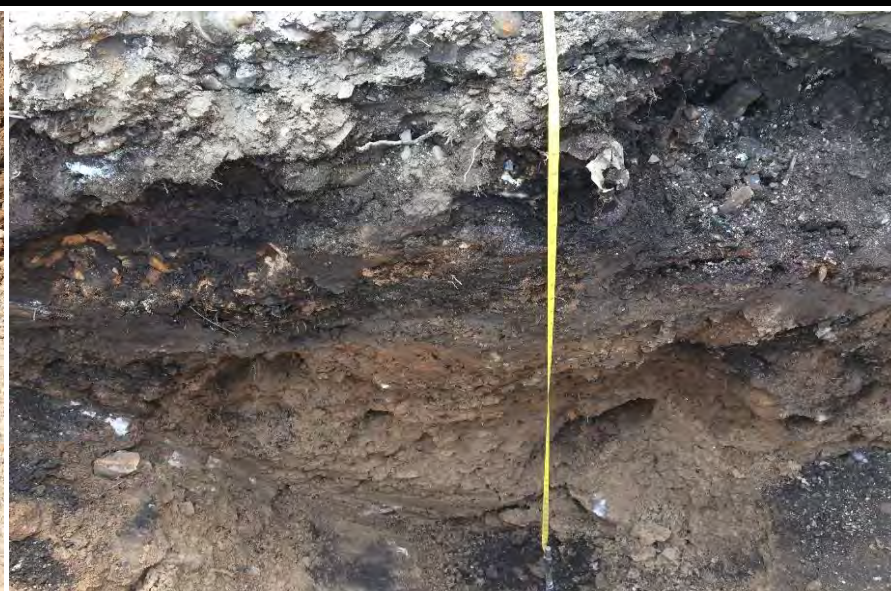
- 1 - PCBs, metals, mercury, TCLP metals
- 2 - PCBs, metals, mercury, TCLP metals
- 3 - PCBs, metals, mercury
- 4 - PCBs, metals, mercury
