SITE MANAGEMENT ACTIVITIES

SUPPLEMENTAL GROUNDWATER INVESTIGATION

INTERIM REMEDIAL MEASURE AT WILLETTS CREEK: PERMEABLE REACTIVE BARRIER

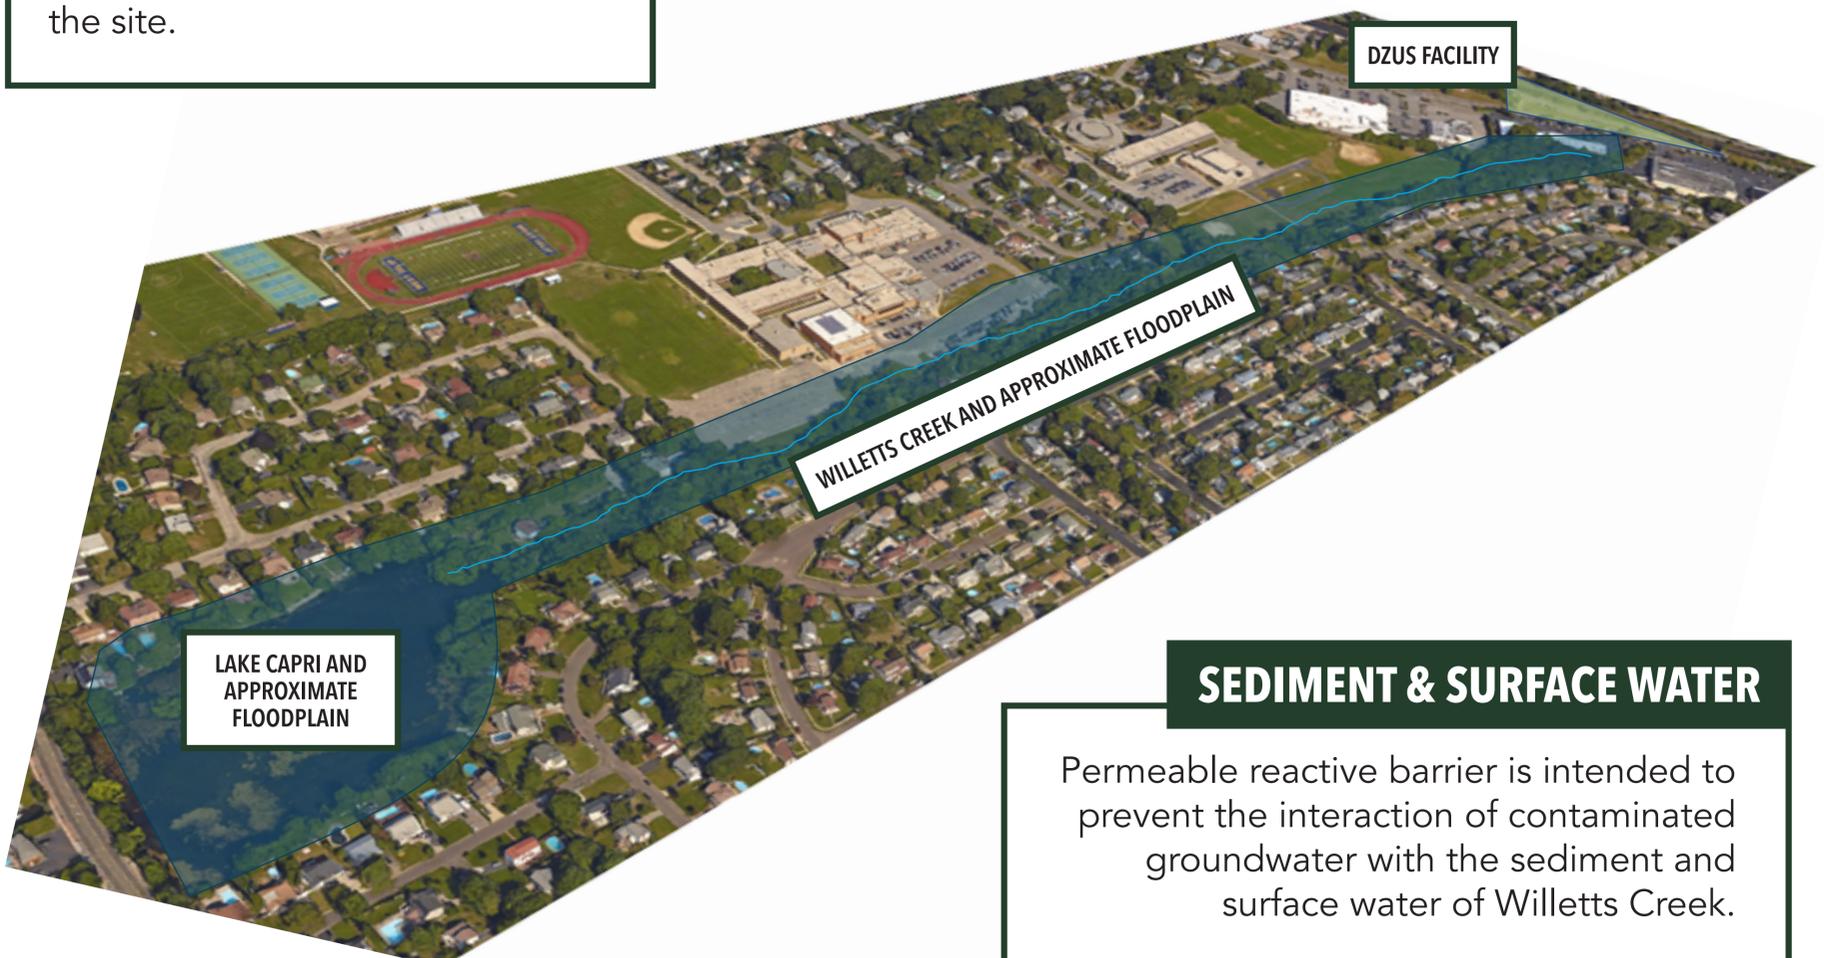
CONCEPTUAL SITE MODEL FOR GROUNDWATER PATHWAY

Onsite operations led to soil and groundwater contamination at the Dzus facility.

Contaminated groundwater flows through the shallow aquifer in the subsurface downgradient of the site.

Permeable reactive barrier is intended to prevent the interaction of contaminated groundwater with the sediment and surface water of Willetts Creek.

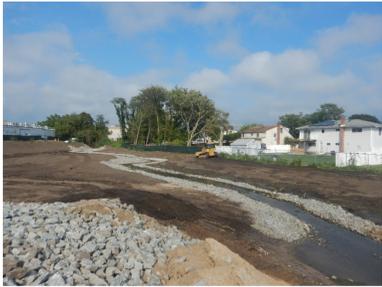
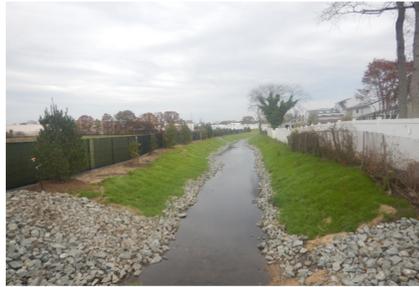
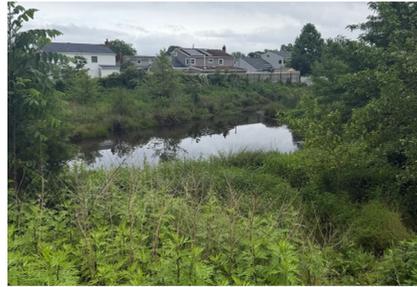
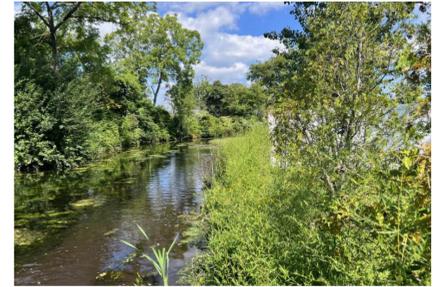
As part of the 2019 remediation effort, a comprehensive wetland mitigation plan was implemented to restore ecological functions and values impacted during the process.

Key indicators of success for the wetland mitigation include the establishment and vitality of planted native wetland vegetation—measured through survivorship counts and observations of growth—and the presence of sustained wetland hydrology in the reconstructed areas. Annual assessments are conducted for the wetland area behind Captree Plaza and along the Willetts Creek stream corridor.

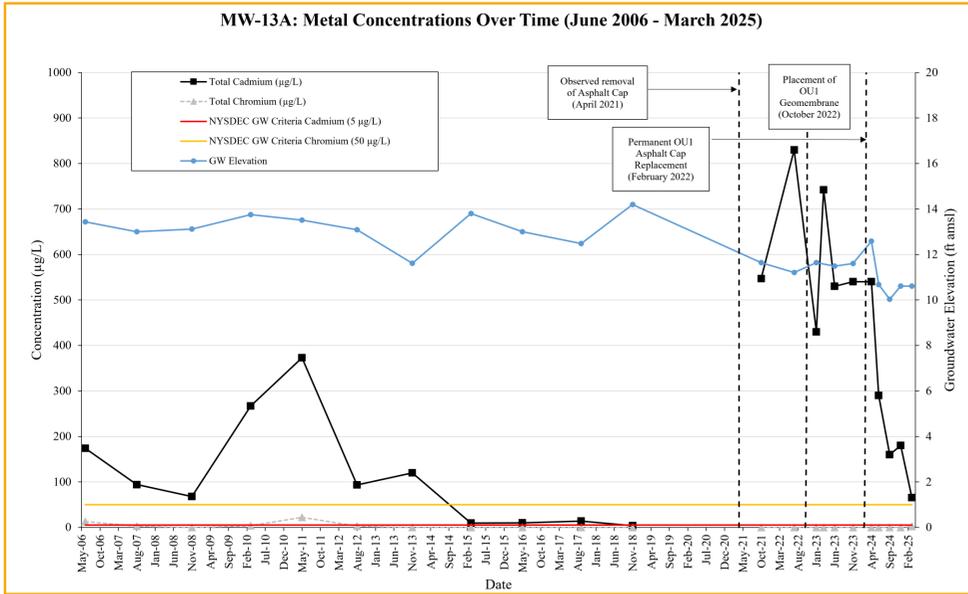
GROUNDWATER TRENDS

Monitoring Well MW-13A has historically exhibited the highest concentrations of cadmium among the monitoring well network. Positioned downgradient from the identified source area, this well has been a key indicator of contaminant migration. Between 2021 and 2025, cadmium levels in MW-13A have ranged from a high of 547 µg/L in October 2021 to a low of 51 µg/L in March 2025. Encouragingly, data indicates a consistent downward trend in both cadmium and chromium concentrations.

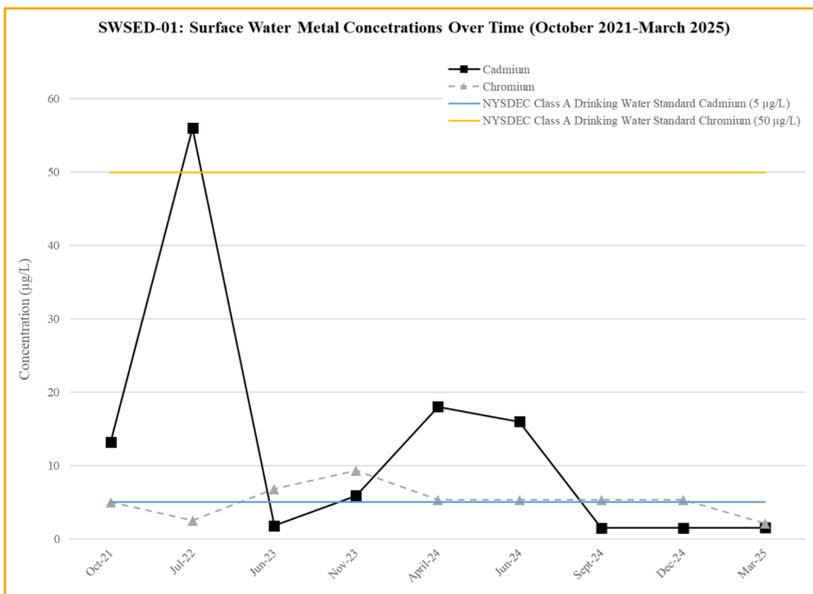
SURFACE WATER TRENDS

Sampling location SWSED-01 has historically exceeded the hardness-adjusted screening level for cadmium. Located downgradient of the identified source area, this site plays a critical role in tracking contaminant migration within Willetts Creek. Between 2021 and 2025, cadmium concentrations have ranged from a high of 56 µg/L in July 2022 to a low of 2.1 µg/L in March 2025. Recent surface water monitoring data indicate a continued downward trend in both cadmium and chromium levels.

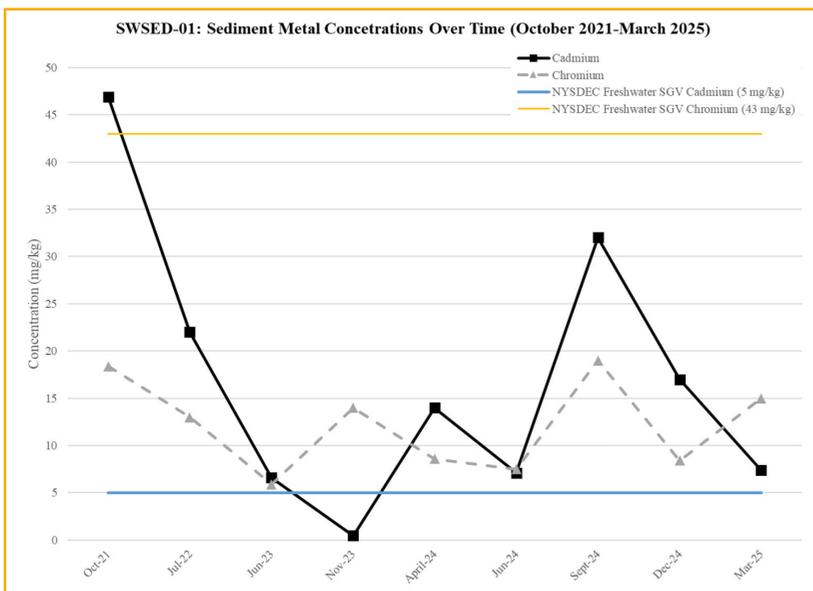
SEDIMENT TRENDS

Sampling location SED-01 historically reported cadmium concentrations ranging from non-detect to 1.3 mg/kg which were aligned with the remedial goal of 1 mg/kg in 2019 (post dredging of Willetts creek). Located downgradient of the identified source area, this location plays a critical role in tracking contaminant migration within Willetts Creek. Between 2021 and 2025, cadmium concentrations have ranged from a high of 46.9 mg/kg in October 2021 to a low of 0.45 mg/kg µg/L in November 2023. Recent Sediment data of 7.38 mg/kg in March 2025 continues to show a downward trend with values slightly above the sediment guidance values.

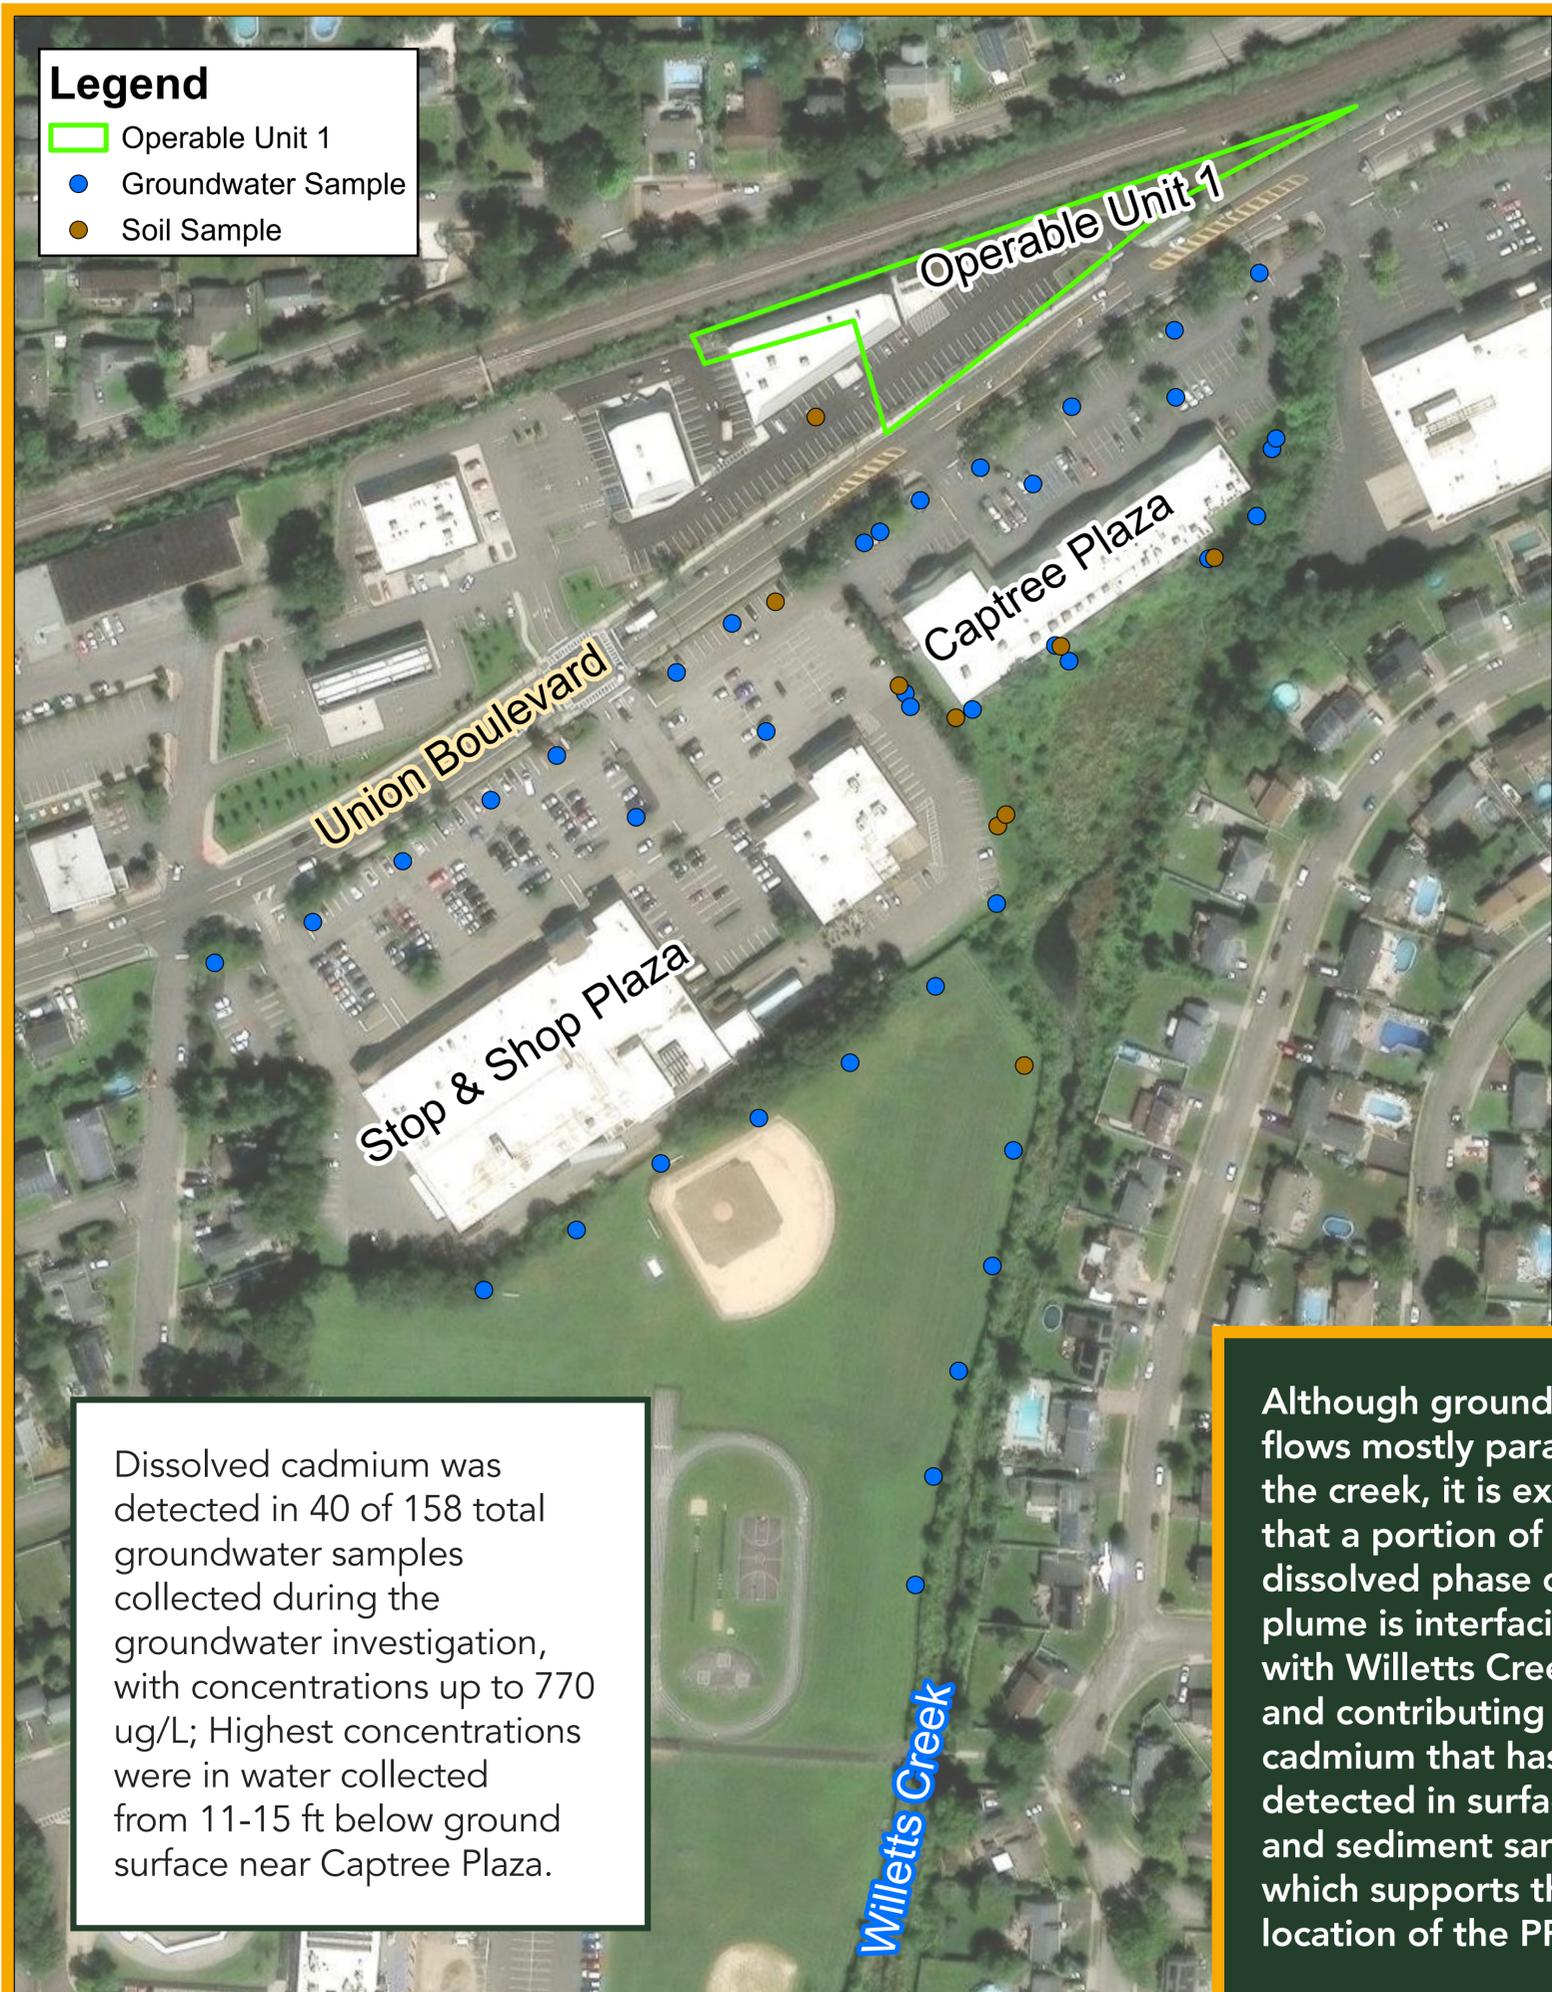
Dissolved cadmium was detected in 40 of 158 total groundwater samples collected during the groundwater investigation, with concentrations up to 770 ug/L; Highest concentrations were in water collected from 11-15 ft below ground surface near Captree Plaza.

Although groundwater flows mostly parallel to the creek, it is expected that a portion of the dissolved phase cadmium plume is interfacing with Willetts Creek and contributing to the cadmium that has been detected in surface water and sediment samples, which supports the location of the PRB wall.

Limited soil samples were collected to support the downgradient groundwater investigation; cadmium was only detected in one sample exceeding criteria.

An investigation of groundwater downgradient from Operable Unit 1 was initiated in May 2024 to better understand the extent of the cadmium plume and aid in the design of an interim remedial measure to prevent impacts to Willetts Creek.

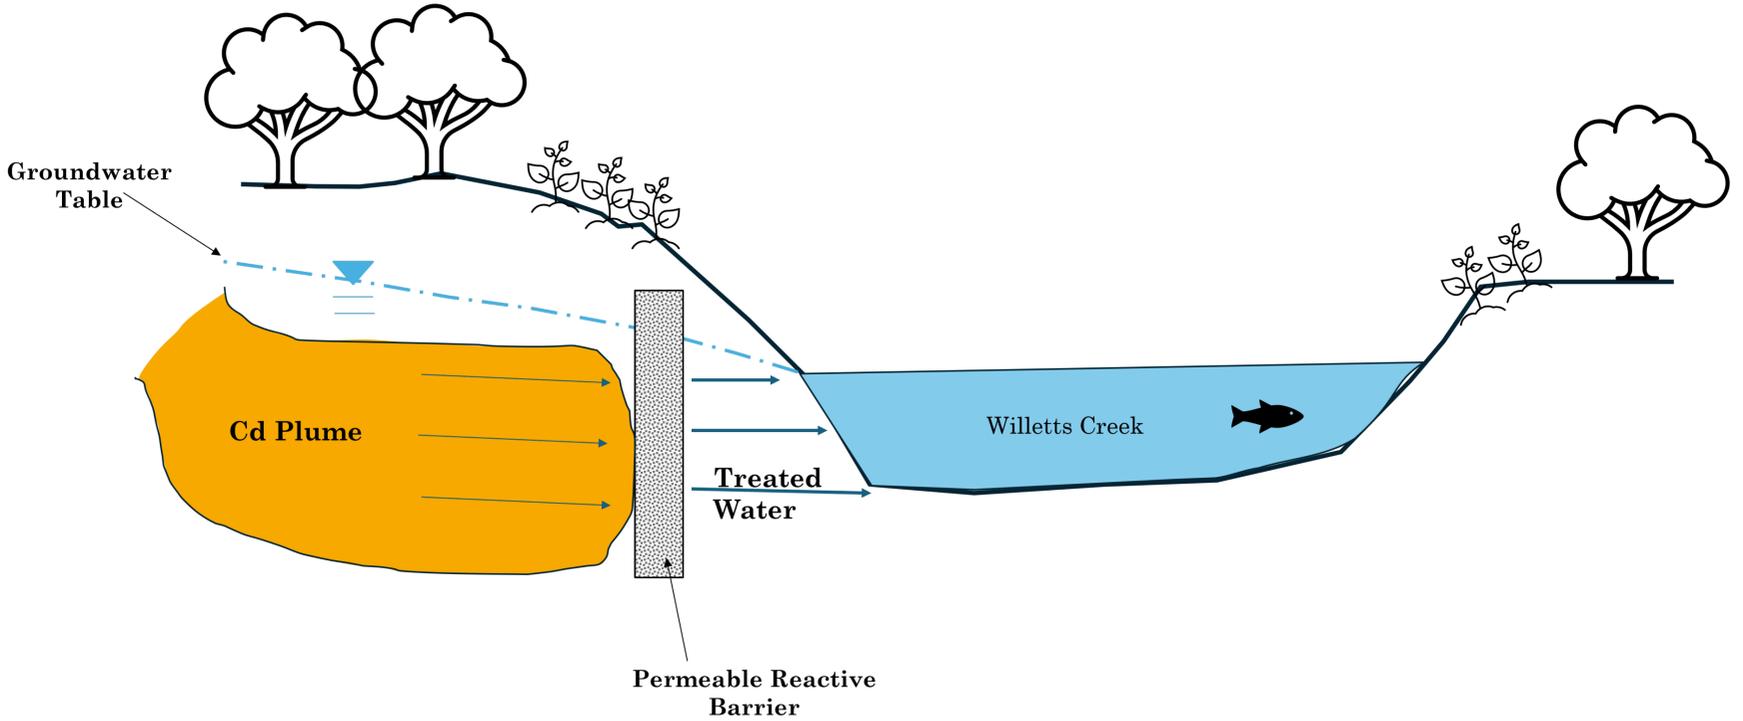
The IRM will consist of a permeable reactive barrier (PRB) which is a remedial technology that involves a water-permeable material that will sequester cadmium as groundwater flows through it, prior to entering the creek.

Apatite II™ will be mixed in situ with native soil in a trench spanning 300 feet along Willetts Creek. The trench will be approximately 5 feet wide and 15 feet deep. The PRB is located to intercept cadmium impacted groundwater before it discharges to Willetts Creek.

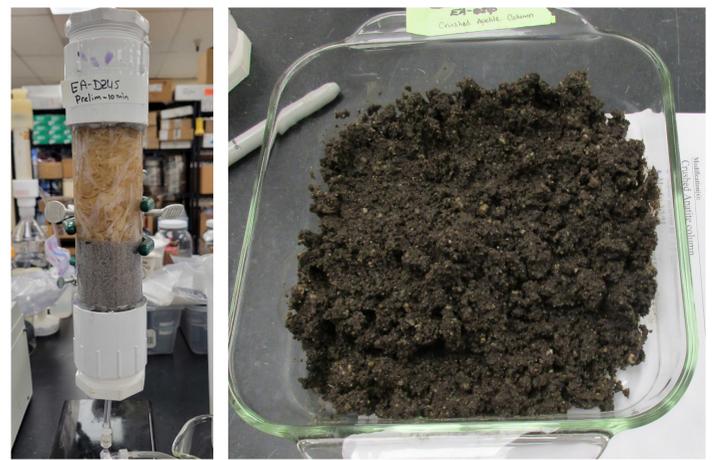
Photo Description: Left: Example column study laboratory set up; Right: Material composition of native material mixed with 3% Apatite II One Krush

A bench-scale study was performed by NYSDEC's consultant to evaluate the effectiveness of cadmium removal under normal Site conditions. The study used Apatite II™ mixed with native soil and evaluated cadmium removal from site groundwater.

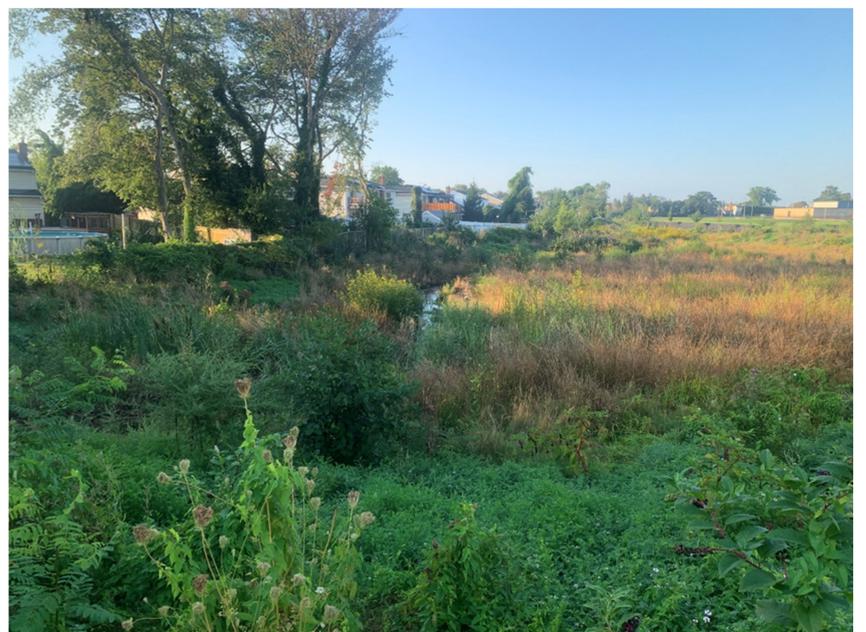
Photo Description: Wetland Area behind Captree Plaza Looking South 1-year post restoration (2021)

The area disturbed to install the PRB will be restored in-kind. The ground will be graded to match existing conditions and seeded with a wetland seeding mix.

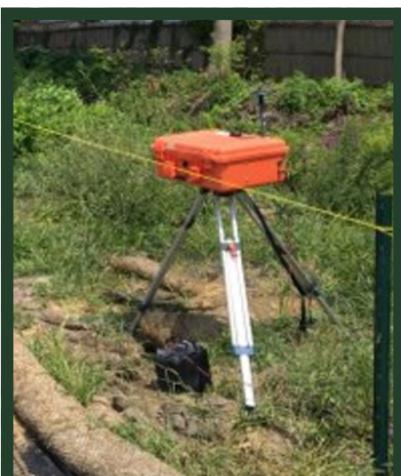
EXAMPLE AIR MONITORING STATION

- **Community Air Monitoring Plan** – Air quality monitors will be used to ensure dust is not migrating outside the work zone.
- **Temporary Fencing** – Temporary chain link fence will be placed around the work zone perimeter to restrict access.
- **Erosion and Sedimentation Control** – Silt fence and/or coir logs will be used to prevent run off from work areas. Exposed soil piles will be covered with sheeting.
- **Odor Control** – Sprays will be used to neutralize and control nuisance odors.
- **Traffic Control** – Construction access will be through the back of the Stop & Shop plaza. Limited material will be imported or exported from site, so there will be no significant increase in truck traffic.

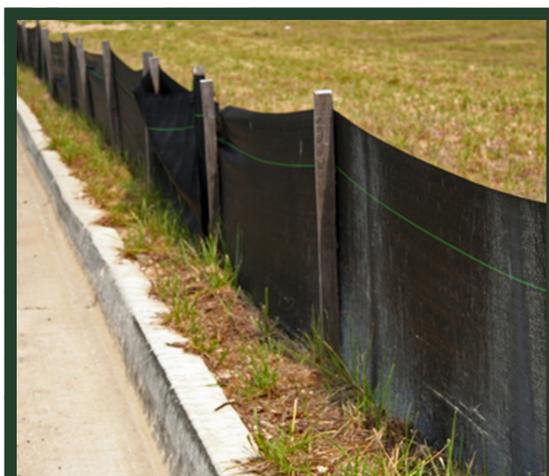
EROSION & SEDIMENT CONTROL FENCING EXAMPLE

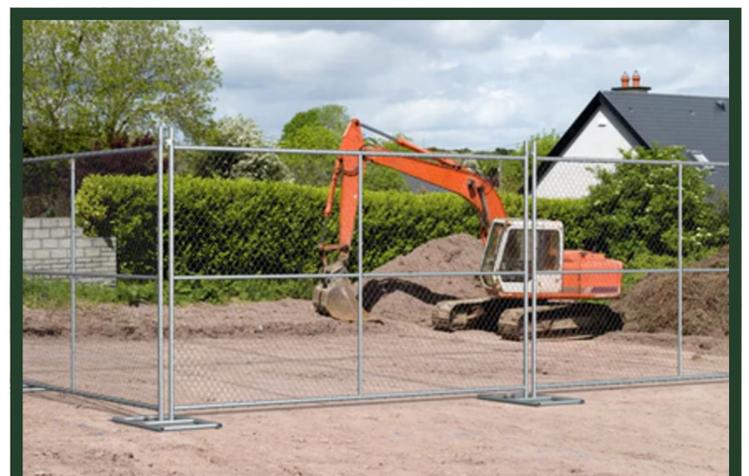
PERIMETER FENCING EXAMPLE
