1-30-003B-001

HISTORY OF VOC INVESTIGATION
NEAR EAST END OF PLANT 3
NWIRP BETHPAGE, NEW YORK

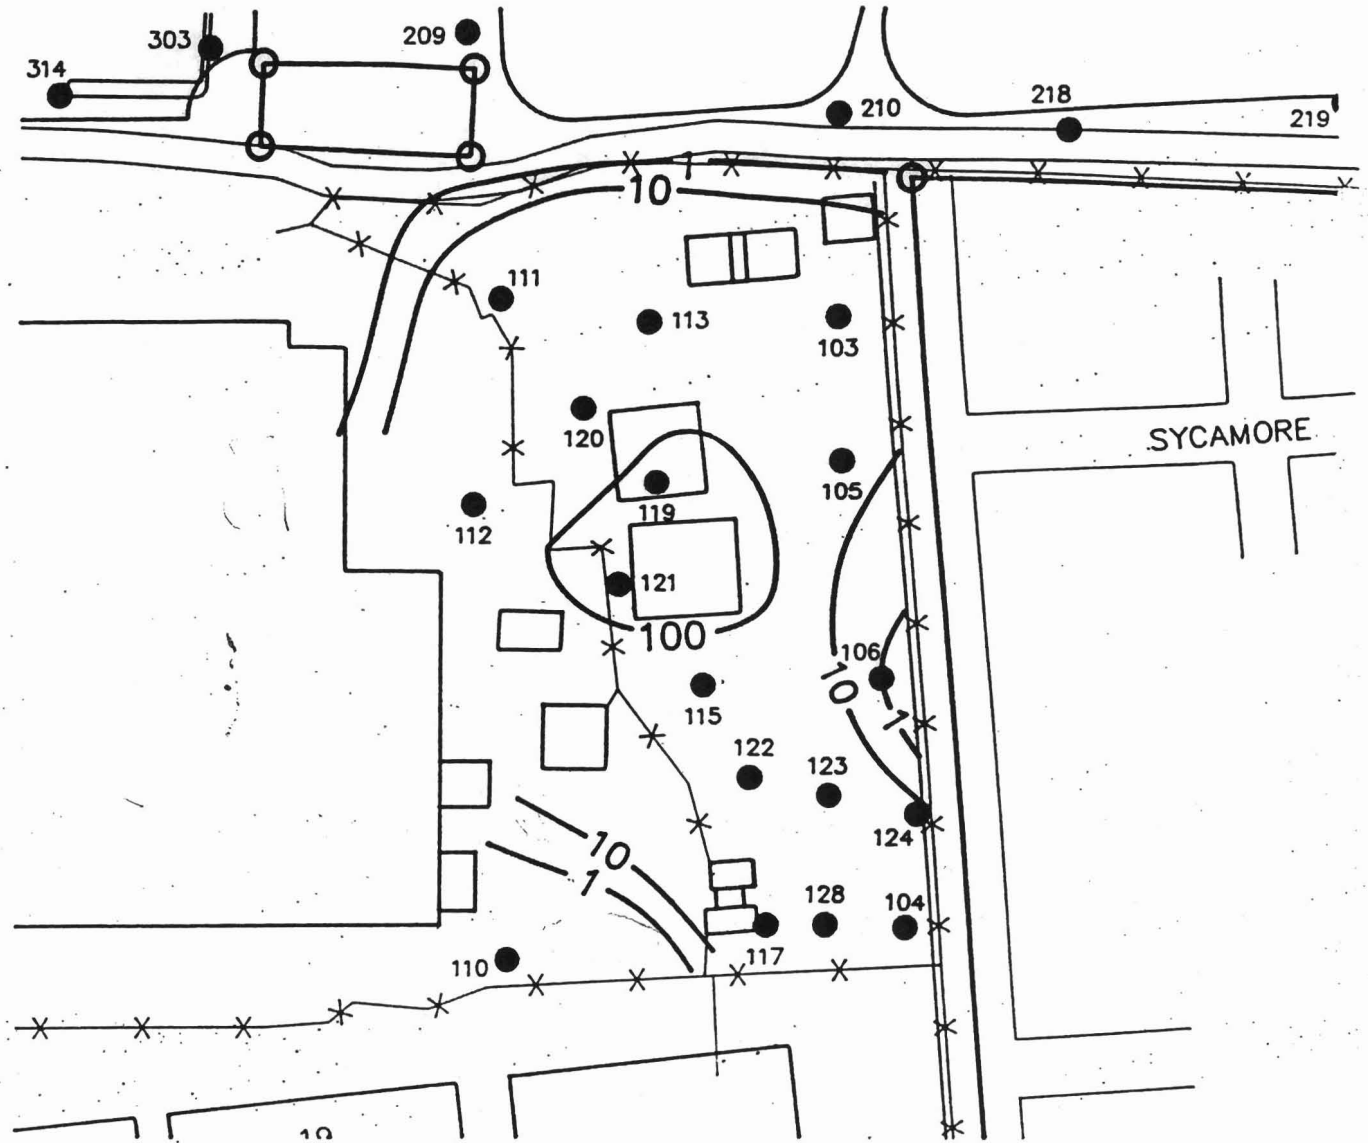
FIGURE 4-1

1991 – Soil gas investigation at adjacent Installation Restoration Site 1, identifies potential source of VOCs at Site 1. Some evidence that soil gas detections may extend under concrete roadway and Plant 3 (Sheets A-1 to A-4).

SOIL GAS RESULTS - SHALLOW
REMEDIAL INVESTIGATION
NWIRP, BETHPAGE, NEW YORK

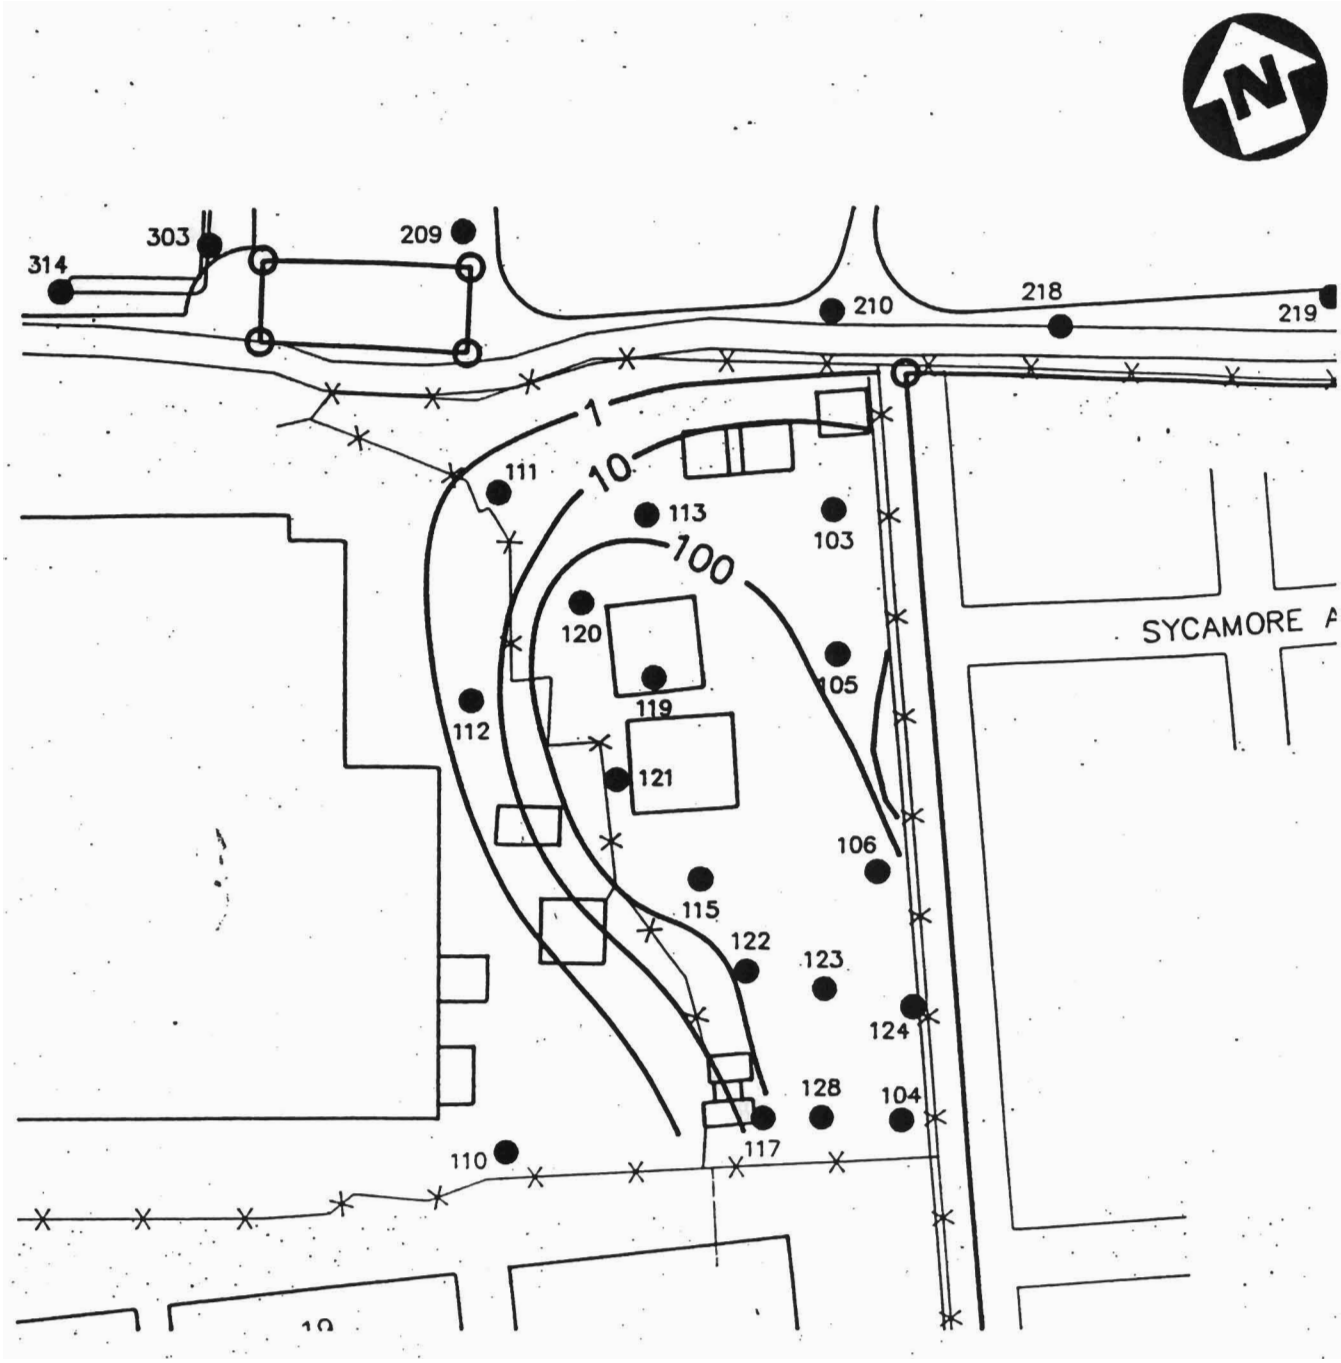
FIGURE 4-2

SOIL GAS RESULTS – DEEP
REMEDIAL INVESTIGATION
NWIRP, BETHPAGE, NEW YORK

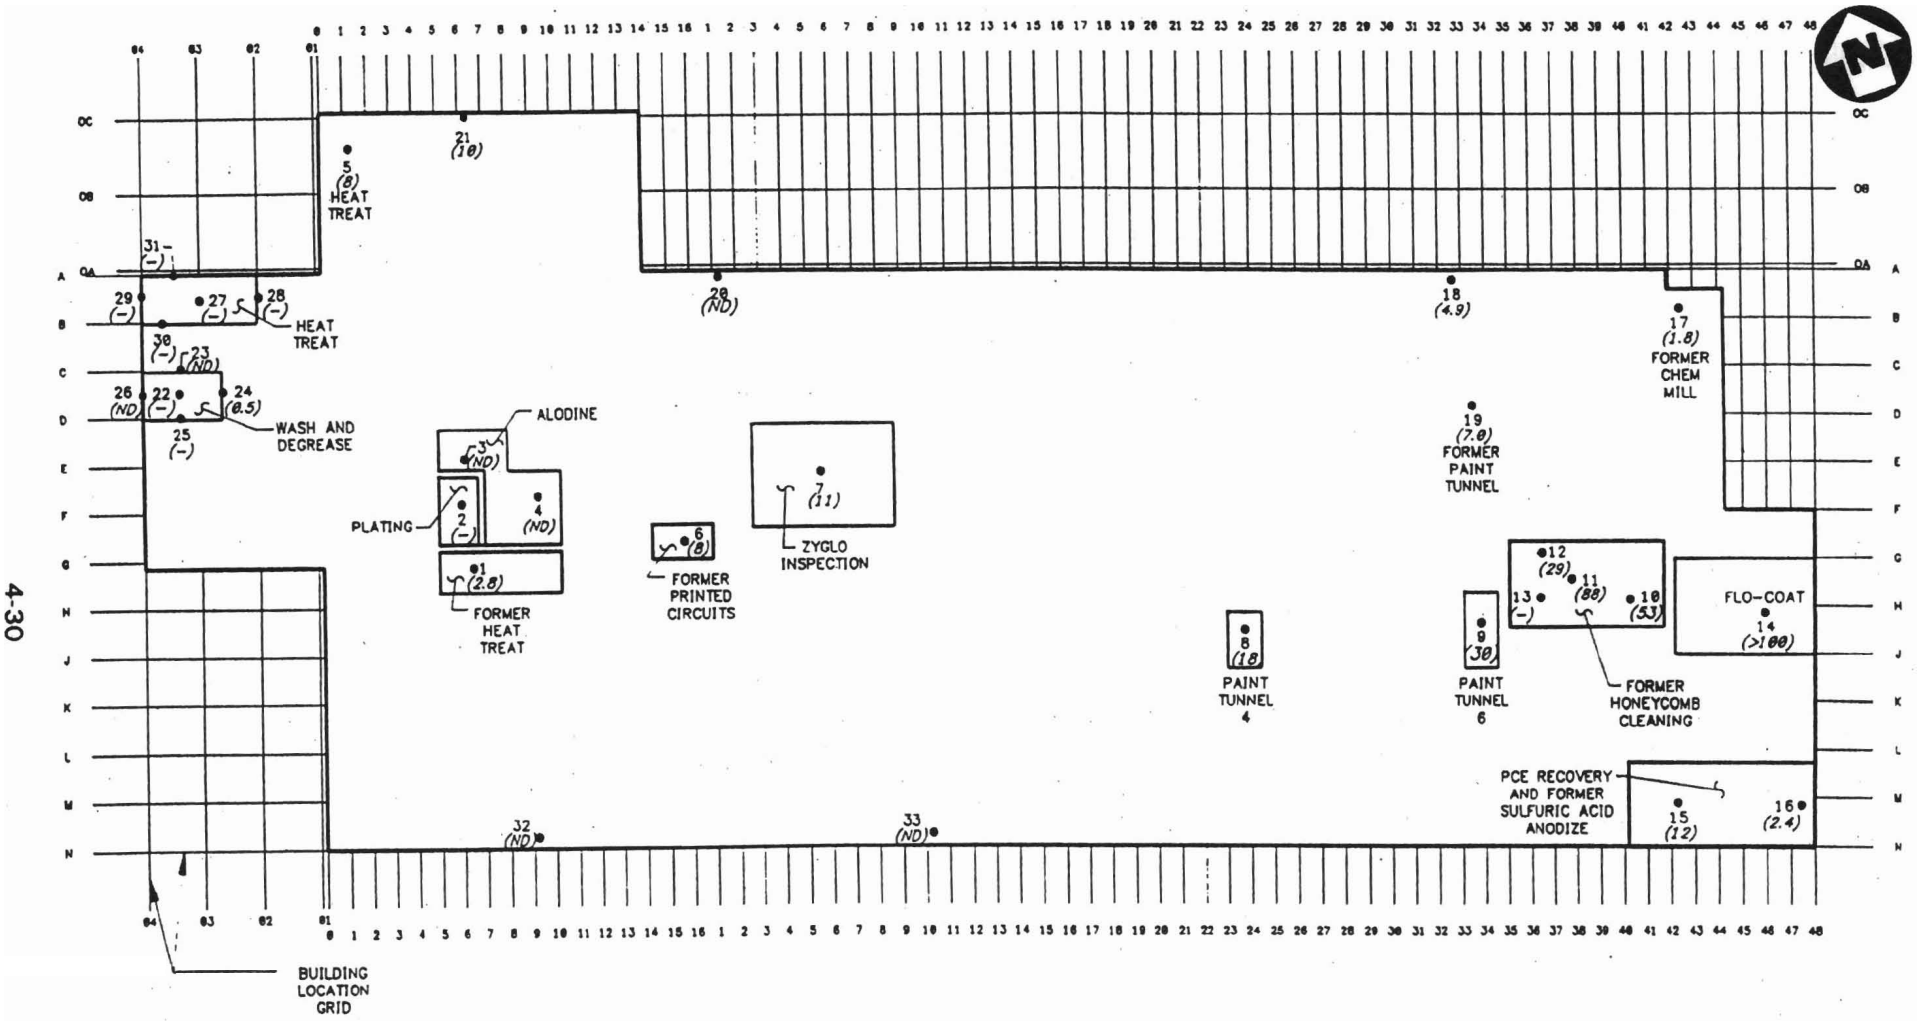
FIGURE 4-10

The results of the soil gas survey are presented on Table 4-9 and Figure 4-10. Areas of highest soil gas readings included the former honeycomb cleaning area (29 to 88 ppm), paint tunnel number 4 (18 ppm), paint tunnel number 6 (30 ppm), the zyglo inspection area (11 ppm), the flo-coat line (>100 ppm), and the tetrachloroethene (PCE) recovery area (2.4 to 12 ppm). Readings of greater than 10 ppm were obtained from all of these areas. Readings of about 10 ppm or less were not considered significant, because of natural organics such as methane and offgasing from contaminated groundwater in this area.

2) The only potential source area of HN-24I contamination from within Plant No. 3 identified during this study is the Former Honeycomb Cleaning Area. The testing in this area did not penetrate a reported sump and as a result it is uncertain if contamination exists underneath the sump.

4) The elevated soil gas readings at the Flo-Coat Area may result from PCE used in the process. Also note that this area is immediately adjacent to Site 1, which was found to have similar elevated soil gas results.

STAGE 1 - SOIL GAS RESULTS
PLANT 3
PHASE 2 - REMEDIAL INVESTIGATION/FEASIBILITY STUDY
NWIRP, BETHPAGE, NEW YORK

5) The stage 2 soil gas program will be used to resolve these issues.

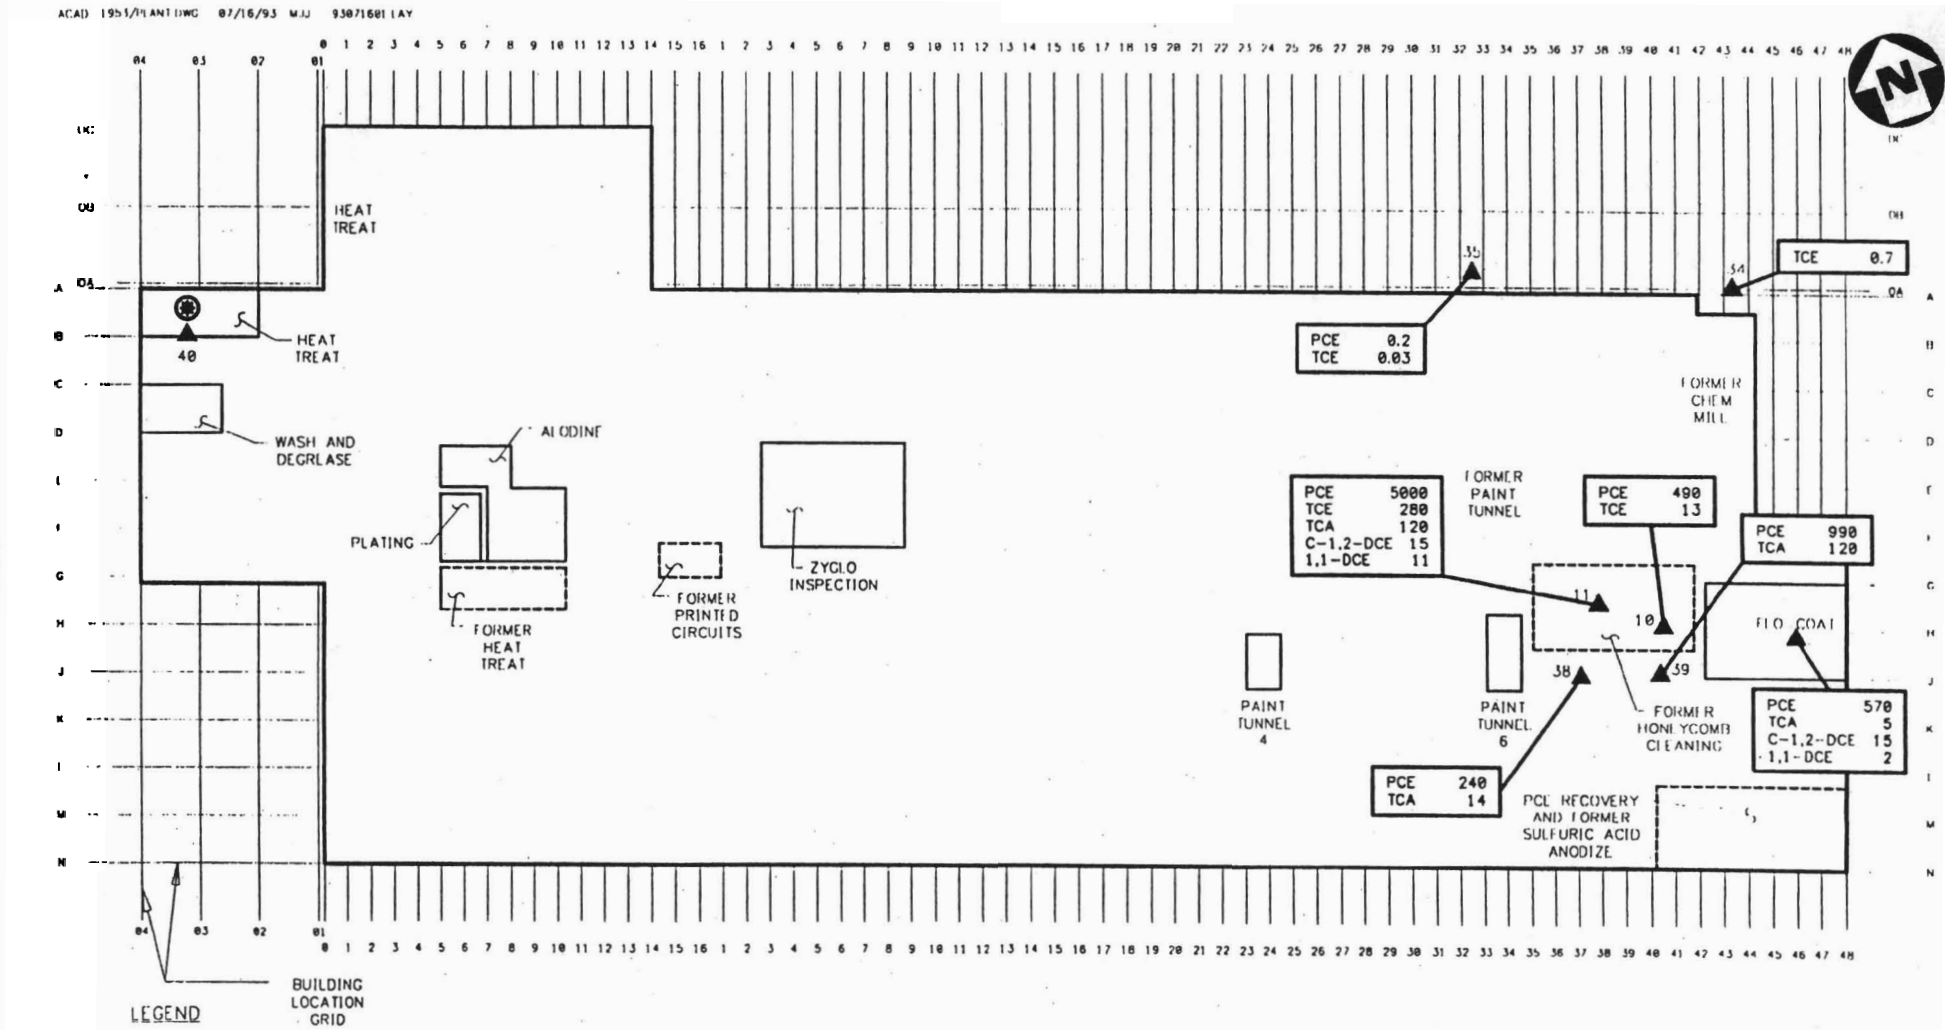
FIGURE 4-11

The results of the second stage soil gas program are presented in Table 4-10. Significant volatile organic contamination was detected at the honeycomb cleaning area. Sample SG-11, located in the southeastern corner of the former sump area, contained PCE at 5,000 ug/l, TCE at 280 ug/l, and TCA at 120 ug/l. Sample SG-10, located in the north-central portion of the former sump, contained PCE at 490 ug/l and TCA at 13 ug/l. Samples SG-38 and SG-39 were taken outside (south) of the former sump. These samples contained PCE at 240 ug/l and 990 ug/l, respectively, and TCA at 14 ug/l and 120 ug/l, respectively. Neither of these samples contained TCE at detectable levels.

The soil gas results indicate that the honeycomb cleaning area is a probable source area of volatile organic contamination. The high levels of contamination detected outside of the former sump area apparently indicate that not all of the volatile organic compounds used during this process were captured or contained by the sump. However, because the honeycomb cleaning area is located

SOIL GAS SURVEY SAMPLE LOCATIONS AND RESULTS (µg/l)
INSIDE PLANT No. 3
PHASE 2 REMEDIAL INVESTIGATION/FEASIBILITY STUDY
NWIRP, BETHPAGE, NEW YORK

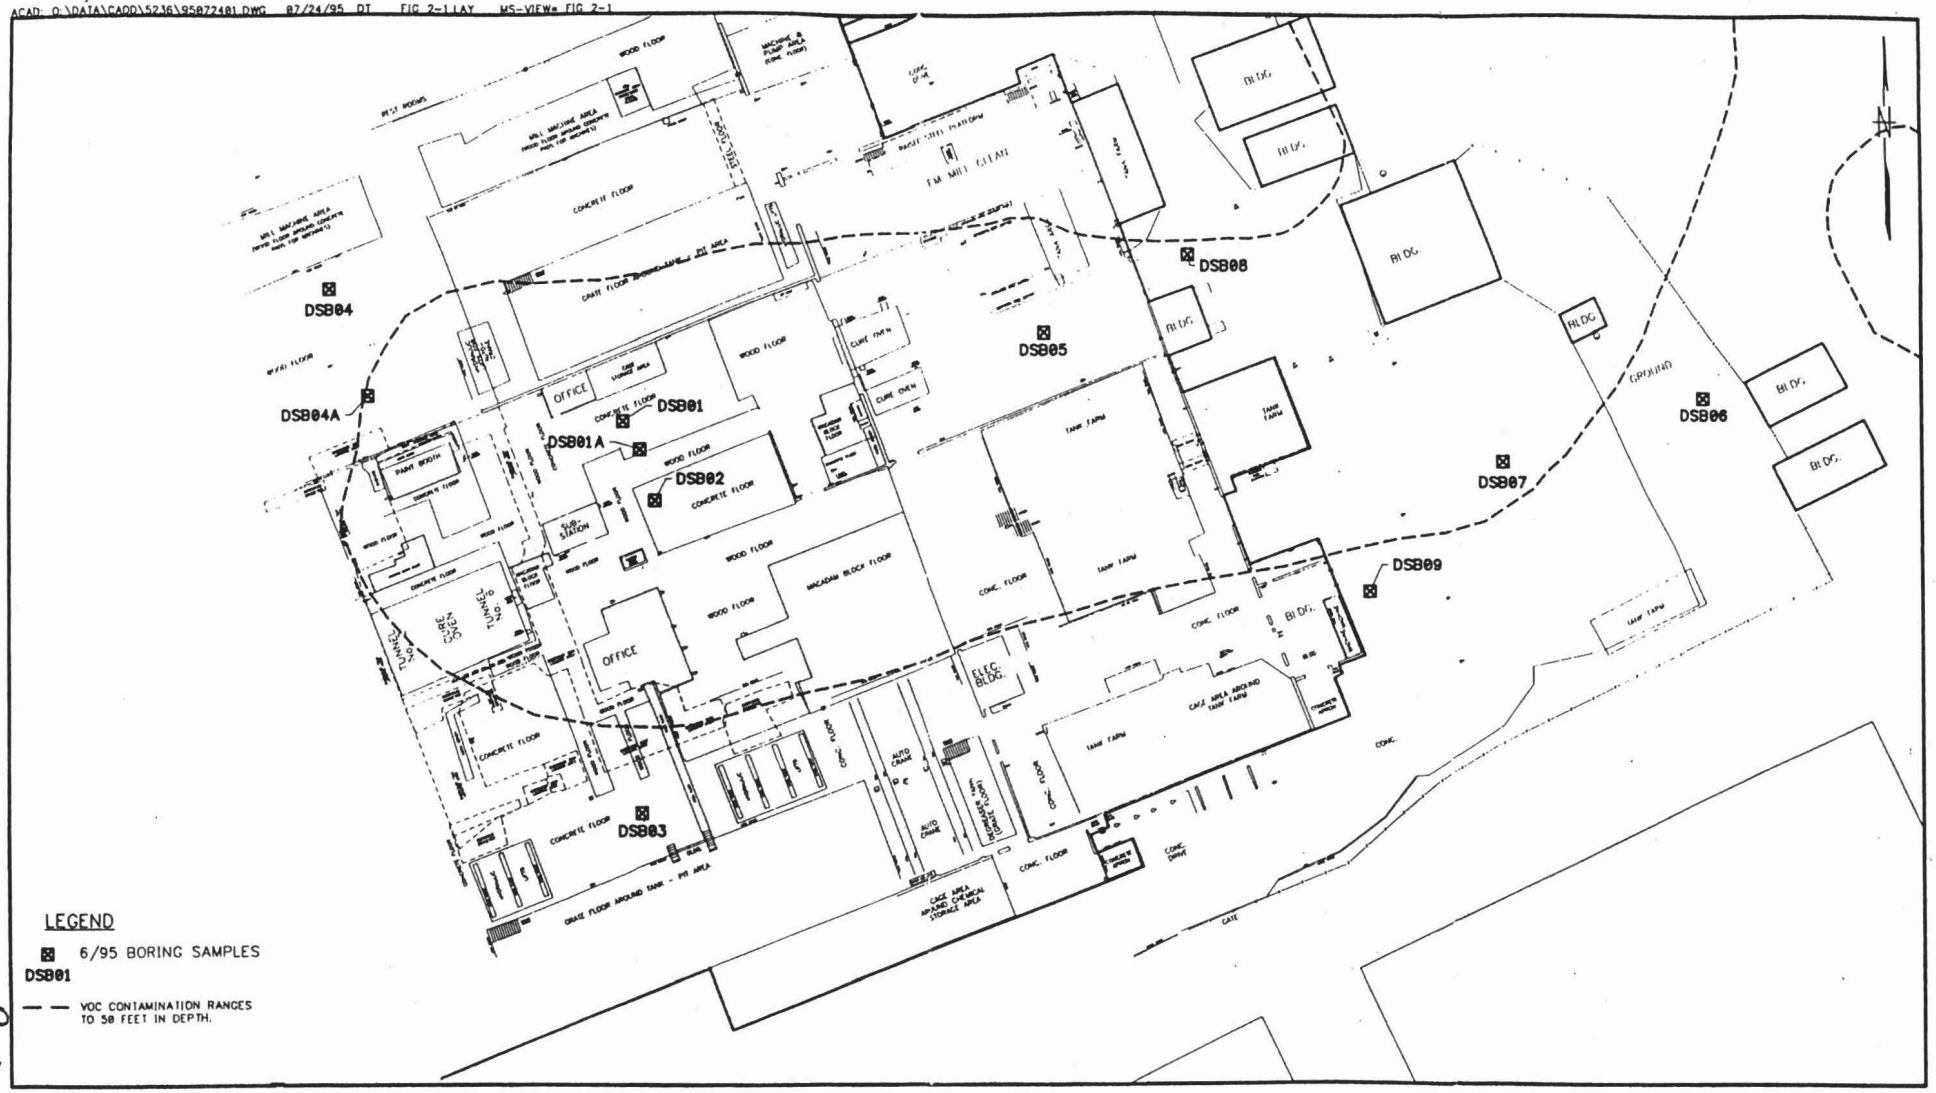
FIGURE 2-1

BORING LOCATIONS
NWIRP, BETHPAGE, NEW YORK

The soil boring locations for the pre-design investigation are shown in Figure 2-1. The borings locations were selected to verify levels of contamination under Plant Number 3 and in the area to the east of Plant Number 3. The borings within Plant Number 3 were selected to verify soil gas samples collected during the Phase II RI and also to verify the extent of the VOC contamination shown previously in Figure 1-3. The high soil gas reading collected during the Phase II RI were in an area referred to as the former Honeycomb Cleaning Area. This area was decommissioned, backfilled with soil and a concrete floor was installed to match the existing Plant Number 3 floor. This area used a high volume of solvents and is a potential VOC contamination source. Based on this information, boring DSB01 was proposed to be drilled within the former Honeycomb Cleaning Area.

During the collection of the samples, field readings using an HNu were recorded (see Table 3-1). Field readings were minimal and correlate with the laboratory data indicating that no major source of contamination was located.

Based on this data, it was concluded that significant sources of VOCs were not present in this area under Plant No. 3 and that extension of the AS/SVE system to this area was not required. This recommendation was included in the Navy's 1997 Design Analysis Report and concurred with by NYSDEC. As a result, design of the AS/SVE system was focused beneath Site 1 only.

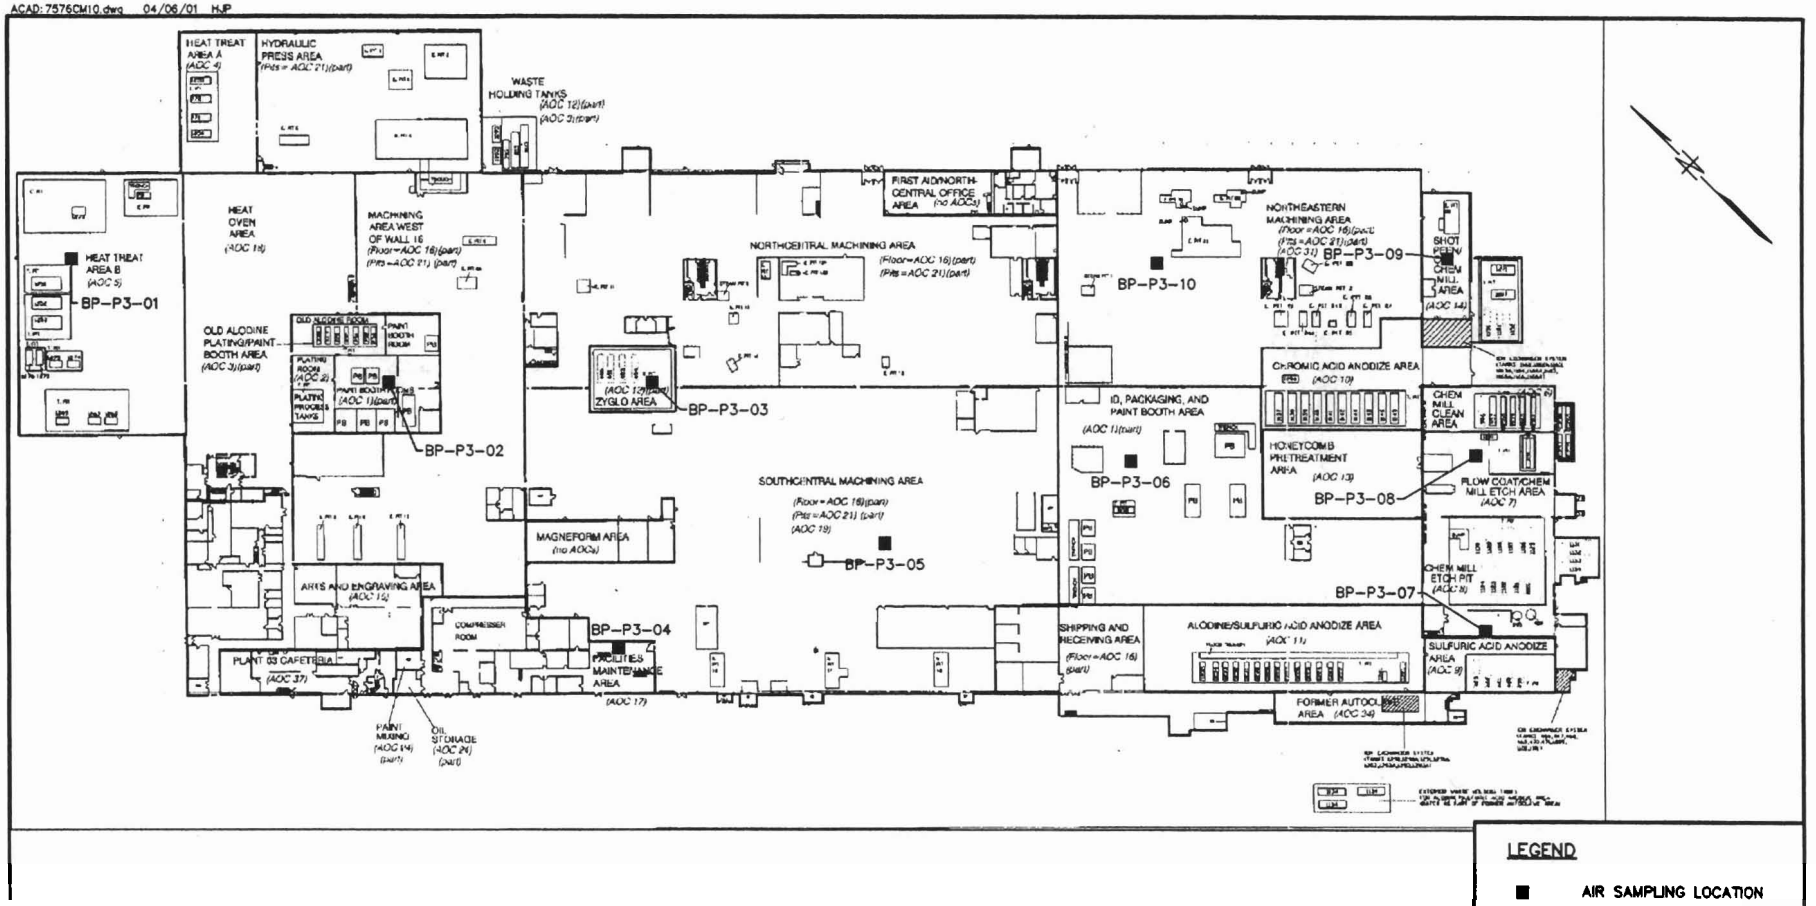
DRAWING NO. FIGURE 2-1

Results of air testing found indoor air quality to be significantly less than applicable standards for an industrial setting. These results were submitted to NYSDOH and NYSDEC at a meeting

INTERIOR AIR SAMPLING LOCATIONS
PLANT 3 – BUILDING 03-01
NWIRP BETHPAGE, NEW YORK
