# 2013 FIVE-YEAR REVIEW

## OPERABLE UNIT 1 (SITES 1, 2, 3) AND OPERABLE UNIT 2 (GROUNDWATER)

NAVAL WEAPONS INDUSTRIAL RESERVE PLANT
BETHPAGE, NEW YORK

December 2014

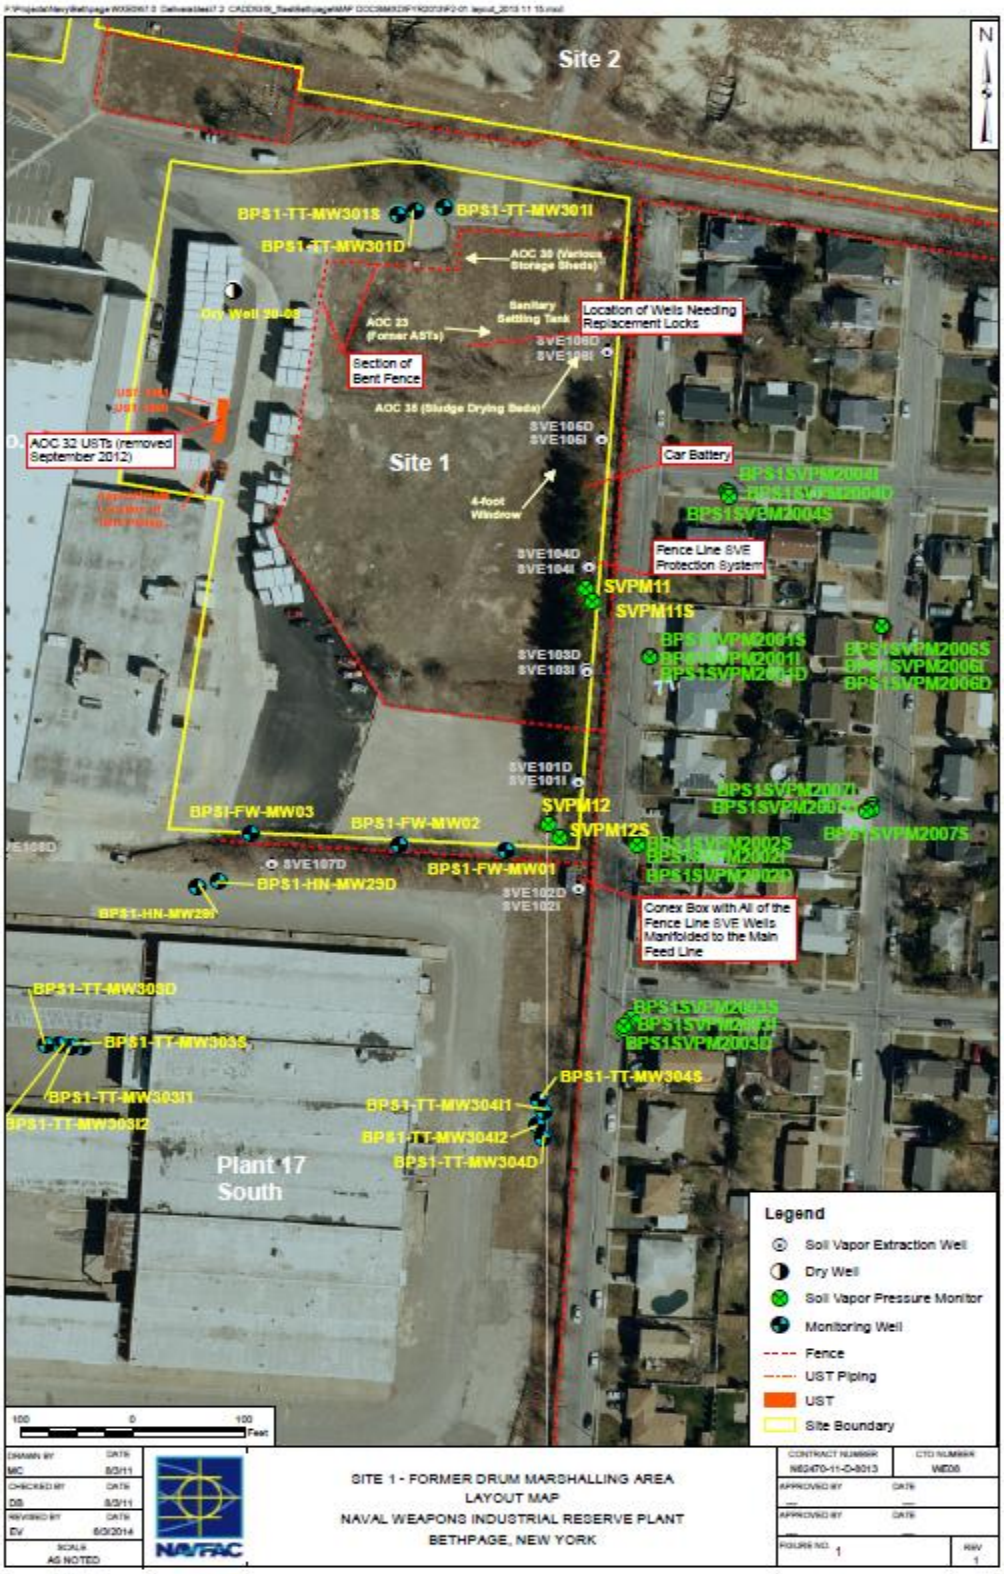
| NWIRP Bethpage - Five Year Review Site Inspection Checklist | | | Remarks |
|---|---|---|---|
| Are monitoring wells functioning, locked and in good condition? | | X | Onsite wells need to have locks replaced |

Site 2
Site 1
Plant 17 South
N
BPS1-TT-MW301S
BPS1-TT-MW301I
BPS1-TT-MW301D
AOC 30 (Various Storage Sheds)
Dry Well 30-08
AOC 23 (Former ASTs)
Sanitary Settling Tank
Location of Wells Needing Replacement Locks
Section of Bent Fence
SVE106D
SVE106I
AOC 35 (Sludge Drying Beds)
AOC 32 USTs (removed September 2012)
Car Battery
4-foot Windrow
BPS1SVPM2004I
BPS1SVPM2004D
BPS1SVPM2004S
SVE104D
SVE104I
Fence Line SVE Protection System
SVPM11
SVPM11S
BPS1SVPM2001S
BPS1SVPM2001I
BPS1SVPM2001D
BPS1SVPM2006S
BPS1SVPM2006I
BPS1SVPM2006D
SVE103D
SVE103I
SVE101D
SVE101I
BPS1SVPM2007I
BPS1SVPM2007D
BPS1SVPM2007S
SVPM12
SVPM12S
BPS1SVPM2002S
BPS1SVPM2002I
BPS1SVPM2002D
BPS1-FW-MW03
BPS1-FW-MW02
BPS1-FW-MW01
SVE107D
BPS1-HN-MW29D
BPS1-HN-MW29I
SVE102D
SVE102I
Conex Box with All of the Fence Line SVE Wells Manifolded to the Main Feed Line
BPS1-TT-MW303D
BPS1-TT-MW303S
BPS1-TT-MW303I1
BPS1-TT-MW303I2
BPS1SVPM2003S
BPS1SVPM2003I
BPS1SVPM2003D
BPS1-TT-MW304S
BPS1-TT-MW304I1

Resolution of noted issues: Nuts will be added to Blower 1-B nuts in 2014; onsite well locks will be replaced during next sampling; Facility Manager will arrange to have eastern perimeter fence checked for debris periodically; missing cesspool lids will be replaced.

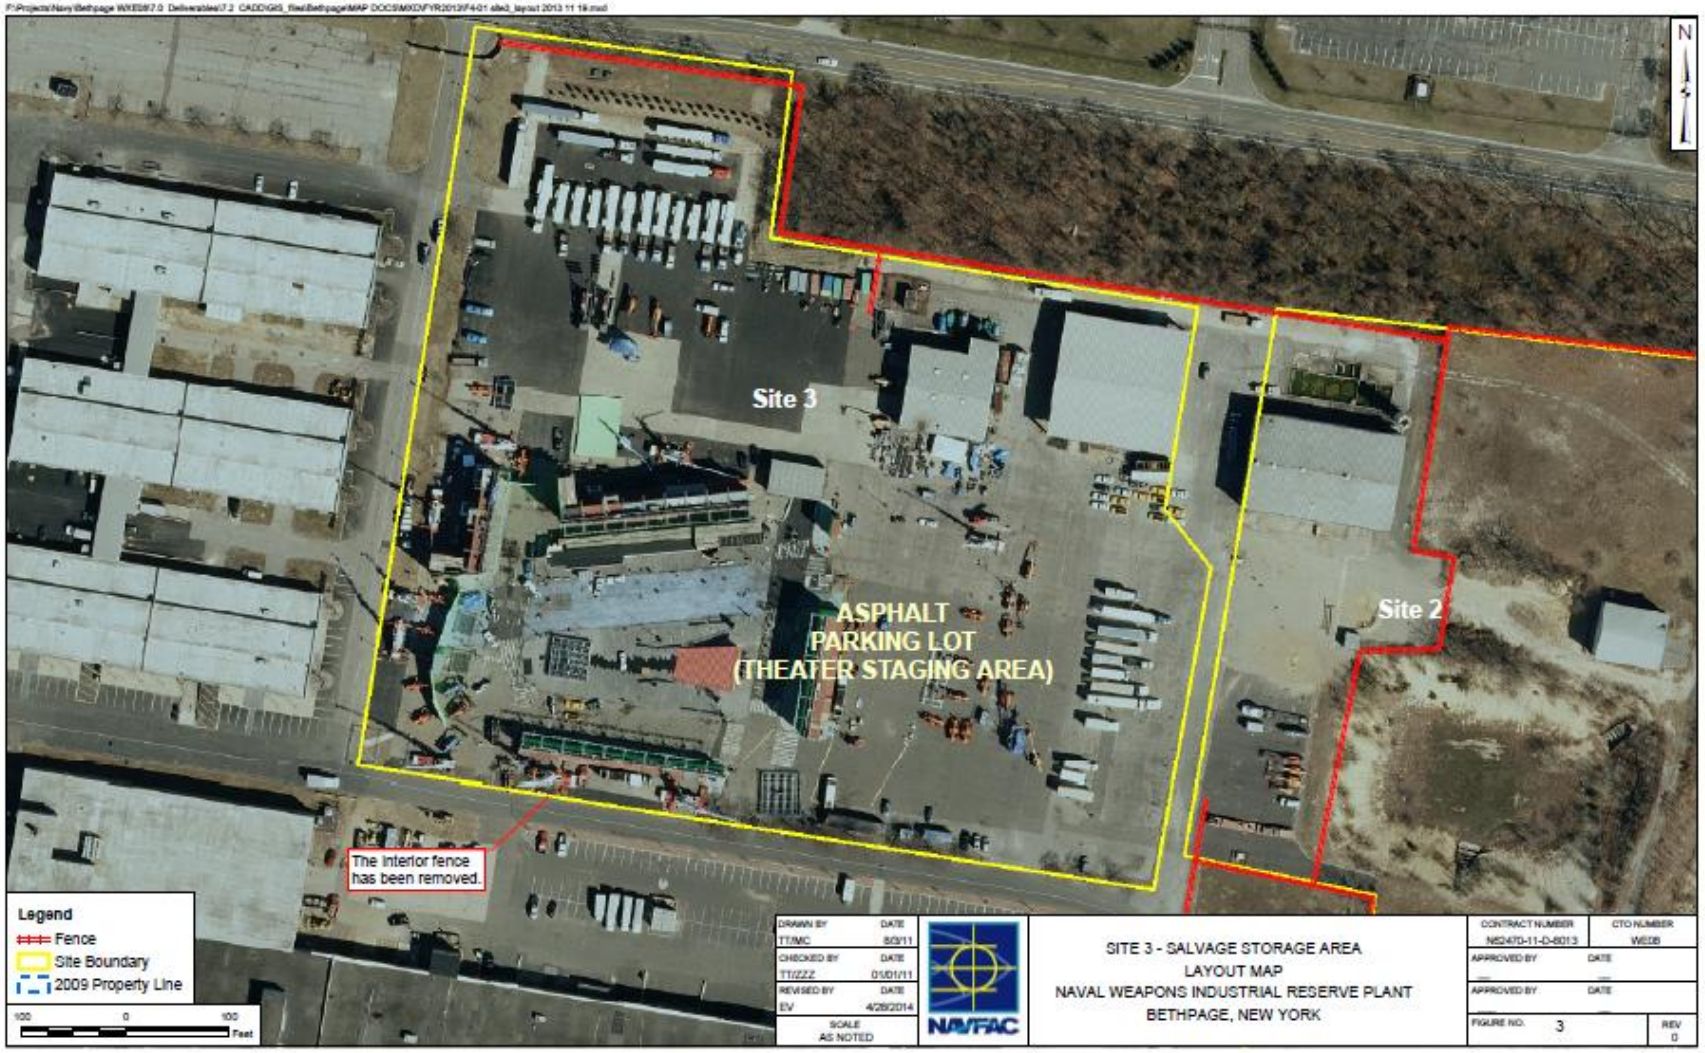
| NWIRP Bethpage - Five Year Review Site Inspection Checklist | | | Remarks |
|---|---|---|---|
| Are there any previously undocumented features/conditions at the site (ie new wetlands, grading, paving, grade changes, roads, etc.)? | X | | A portion of the parking area is utilized as a movie set; the interior fence has been removed |

Site 3
ASPHALT
PARKING LOT
(THEATER STAGING AREA)
Site 2
N
The interior fence has been removed.
Legend
Fence
Site Boundary
2009 Property Line
100 0 100
Feet
DRAWN BY TT/MC DATE 5/3/11
CHECKED BY TT/ZZZ DATE 01/01/11
REVISED BY EV DATE 4/28/2014
SCALE AS NOTED
NAVFAC
SITE 3 - SALVAGE STORAGE AREA
LAYOUT MAP
NAVAL WEAPONS INDUSTRIAL RESERVE PLANT
BETHPAGE, NEW YORK
CONTRACT NUMBER N62470-11-D-8013
CTO NUMBER WE0B
APPROVED BY
DATE
APPROVED BY
DATE
FIGURE NO. 3
REV 0

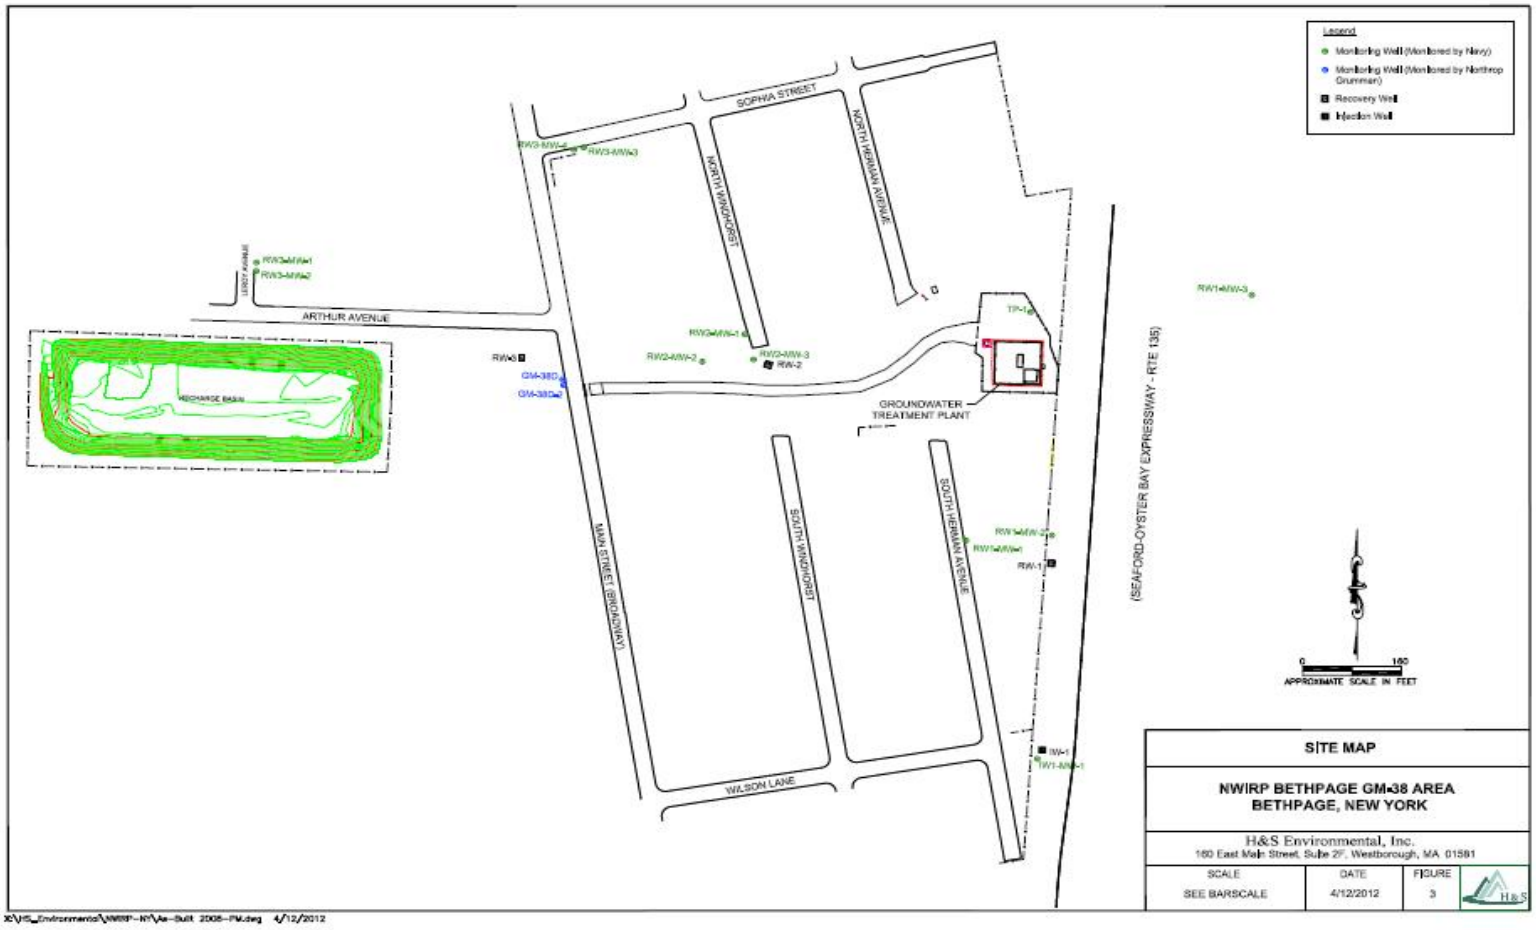
Figure 4.

GM-38 Groundwater Treatment System Site Layout (Source: 2012 Annual Operations Report, GM-38 Area Groundwater Remediation, Naval Weapons Industrial Reserve Plant, Bethpage New York. H&S Environmental, 2013).
