Monthly Report of the Operations & Maintenance Activities

Claremont Polychemical Operable Unit 5

Groundwater Treatment System

November, 2020

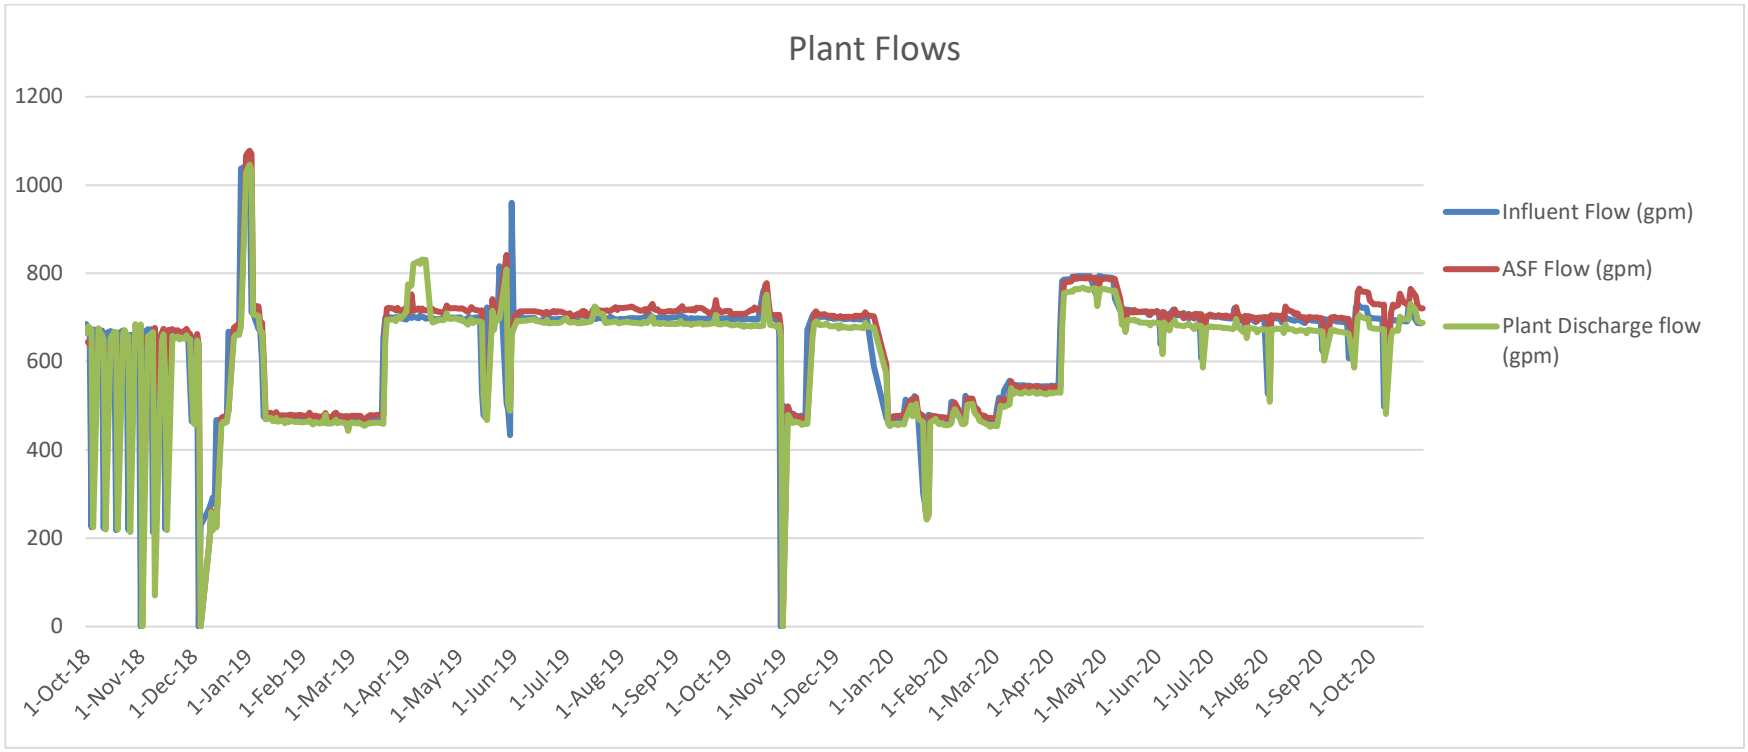
Figure 1 – Plant Discharge Daily Flow

The total volume of treated water discharged from ~0830 hours, November 1 to ~0830 hours December 1, was approximately 30,942,000 gallons. The plant discharge is now directed to recharge Basin-1. The data in **Table 1** shows selected monthly flows discharged from the plant.

A graphic representation of the system's daily plant discharge output is provided in **Figure 1** and the daily plant totalizer readings for November are provided in **Table 4**, both following the text of this report.
