PHASE II INVESTIGATION REPORT FOR

NASSAU COUNTY SECTION 11
BLOCK 7
LOT 13-15, 69-72

67 Sylvester Street
Westbury, New York

NEW CASSEL INDUSTRIAL AREA (SITE NO.130043)
INACTIVE HAZARDOUS WASTE DISPOSAL SITE

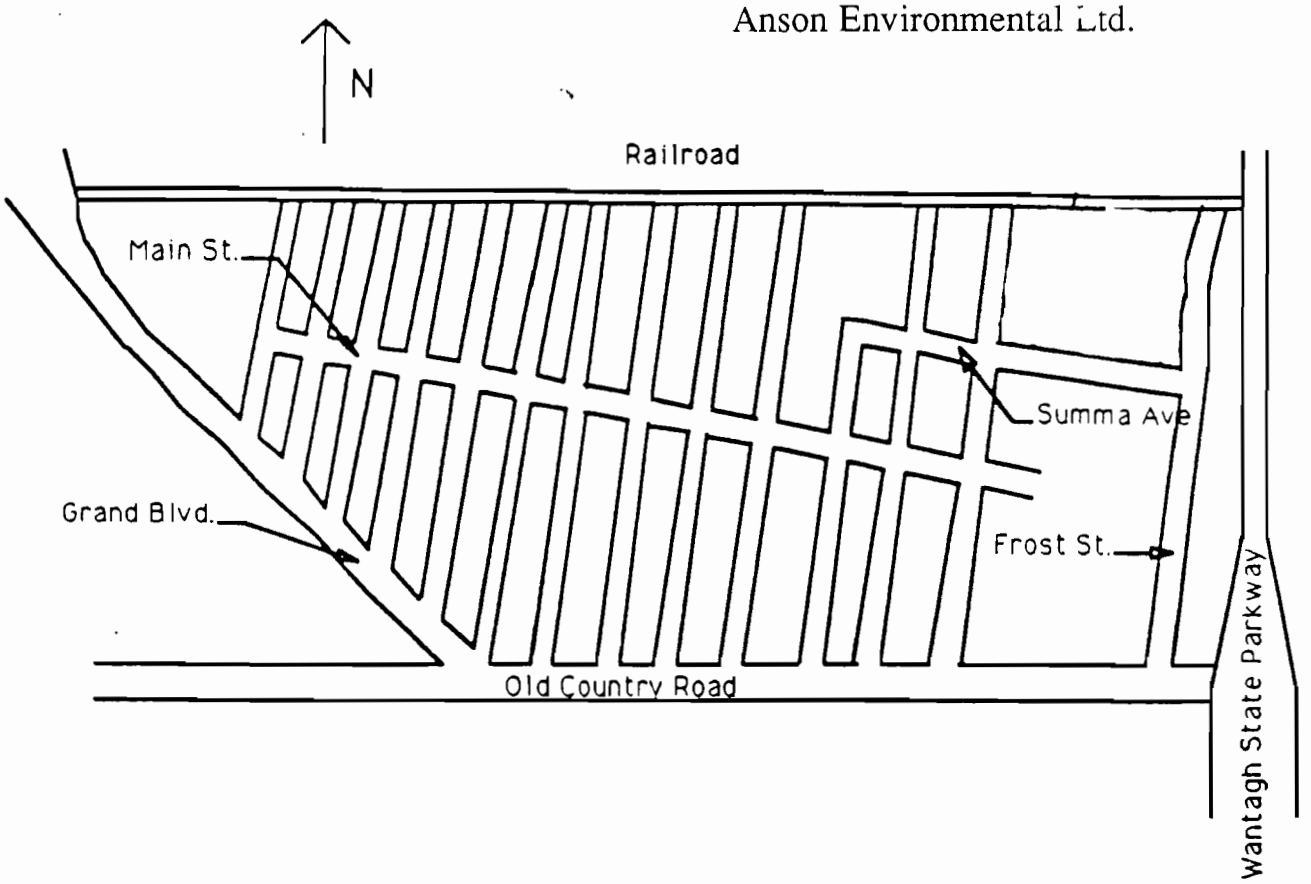
Figure 2 New Cassel Industrial Area

Borings were installed into the abandoned leaching pool (LP#1) and two drywells (DW#1 and DW#2) located in the parking lot on the southeast side of Doak Pharmacal (see Figure 2). Samples collected from the abandoned leaching pool LP#1 were obtained at 0-2 and 2-4 (boring construction began at 2.4 feet below grade). Borings from drywells DW#1 and DW#2 began construction from the bottom of the drywells at 17.4 feet and 18.4 feet below grade, respectively. Samples collected were obtained at 4-6 feet and 8-10 feet for each drywell. Headspace readings obtained from the abandoned leaching pool and drywell samples were all at background levels.

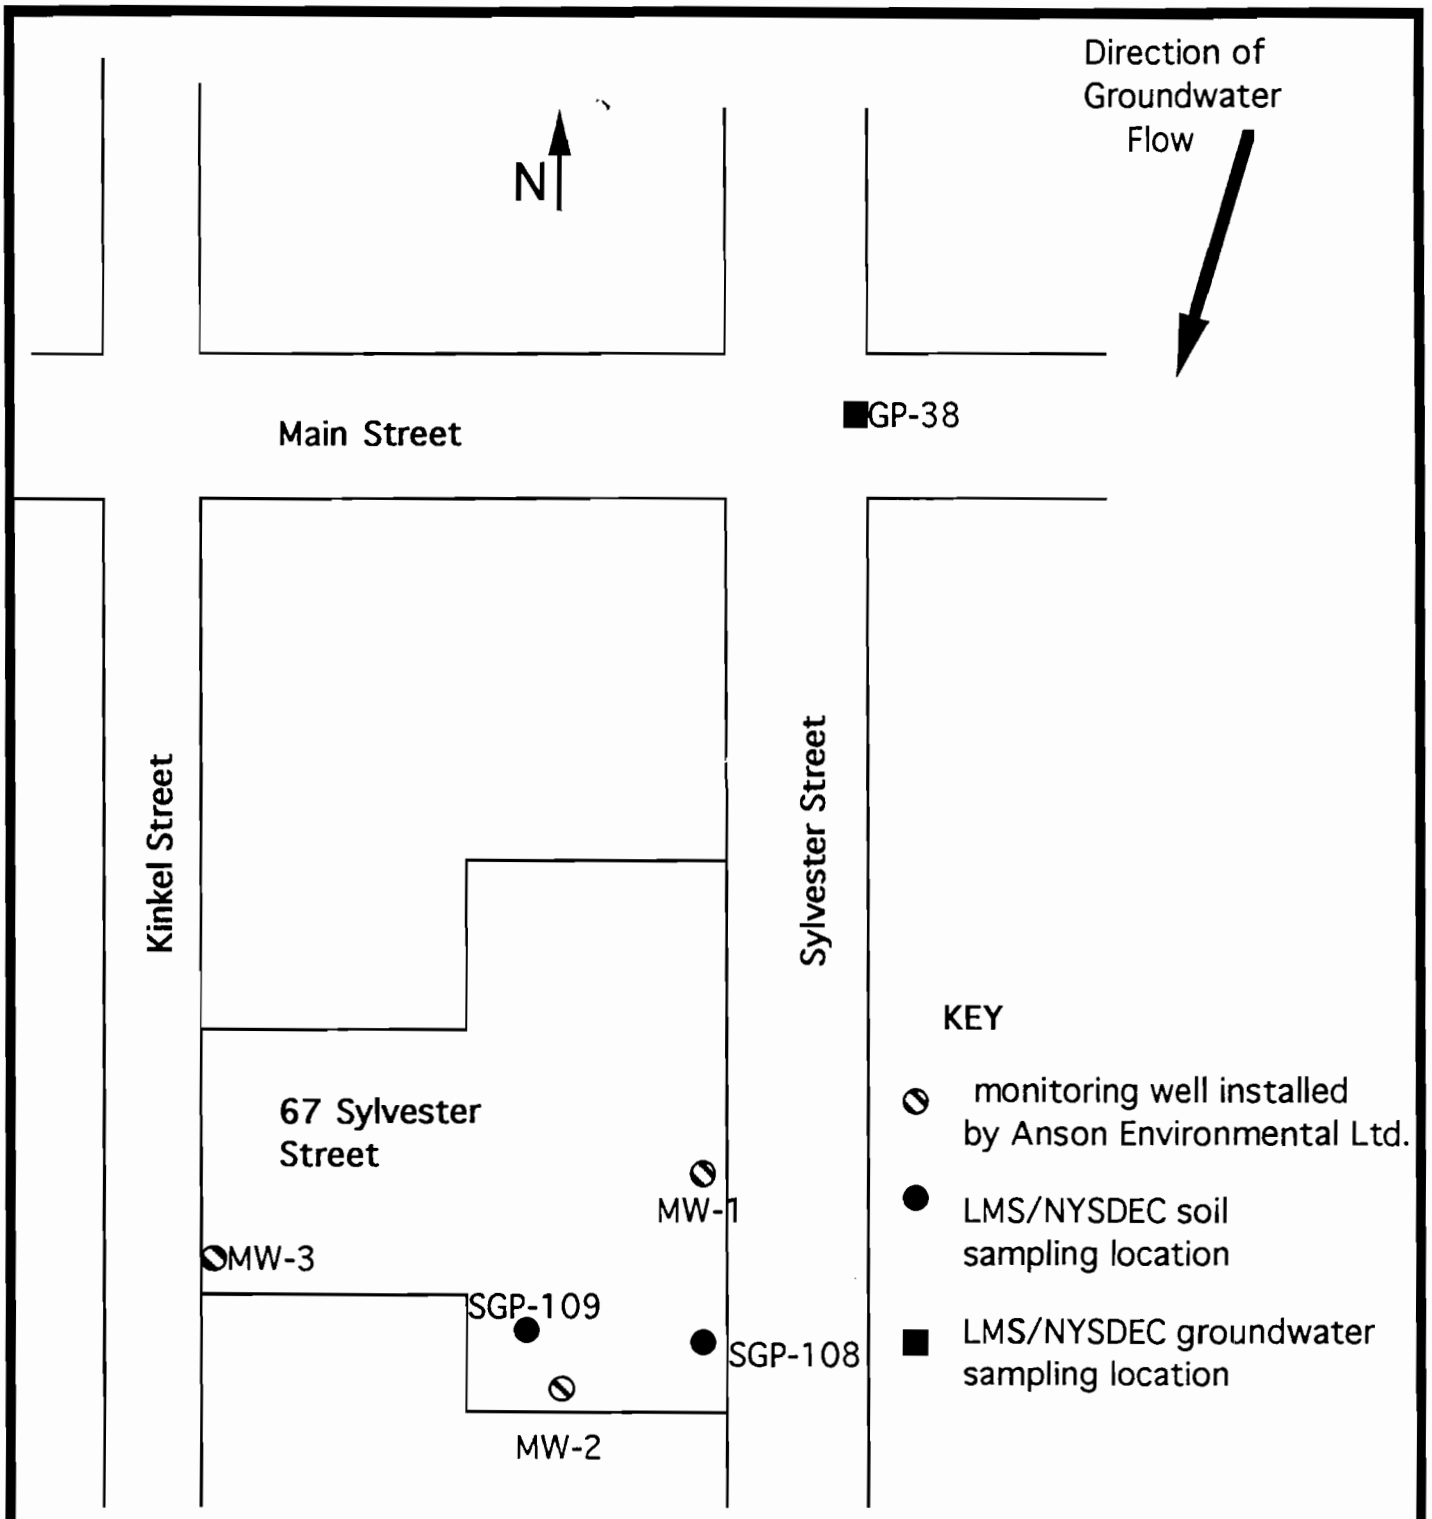
Figure 3
Location of on SITE monitoring wells and LMS/NYSDEC sampling locations

Prior to the sampling conducted in July 1994, LMS/NYSDEC collected a groundwater sample from GP-38 in October 1993. This Geoprobe sampling point is upgradient of MW-1 on the Doak property, located approximately 375 feet northeast. (See Figure 5 which was assembled from LMS/NYSDEC Drawing number DWG#650027-4). The levels of volatile organic compounds detected at GP-38 were comparable to the levels found nine months later at MW-1 (see Table 3 below).

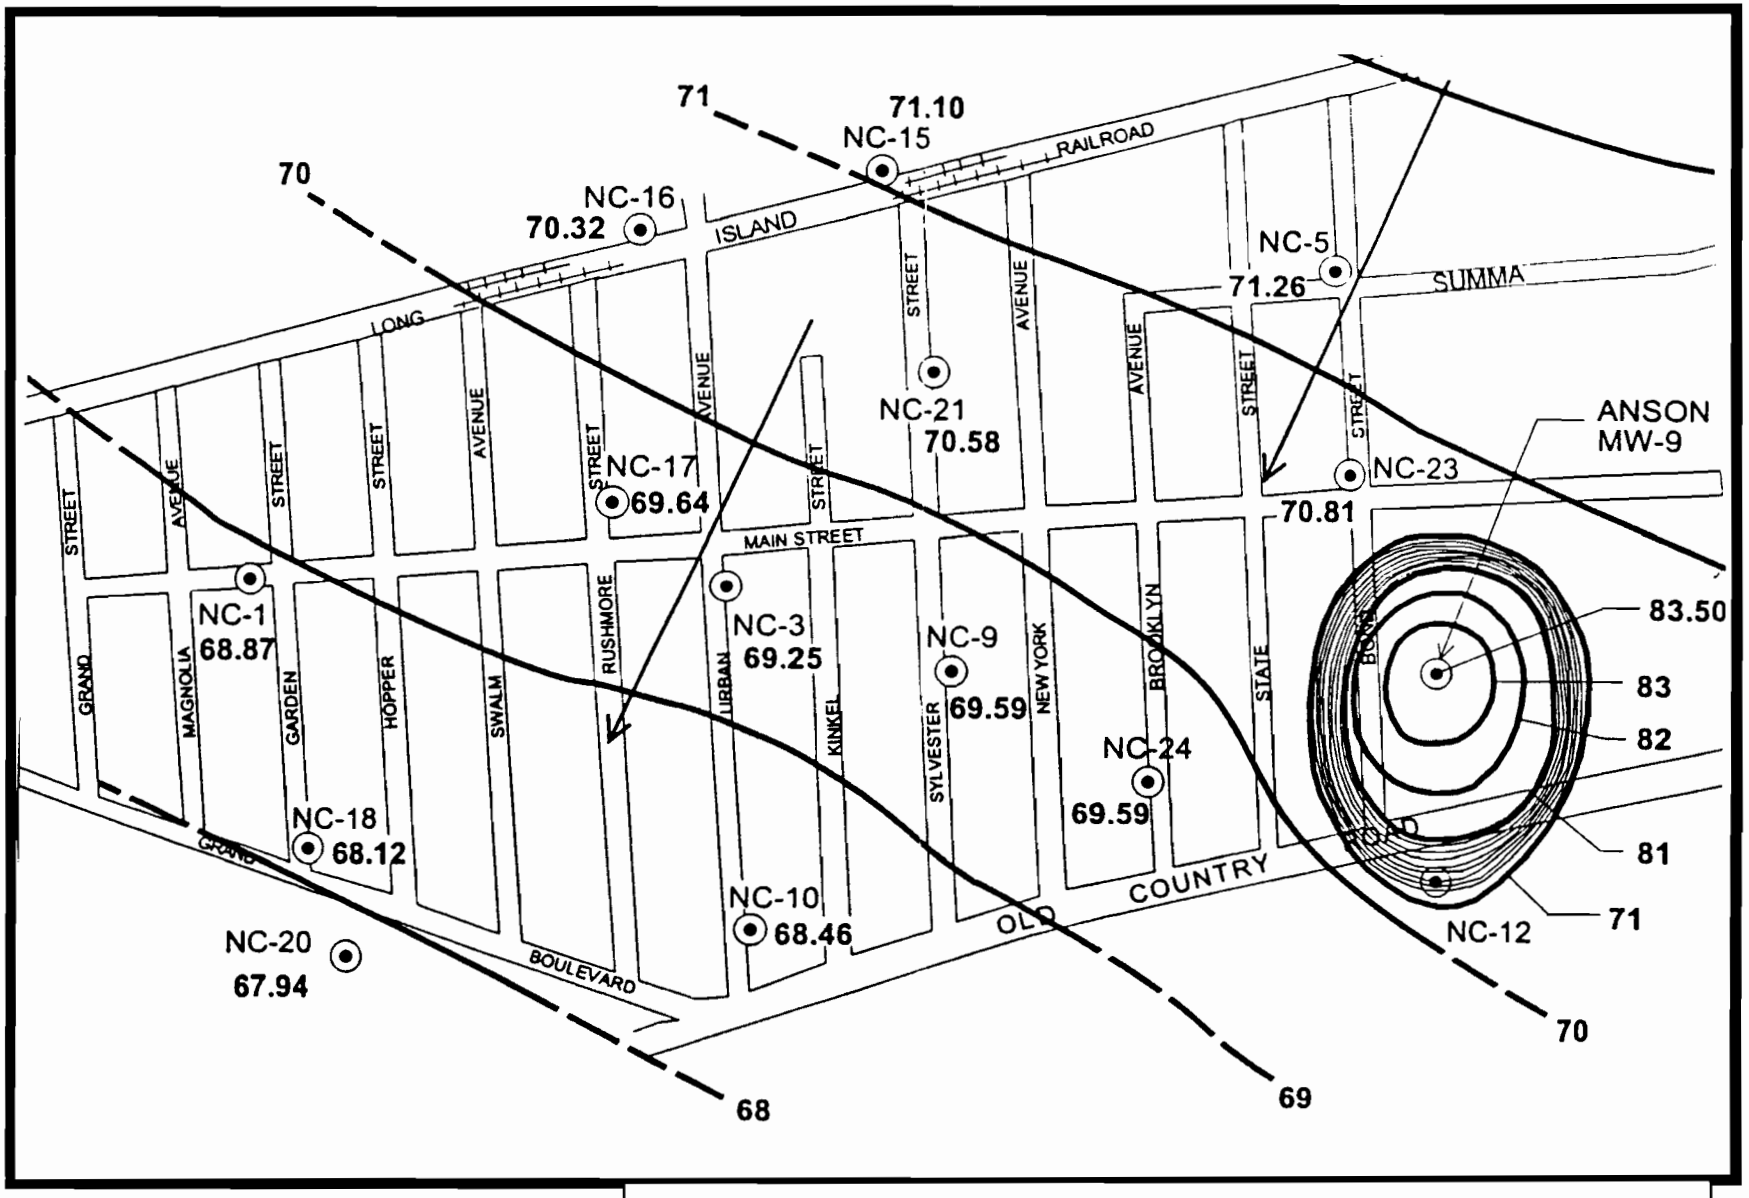
Figure 7 New Cassel Water Level Contours
(From: LMS/NYSDEC October 1994 Report.

Regional groundwater flow in the New Cassel Area is toward the southwest, according to the Nassau County Department of Public Works groundwater elevation maps. This flow direction was confirmed by the NCDH study conducted in 1984 to 1985 (see Figure 7). According to the NCDH study vertical flow in the New Cassel area is not consistent.

According to the water level contours identified in the Nassau County 1986 study, groundwater in the NCIA flows in a southwesterly direction (see Figure 7).
