APPENDIX 1 – PROPERTY DESCRIPTION

ENVIRONMENTAL EASEMENT GRANTED PURSUANT TO ARTICLE 71, TITLE 36 OF THE NEW YORK STATE ENVIRONMENTAL CONSERVATION LAW

AECOM has prepared this PRR for the Farmingdale Plaza Cleaners Site, located in the Town of Farmingdale, Nassau County, New York. This PRR covers the period of September 2011 through January 2013. This work was performed for the NYSDEC under Work Assignment D007626-14 of AECOM's Superfund Standby Contract with NYSDEC. The NYSDEC has assigned the Site the ID No. 1-30-107 on the NYSDEC's registry of inactive hazardous waste sites. Farmingdale Plaza Cleaners is a Class 2 site.

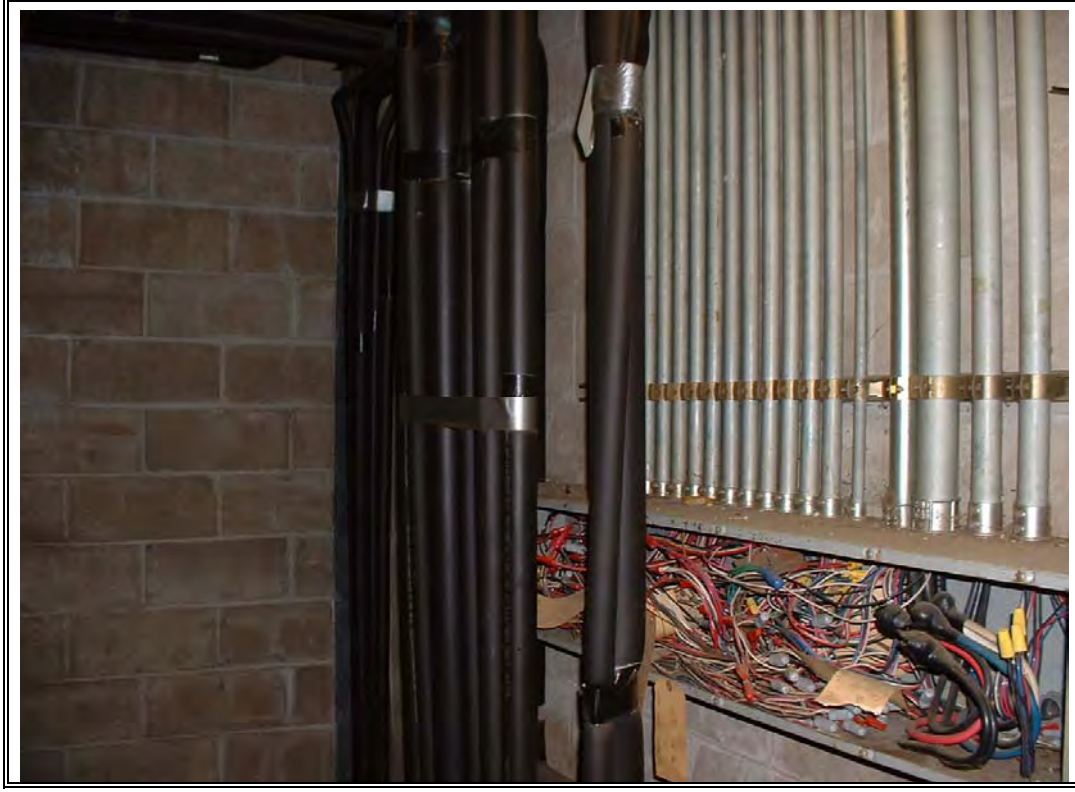
Photograph Number 10: Electrical Room looking at panels of exposed wires and conduit- looking West

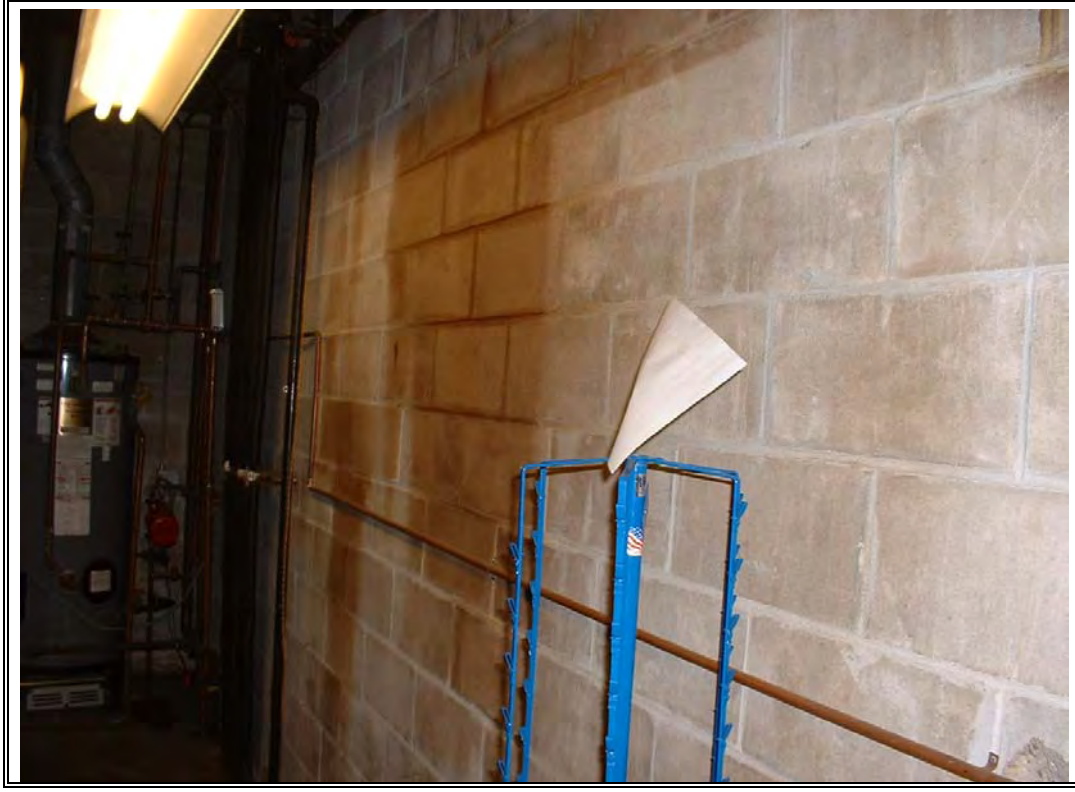
Photograph Number 13: Staining on concrete block wall on North side of heater room
