Fourth Quarter 2019
Quarterly Monitoring Report
Former Zoe Chemical Site
1801 Falmouth Avenue
New Hyde Park, New York
Site No. 1-30-211

January 2020

CA RICH CONSULTANTS, INC.
17 Dupont Street
Plainview, NY 11803-1614

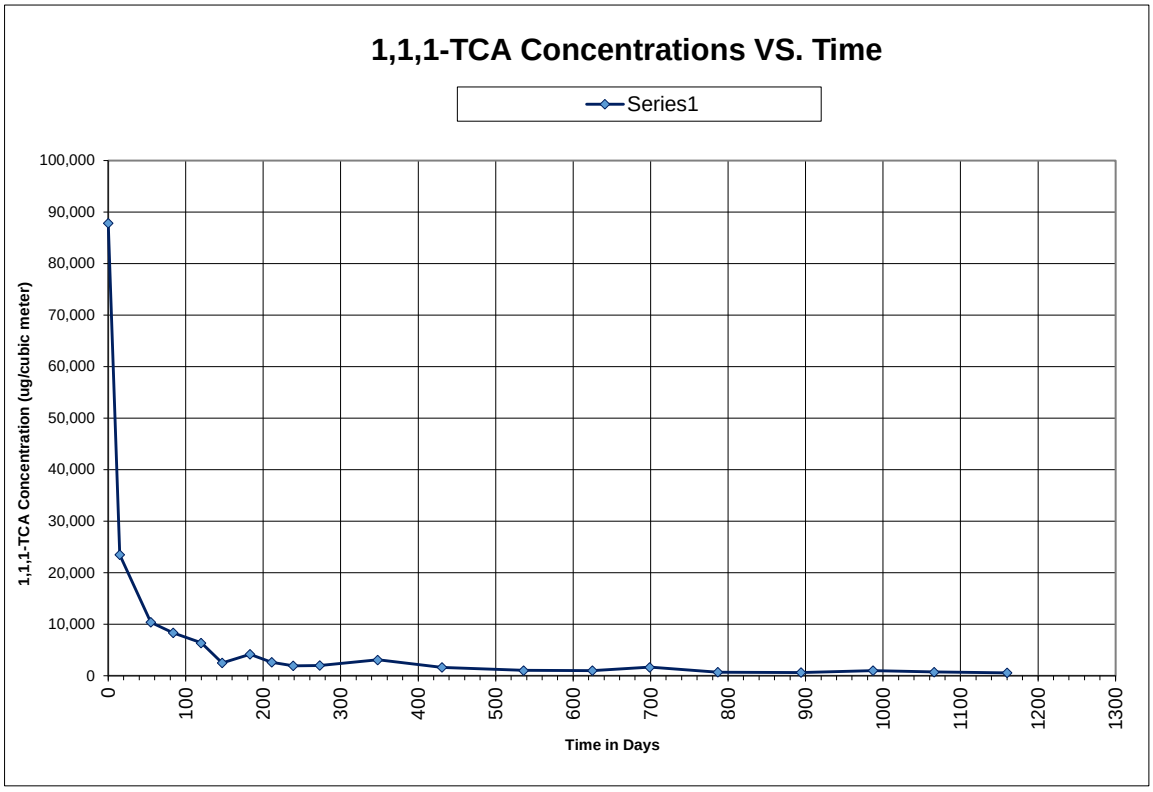
Table 2

Untreated Soil Vapor – The first soil vapor sample collected from the system was conducted on September 21, 2016. The initial untreated soil vapor sample contained a TCA concentration of 87,800 ug/m^3. At the end of the fourth quarter 2016, the concentration of TCA was 8,350 ug/m^3. At the end of the fourth quarter 2017, the concentration of TCA was 1,630 ug/m^3. At the end of the fourth quarter 2018, the concentration of TCA was 693 ug/m^3. The most recent sample collected on December 17, 2019, detected a TCA concentration of 589 ug/m^3.

Results of the untreated soil vapor sampling program are summarized on Table 2. In addition, plots of the laboratory results versus days in operation are included.

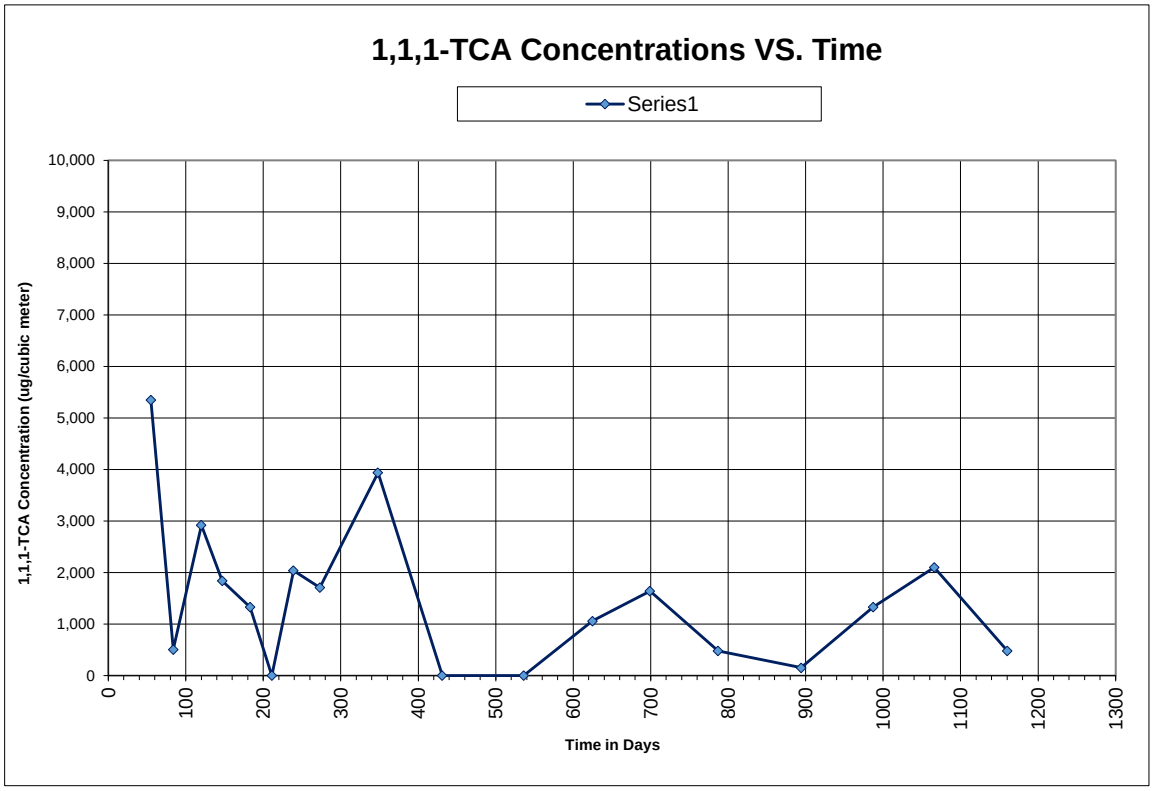
Table 3

Mid-Carbon Soil Vapor – This sample is used to determine when breakthrough occurs at the first carbon drum, which in turn provides sufficient information to determine when the carbon drums should be replaced. The fourth quarter 2019 mid-carbon sample was collected on December 17, 2019 and detected a TCA concentration of 482 ug/m^3. Results of the mid-carbon sampling are summarized on Table 3.

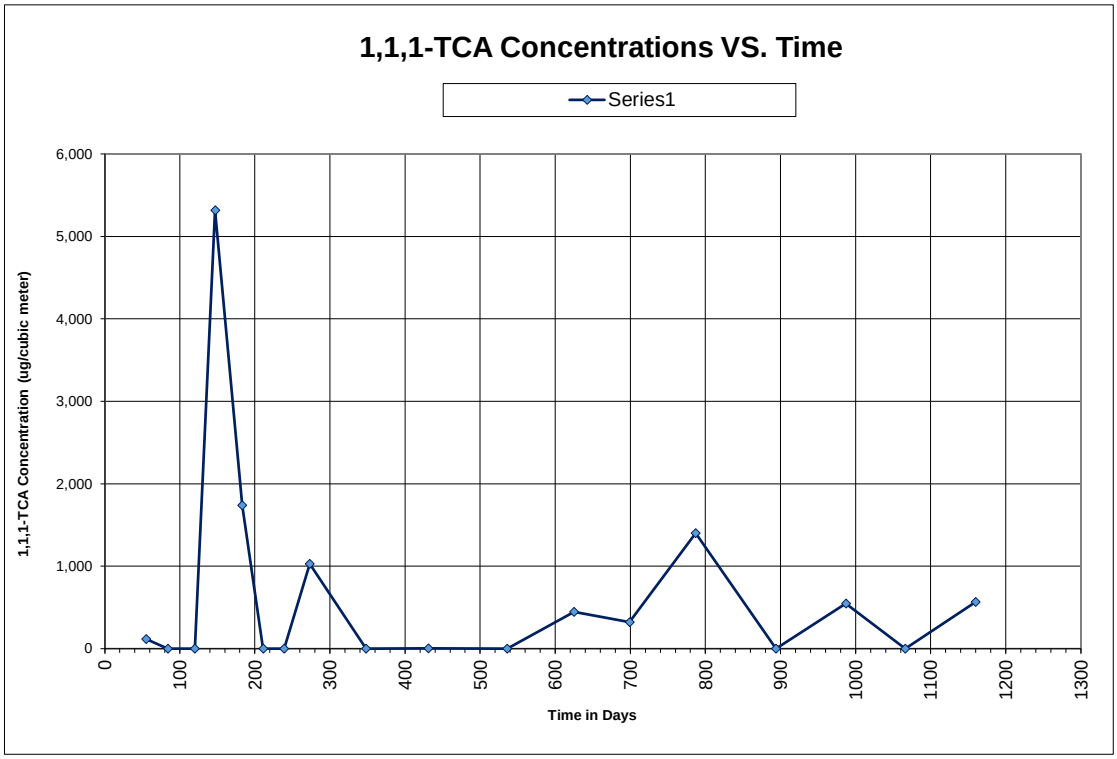
Table 4

Treated Soil Vapor – A treated soil vapor sample was also collected on December 17, 2019 using a SUMMA canister. The sample detected a TCA concentration of 567 ug/m^3. A summary of the laboratory data is summarized on Table 4.
