PERIODIC REVIEW REPORT

August 29, 2024 to August 29, 2026

1966E Broadhollow Road
Farmingdale, NY 11735
Site #152119

Tyll Engineering and Consulting, PC
169 Commack Road, Suite 173
Commack, New York 11725

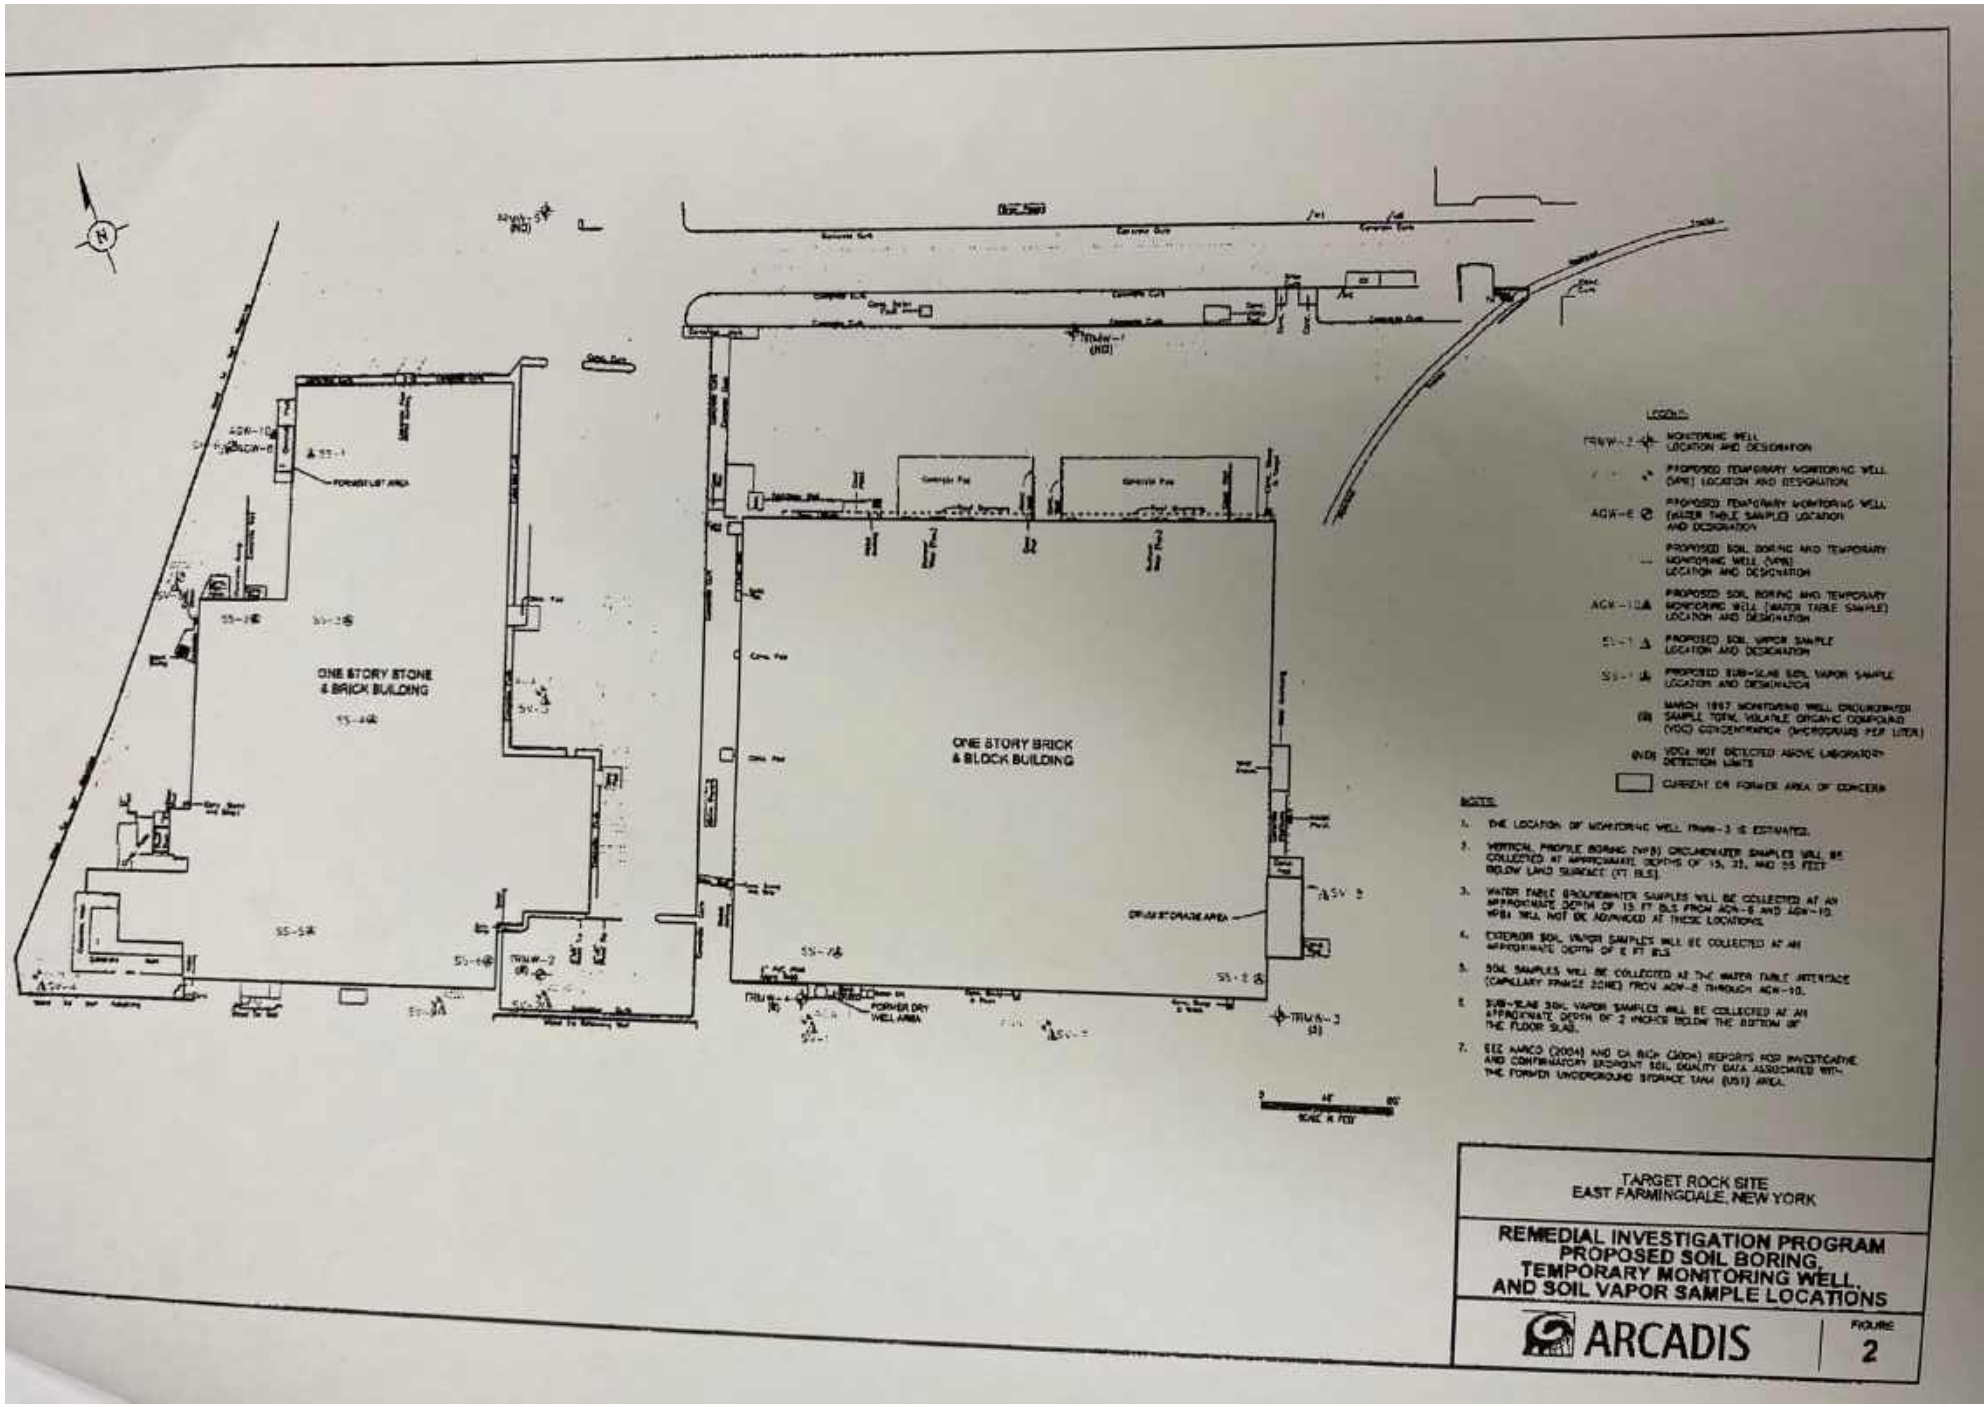
LOCATION.	9 AM. READING	12 NOON READING.	2 PM READING
SS-1	,023	.023	.022
SS-2	.013	.014	.014
SS-3	.018	.017	.017
SS-4	.016	.018	.018
SS-5	.016	.017	.017
SS-6	.017	.016	.016
SS-7	.017	.017	.018

Space pressure in relation outside was a positive at all location intervals.
