DAILY STATUS REPORT
Prepared By: David Klein

Project Name:	3547 Webster Avenue	**Date:**	8/26/2024

DAILY AIR MONITORING REPORT
3547 Webster Avenue
Bronx, New York

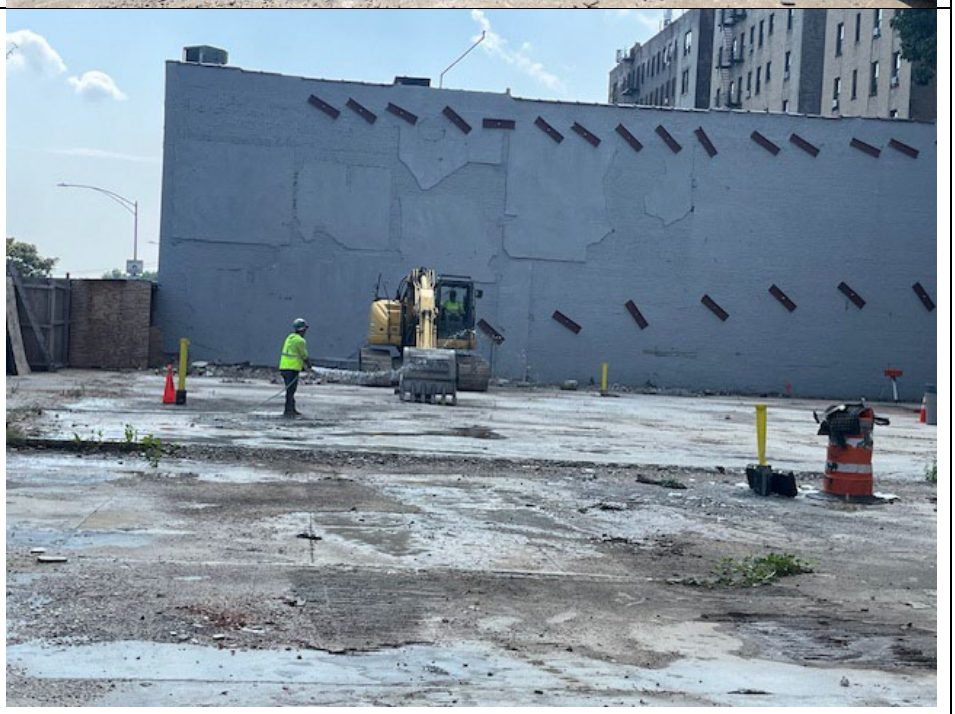
Photo 1: Raptor Concrete breaking up concrete in Grid B looking south	
Photo 2: Raptor Concrete wetting down concrete slab

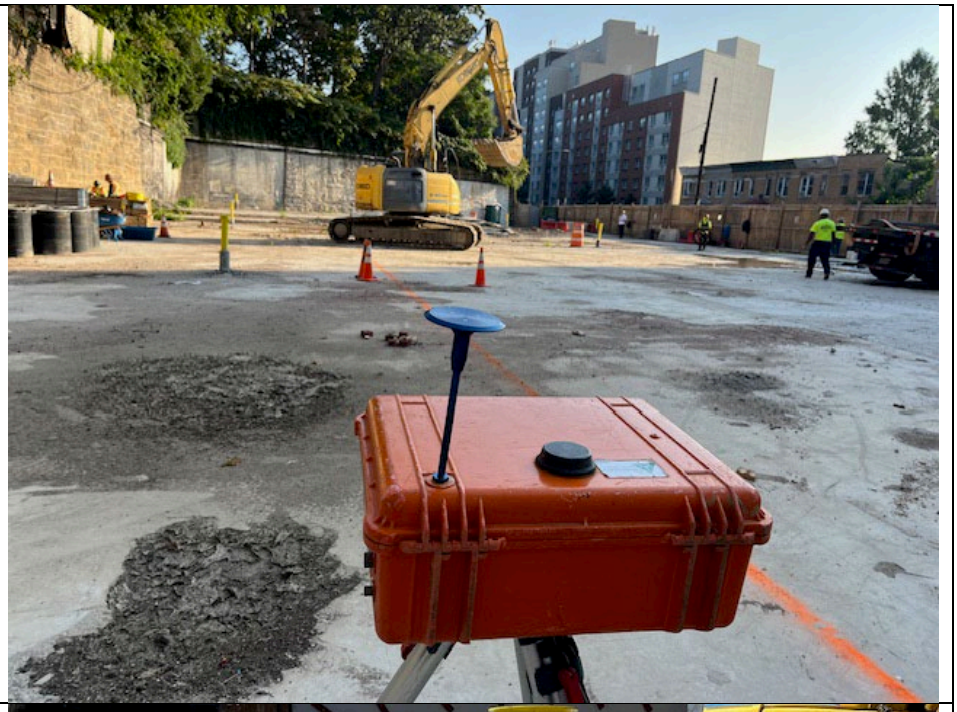
Photo 3: View of downwind CAMP station and Site looking north

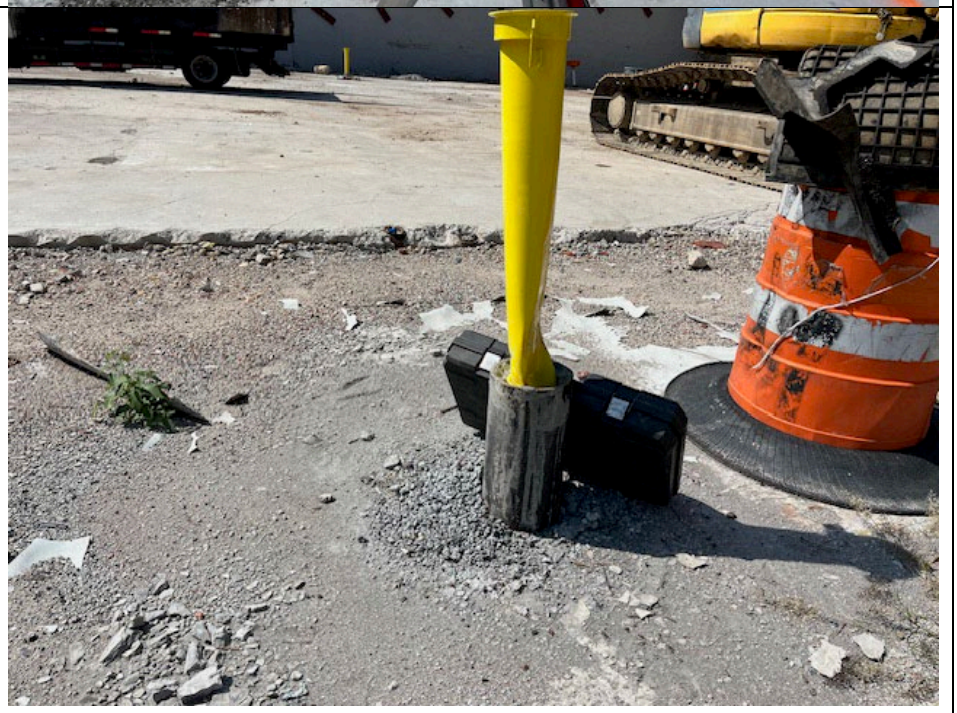
- During concrete breaking activities a natural gas smell was observed emanating from exposed soil and the FDNY and utility services were called. The FDNY investigated the natural gas smell and cleared the Site to resume activity. ConED investigated utility connections to make sure no lines were running to the Site and cleared the Site to resume activity
- Prior to the start of work, MW-10 was observed to be damaged above the steel casing.

Photo 4: View of damaged MW-10 observed prior to the start of work

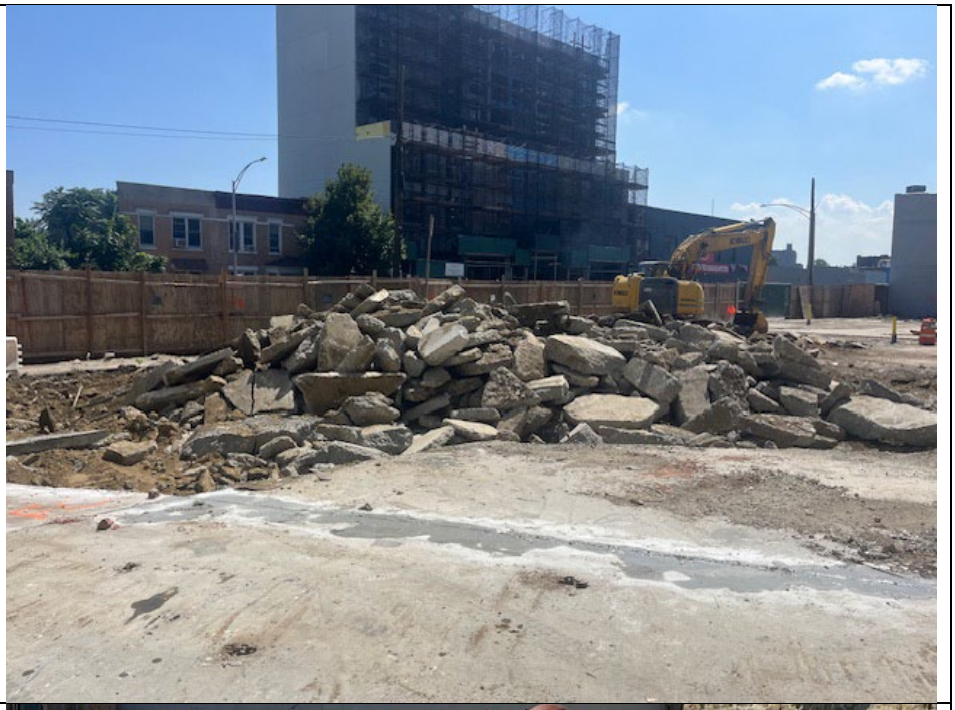
Photo 3: View of broken up concrete in Grid B

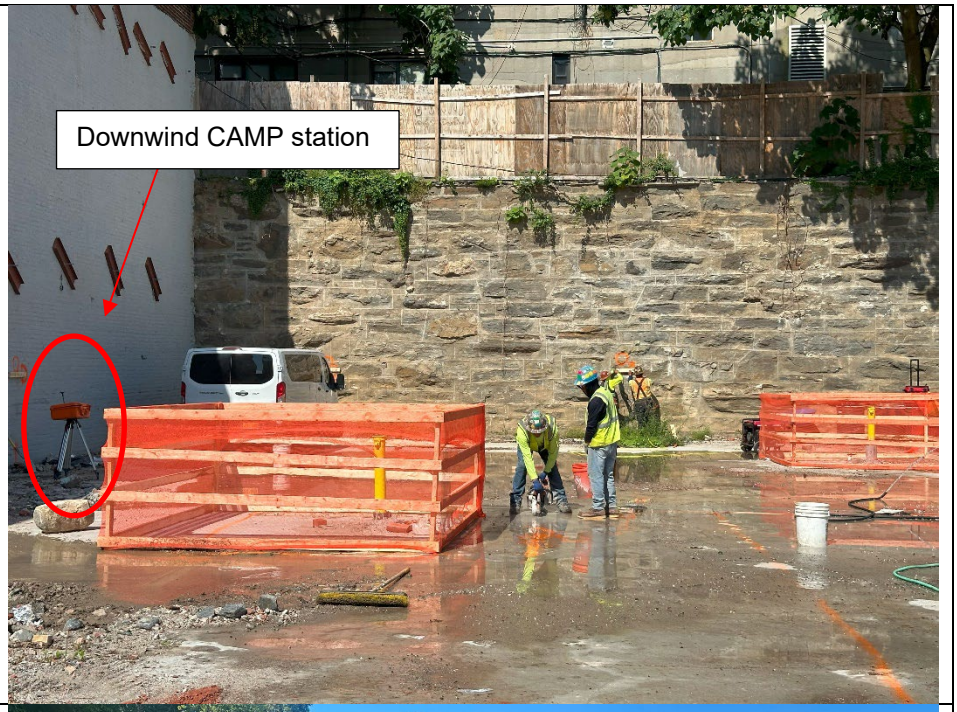
Photo 3: Workers saw cutting the concrete slab using water to suppress dust, downwind CAMP station in view.

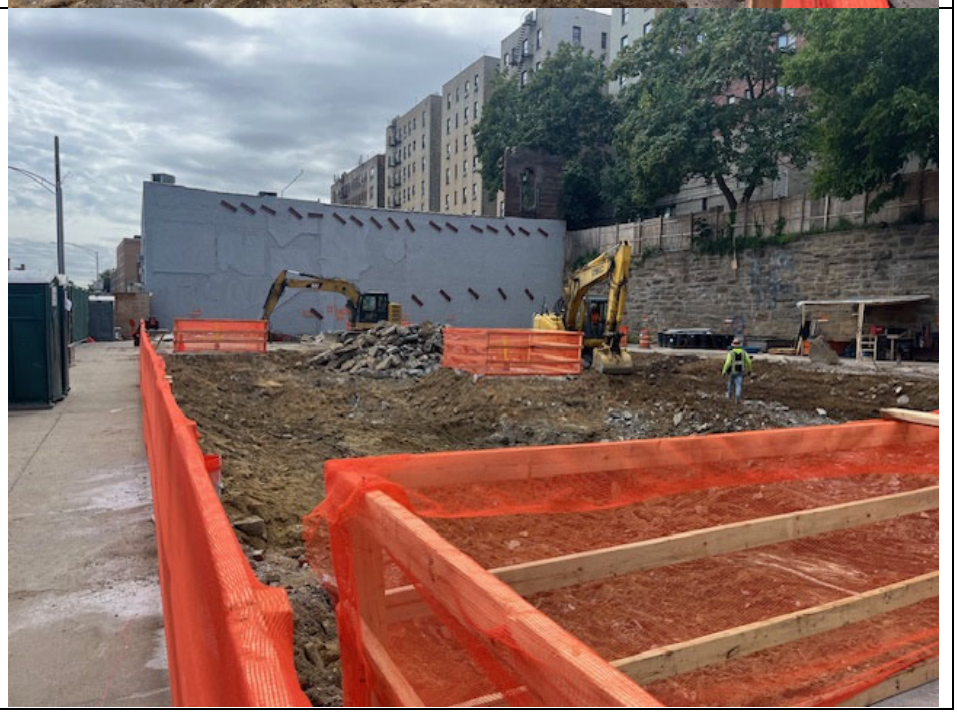
Photo 3: View of worker wetting down area	
Photo 4: View of site at the end of the work day, looking south.
