Periodic Review Report

June 17, 2025 – June 16, 2026

Former Columbia Smelting a.k.a Red Hook Recreation Area Ball Fields 5-8 and Ball Field 9

TRC Engineers, Inc.
1407 Broadway, Suite 3301
New York, New York 10018

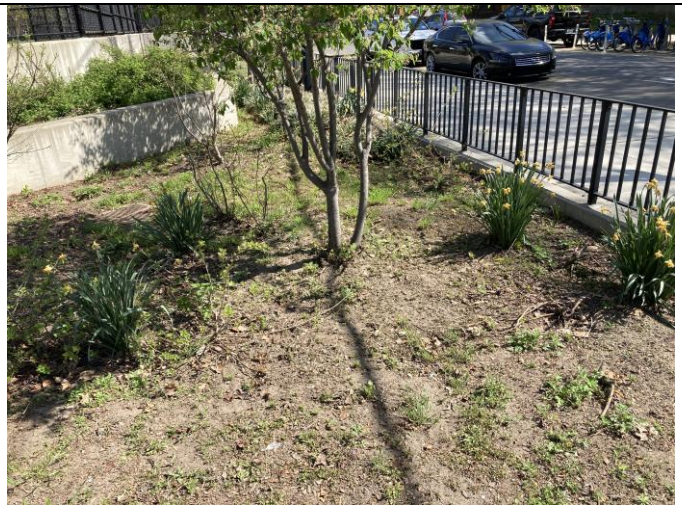
Photo 6: Additional mulch and grasses needed at Bioswale Area along Henry Street.

Photo 7: Additional mulch needed at Planting Area along Henry Street.

Photo 8: Additional mulch needed at Planting Area along Bay Street.

- Sufficient mulch and vegetation should be added to the Site planting beds, bioswales, and tree area noted during the April 2026 site inspection. TRC notes mulch restoration is ongoing and plantings are planned for Fall 2026. In accordance with the as-built drawings provided in **Appendix C** of this report, the mulch layer atop the planting beds and tree area of the Site should be 3 inches thick. In addition to mulch, vegetation is required within the bioswale areas.

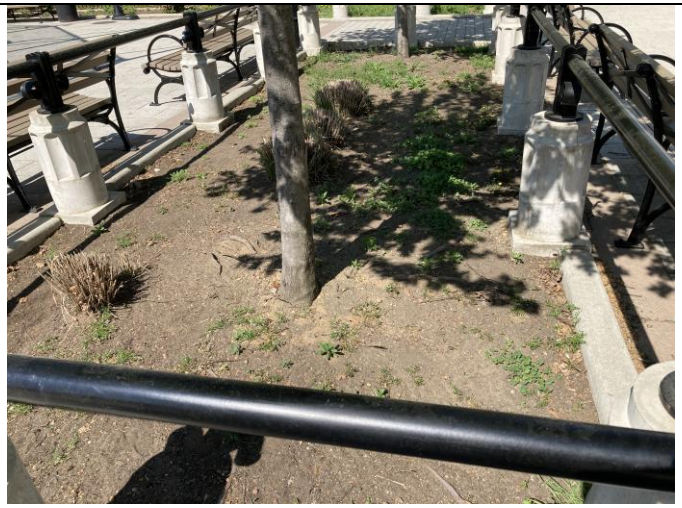
Photo 13: Additional mulch needed at Planting Area along Bay Street (Ballfield 9 Area).

Photo 14: Additional mulch needed at Planting Area along Bay Street (Ballfield 9 Area).

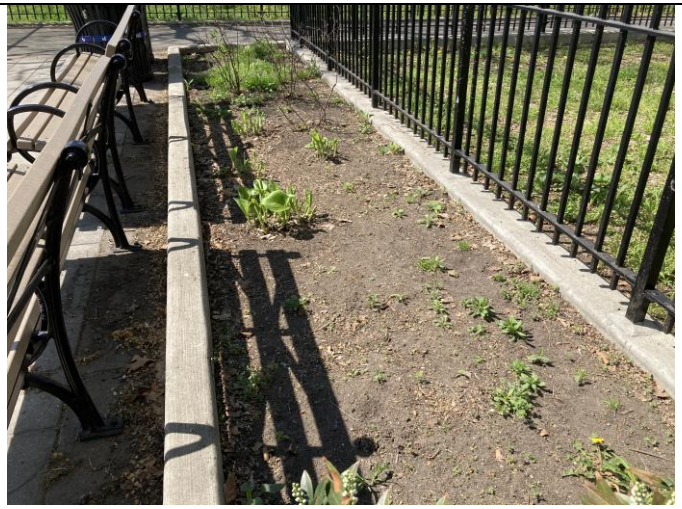
Photo 15: Additional mulch needed at Planting Area along Ballfield 9 Area.

Photo 16: Additional mulch needed at Planting Area along Ballfield 9 Area.

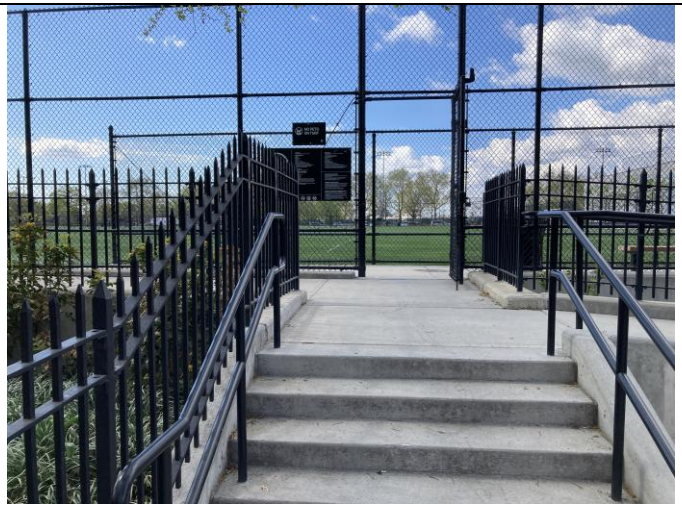
Photo 17: Inspection of paved area adjacent to Ball Field 5-8 site.

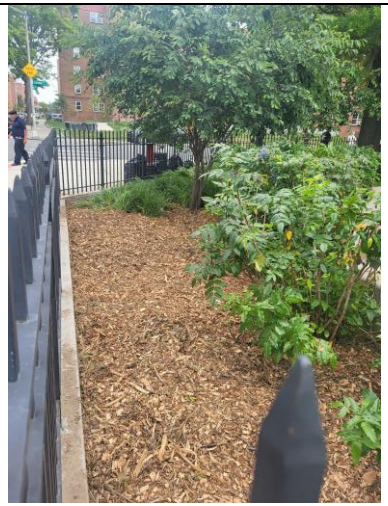
Photo 3: Additional mulch installed at bare area at corner of Hicks Street and Lorraine Street.

Photo 4: Additional mulch installed at bare area at corner of Hicks Street and Lorraine Street.

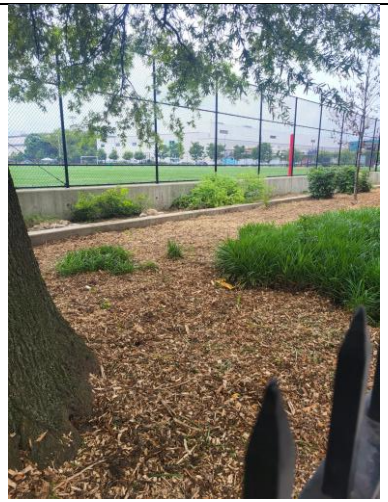
Photo 5: Additional mulch installed at bare area along Lorraine Street.

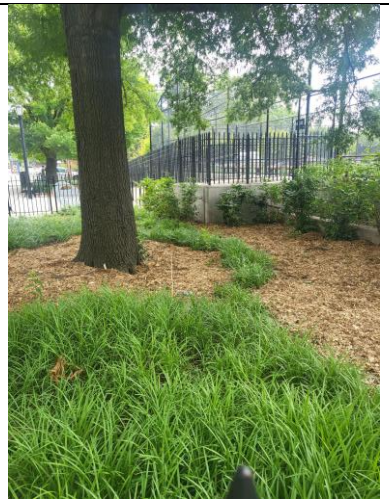
Photo 6: Additional mulch installed at bare area along Lorraine Street.

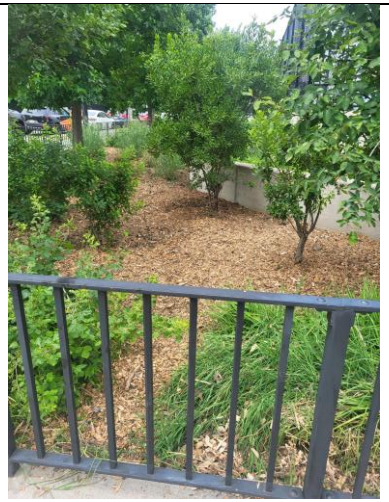
Photo 7: Additional mulch installed at bare area at corner of Henry Street and Lorraine Street.
