APPENDIX D

Laboratory Data Packages - Soil Vapor

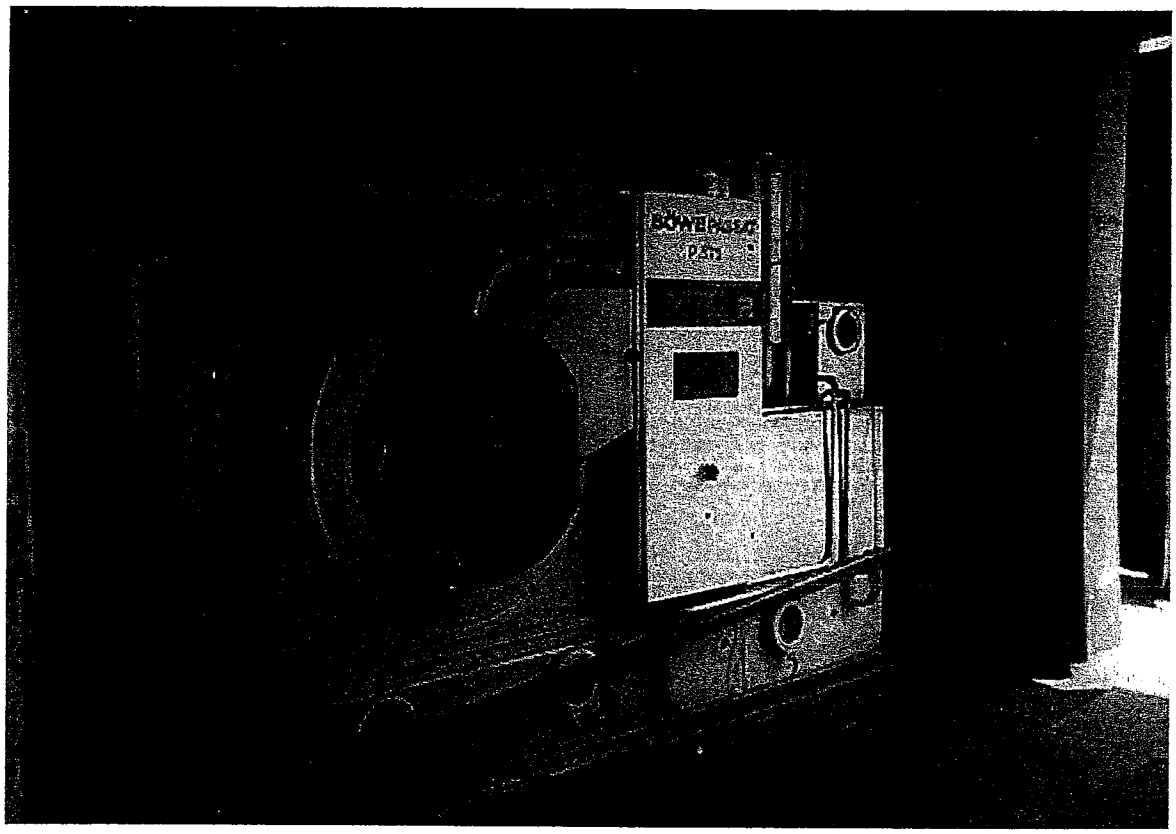
Boiler Room

Inactive Dry-cleaning equipment

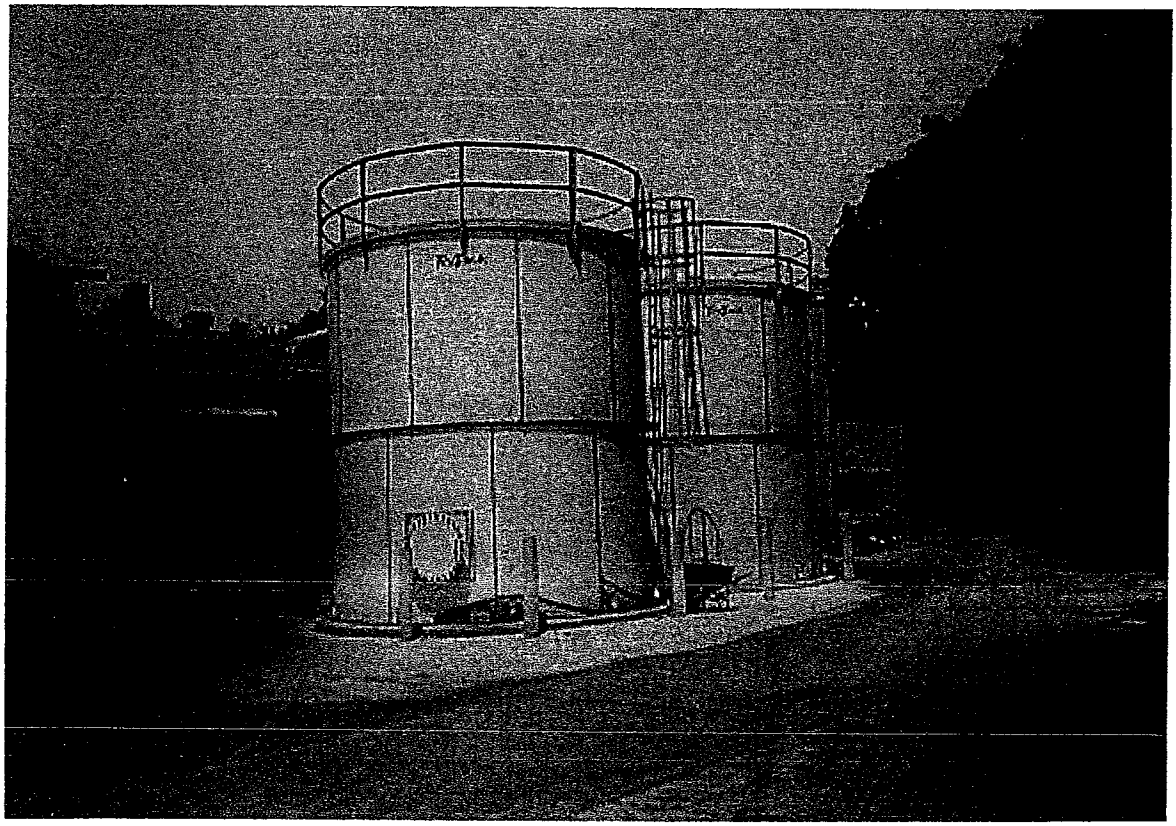
Equalizer tanks on concrete pad

Western parking lot depicting drywell/tank mat
