# Supplemental Remedial Investigation Report

Former NOW Corporation Facility (Site No. 314008)

New York State Department of Environmental Conservation

December 2025

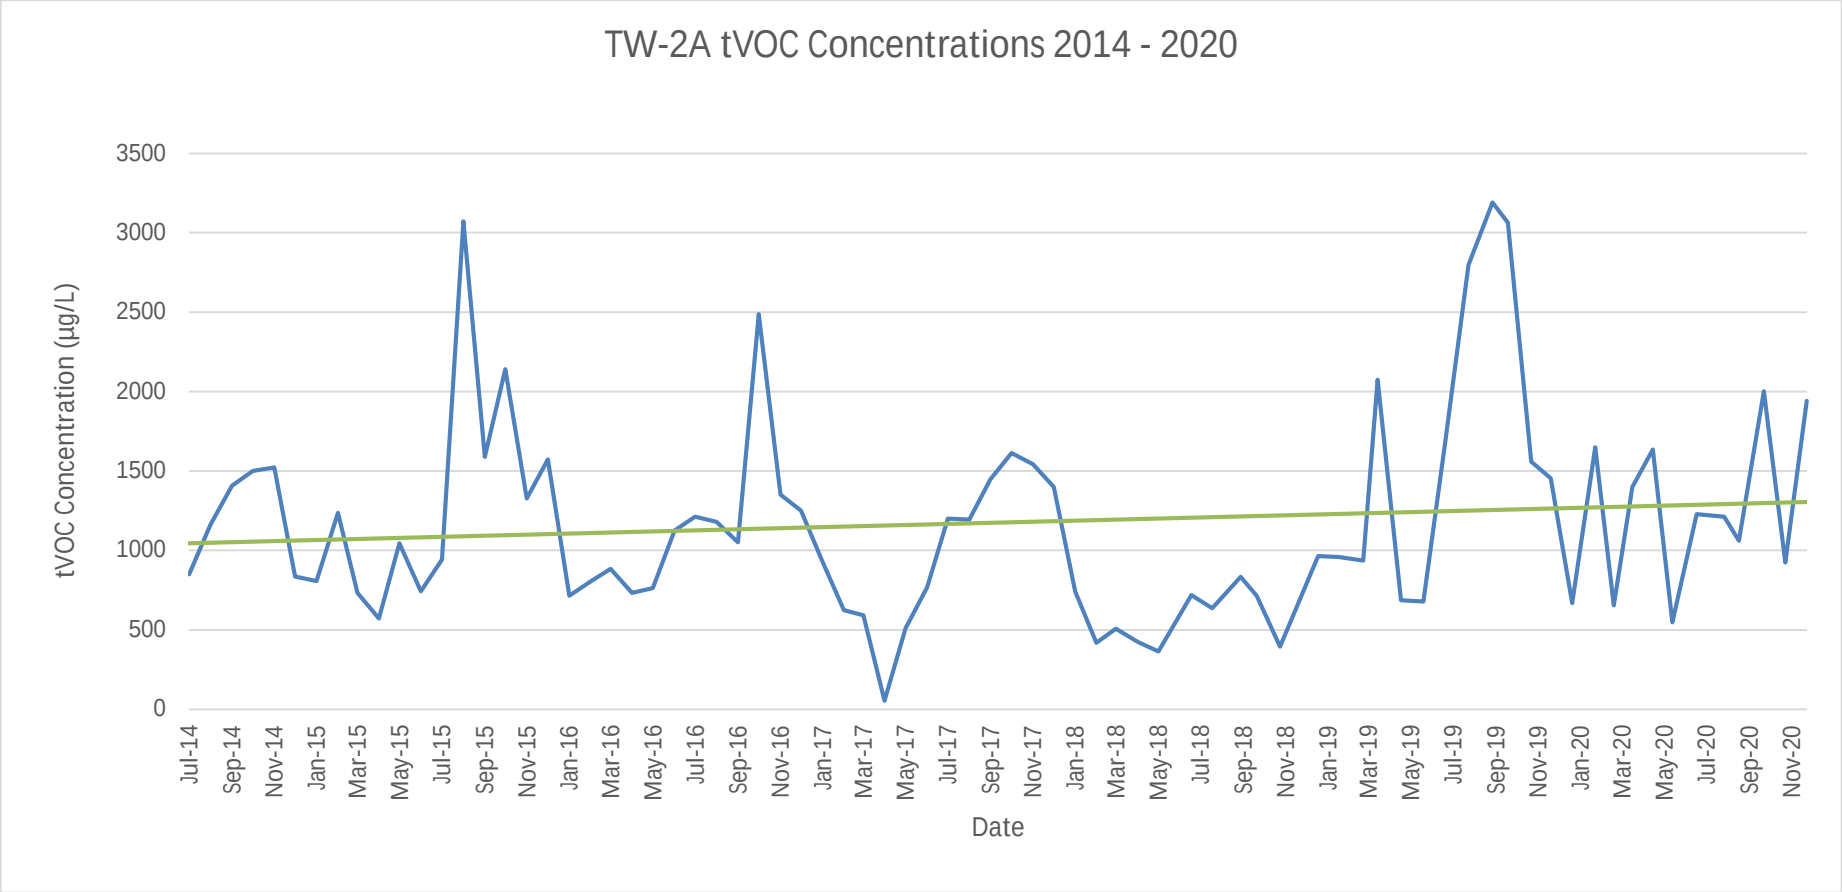
**Figure 3**
**TW-2A tVOC Concentrations**
**Former NOW Corporation Site**
**Site No. 3-14-008**

Several VOC spills are associated with the Site. A RI was previously performed to delineate the extent of the VOC impacts associated with these spills and remedial actions were designed and deployed based on the findings of that RI. After running the groundwater treatment system for over twenty years, it appears that a NAPL source remains on-site that was not delineated in the RI. An un-delineated NAPL source is inferred by high concentrations of 1,1,1-TCA found in TW-2A, which remained relatively stable for the last six years of operation. TW-2A total VOC (tVOC) concentrations from 2014 through November 2020 are plotted on **Figure 3**.

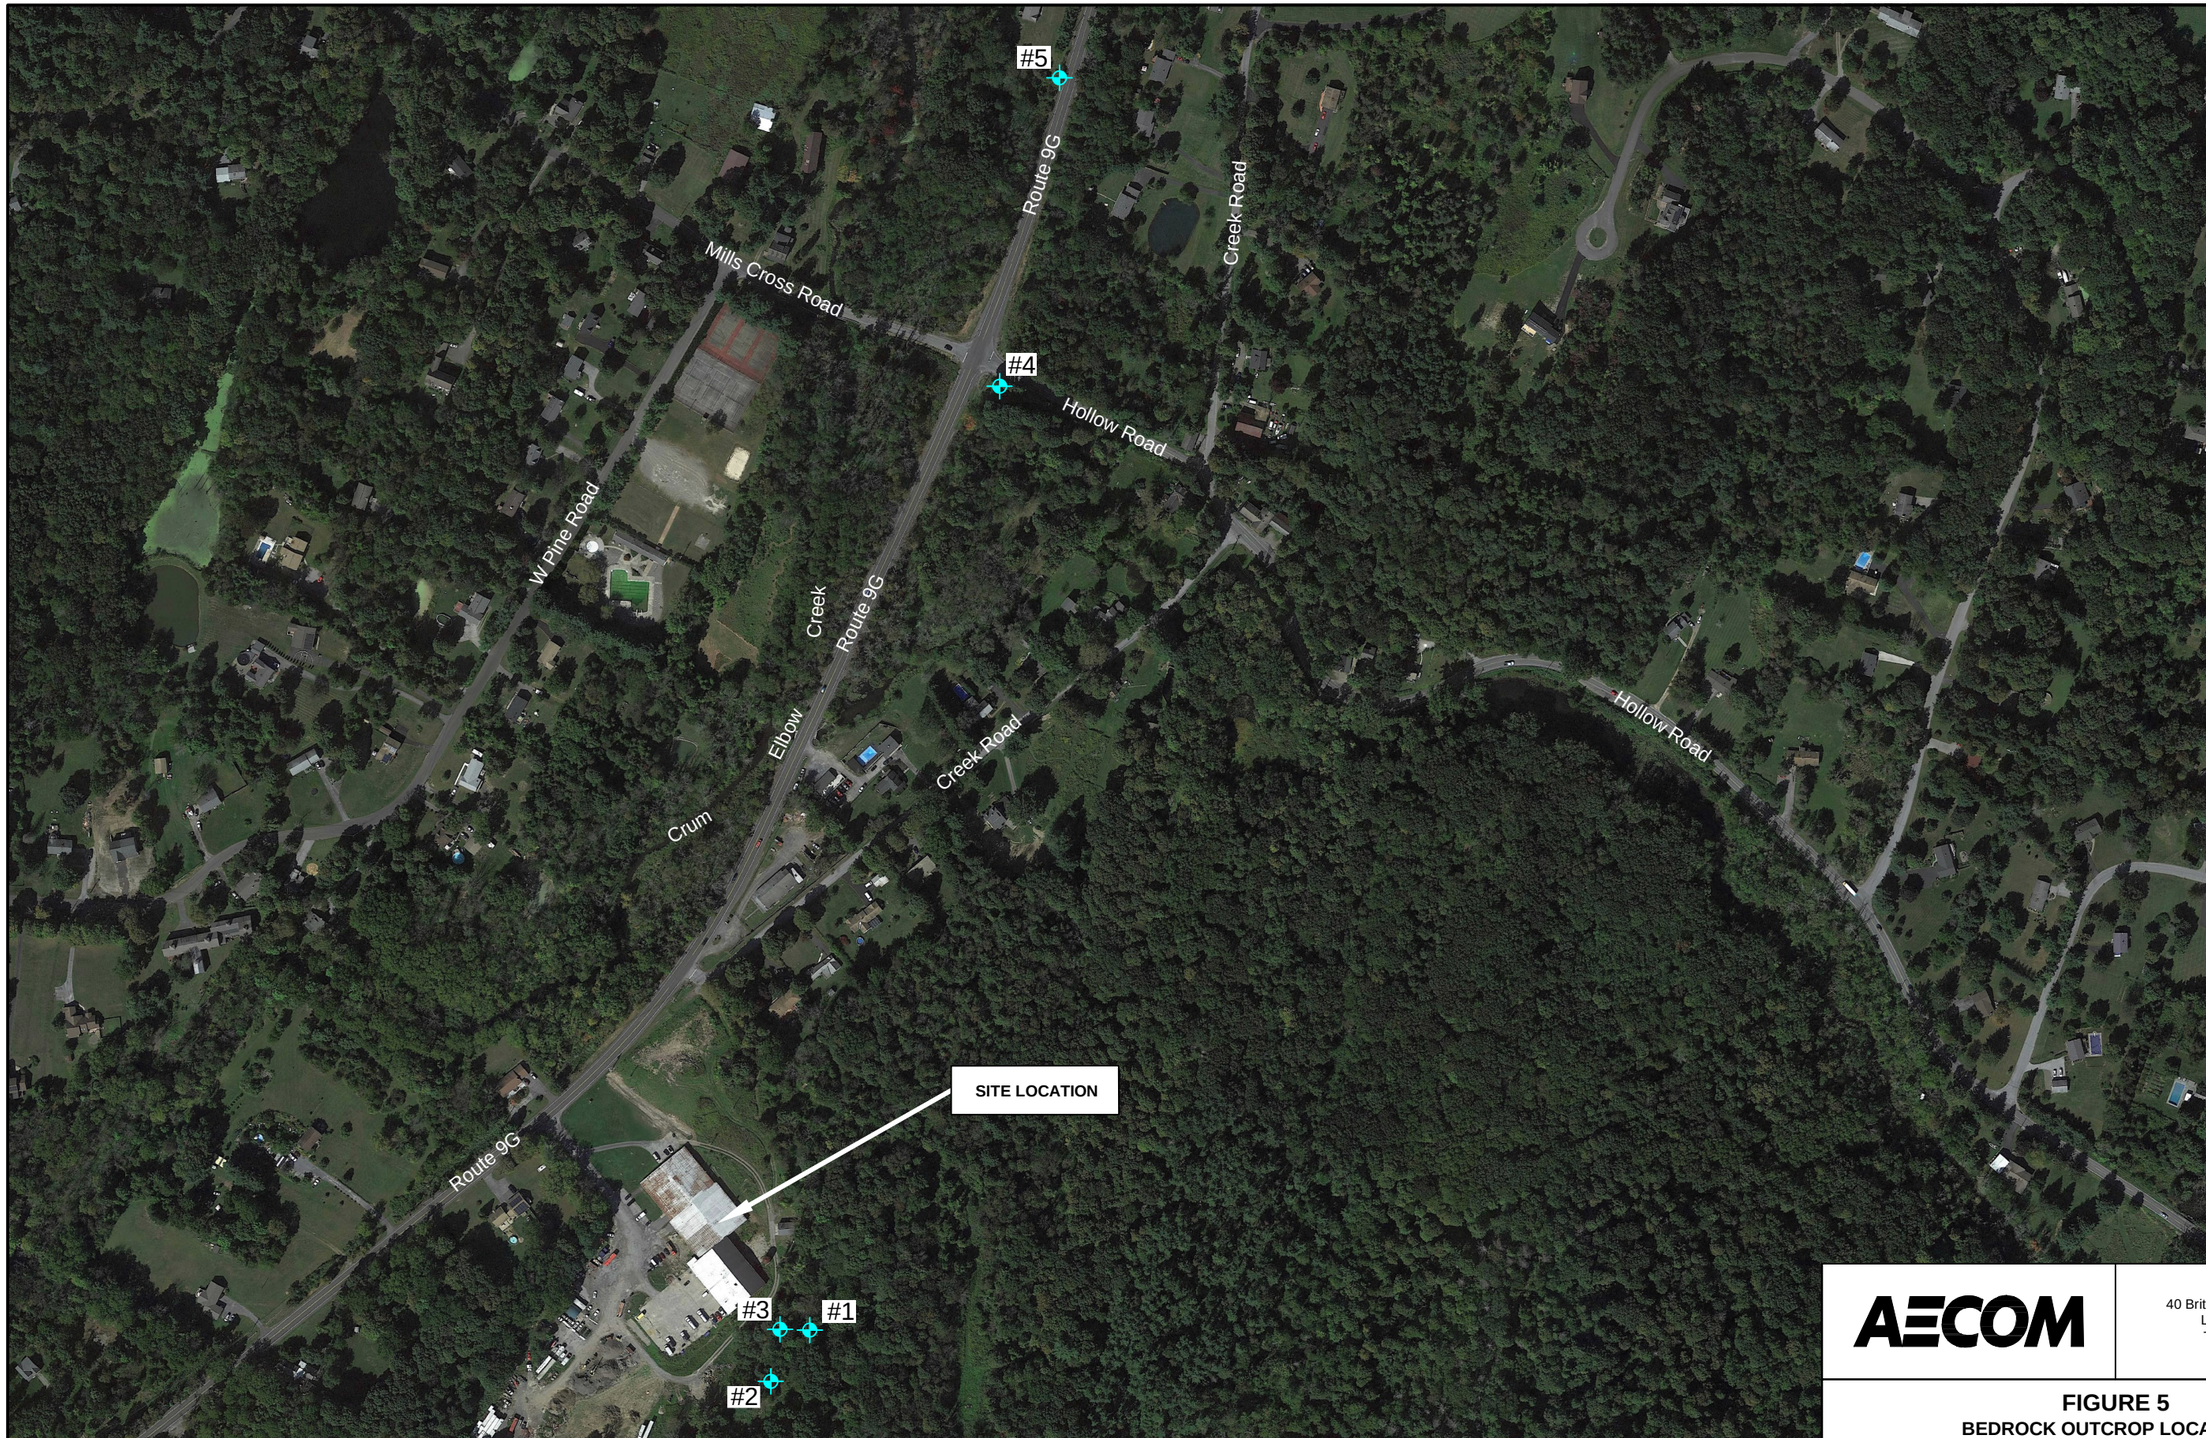
**FIGURE 5**
**BEDROCK OUTCROP LOCATIONS**

AECOM conducted a site walk on September 5, 2024 to locate bedrock outcrops on and adjacent to the Site. On September 23, 2024, AECOM mobilized to the Site and collected structural trend data in the form of strike and dip measurements from five identified outcrops. Outcrops #1, #2 and #3 are located on the Site property while outcrops #4 and #5 are located off-site. On-site bedrock outcrop bedding planes had strikes ranging from 4° to 30° (north to north-northeast) and dip magnitudes ranging from 56° to 68°. Off-site outcrops had bedding plane strikes ranging from 4° to 185°. The bedding interface measured to have a strike of 185° was taken from a road cut and displayed signs of possibly being altered during the road cut's construction; therefore, this measurement's accuracy is questionable. Removing the 185° bedding plane, the off-site bedding planes had strikes ranging from 4° to 17° and dips ranging from 76° to 85°. A summary of the bedrock outcrop mapping data is displayed in **Table 1**, while mapped bedrock locations are displayed on **Figure 5** and strike/dip measurements are shown on **Figure 6**.

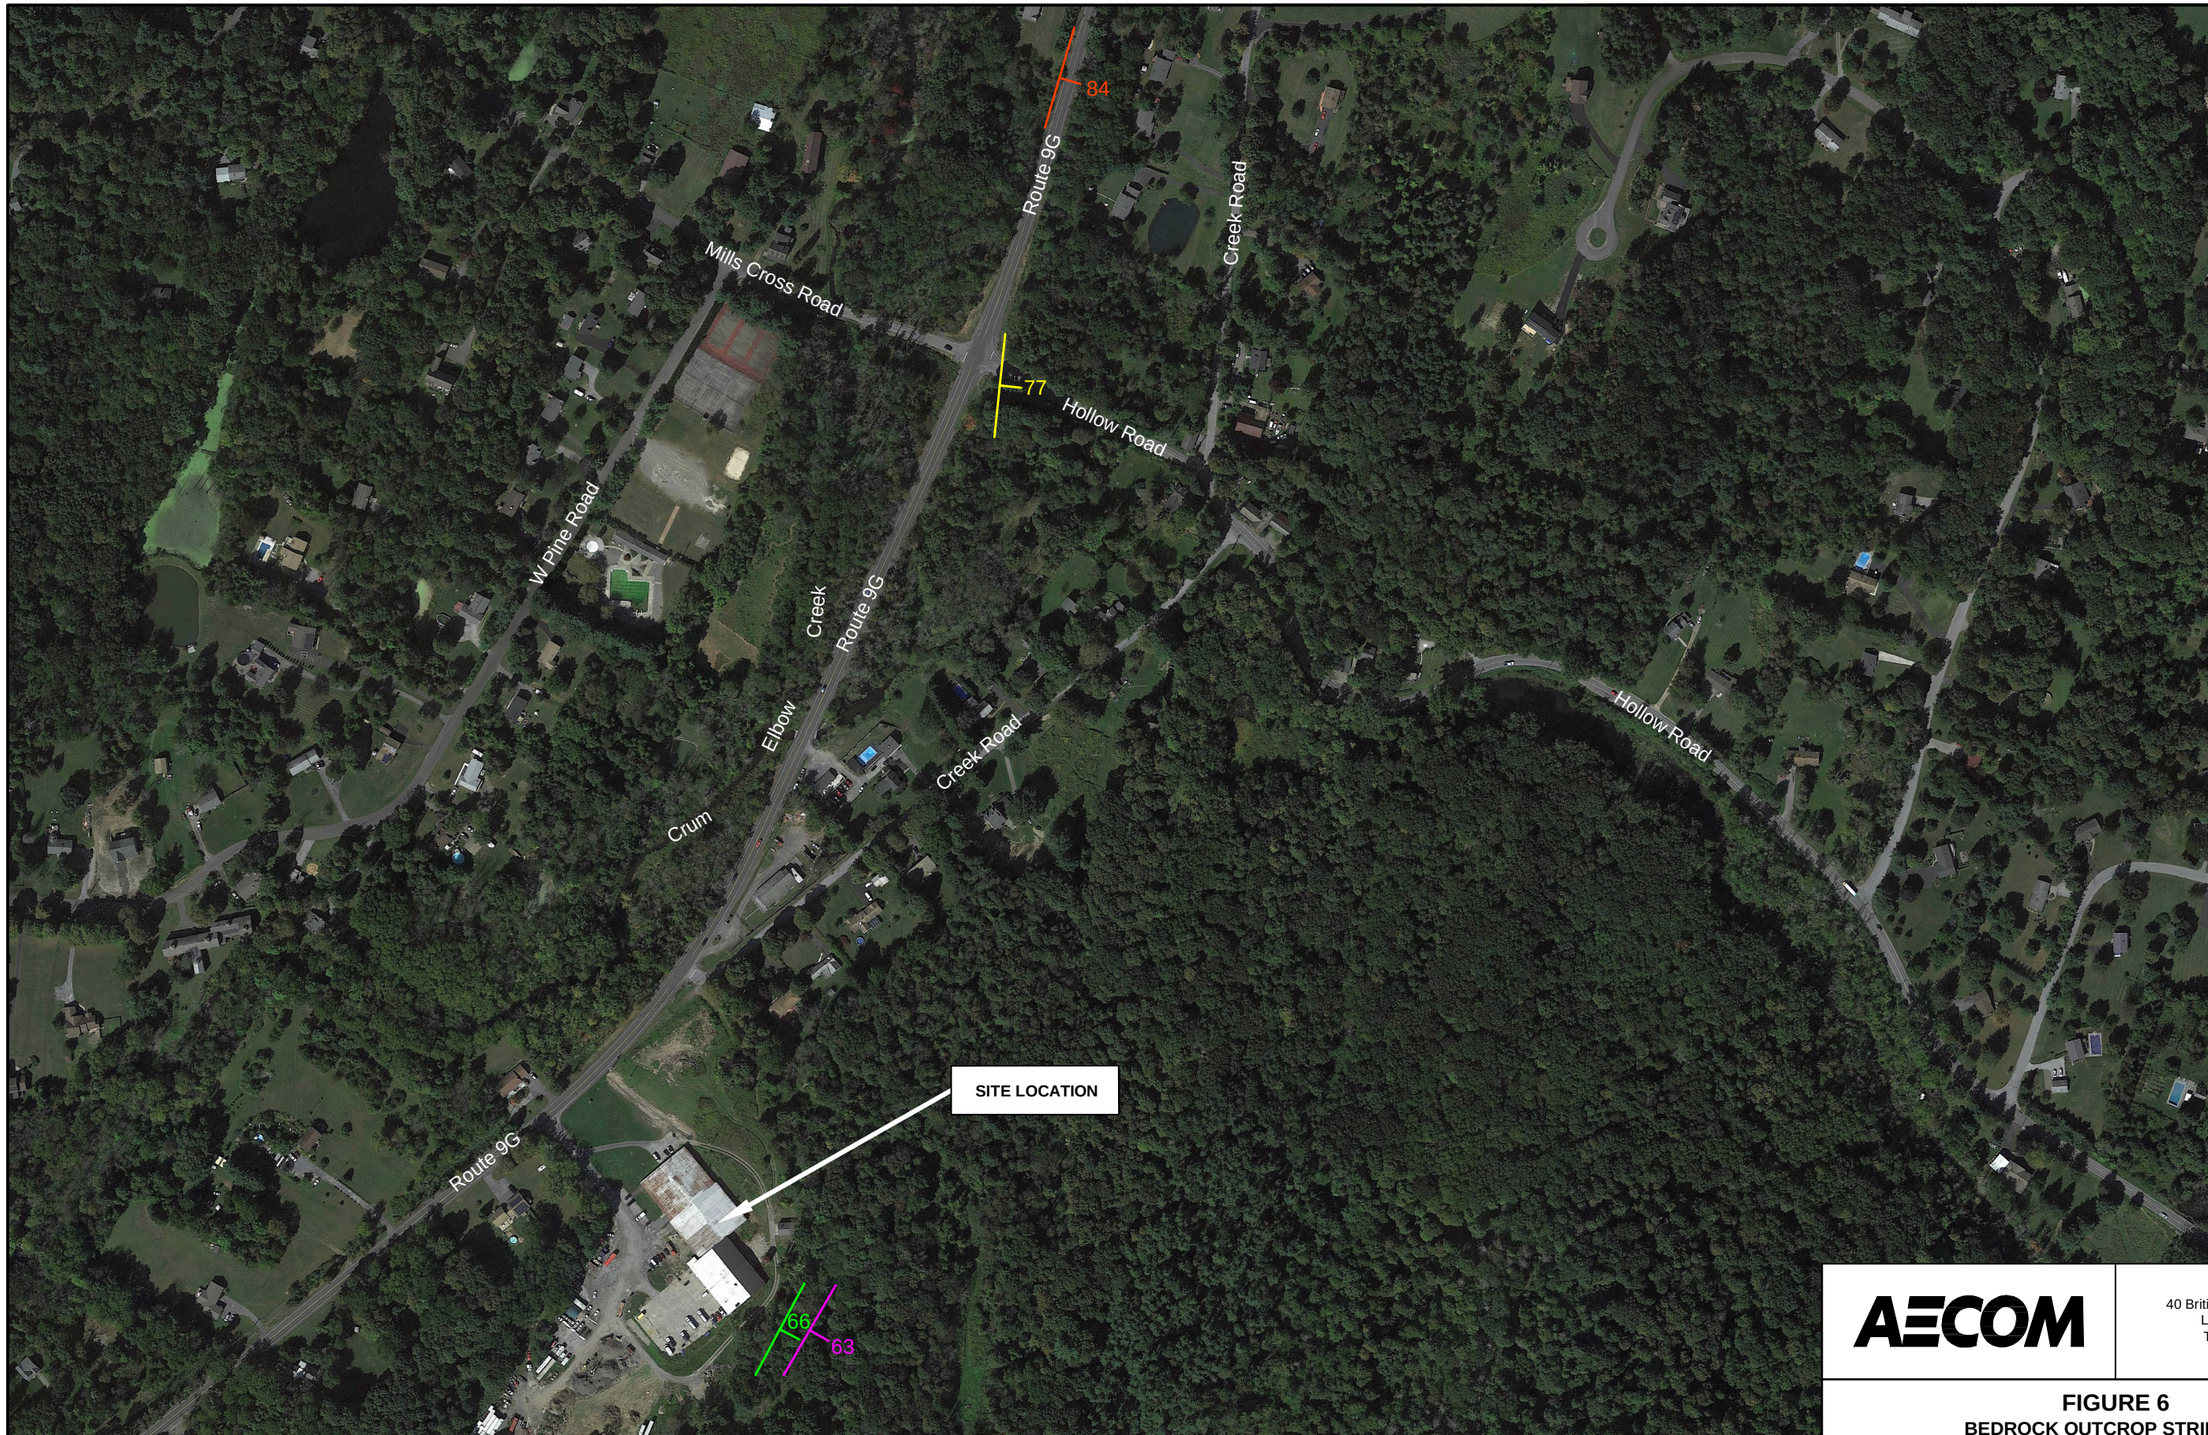
**FIGURE 6**
**BEDROCK OUTCROP STRIKE/DIP**

was photographed with a measuring rod to provide scale, and it was examined for structural trends. Planar features (bedding planes, fractures, faults) identified were then measured for their strike and dip with a Brunton pocket transit. Strike and dip measurements, GPS coordinates and other field observations were recorded in a field notebook. The strike and dip measurements are presented on **Figure 6** and in **Table 1**.

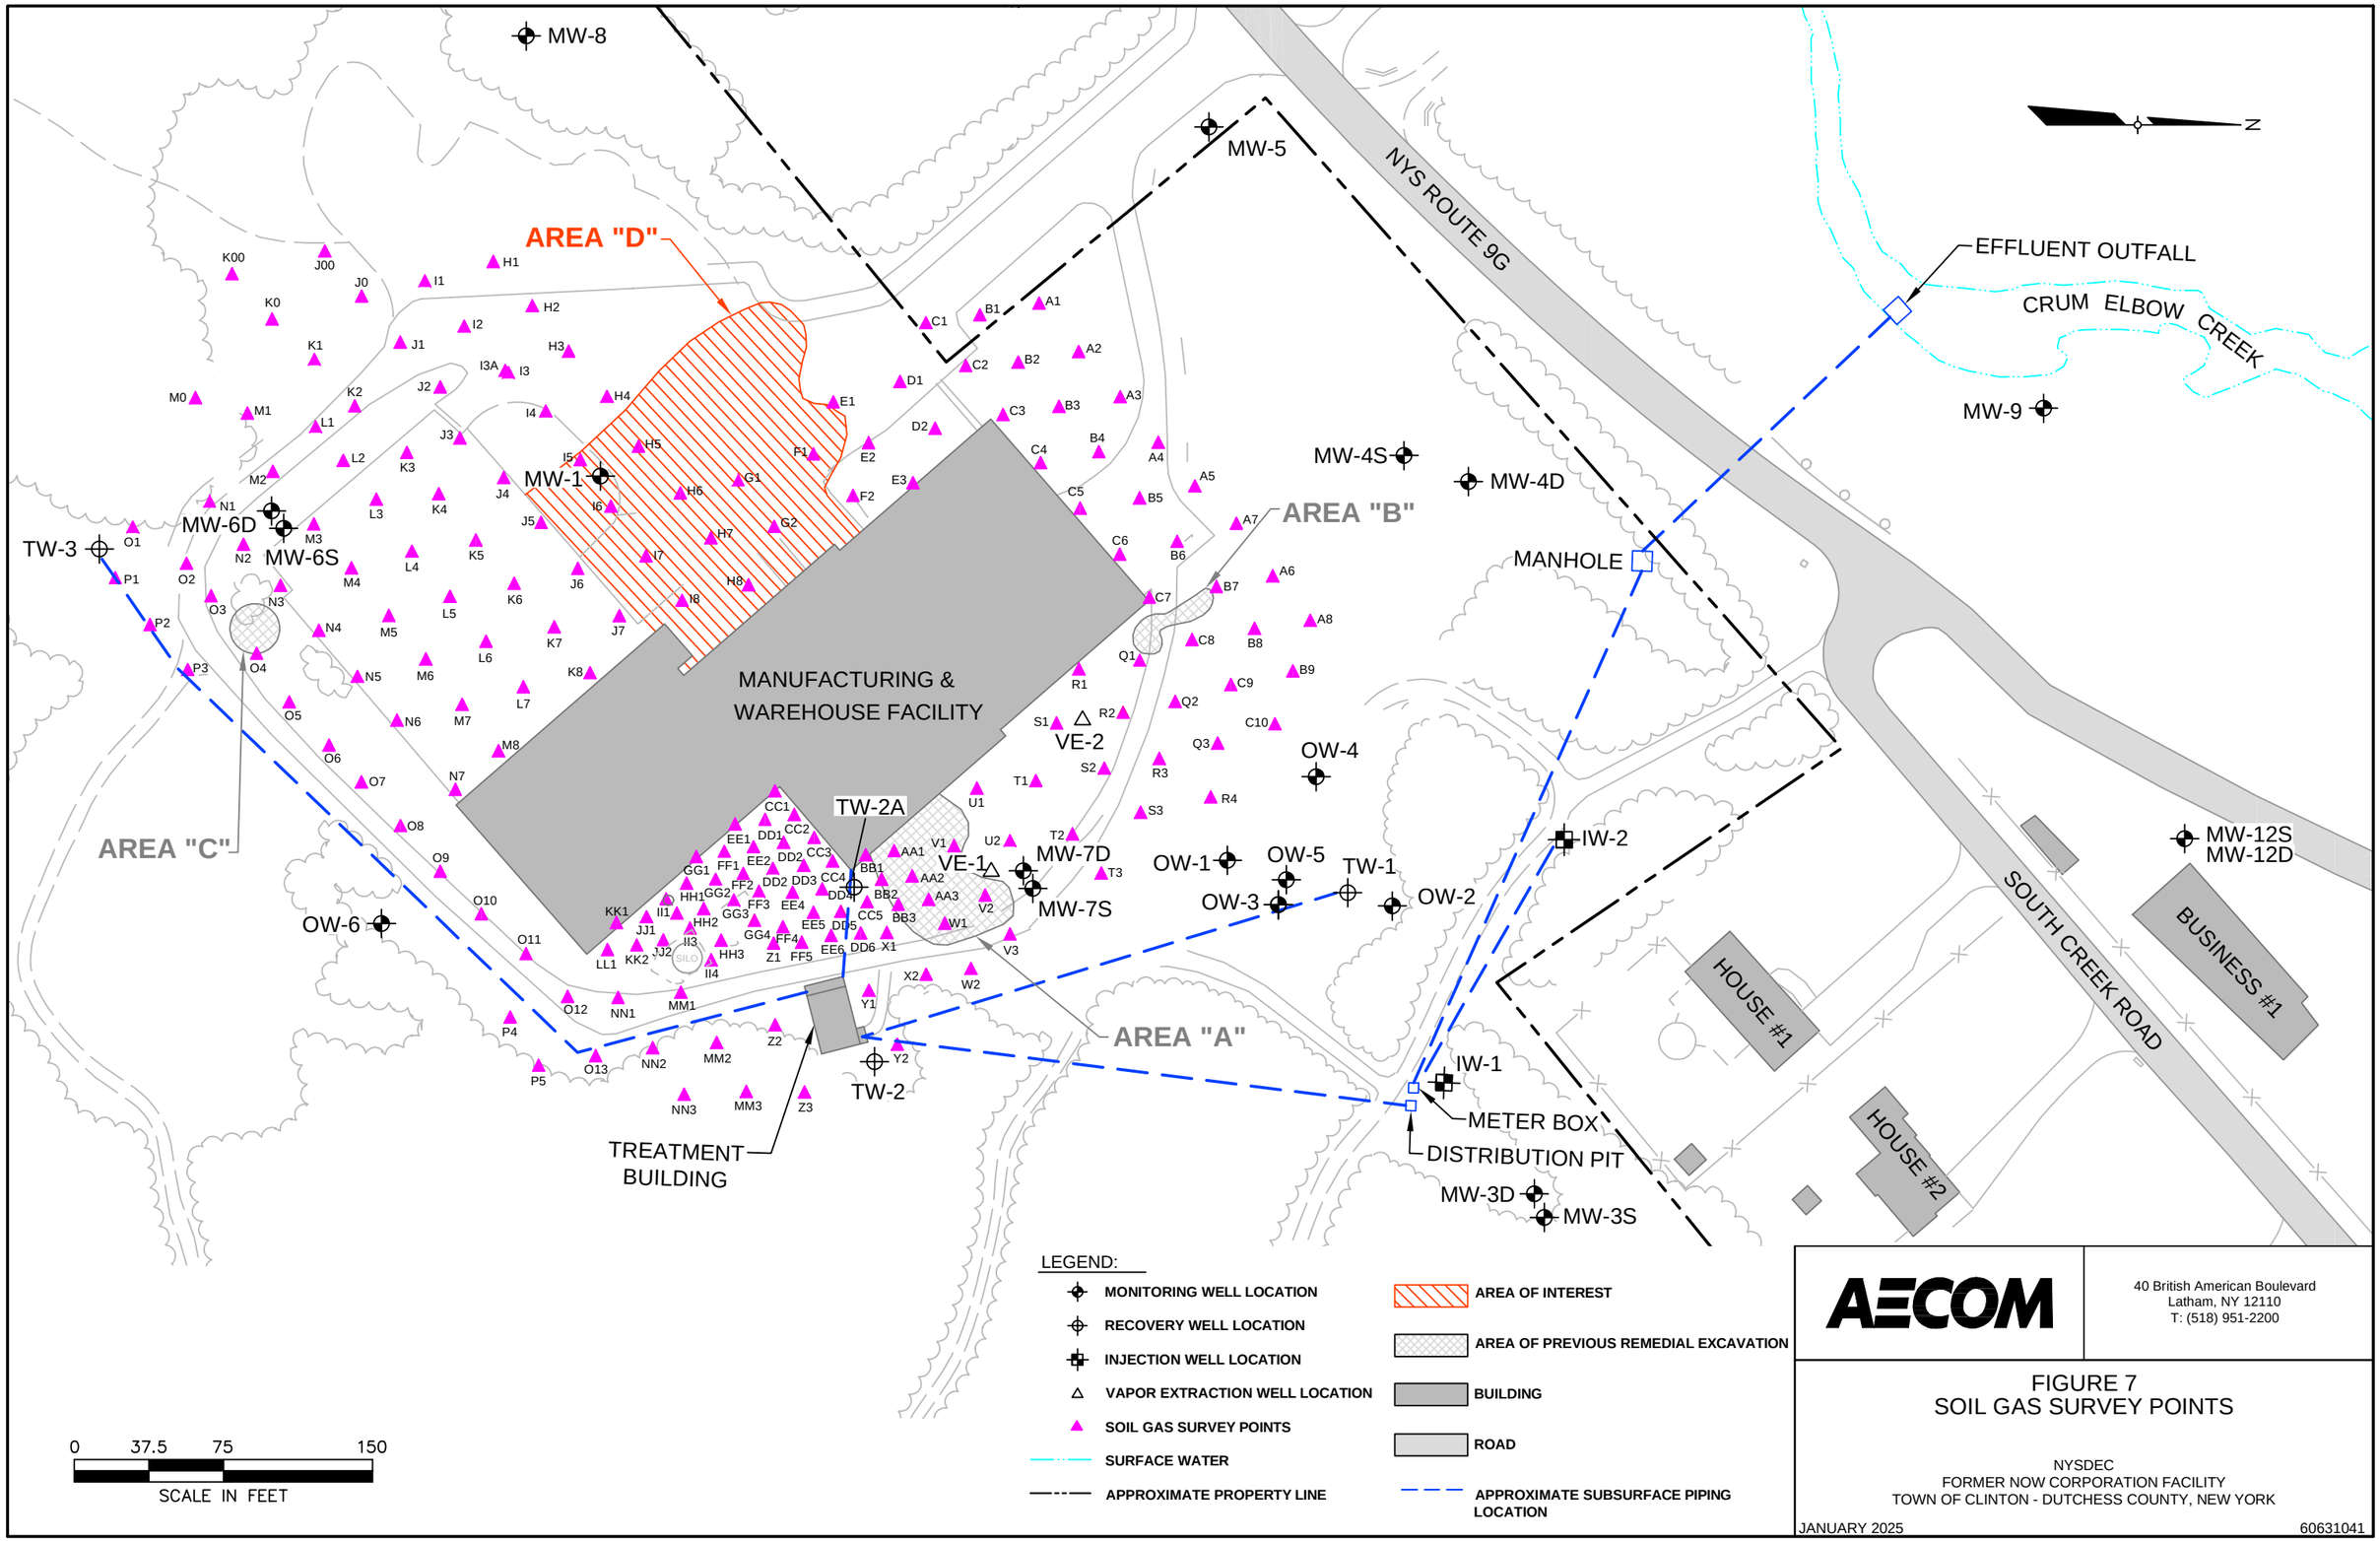
FIGURE 7
SOIL GAS SURVEY POINTS

The soil gas survey was conducted from August 21, 2024 to September 5, 2024. Sampling locations are provided on **Figure 7** and in **Appendix F** (Figure 1). **Appendix F** also contains the laboratory reports including chains of custody and isopleth maps for cis-1,2-DCE, 1,1,1-TCA, and TCE (Figures 2 through 4). The soil gas mass analysis results are presented in **Table 2**.

The data suggests four primary areas of contamination: the western parking area, the southeastern side of the former building slab, the vicinity of TW-2A and the northern ditch. These areas roughly coincide with OU2 soil remediation areas A through D (shown on **Figure 7**). Areas A, B and C were excavated to the top of bedrock and the soil was thermally treated on-site and then used for backfill. Based on the results of the soil gas survey, the excavations failed to encompass all VOC impacts, or the source of the soil gas had penetrated the bedrock and was not removed by excavation. The soil gas screening results in the vicinity of soil remediation Area C indicate that a source of VOCs may still exist in the overburden. Soil gas sampling points N3 and O4 were located adjacent to historical soil remediation Area C. While

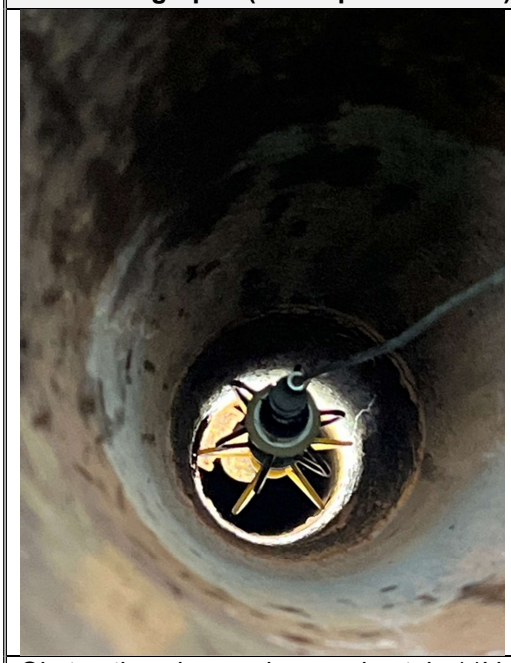
| Site Photographs (Descriptions Below) | |
|---|---|
| Obstruction observed approximately 11' below top of casing in IW-2. | AGS set up at IW-2 in the morning. |

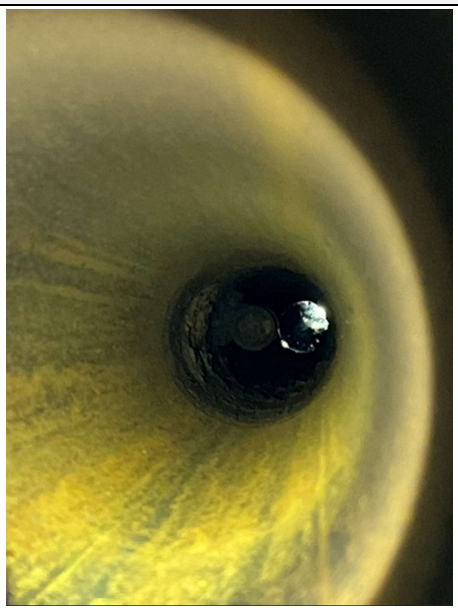
| Site Photographs (Descriptions Below) | |
|---|---|
| Obstruction observed in IW-1. AGS was able to complete three-armed caliper and polyprobe surveys at this location. | AGS preparing equipment for surveys at IW-1. |

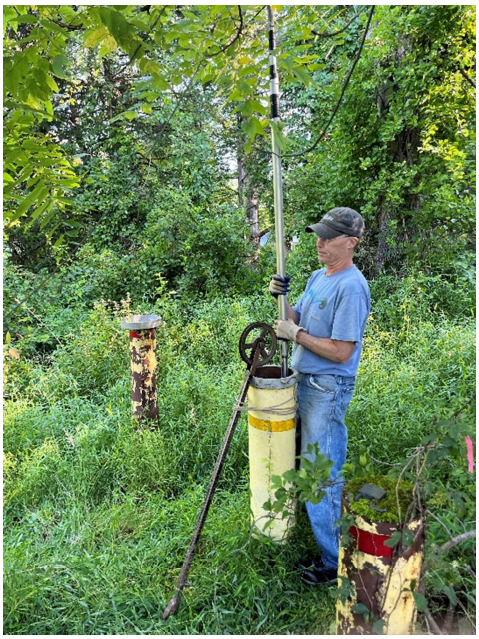
| Site Photographs (Descriptions Below) | |
|---|---|
| AGS employee deploying three-armed caliper in location IW-1. | AGS employee preparing equipment for geophysics work at TW-2A. |

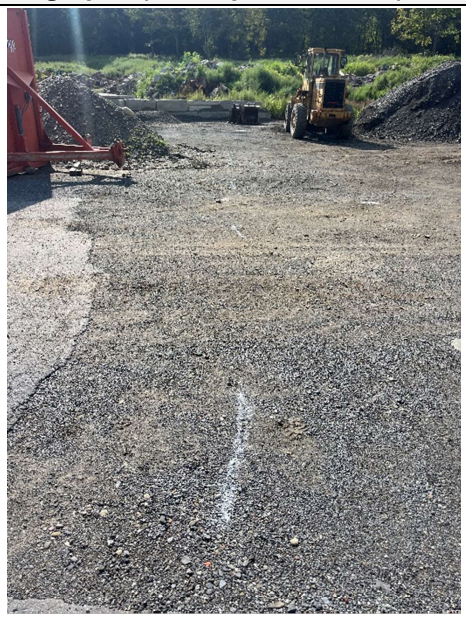
| Site Photographs (Descriptions Below) | |
|---|---|
| Stacked logs on the right side of the photo illustrate potentially inaccessible soil vapor points. | AECOM began marking out proposed soil vapor points with spray paint. |

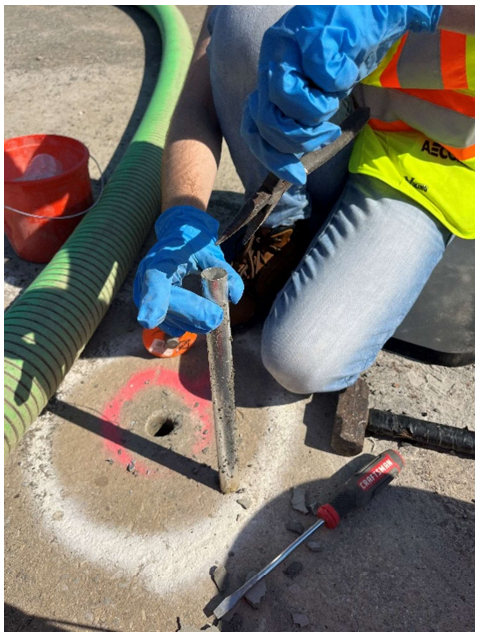
| Site Photographs (Descriptions Below) | |
|---|---|
| Soil gas passive sampling vial broke during retrieval. Vial contents were immediately transferred to a sealed a plastic bag and later transferred to a new vial. | AECOM employees patched all project-related asphalt and concrete disturbances. |

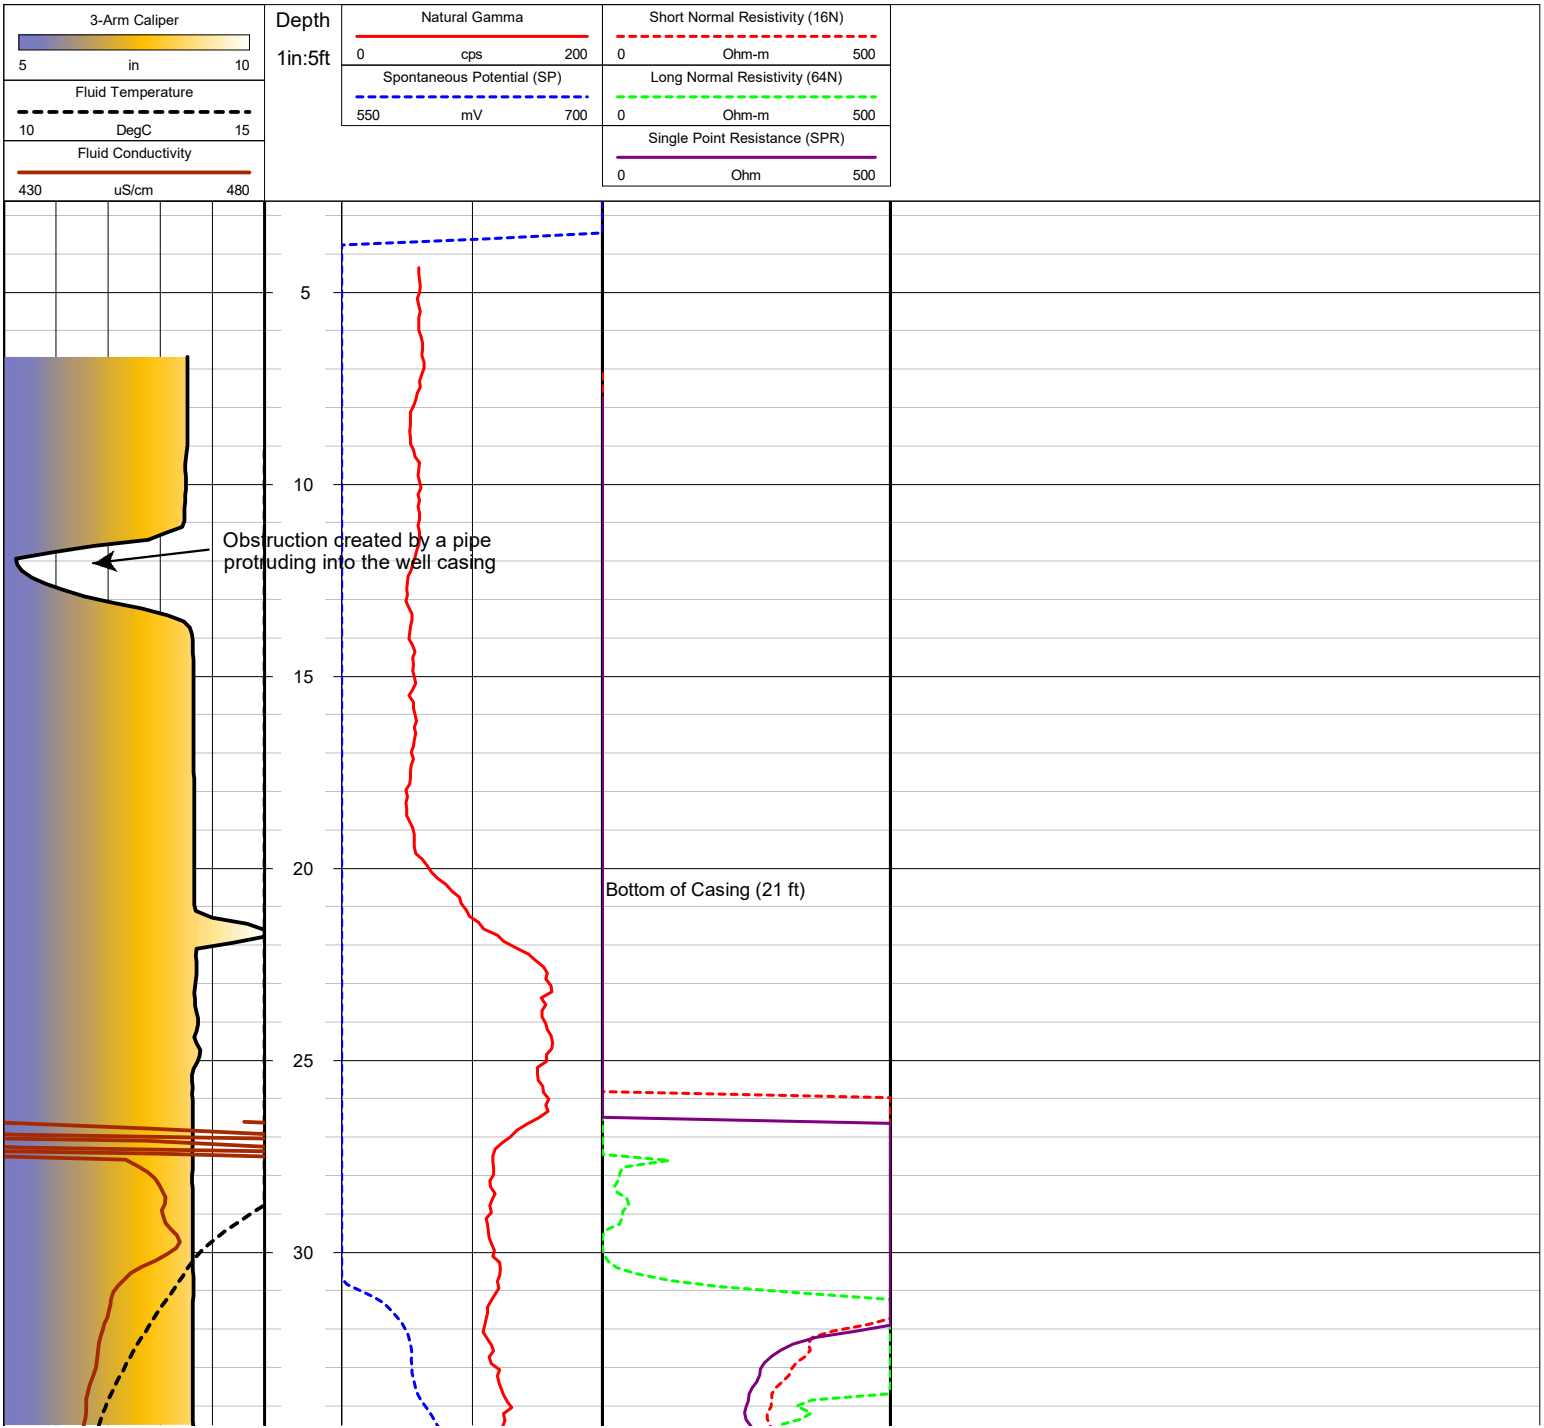
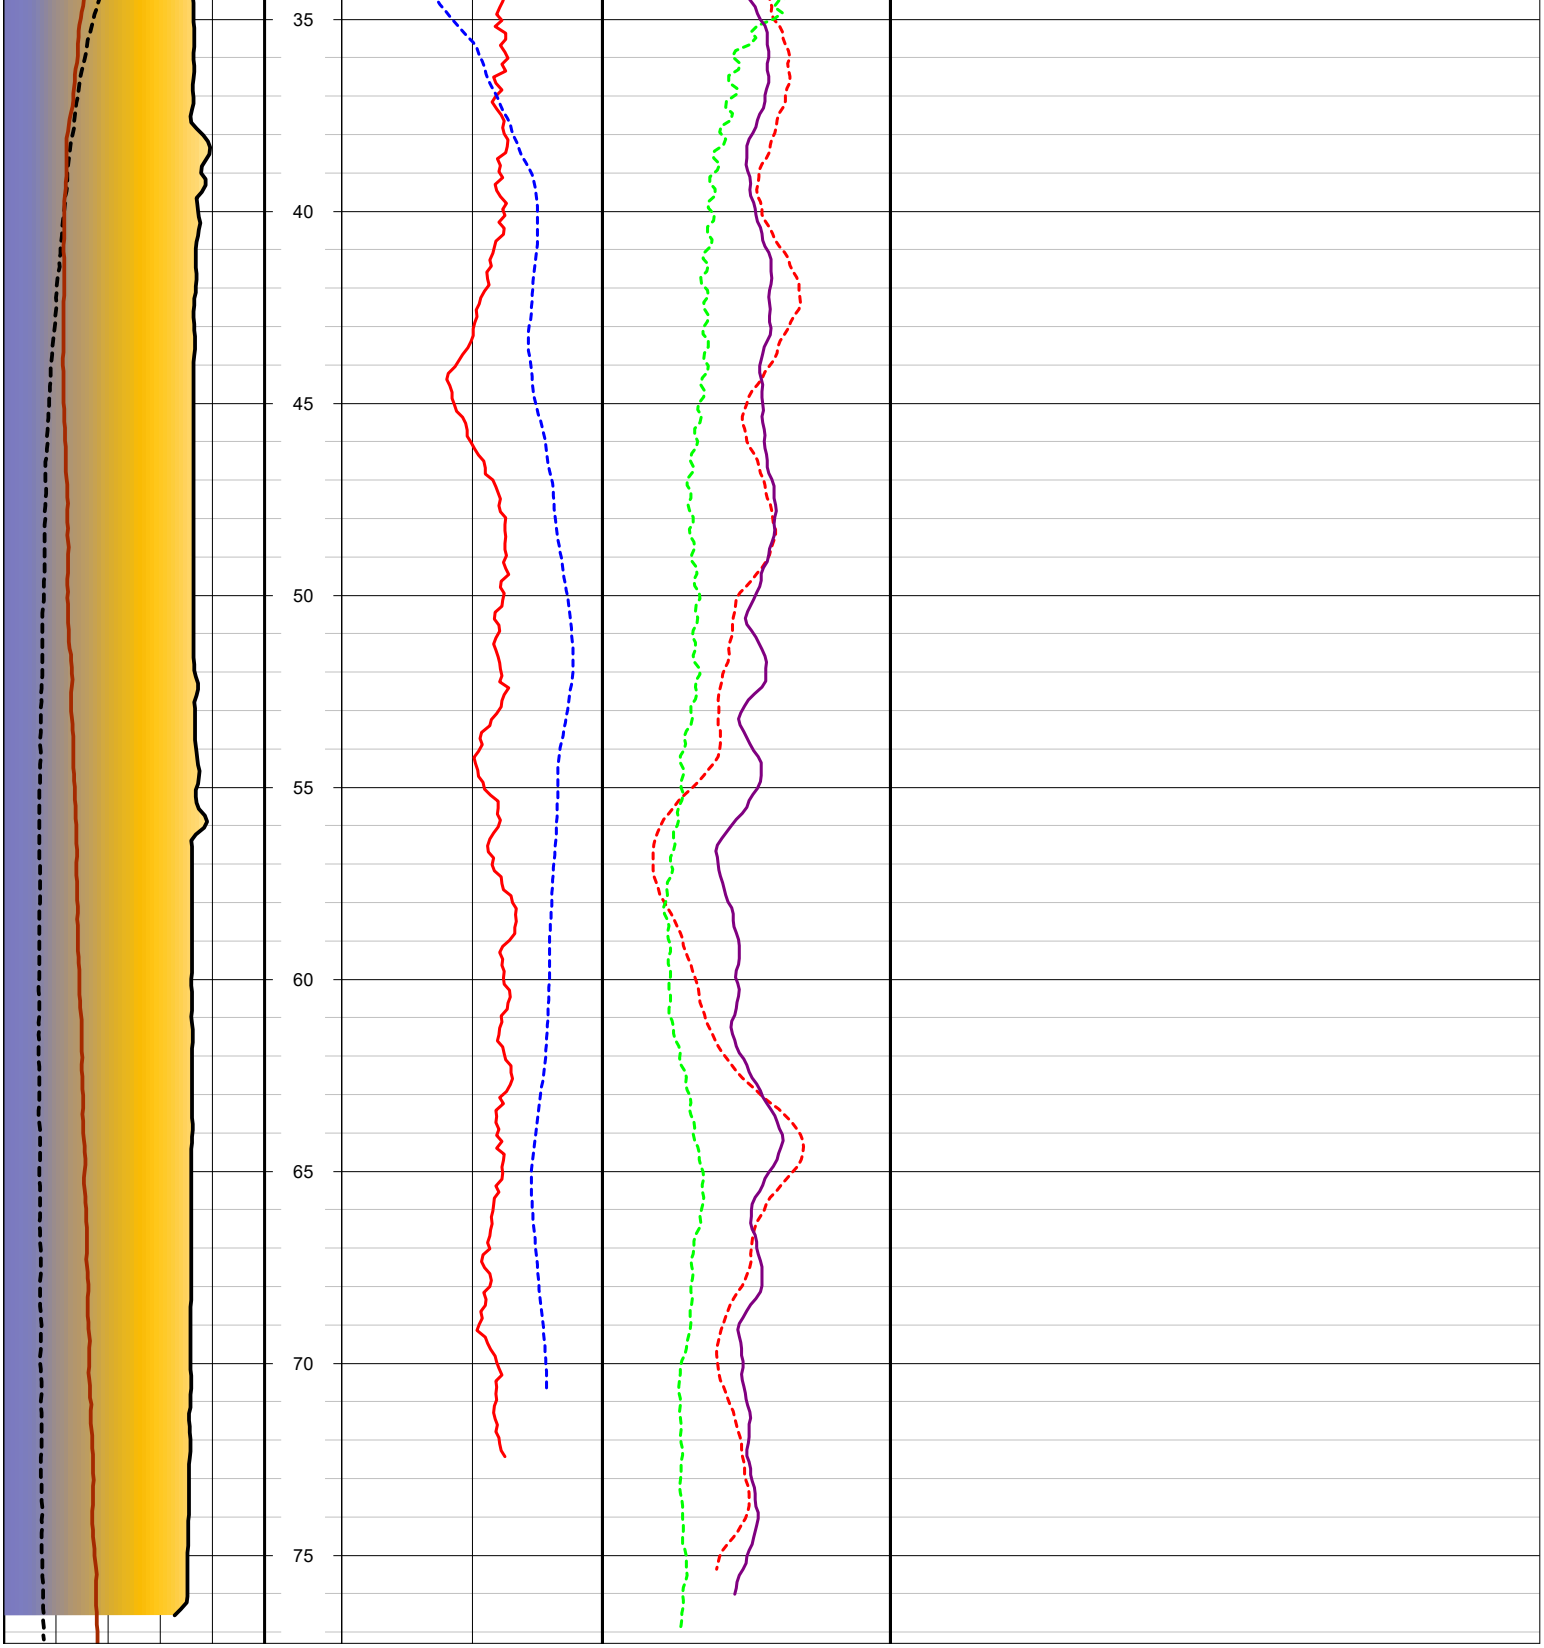
Remarks: Acoustic televiewer, optical televiewer, and heat pulse flowmeter data could not be collected in this well because of a pipe protruding into the cased portion of the well at a depth of 12 feet.

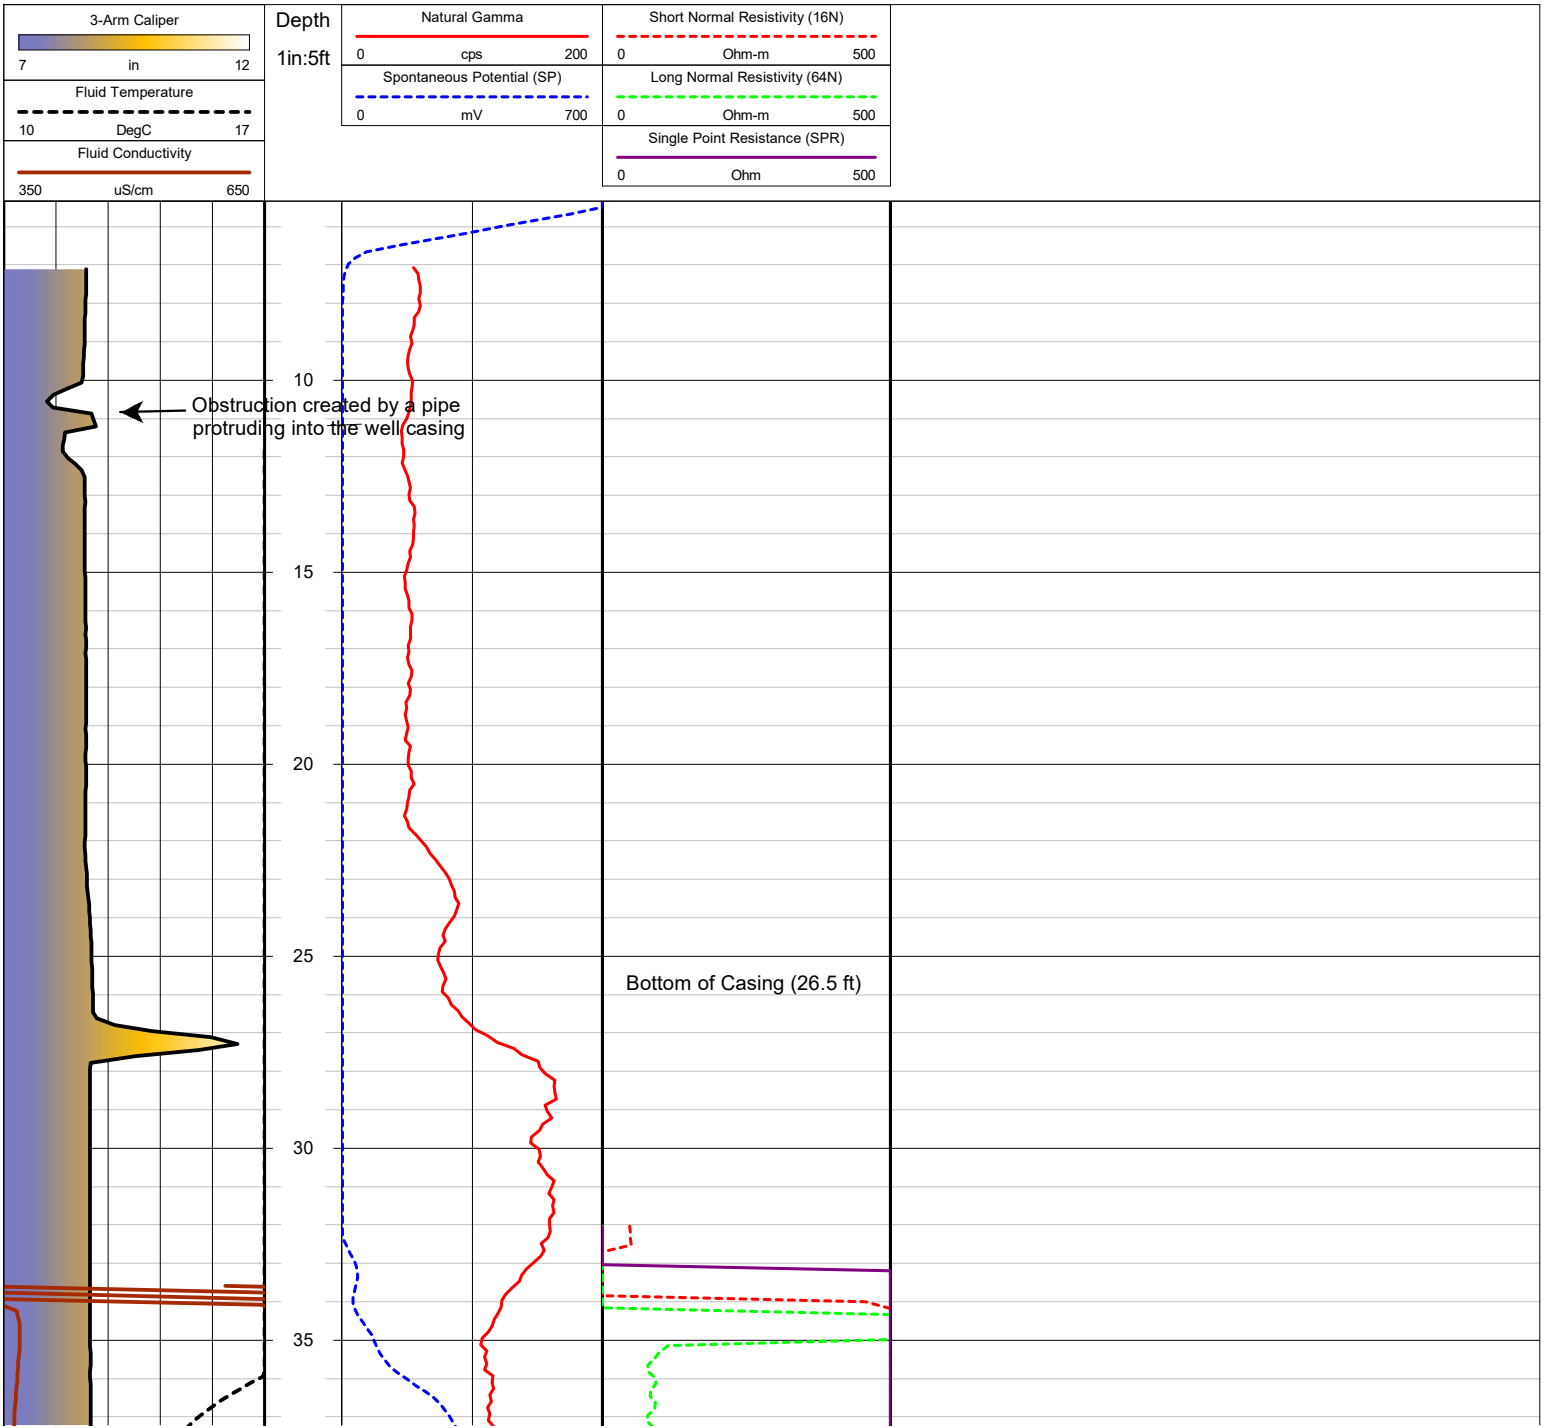
Remarks: Acoustic televiewer, optical televiewer, and heat pulse flowmeter data could not be collected in this well because of a pipe protruding into the cased portion of the well at a depth of 11 feet.
Note that the 3-arm caliper did become jambed by this pipe and required some effort to safely retreive the tool.
